APPENDIX A

ASSESSMENT PROTOCOL

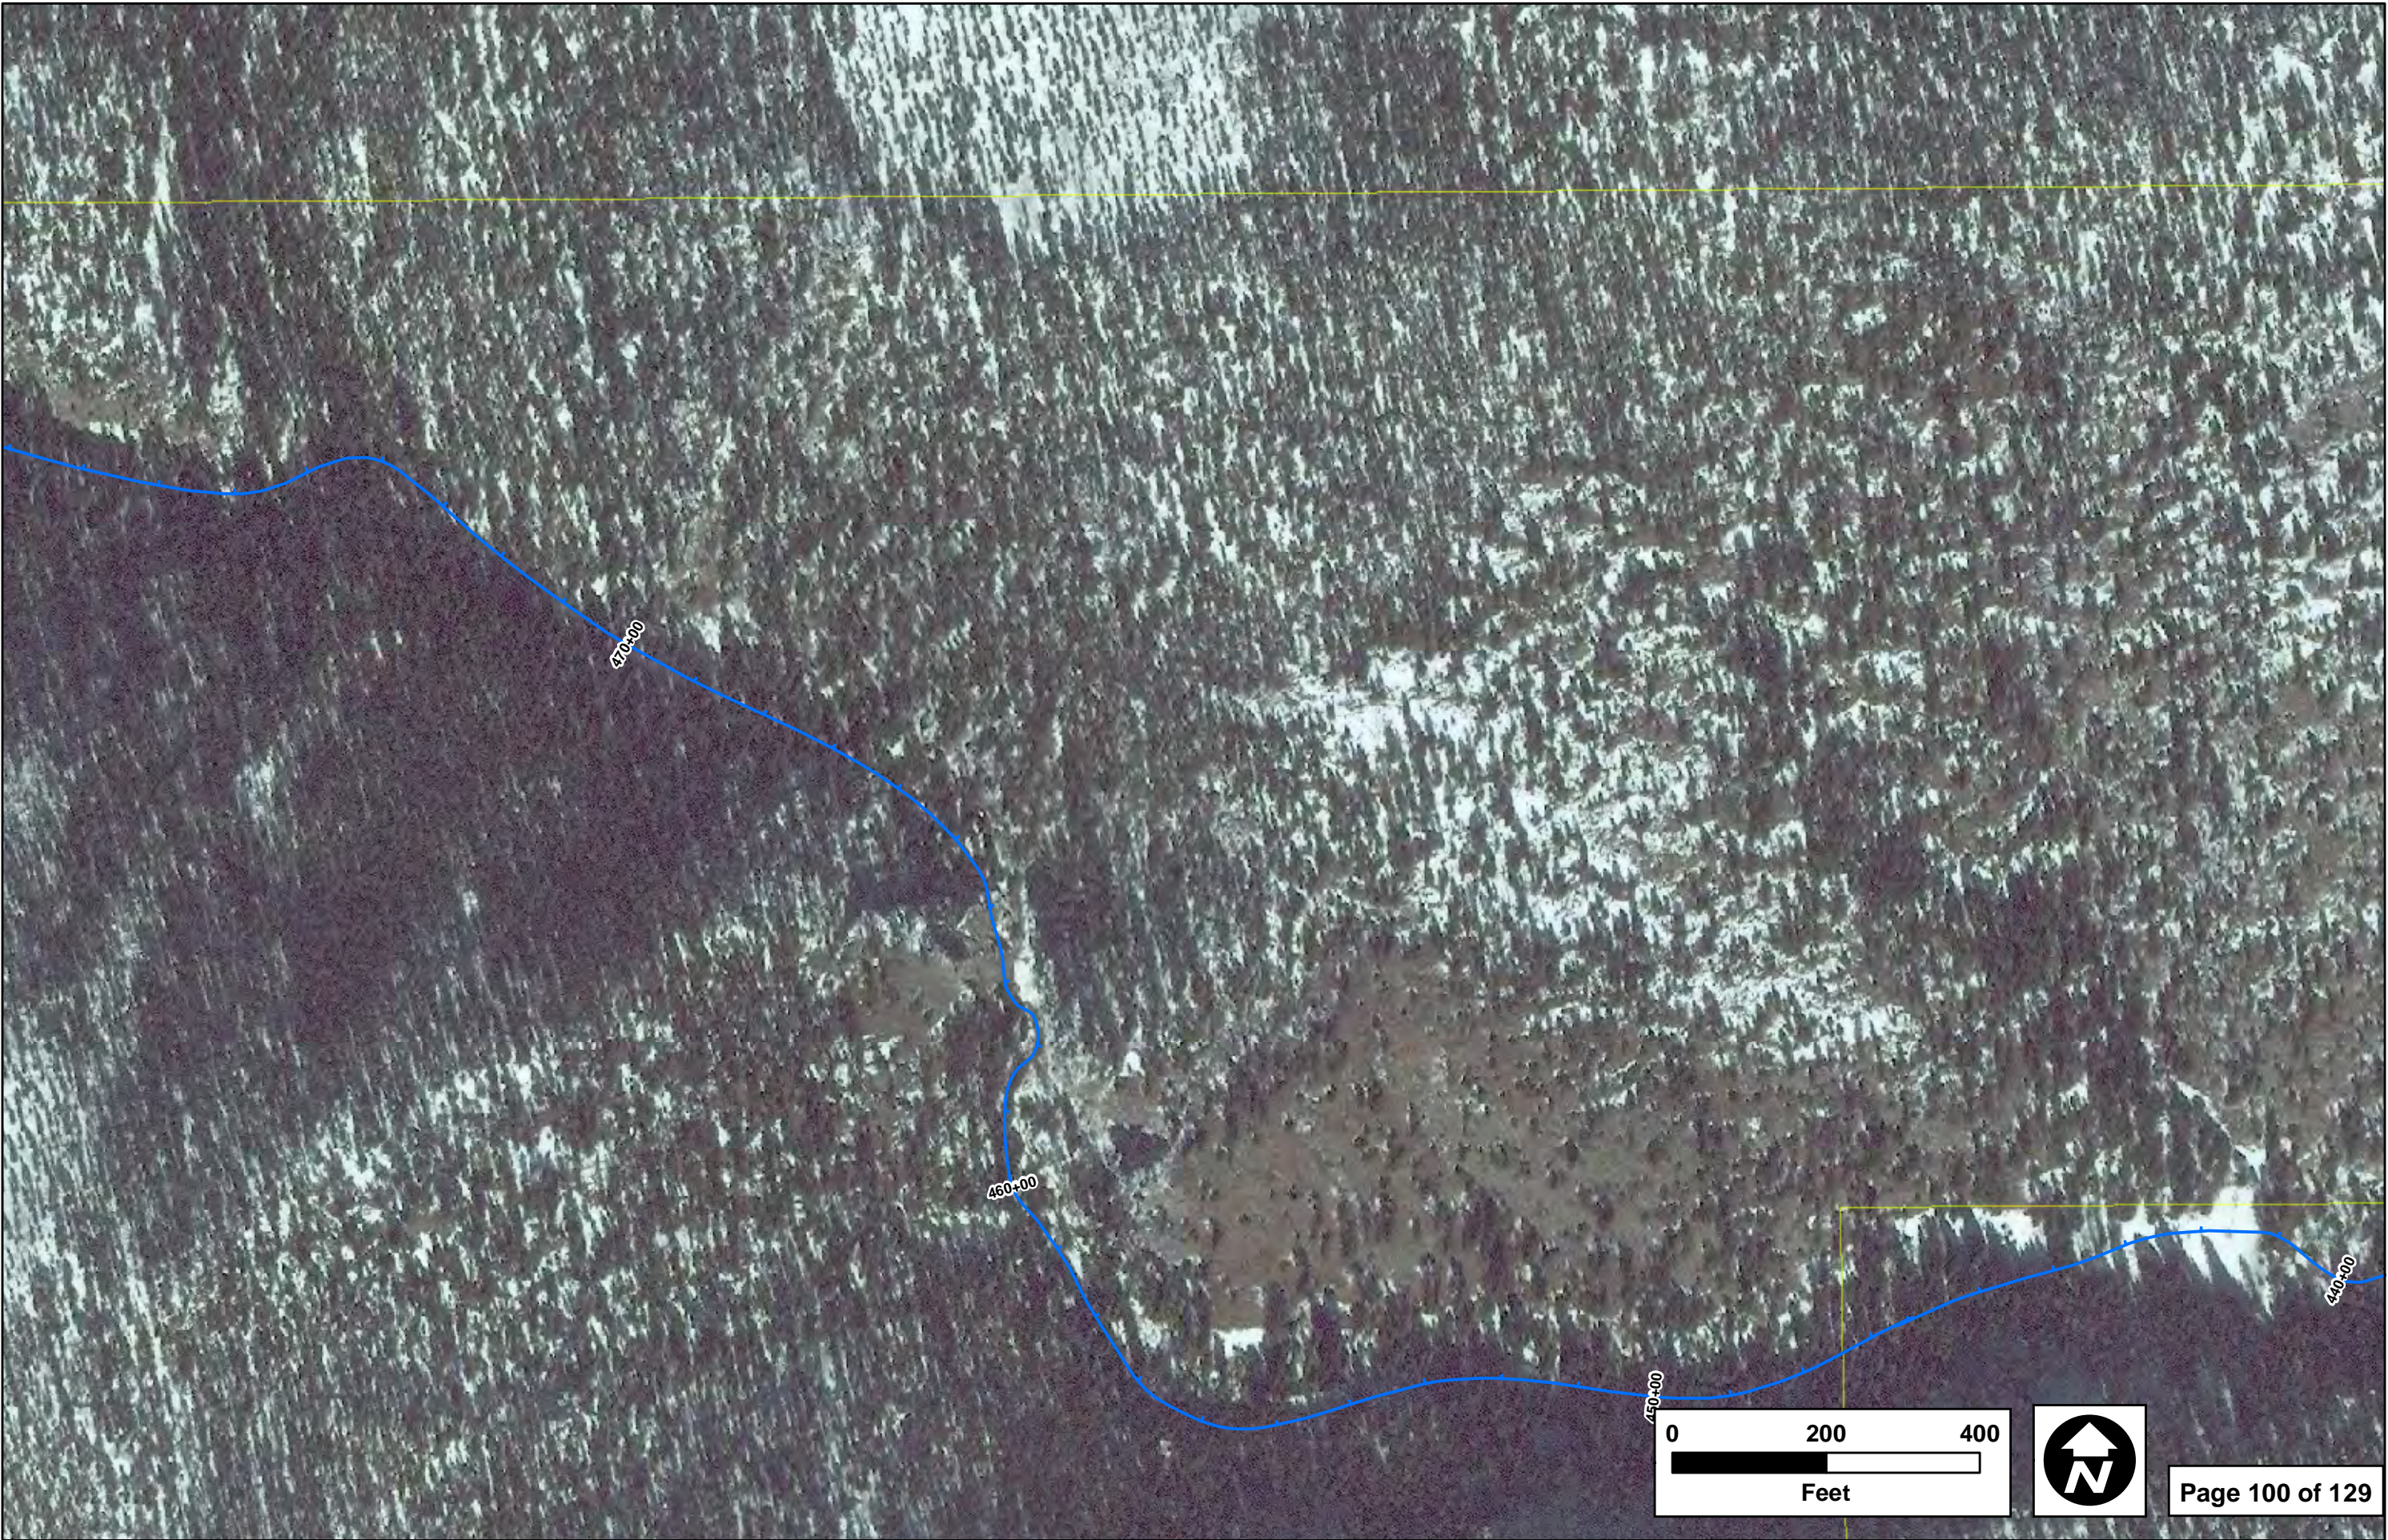
NEIGHBORHOOD: Big Elk Meadows
SHEET: 101
STATION: West Fork above Big Elk Meadows

The West Fork upstream of Big Elk Meadows is generally canyon-bound with rock outcrop and walls. This reach is isolated with very limited encroachment on the river corridor. Aerial images indicate a potential debris flow in the upper watershed that may have contributed to the deposition observed in the portions of the West Fork in and near Big Elk Meadows. However, the river appears relatively stable and expected to recover without restoration activities. The USFS has no plans for debris removal or restoration activities.

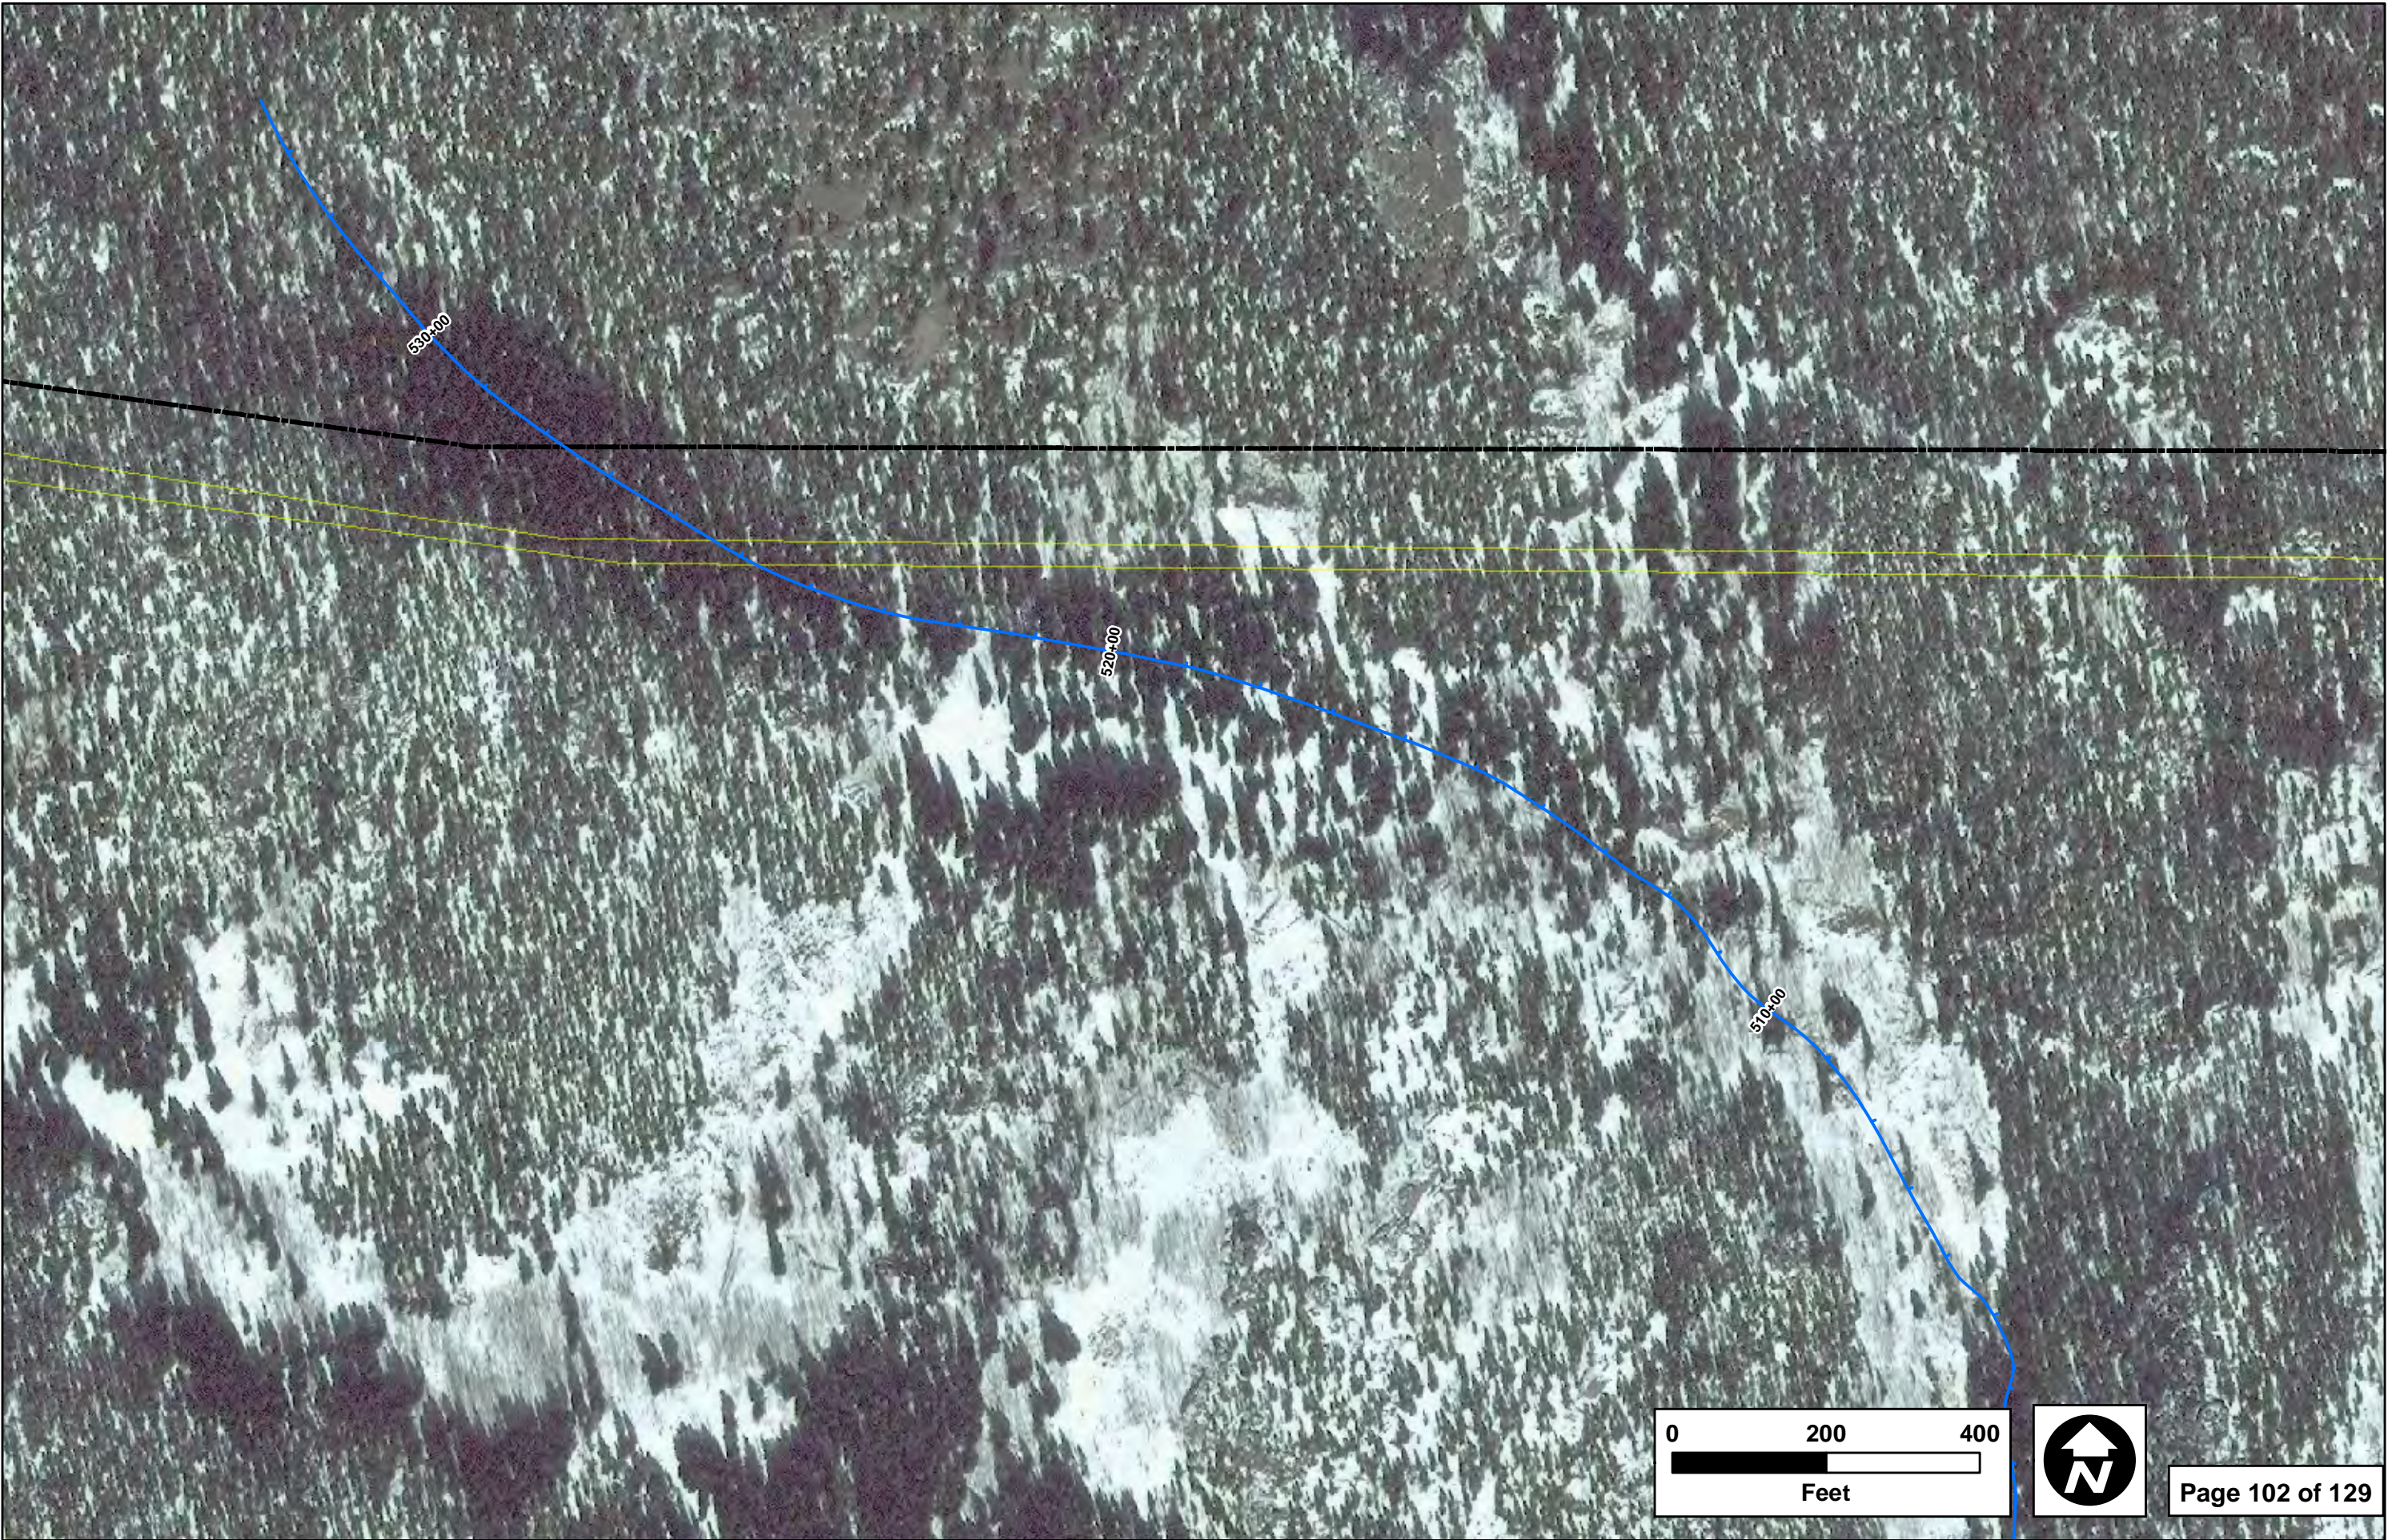
NEIGHBORHOOD: Blue Mountain
SHEET: 103
STATION: North Fork—upstream of confluence

Aerial photos of pre-flood conditions and anecdotal information indicate this reach had a densely vegetated riparian corridor, approximately 100 feet wide, comprised primarily of cottonwoods and willows, some of which were torn out during the flood. The river is narrow and canyon bound, setting the sinuosity and river corridor alignment. The North Fork is a relatively small stream system that often goes dry by late summer.

Geomorphic functions of this reach is likely sufficient to allow for the natural regeneration of cottonwood, willow, and other riparian species through seeding and cloning without active restoration. No further actions are suggested at this time.

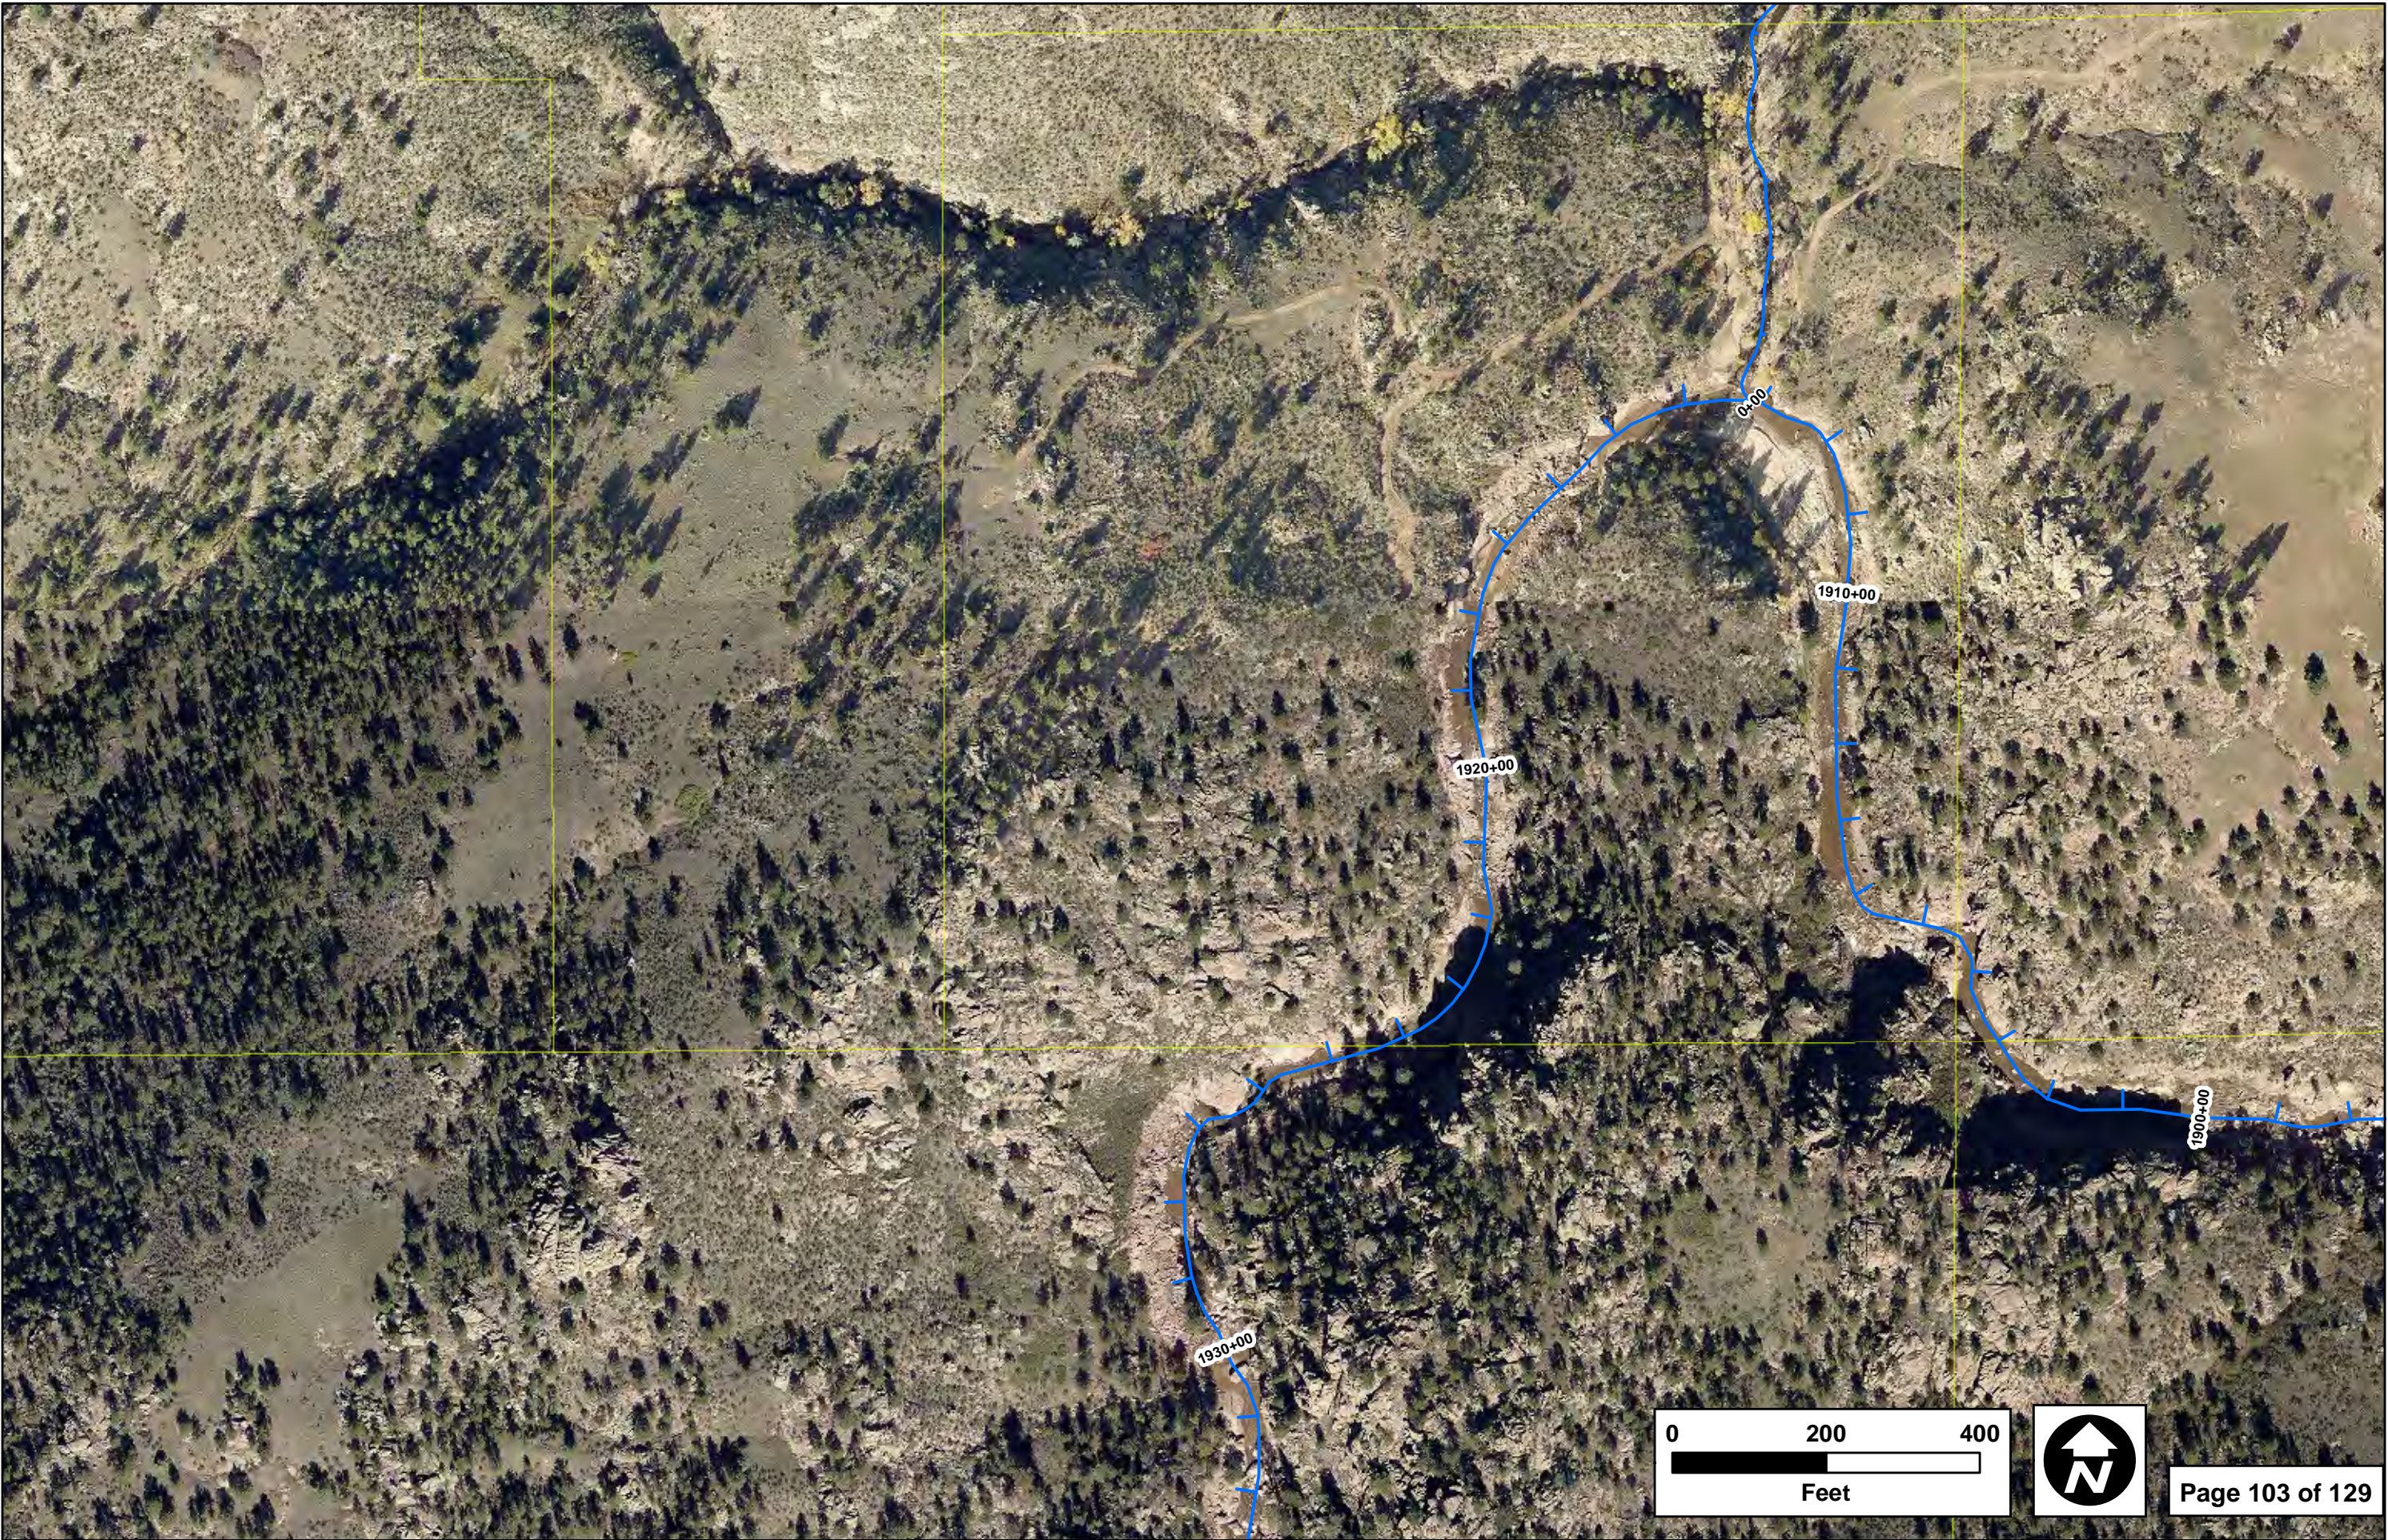
NEIGHBORHOOD: Blue Mountain
SHEET: 104
STATION: North Fork—upstream of Stagecoach Trail

Aerial photos of pre-flood conditions and anecdotal information indicate this reach had a densely vegetated riparian corridor, approximately 100 feet wide, comprised primarily of cottonwoods and willows, some of which were torn out during the flood. The river is generally canyon bound, setting the sinuosity and river corridor alignment. The North Fork is a relatively small stream system that often goes dry by late summer.

This specific reach includes a road crossing where Stagecoach Trail/Pinwheel Ranch Road crosses the river. The crossing was reportedly washed out but had been replaced prior to conducting the site assessments. The driveway to the one residence was also washed out but has since been replaced. The new driveway is located to the east of the river, thereby eliminating one culvert crossing. Additional recommendations are noted below.
