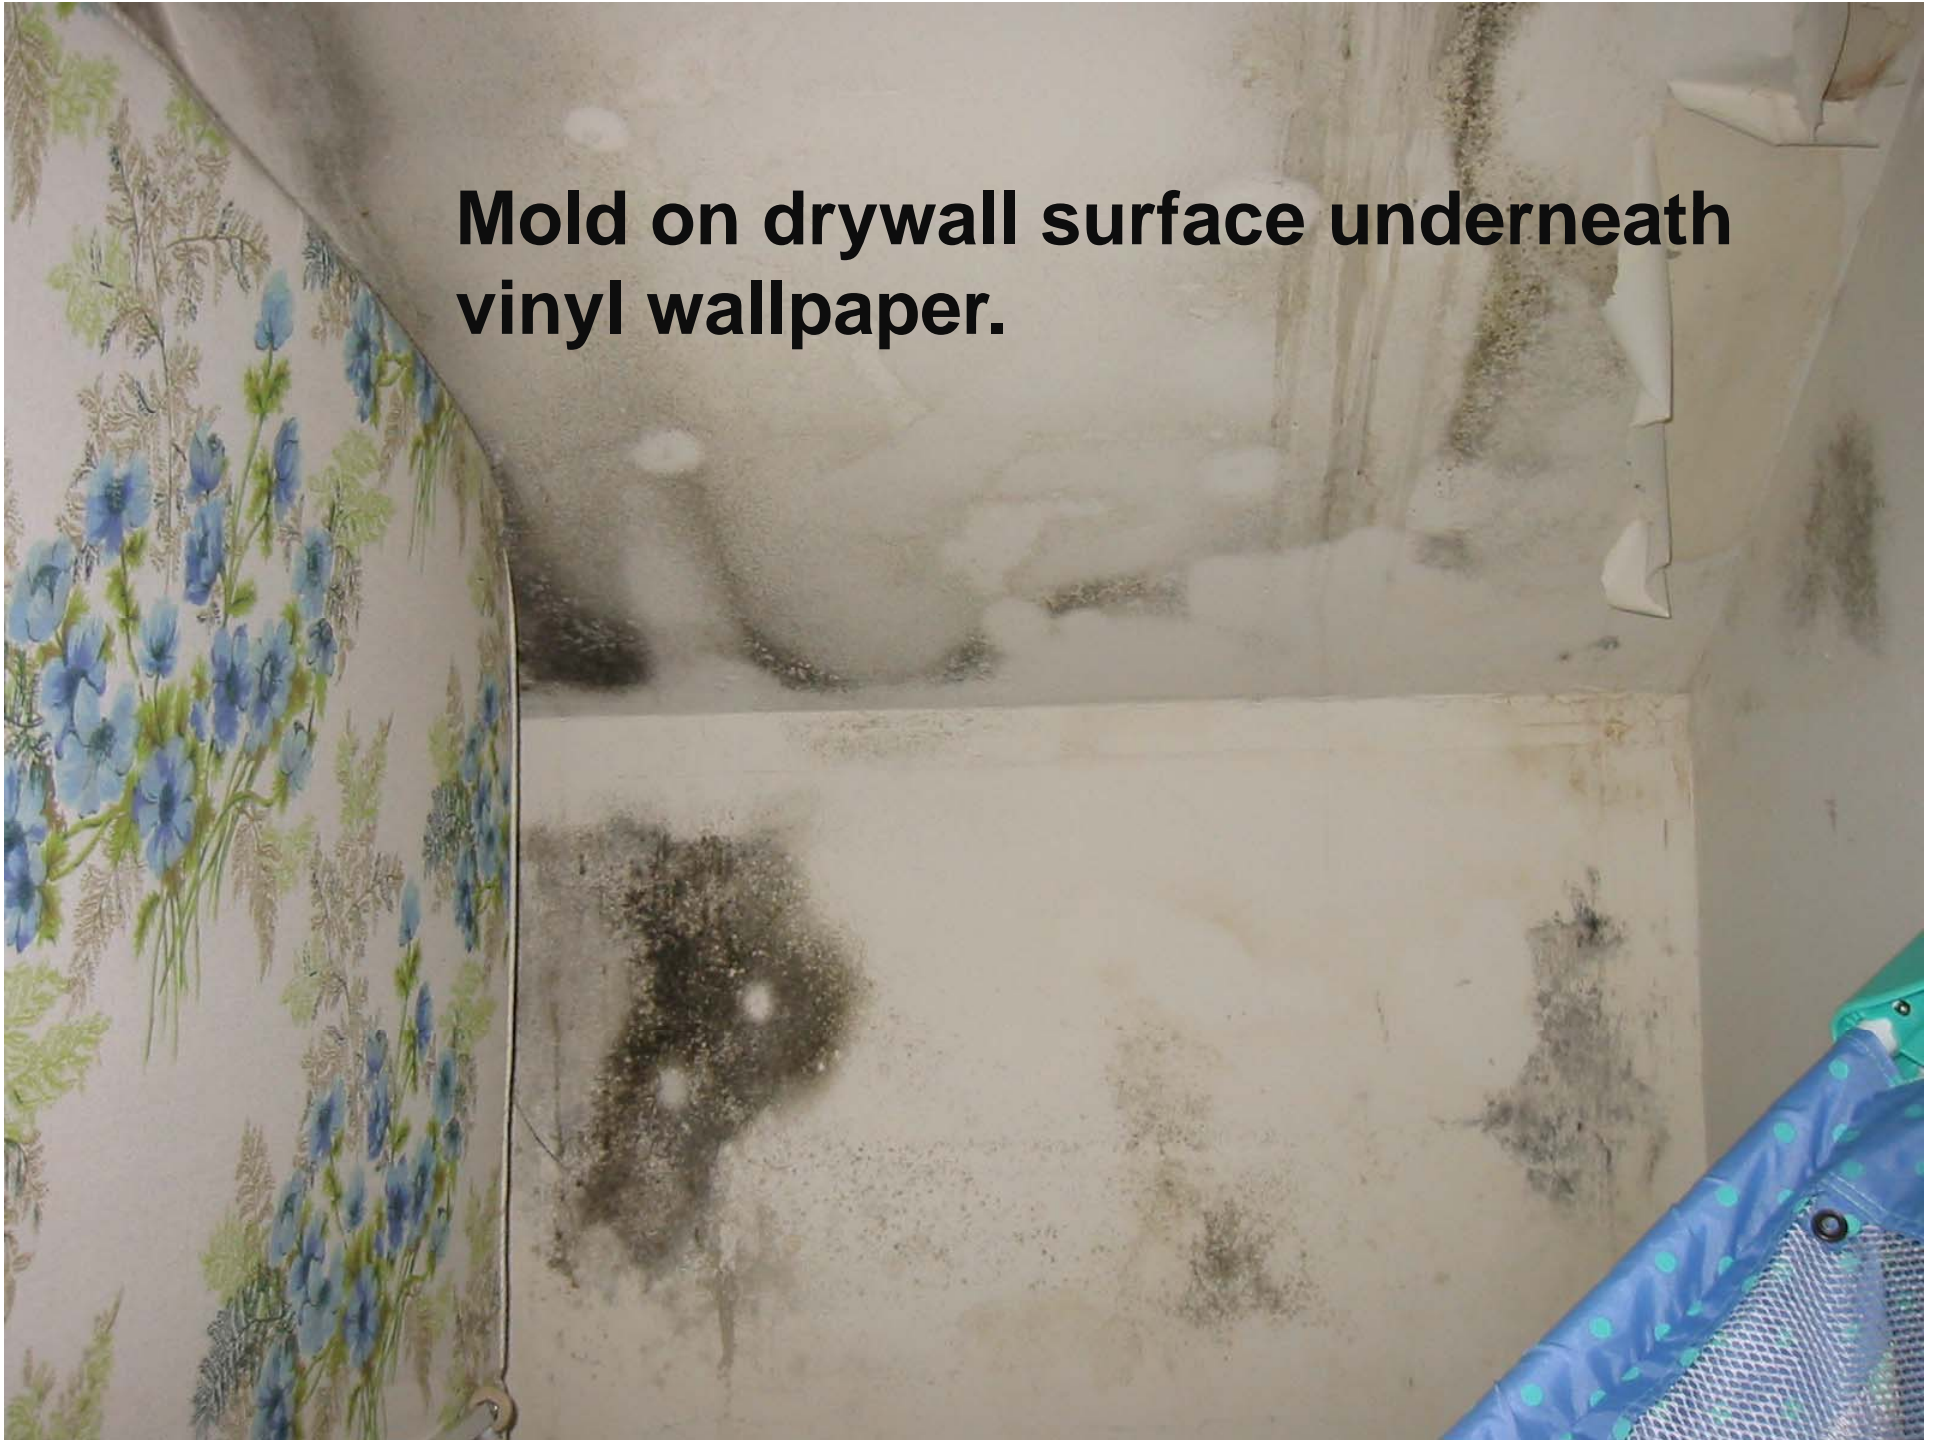
**Mold on drywall surface underneath vinyl wallpaper.**

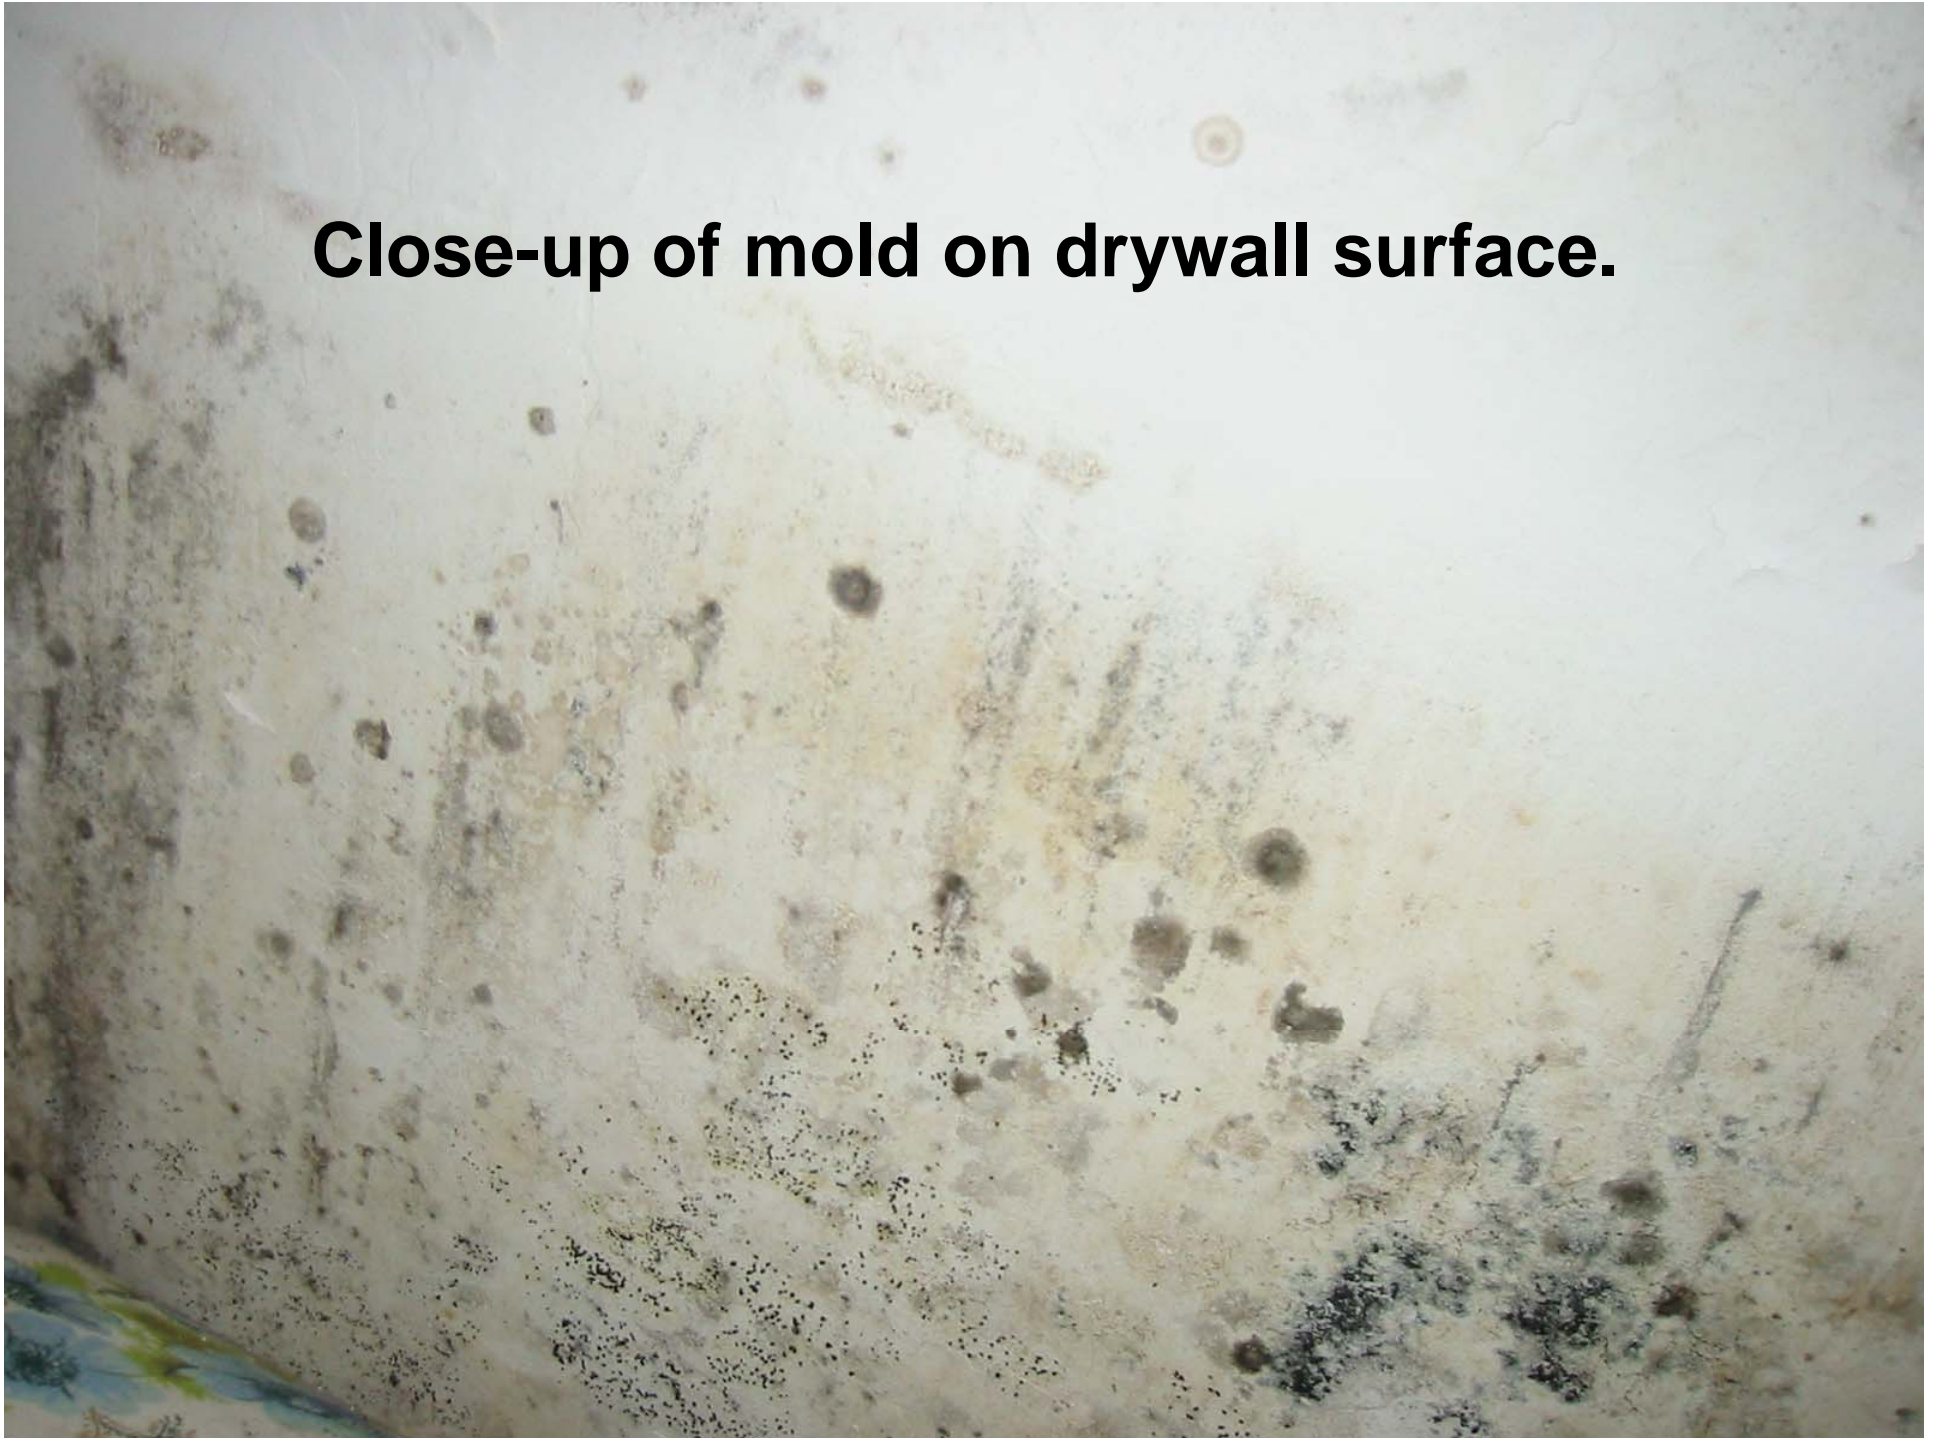
**Close-up of mold on drywall surface.**

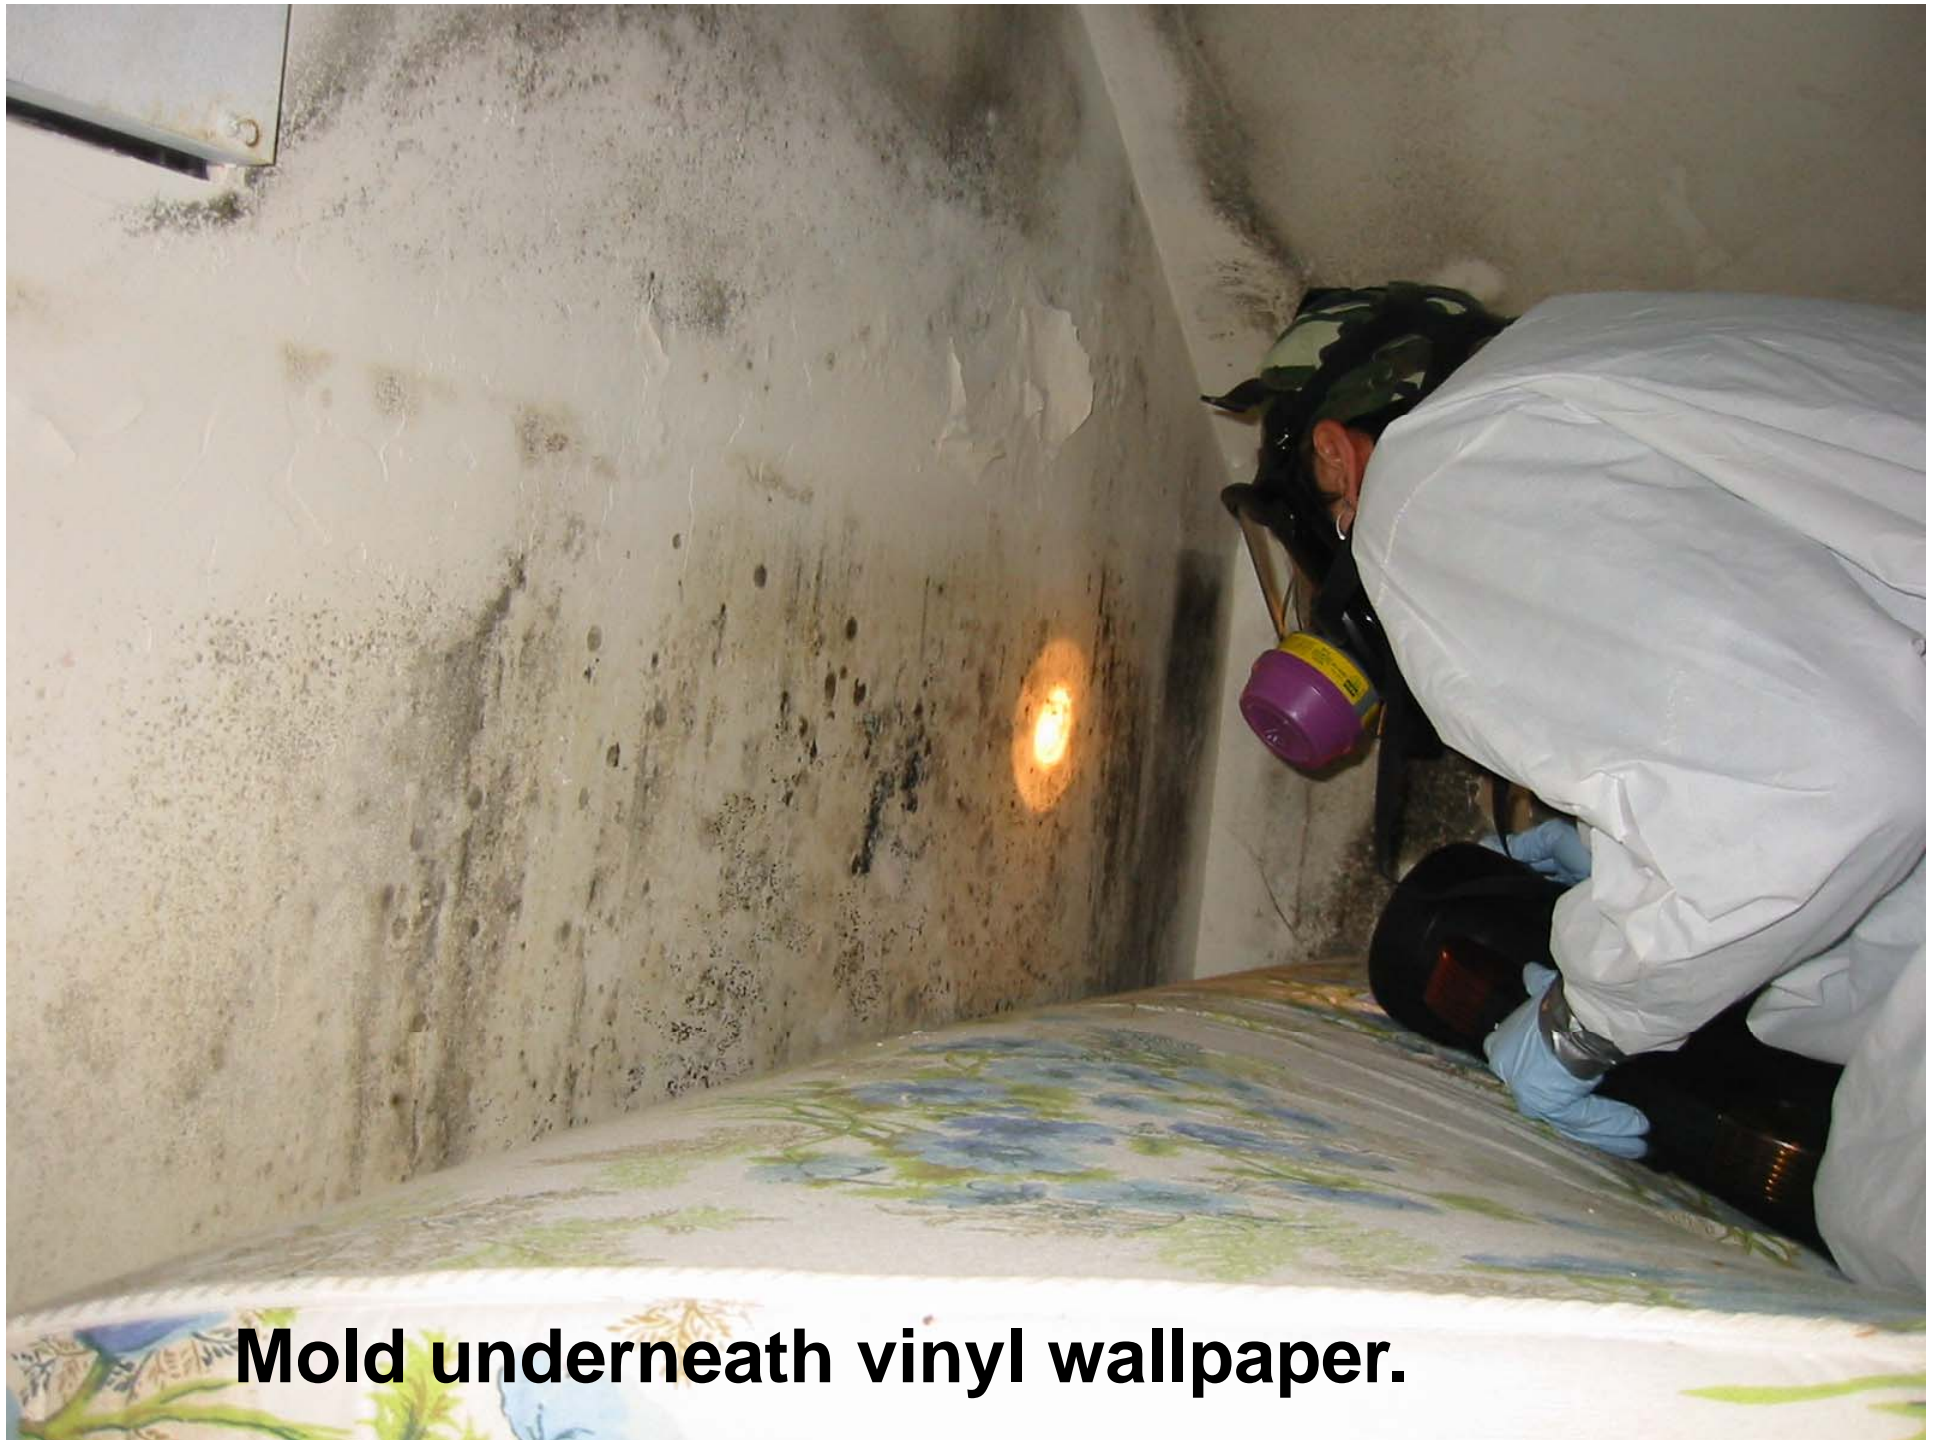
**Mold underneath vinyl wallpaper.**

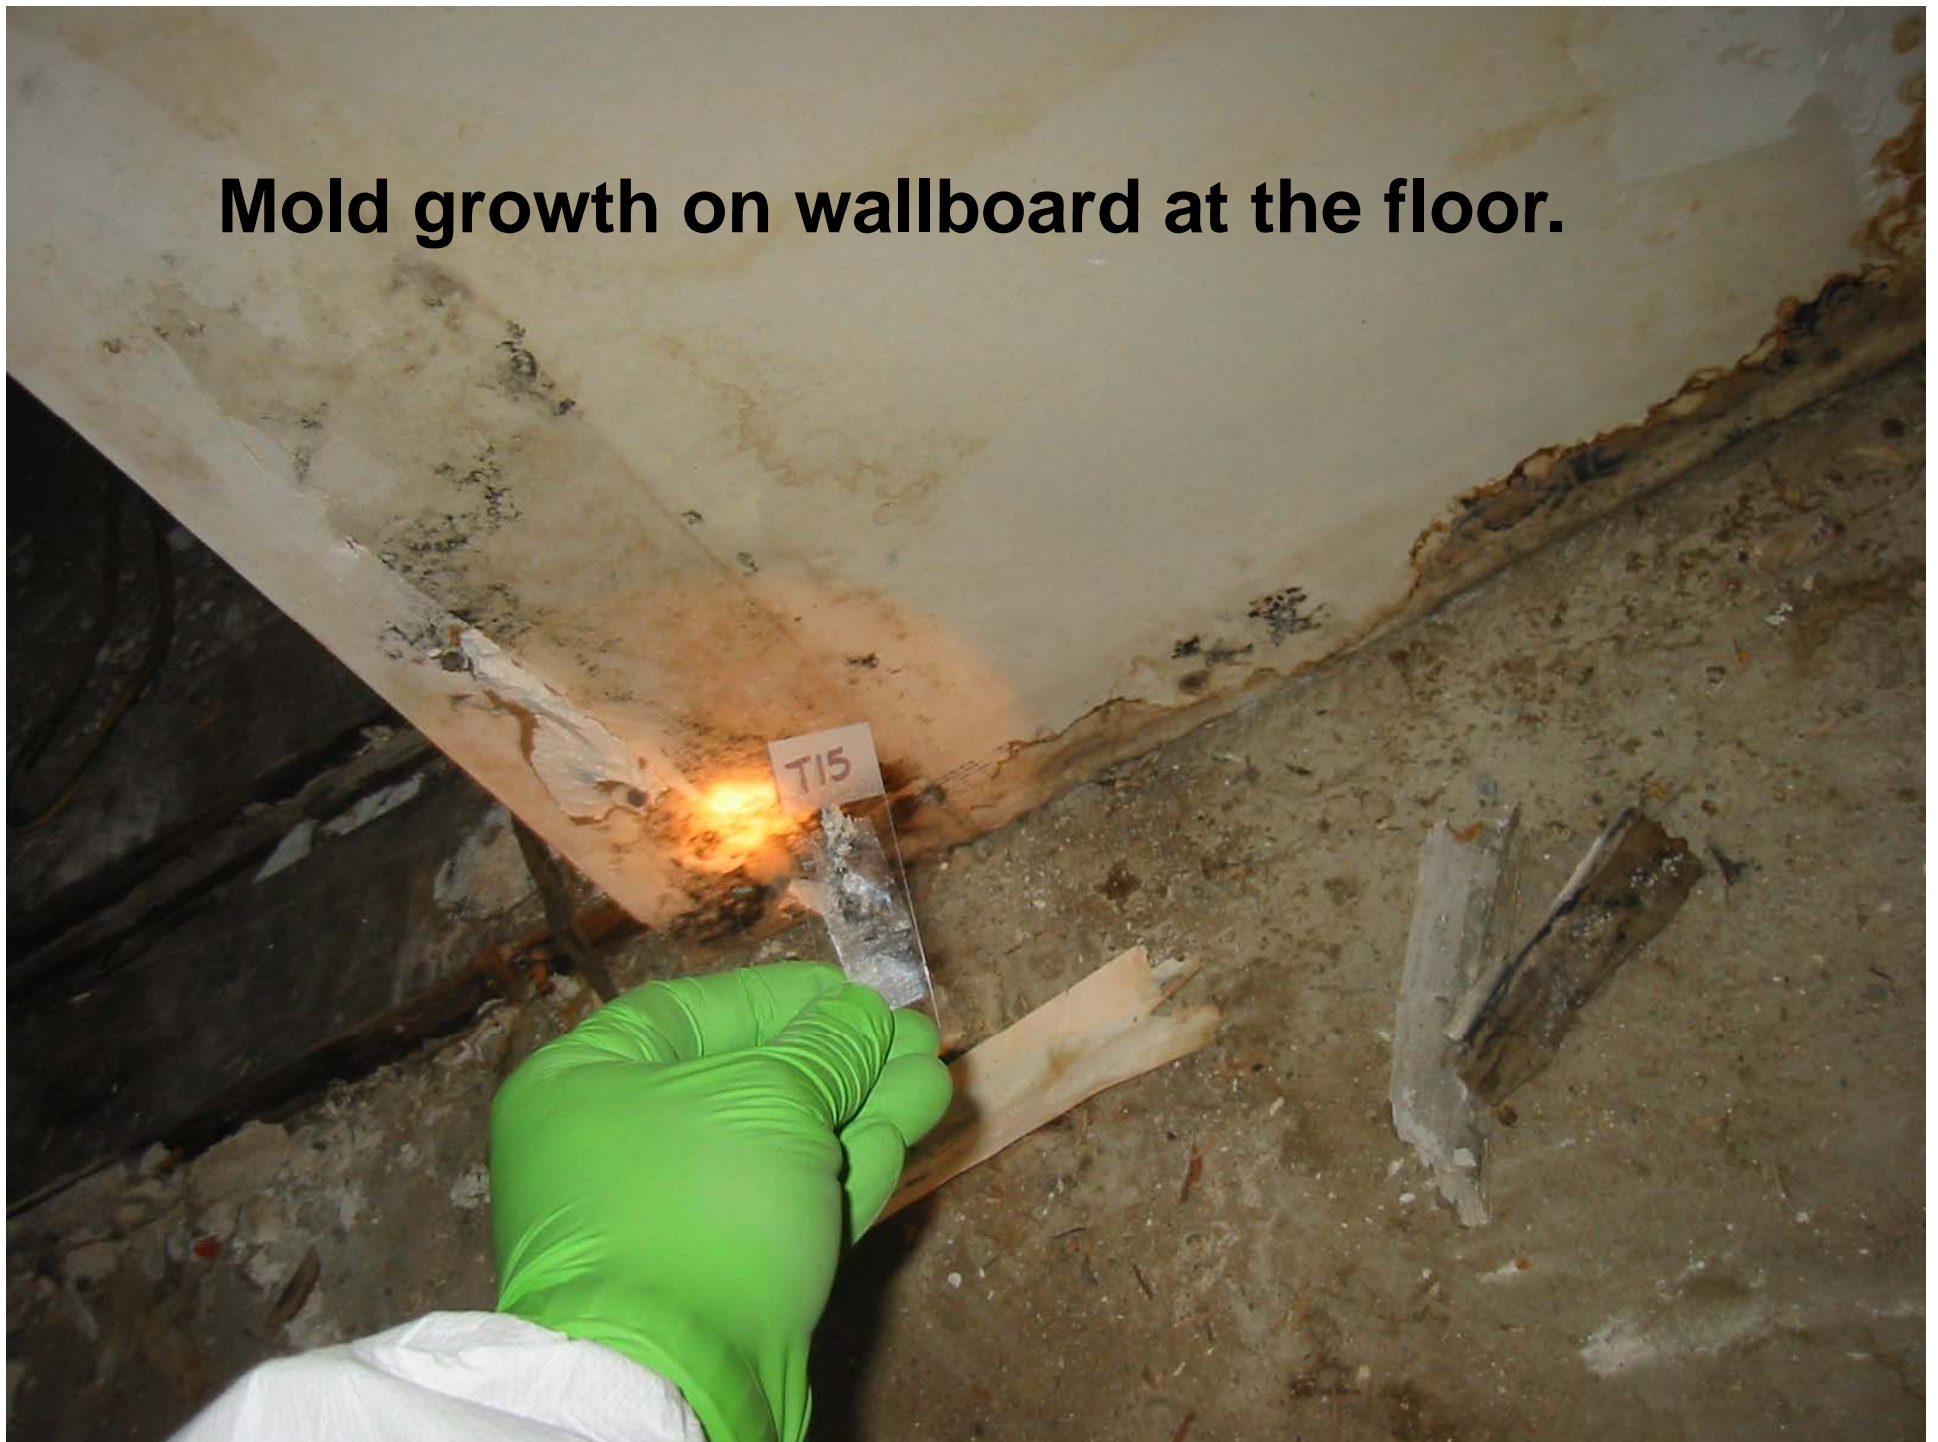
**Mold growth on wallboard at the floor.**

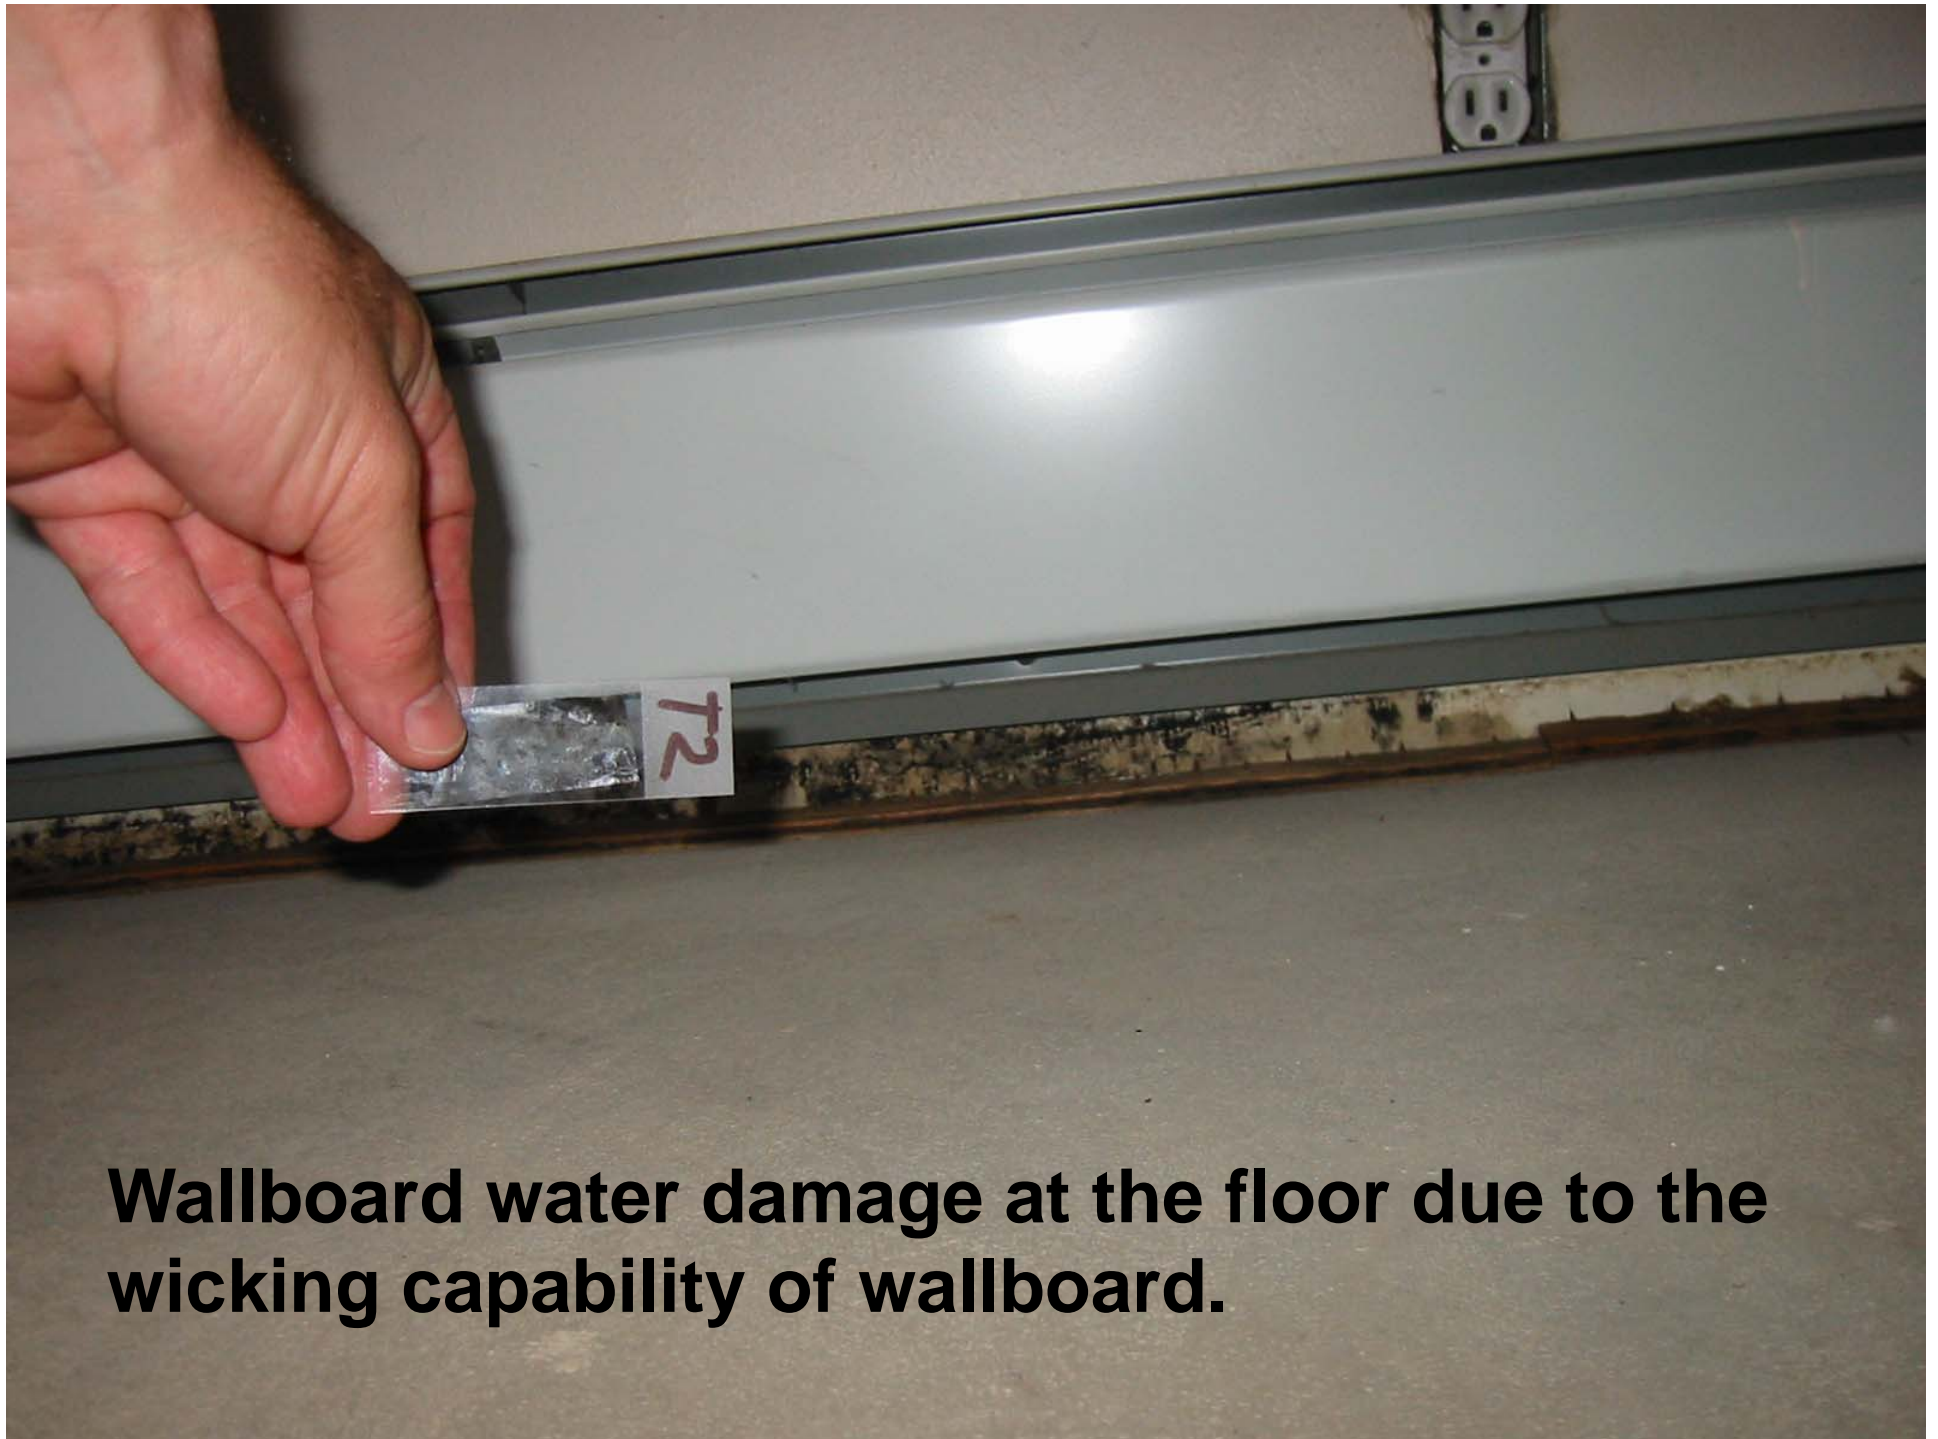
**Wallboard mold growth is worse at the floor due to the wicking capability of drywall.**

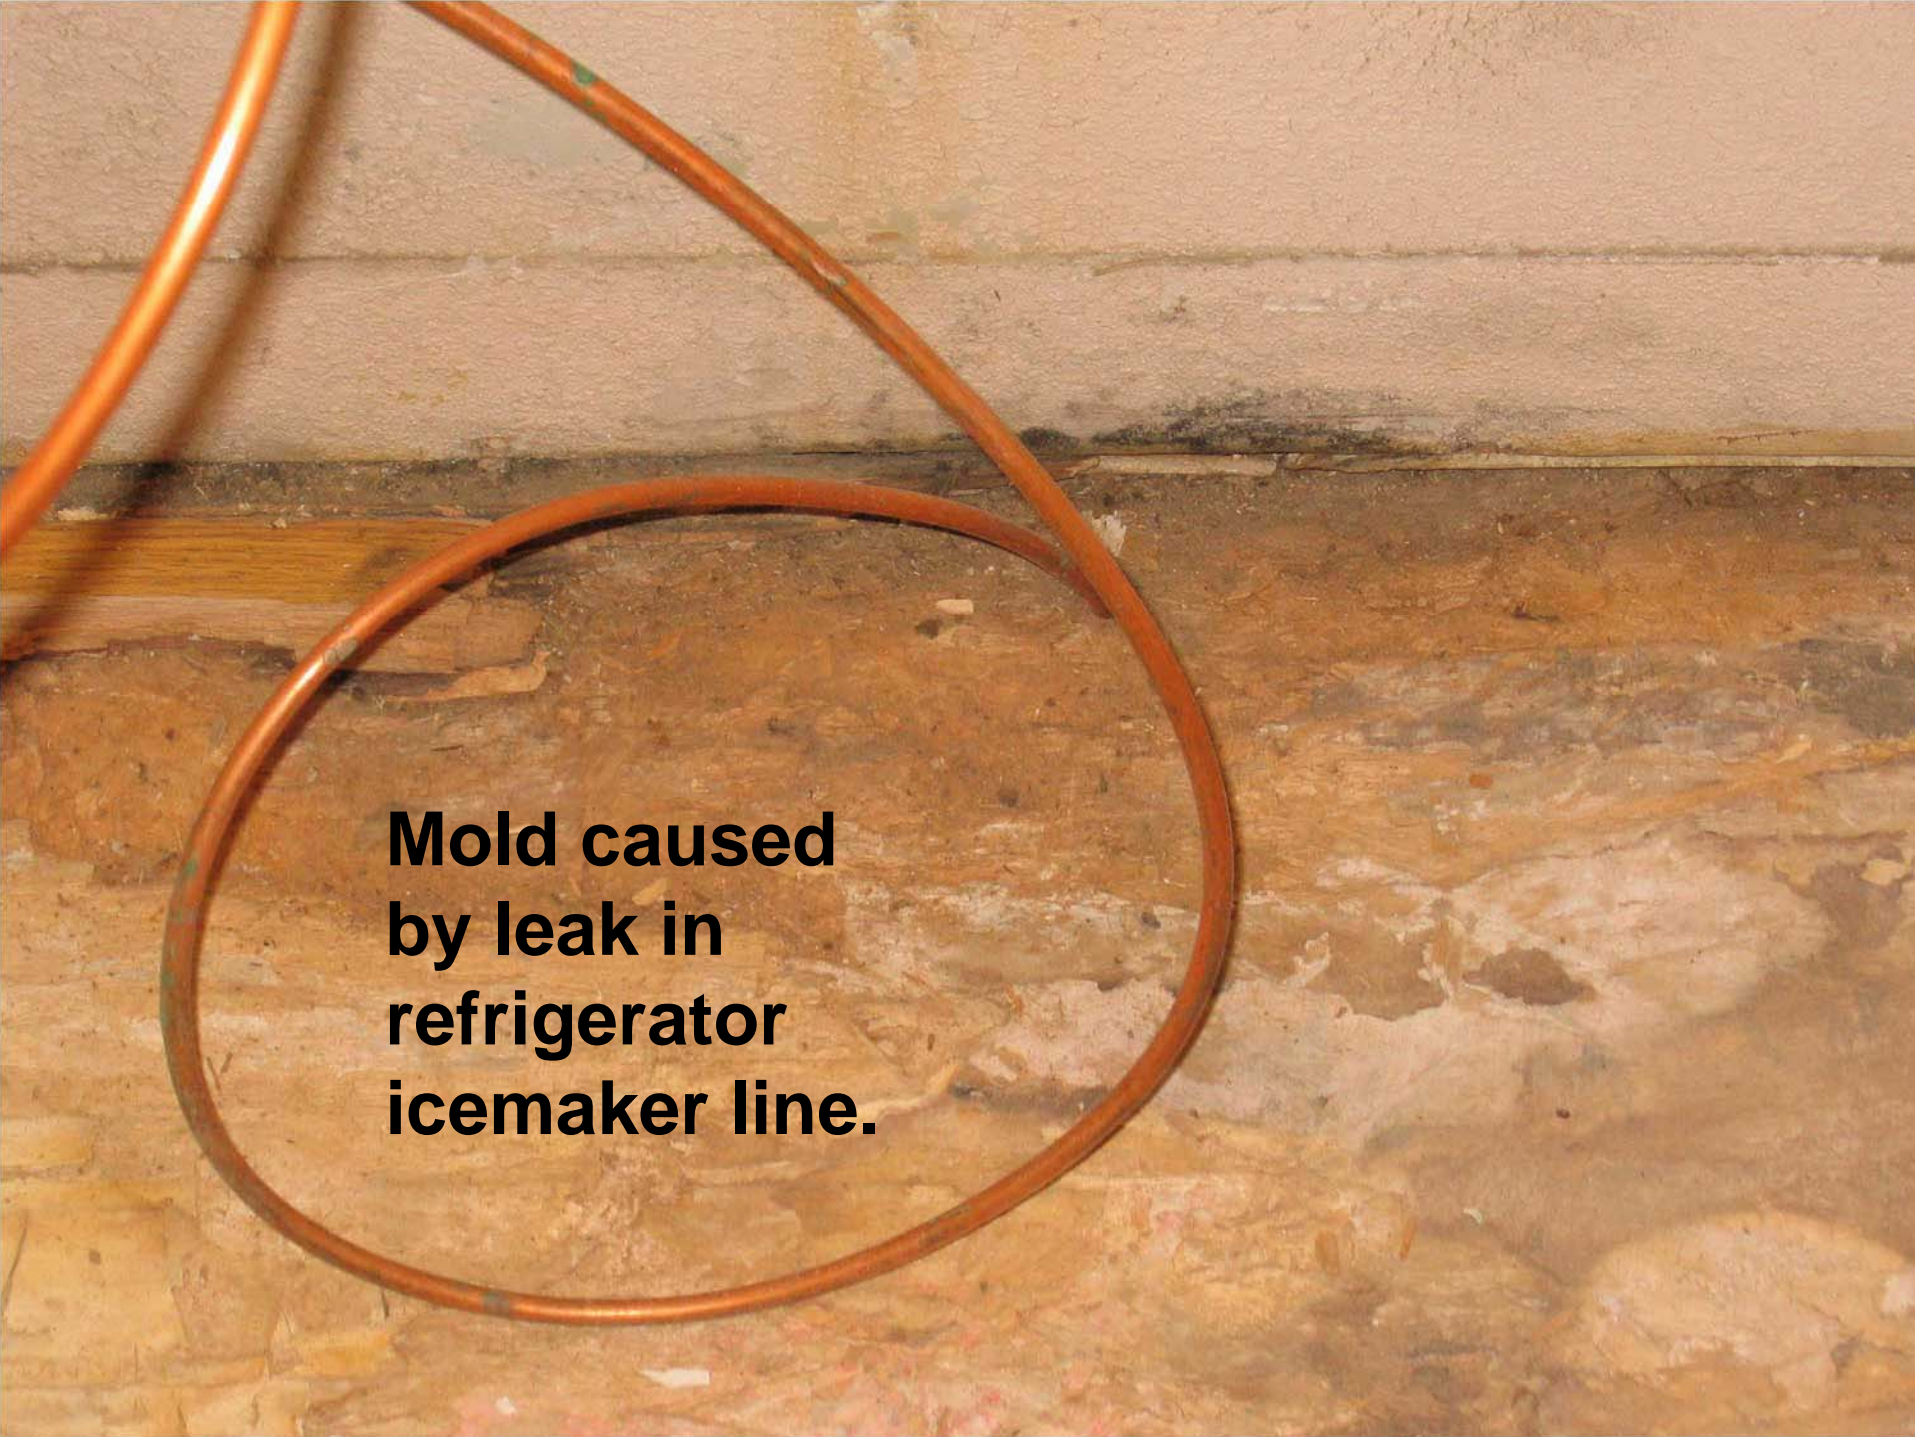
**Wallboard water damage at the floor due to the wicking capability of wallboard.**

**Mold caused  
by leak in  
refrigerator  
icemaker line.**

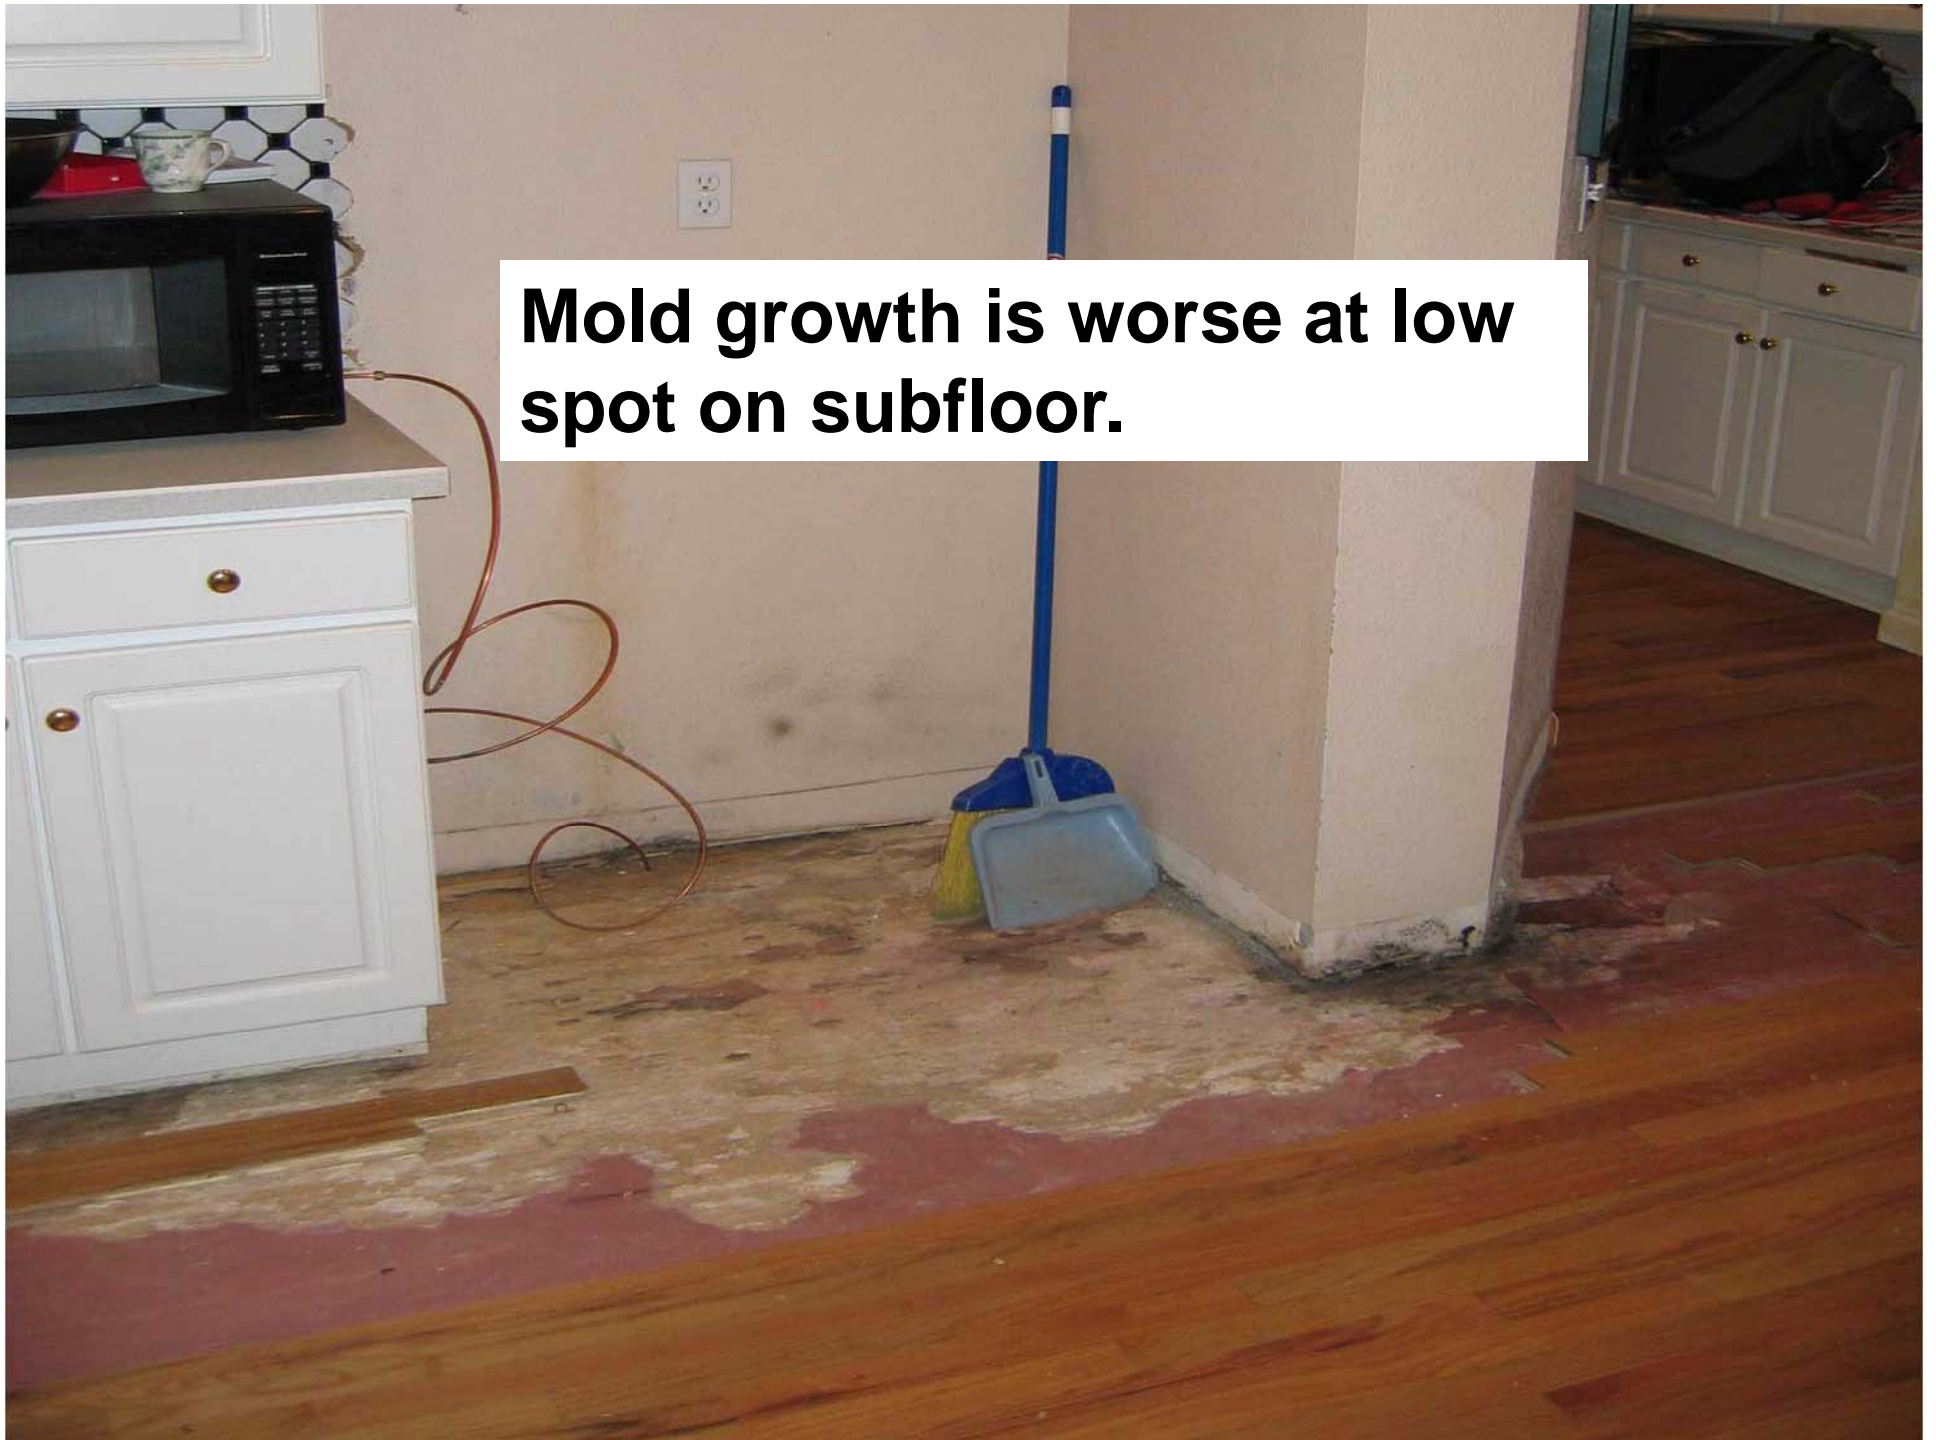
**Mold growth is worse at low spot on subfloor.**

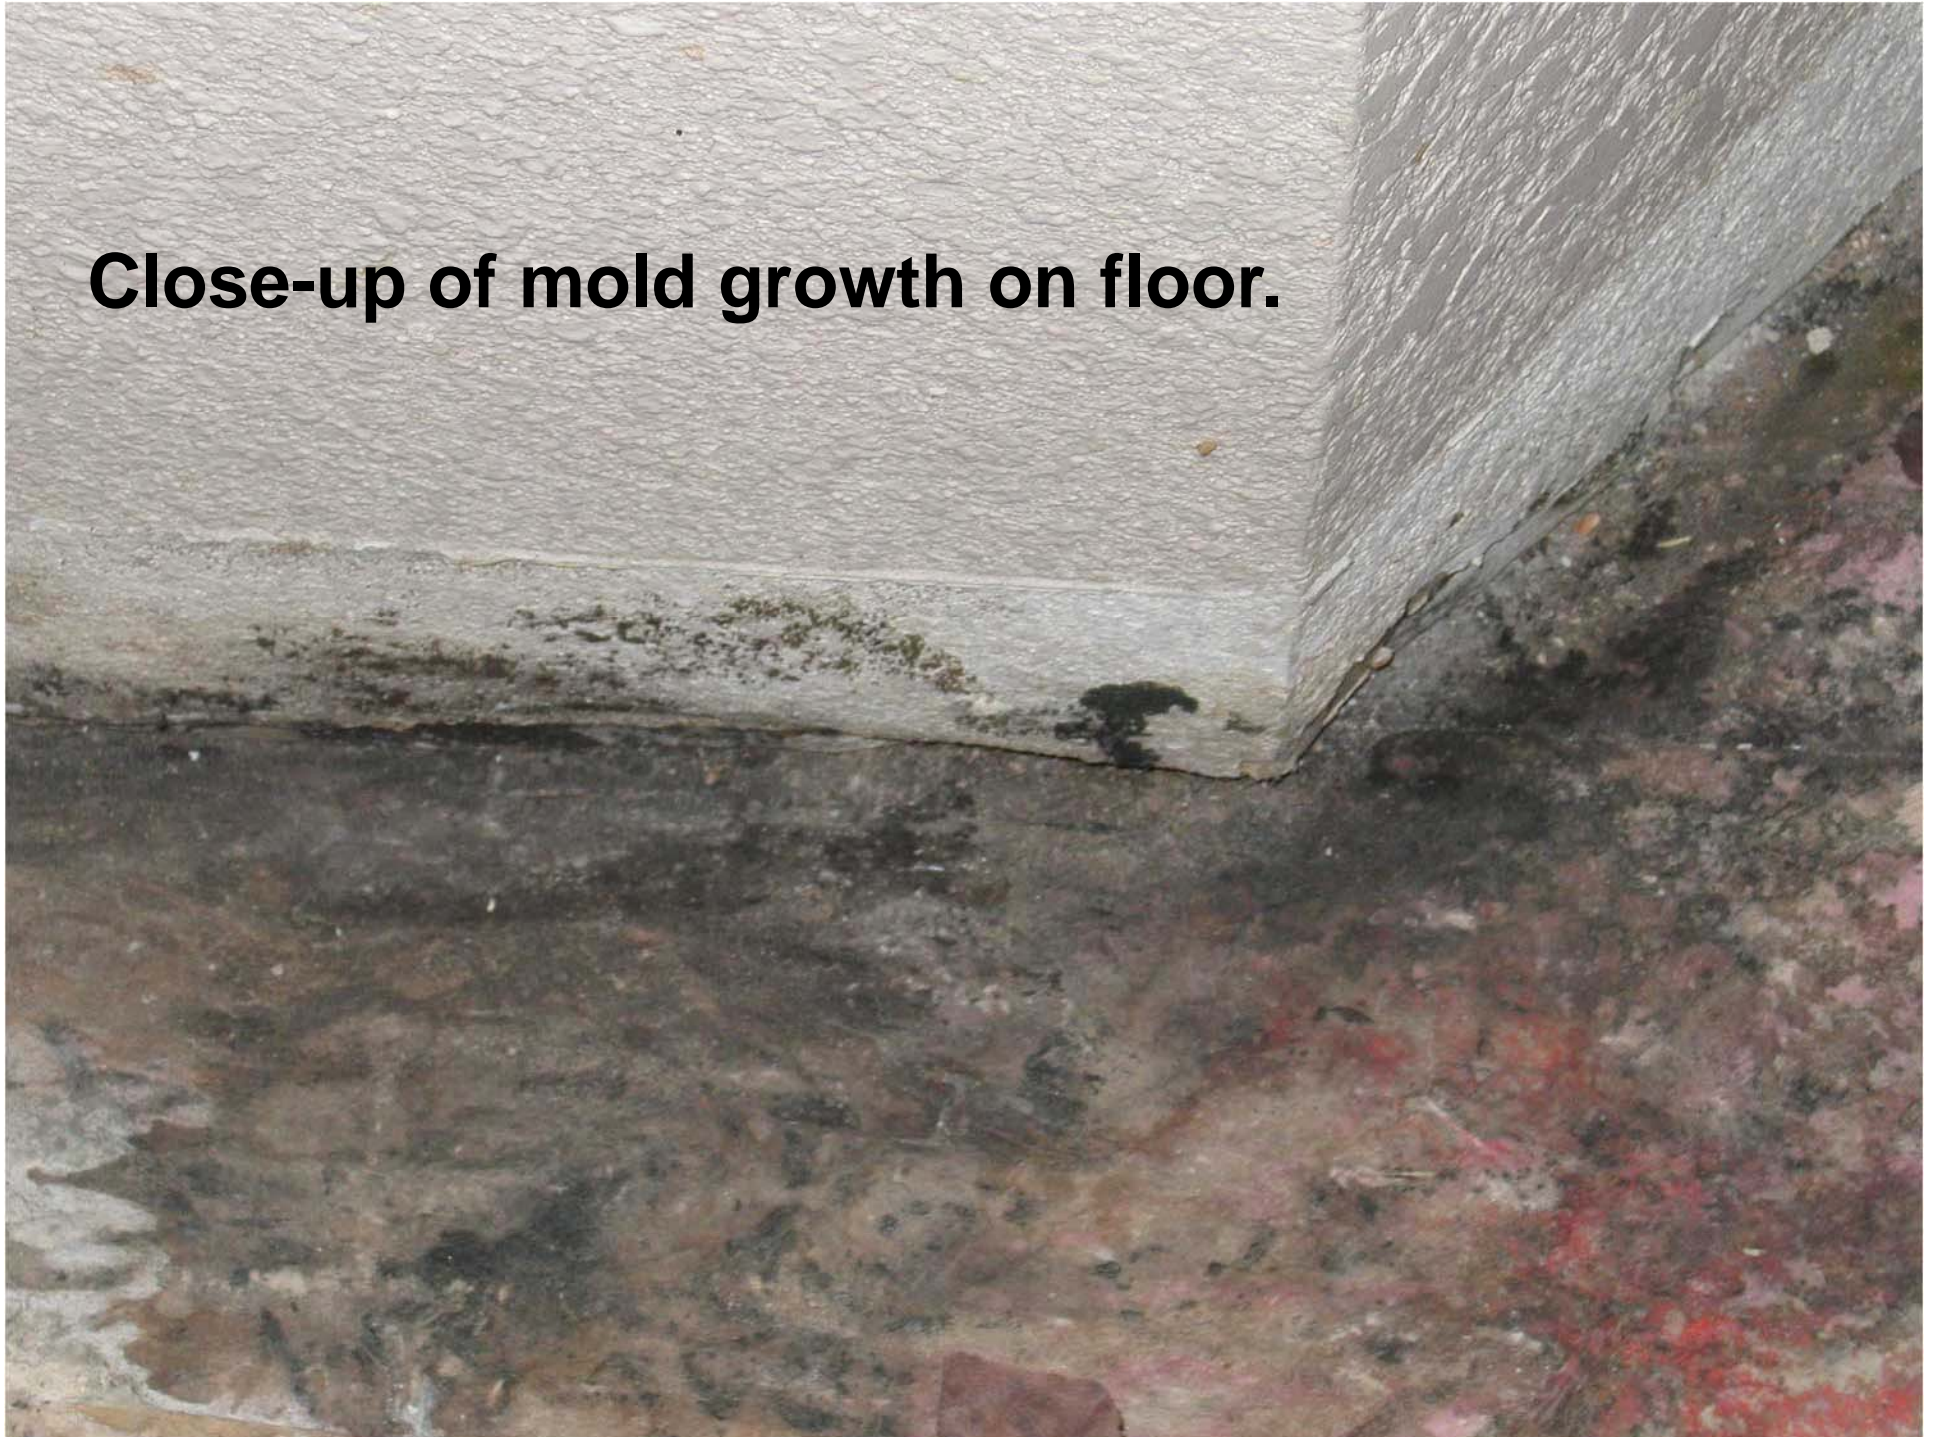
**Close-up of mold growth on floor.**
