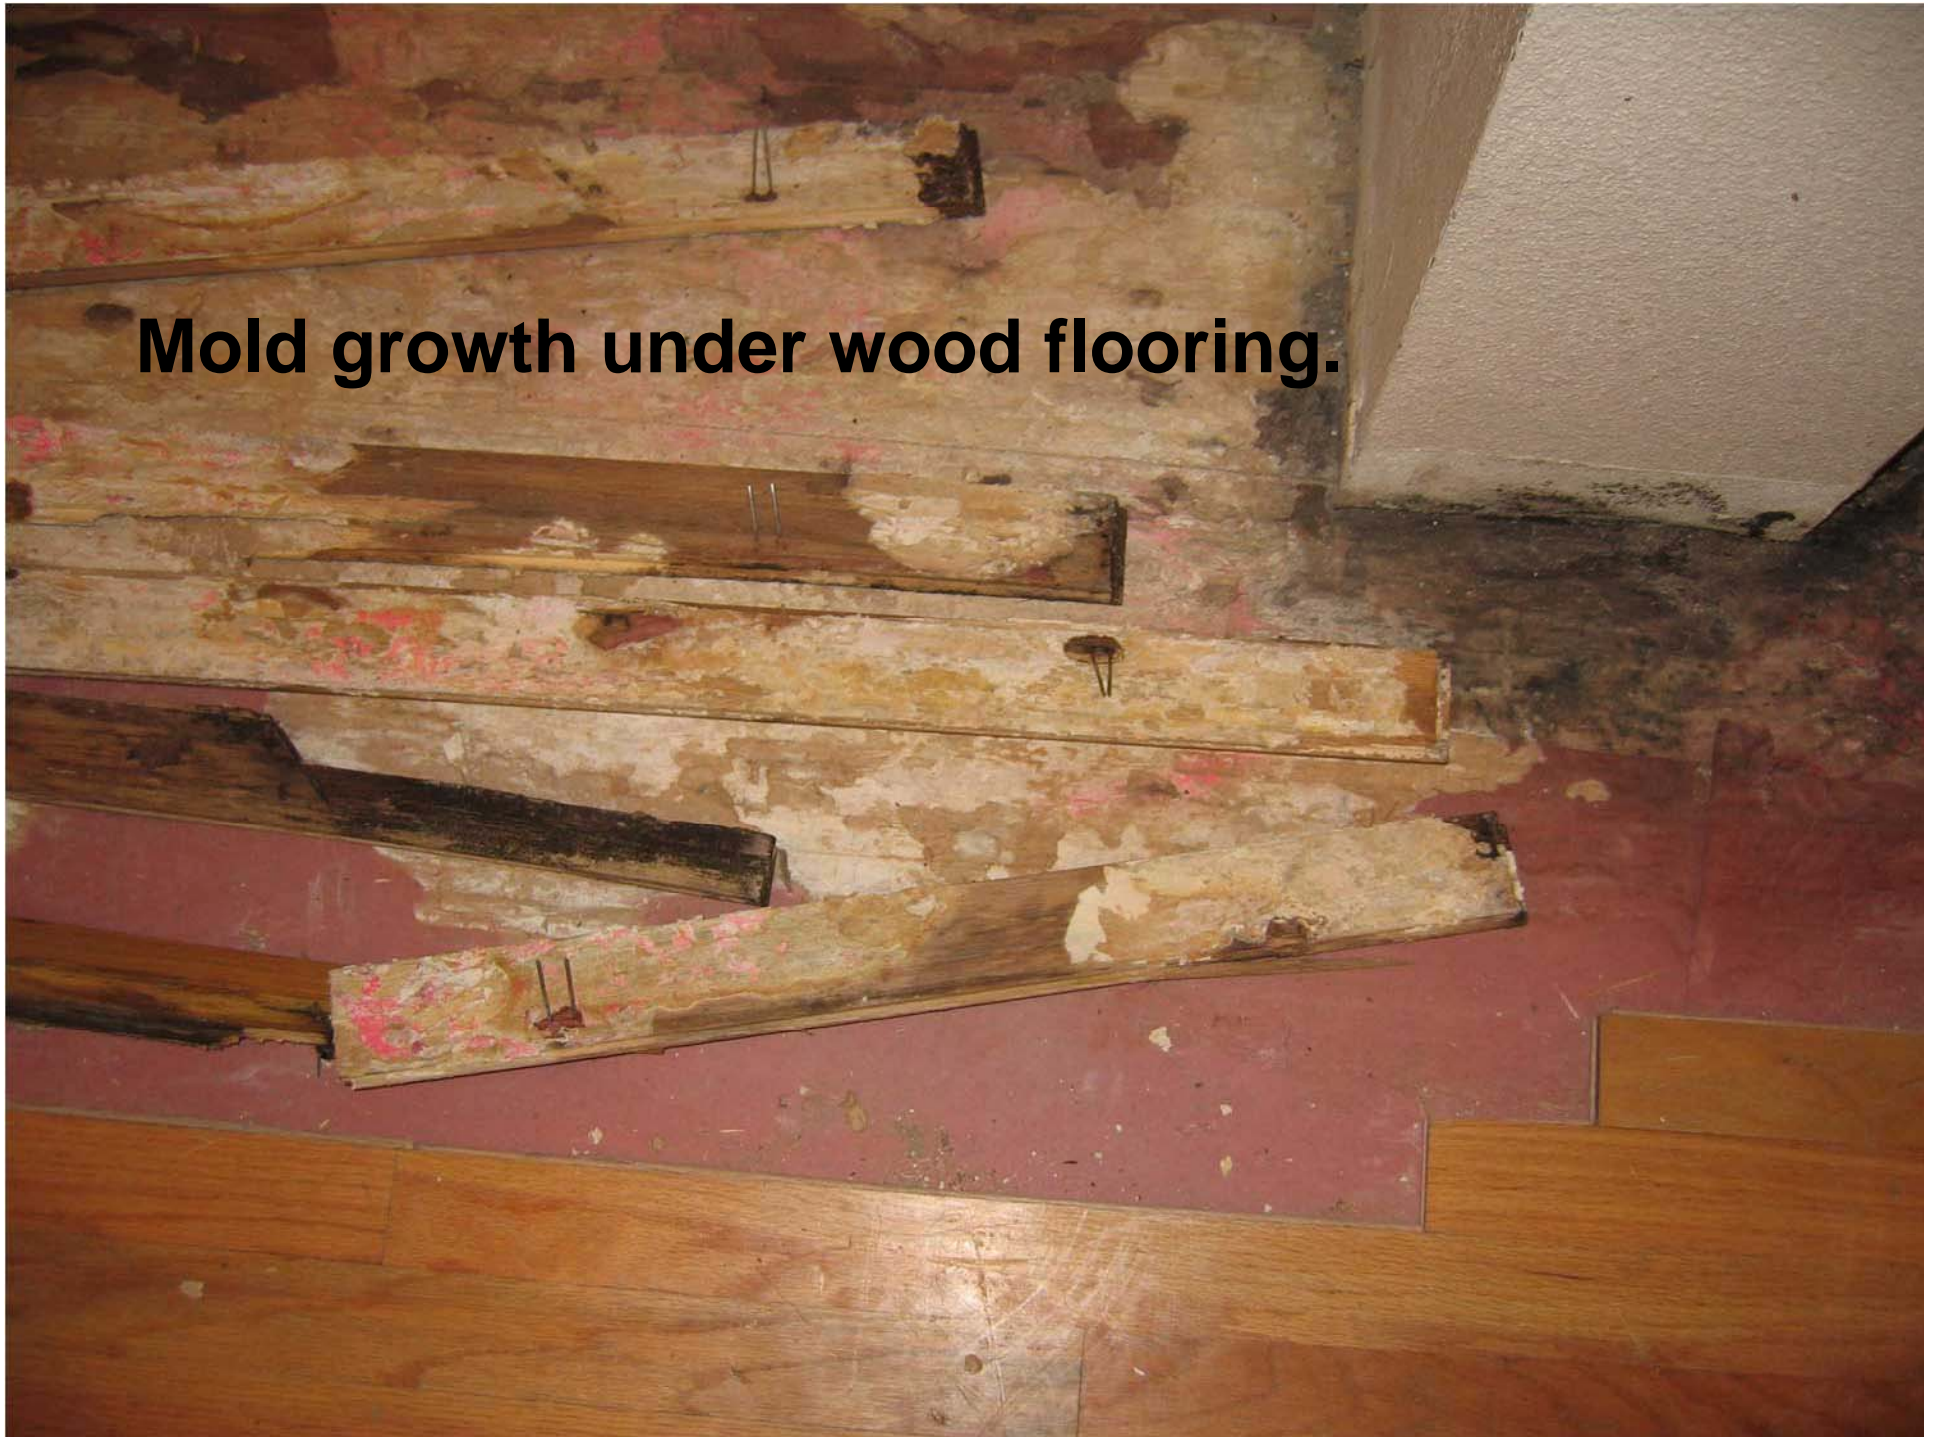
**Mold growth under wood flooring.**

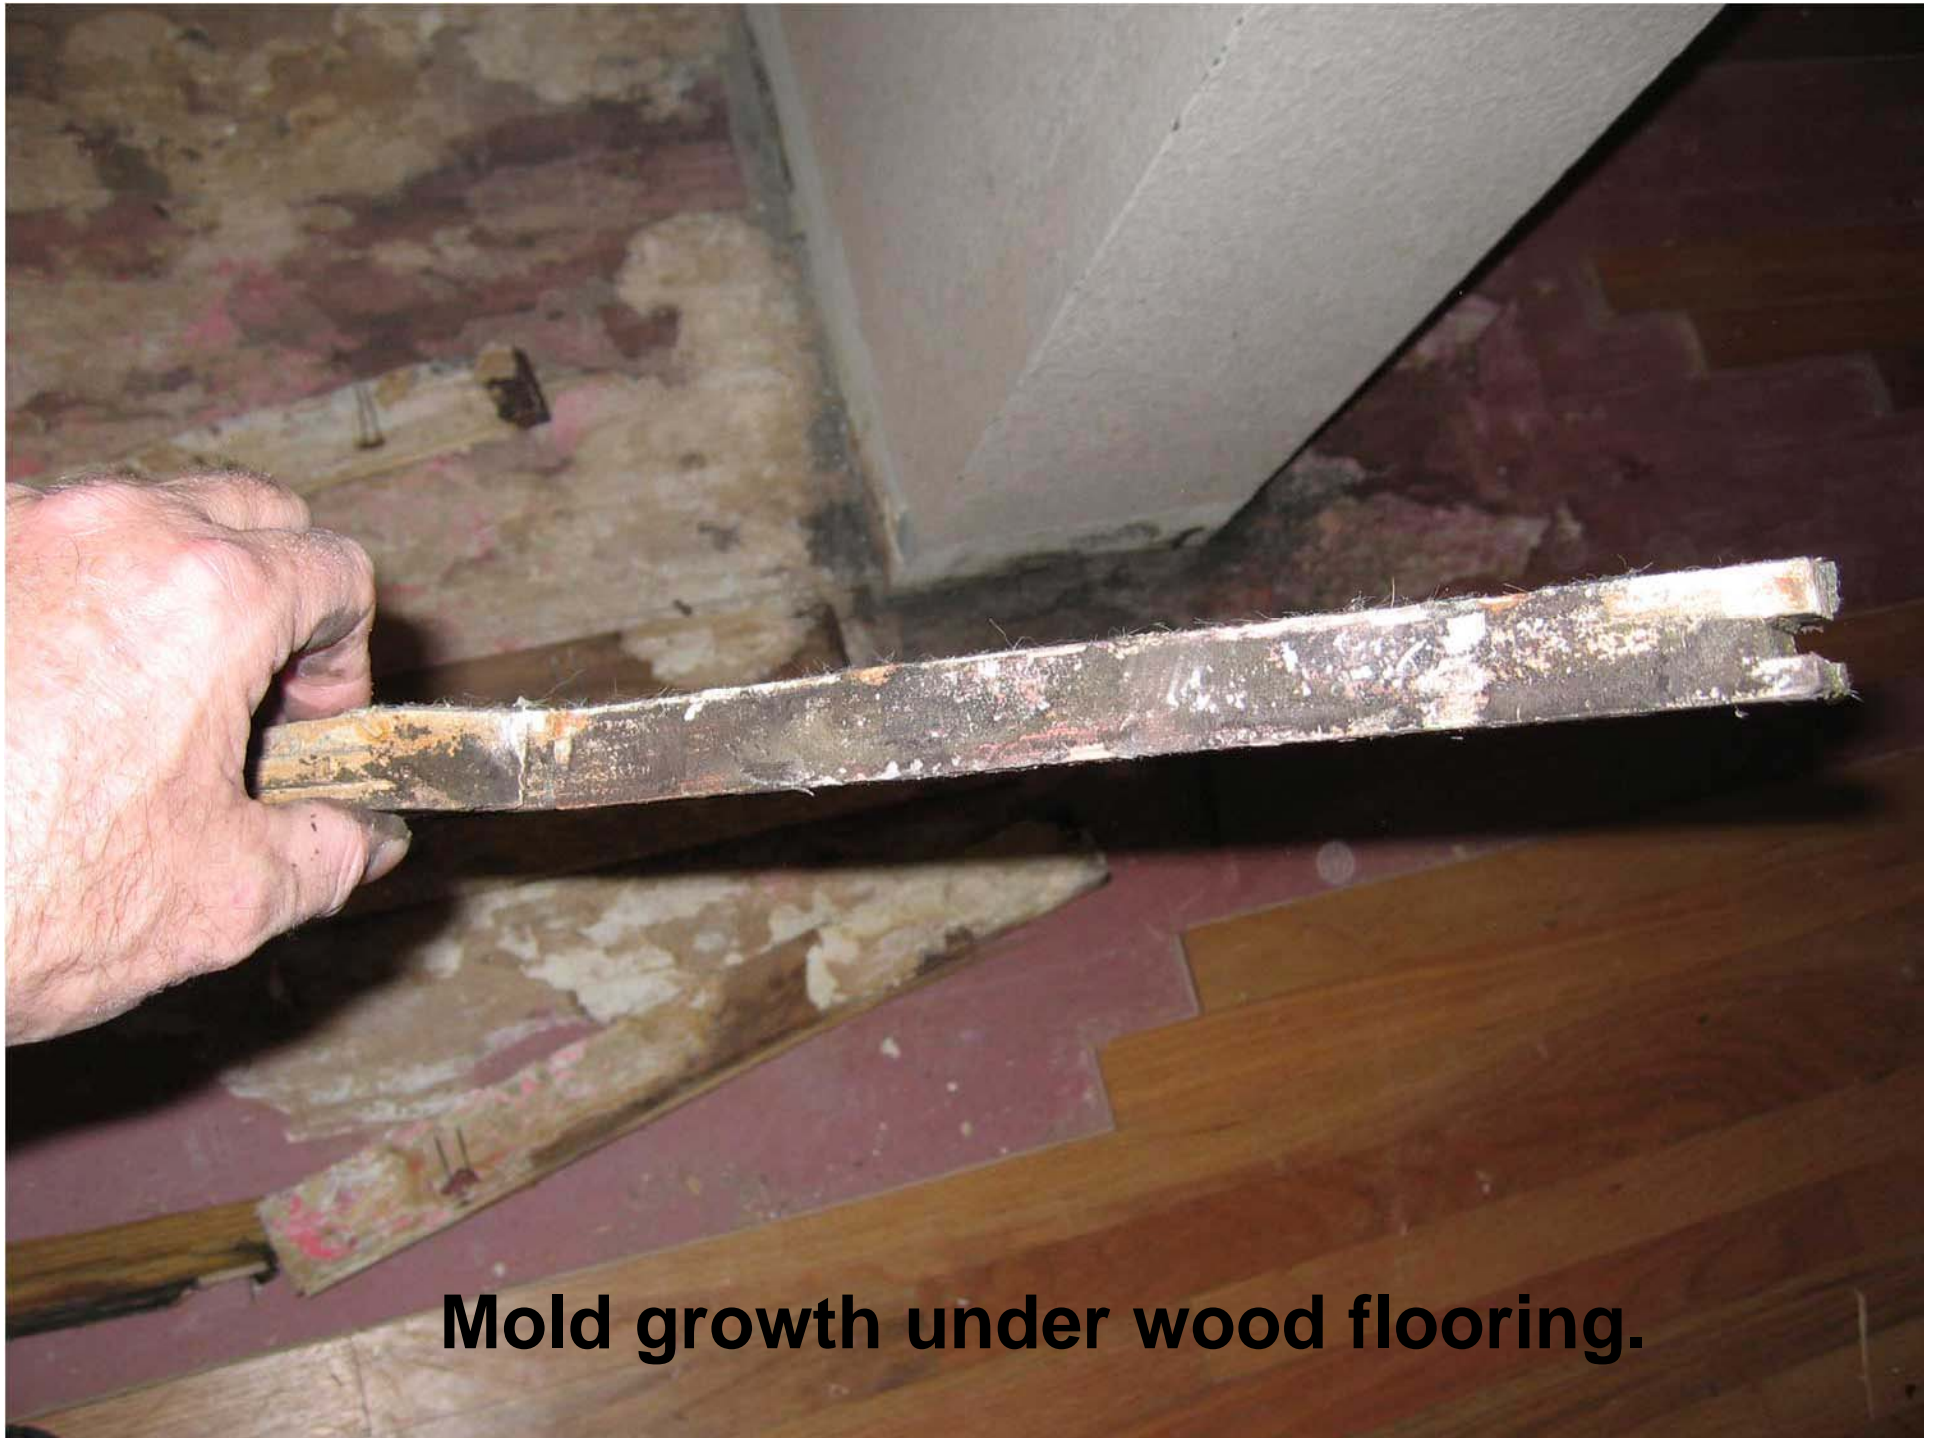
**Mold growth under wood flooring.**

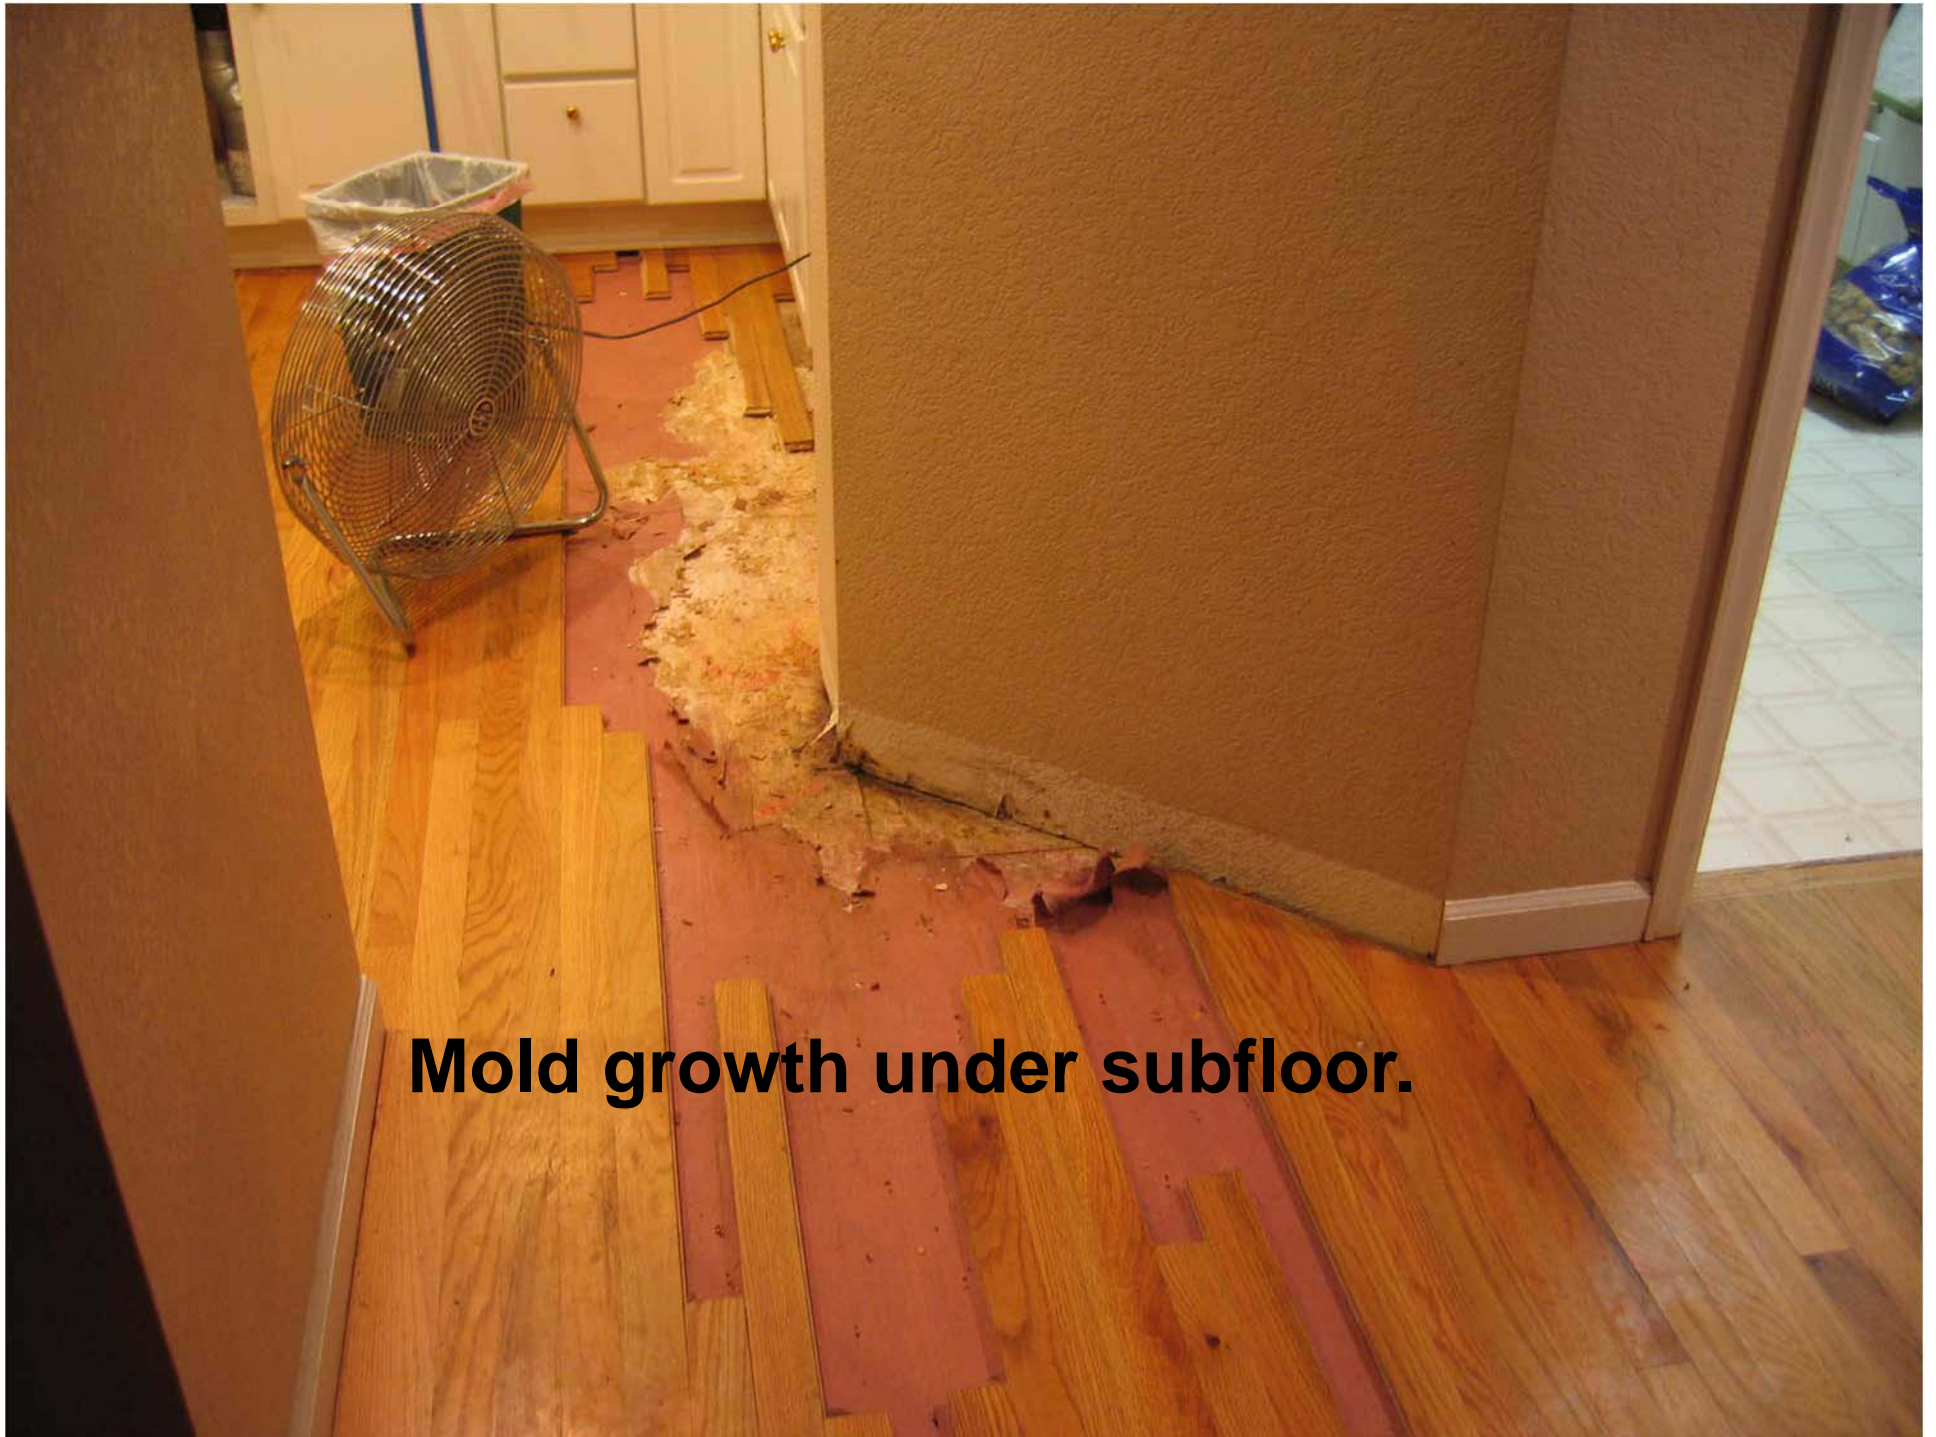
**Mold growth under subfloor.**
