Boulder County Parks and Open Space Small Grant Program

***Rapid Stream Stability Assessment Validation Study
South St. Vrain River, Hall-II
St. Vrain River, Western Mobile***

December 14, 2015

AloTerra Restoration Services, LLC

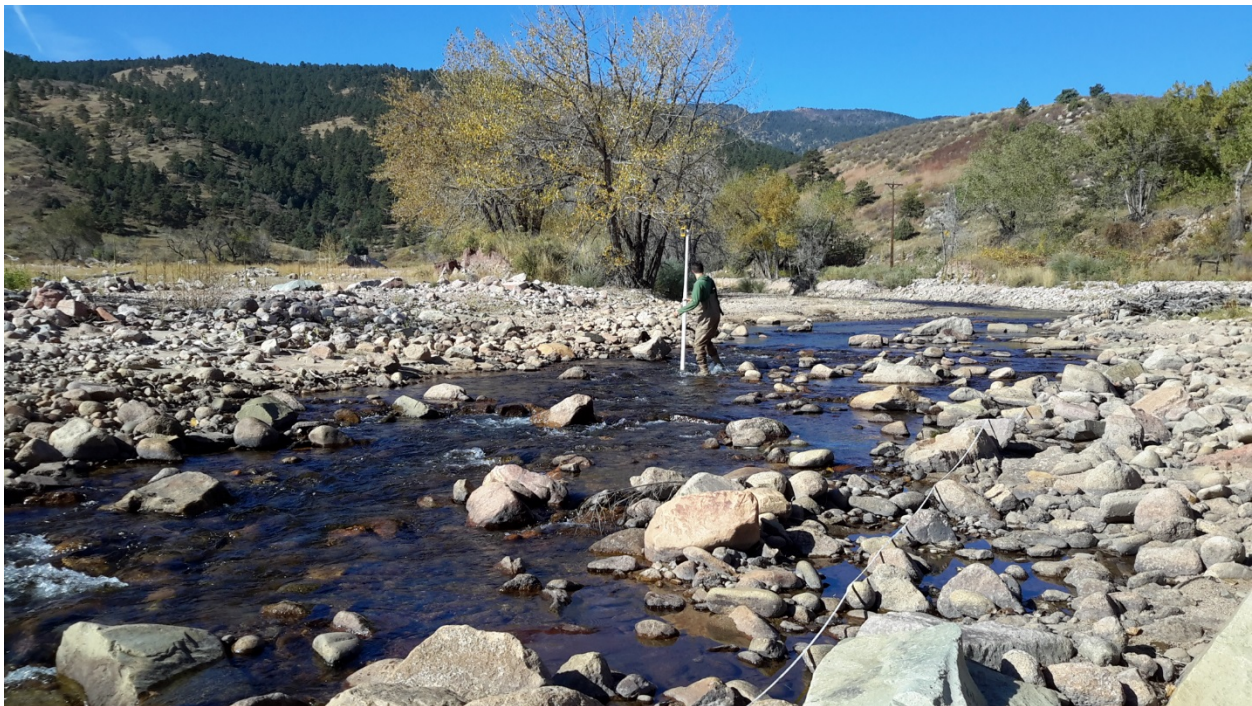
Figure 1. South St. Vrain River at Hall-II property looking upstream.

boulders. Though little vegetation had established on these banks, they were mostly stable having found their angle of repose. Along the downstream-most reach (Hall-3), the banks were composed of cohesive clayey-silt material and were vertical and undercut in some places. Evidence of mass-wasting in some locations was evident. As indicated in Table 3, below, the banks of this reach were most unstable. The Hall-1 and Hall-2 reaches were fairly similar in their bank stability metrics.

Based on results from the SSA and our overall observations, very little woody or herbaceous vegetation was observed on banks or in the entire riparian zone because of severe floodplain scour and deposition from the recent floods. Negligible recruitment of woody vegetation was observed as well, though some live mature cottonwood trees were observed near the active river channel. Side or relic channels were observed on either side of the main channel in the floodplain. Based on observations from pre-flood aerial photographs, the main channel has shifted south from its previous location where it ran up against the bedrock bluff located at the north end of this site.

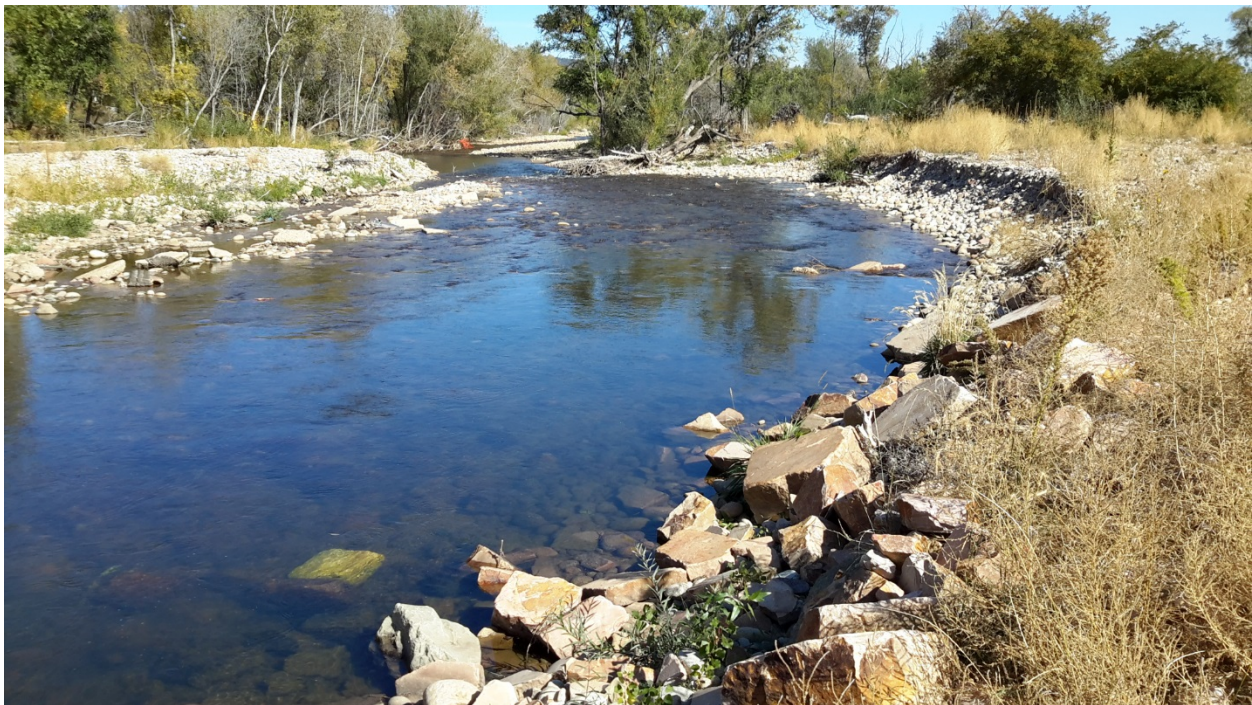
Two reaches were assessed along the main stem of the St. Vrain River near the Western Mobile property. Based on pre- and post-flood aerial photography, a meander bend migrated several hundred feet downstream cutting into the left bank (Figures 5-6). The channel also avulsed at this site taking a temporary southern route. This avulsion resulted in bank and floodplain scour on river right as well as sediment deposition. It appears that the right bank has been re-constructed at this site and several hundred feet of boulder-sized riprap have been installed. Some of this riprap has stabilized the cohesive banks located behind this revetment, but evidence of rip-rap and bank failure was observed over at least 100 feet of bank. It appears that this rip rap was hastily

installed. The thin layer and lack of size gradation have allowed high flows to scour the bank material behind this rip rap.

This section of river is very wide, possibly over-widened due to the flood, with top-of-bank widths ranging from approximately 110 to 150 feet and width-to-depth ratios of 16 to 25. Mid-channel bars observed along WM-1 may indicate that the channel is aggrading and beginning to narrow. The banks of WM-1 are very steep and unstable, especially on river left where maximum bank height is about 9.5 feet. The WM-2 reach is a meander bend with more shallow banks on river right and a point bar on river left (max bank height \approx 4.5 feet). Negligible vegetation exists on the banks and riparian area of WM-1. A mature cottonwood and willow forest exists on river left of WM-2 at the edge of the active point bar. Approximately two year old cottonwood seedlings were observed along the toe of the right bank of the downstream end of WM-1 and upstream end of WM-2 providing some level of stability to these banks. However, no perennial vegetation was observed within the rip rapped portion of this bank, only annual herbs and grasses.

Figure 2. St. Vrain River at Western Mobile, looking downstream.

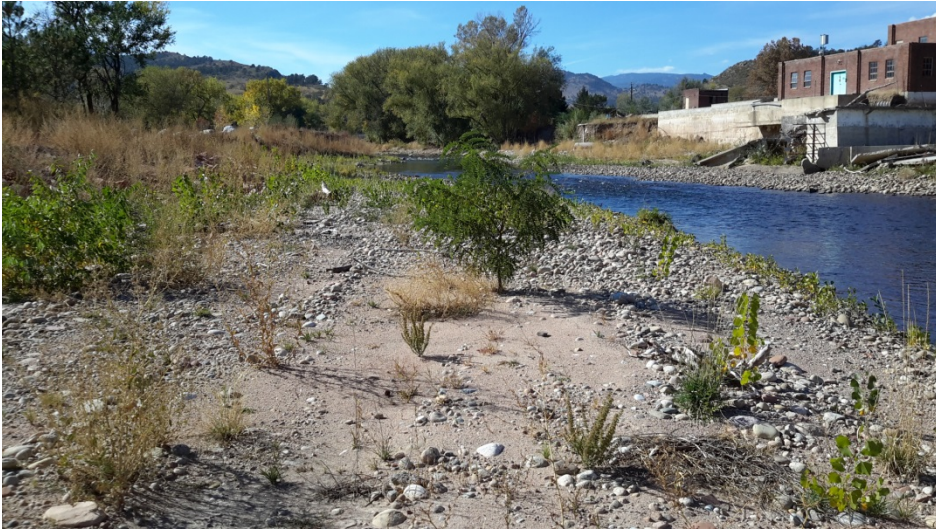
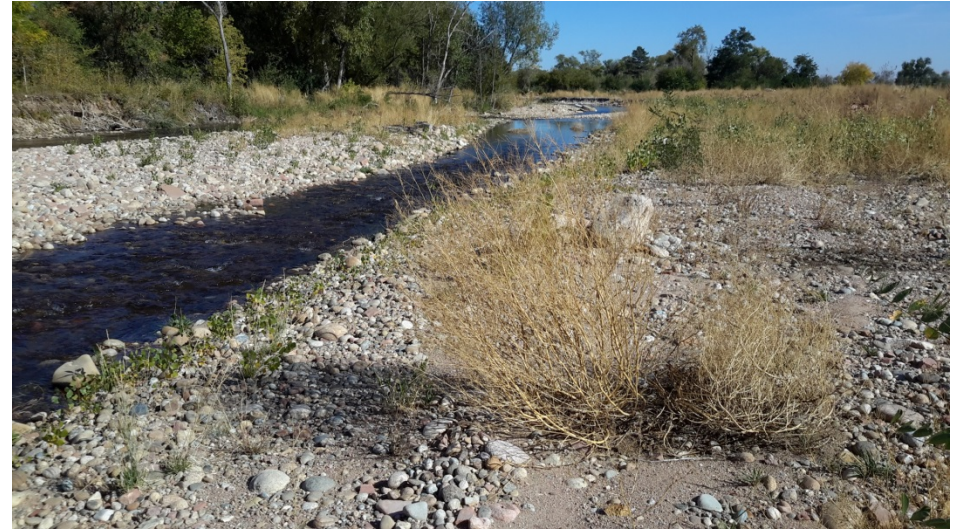
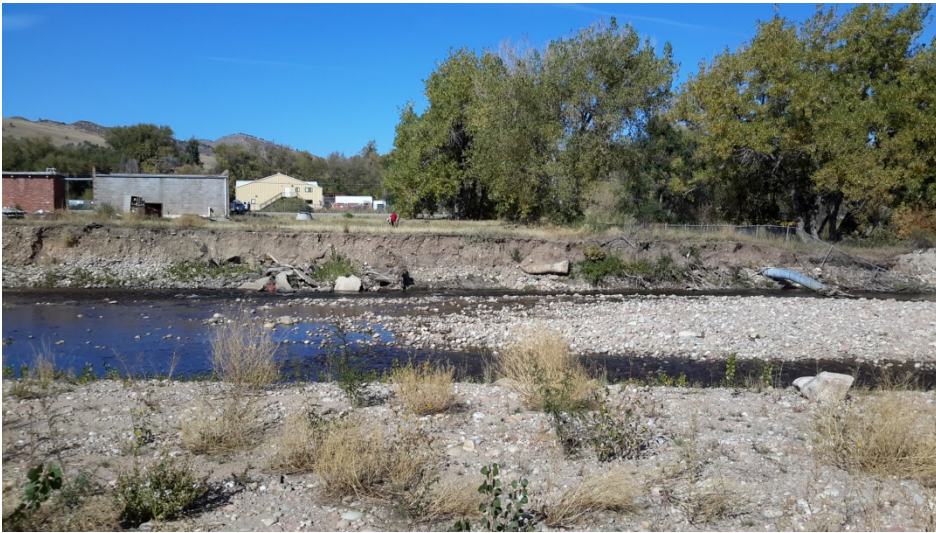
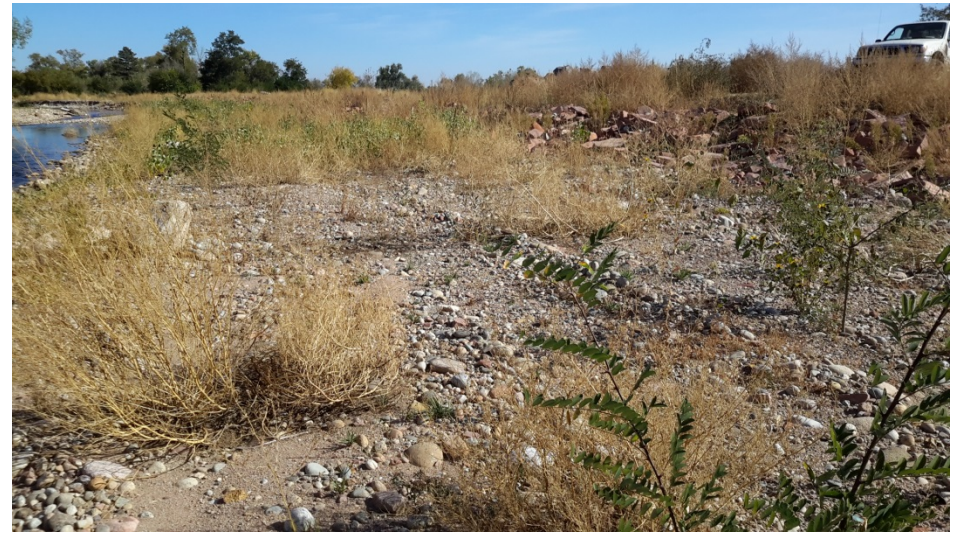
REACH NOTES: Channel widened from flood. Cohesive banks undermined in places along bank toe. Mid-channel cobble/gravelbar. Stratified bank aiding in bank undermining / failure. Groundwater leaking out of bank face on this hard pan. Some boulders. Bank failure in places on LB. Mass-wasting. Floodplain high and dry on LB.

Western Mobile Reach 1. Clockwise from top left: upstream, downstream, left bank, right bank.

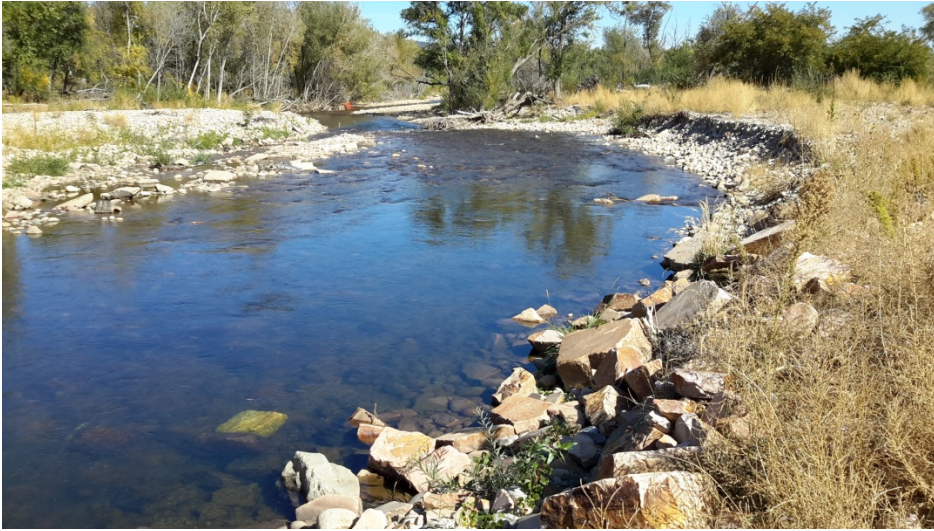
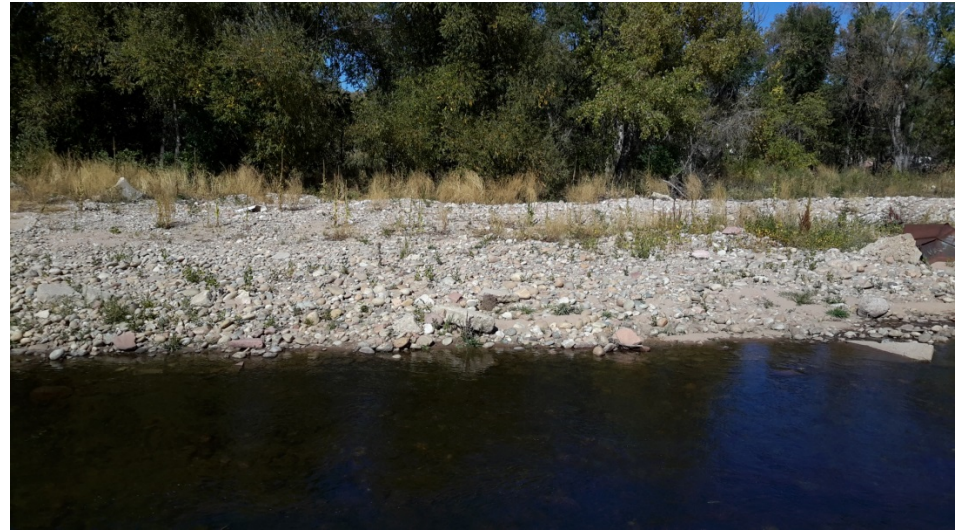
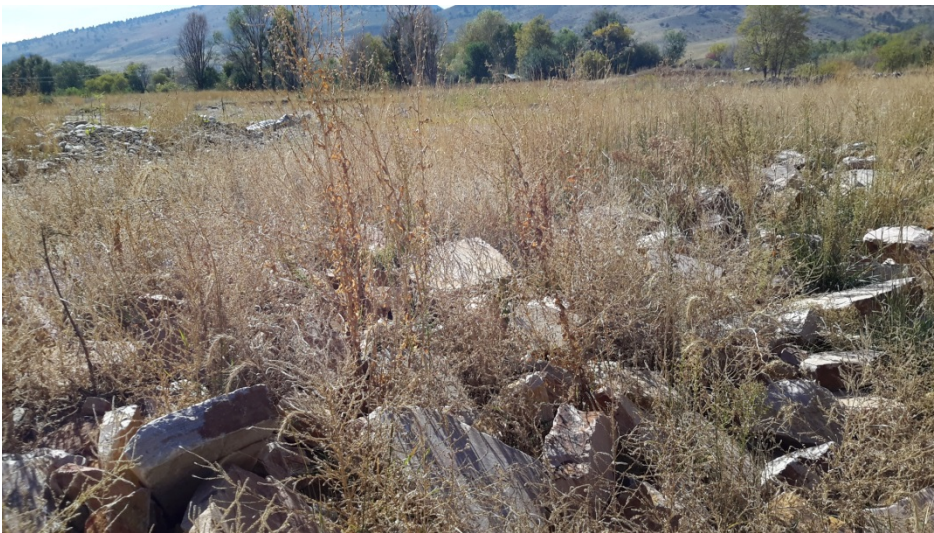
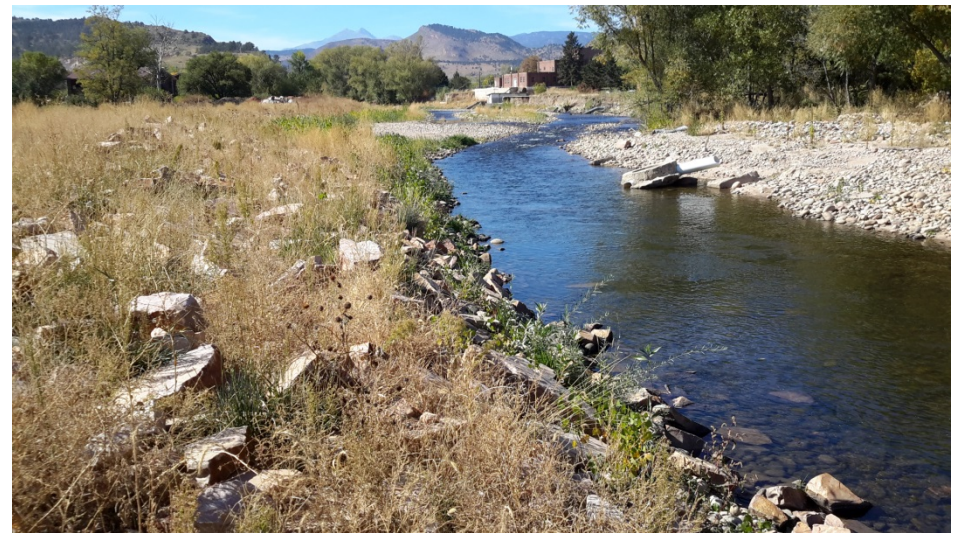
REACH NOTES: Reach is along a cutbank on the right bank. Riprap on RB is failing along ~50 ft at location of max bend shear stress. Left bank is a point bar composed of cobble, gravel, and sand. Good tree cover on LB, none on RB, which is high and dry. Surveyed from toe of riffle to toe of riffle.

Western Mobile Reach 2. Clockwise from top left: upstream, downstream, left bank, right bank.
