Reach 4b SSV1 and SSV2

Weekly Construction updates

Date: 10/18/2017

Location: South St. Vrain, West of Lyons, CO

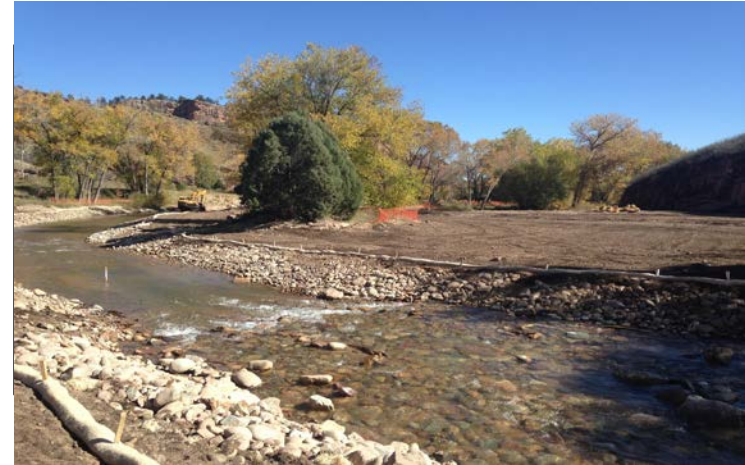
Downstream View, Right bank: Creek platform, floodplain benching, fine grading and soil conditioning between main St. 84+50 to 88+00.

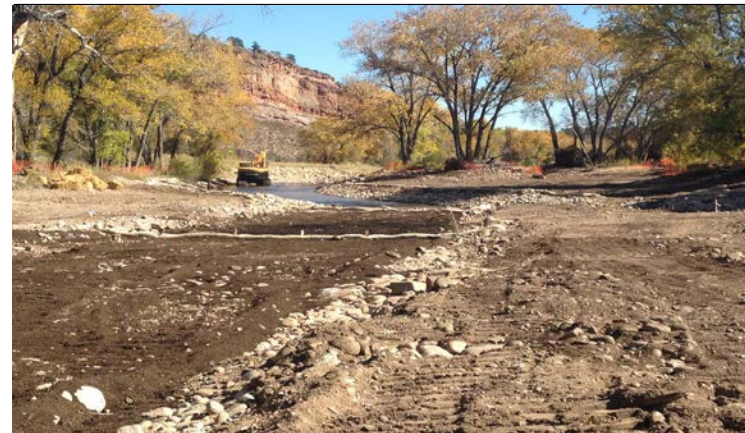
Downstream View: Buried rock ramp and confluence of overflow channel A and main channel.

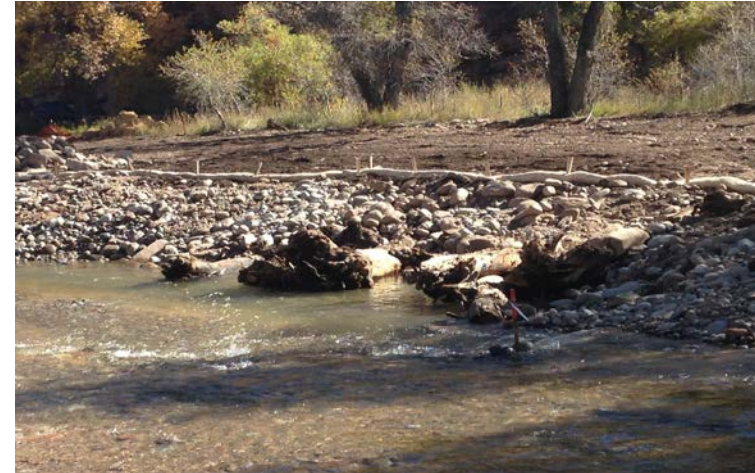
Downstream view: Type 2 large woody structure at main channel St. 89+90 right bank .

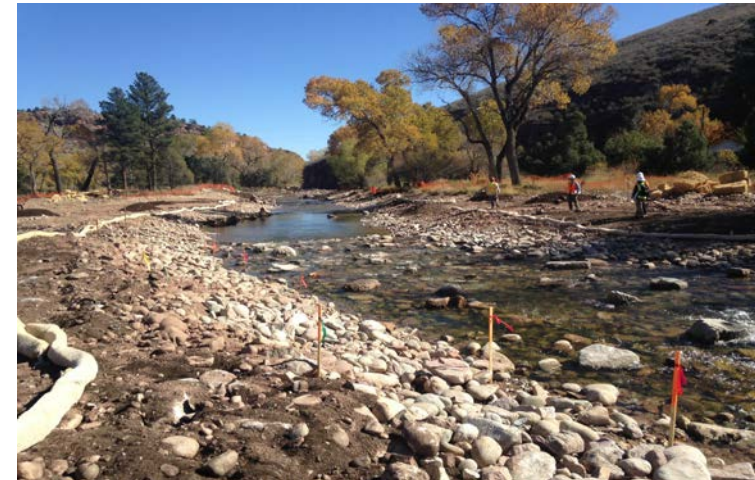
Downstream View: Boulder toe bank stabilization with cobble as filler and face material between main channel St. 92+94 to 94+30 left bank.

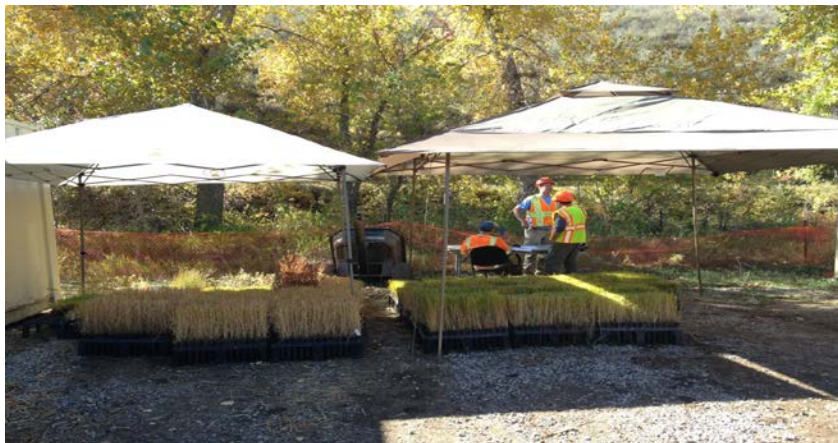
Perennial tubelings staged for riparian areas.

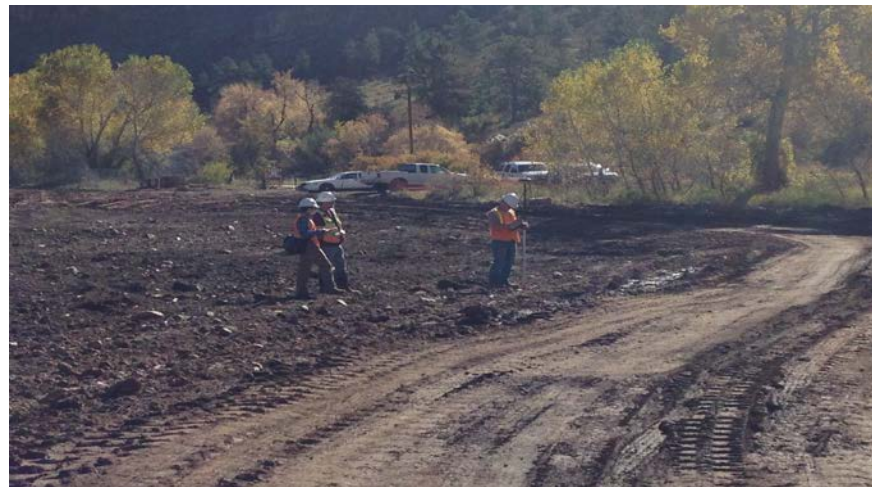
Spot checks and grade verifications of right flood plain between St. 74+00 to 82+50.

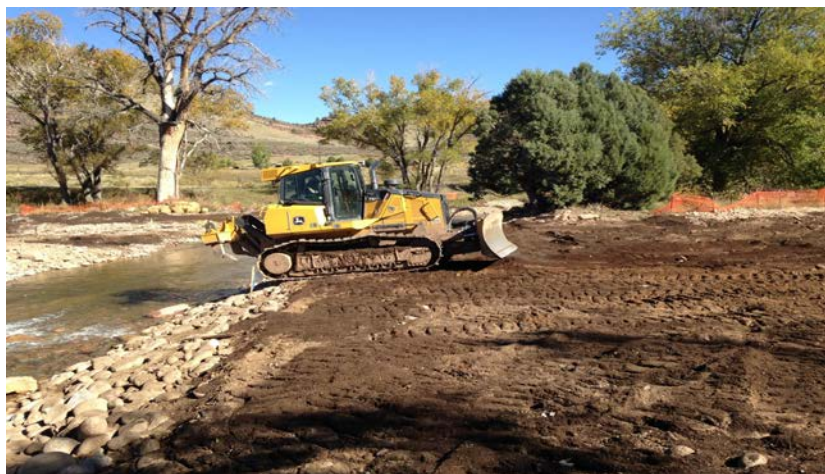
Downstream View: Soil Conditioning in progress in right floodplain adjacent to main channel St. 86+50.

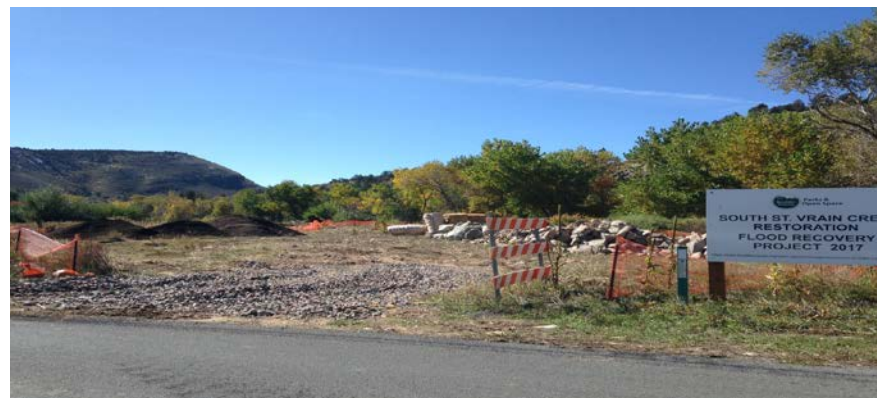
SSV2 staging area with project limits delineated
