# Hall Ranch II Access Road Repair and Hazard Mitigation

## Weekly Construction updates

**Date: 05/01/2018**

**Location: South St. Vrain, West of Lyons, CO**

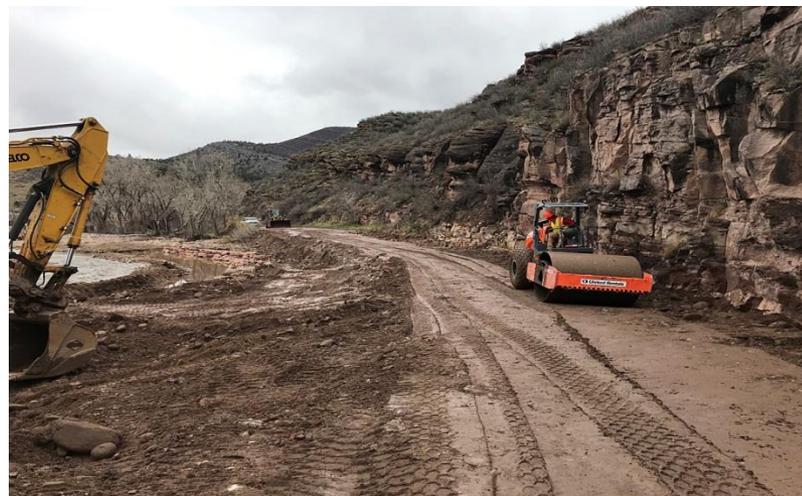
**Looking Downstream: construction of compacted soil lifts at washout road location.**

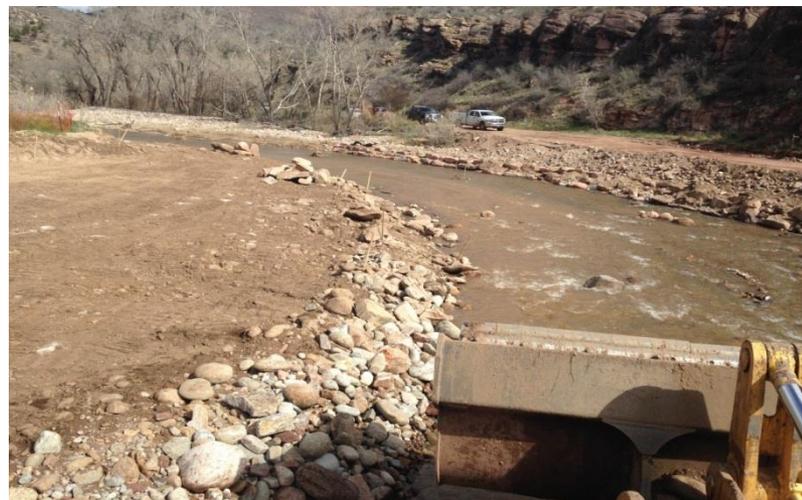
**Looking downstream: cobble toe river left bankline construction.**

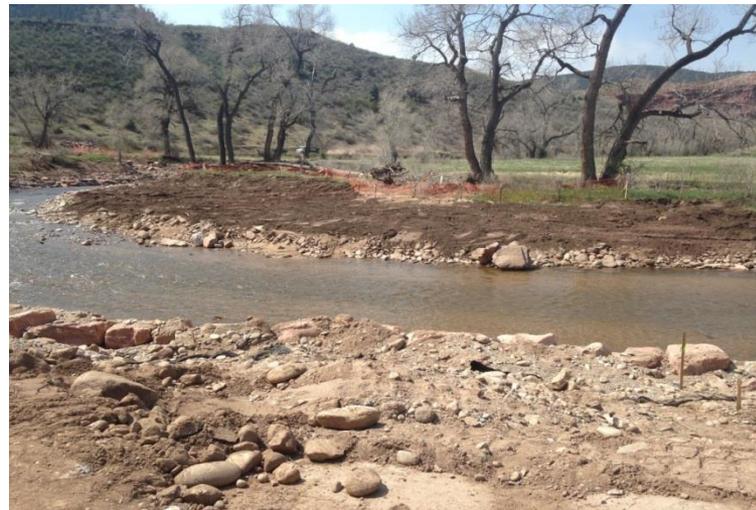
**Looking upstream: River left floodplain tie-ins and top soil placement.**

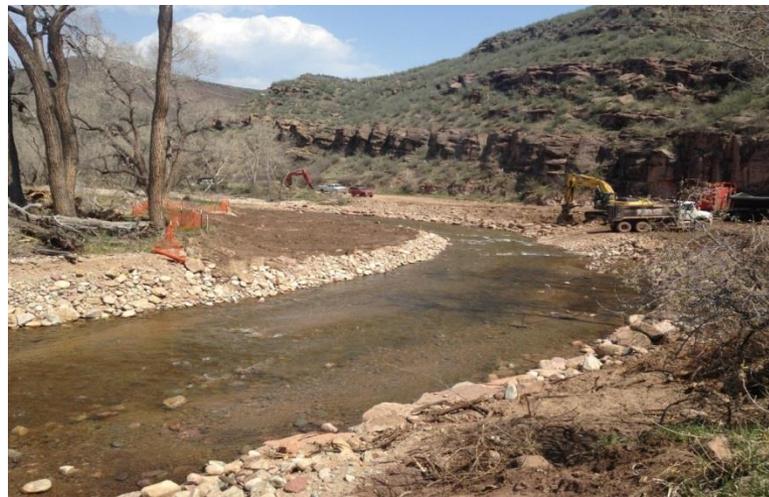
**Looking downstream: Construction of low flow channel**

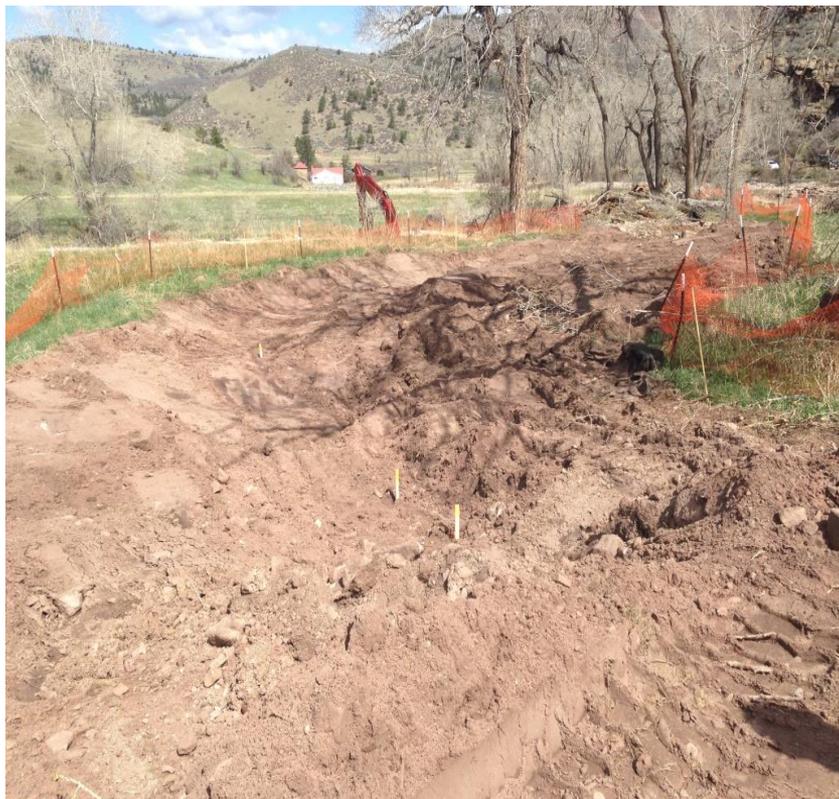
**Looking downstream: excavation of downstream ditch profile to creek outfall .**

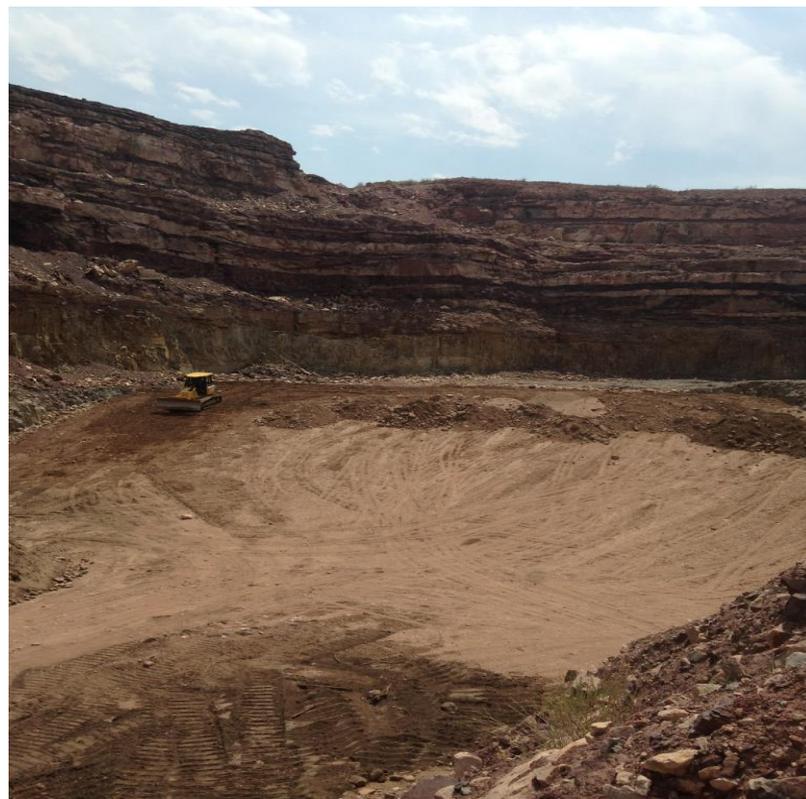
**Material disposal in Lyons Quarry**
