CONSTRUCTION REPORT ST. VRAIN CREEK REACH 3 RESTORATION

Construction Report St Vrain Creek Reach 3 Restoration Boulder County, Colorado

Project No. 110666

June 2018

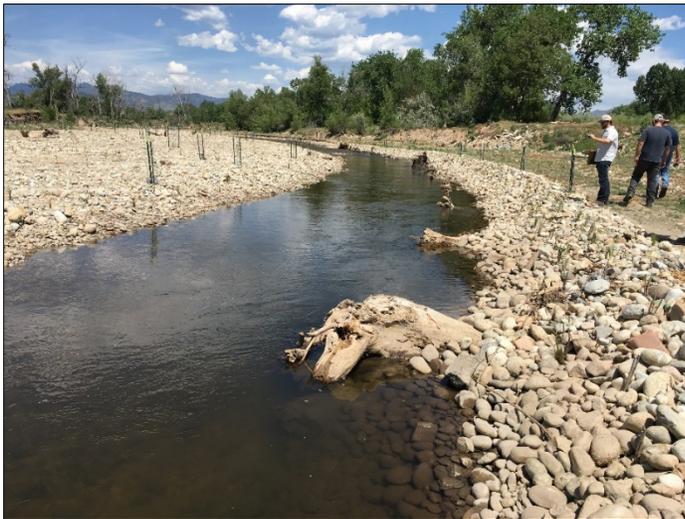
Observed rack lines provided evidence that at some locations the channel started to extend beyond the constructed bankfull channel during the higher flow event.

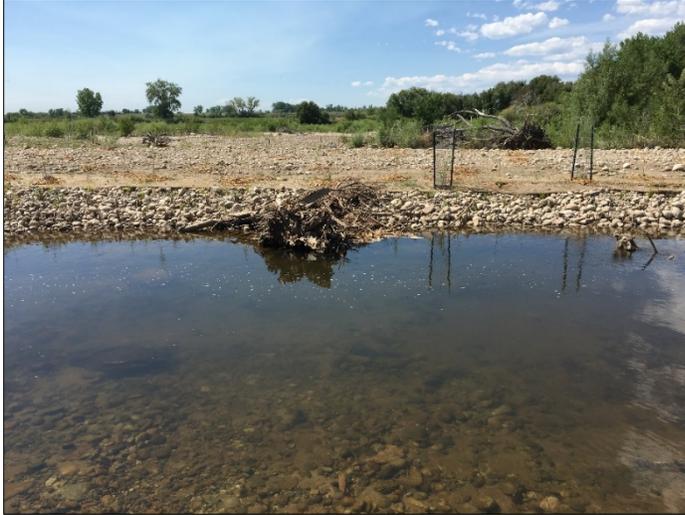
Root wads in this modified (lowered 0.5 feet) Type D bank stabilization provided good channel complexity while helping to maintain a stable channel bank.

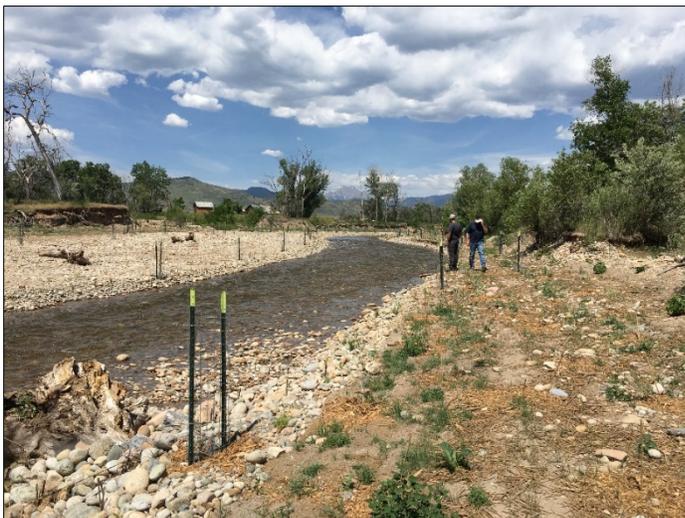
Installed root wads also appear to be creating some flow irregularities that are causing some shifting of the channel. It appears that some of the root wads dampened flow along the outside bend so much in areas that they lead to upstream deposition which effectively narrowed the channel. The stream responded by eroding and widening the opposite bank and by shifting the thalweg away from the outside bend in other locations.

The photo shows deposition that occurred upstream of a root wad. Material deposited in the eddy that was created upstream of the root wad and the channel both jumped the bank on river left (right side of photo) and widened on river right. As a result of this sediment pattern the thalweg migrated from the left bank to the right bank.

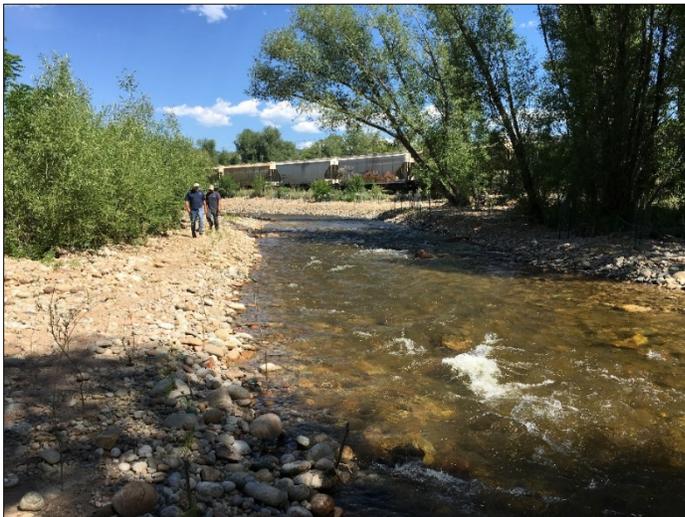
Higher flows caused the channel edges, which were constructed somewhat uniformly, to adjust. The result was a naturally appearing stream edge after the first flows.

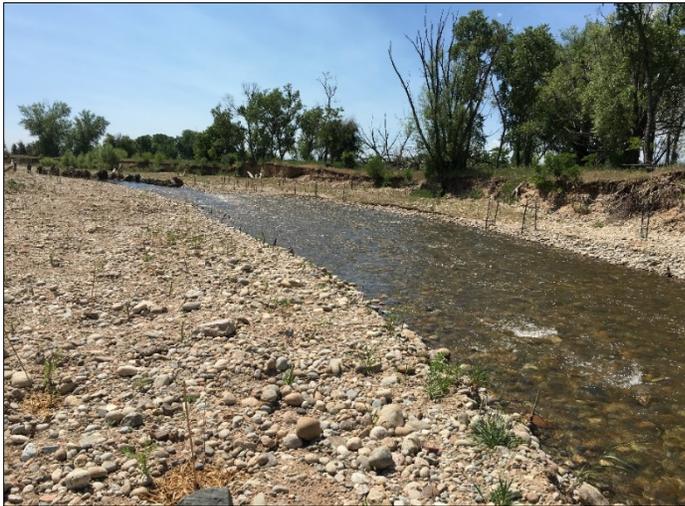
Wetland plugs that were installed in below bankfull had mixed success. Those that were on outside bends and will below bankfull did not withstand the higher flows. Those on inside bends and higher up closer to the bankfull elevation had better initial success. The lesson reinforced by this is that installing plugs within the active channel may not be appropriate. Particularly in locations such as the outside of a channel where scour occurs, this approach doesn't work. Wetland plugs that have had the most success after a single higher flow event are those that were installed in lower elevation depressions outside of the main channel and those that were on inside bends at higher elevations near bankfull.

Wetland plugs shown in the foreground above the current channel wetted perimeter on the inside bend appear to be mostly intact. Plugs on the outside bend (right side of the photo) appear to have all scoured out.

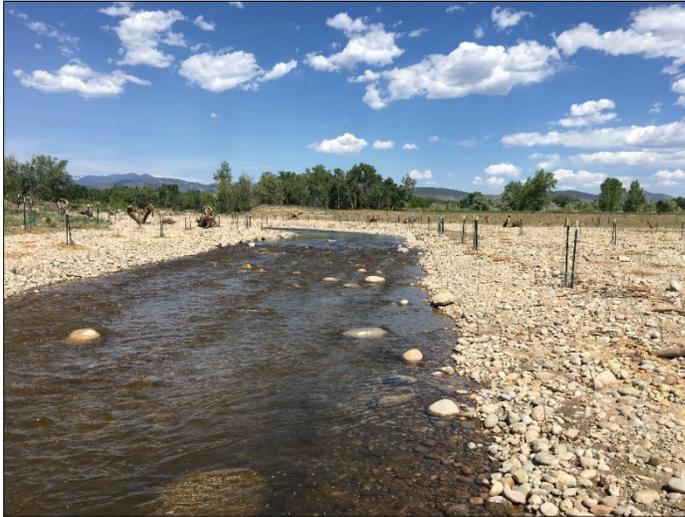
Habitat boulders such as those seen in this photo provide good channel diversity and habitat

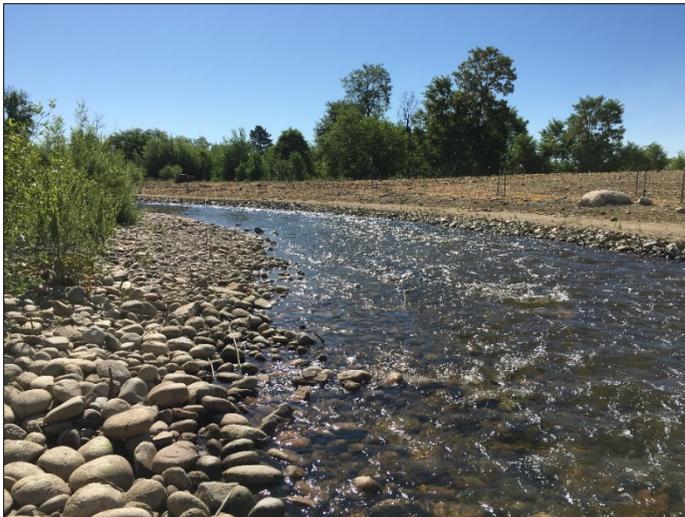
Higher flows brought in additional larger gravels and cobbles that helped the stream take on a natural appearance.

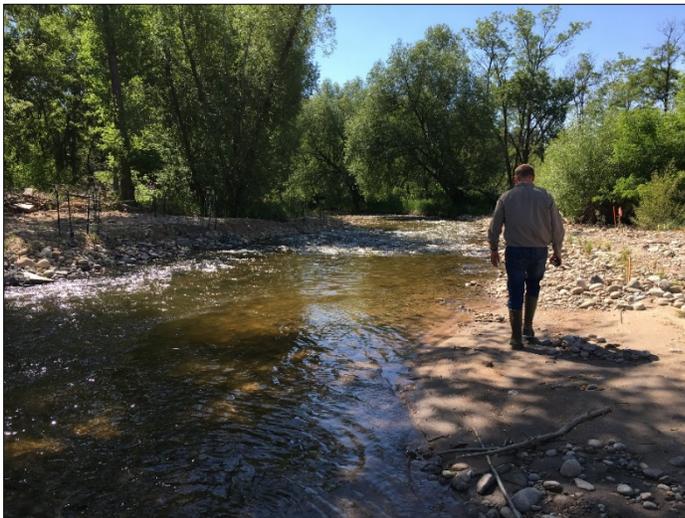
Sand on the inside bend was deposited as a result of the higher flows. These same higher flows created a deeper thalweg at this cross section.

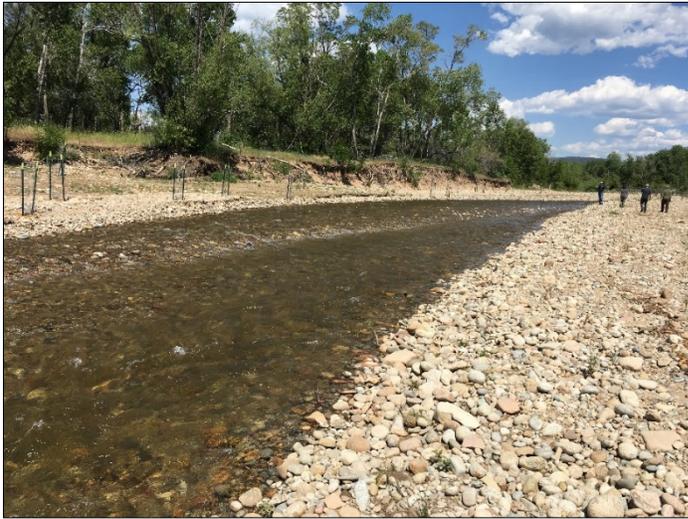
The one location of pronounced channel widening was near station 47+00. In this location it appears that flows didn't get out of their banks and there was erosion from the riffle. This may have been aggravated by the root wads at about station 45+50 backing up flow. Eroded material appears to have deposited in the channel and the stream is overly wide. The worst result in this location is that the channel is wide and there isn't a well defined thalweg due to the deposition of new material. This location should be watched in the future for further evolution.

The mid channel formation shown in this photo at about Sta. 48+00 is likely the result of the higher flows not accessing their banks and higher shear stresses eroding the riffle banks. As the material deposited the channel widened and the feature shown in the photo was formed.

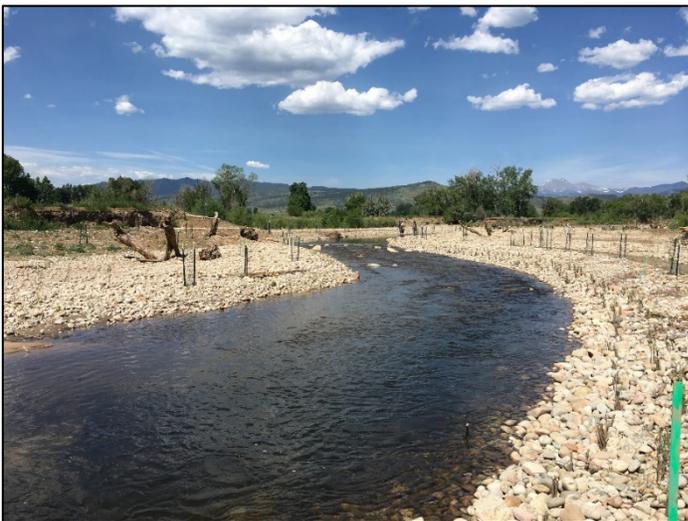
The higher flows worked well with the constructed riffle/pool features and the meandering channel concept. The stream system appears and is functioning in a natural manner.
