ADDENDUM #2
Community Planning & Permitting
Preliminary Design of Crossings at Kenosha Road at Coal Creek and State Highway 7 at
Dry Creek #3
RFP # 7210-21

ANSWER: Please see the attached documents at the end of this addendum for the bridge inspection reports.

KENOSHA ROAD (CR 28) OVER COAL CREEK
INSPECTION DATE 8/31/2020

PREPARED BY HDR ENGINEERING, INC. FOR THE COLORADO DEPARTMENT OF TRANSPORTATION

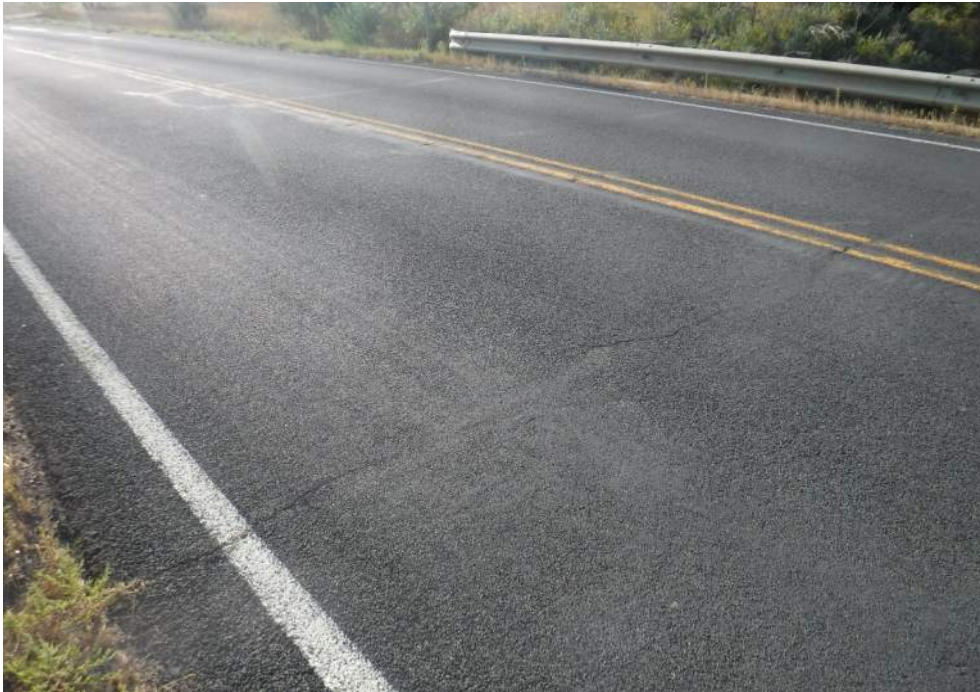
View 7

Transverse crack in asphalt at west end of bridge has been sealed, but is re-cracking.

GENERAL VIEW OF DECK SURFACE

Seal cracks in west end of deck.

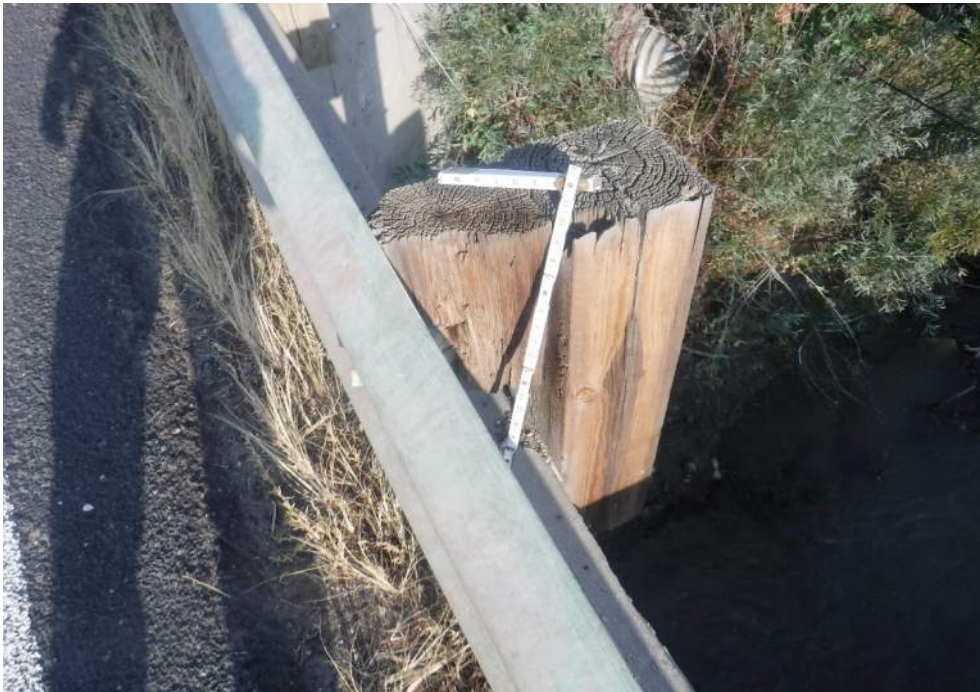
View 10

Broken timber blockout on north rail side, 2nd post from west.

SPLIT SPACER BLOCK AT 2ND POST FROM WEST IN NORTH RAIL

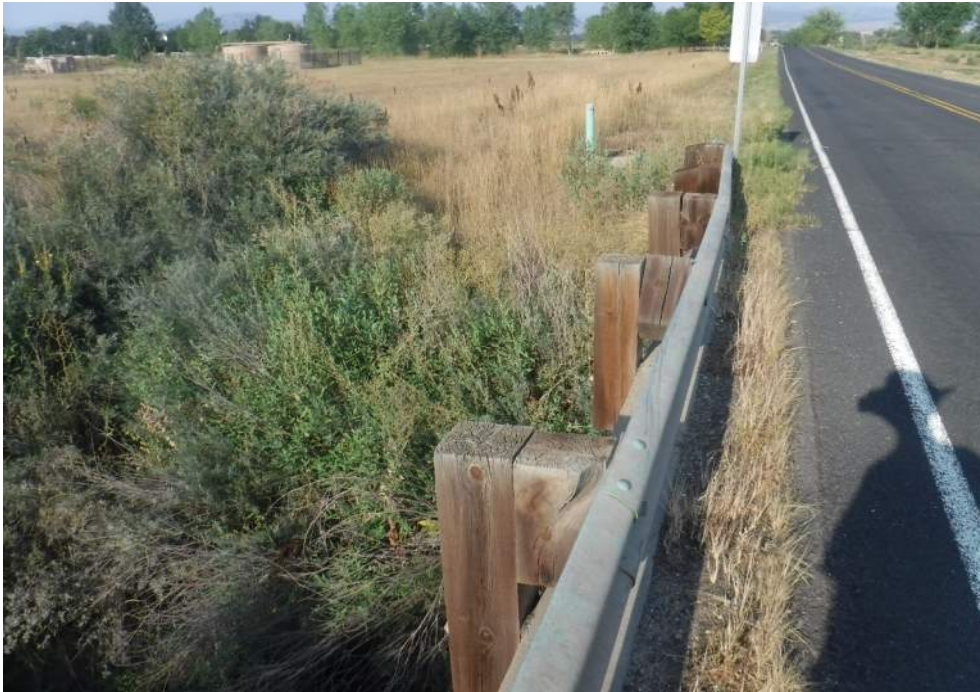
View 11

TWISTED SPACER BLOCKS IN SOUTH RAIL

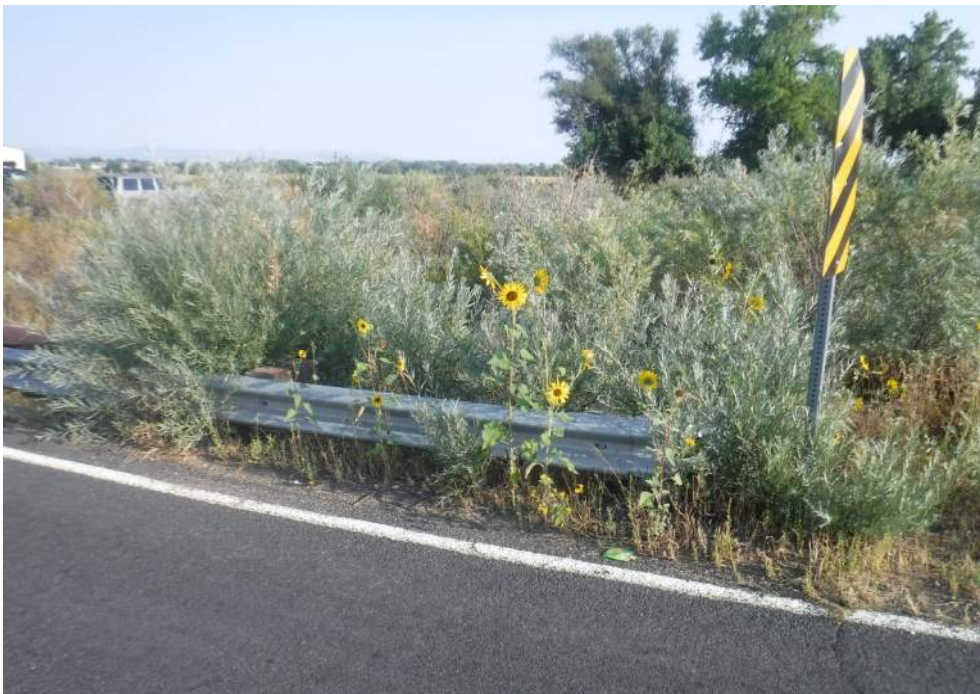
View 12

HEAVY VEGETATION AT NORTHEAST APPROACH RAIL

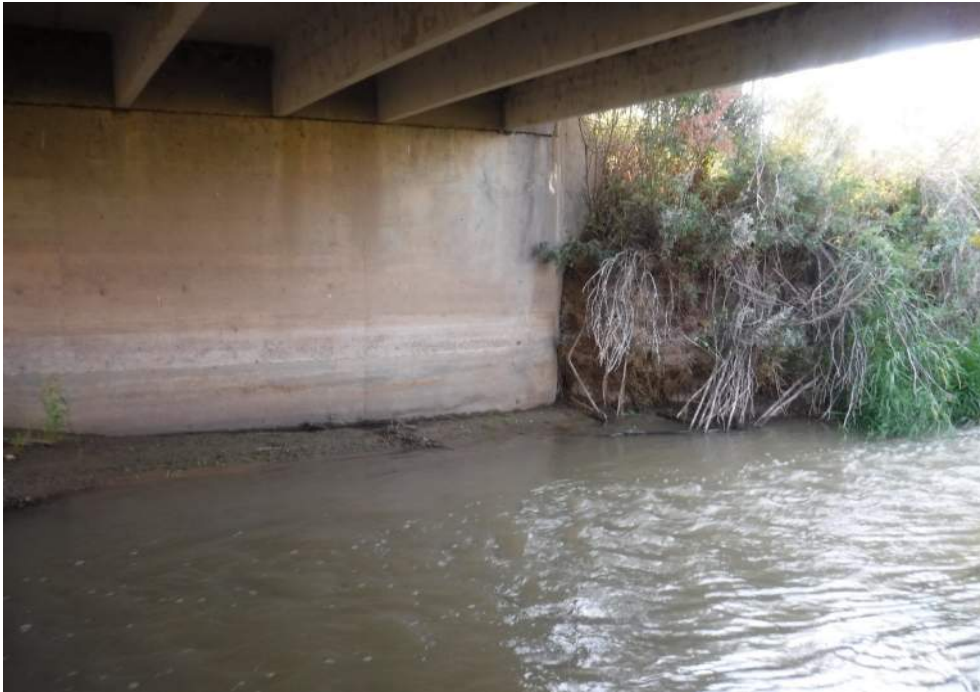
View 13

BANK EROSION AT SOUTHEAST CORNER

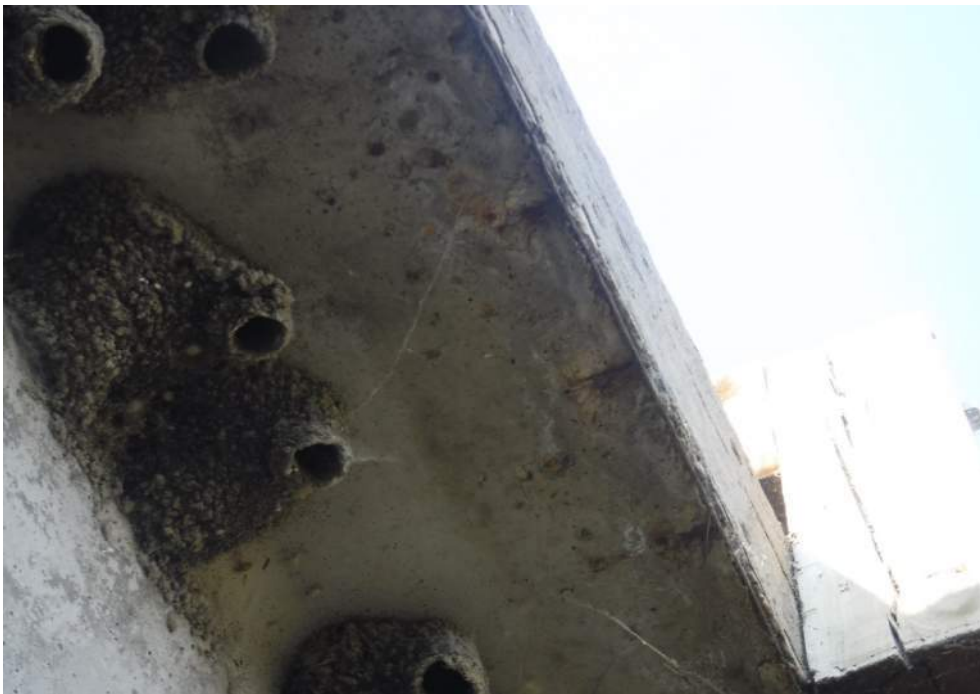
View 14

Exposed and corroded rebar (no section loss), exterior face of Girder H at Abutment 1, 2 inches in diameter and along south edge of Girder H top flange for 60% length. Exposed and corroded rebar (no section loss) approximately 2 inches long in bottom stem of Girder F at Abutment 1 bearing. Exposed and corroded rebar (no section loss) along north edge of Girder A top flange for 30% length.

EXPOSED AND CORRODED REBAR ALONG NORTH EDGE OF GIRDER A TOP FLANGE FOR 30% OF LENGTH

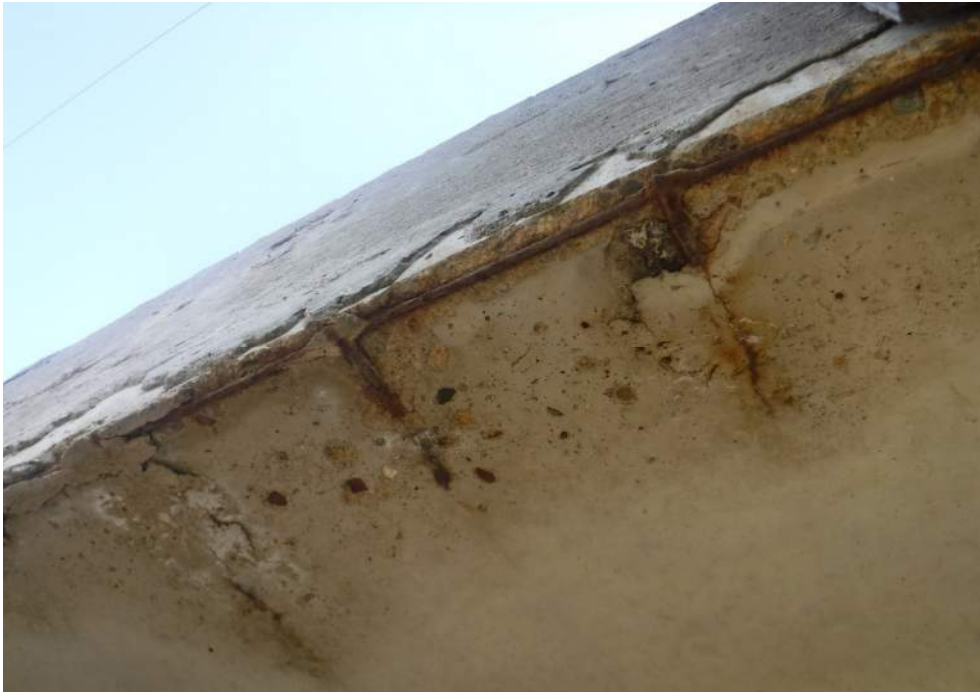
View 15

EXPOSED AND CORRODED REBAR ALONG SOUTH EDGE OF GIRDER H TOP FLANGE FOR 60% OF LENGTH

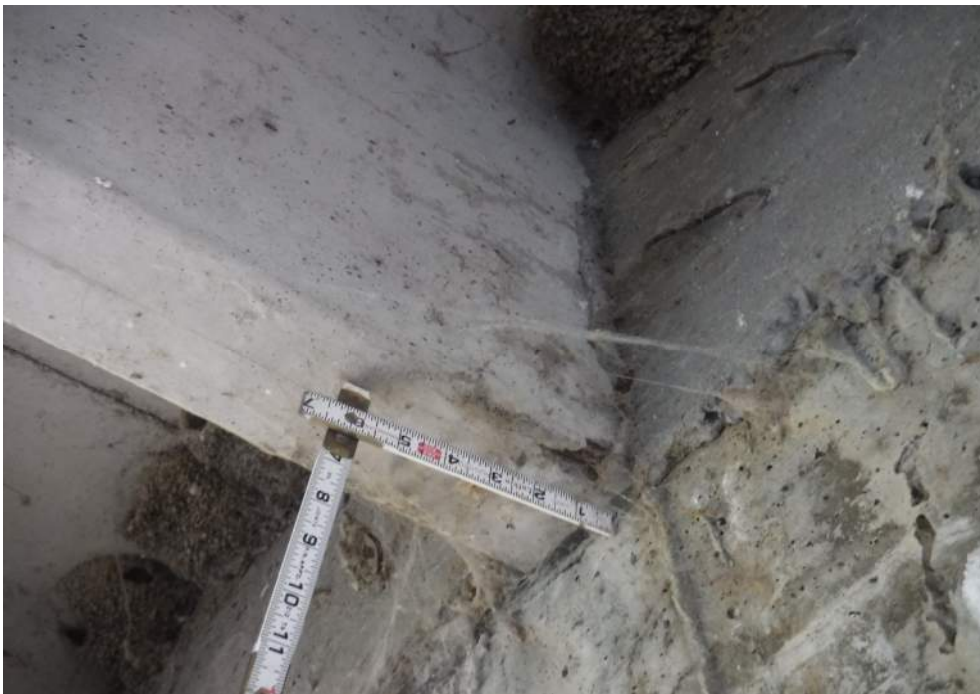
View 16

EXPOSED AND CORRODED REBAR APPROXIMATELY 2 INCHES LONG IN BOTTOM STEM OF GIRDER F AT ABUTMENT 1 BEARING

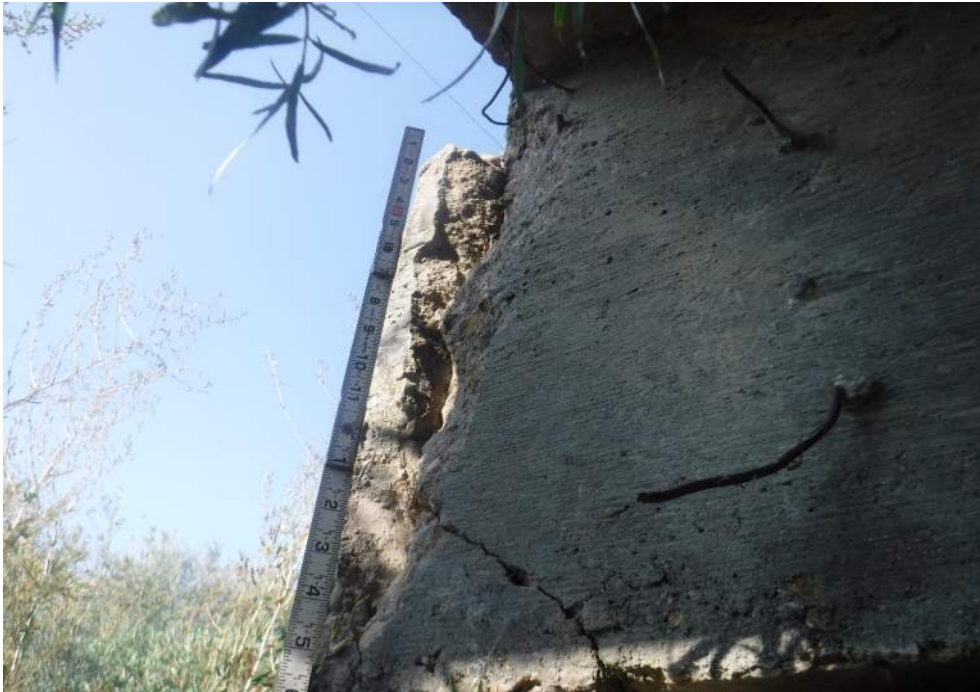
View 17

(4) 24 inch x 7 foot 0 inch double tee girder sections, (8 girders total). 21 inch long x 4 inch wide x 1 inch deep spall in joint of southwest end diaphragm.

21 INCH LONG X 4 INCH WIDE X 1 INCH DEEP SPALL IN JOINT OF SOUTHWEST END DIAPHRAGM

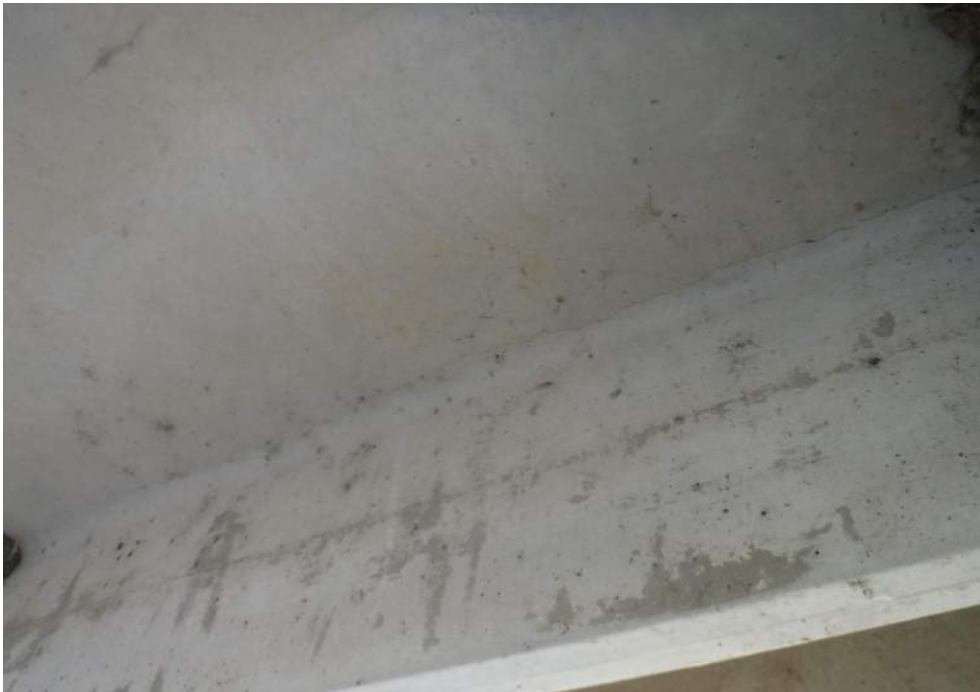
View 18

Cracks up to 0.09 inches wide in fillet of all girders. Full quantity of 252 in CS2 not represented in condition states to eliminate double counting

TYPICAL CRACKS UP TO 0.09 INCHES WIDE IN GIRDER FILLETS

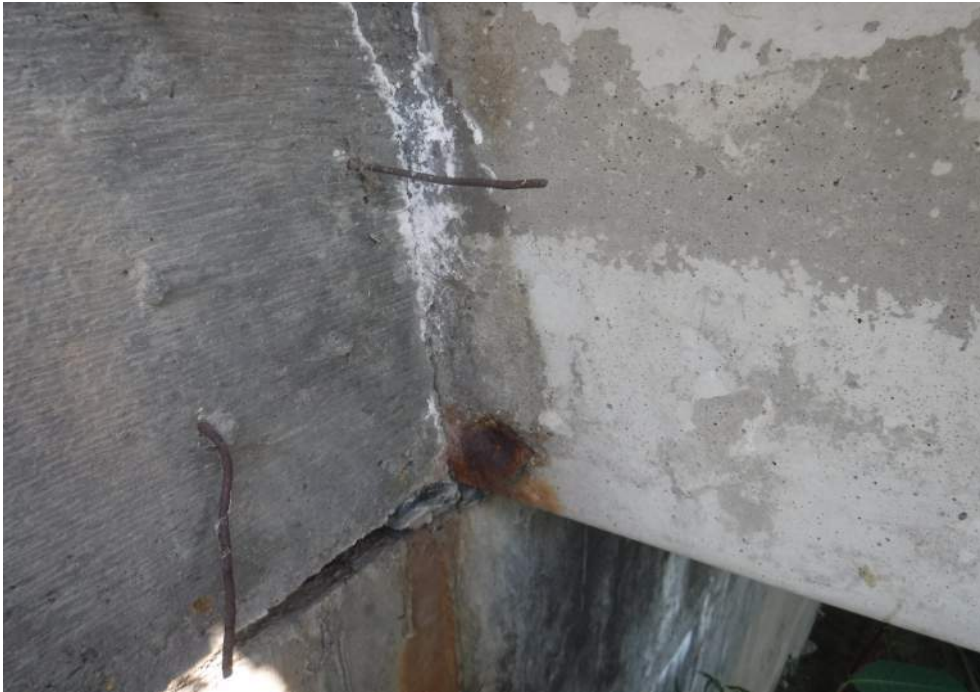
View 19

2 INCH DIAMETER POP OUT WITH EXPOSED AND CORRODED REBAR IN GIRDER H
AT ABUTMENT 1

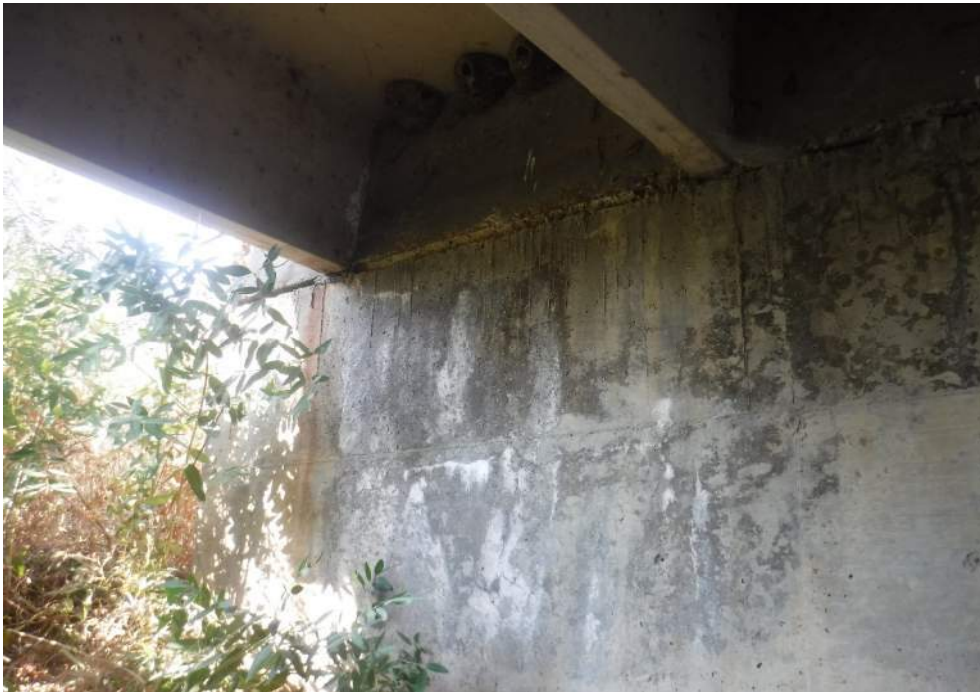
View 20

Few insignificant width vertical and horizontal surface cracks with efflorescence approximately 3 feet long in southwest corner of Abutment 1.

3 FEET OF VERTICAL AND HORIZONTAL SURFACE CRACKS WITH EFFLORESCENCE
THROUGHOUT SOUTHWEST CORNER OF ABUTMENT 1
