USDA Forest Service	Wildland Fire Origin and Cause Supplemental Incident Report (Reference FSH 5309.11, Chapter 20)				Incident Number		22-02-IAIP002										
					Incident Date		12-30-21										
LOCATION																	
Fire Name		Dispatch #	Account Code	Region	Forest	District	State	County									
Marshall Fire-Marshall Mesa Trailhead		COBLX-995	PEPNR9	02	10	1	CO	13									
Origin Location: geographical landmarks, highways, roads, trails, etc.				Township	Range	Section	¼ Sec	Meridian/Datum									
Marshall Mesa Trailhead, Eldorado Springs Rd and Highway 93, Boulder, CO				T1S	R70W	21	NE1/4	WGS 84									
				Latitude (D – M' – S")		Longitude (D – M' – S")											
				39	57	03	105	13 58									
JURISDICTION																	
USFS Only		Identify Other Agency(s)		Lead Origin & Cause Investigator		Est. Suppression Cost		Injuries/Deaths									
N/A		Boulder County Sheriff's Office		Special Agent Travis Lunders		Undetermined		2

USDA Forest Service	Wildland Fire Origin and Cause Supplemental Incident Report (Reference FSH 5309.11, Chapter 20)	Incident Number	22-02-IAIP002
		Incident Date	12-30-21
SYNOPSIS (DATE, FIRE NAME, ESTIMATED ACRES, LOCATION, JURISDICTION); (ESTIMATED

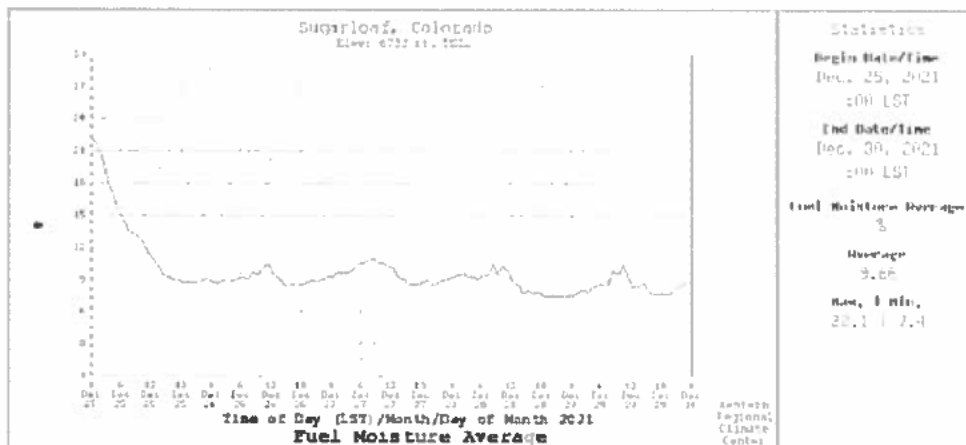
Figure 5: This is the fuel moisture trace for December, 2021 from Sugarloaf, Colorado, which is approximately 10 miles northwest of the Marshall fire ignition area. Fuels were near record dry at the end of December.

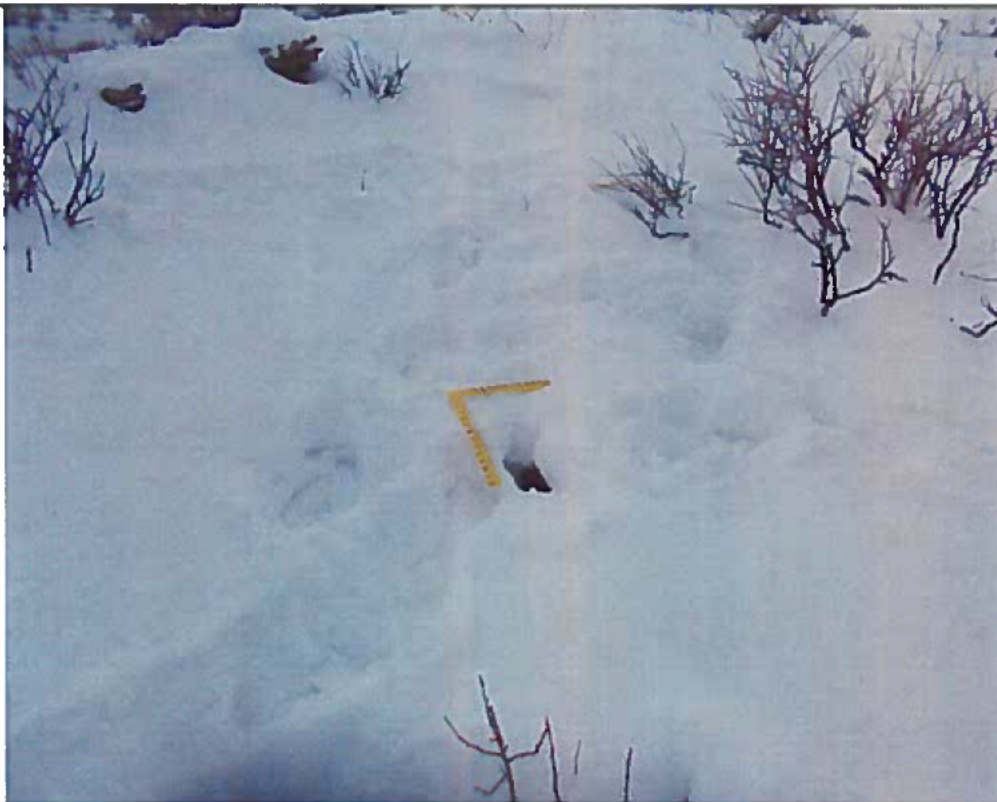
Photograph Number: DSCN 0043

Subject:
Holes created in the snow above
visible holes and cracks in the rock

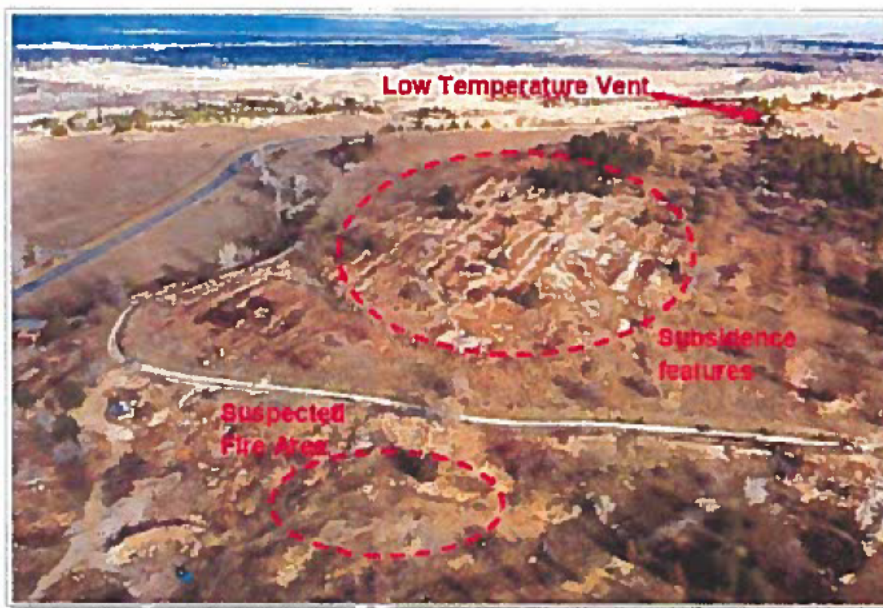
Figure 4-1 – Lewis Mine Fire Looking North

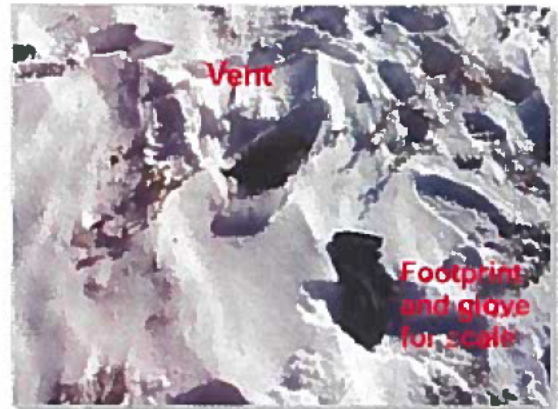
On February 12, 2018, the site was revisited to collect snowmelt pictures. One vent (Figure 4-2) was found at 39° 57' 31.93", 105° 13' 10.49". The gas temperature was slightly above ambient. The landowner mentioned that he has observed steam and snowmelt in the winter time in an area south of the lined irrigation ditch, but that area was not active at the time of this inventory.

Figure 4-2 – Lewis Mine Fire Vent

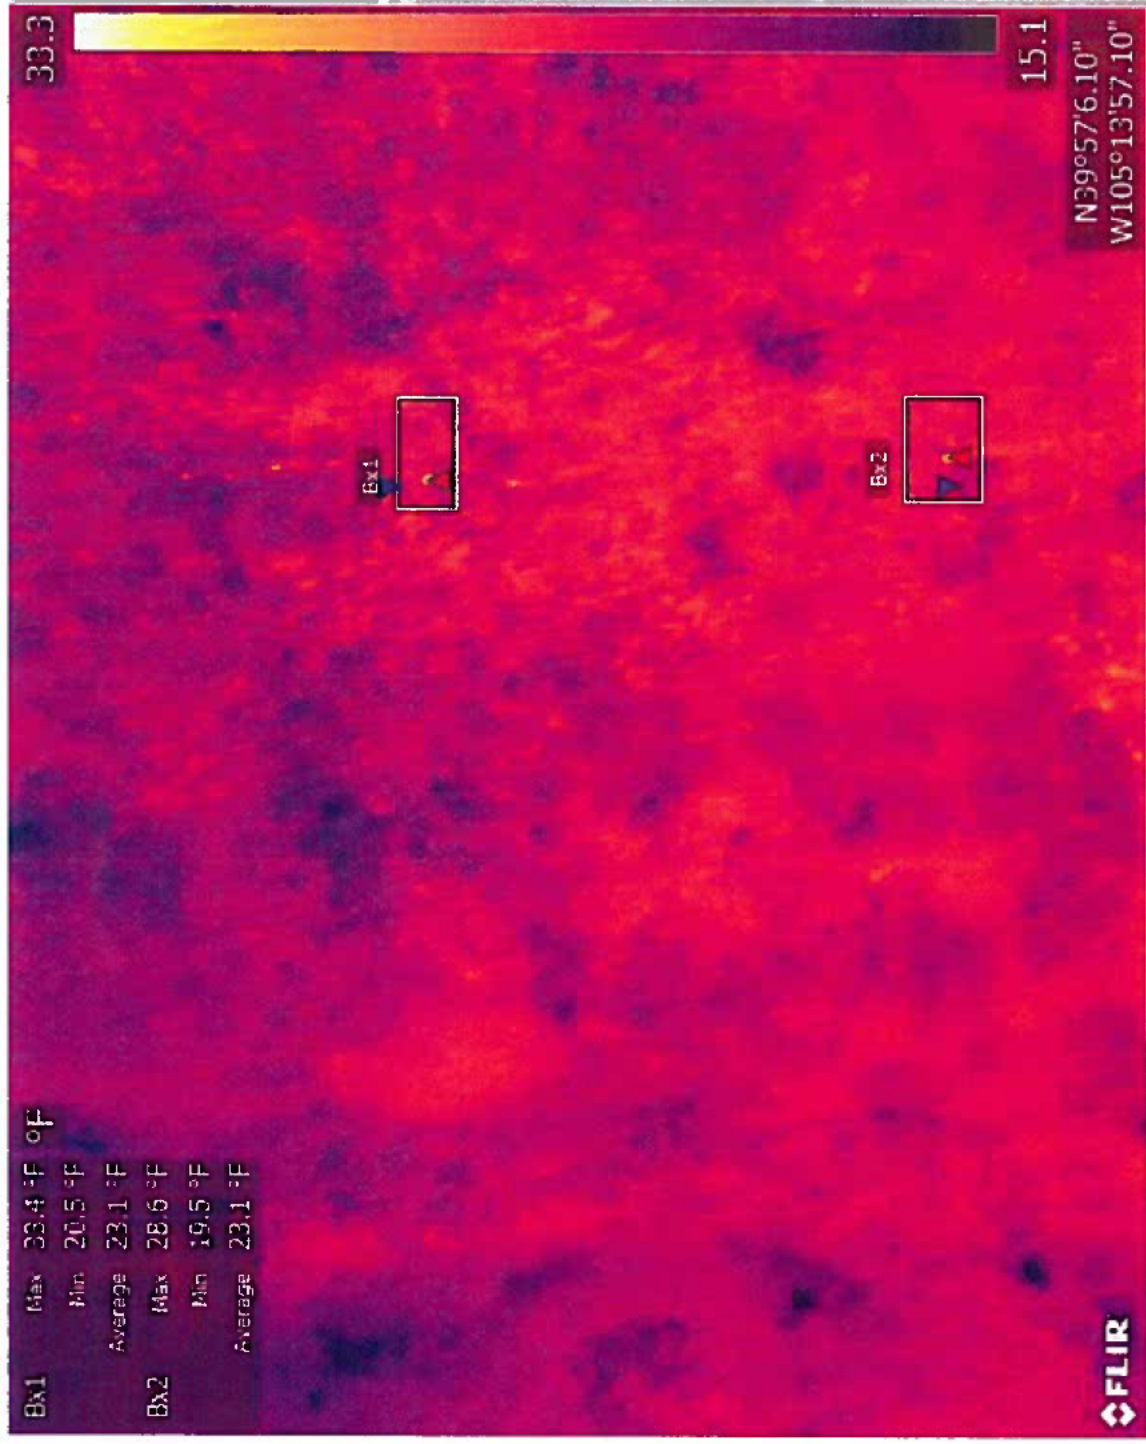
Photo S1 – Holes along buried fracture in Reclaimed Surface

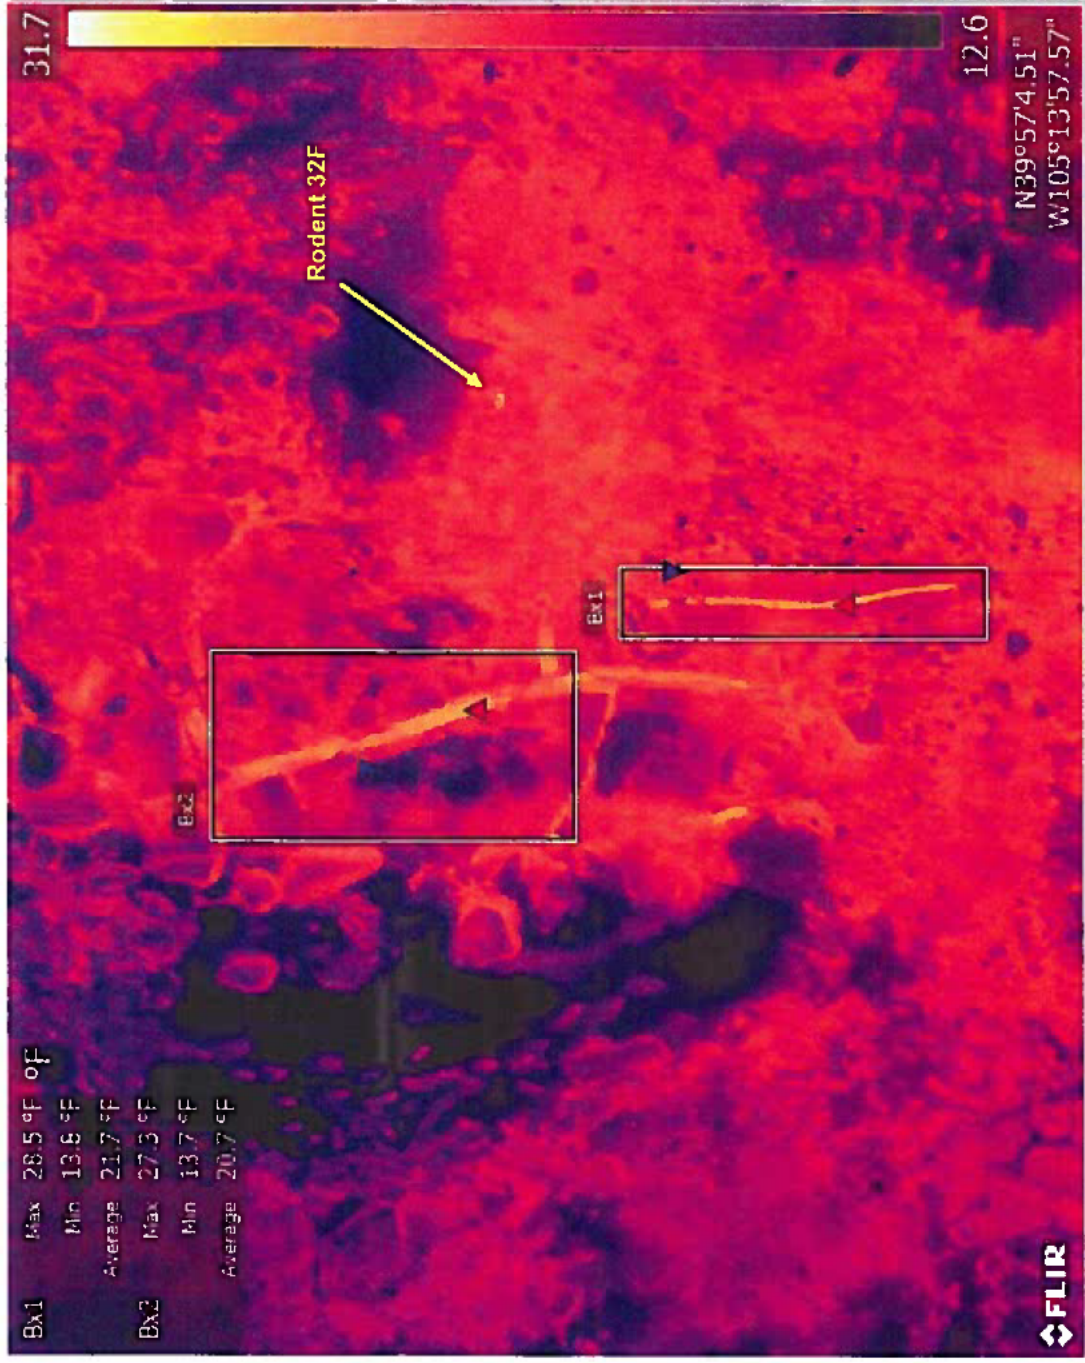
Photo S2 – Fractures in Outcrop South of Reclaimed Area

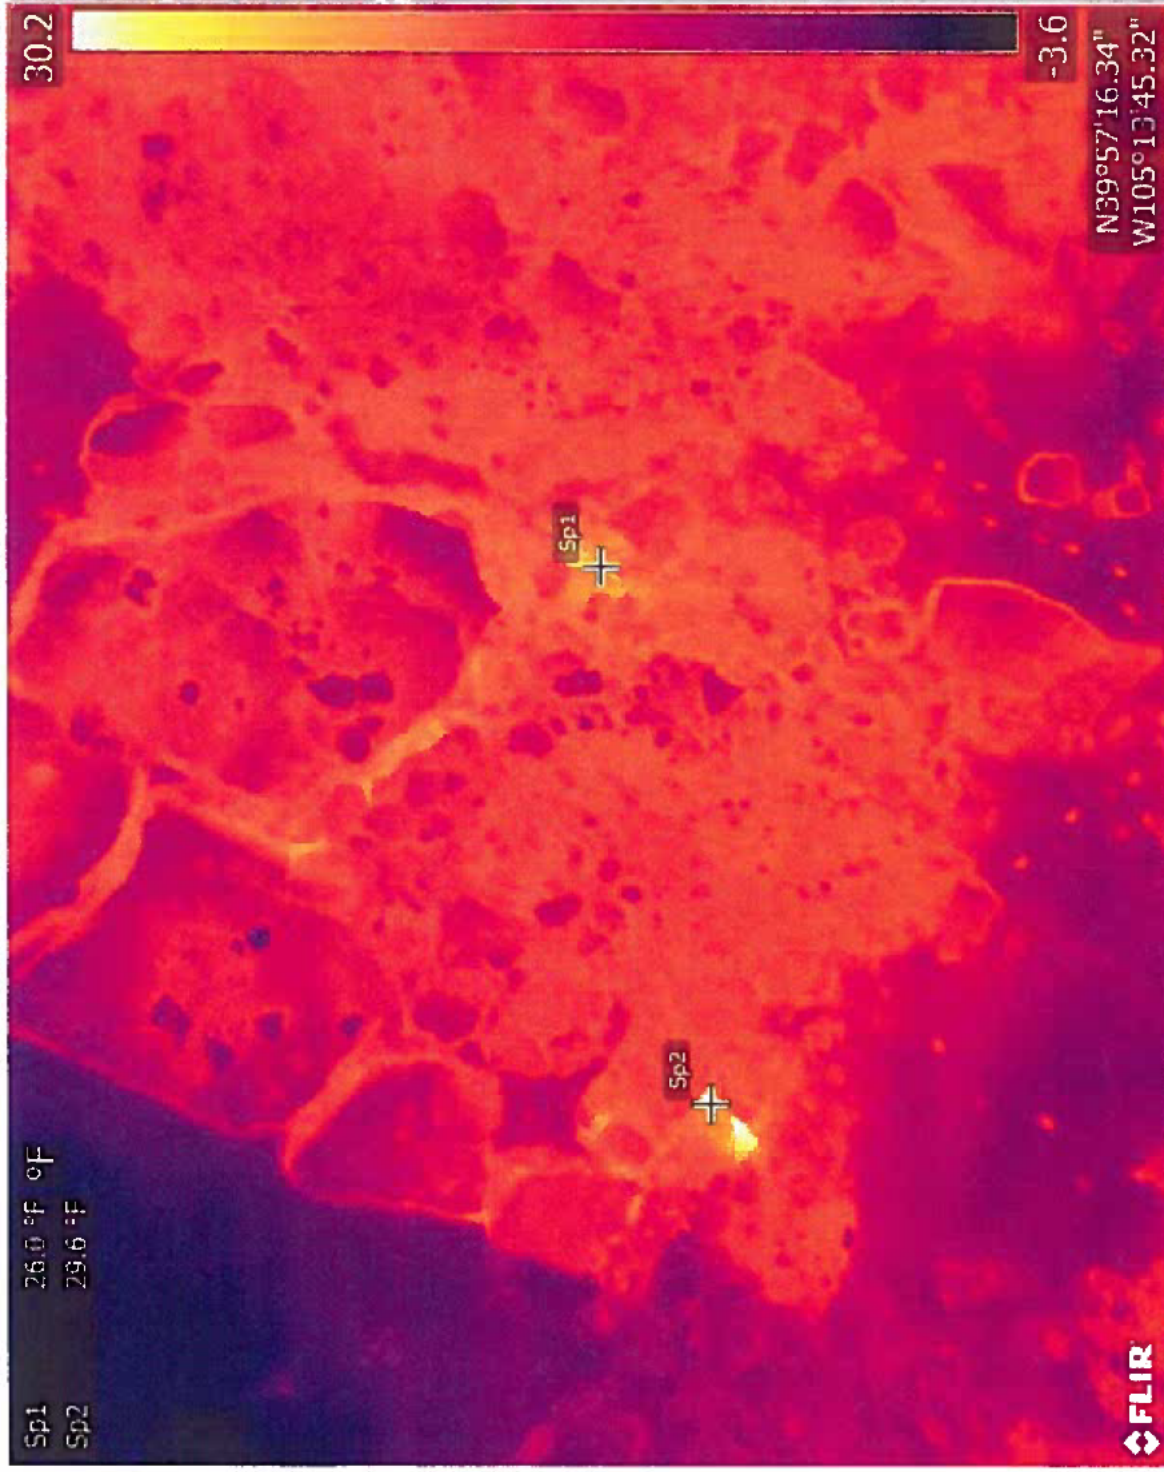
Photo N1 – Feature in Outcrop

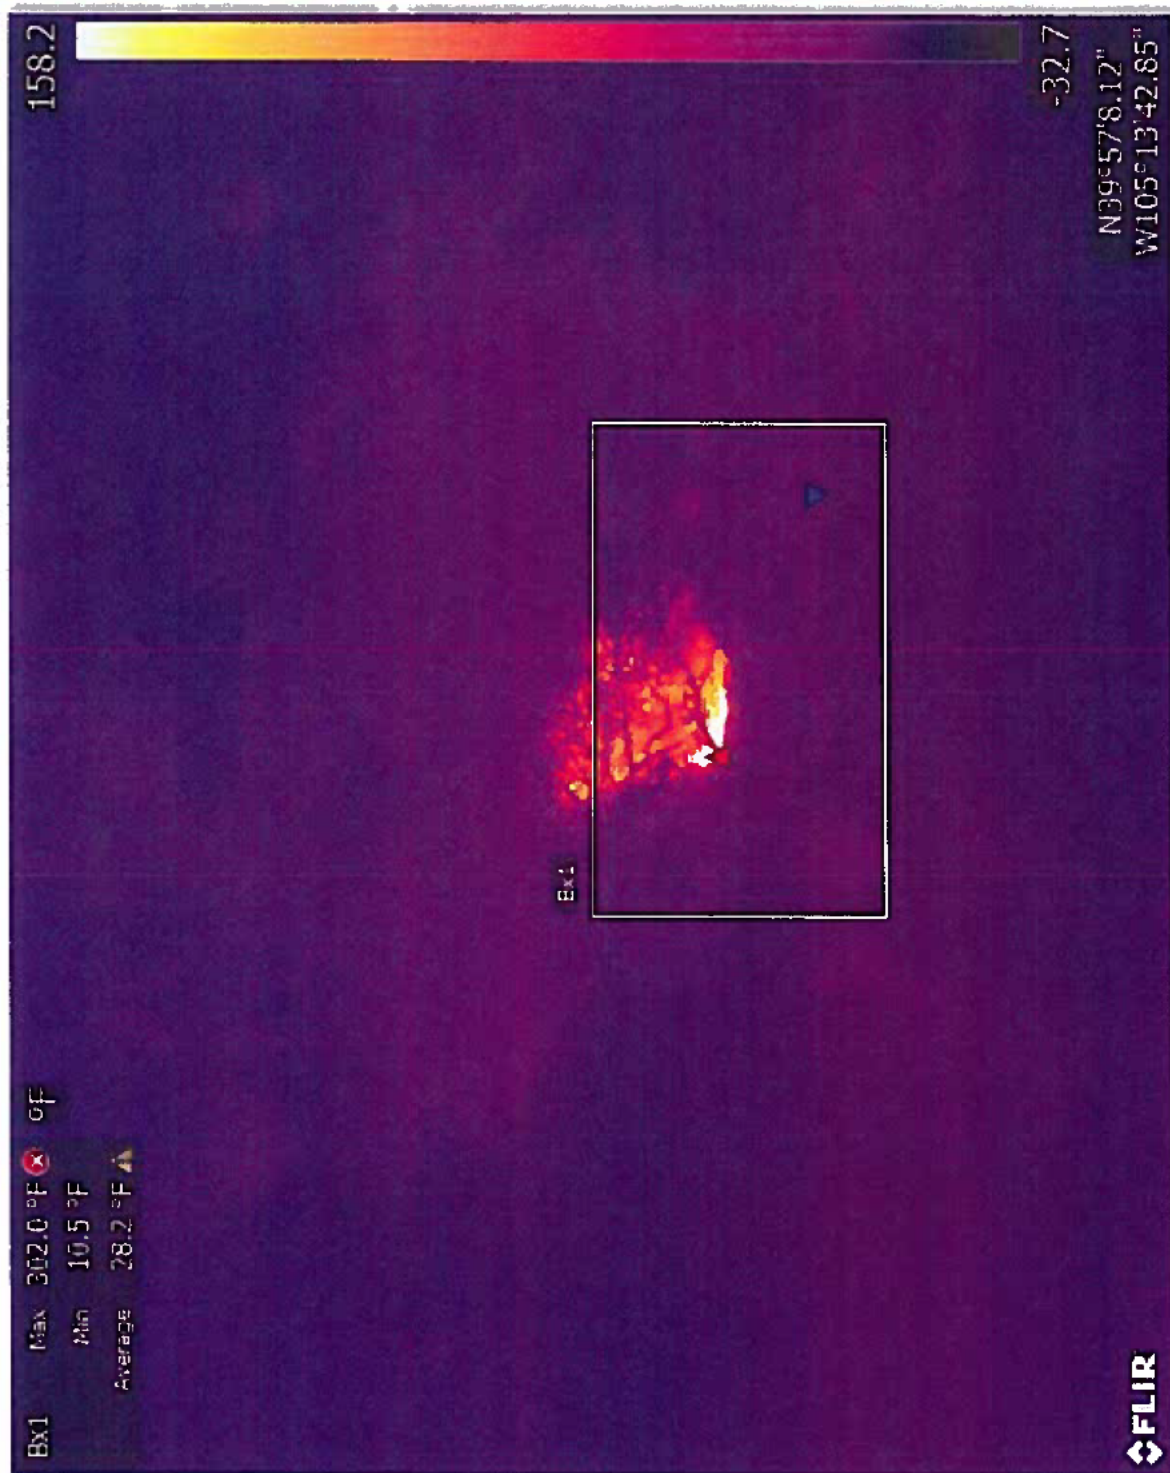
Photo E1 - >302F Hotspot North of Marshall No. 3

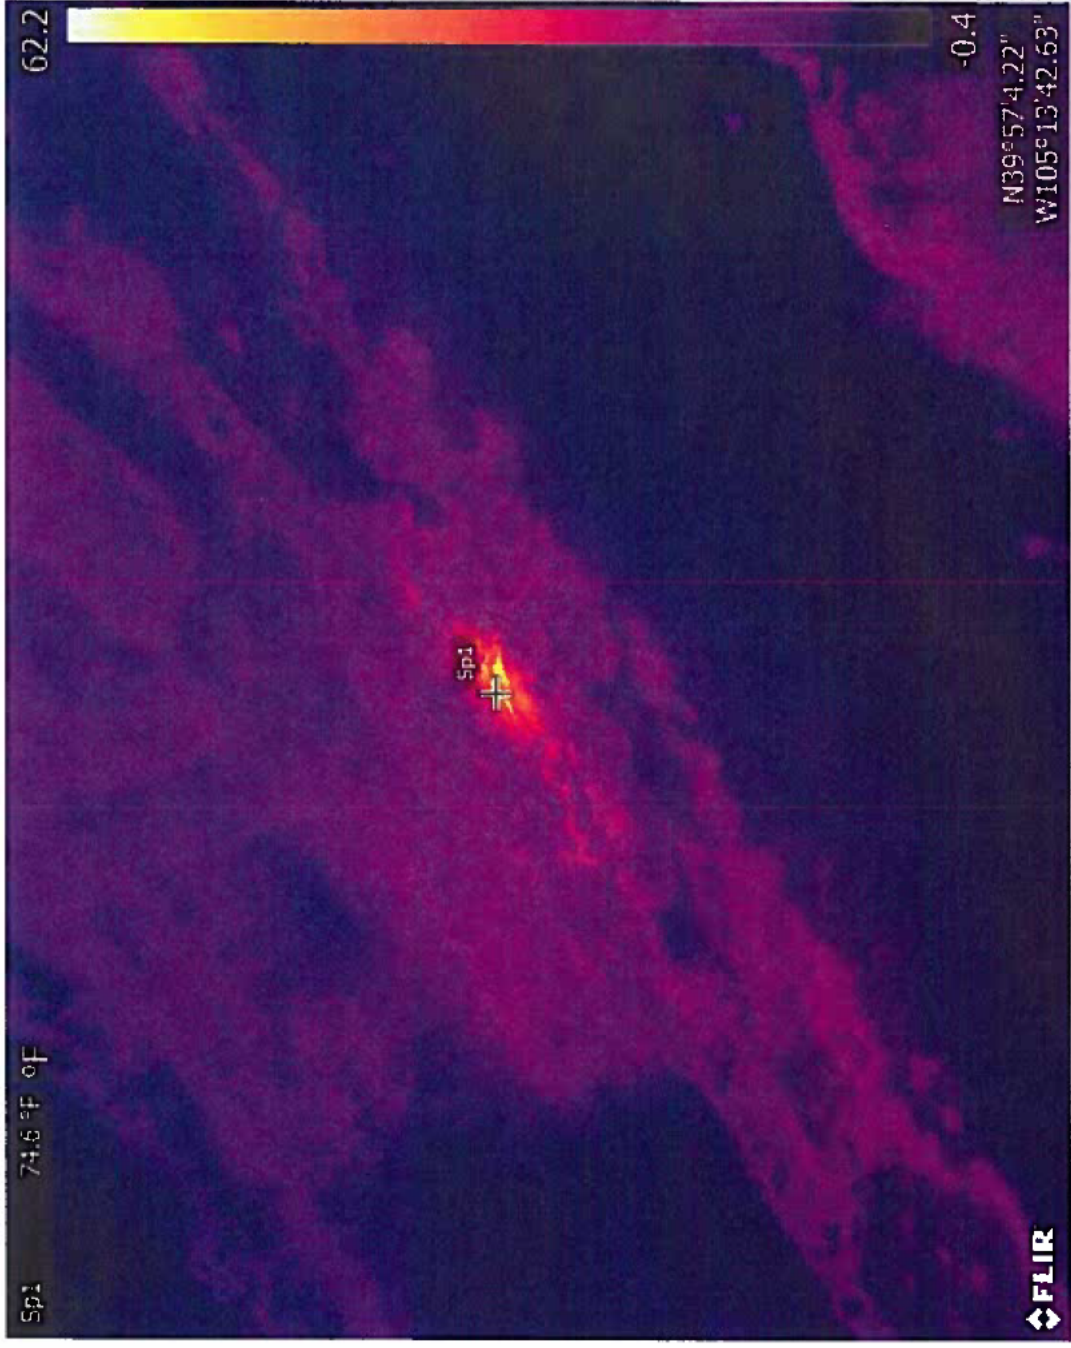
Photo E2 – Western Most Hotspot on Davidson Ditch

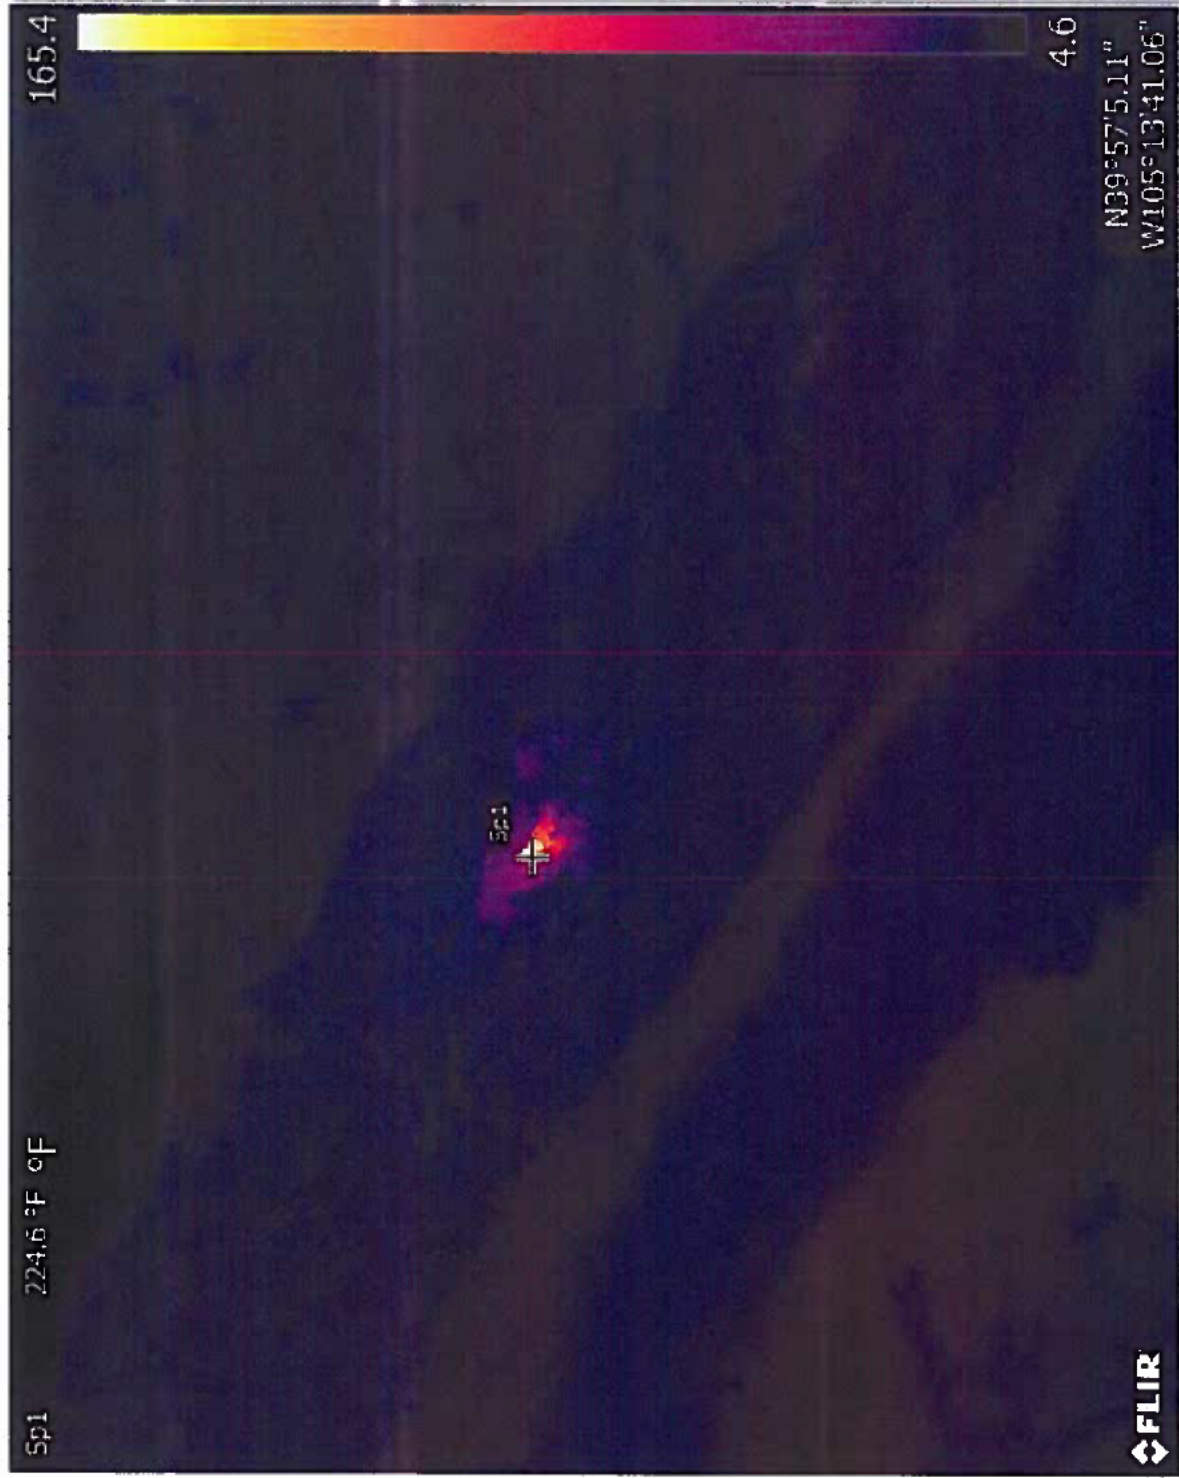
Photo E3 – 225F Hotspot on Davidson Ditch

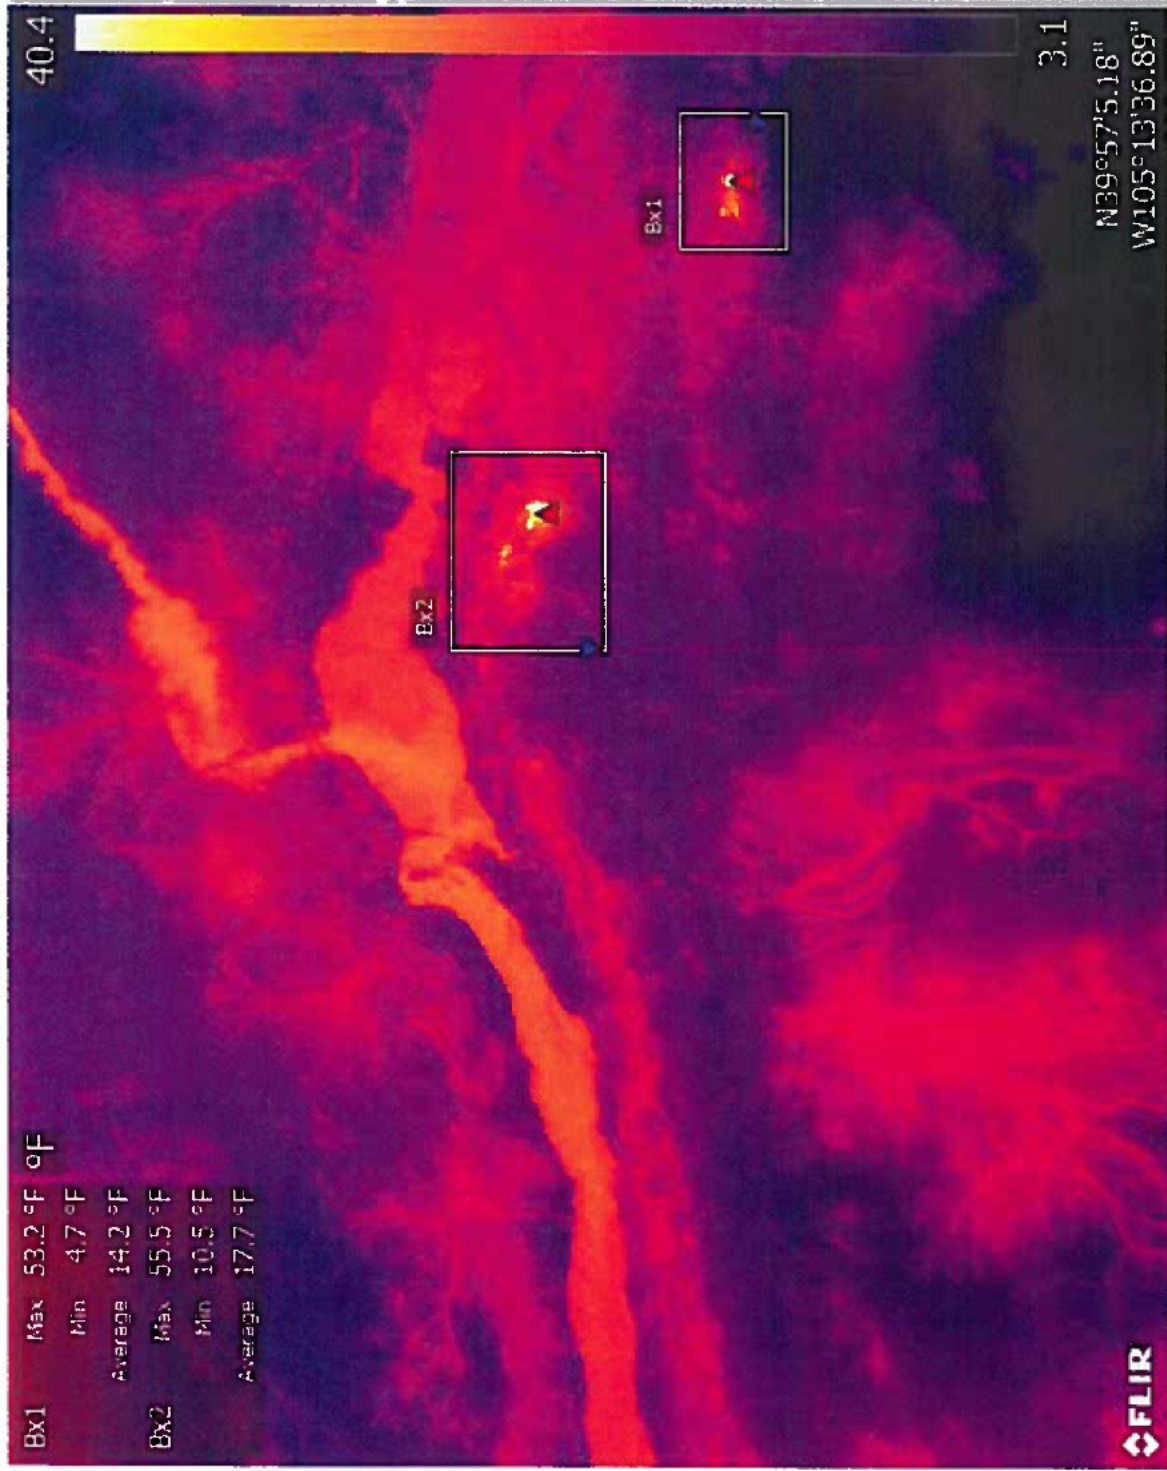
Photo E4 – Eastern Most Hotspots on Davidson Ditch

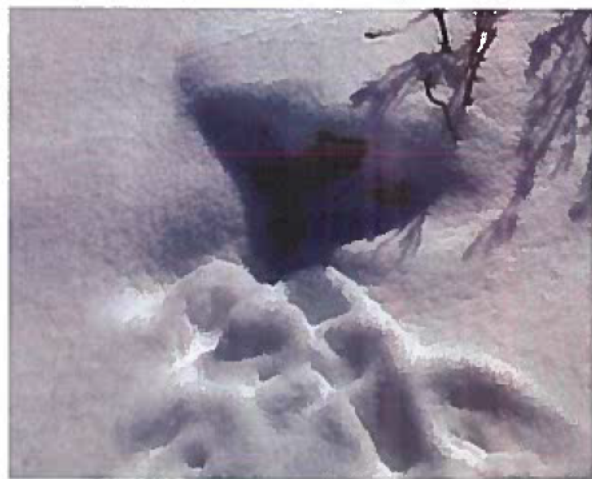
PHOTOGRAPH 3 Fracture sample location MV07 with animal tracks entering/exiting.
