USDA Forest Service		Wildland Fire Origin and Cause Supplemental Incident Report (Reference FSH 5309.11, Chapter 20)				Incident Number 22-02-IAIP002	
						Incident Date 12/30/2021	
LOCATION							
Fire Name		Dispatch #	Account Code	Region	Forest	District	State
MARSHALL WILDFIRE		COBLX-995	PNPER9	02	10	1	CO
Origin Location: geographical landmarks, highways, roads, trails, etc.		Township	Range	Section	1/4 Sec	Meridian/Datum	
East of Highway 93, West of garden area at 5329 Eldorado Springs Drive, Boulder, Colorado		T1S	R70W	21	NE 1/4	WGS 84	
		Latitude (D-M'-S")			Longitude (D-M'-S")		
		39° 57' 23.10"			105° 51' 49.73"		
JURISDICTION							
USFS Only		Identify Other Agency(s)		Lead Origin & Cause Investigator		Est. Suppression Cost	
N/A		Boulder County Sheriff's Office		SA Travis Lunders		To Be Determined	
						Injuries/Deaths 2	
EVENT SEQUENCE							
Estimated Time of Ignition				Time Fire Reported

USDA Forest Service	Wildland Fire Origin and Cause Supplemental Incident Report (Reference FSH 5309.11, Chapter 20)	Incident Number	22-02-IAIP002
		Incident Date	12/30/2021
SYNOPSIS (DATE, FIRE NAME, ESTIMATED ACRES, LOCATION, JURISDICTION); (ESTIMATED COST, DAMAGE; PROPERTY / RESOURC

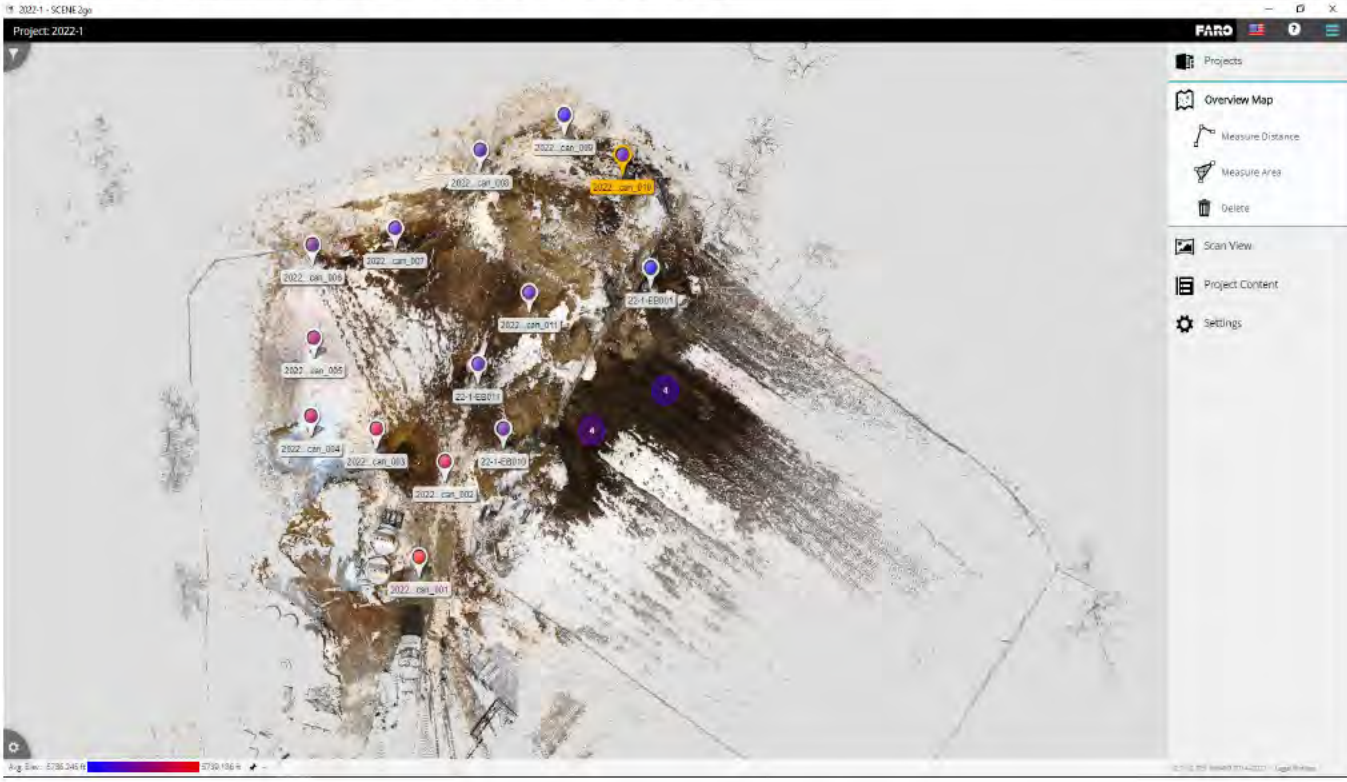
3D Laser scan completed by Colorado Bureau of Investigation. See attached Exhibit for to scale measurements and scene documentation.																			
SCALE		TO SCALE		AUTHOR		SA LUNDERS		DATE		1/5/2022		TIME		13:50 HRS

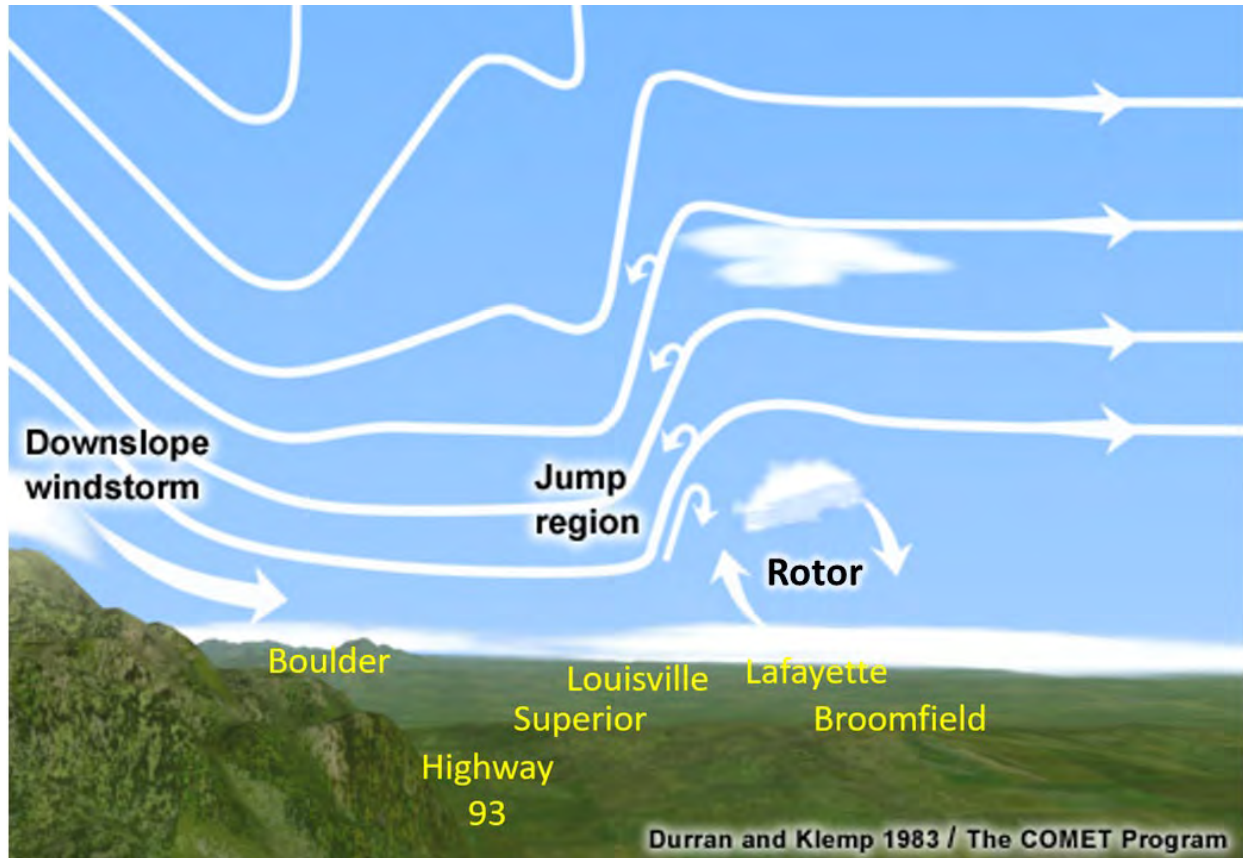
Figure 1: An idealized schematic of how downslope wind storms occur in the lee of the Rocky Mountains. The typical set up is shown, and the strongest winds occur along and west of the “Jump Region with locations shown in yellow. A rotor is shown over Lafayette, along with a rotor cloud.

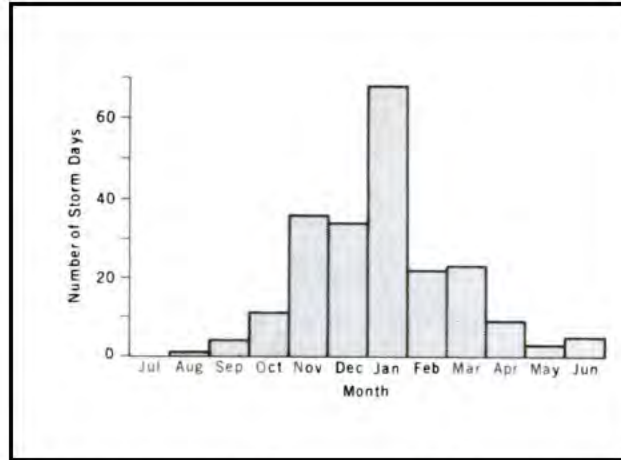
Figure 3: Taken from NOAA technical report Whiteman and Whiteman (1974). These are 151 identified wind storms in Boulder, defined as having at least one gust > 58 mph in the Boulder area during the period of study ending in 1974.

Figure 3 shows the peak occurring in the cold season and in particular in January. This graphic is from the 1970s but the trends are the same as today. An updated study looking at months with gusts greater than or equal to 70 mph from 1969-2021 in the Boulder area shows a similar trend to the dataset that ended in 1974. There is a distinct peak in the occurrence of extreme downslope wind in December and January. Here is the table of days by month with at least one wind gust > 70 mph across the CO-93 corridor from 1969-2021:

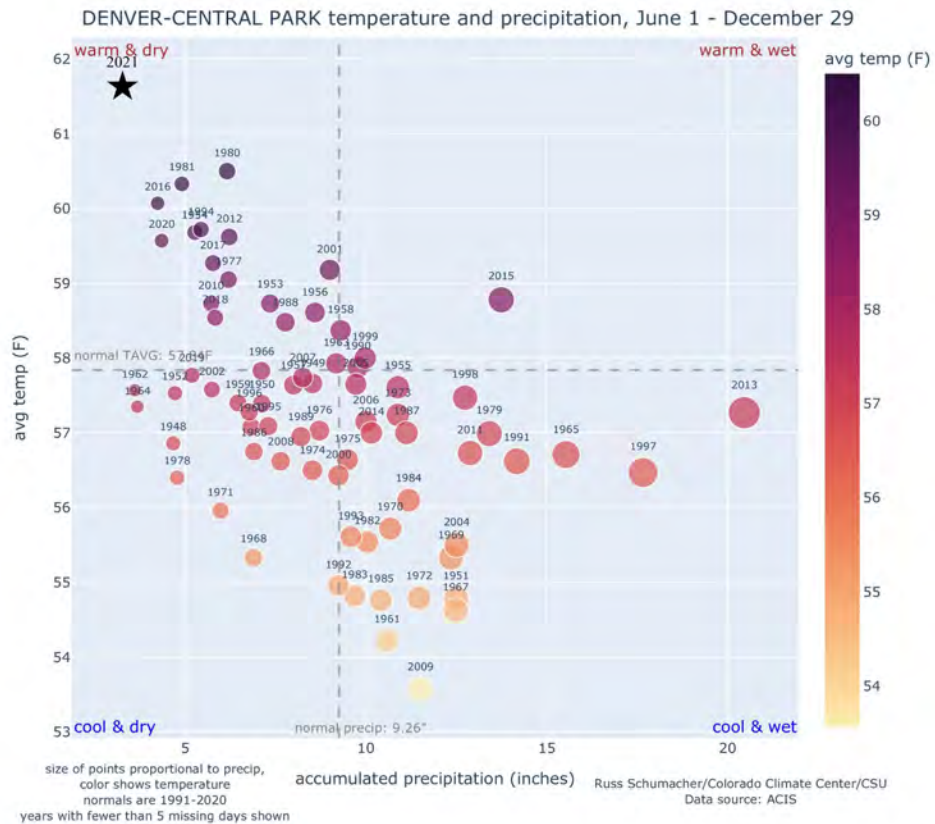
Figure 4: Climate data from Denver-Central Park that combines the effects of temperature and precipitation. Warmest/driest years on record appear in the top left, while cool and wet in the bottom right. 2021 was far and away the warmest and driest on record over the last ~75 years.

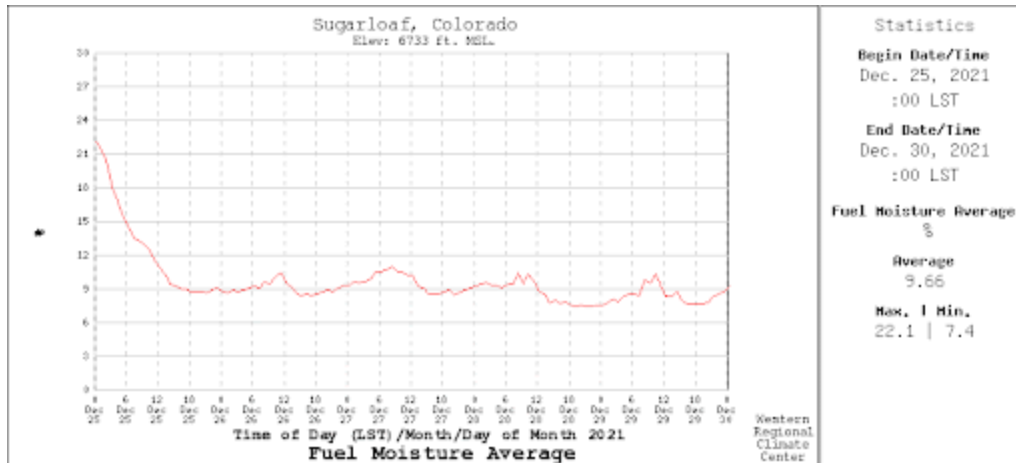
Figure 5: This is the fuel moisture trace for December, 2021 from Sugarloaf, Colorado, which is approximately 10 miles northwest of the Marshall fire ignition area. Fuels were near record dry at the end of December.
