Lewis Mine Fire Mitigation

PKAA# 2024-0026

Colorado Department of Natural Resources
Division of Reclamation Mining & Safety
Inactive Mine Reclamation Program

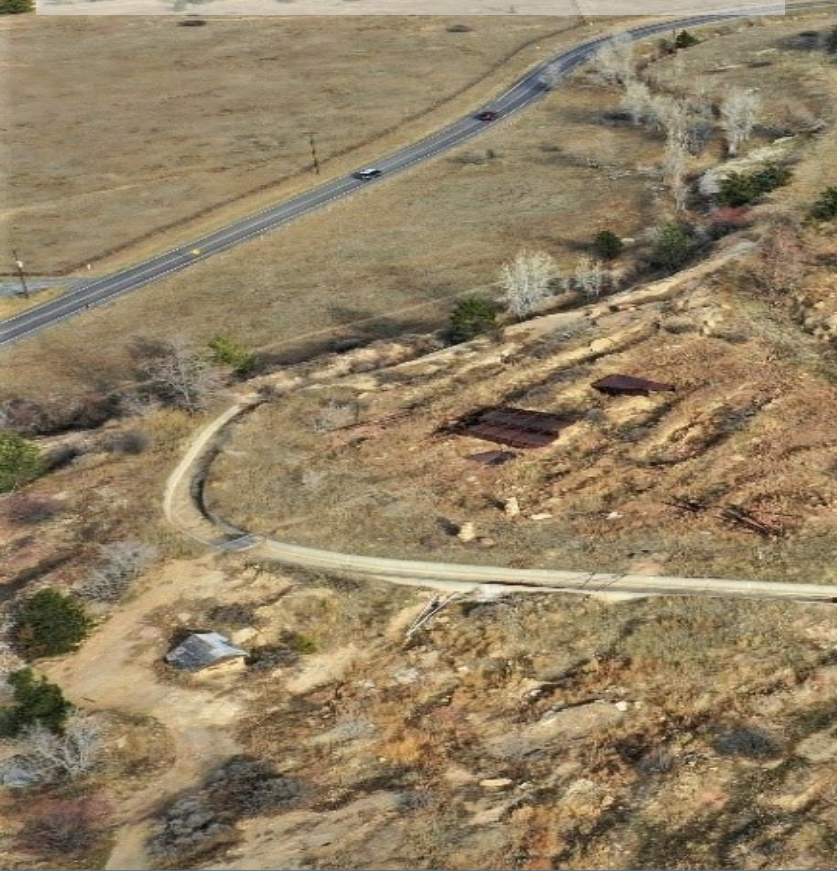
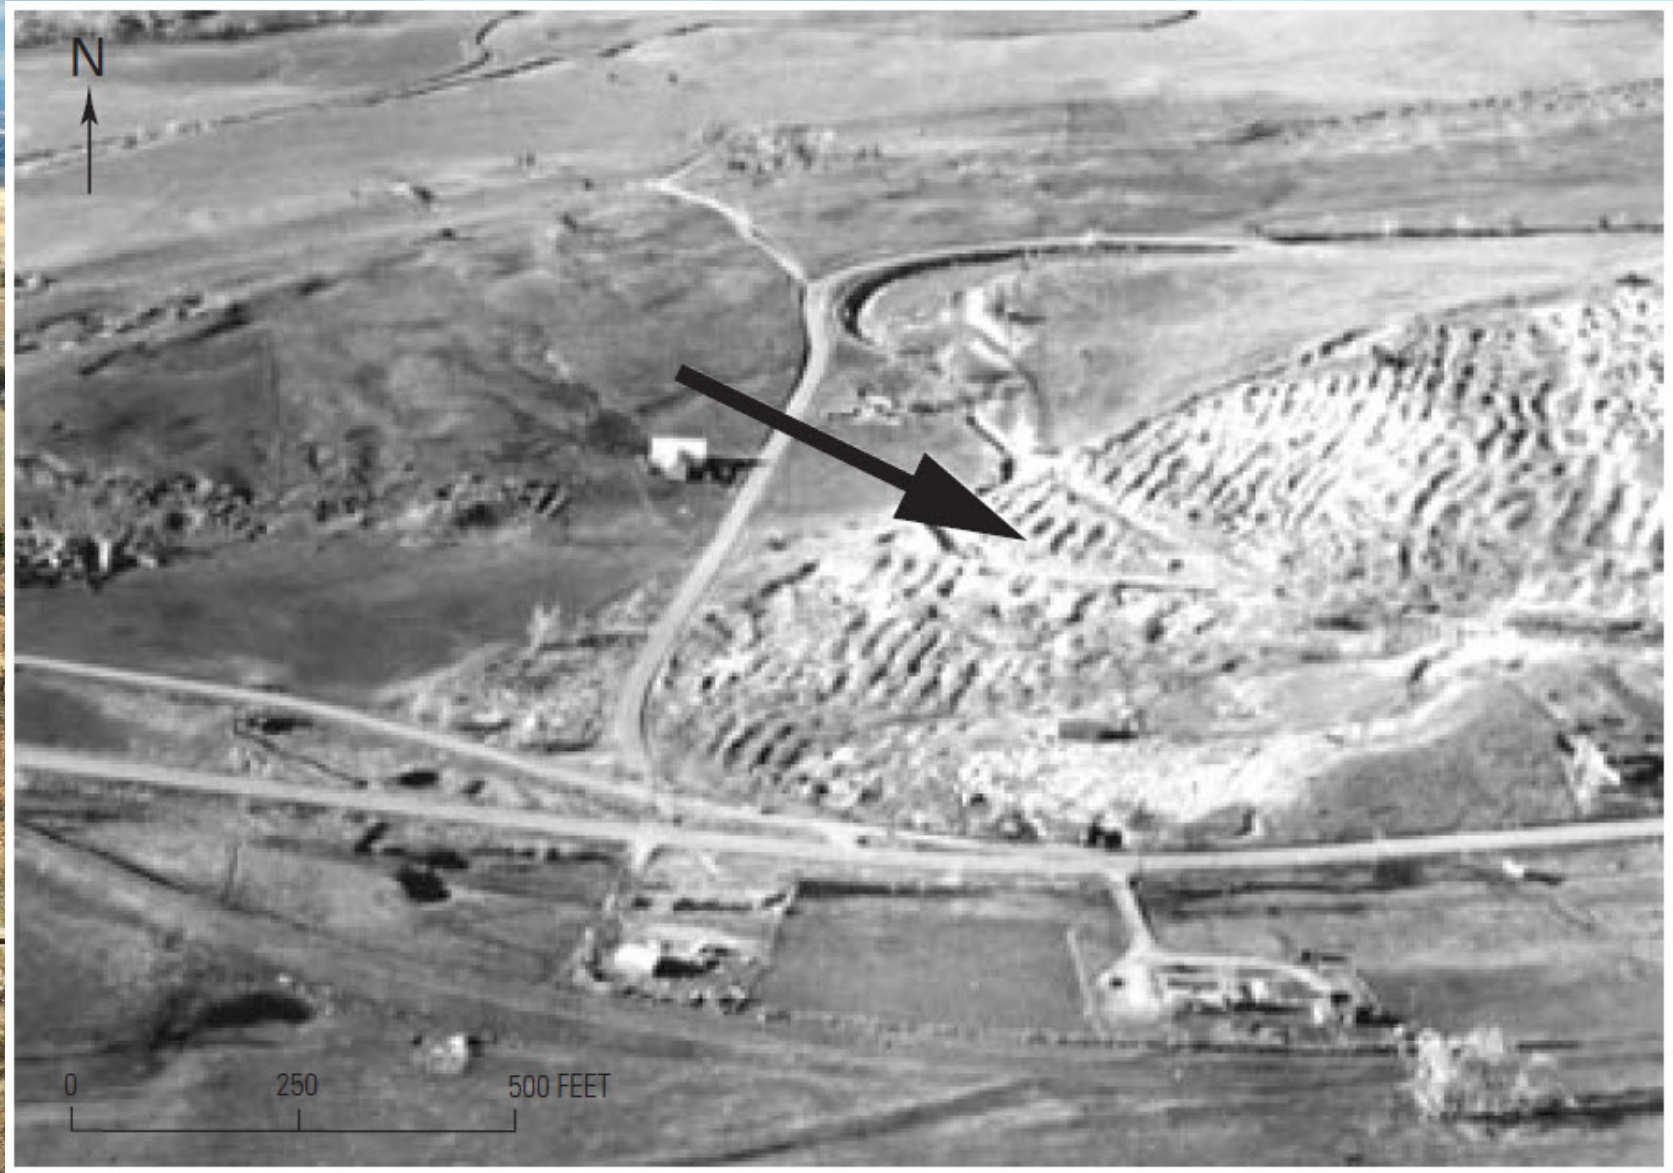
Lewis Mine (circa 1950?) – RB Cotton; US G5 Denver

Surface subsidence resulting from the shallow mine workings began almost immediately after mining at the Lewis Coal Mine was complete.

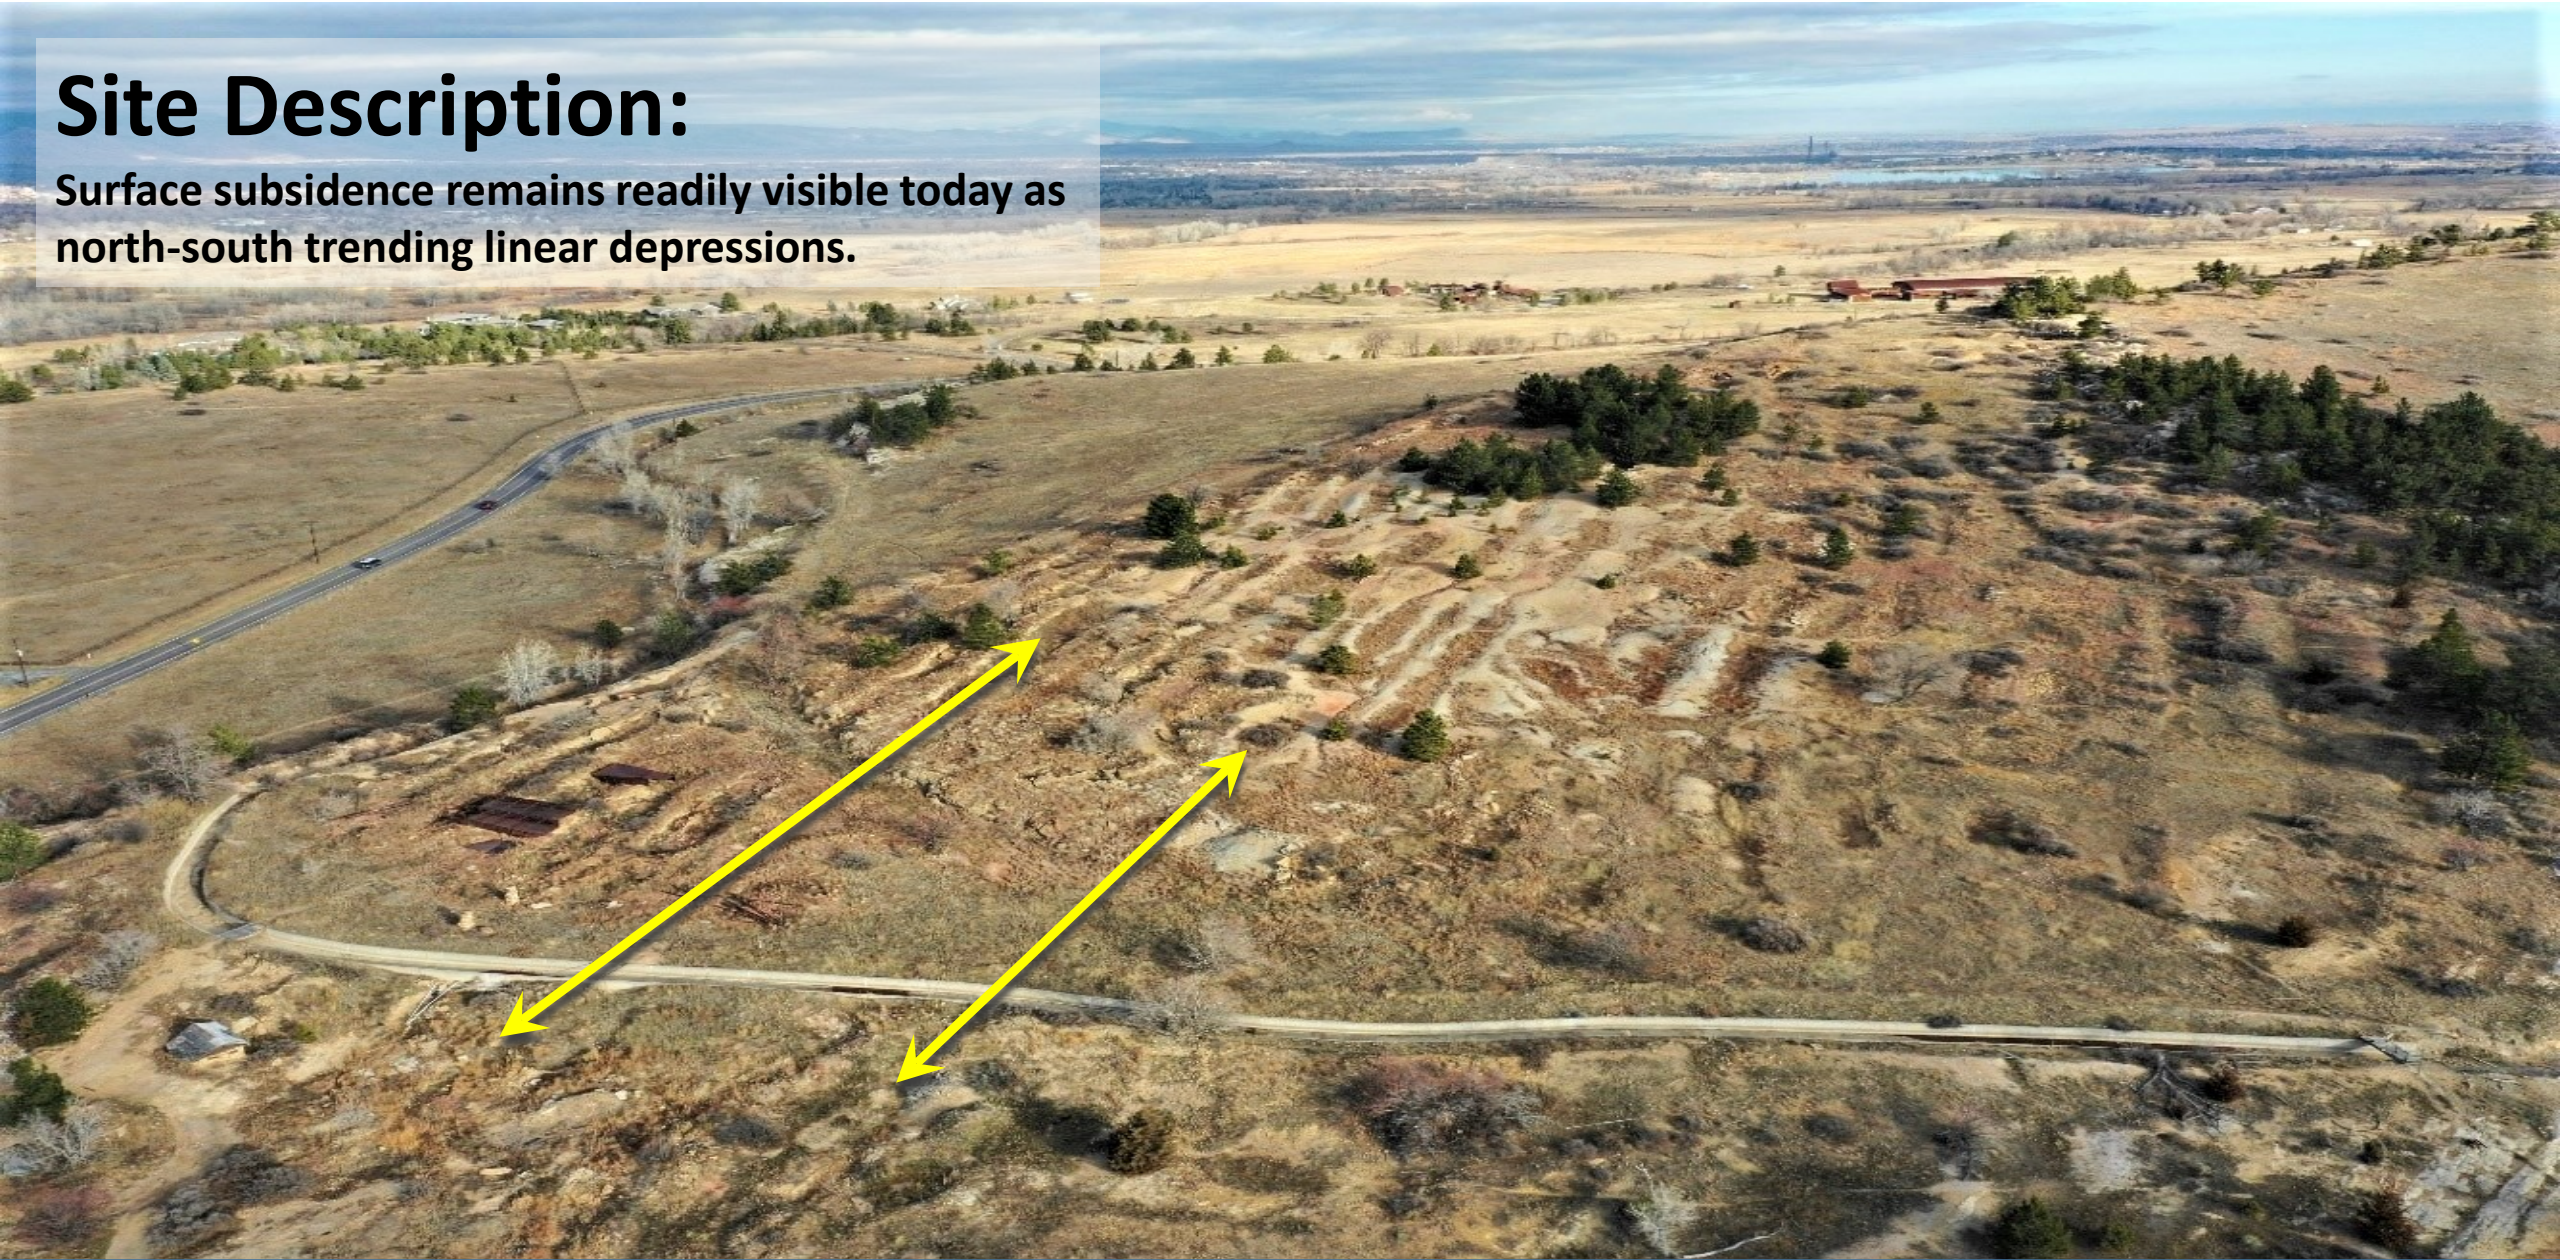
Surface subsidence remains readily visible today as north-south trending linear depressions.

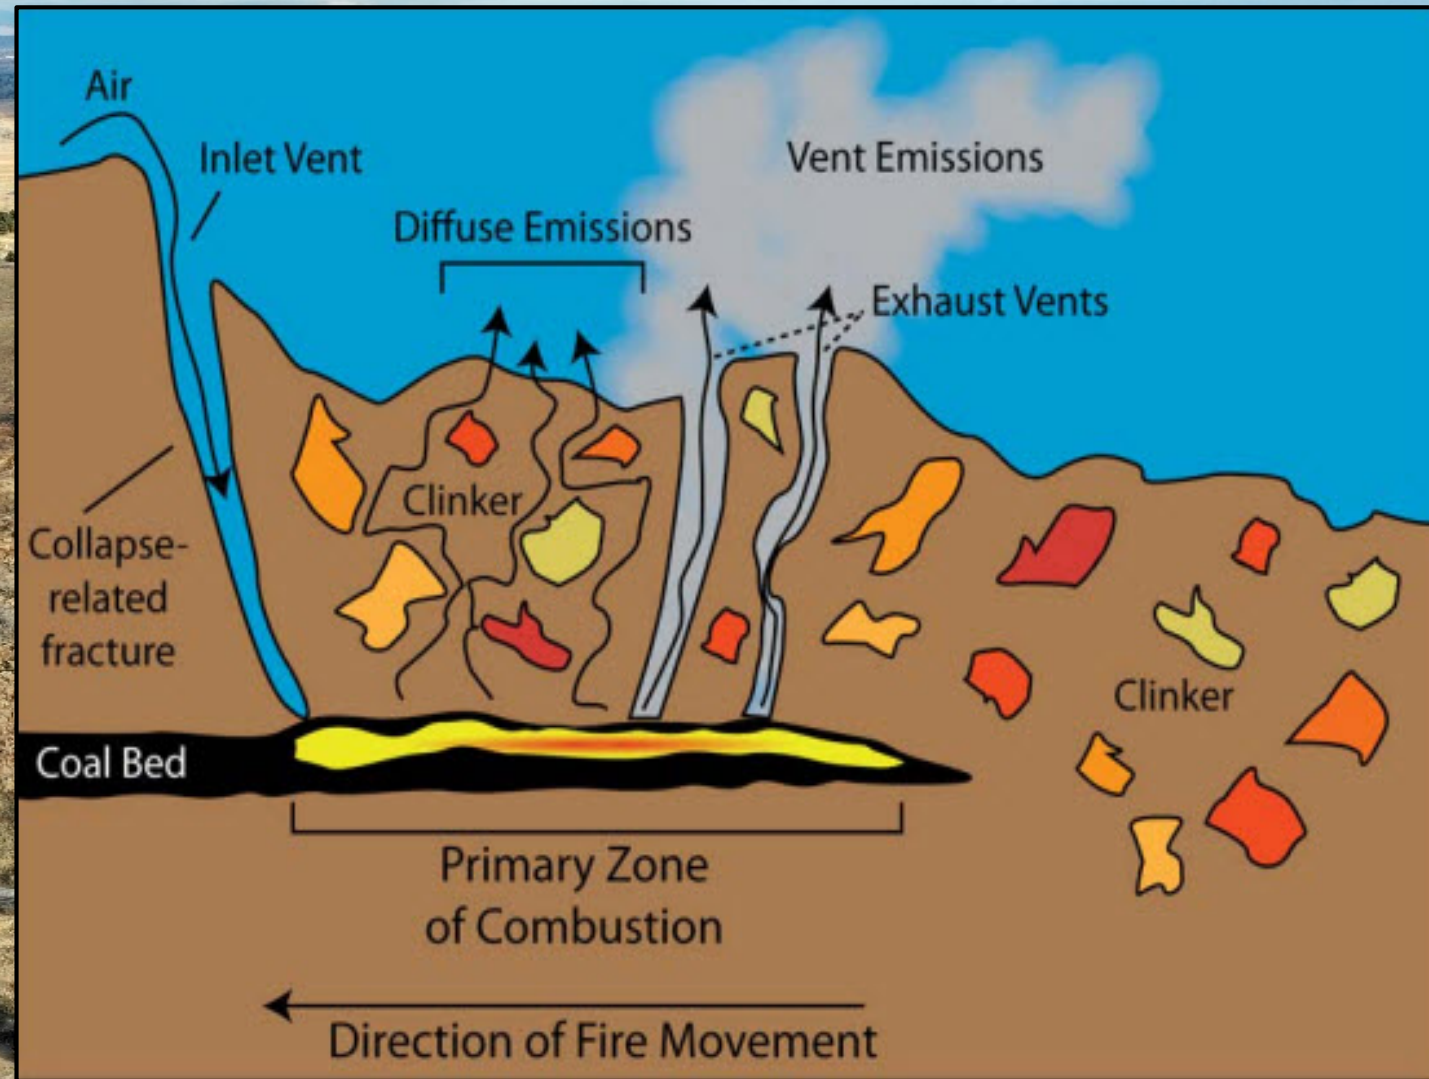
From Engle, et. Al., 2010

- The initial cause of the Lewis Mine Fire is unknown but likely resulted from spontaneous combustion.
- Observations from long time local residents indicate that the Lewis Mine Fire has been burning for more than 50 years.
- Subsidence related to the mine fire and shallow mine workings continues.

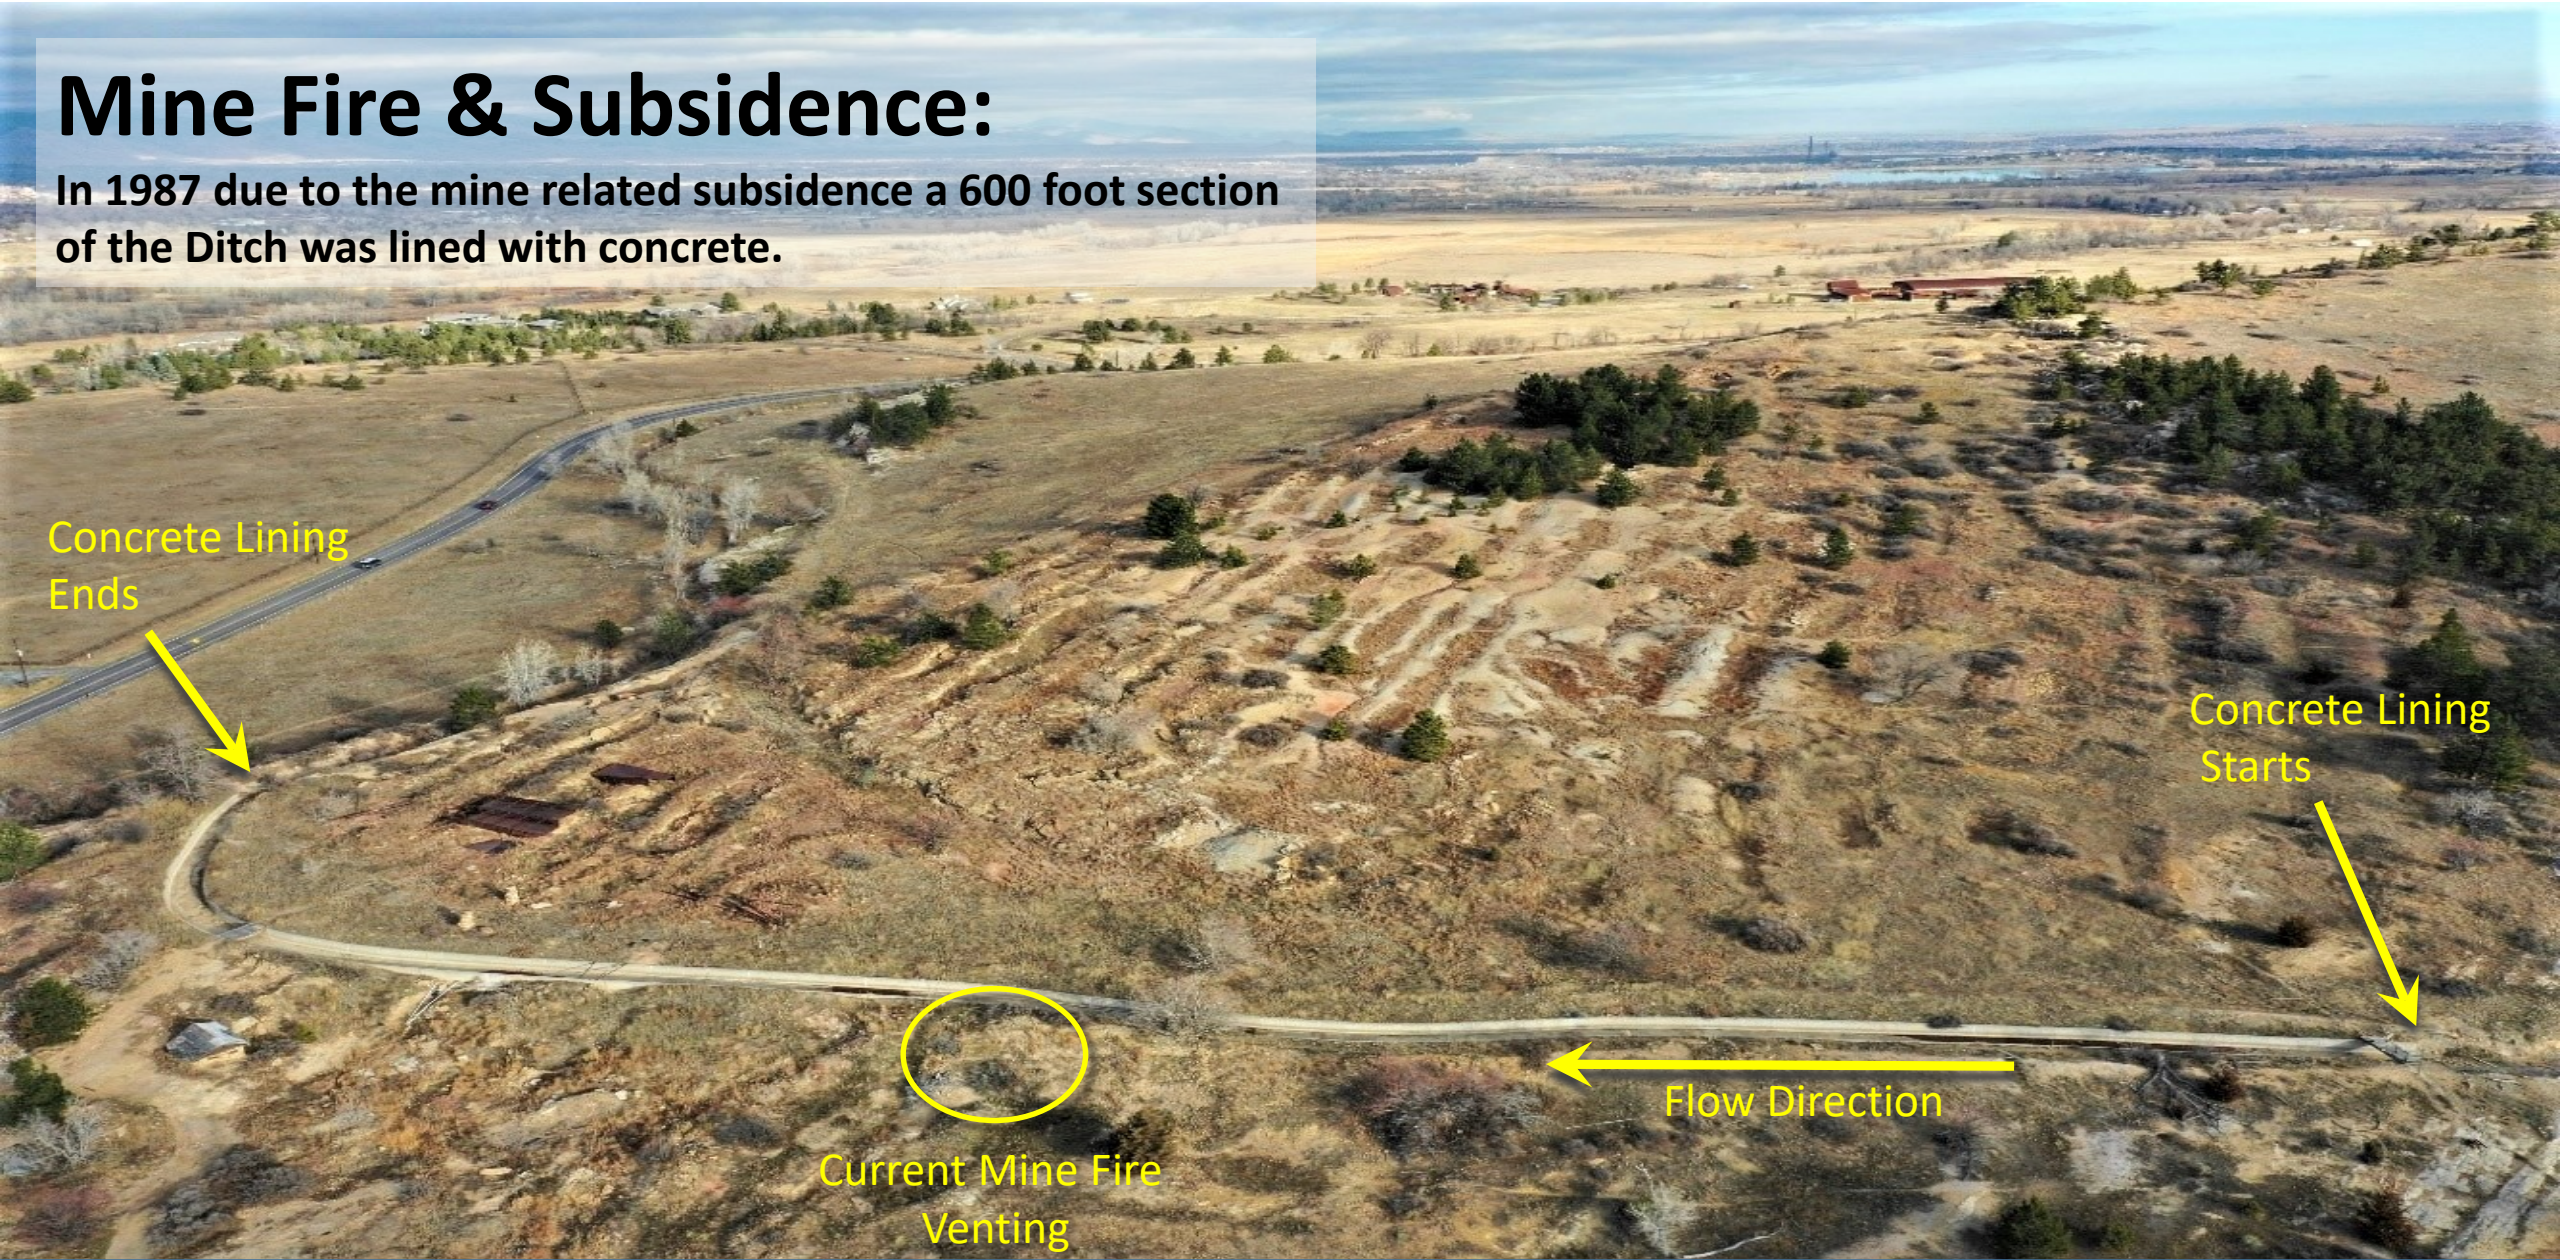
In 1987 due to the mine related subsidence a 600 foot section of the Ditch was lined with concrete.

The Lewis Mine Fire continues to burn at a low intensity adjacent to the south edge of and possibly underneath a portion of the concrete lined section of the Davidson Ditch⁽²⁾.

Active mine fire vents emitting noxious fumes at ~120°F.

Stressed and dying vegetation.

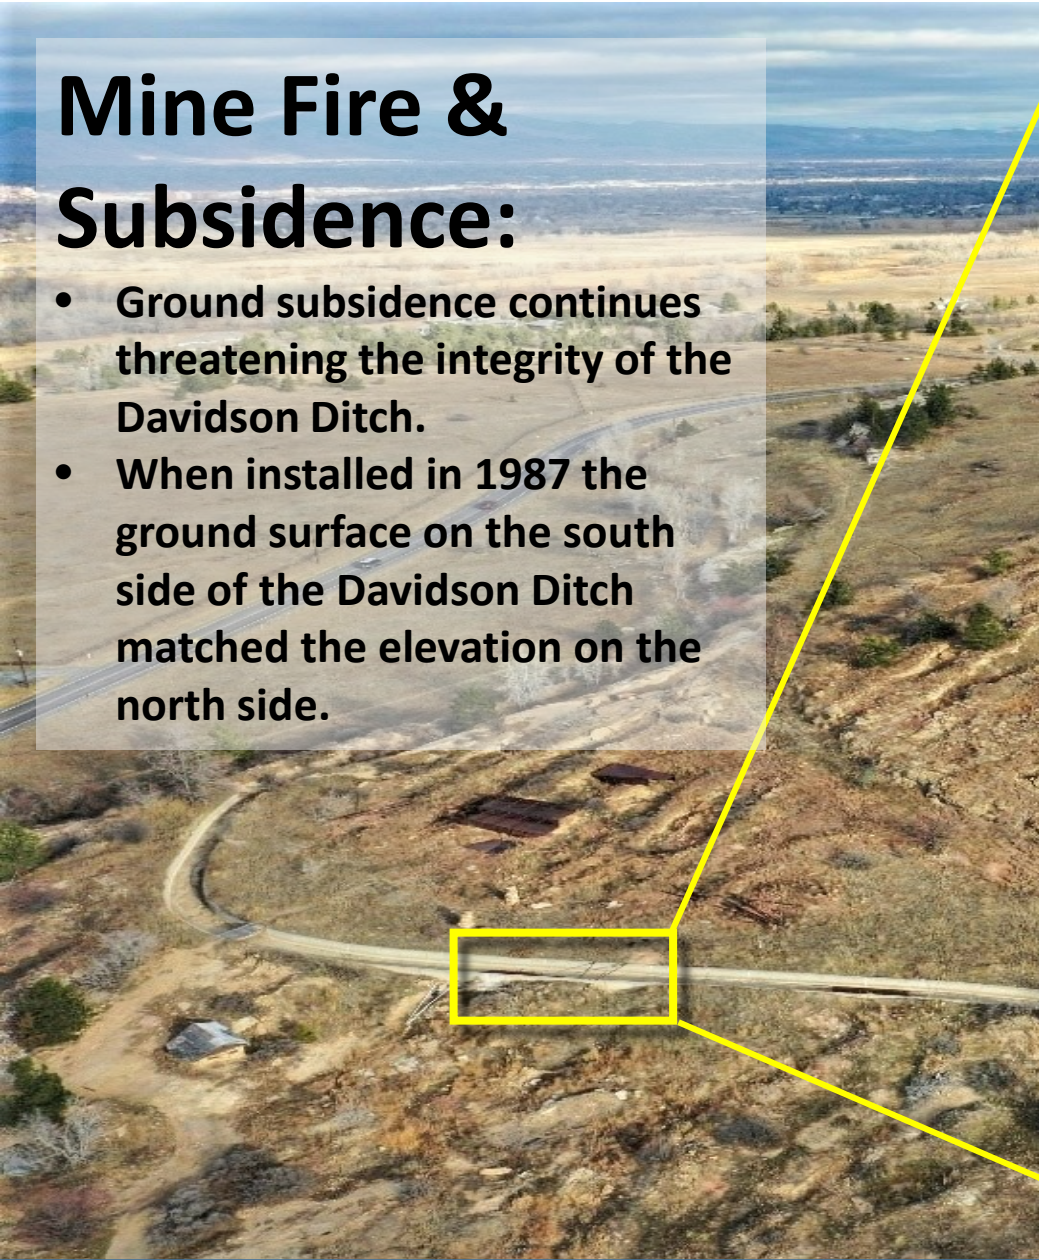
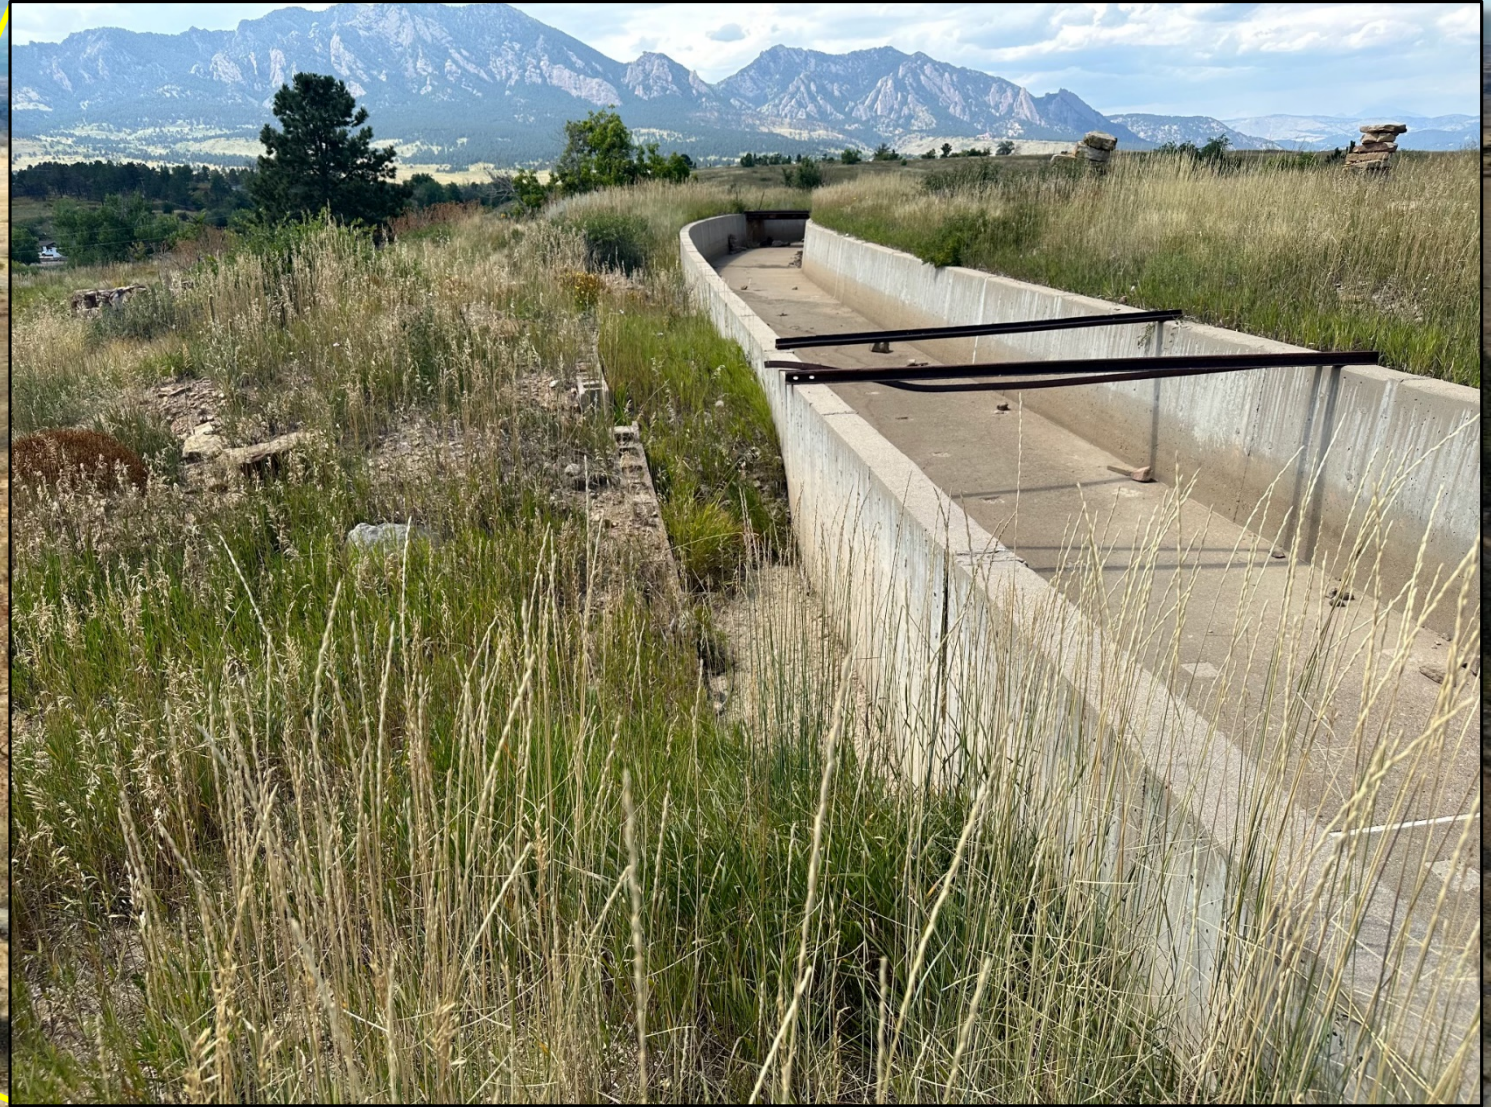
Colorado DRMS, 2023

- Ground subsidence continues threatening the integrity of the Davidson Ditch.
- When installed in 1987 the ground surface on the south side of the Davidson Ditch matched the elevation on the north side.

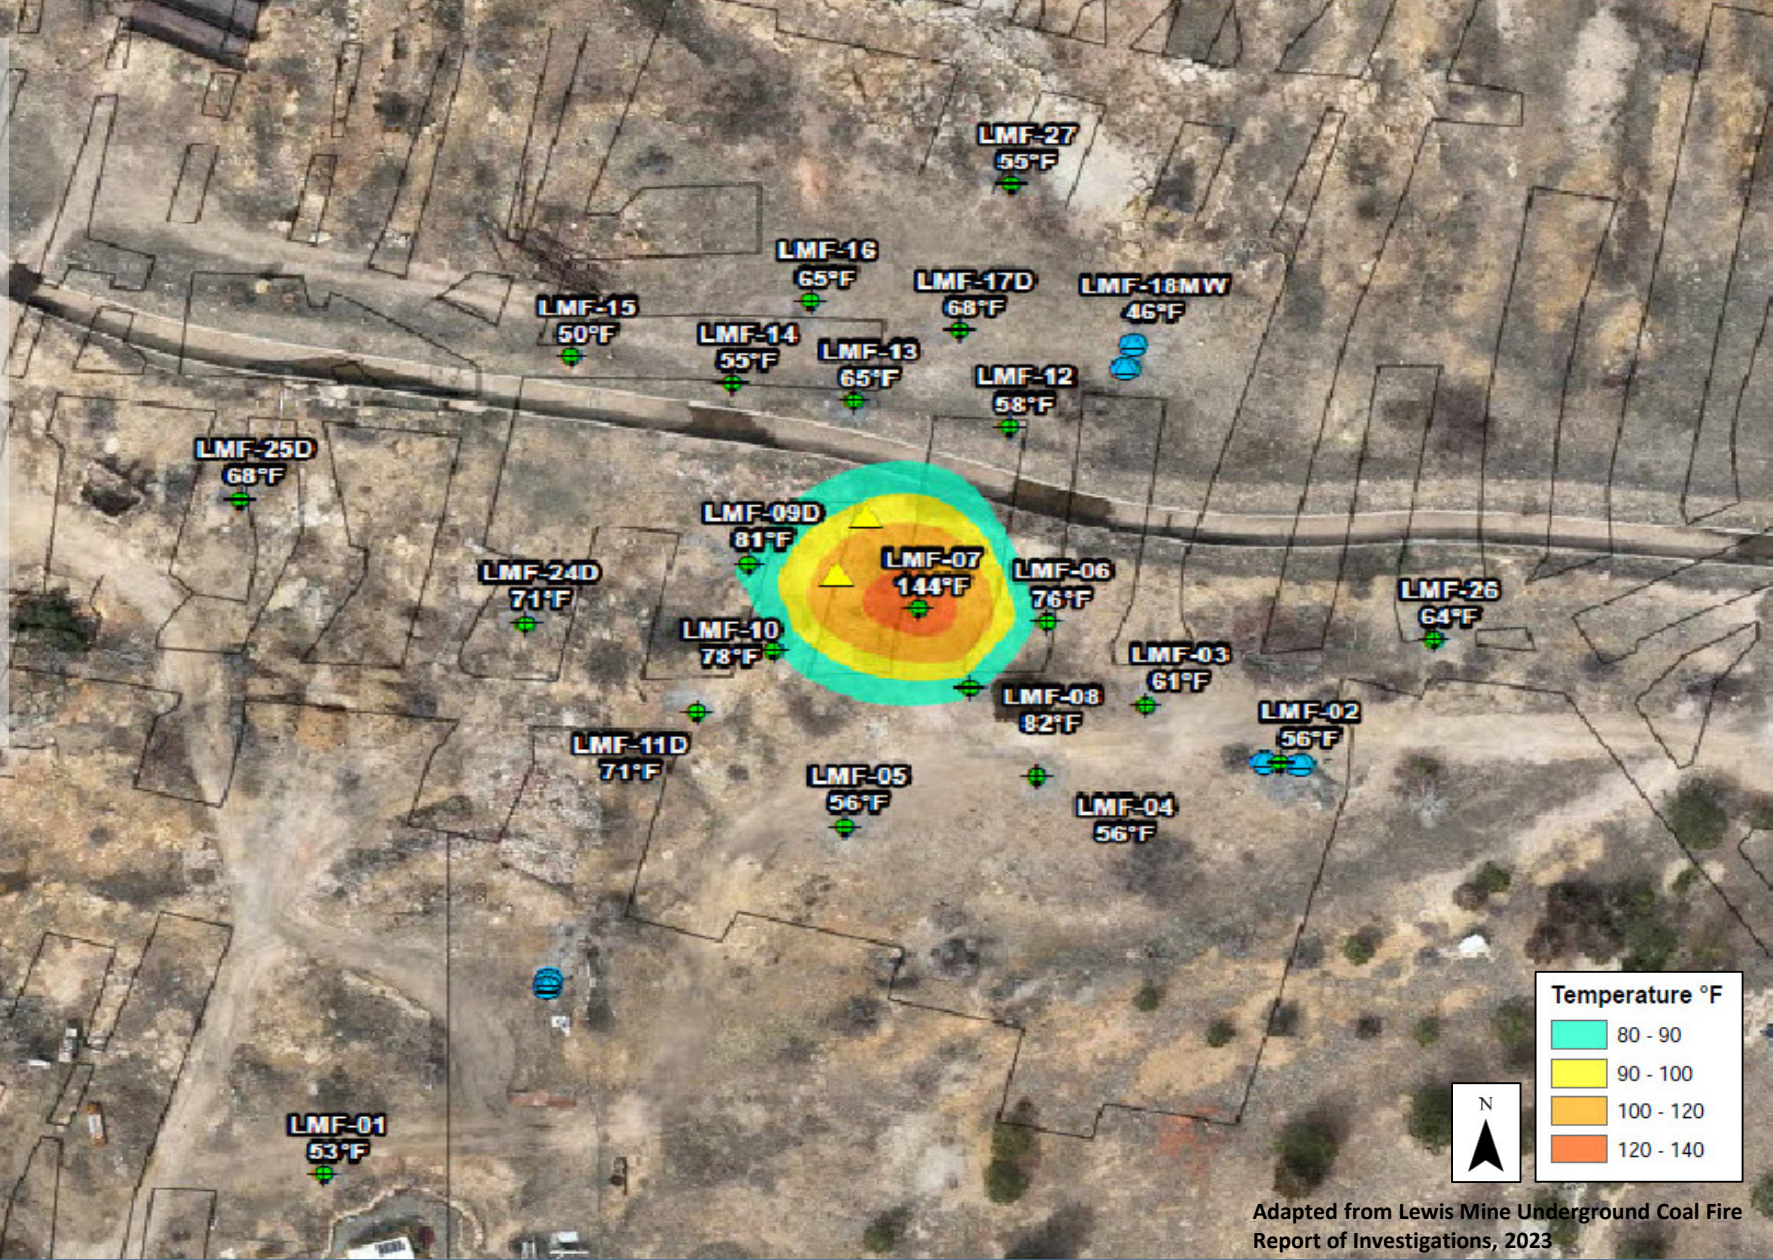
- Twenty seven (27) borings were completed surrounding the area of active surface venting ⁽²⁾.
- Temperature probes were installed in 21 of the boings.
- The remaining 6 boings were completed as groundwater monitoring points.

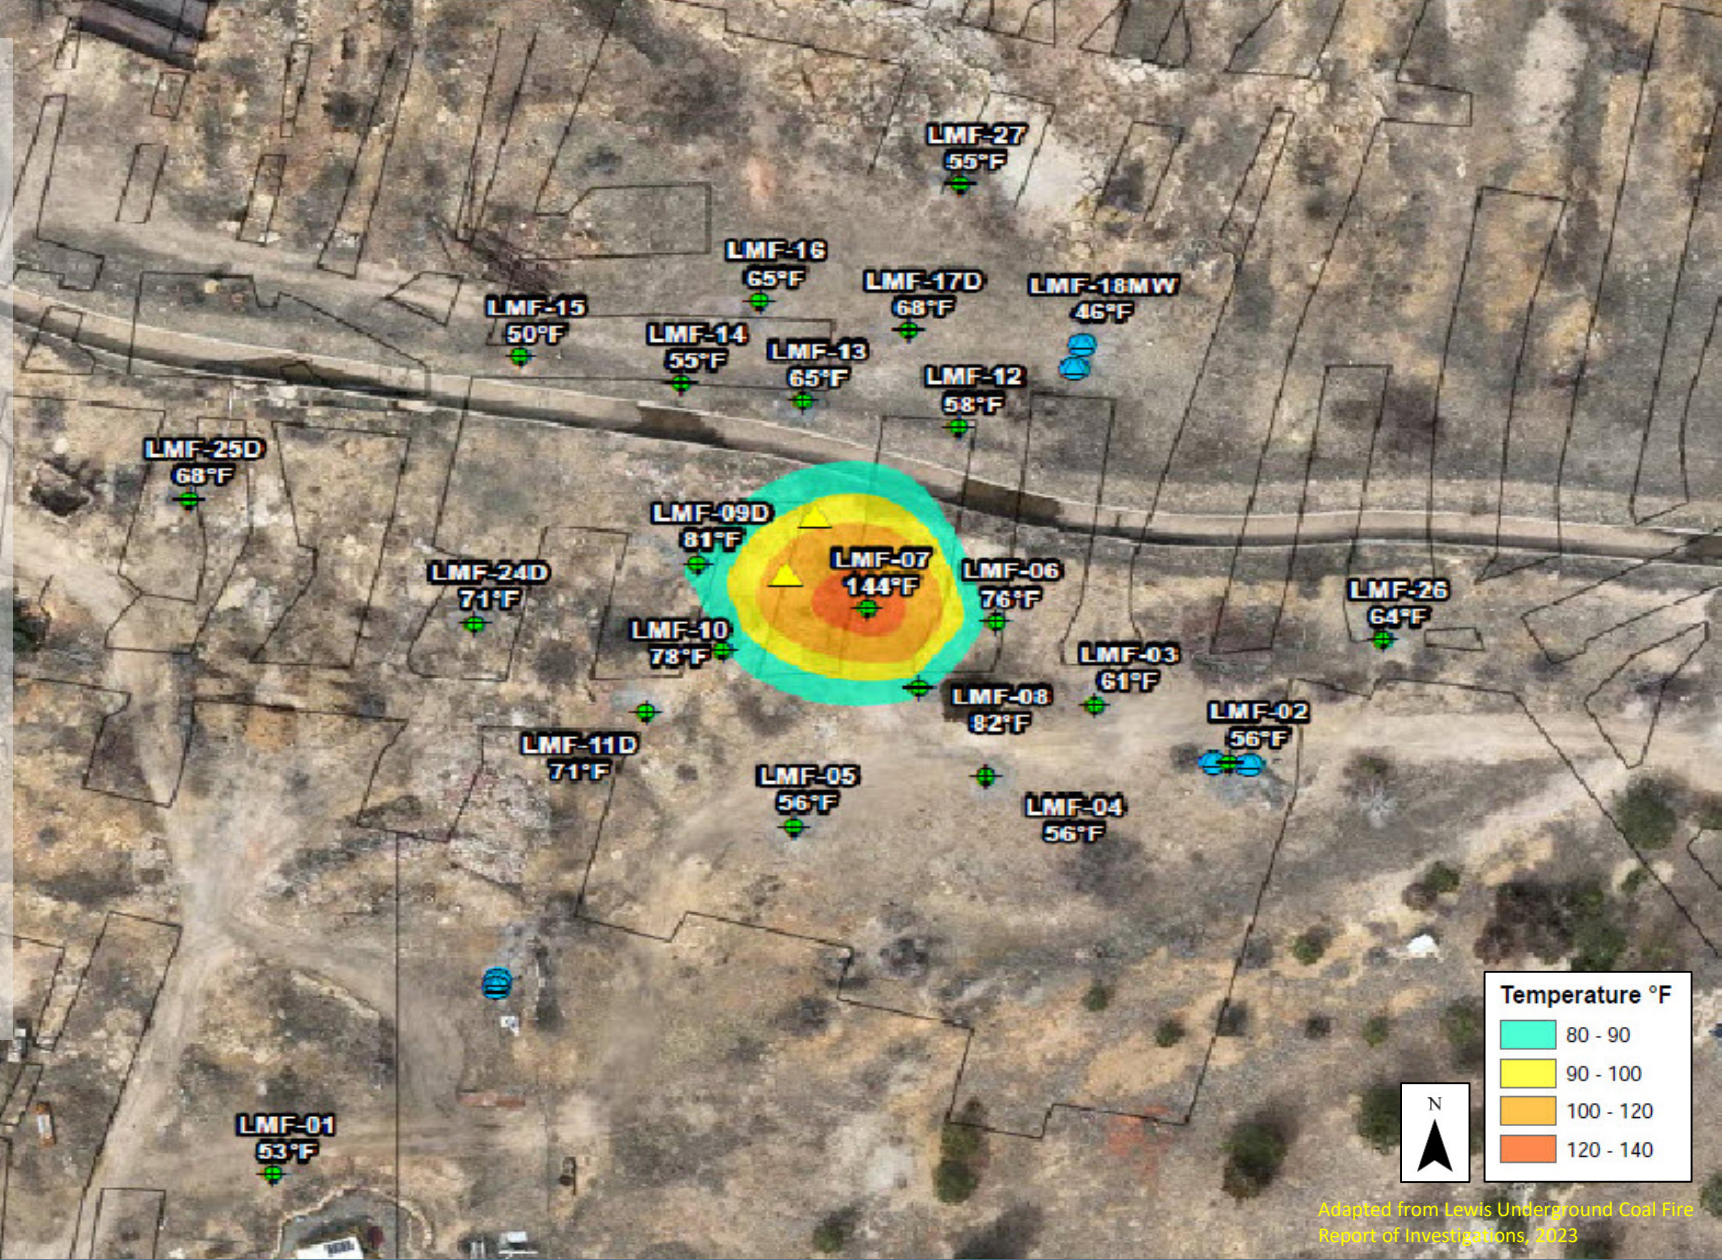
Adapted from Lewis Underground Coal Fire Report of Investigations, 2023

- Results from the subsurface investigation indicate the uppermost coal bed is approximately 10 to 20 feet below ground surface⁽²⁾.
- Heat is localized to an area 2,500 ft² in size centered around the active surface vents⁽²⁾.
- The maximum subsurface temperature measured was 144° F.
- Surface and subsurface observations are consistent with a low intensity, smoldering coal fire.

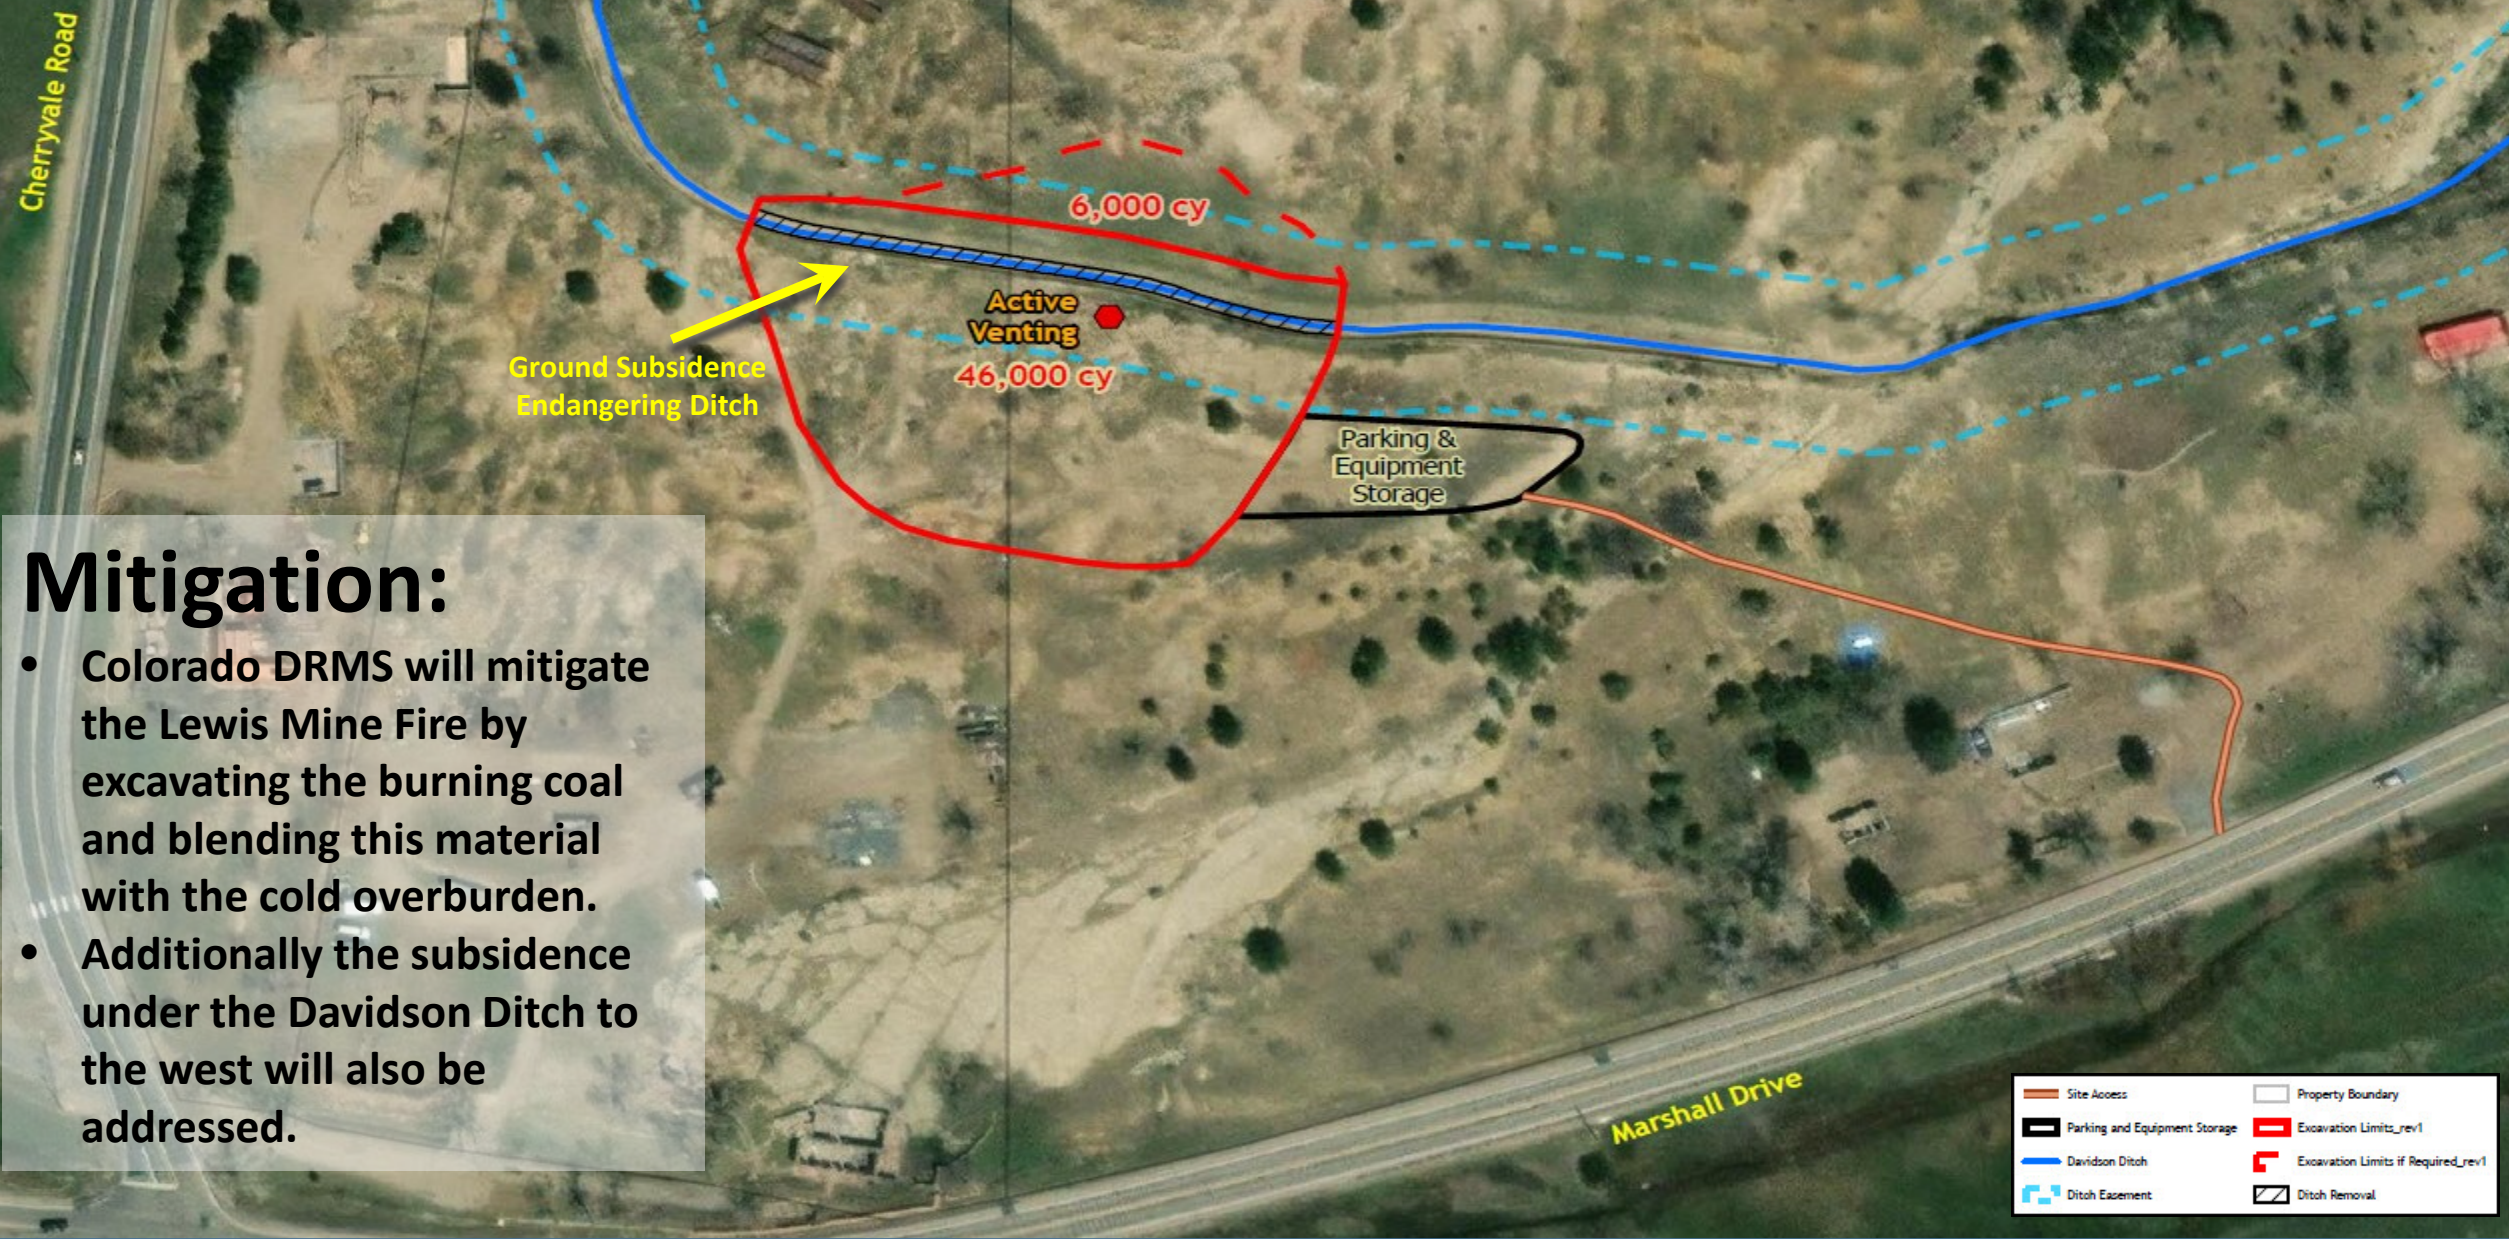
Ground Subsidence
Endangering Ditch

Active
Venting
46,000 cy

- Colorado DRMS will mitigate the Lewis Mine Fire by excavating the burning coal and blending this material with the cold overburden.
- Additionally the subsidence under the Davidson Ditch to the west will also be addressed.

- A 300 foot section of the Davidson Ditch will be removed.
- The area will be excavated to just below the Lewis Mine workings, approximately 25 feet to 30 feet below ground surface.

- Any material exceeding 100° F will be blended with cold overburden (rock & soil) at a ratio of 5 parts cold material to 1 part hot material.
- This process breaks up any hot or smoldering material and disperses it within the cold soil and rock.

- The blended material will then be monitored until the temperature is less than 100° F.
- Once cooled, the blended material will be backfilled into the excavation.

- The excavated area beneath the Davidson Ditch will be backfilled with clean, non-carbonaceous (non-coal) compacted fill.
- Depending on Site conditions clean fill material may need to be imported to the Site.
- A 24-inch compacted clay liner will be installed in the reconstructed section of the Davidson Ditch.

- Any areas disturbed by the mitigation effort will be regraded to match the surrounding undisturbed topography.
- The site will then be seeded with a native seed mix developed for the area.
