## HISTORIC PRESERVATION ADVISORY BOARD

**Thursday, May 4, 2017 – 6:00 p.m.**  
Commissioners Hearing Room  
Third Floor of the Boulder County Courthouse

4. Landmark:
  - a. **Docket HP-17-0002: Kolb Farm**  
Request: Boulder County Historic Landmark Designation  
Location: 7715 Arapahoe Road, in Section 25, T1N, R70 in the 6<sup>th</sup> Principal Meridian.  
Zoning: Rural Residential (RR)  
Owner: Boulder Municipal Property Authority  
Applicant: City of Boulder, Open Space and Mountain Parks

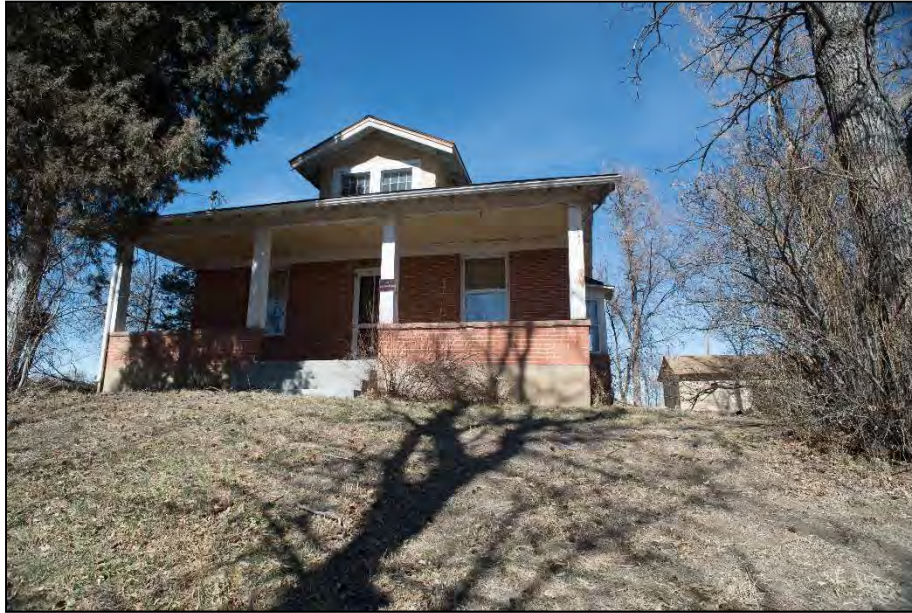
Photo DSC\_5282: BL1, Main Residence, Facing North-Northwest.

BL1 is a simple one and a half story rectangular-plan Craftsman style house located at the southern edge of the proposed site boundary (CPR 2014). The building is set on a concrete foundation that forms a full basement, access to the basement is provided via the house interior, and a cellar entrance set into the ground on the eastern elevation. The first floor of the building consists of brick masonry and the upper story is clad in stucco over wood framing.

Overall, the building is currently in good condition. White trim around windows, doors, and at the eaves are weathered and some of the exterior brick on the first floor is stained. The building retains integrity and is a good example of Craftsman style rural residential architecture. The interior of the house was not evaluated for the current project and a more detailed description of the building interior can be found in the 2014 Historic Structure Assessment (CPR 2014).

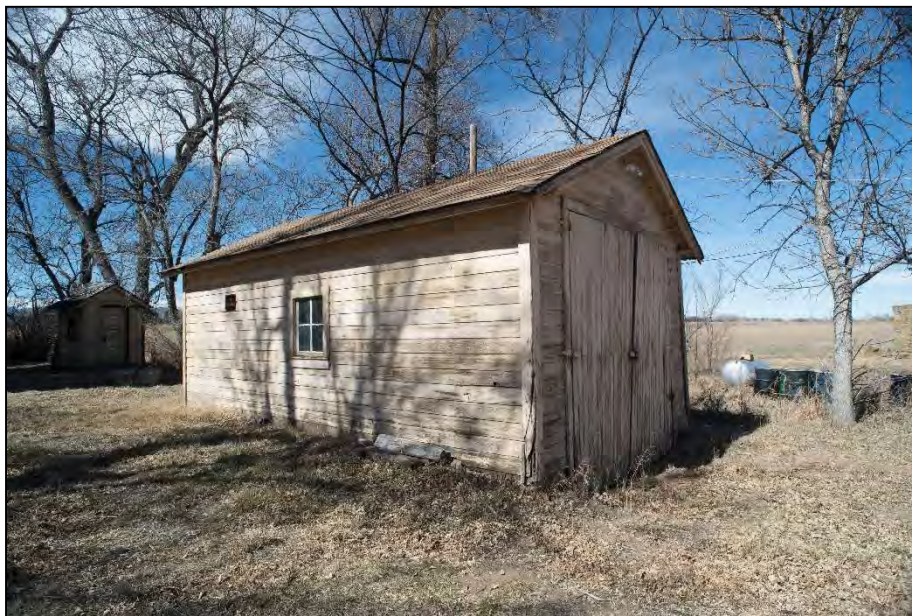
BL3 is a small, unidentified square plan building that measures approximately five by seven feet and is located near the northwest corner of the proposed site boundary. A low concrete perimeter wall forms the foundation and the walls of the building consist of horizontal siding painted beige. The exterior corners of the building are clad with vertical planks that form corner posts. The northern and southern elevations each include a centered four-light sliding window, and the northern window is covered with wire mesh. The main entrance consists of a narrow paneled door centered on the eastern elevation and a steel clothesline post is positioned against the eastern edge of the doorframe. A front gabled roof with exposed rafters and clad in a mix of wood shake, asphalt composite shingles, and corrugated metal roofing panels caps the building.

BL3 is in overall good condition. The beige paint on the exterior is weathered and portions of the roof have been repaired with materials other than the original wood shake. Despite these condition issues the building retains integrity and contributes to the historic significance of the site overall.

Photo IMG\_20170323\_143427: BL3, Unknown Building, Facing Northwest.

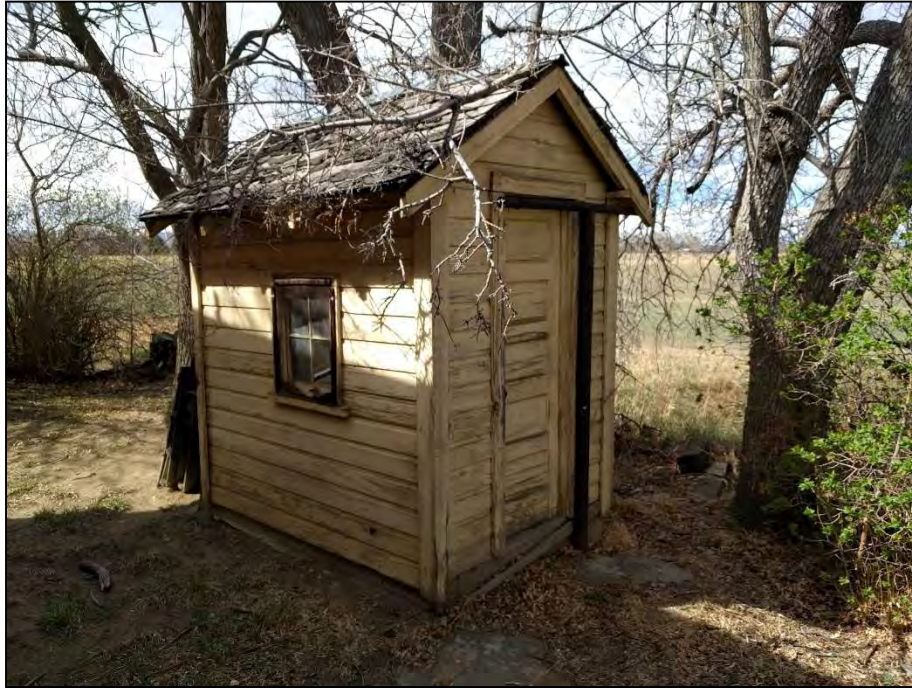
Overall BL4 is in fair to moderate condition. Currently, a variety of materials including metal drums, irrigation siphon tubes, irrigation pipes, vehicle components, and trash are stored within building. A collection of trash and abandoned agricultural equipment rests against the western elevation. The northern wall is in poor condition, however, the western wall, roof, and vertical supports are all in relatively good condition. Despite the damage to the building, BL4 retains integrity, is a good example of a vernacular farm building, and contributes to the historic significance of the site overall.

Photo IMG\_20170323\_143602: BL4, Shed, Facing Northeast.

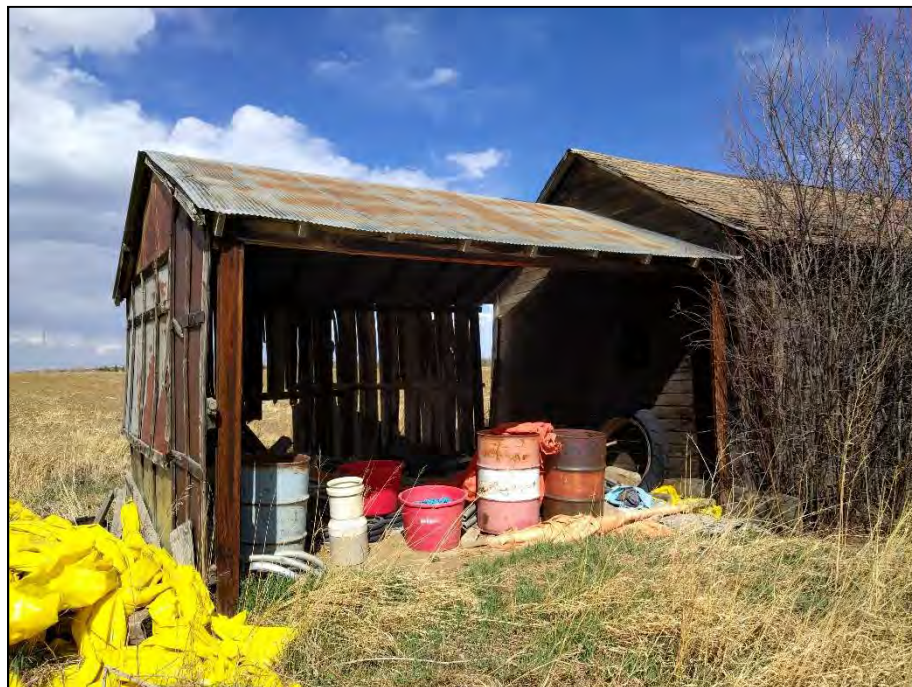
BL5 is a single story rectangular-plan building measuring approximately 12 by 22 feet located at the northern edge of the proposed landmark boundary. The building has no permanent foundation and rests on piers consisting of cinderblock and scrap lumber. The exterior of the building is clad in horizontal wood siding attached to an interior frame with wire nails and the

BL5 is in overall fair condition. The building is well constructed; however, the structure leans noticeably to the east. Damage includes holes, degrading roofing material, and weathering on all elevations and the building interior. At the time of the 1994 evaluation, the window frames on the western elevation also included four-light hopper windows; however, these windows currently lack glazing (McWilliams 1994). Pictures from the 1994 recording also indicate that much of the white paint on the siding recorded in 1994 has since degraded (McWilliams 1994). Despite the damage to the building BL5 retains integrity, is a good example of a vernacular farm building, and contributes to the historic significance of the site overall.

Photo IMG\_20170323\_143617: BL5, Shed, Facing Northwest.

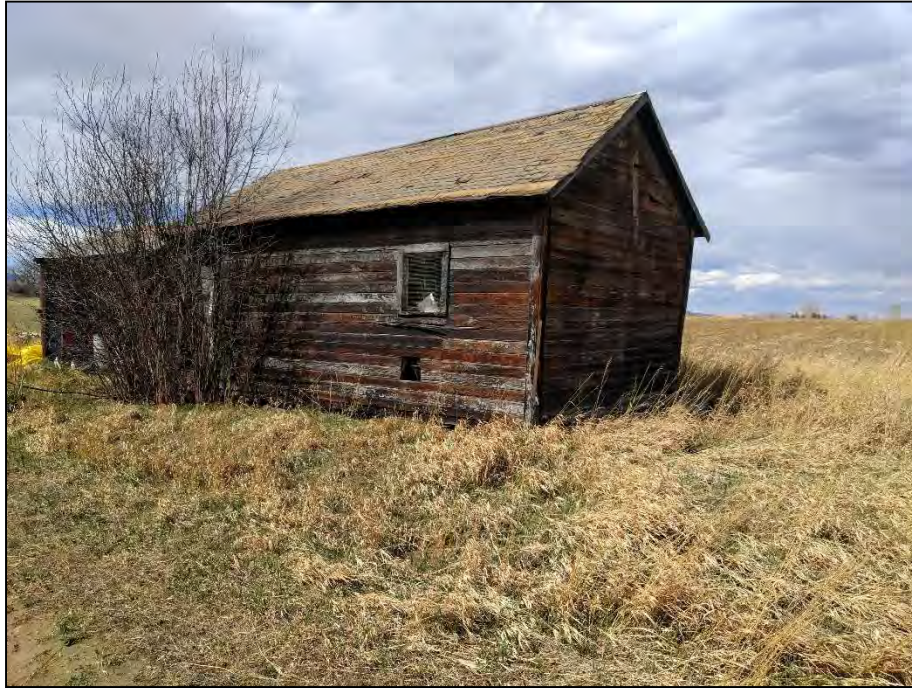
BL6 is a two-bay rectangular plan poultry house measuring approximately 8 by 22 feet, situated north of the silo near the center of the site. The building is oriented east-west and is set on a roughly poured concrete slab foundation that also serves as the floor. The walls of the building consist of horizontal dimensional lumber planks attached to the building frame with wire nails and clad in green rolled asphalt composite siding. The main entrance is positioned on the southern elevation near the southwest corner and a smaller secondary entrance is located on the western elevation which lacks rolled asphalt siding. Two horizontally centered rectangular window frames are located to the left of the main entrance on the southern elevation, and a wood framed six-light window covered in medium-gauge wire mesh is located on the eastern elevation. A corrugated metal shed roof with exposed two by 4 inch rafter ends caps the building. Two circular stovepipe holes in the roof above both bays likely indicate the presence of one or more stoves when the building was in use. Three ceramic insulators with the remnants of electrical wiring are visible attached to exposed rafter ends on the southern elevation.

The building is in fair condition. The shed roof over the western bay is sagging, and portions of the green asphalt composite siding are heavily degraded on the southern elevation, and entirely lacking on the western elevation. Numerous small holes, some of which are covered with mesh, were observed in various locations, and the entrance on the western elevation is partially blocked with a corrugated metal panel. Despite the damage to the building the poultry house retains integrity, and contributes to the historic significance of the site overall.

Photo IMG\_20170323\_143801: BL6, Shed, Facing Northeast.

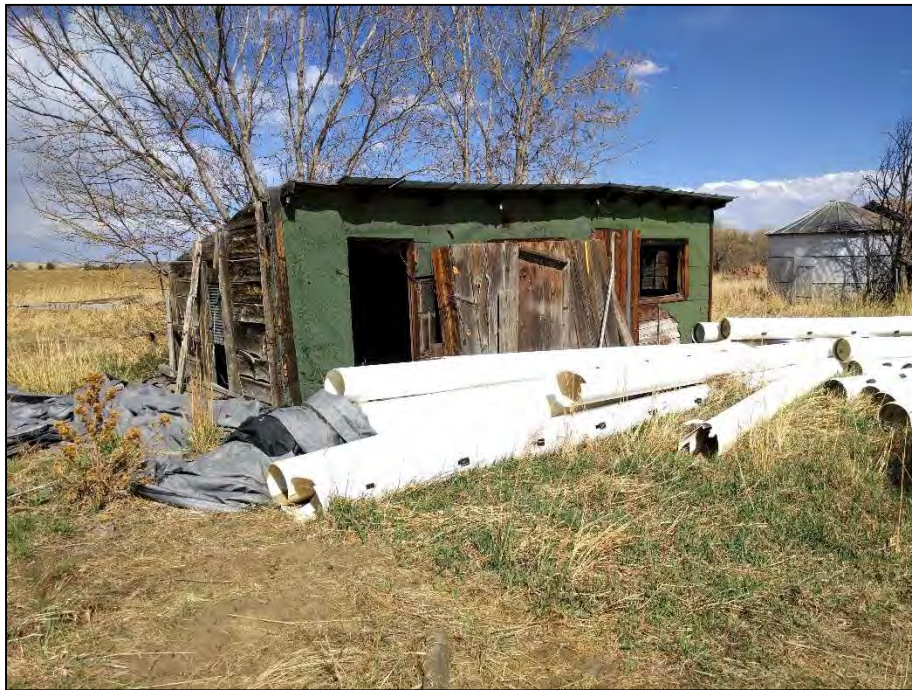
ST1 is a small square-plan privy measuring approximately 4 by 4 feet located adjacent to the eastern elevation of BL6, near the center of the site. The privy foundation consists of several unmortared cement blocks set on edge to form a square vault on top of which the poured concrete privy floor is set without the use of mortar. The floor of the privy consists of a square slab of concrete with a small raised square dais set at a 45-degree angle and positioned in the northwestern corner of the structure. Along the edges of the concrete floor are several vertically protruding attachment points consisting of flat metal stock to which the walls of the structure are attached with the use of metal bolts. The walls consist of horizontal siding attached to an interior frame with wire nails and the exterior corners of the building are clad with vertical planks that form corner posts. An off-center doorway with a vertical plank door reinforced with diagonal braces is positioned at the southeast corner of the south elevation. A moderately pitched shed roof edged with 6-inch fascia board and covered with a wood shake shingles. Based on the remnants of weathered paint, the entire privy was once painted bright green.

Photo IMG\_20170323\_143541: ST1, Privy, Facing North-Northwest.

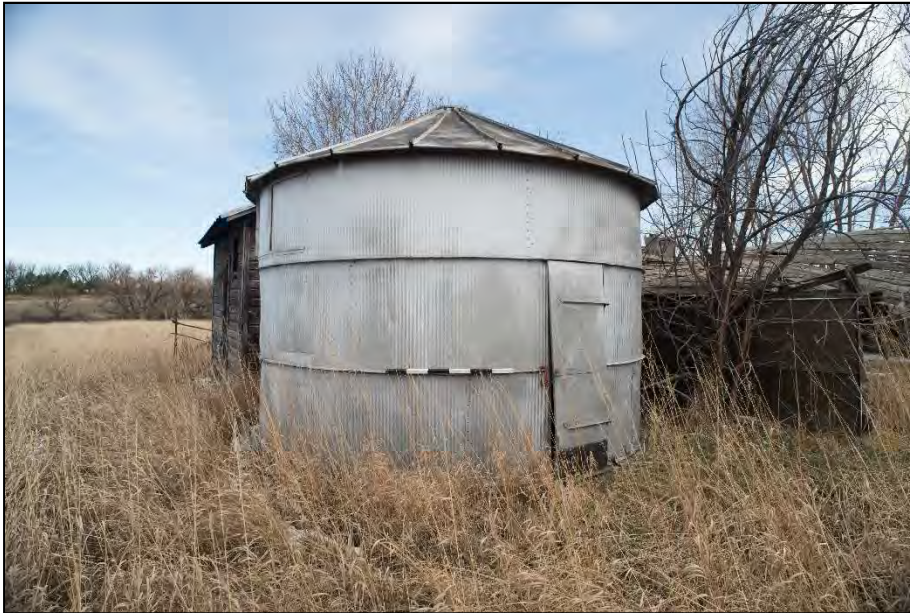
Photo DSC\_5386: ST2, Grain bin, Facing East-Southeast.

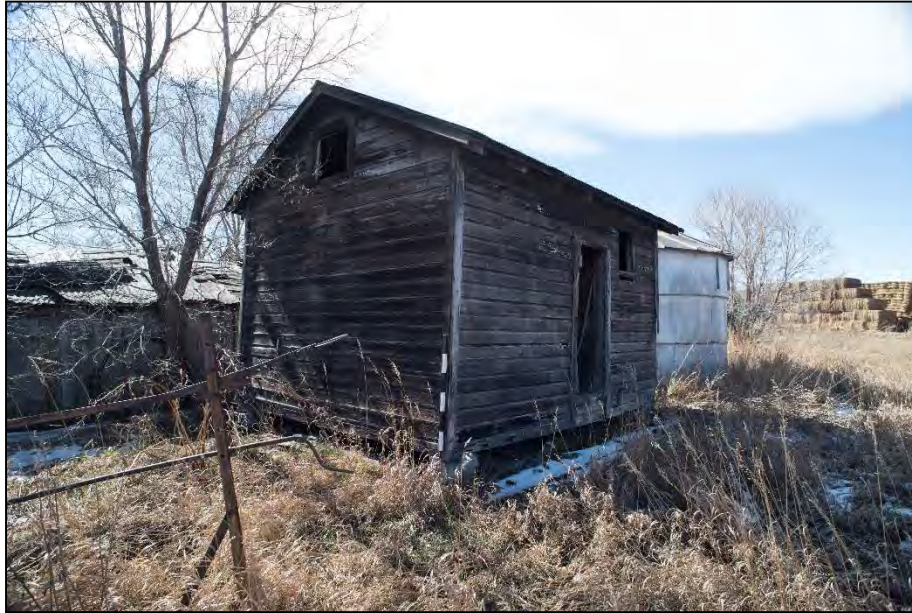
Photo DSC\_5301: BL7, Granary, Facing Southwest.

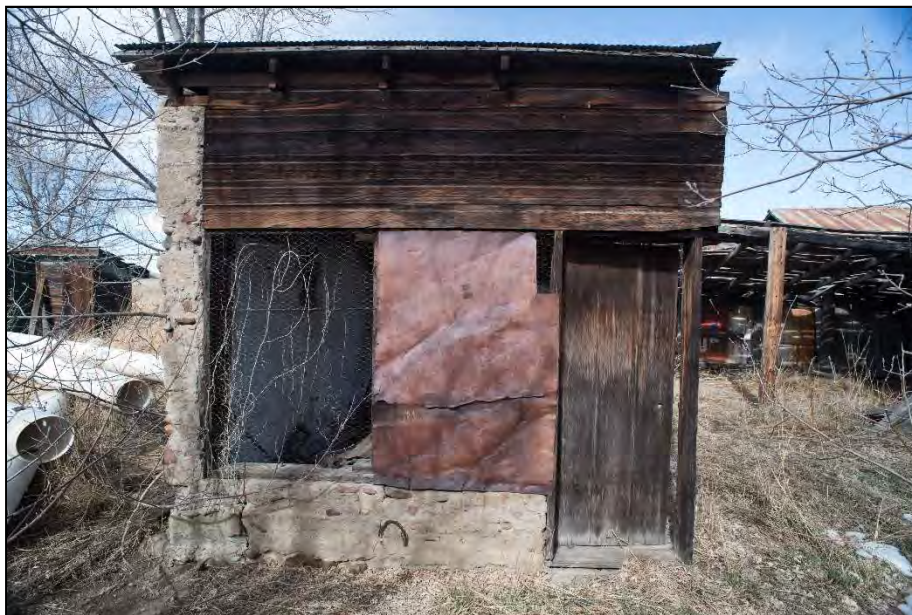
Photo DSC\_5339: BL8, Poultry House, Facing North.

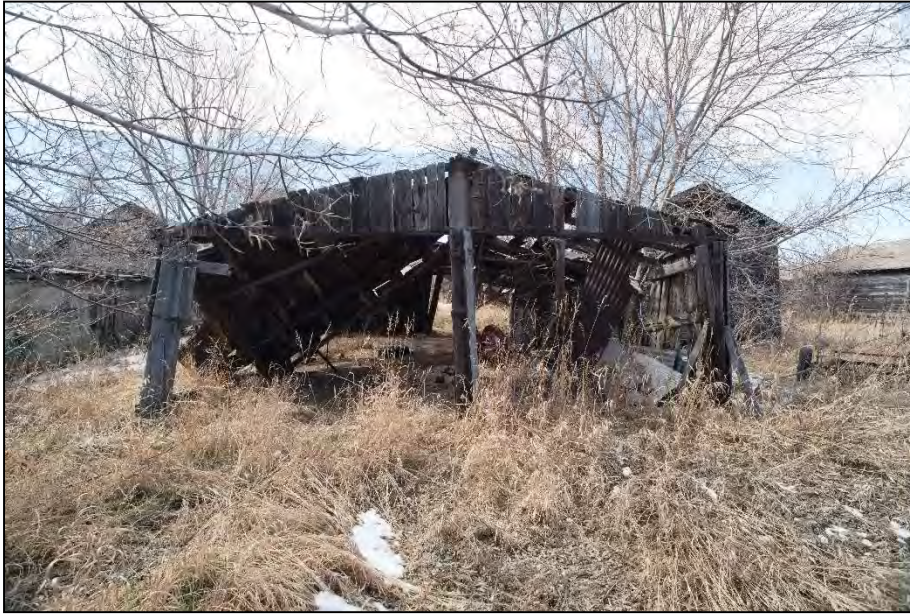
Photo DSC\_5352: BL9, Machine shed, Facing West.

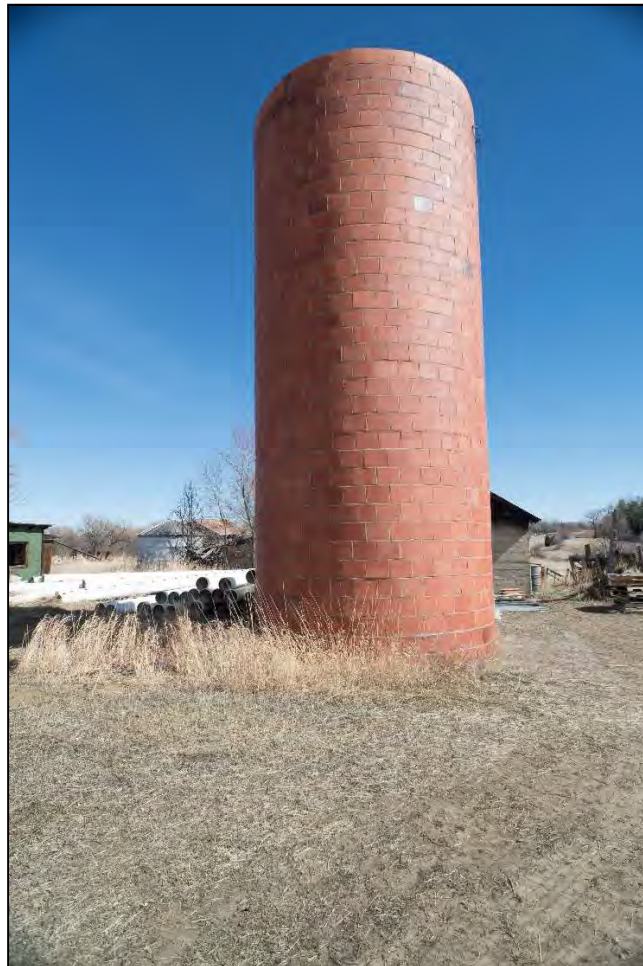
Photo DSC\_5312: ST3, Silo, Facing East.

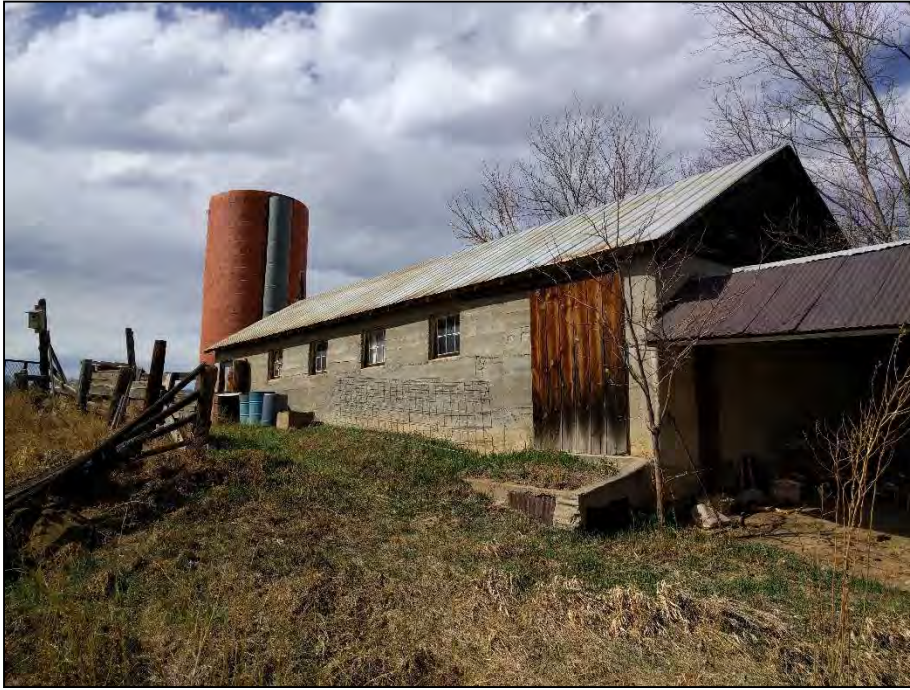
Photo IMG\_20170323\_143723: BL10, Dairy Barn, Facing Northwest.

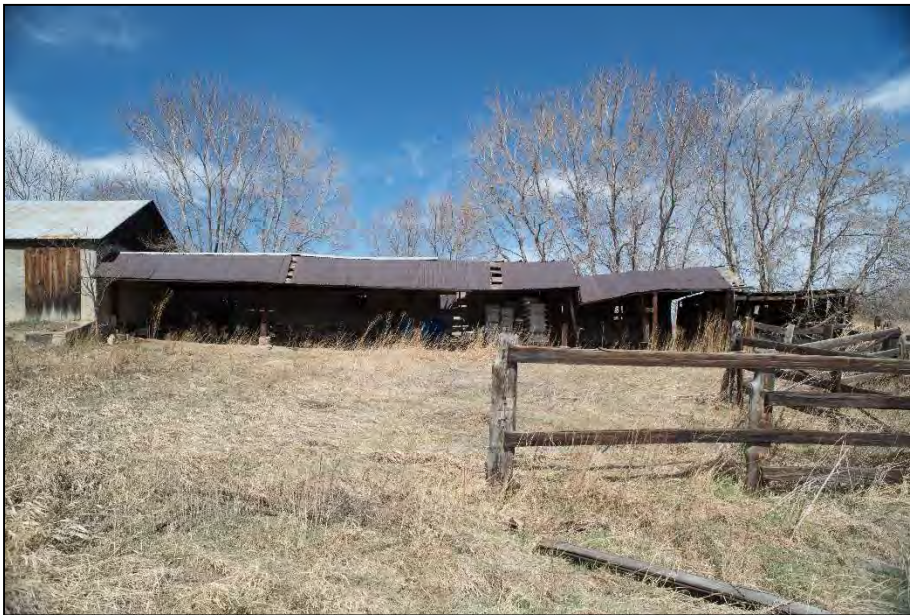
Photo DSC\_5424: BL11, Loafing Shed, Facing North.

Despite damage to the structure, the loafing shed retains integrity overall, is a good example of a vernacular farm building, and contributes to the historic significance of the site.

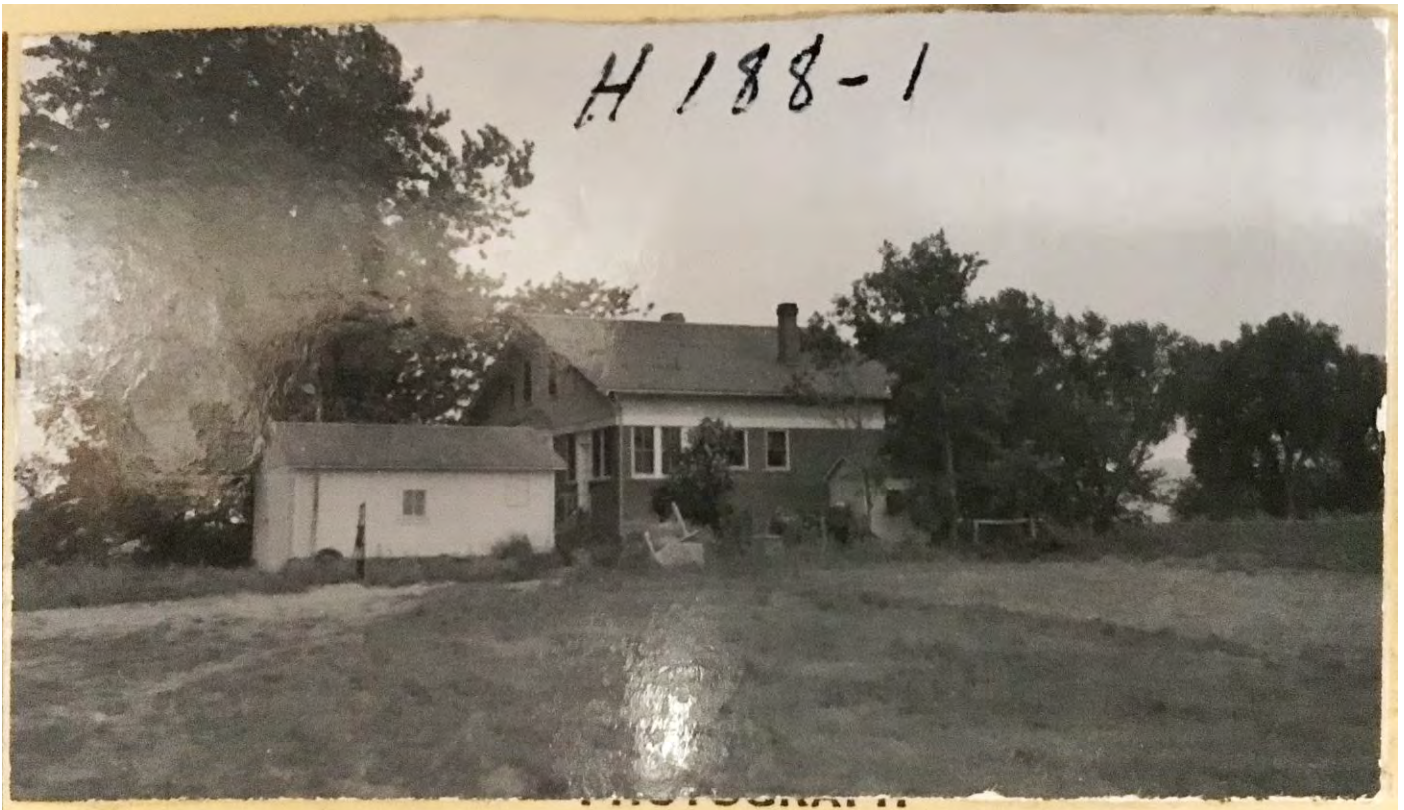
Rear of house, garage and unidentified building

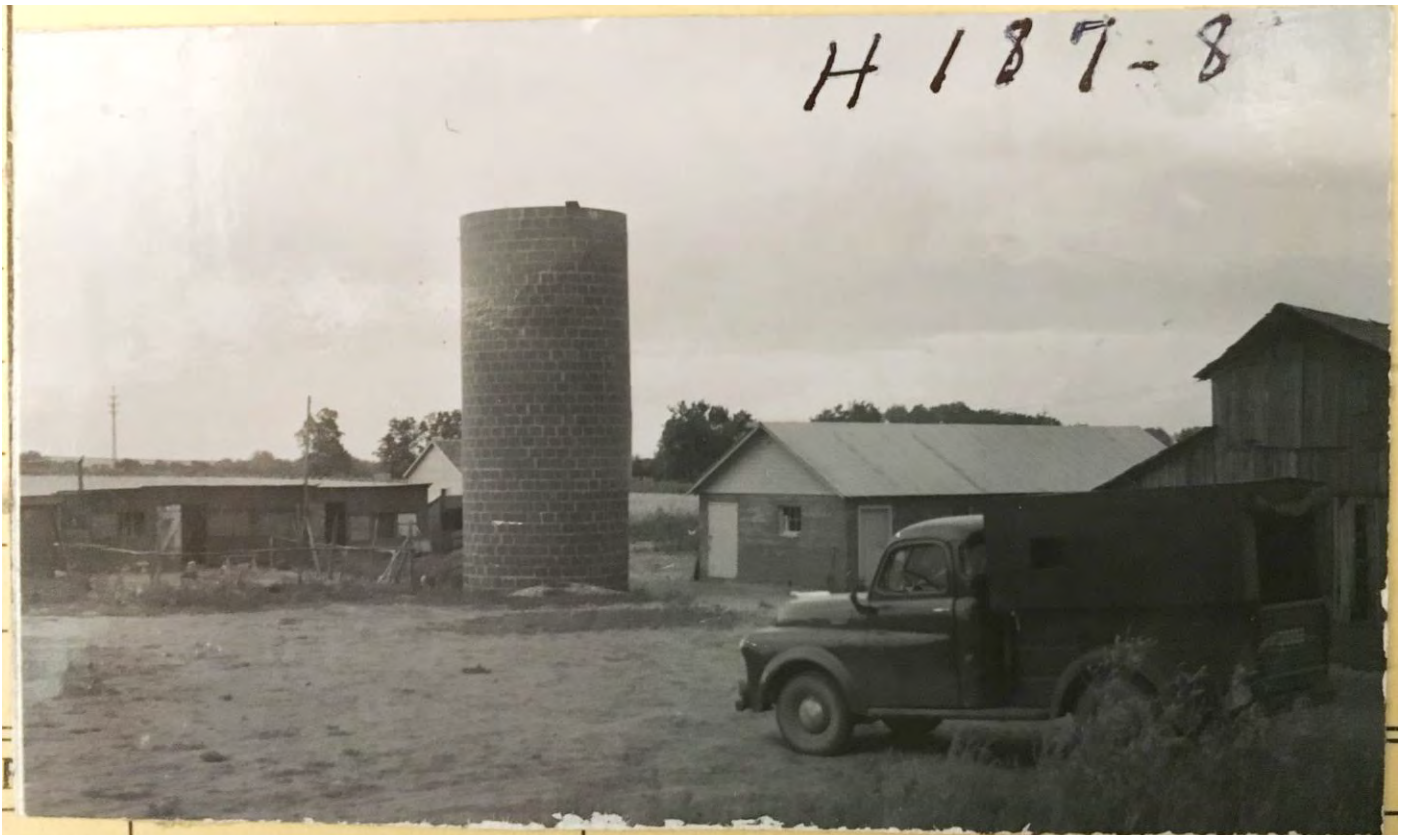
Poultry (brooder) house, silo, dairy barn and missing barn

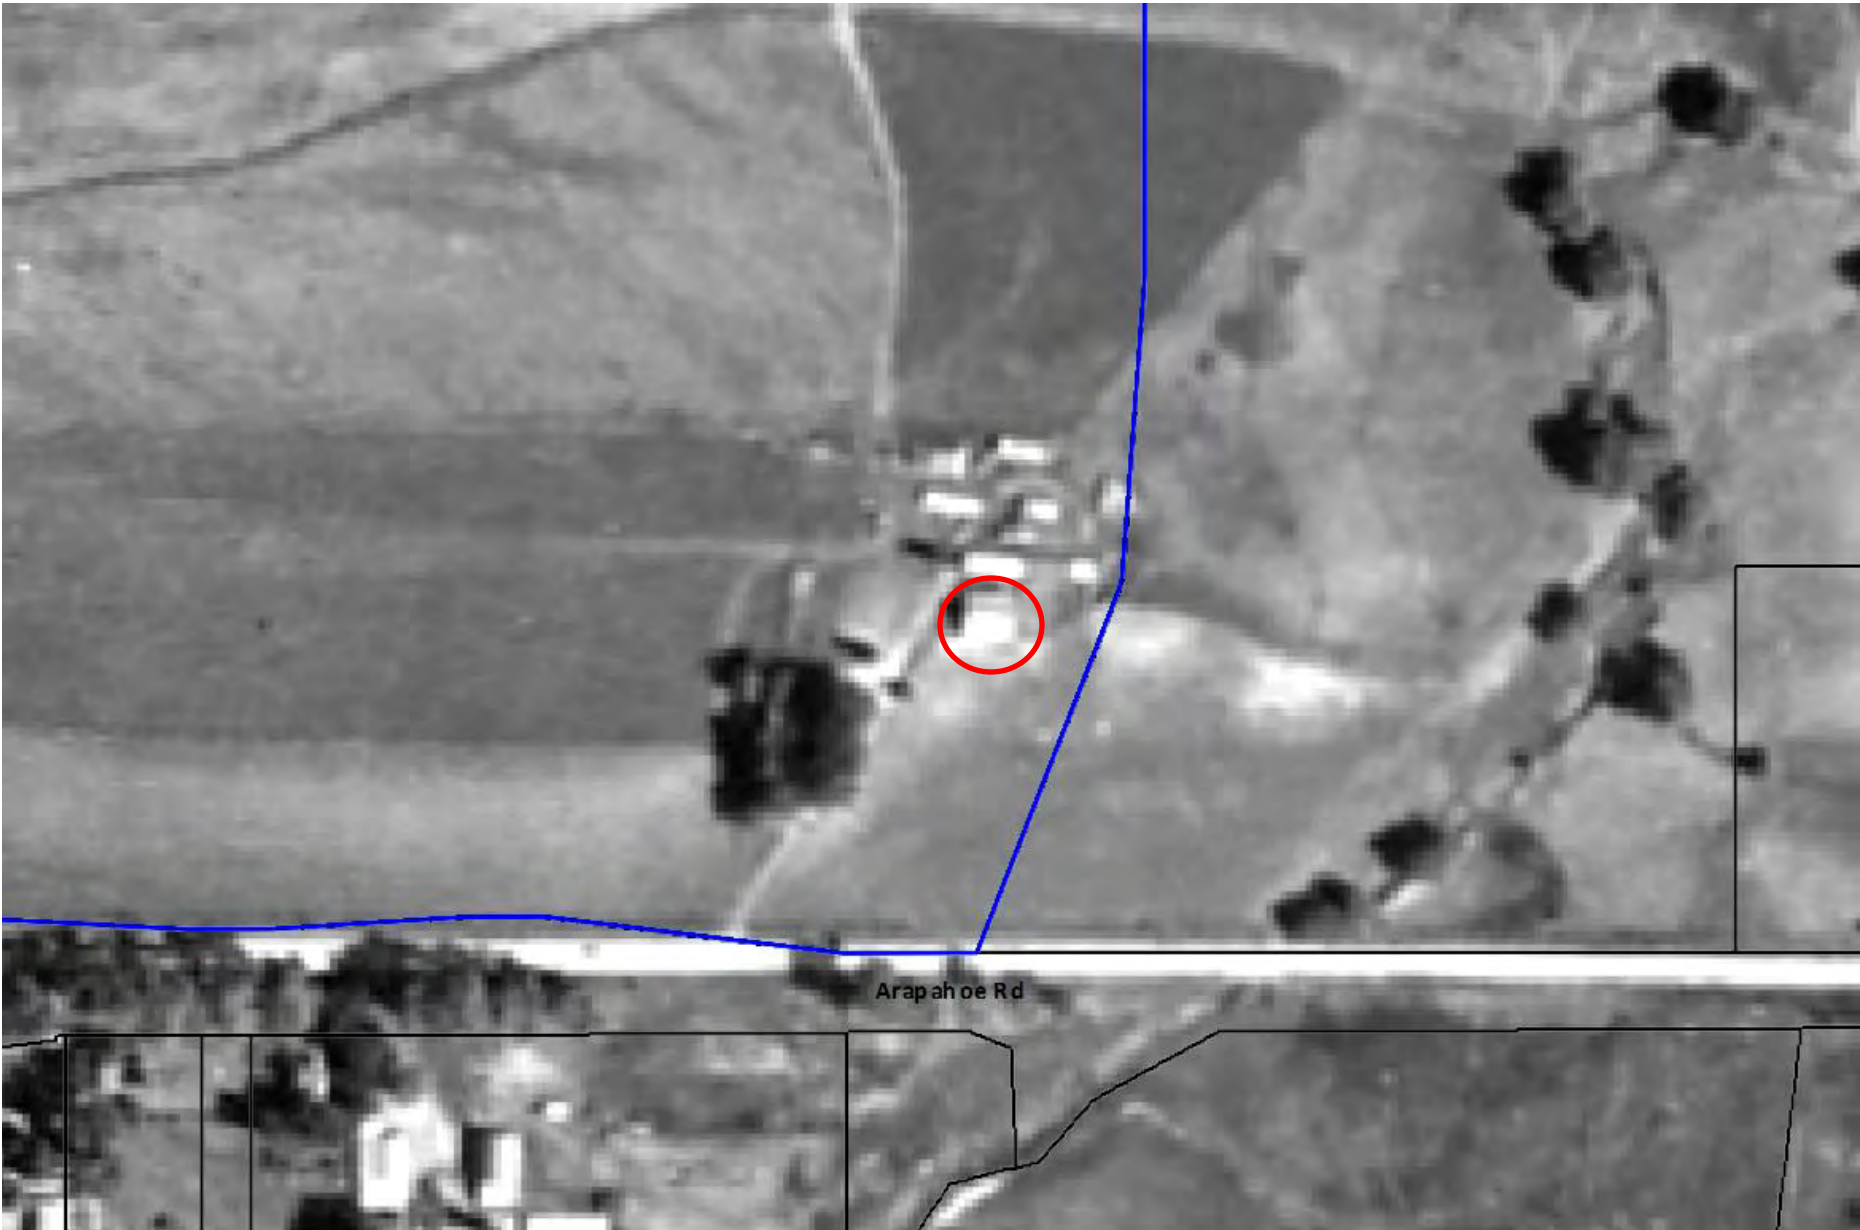
1963 aerial of farm complex with building now gone

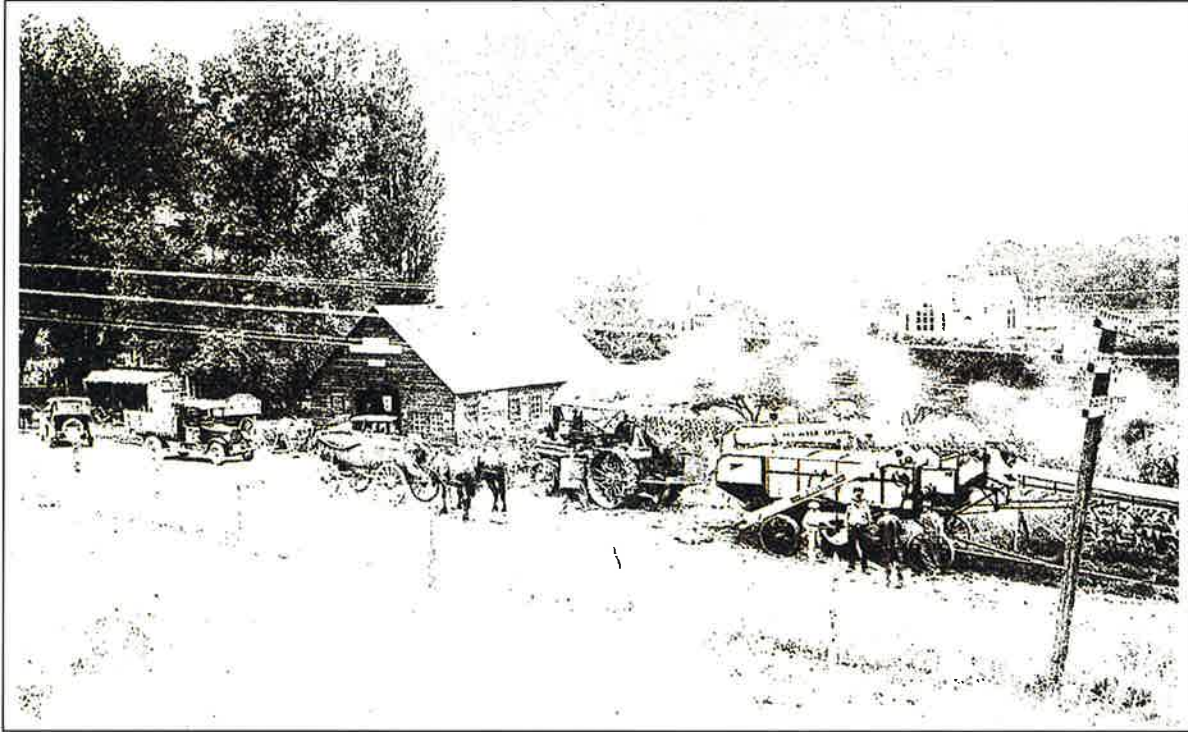
Valmont Road, 1920. Polzin's blacksmithy, left. "Lucky Strike" ad on the east side of smithy.  
Paul Hummel's steam engine and "Red" and threshing machine at right.  
For more information, see p. 150 of Boulder in Perspective.

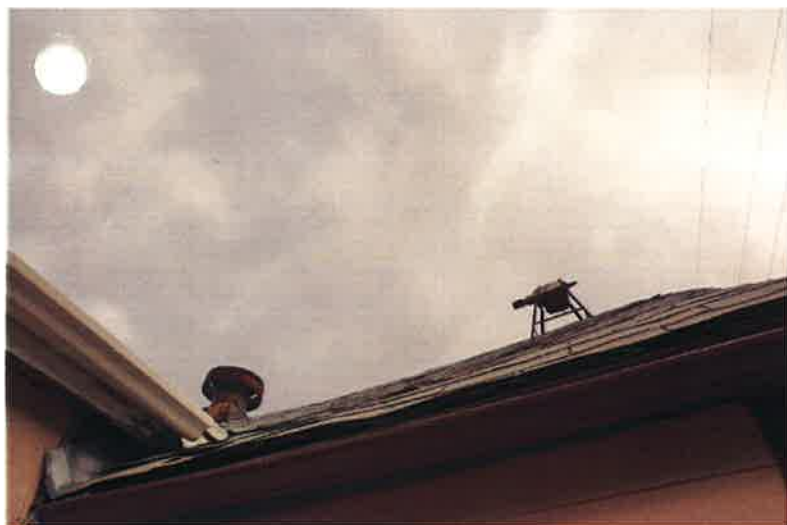
DSC02354.JPG

Photo No	Caption
2354	Roof plane from SW – note deep dip
2355	Existing south elevation
2356	Roof plane from SE – note deep dip
2357	East elevation, south portion
2358	East elevation, north portion
2359	Roof plane from NE
2360	North elevation
2361	North elevation, concrete foundation infill. Note bottom wall plate buried under concrete slab
2362	North elevation, window is not original (typical) smaller than opening
2363	Interior, east wall, the support is plumb, the adjacent wall is not
2365	Roof structure, widely spaced 2 X 4 rafters
2366	Continued south to north
2367	Continued south to north
2368	Continued south to north
2369	Wall gaps indicated by light
2370	Roof structure
2371	Roof structure
2372	Roof structure
2373	Roof structure
2374	Roof structure
2375	Bottom of studs, buried in slab, stained by water uptake
2376	Broken stud
2379	Broken rafter
2380	Broken roof sheathing (typical)
2382	Broken and rotted roof sheathing

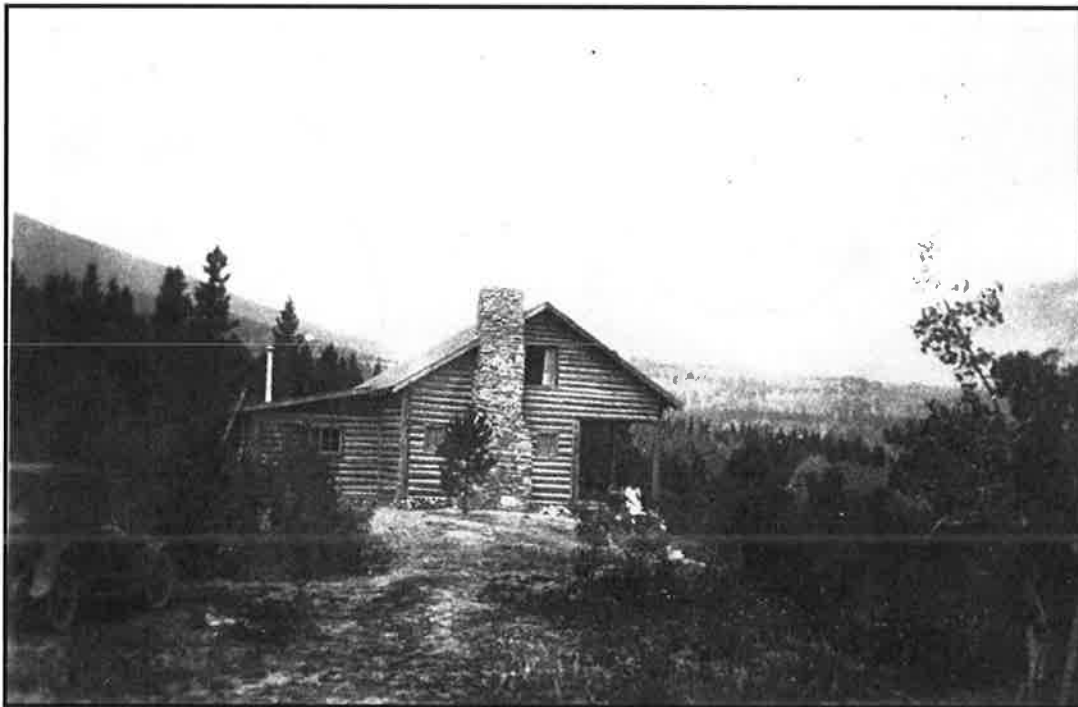
Figure 4 East façade of the completed cabin in 1925. View is to the west.

Warren “Earl” Long and Mary Emolyn Long (McCarty), former residents of Michigan, spent their summers vacationing all over the United States, in a search of their future retirement home location. After a number of years they settled on Colorado, and set about building their summer home and future retirement cabin in the woods. They secured a special use permit from the Forest Service in 1921 and found the perfect location for their cabin in the Roosevelt National Forest just outside Allenspark.<sup>23</sup> They started construction of their cabin the summer of 1922 (Figures 1-2), living in a tent all summer while they worked (Figure 3). The couple did most, if not all, of the work themselves, including collecting downed trees from nearby Jackstraw Mountain that they drug one by one back to the cabin site with the assistance of horses. After laying out the plan of the cabin, they built the kitchen first (the room that appears to be an addition on the south façade) so that they could live in it—rather than a tent--the following year. The cabin was completed in 1924 (Figure 4).

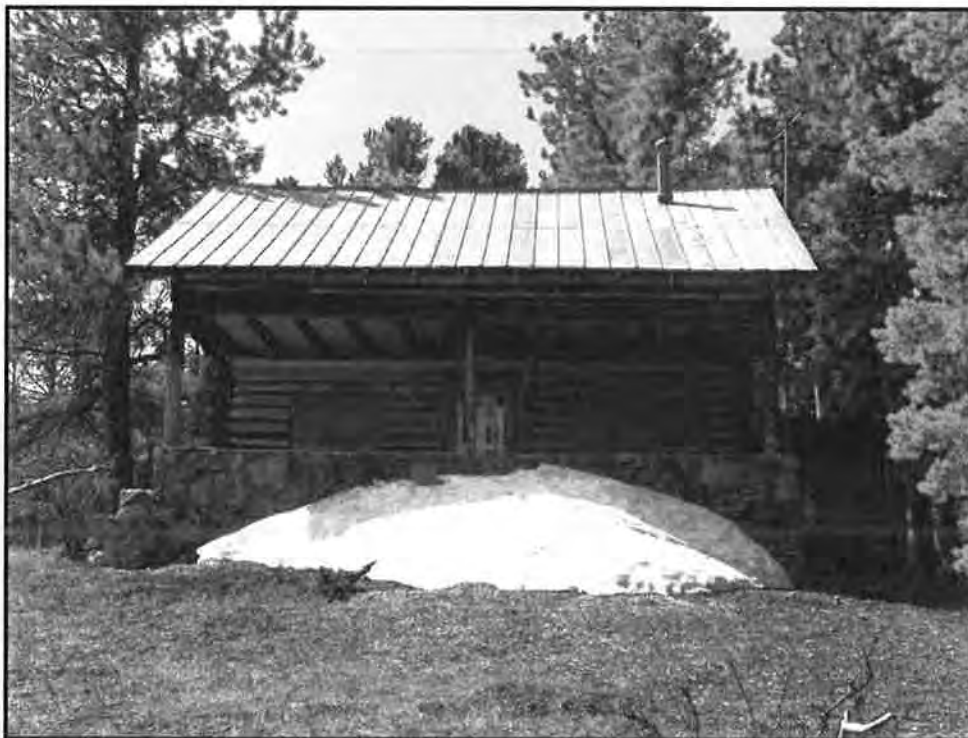
Photo 4

The front door is centered on the north façade under the covered porch (Photo 4). There is an interior, plain vertical wood plank door and a wood six-lite exterior door. Like the other doors in the cabin, both are original. There two fixed, plate glass windows, one on each side of the door; these are the only windows in the cabin that are not original, but were installed in the late 1940s. The one left of the door is square, the one on the right is rectangular. They are protected by exterior wood shutters painted the same dark green as the front exterior door.

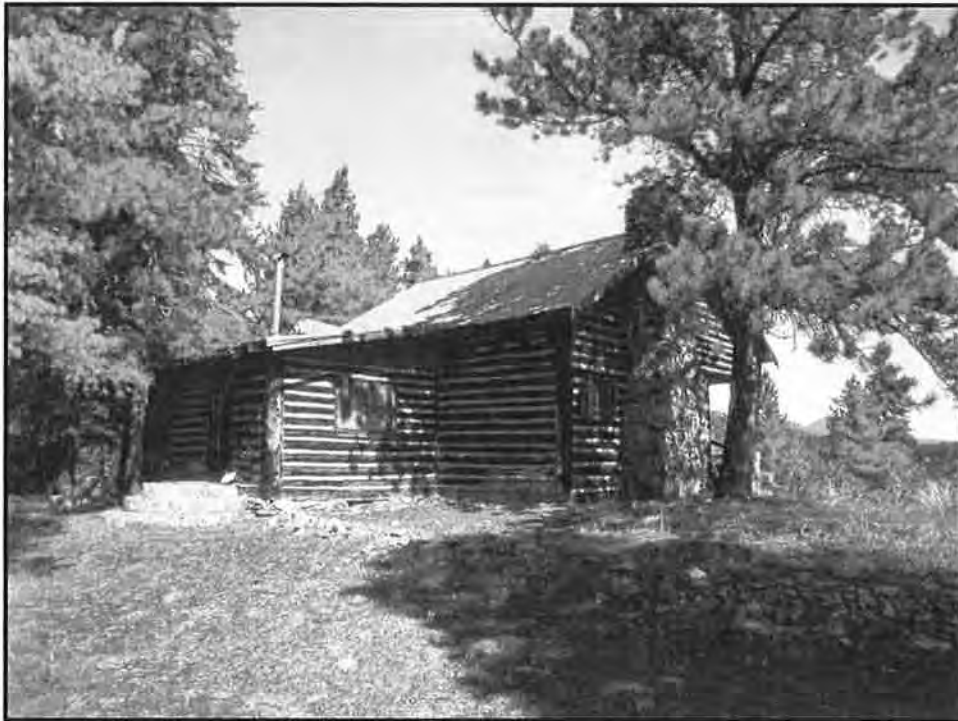
Photo 7

The southern façade is unique in that the small rectangular room there (the kitchen) *looks* like an addition, when in reality it was the first room of the cabin to be built (Photos 7-8). The room is situated in the center of the south wall of the main portion of the cabin--in essence, a rectangle attached to a larger square (the main cabin). When Mary and Earl started building the cabin in 1922 they spent the summer living in a tent on the property (Figure 3). Not wanting to live in such primitive conditions the second summer of construction, they built the kitchen first—it was smaller than the main part of the cabin, and was single story, so it was quicker to build the room before building the cabin. In 1923 they lived and slept in the kitchen. A 1925 photograph (Figure 4) confirms that the kitchen was actually part of (and slightly predates) the original cabin. The south facing kitchen features a single window in its east façade. The type is unknown since it was shuttered during the site visit. The south façade has a doorway that leads from the kitchen to the outside. There is a simple wood and screen exterior door, and a plain, wood vertical plank interior door. Three concrete and stone half-circle stairs lead from the kitchen, down into the backyard area.

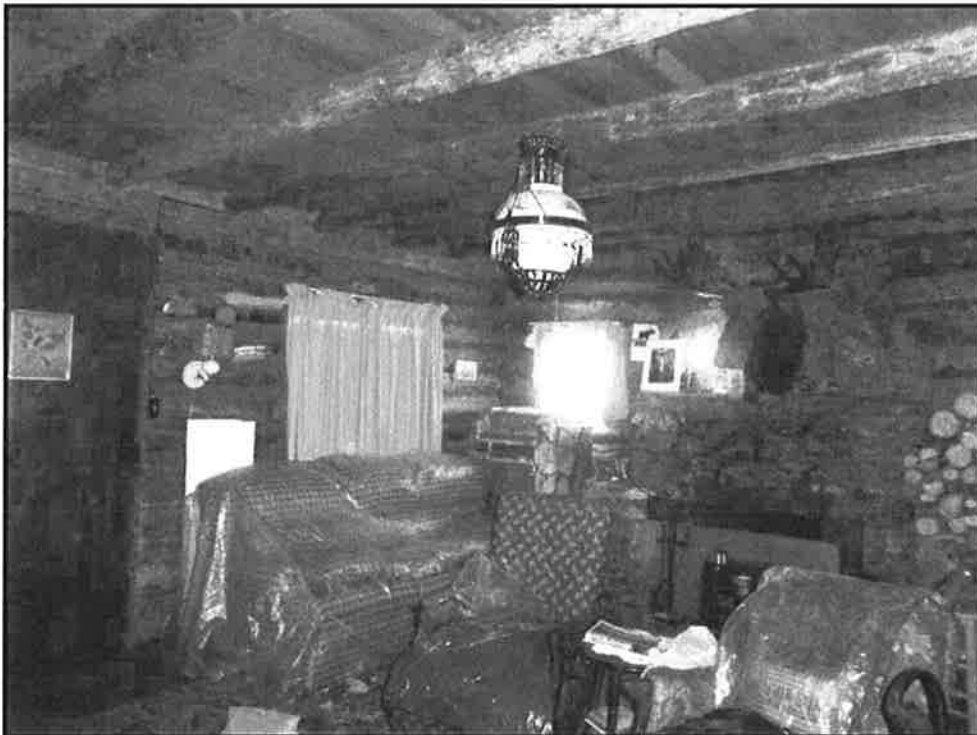
Photo 10

The interior of the cabin has two living spaces, upstairs and downstairs (Photos 10-17). All of the interior walls are exposed logs. The ceiling is made of wood planks with log support beams (Photos 10 and 12) and the floor is wood (tongue-and-groove). The downstairs of the main portion of the cabin is a single open room with a closet under the stairs in the southwest corner (Photos 10-13). There is a massive stone fireplace on the eastern wall of the living room, flanked by two small, square, fixed windows. The tiered fireplace mantle is also stone. The L-shaped wood plank staircase is built along the south and western walls, and the handrail and balustrade at the top of the stairs are thick tree branches.

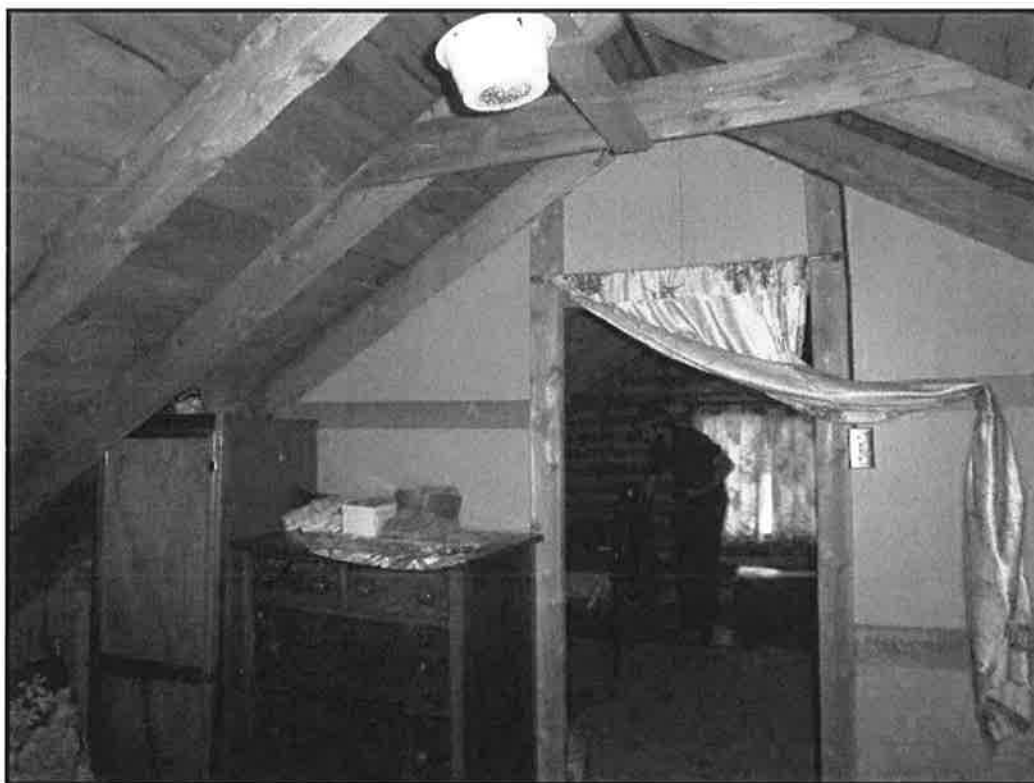
Photo 14

The upstairs sleeping loft is reached by wood plank stairs and may have initially been one large room under the pitched roofline (Photo 14). At some point, prior to Mr. McCarty's 1942 visit, the single room was divided into two small bedrooms with a doorway, but no door, between the two rooms. It is not known if this was done when the cabin was built or at some later time in the twenty years that followed. The dividing wall is exposed wood frame and sheetrock. The sloped wood plank ceiling has exposed rafters and the floor is wood.

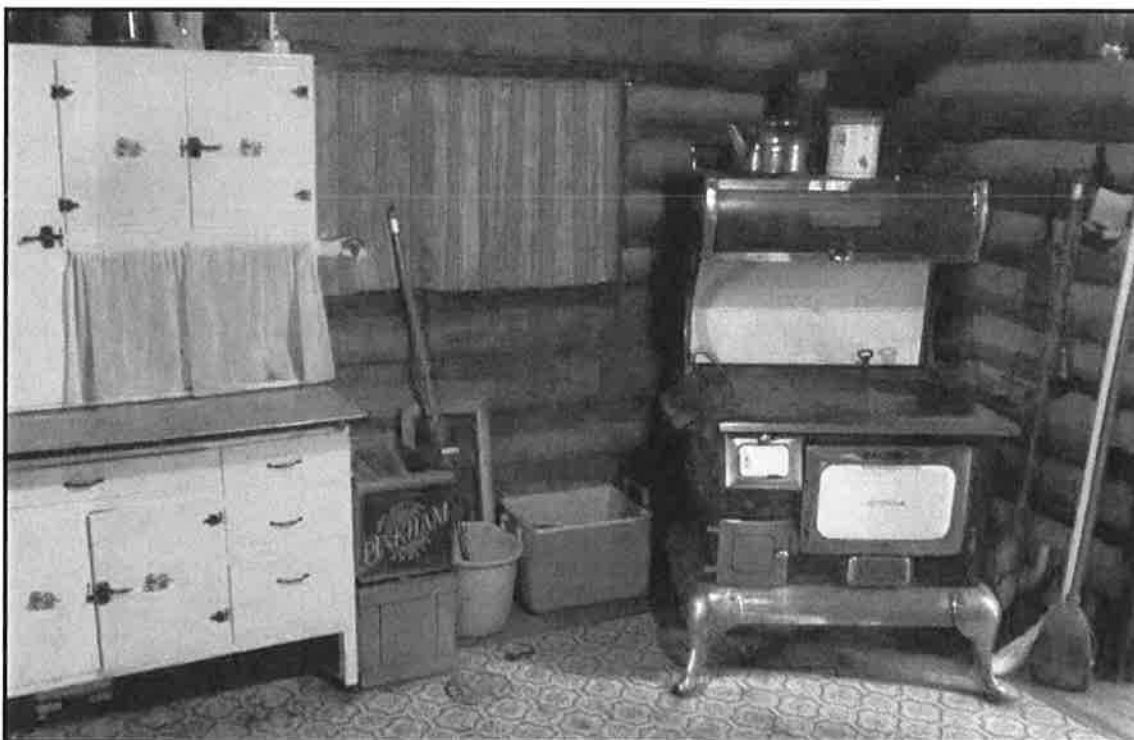
Photo 15

To the left of the stairs is the doorway to the kitchen (Photos 15-16). The door is constructed of plain, vertical wood planks. As mentioned above, there is a door in the south wall of the kitchen that leads outside. The Peninsular wood-burning cook stove (purchased used during World War II), the kitchen cabinets, the water tank, and the small kitchen sink were installed during the summer of 1942. Linoleum flooring was installed in the kitchen before Mary's grandson, John McCarty's, first visit in 1942, leaving the original tongue-and-groove flooring intact, according to Mr. McCarty.<sup>2</sup> There is a set of French doors in the west wall of the kitchen that lead to the western addition (Photo 16). The small western room, the former screened in porch, receives an abundance of natural light since the south and west walls are mostly windows. There is an exterior door in the southern wall, in the southwest corner. At the north end of the addition,
