## HISTORIC PRESERVATION ADVISORY BOARD

**Thursday, May 4, 2017 – 6:00 p.m.**  
Commissioners Hearing Room  
Third Floor of the Boulder County Courthouse

4. Landmark:
  - a. **Docket HP-17-0002: Kolb Farm**  
Request: Boulder County Historic Landmark Designation  
Location: 7715 Arapahoe Road, in Section 25, T1N, R70 in the 6<sup>th</sup> Principal Meridian.  
Zoning: Rural Residential (RR)  
Owner: Boulder Municipal Property Authority  
Applicant: City of Boulder, Open Space and Mountain Parks

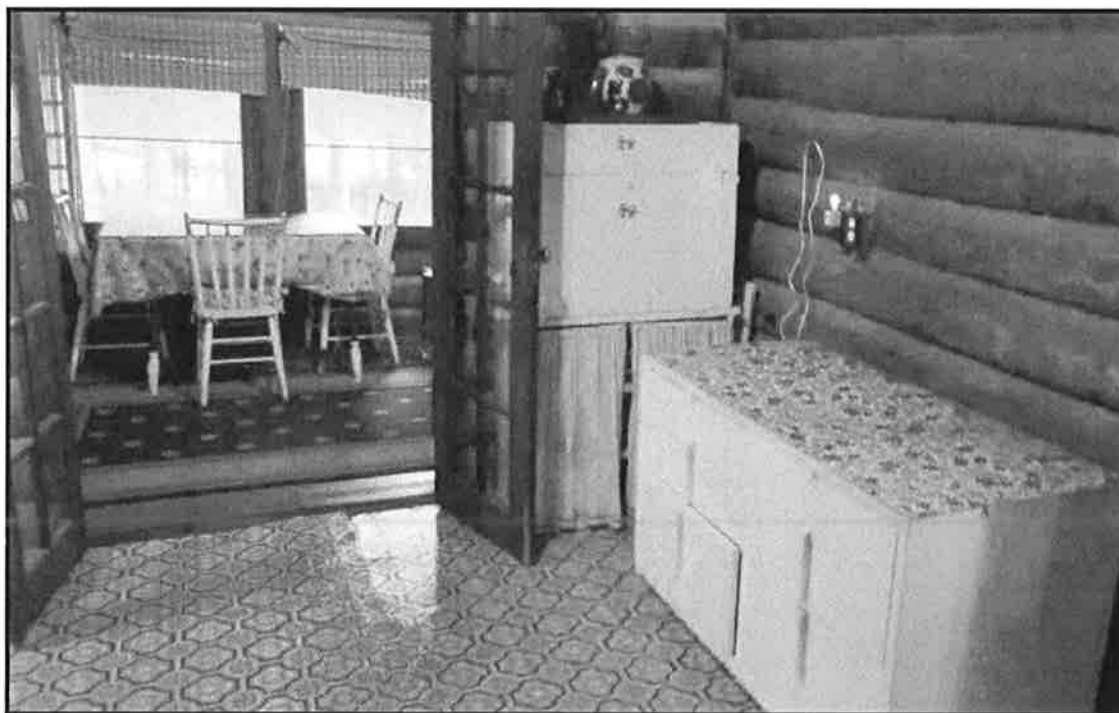
Photo 16

To the left of the stairs is the doorway to the kitchen (Photos 15-16). The door is constructed of plain, vertical wood planks. As mentioned above, there is a door in the south wall of the kitchen that leads outside. The Peninsular wood-burning cook stove (purchased used during World War II), the kitchen cabinets, the water tank, and the small kitchen sink were installed during the summer of 1942. Linoleum flooring was installed in the kitchen before Mary's grandson, John McCarty's, first visit in 1942, leaving the original tongue-and-groove flooring intact, according to Mr. McCarty.<sup>2</sup> There is a set of French doors in the west wall of the kitchen that lead to the western addition (Photo 16). The small western room, the former screened in porch, receives an abundance of natural light since the south and west walls are mostly windows. There is an exterior door in the southern wall, in the southwest corner. At the north end of the addition,

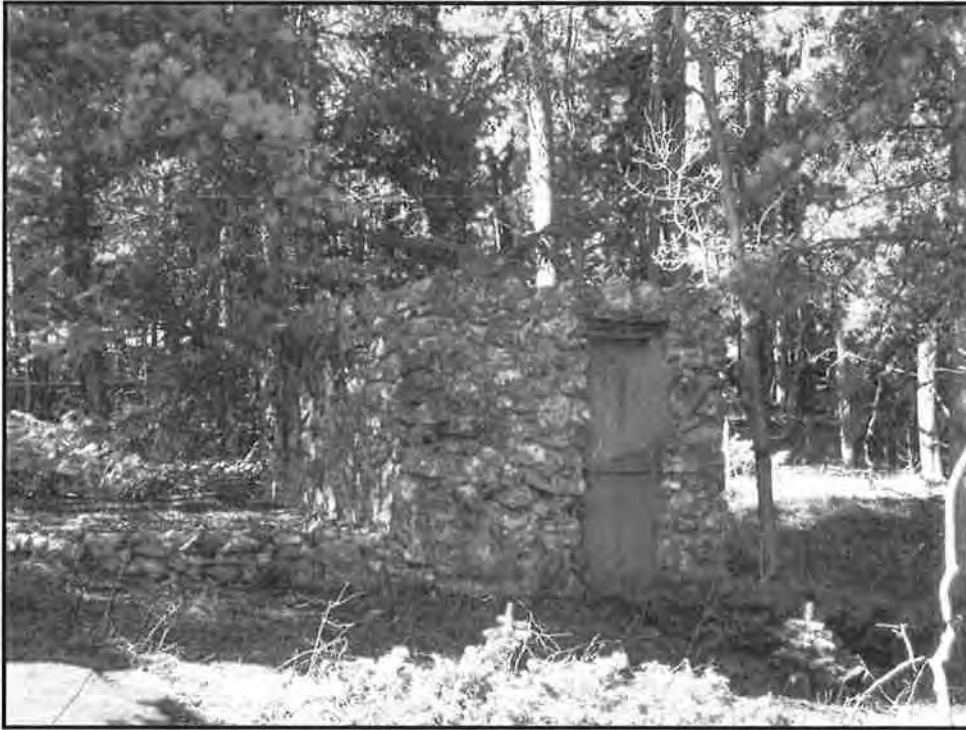
Photo 18

**Spring House ("Laundry Room"), 1943, Building, (Feature B, Photo 18):** There is small stone spring house to the southwest of the cabin. The north-south oriented building was the last to be built on the property and was constructed in 1943 by an Allenspark stone mason, Omar Boyle, utilizing stones found on the land. It is 8' x 7'-8" and is made of crudely stacked stones with concrete mortar and a similar low, stone landscape wall extends to the east from the northeast corner of the building. The doorway to the building is in the north wall; it has two doors, the inner door is of plain vertical wood planks, the outer is a wood and screen door. There is a round vent hole high in the western wall. Inside the building, built into the floor against the south wall, is a roughly 6"-deep concrete trough that spans the width of the wall. When the spring house was built, blocks of ice were used to cool the room, but the intention was that ultimately cold water would continuously circulate through the trough and prevent perishable foods and beverages from spoiling. It was eventually piped for this purpose, but the spring house never worked in the intended fashion so that use was abandoned and the small building was used for storage. At the time this nomination was written, an antique hand-cranked tub-style washing machine was also in the building, so the stone room has come to be known as the laundry room, although it was never used as one.<sup>4</sup>

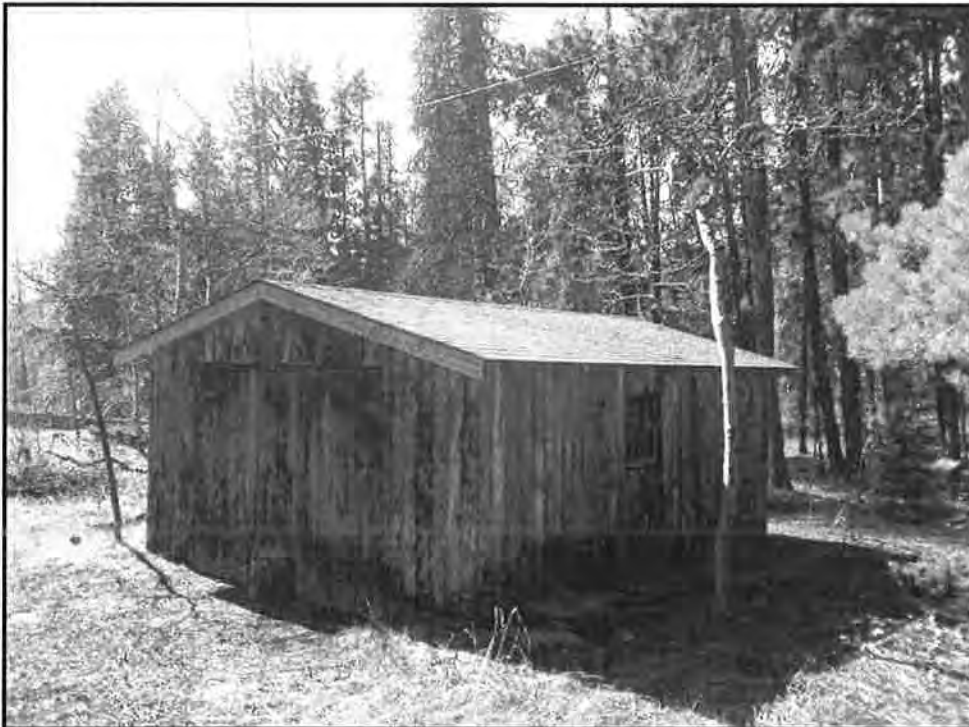
Photo 19

**Garage, 1943, Building** (Feature C, Photo 19): Southeast of the cabin is the garage, which measures 14'-4" x 20'-4". The garage is a pole building with a wood frame and walls of unpeeled vertical logs that have been cut lengthwise down the center making them half as thick (or less) than whole logs. The roughhewn façade mimics the outhouse and the cabin in appearance. The low-pitched, front-gabled roof has exposed rafter tails under the eaves on the east and west sides. There are two six-lite windows, one each in the center of the east and west walls. It is not known if they open or not. The doorway, which is large enough for a car to drive through, is in the north wall and features two hinged doors that swing outward from the sides.

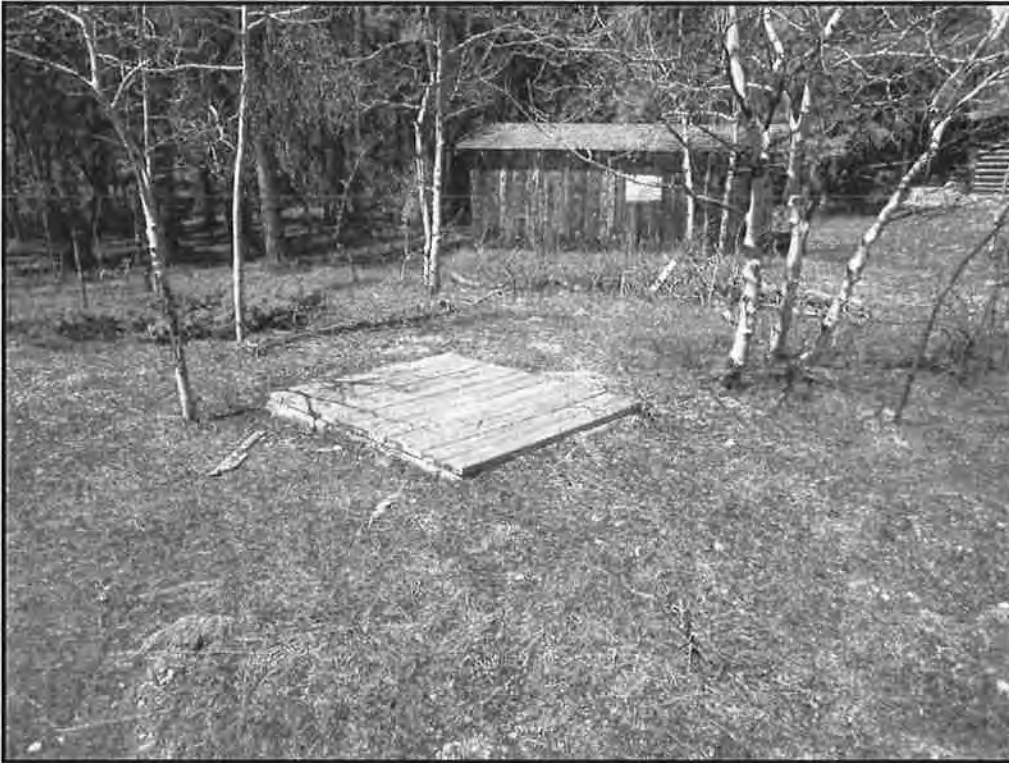
Photo 21

**The "Government Well" (Cistern), late 1930s, Structure** (Feature E, Photo 21): There is a cistern/well to the southeast of the garage. The visible portion is flush with the ground and measures approximately 5' x 6'. The concrete square collar is over a circular opening, and both are capped (like the other cistern) with a wood frame and plank cover. In the cabin's Rules and Regulations book, Mary referred to it as the "Govt. Well" and said the well was 20' deep, and had 12' of water in it; the entry was dated 8-28-44<sup>5</sup>. This is the first mention of the well/cistern, and John McCarty said it was already there when he first visited in 1942, so he suspects that it was dug in the late 1930s. No one can recall why Mary referred to it as the government well, or what the name means. Despite the fact that Mary noted water in the well/cistern in 1944, and a Forest Service employee also did when the cabin was recorded in 2014, John McCarty said that when it was built they were unable reach groundwater, so the structure was never actually used for its intended purpose.<sup>6</sup>

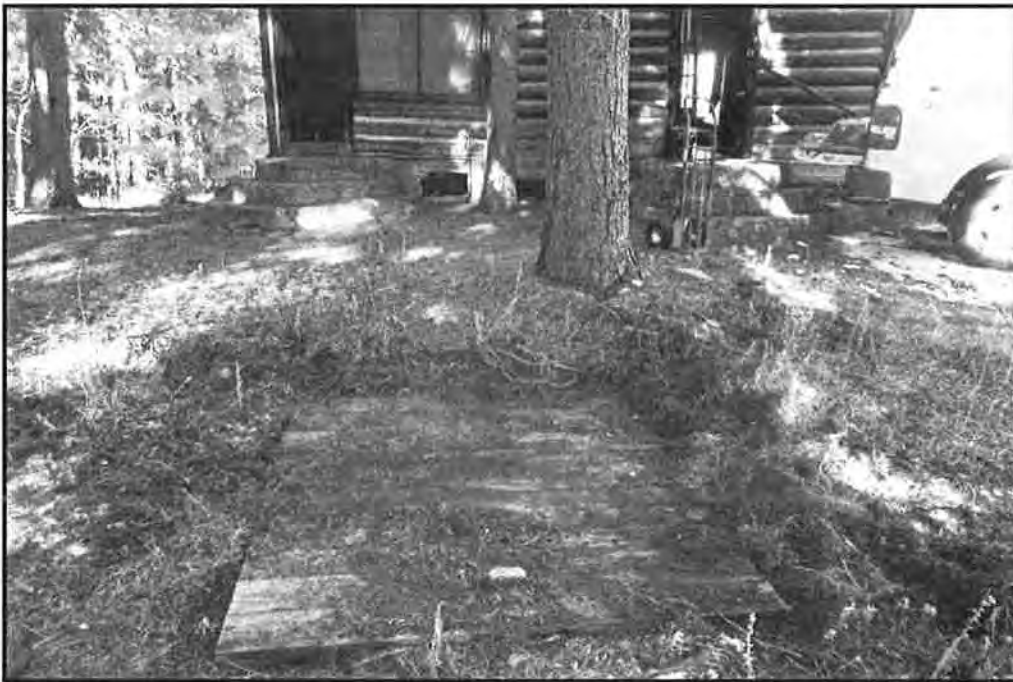
Photo 22

**Cistern, 1930s, Structure (Feature F, Photo 22):** Due south of the cabin is a subsurface cistern that is covered by a heavy, square, wood plank door that is flush with the ground. The cistern was dug in the 1930s by friends of John McCarty's cousin, Kermit Carr. They were told they could stay at the cabin temporarily, but then became squatters. It was during this time that they decided they needed a cistern since there was no running water at the cabin. They hand dug and used dynamite to excavate a big enough hole, and then lined it with concrete. This feature was never used as a cistern, and is easily missed—the wood cover is totally concealed by dirt and pine duff.
