HISTORIC PRESERVATION ADVISORY BOARD

BOULDER COUNTY HISTORIC PRESERVATION ADVISORY BOARD

MINUTES

Proposed Hartnagle Farm
landmark with 25' boundaries
around each contributing
structure.

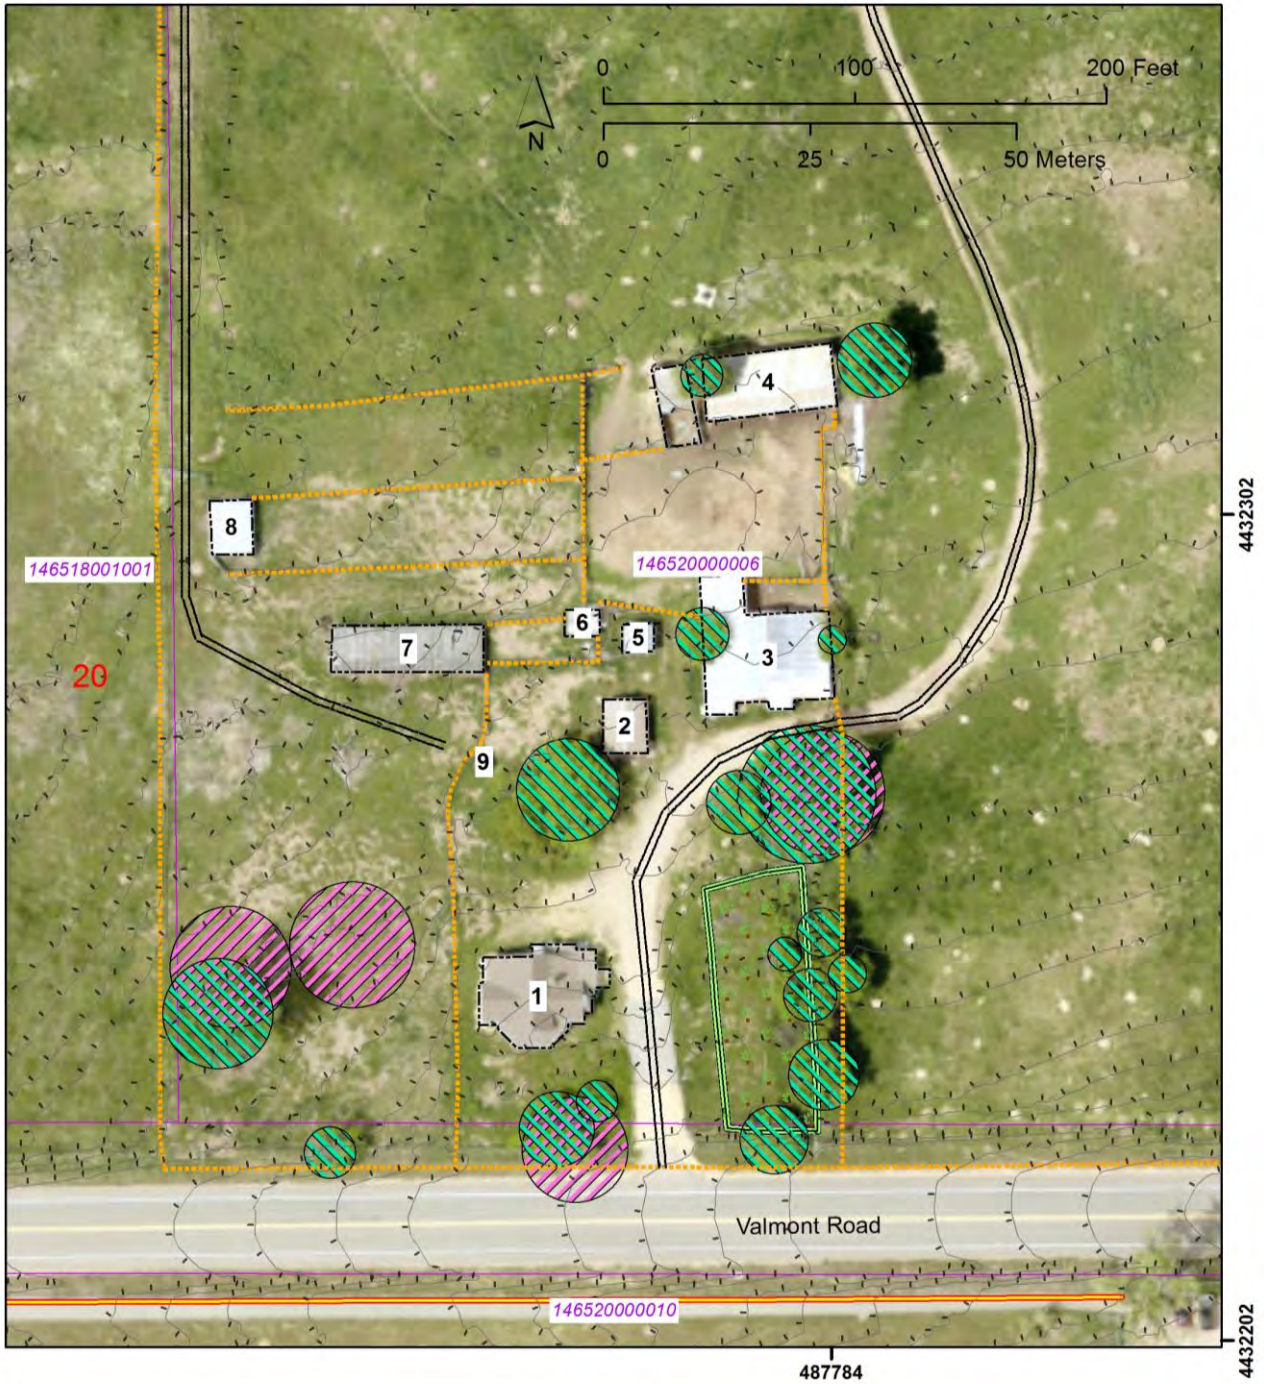
Figure 1: Hartnagle Farm Site Plan

The site consists of a farmstead core containing nine agricultural buildings and structures in the northwest quarter of Section 20, Township 1 North, Range 69 West and with agricultural fields north of the core in the southwest quarter of Section 17, Township 1 North, Range 69 West. European pasture grasses and alfalfa crop dominate ground cover at the Hartnagle Farm. There is little woody cover outside of planted trees and shrubs, which include narrowleaf cottonwood and lilac bushes. Two cottonwood trees and one lilac bush were found from the farm's period of significance, which are shown as overlapping tree features from 1971 and 2016 in Figure 1. Surficial soils at the farm include a Manter series sandy loam, a deep and excessively drained loam found in outwash, and an Ascalon sandy loam, a well-drained loam found in moderately coarse texture calcareous material (USDA NRCS 2013).

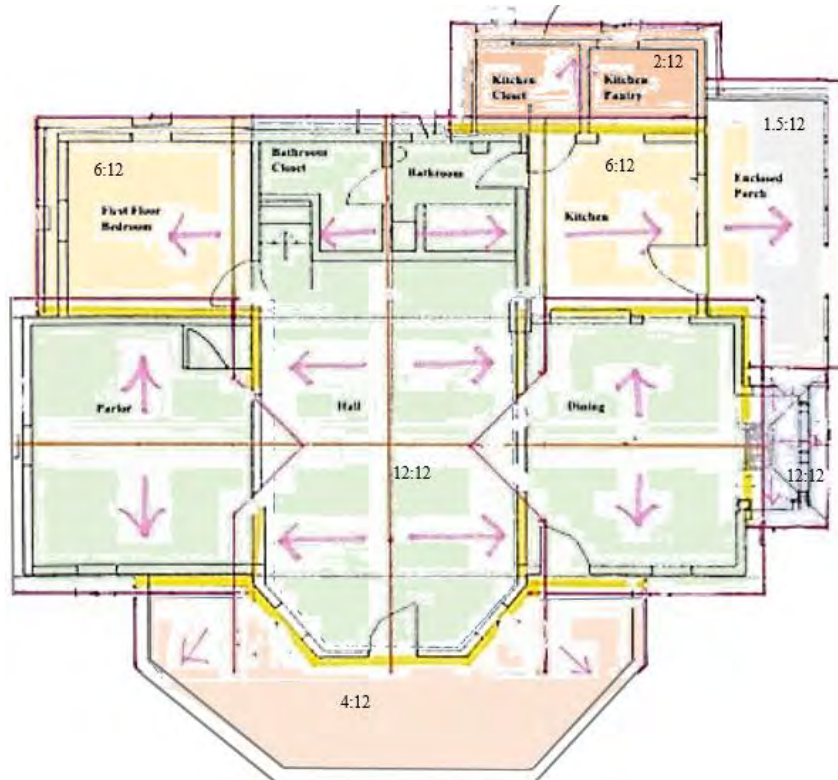
Figure 3: Roof configuration (TCI 2015: 33, modified)

quadrant of the shed roofs intersect the cross gable. There is one chimney, located at the northeast inside corner of the intersection of the two gable roof sections, that is constructed of brick and estimated to be 30 courses in height above the roof line. It extends into the basement.

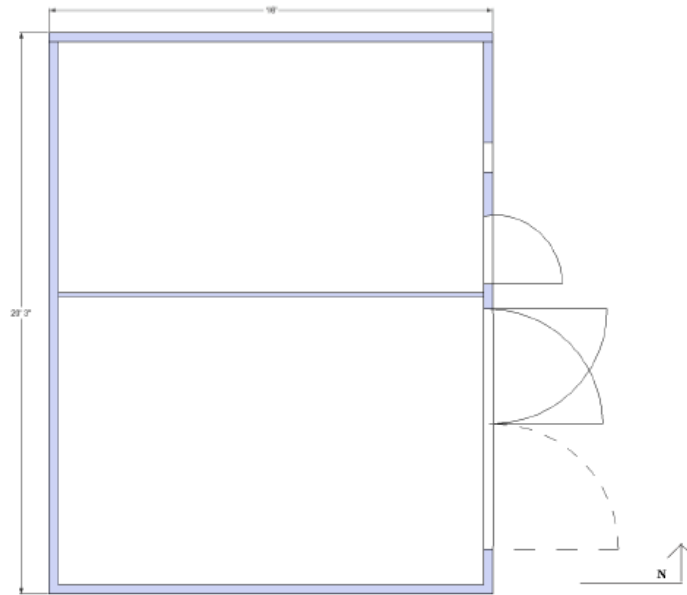
Figure 4: Plan sketch of the Chicken House (TCI 2015: 69)

Building 2 is the Chicken House, a single-story wood frame building located in the center of the farm core. The building measures 16 feet wide by 20 feet 3 inches long. Figure 4 shows a plan sketch of the building. The building has two rooms created by a three-quarters building height east-west oriented internal wall. The building foundation is the southwest and southeast floor joists sitting on a reused 4-inches by 8-inches piece of dimensional lumber. Scattered stones and wood beams support the west and east walls as well. The walls are framed with 2-

inches by 6-inches dimensional lumber. The wall siding is made of lapped horizontal wood planks on the north and south elevations and laid like a corn crib on the east and west sides. It's likely that the building was once a corn crib that was converted to a poultry house. The sidewalls are leaning west at 1/8 inch in 9-inch section. There are open knot holes in the sidewalls, end and edge splits, minor missing material, and deterioration of bottom planks. Some of the sidewalls have been patched with metal can ends.

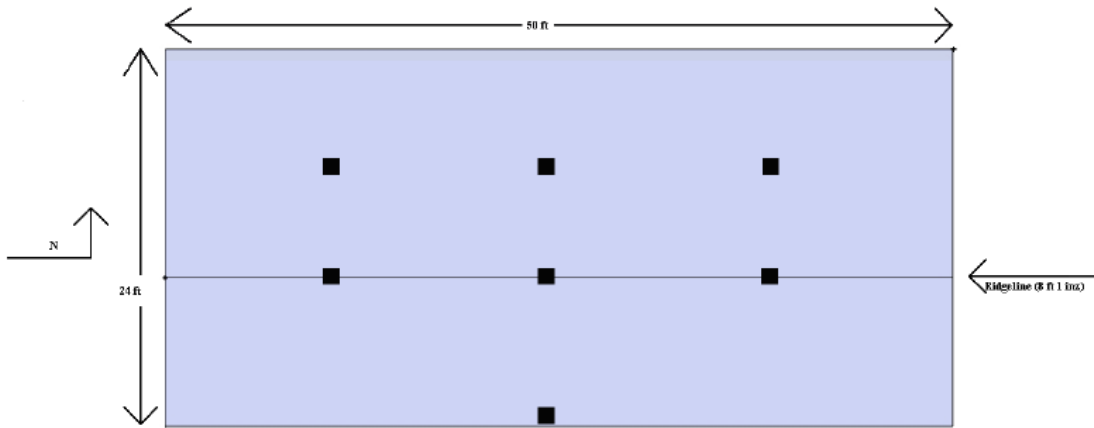
Figure 6: Plan of the Loafing Shed (TCI 2015: 111)

Building 4 is the Loafing Shed, a one story three-sided wood structure at the northeast corner of the farm core. The open side faces south. The building measures 24 feet by 50 feet. The building is set onto a concrete foundation wall along the east, north, and west sides of the building. The foundation wall is set onto a poured concrete footer. The floor of the building is bare earth. The building has an east-west oriented side gable roof that is covered with corrugated sheet metal. The roof is supported by seven wood posts, shown in Figure 6, that are embedded in truncated pyramid concrete piers and further stabilized by bolted steel straps between the bases and posts. The exterior sheathing is red painted wood shiplap siding. The interior walls are braced by diagonal planks. The Loafing Shed does not have doors, windows, exterior appurtenances, mechanical or electrical systems.

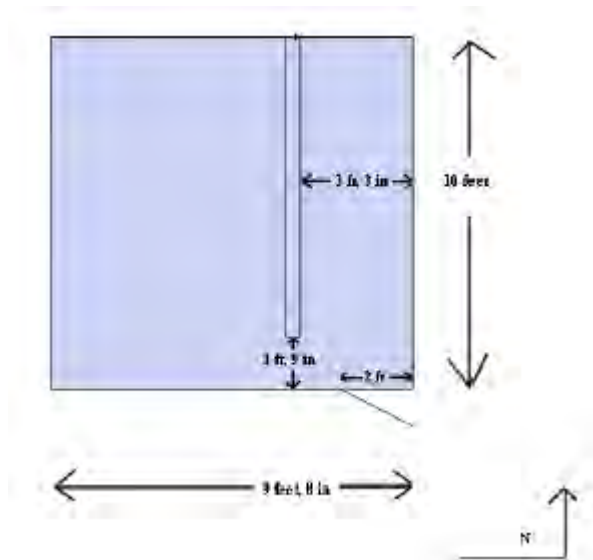
Figure 7: Plan of the Corn Crib (TCI 2015: 137)

Building 5 is the Corn Crib, a single-story wood frame building with sheathing on the interior walls and studs on the outside of the frame. The crib measures 10 feet long (north-south) and 9 feet 8 inches wide (east-west). The crib is set on cast concrete piece and field stone foundation that are set at each of the building corners. Stone piles support the end of the center floor beam. The support stones are not set at the same level and should be reset to level the building. The crib has a front-gabled roof that is covered by corrugated sheet metal roof and a hinged single door on the east end of the south elevation. The sidewalls consist of vertical planks on the exterior face of studs between a double plank top plate and a single plank bottom plate. The exterior walls of the crib consist of horizontal shiplap siding on the interior of the studs. The walls are in generally good condition except that the south gable end has no siding. A few pieces of salvaged wood have been used to stabilize the structure on the outside between studs. The crib has a wood plank that runs east-west. It is unfinished and extends under the exterior walls to the exterior. There are no mechanical or electrical systems in the Corn Crib. The building leans slightly to the north and east.

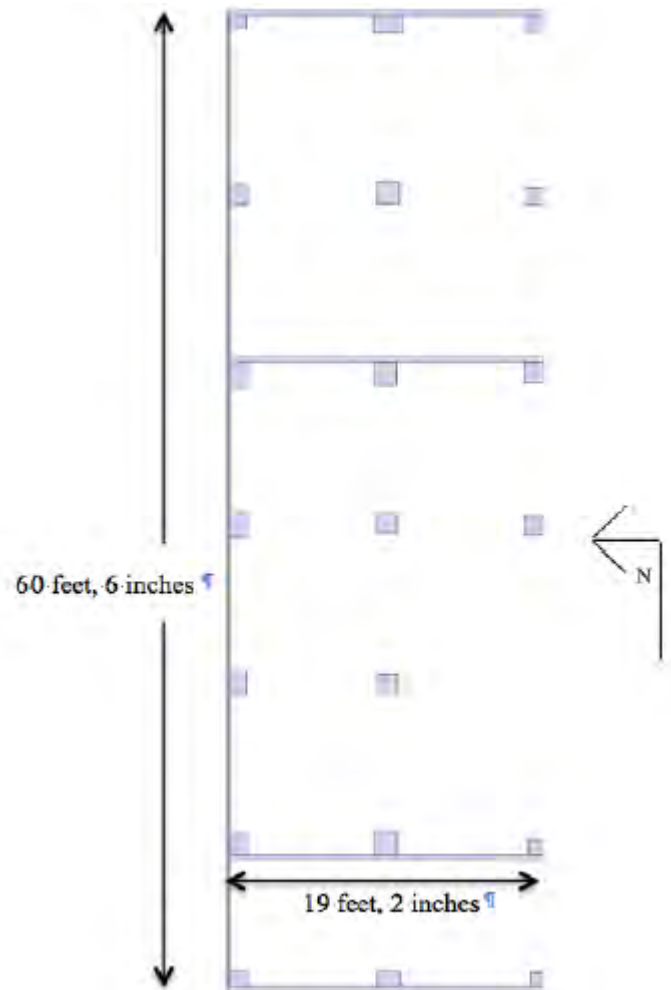
Figure 8: Plan of the West Loafing Shed (TCI 2015: 122)

Building 7 is the West Loafing Shed, is a single-story three-sided wood frame building located in the central west area of the farm core. The building measures 60 feet 6 inches by 19 feet 2 inches. The open side faces south. The building has a bare earth floor. There is no visible foundation. However, fourteen wood posts are used to support the walls and roof. The posts are a mix of natural and treated woods, some are set into concrete pads and some are set into the ground, and six posts are missing from their intended location as shown in building plan (Figure 8). The sidewalls are supported by vertical boards, braces, and girts that tie into the rafters and end posts. The wall siding is comprised of vertical corrugated metal sheets painted red, which provides a strong visual contrast to the building’s surroundings. The building has a shed roof that is covered by asphalt shingles and rolled mineral coated roofing strips. This covering is notable for the area and was likely used by salvaging from other building materials. The building has no windows and only two doors, both of which are not functional. There are no mechanical or electrical systems.

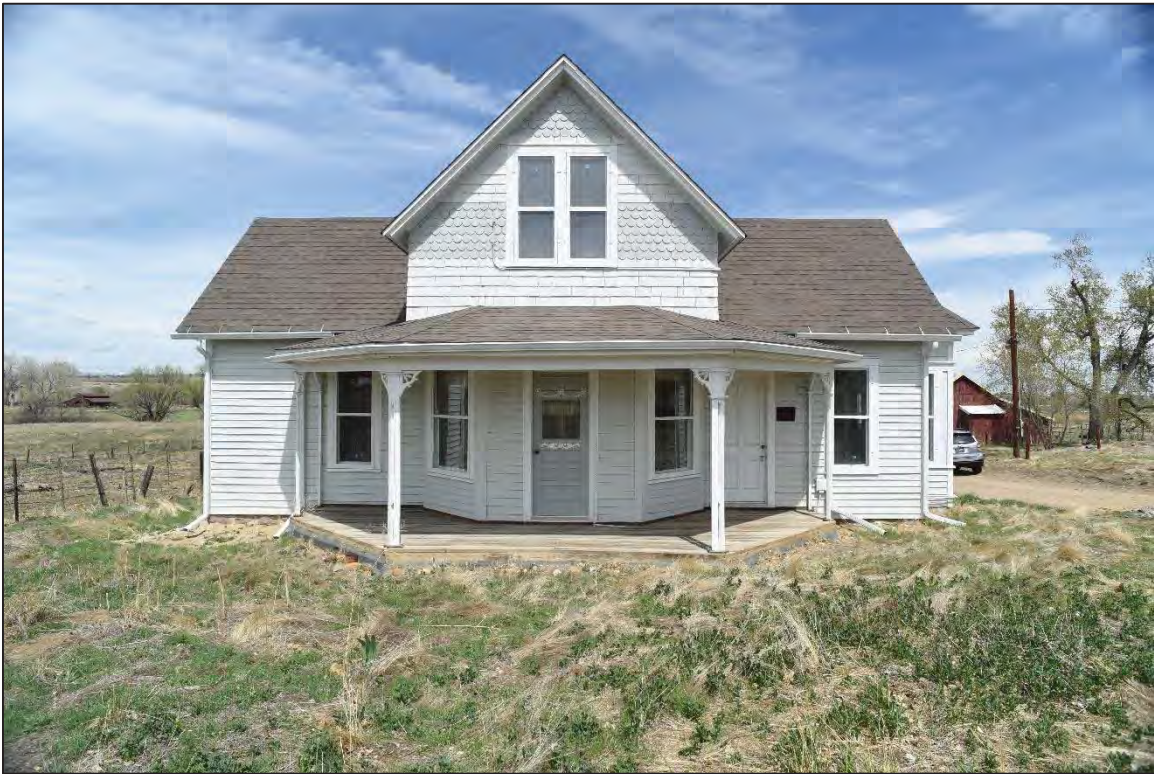
Photo 6166: Southern elevation of the Farm House.

Building 1 is the Farm House, a one and a half story irregular-plan Folk Victorian style house located at the southern end of the farm. The building is set on a mixed dry and wet laid stone foundation that forms a cellar and crawlspace under the main floor of the house. The entrance to the cellar and crawlspace is through a plain bulkhead door via concrete stairs on the northern elevation of the house. An attic space is accessible from the second story.

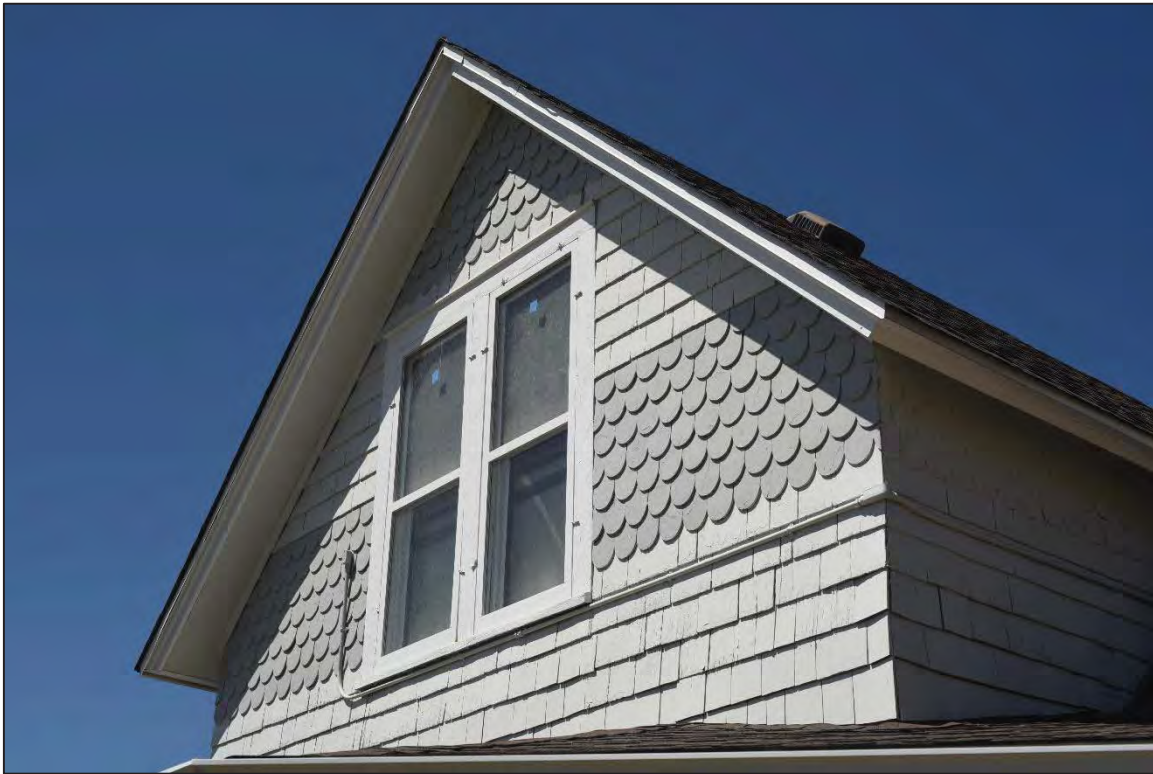
Photo 6240: Second story of the southern elevation showing decorative siding shingles on Farm House.

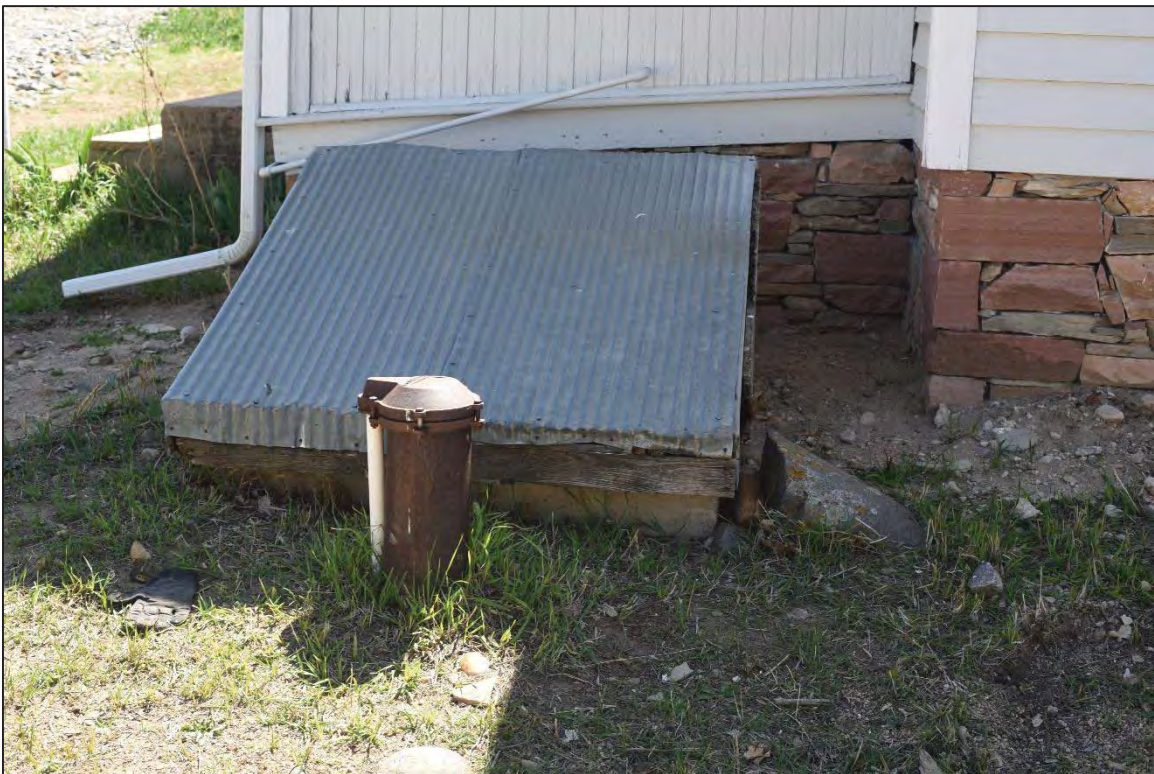
Photo 6230: Well head at northeast corner of Farm House.

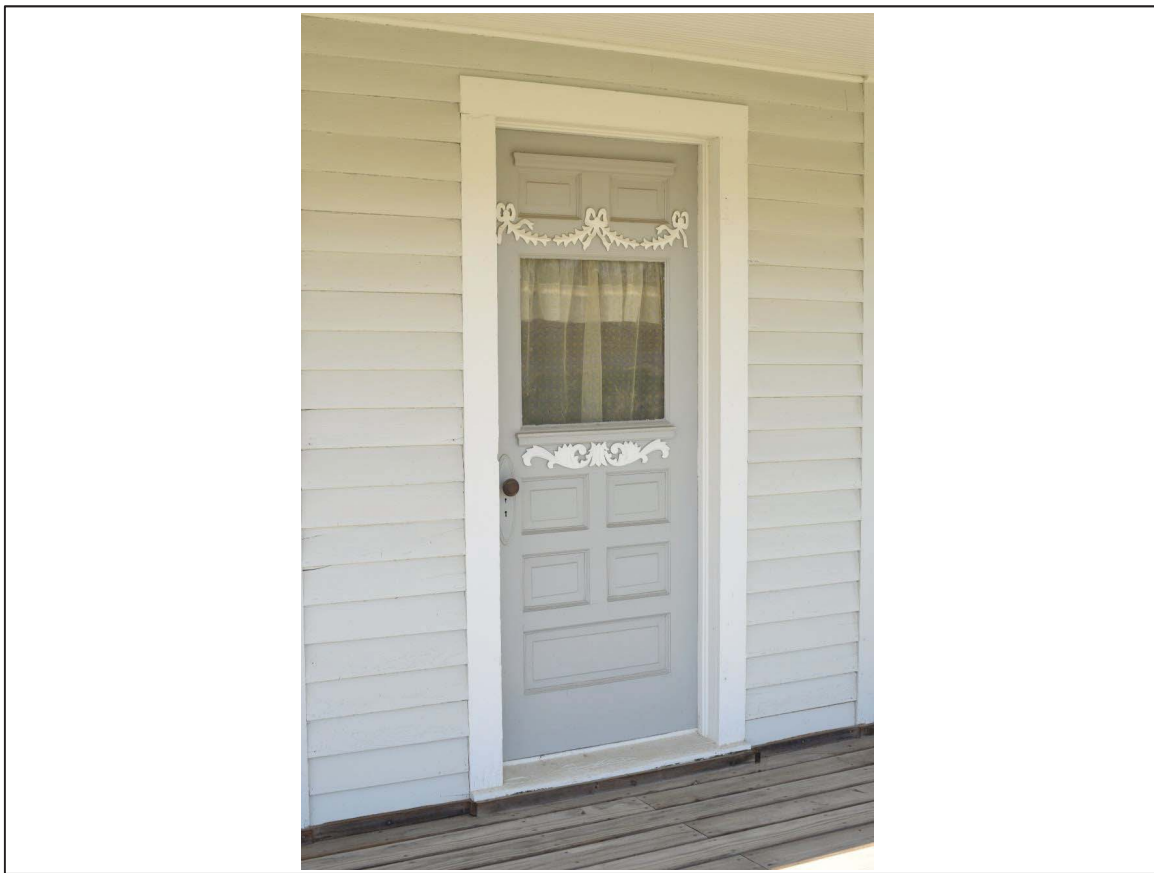
Photo 6237: Ornamental door (primary entry door) with carved wood appliques on southern elevation of Farm House on covered porch.

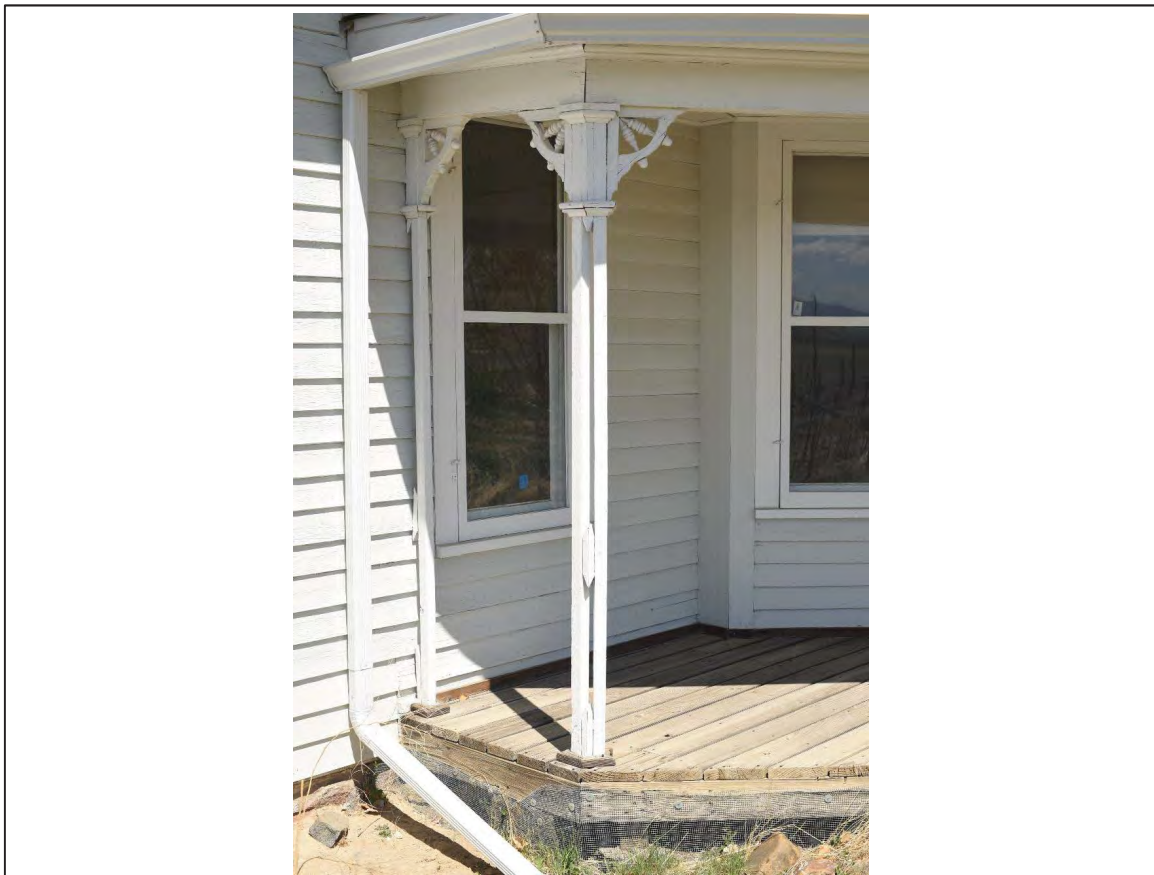
Photo 6233: Overview of typical capital columns and spindles supporting roof over house's open porch.

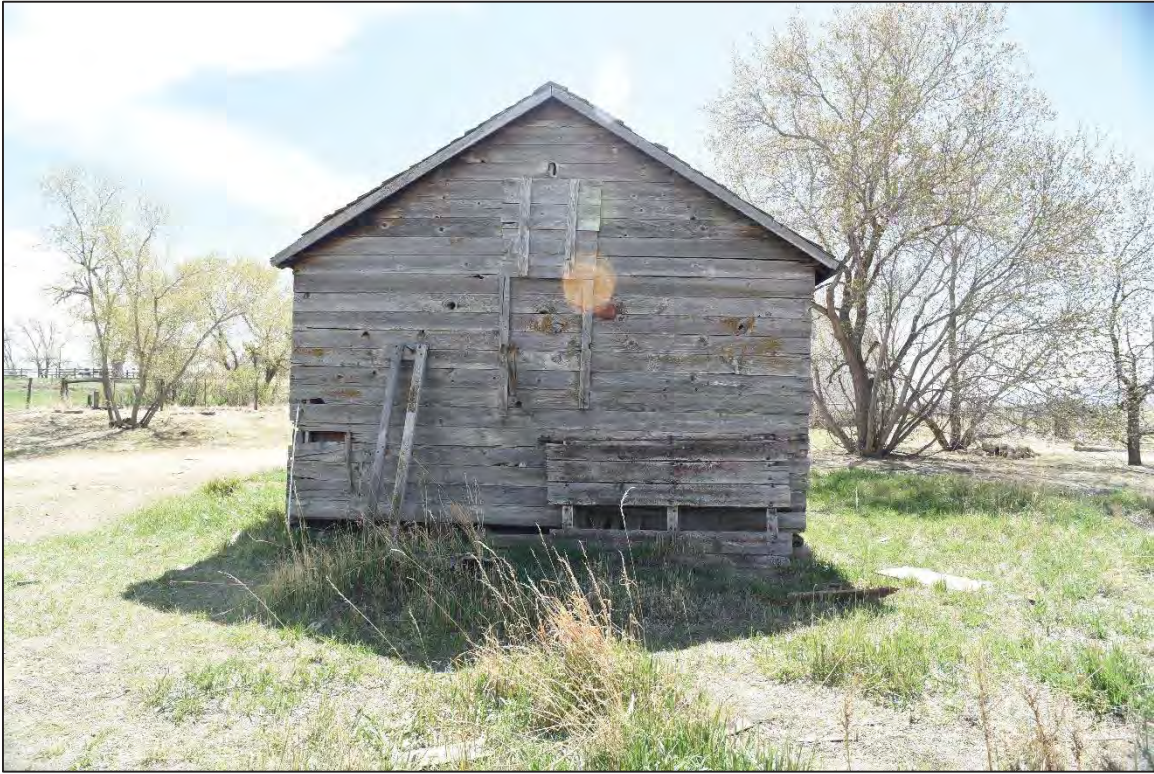
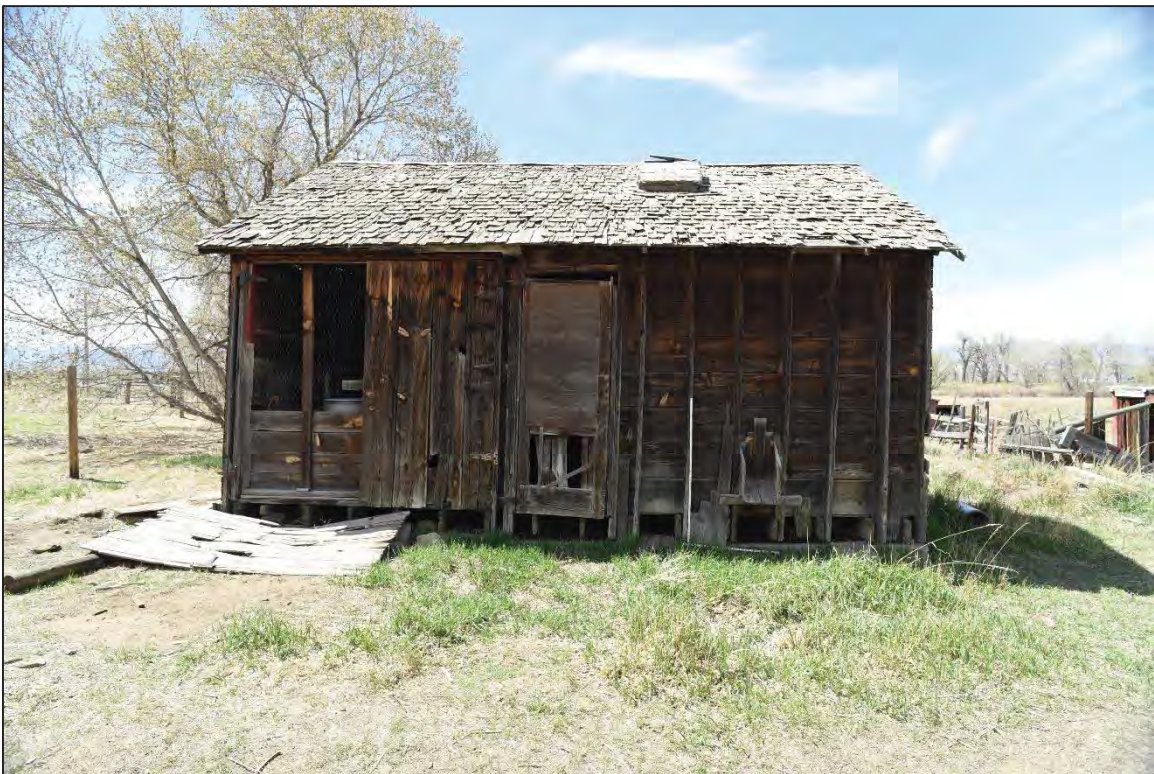
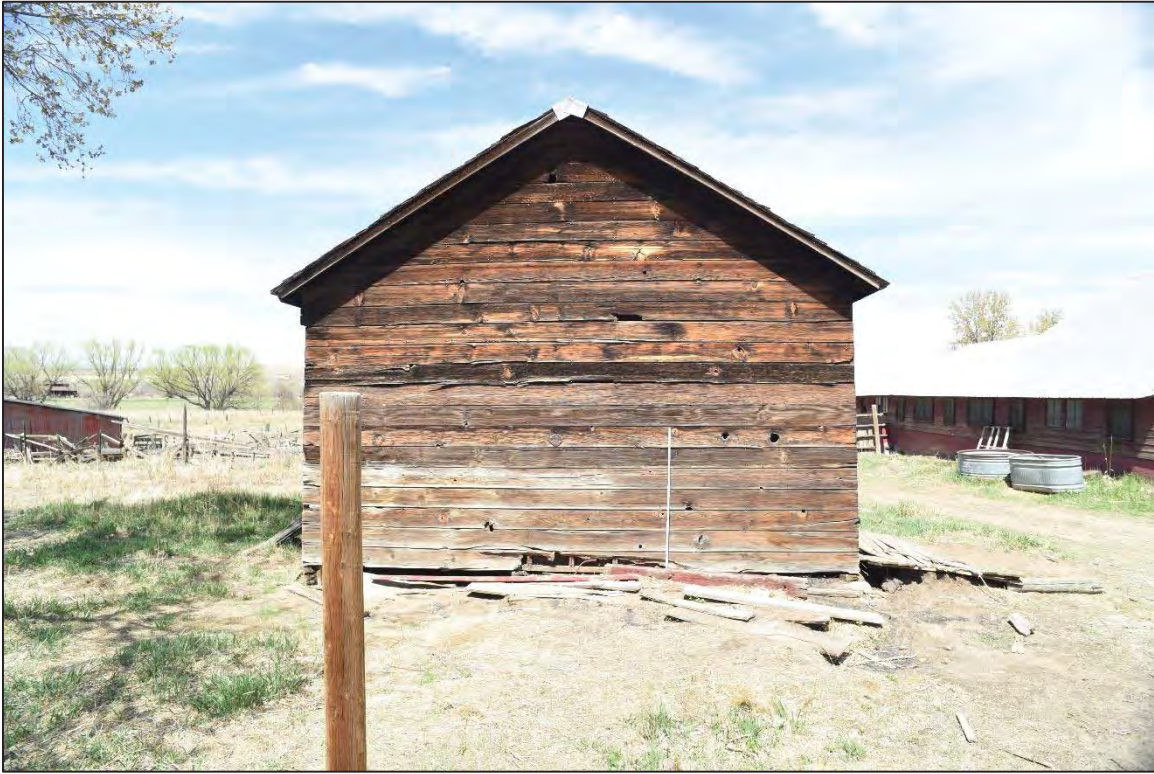
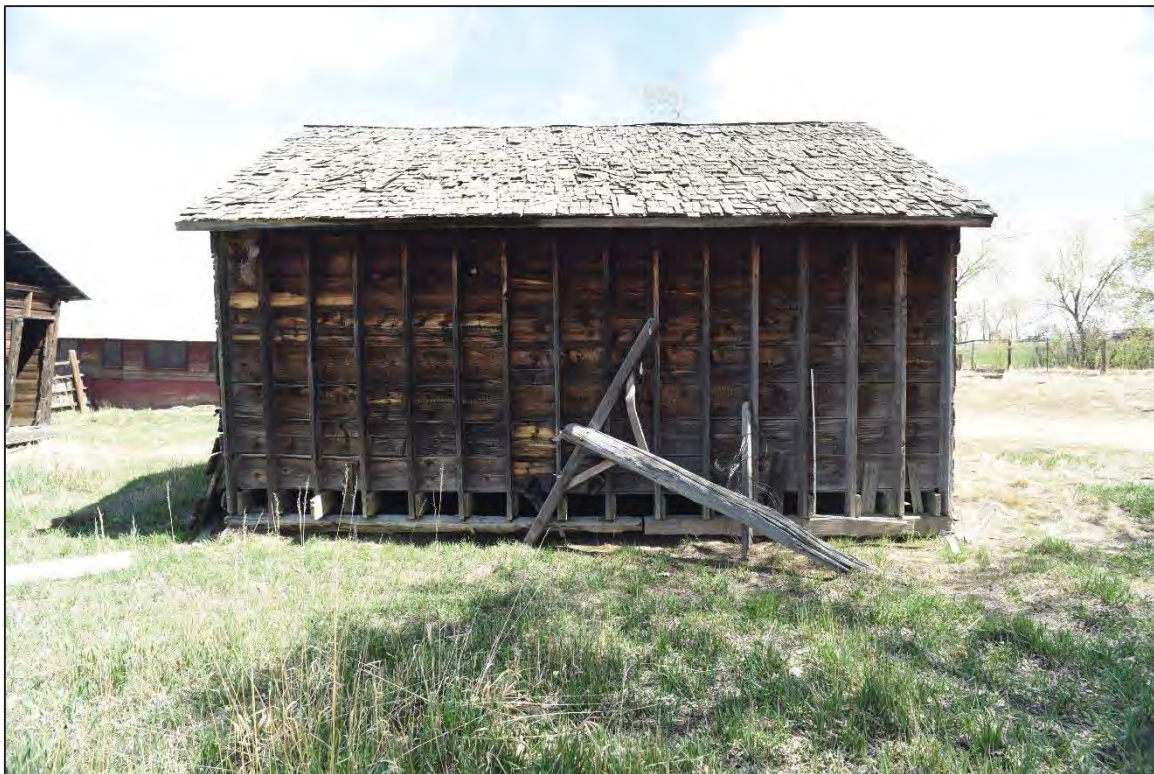
Photo 6203: Northern elevation of the Chicken House.

Photo 6206: Eastern elevation of the Chicken House.

Photo 6207: Southern elevation of the Chicken House.

Photo 6209: Western elevation of the Chicken House.

The Chicken House has three doors: a set of double doors with one door missing that has vertical planks and a back-up frame, one single typical interior door that has been modified for exterior use by an exterior plywood overlay, and a 1 foot by 1 foot chute on the east wall. There is also a north gable end opening (approximately 2 feet by 2 feet). The hardware on the doors consists of strap hinges with pressed metal pattern, which is in poor condition from severe rusting. The floor of the Chicken House is 1-inches by 4-inches dimensional lumber flooring and is in good condition. There is an interior wall that divides the building into two rooms. The wall runs east-west and is not full height. There are no mechanical or electrical systems in the Chicken House. Photographs 6203, 6206, 6207, and 6209 show the exterior of the Chicken House.

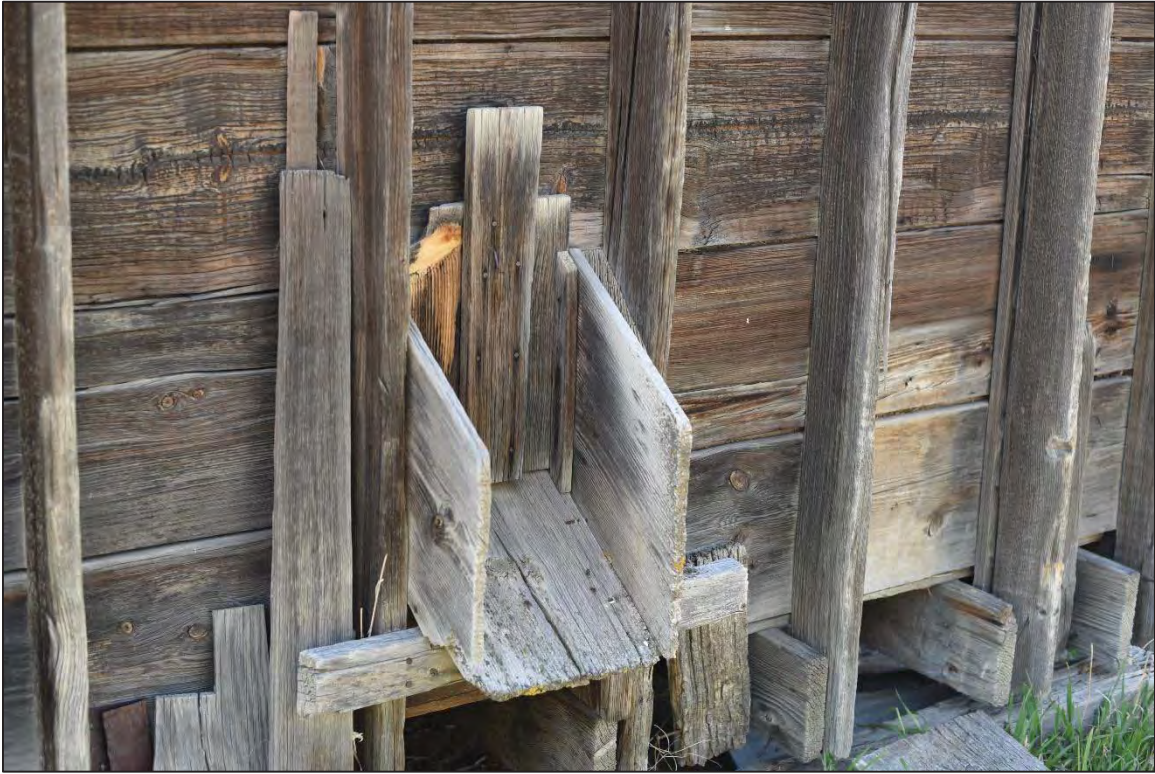
Photo 6227: Grain chute on western elevation of Chicken House.

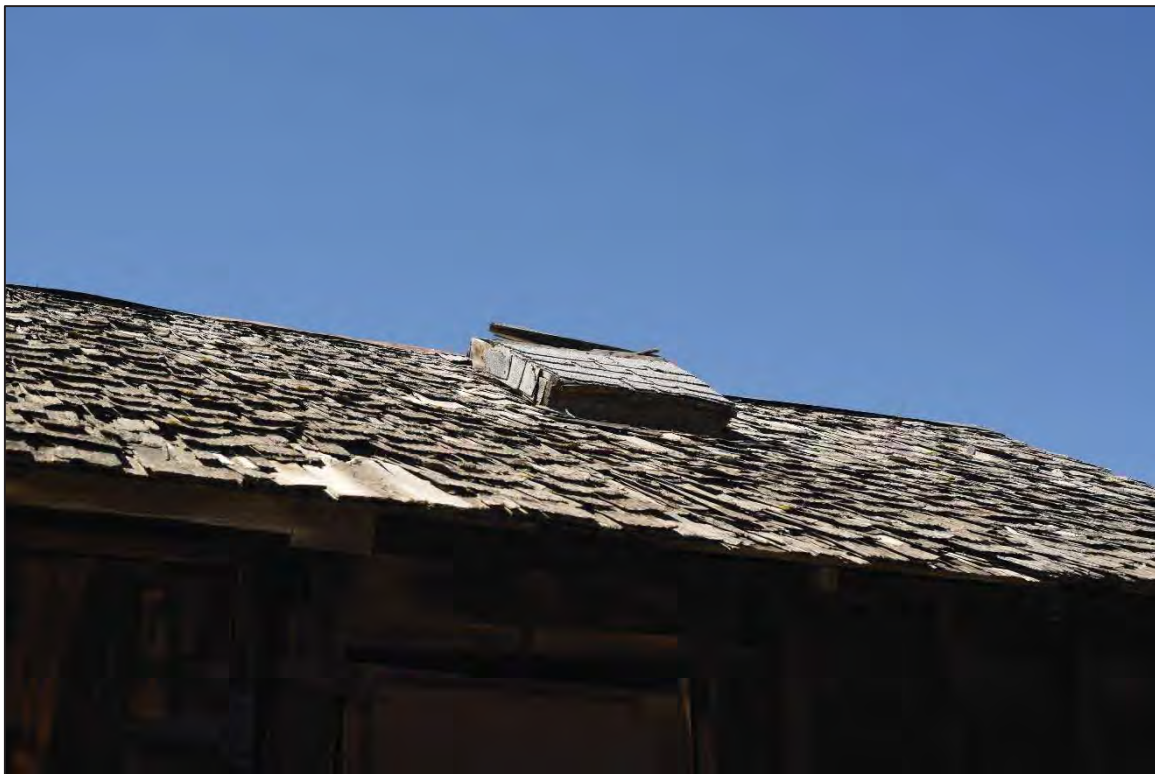
Photo 6228: Hatch on east-facing roof pitch of Chicken House.

The roof is gabled and covered by original wood shingles. Many of the roof shingles are cupped, split, or missing. The gable ends are constructed of 2-inches by 4-inches dimensional lumber let into the top of studs as a top plate with more 2-inches by 4-inches lumber as the bottom plate. The north and south walls are sheathed inside and outside. The joists are 2-inches by 8-inches dimensional lumber that run east to west. There are a carriage beam at the upper third point and a carriage beam at the lower third point of the gable ends. The roof structure is a rafter made from 2-inches by 4-inches dimensional lumber. There are no collar ties or ridge beam. The fascia at the gable ends is partial on the east and west sides, covering the ends of the rafters. A small section of flashing is visible along the roof ridge. There is no indication of settlement in the roof plane. The roof has a single hatch comprised of wood covered with asphalt shingles.

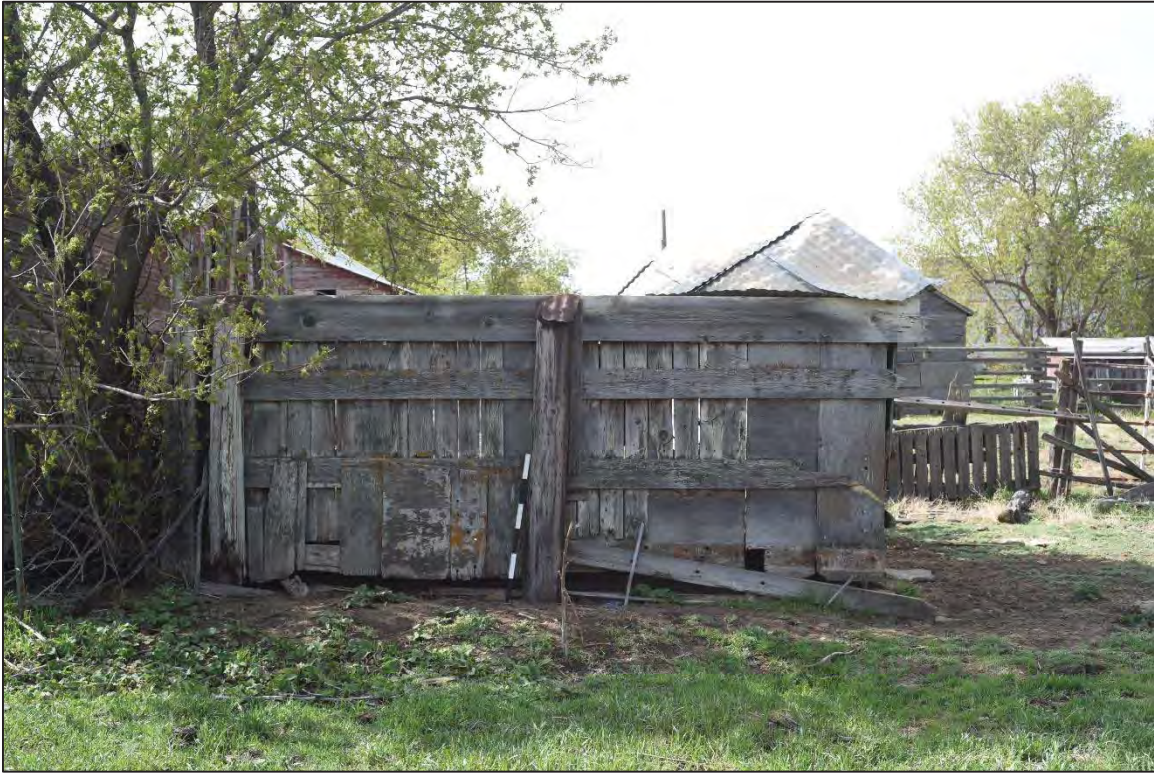
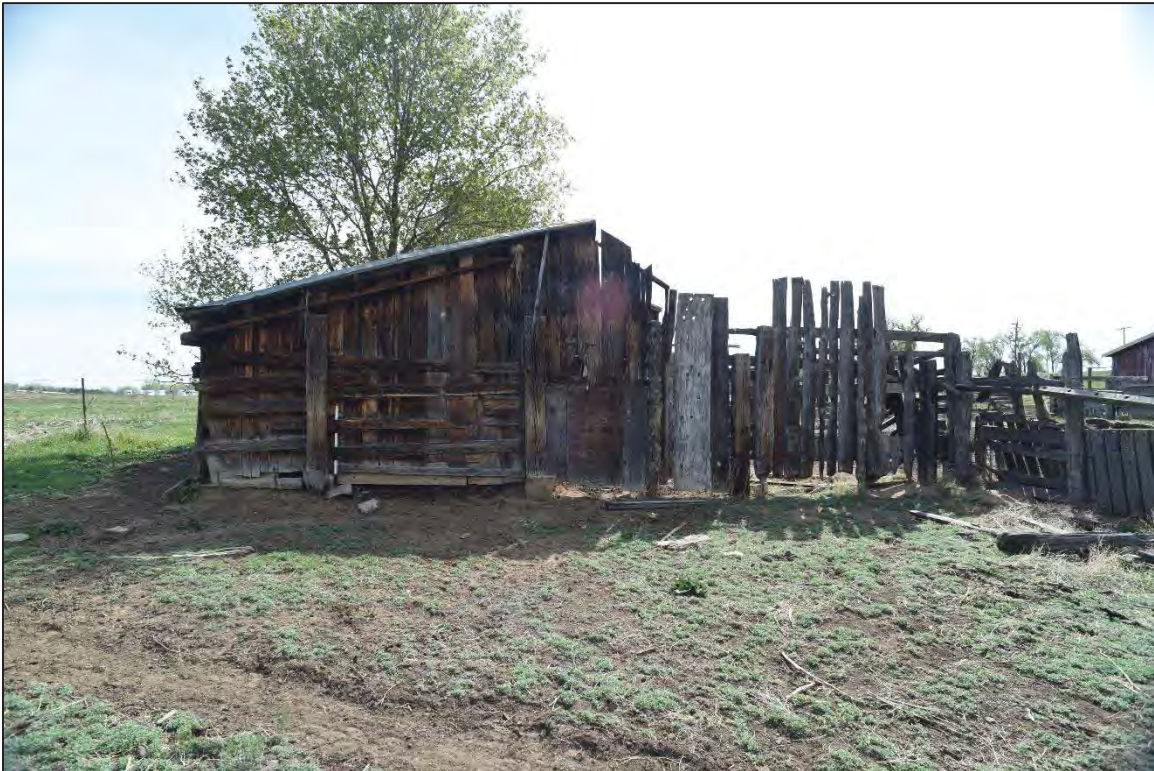
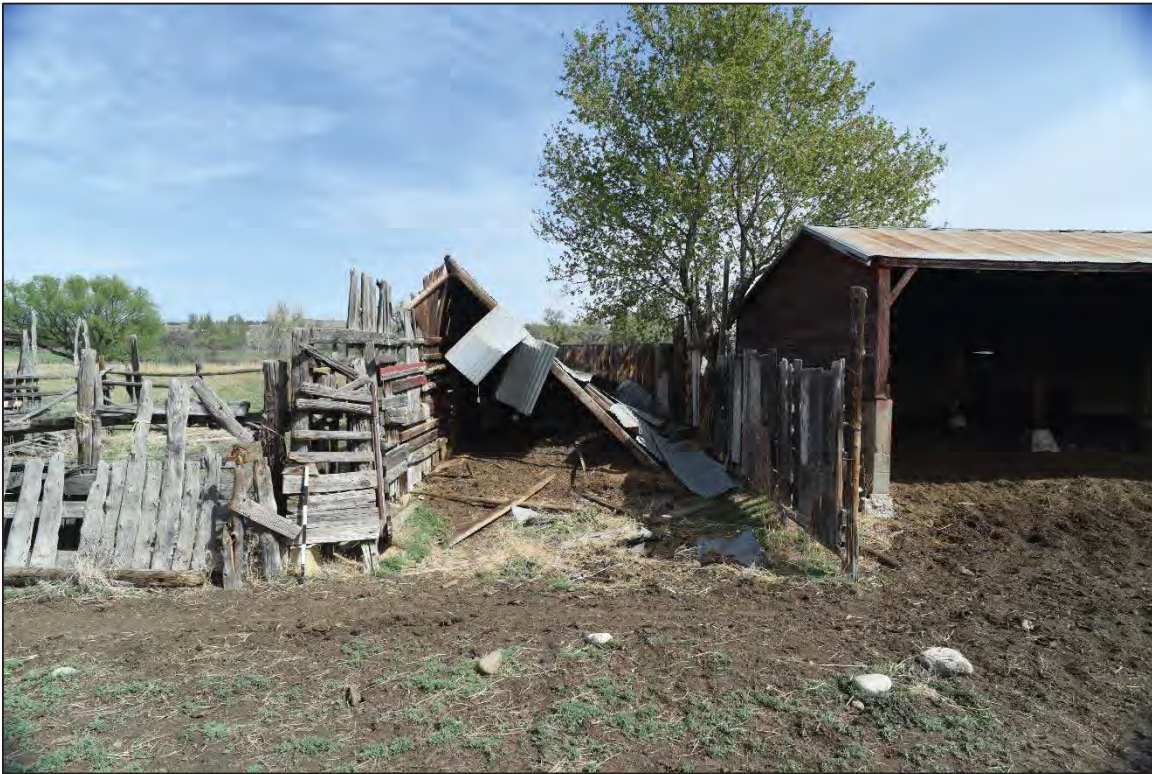
Photo 6396: Northern elevation of collapsed section of Loafing Shed .

Photo 6398: Western elevation of Loafing Shed , featuring collapsed section.

Photo 6403: Overview of collapsed Loafing Shed section from the south.

An unnumbered building, presumably a loafing shed, adjacent west to Building 4 (Loafing Shed) is also present at the Hartnagle Farm. It is the collapsed remains of a three-sided single story rectangular wood building. The building remains were not included as part of the HSA or previous recordings. The building was open to the south and had a gable roof covered by corrugated sheet metal. The walls consist of vertical wood siding attached to an exterior wood frame. Salvaged wood was used as horizontal siding on the interior to stabilize the shed prior to its collapse. Extreme deterioration of the eastern and western elevations likely lead to the collapse of the roof, which was supported by a central and end rafters only. No evidence of interior supporting features was observed. The remains measure 28 feet north-south and 14 feet east-west and are parallel with the rest of Building 4 (Loafing Shed). Based on the standing height on the west elevation, the building was likely 18 feet tall at roof apex and 12 feet at the north elevation. Remains of a gate constructed similarly of vertical salvaged planks are located adjacent west of the south elevation of the collapsed shed. Photos 6396, 6398, and 6403 show the shed remains. Because the building is no longer standing with diminished integrity, it is not recommended as a contributing resource of the Hartnagle Farm.

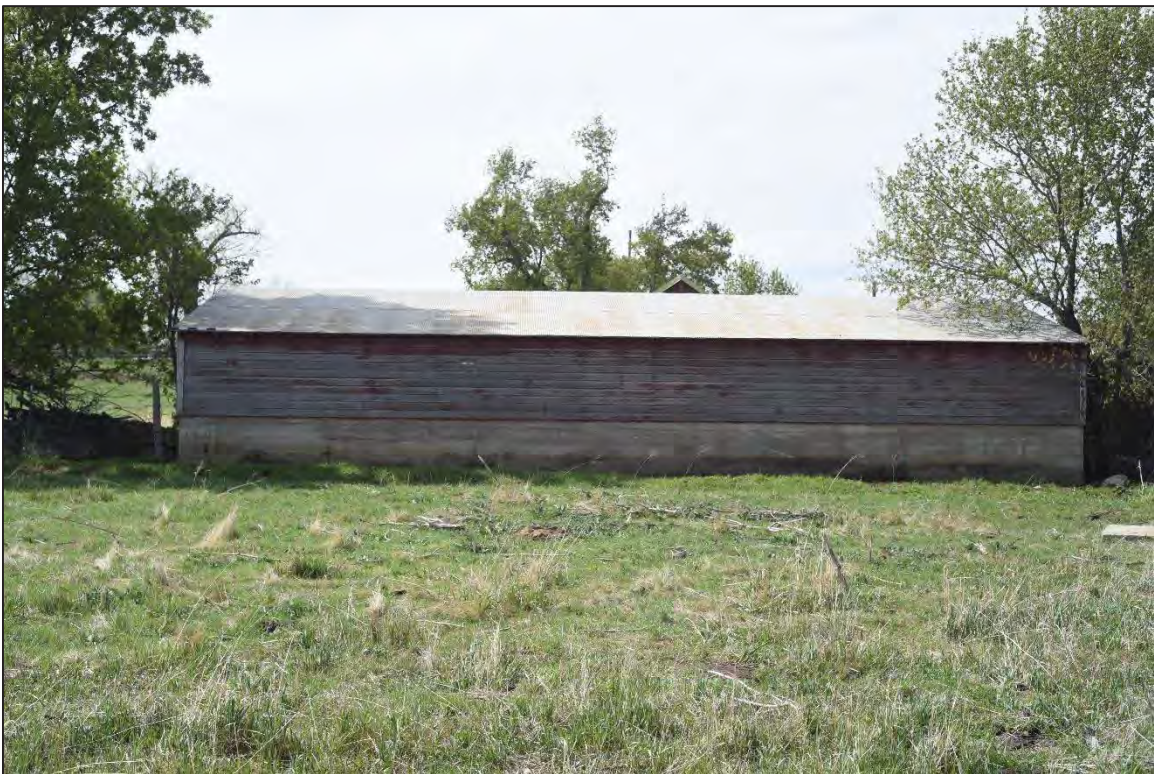
Photo 6392: Northern elevation of Loafing Shed . The collapsed section of the loafing shed is not visible and is separate from the main section by the tree visible on the right edge of the frame.
