HISTORIC PRESERVATION ADVISORY BOARD

BOULDER COUNTY HISTORIC PRESERVATION ADVISORY BOARD

MINUTES

Proposed Hartnagle Farm
landmark with 25' boundaries
around each contributing
structure.

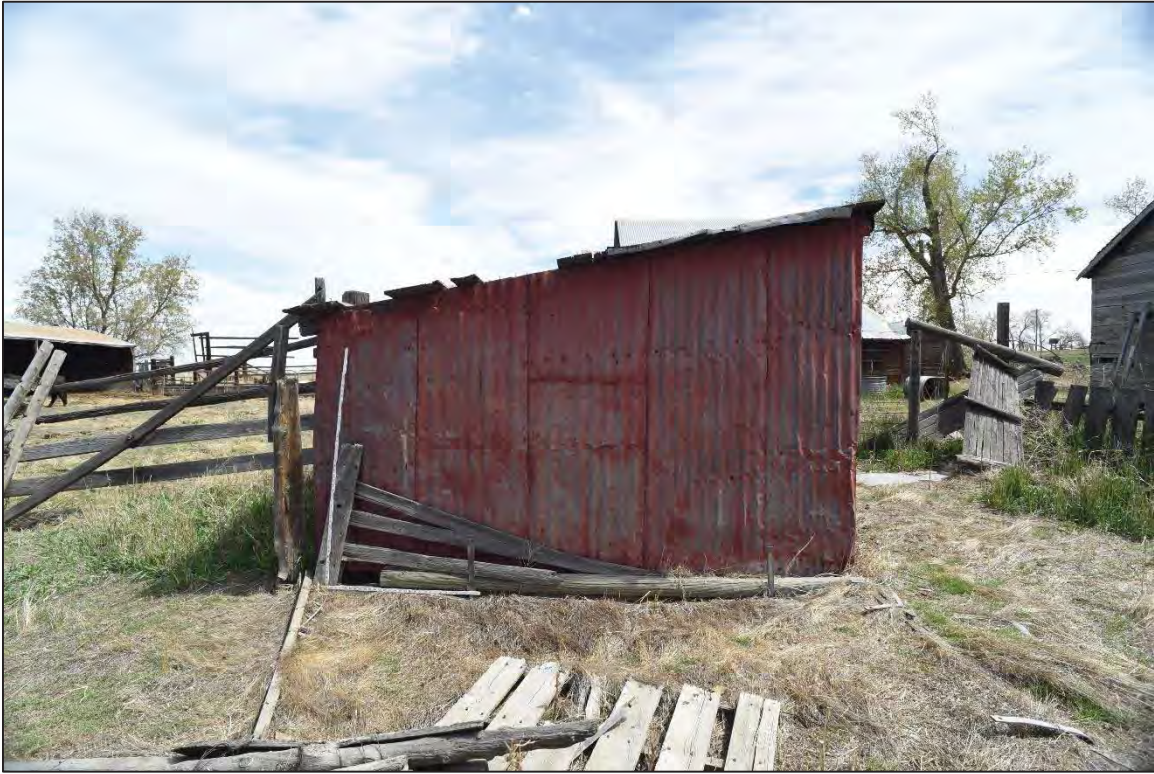
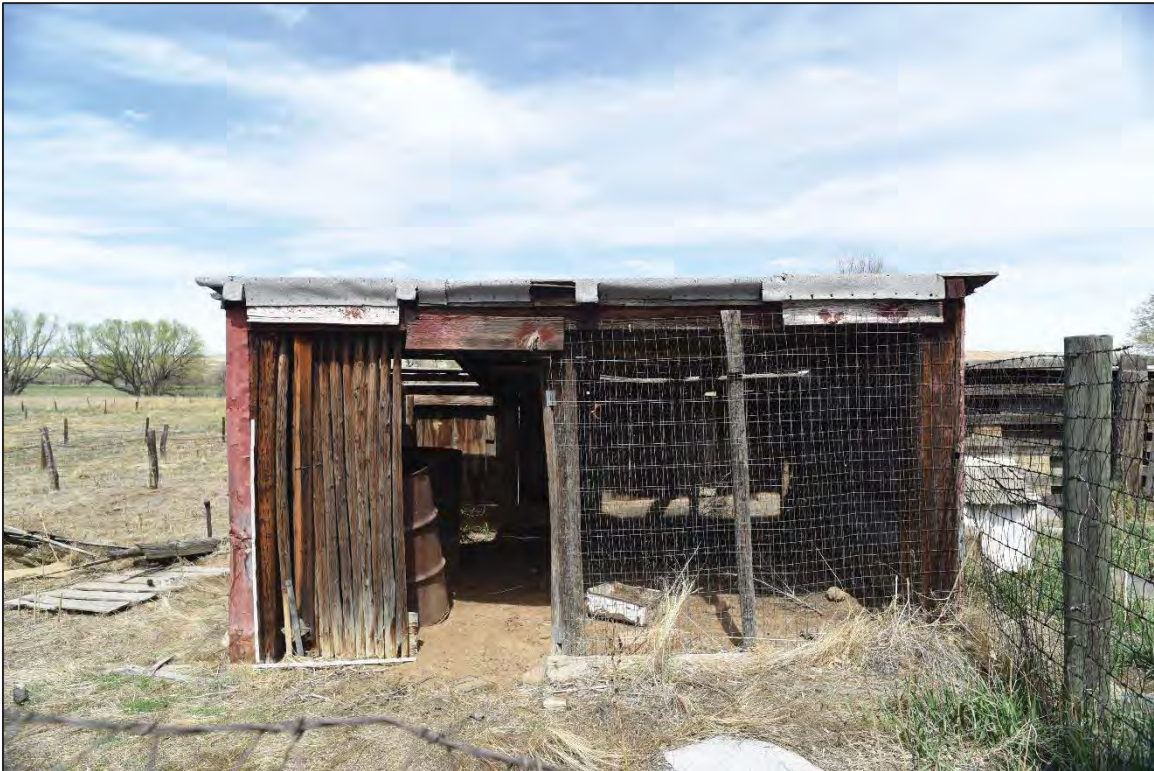
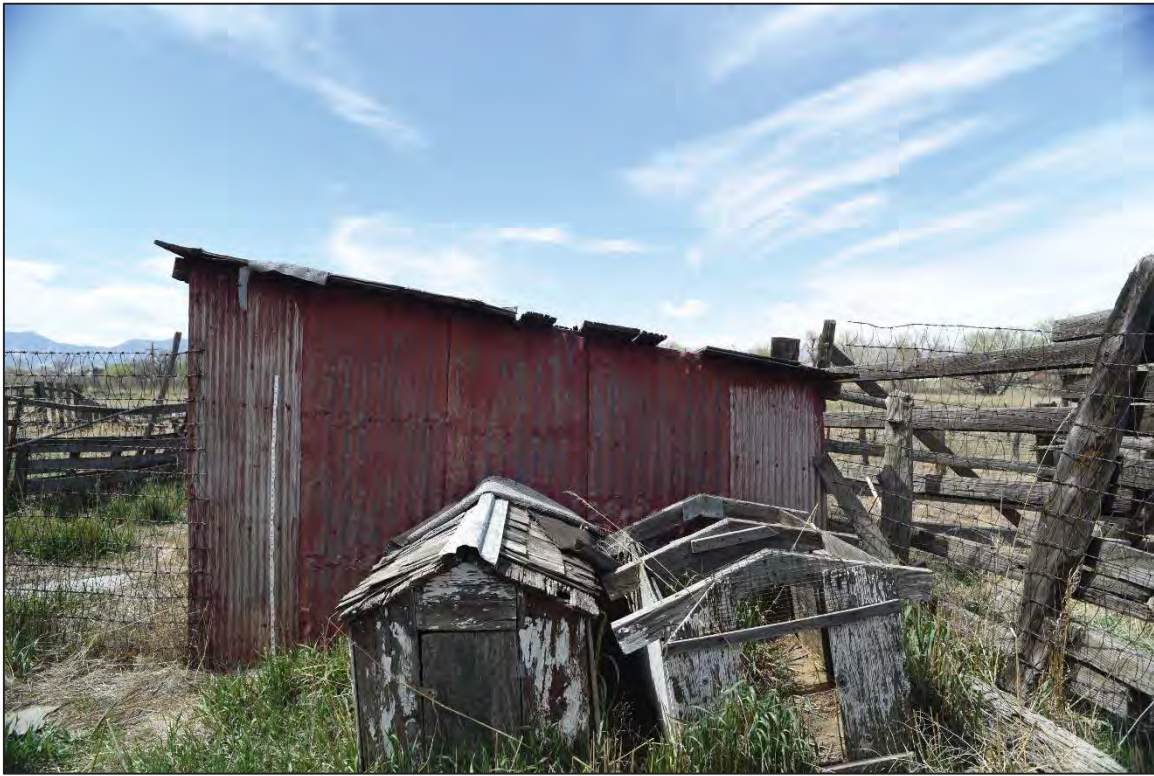
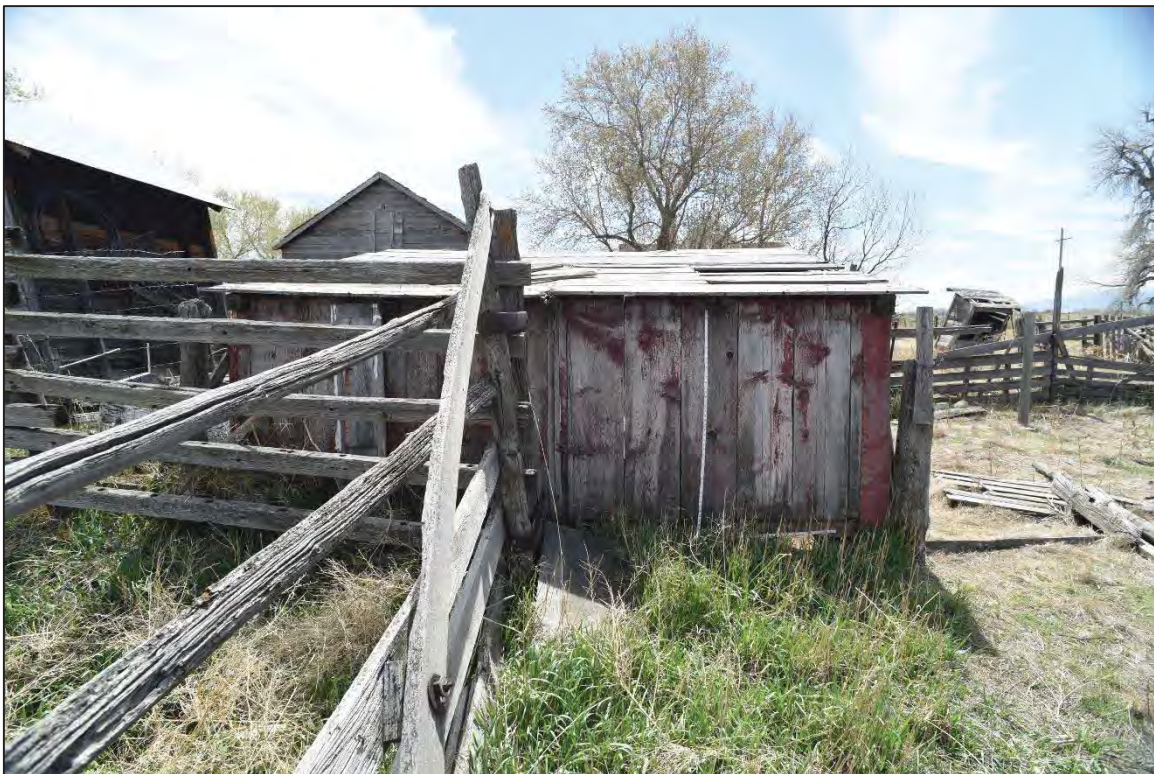
Photo 6190: Western elevation of the West Shed.

Photo 6193: Southern elevation of the West Shed.

Photo 6195: Eastern elevation of the West Shed.

Photo 6192: Northern elevation of the West Shed.

Building 6 is a shed, known as the West Shed, located at the center of the Hartnagle Farm. It is a rectangular three-sided wood structure (12 feet by 9 feet 3 inches) with vertical corrugated sheet metal siding and a shed roof, shown in photos 6190, 6192, 6193, and 6195. The roof currently does not have a cover over the bare planks. Feinberg (TCI 2015: 134) noted that mineral coated rolled asphalt was the roof covering at the time of the HSA. The south elevation is open with half of its length covered by wire fencing, which serves as a wall with a quarter of its length covered by vertically placed poles. The shed uses girts along the east, north, and west walls and bracing between girts and rafters. Feinberg noted (TCI 2015: 134) that several of the girts are deteriorated and require replacement. The corrugated sheet metal siding is not original and was very likely salvaged from another building's roofing materials. The non-original materials, changed design, quality of workmanship, and feeling deter from the shed's integrity. Additionally, it is estimated to take fifty or more percent of new materials to repair the shed. While the shed was one of the original farm buildings, likely dating to ca. 1898, it's been substantially modified and no longer conveys the historic significance of the Hartnagle Farm. It is not recommended to be considered as a contributing resource of the Hartnagle Farm.

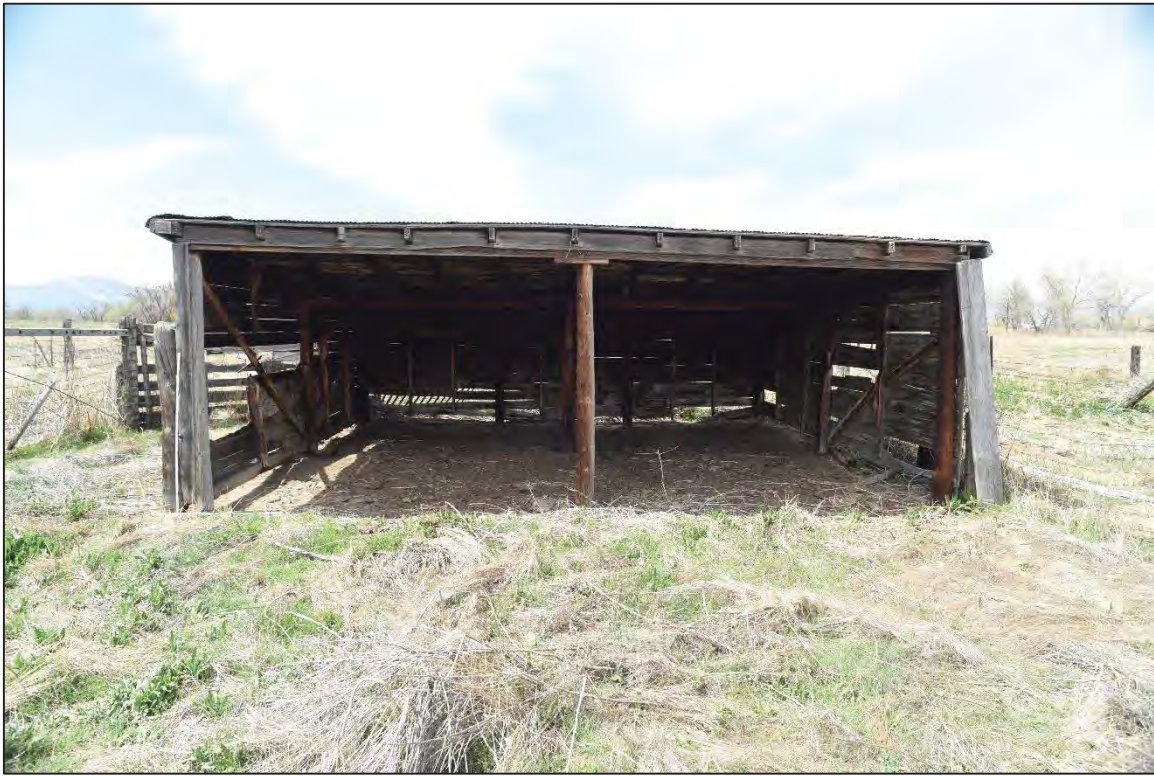
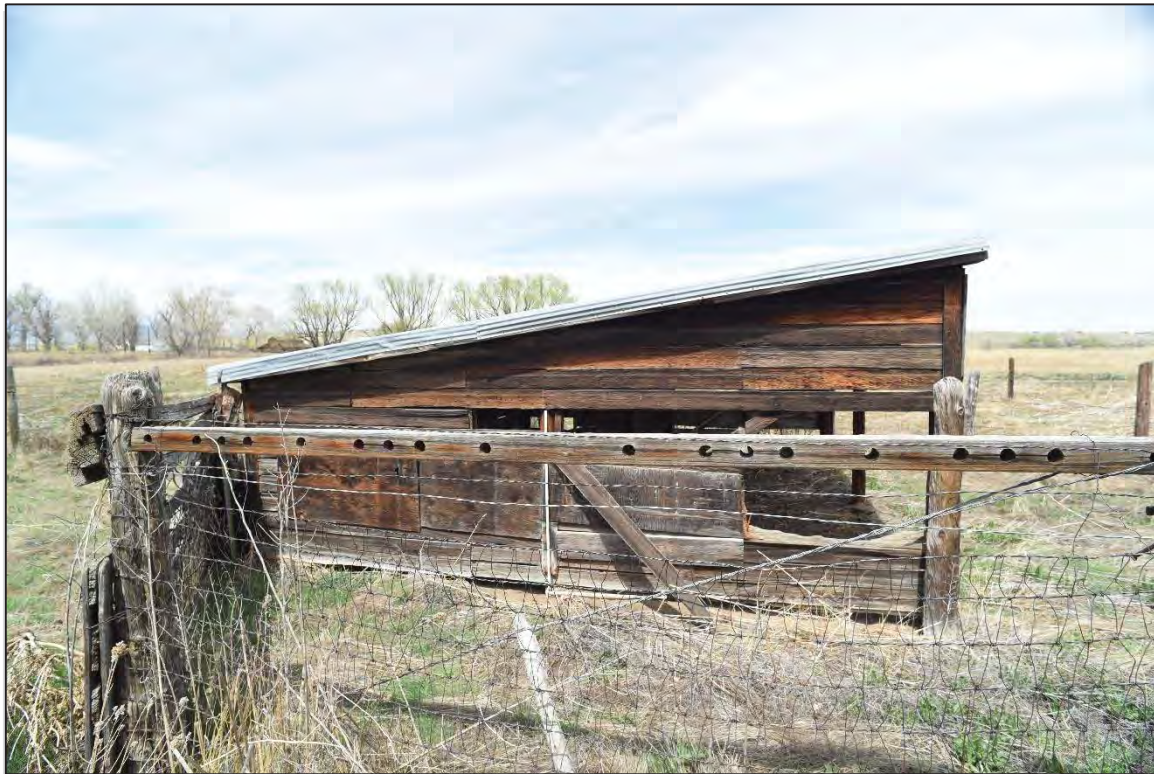
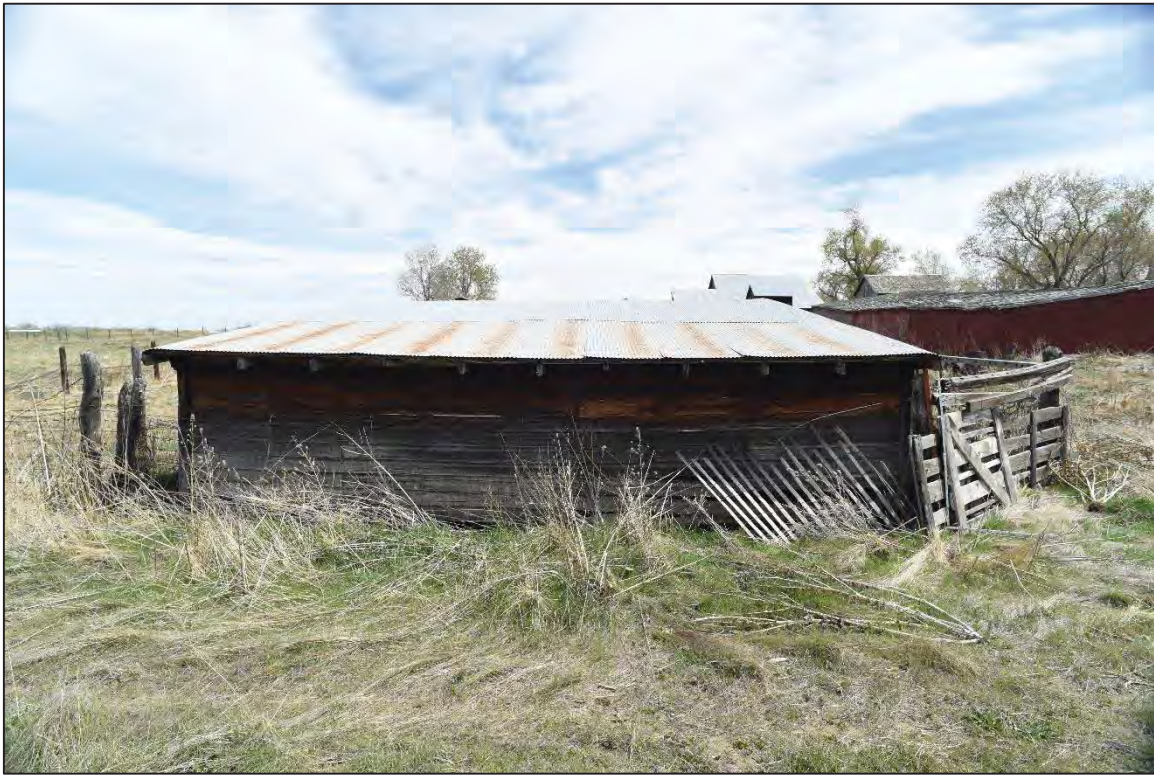
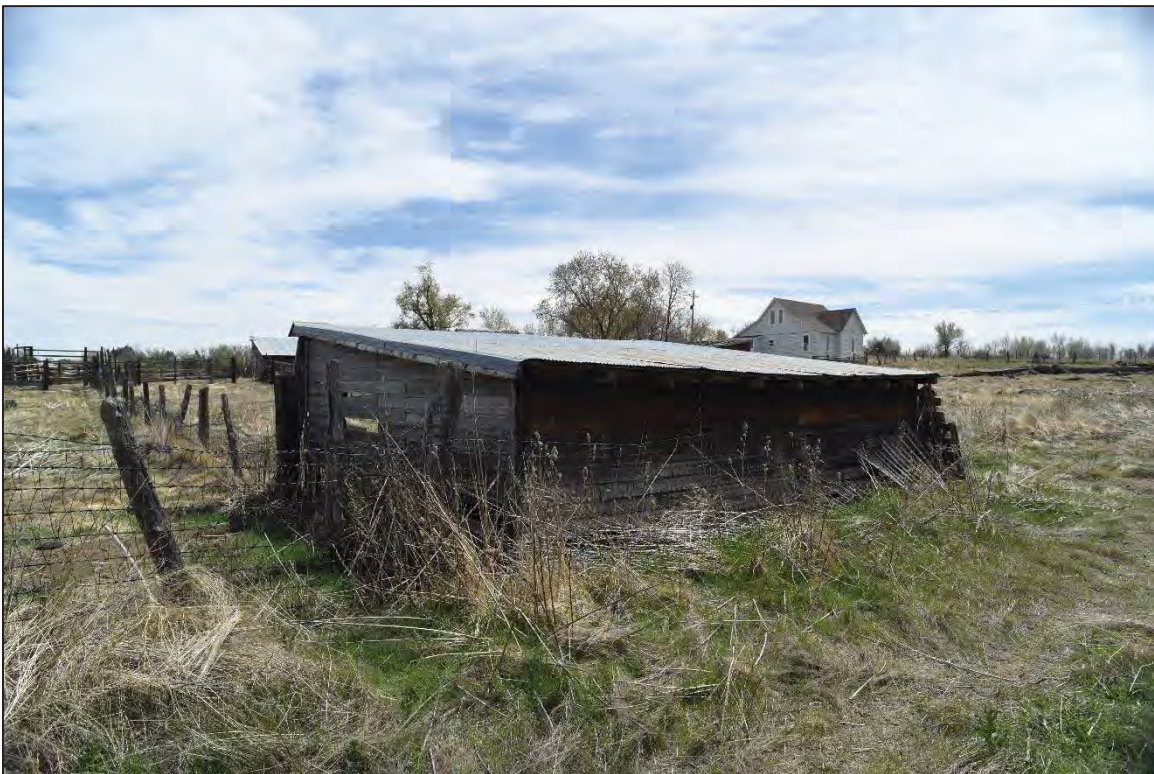
Photo 6181: Southern elevation of the Bull Shed.

Photo 6183: Western elevation of the Bull Shed.

Photo 6185: Northern elevation of the Bull Shed.

Photo 6187: Oblique view of the eastern and northern elevations of the Bull Shed.

Building 8 is a loafing shed, known as the Bull Shed, located at the west end of the farm core. It is a rectangular-plan shed (16 feet 2 inches x 20 feet 5 inches) with three closed and one open side (east-facing) and a corrugated sheet metal shed roof over the original wood shingles. The shed does not have a visible foundation with walls and ten support posts that appear to be set into the ground. The walls consist of mixed shiplap and plywood siding, which are very weathered with about half of the siding missing or deteriorated beyond salvage, nailed to treated wood posts on an internal frame and with diagonal plank bracing, shown in photos 6181, 6183, 6185, and 6187. The mixed materials, quality of workmanship, feeling, and lack of association with early twentieth century farm operations deter from the shed's integrity. The shed was reported to be built in 1957 (TCI 2015: 147), which is corroborated as possible by aerial imagery (USGS 2017) from 1949 (not present) and 1963 (present). The shed has structural integrity but fails to convey the historic significance of the Hartnagle Farm as it post-dates the farm's period of significance. It is not recommended to be considered as a contributing resource of the Hartnagle Farm.

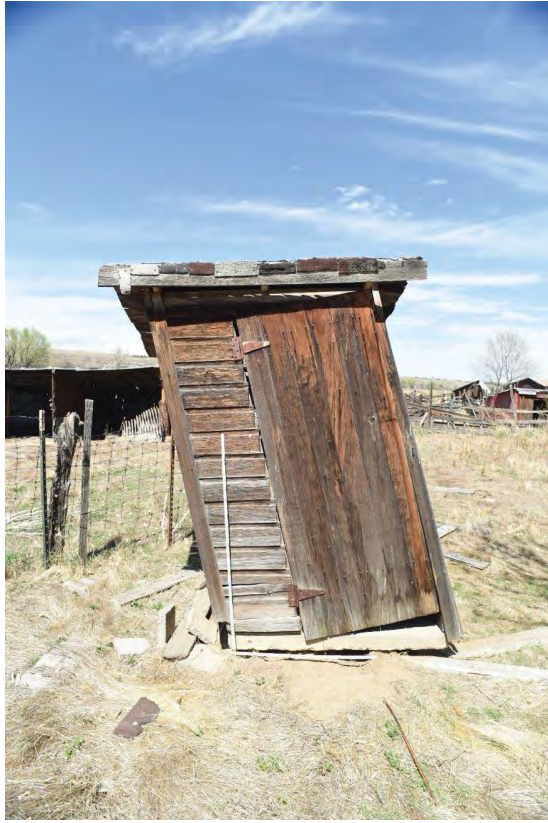
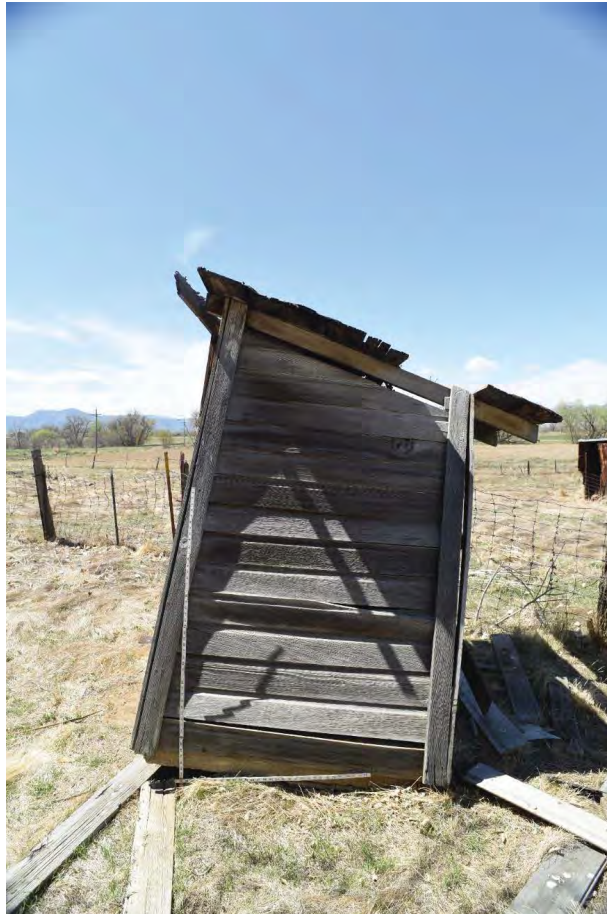
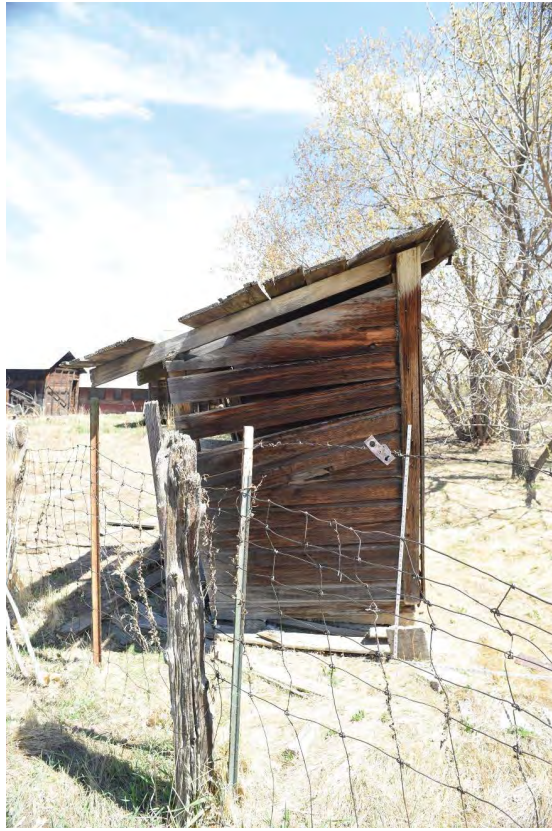
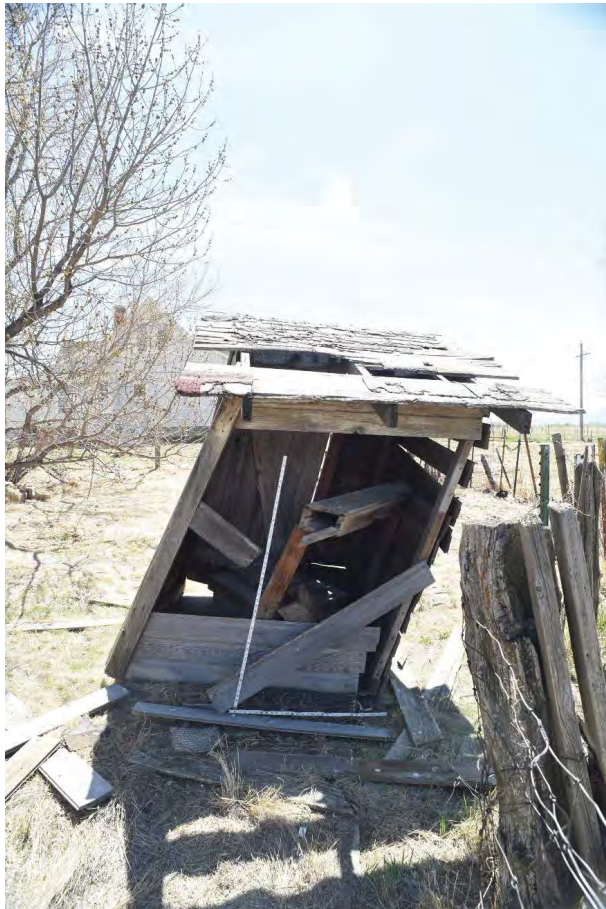
Photo 6213: Southern elevation of the outhouse.

Photo 6214: Eastern elevation of the outhouse.

Photo 6216: Western elevation of the outhouse.

Photo 6217: Northern elevation of the outhouse.

Building 9 is an outhouse located immediately south of the West Loafing Shed (Building 7). It is a small square-plan outhouse with 4-foot long sides. It follows the several of the type specifications by the Works Progress Administration (WPA) for sanitary privies. It has a poured concrete foundation and floor. The outhouse contains remains of the T-shaped vent hole that is characteristic of the design from the WPA, shown in photo 6217. The walls consist of horizontal siding attached to an interior frame with wire nails while the exterior corners of the building are clad with vertical planks that form corner posts. An off-center doorway with a vertical plank

door reinforced with one diagonal brace is positioned at the eastern corner of the south elevation. The outhouse has a shed roof with less than 40% of the original wood roofing shingles intact. The outhouse has a severe western lean, the result of displacement from the foundation and collapse of the west elevation and south elevation siding. The wall anchors are lost. The building is in poor condition. While it is still standing, it is fragile and motion from opening the outhouse door will likely collapse the building. Additionally, repair of the outhouse would require fifty or more percent of original materials to be replaced. Character defining features of the outhouse have been destroyed and the building lacks overall structural integrity. The building does not convey its significance as an outhouse and symbol of progressive techniques. It is not recommended to be considered as a contributing resource of the Hartnagle Farm.
