APPENDIX A
CORRIDOR CONDITIONS ASSESSMENT FOR STATE HIGHWAY 7
PLANNING AND ENVIRONMENTAL LINKAGES STUDY
JANUARY 2017

**CORRIDOR CONDITIONS ASSESSMENT REPORT
FOR
STATE HIGHWAY 7
PLANNING AND ENVIRONMENTAL LINKAGES (PEL)
STUDY**

JANUARY 2017

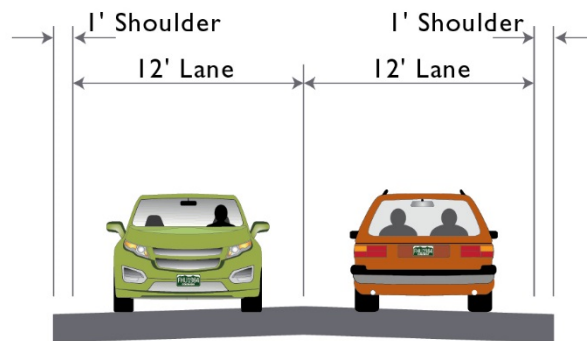
Figure 2.1 Typical Cross Section on SH 7 (N 75th St to US 287)

Within the study limits of the SH 7 PEL (N 75th Street to US 287), the geometric characteristics of SH 7 are highly variable. SH 7 primarily consists of two-lane cross sections with approximately 64 feet of right-of-way. The surface type for the corridor is primarily asphalt, except for the intersection of SH 7 and US 287, which is concrete. Approaches from both directions on SH 7 at N 75th Street are configured with two through lanes in each direction, but the remainder of the corridor consists of a single travel lane in each direction. Typical cross sections are shown in **Figure 2.1**, along with corridor constraints and deficiencies that have been identified.

Shoulder widths vary significantly on the roadway, primarily due to varying auxiliary lane configurations. All shoulders are paved, but most are not curbed. Typical shoulder widths range between 1 and 12 feet. Areas with shoulders less than 5 feet in width are typically found on segments of the highway with no access drives or auxiliary lanes. Auxiliary lanes are frequently provided throughout the corridor at both signalized and stop-controlled public street intersections for deceleration and acceleration movements.

Most of the corridor has no median, but when present, median configurations vary significantly. Raised medians exist at the intersection of SH 7 and N 75th Street, as well as for channelized right-turn movements at other intersections including SH 7 and US 287. However, most median configurations are painted and exist only near access drives and auxiliary lanes. Widths of painted medians range from 3 feet to 18 feet but typically range between 4 and 13 feet.

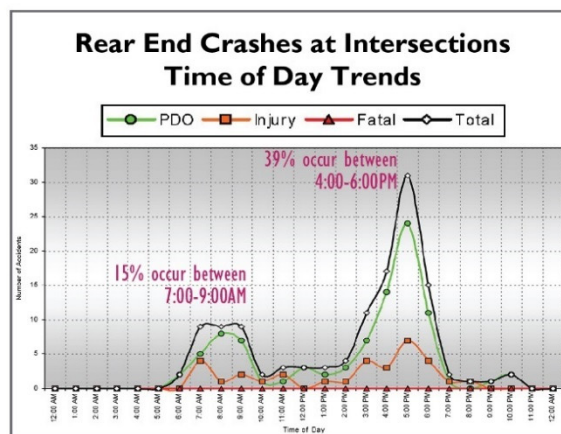
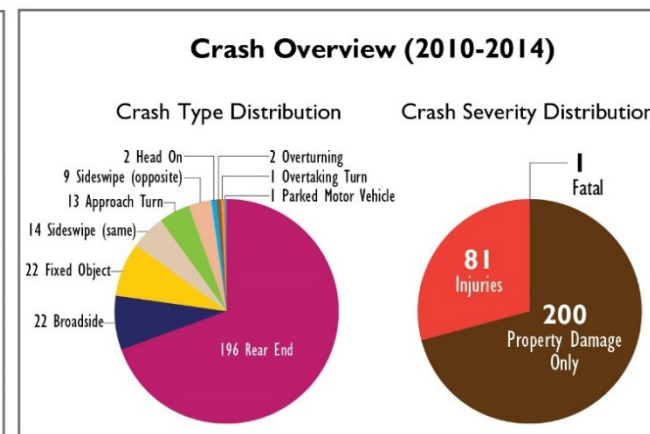
Figure 2.3 Safety Summary

The crash summary is based on the comprehensive analysis of five years of crash history (1/1/10 to 12/312014), which was examined to locate crash clusters and identify collision causes. During this period, a total of 282 crashes were reported along SH 7 within the study section, including both intersection-related and non-intersection related crashes. The majority (about 70 percent) were property damage only (PDO) crashes. In addition, there were 81 injury crashes and one fatal crash, with 116 persons injured and one person killed overall. The fatal crash (a head on crash to the east of Arapahoe Road) occurred in June 2012. **Figure 2.3** presents graphical representations of the crash types and crash severity for this corridor. Rear end crashes (70 percent) were the predominant crash type, followed by broadside (8 percent) and fixed object (8 percent) crash types.

queuing from nearby intersections because these crashes primarily occurred during the peak hours. The other two most frequent non-intersection crash types are fixed object (13 percent) and sideswipe (same direction) (8 percent).
