## HISTORIC PRESERVATION ADVISORY BOARD

**Thursday, July 12, 2018 – 6:00 p.m.**

1. Citizen participation for items not otherwise on the agenda
2. Approval of minutes from previous meetings
3. Building Permit Reviews for Structures 50 Years of Age and Older
4. Landmarks:
  - a. **Docket HP-18-0006: Eldorado Springs Resort**

Request:	Boulder County Historic Landmark Designation of the historic resort complex.
Location:	255 Artesian Drive (Parcels 157925406018, 157925414028, and 157925400019), on the north side of Artesian Drive approximately 3 miles west from the intersection of SH170 and SH93, in Section 25, Township 1S, Range 71W of the 6th Principal Meridian.
Zoning:	Agricultural (A), Business (B), Estate Residential (ER), and Forestry (F)
Owner/ Applicant:	Eldorado Artesian Springs, Inc.
5. Certificate of Appropriateness:
  - a. **Docket CA-18-0013: Hornbaker House – addition and renovations**

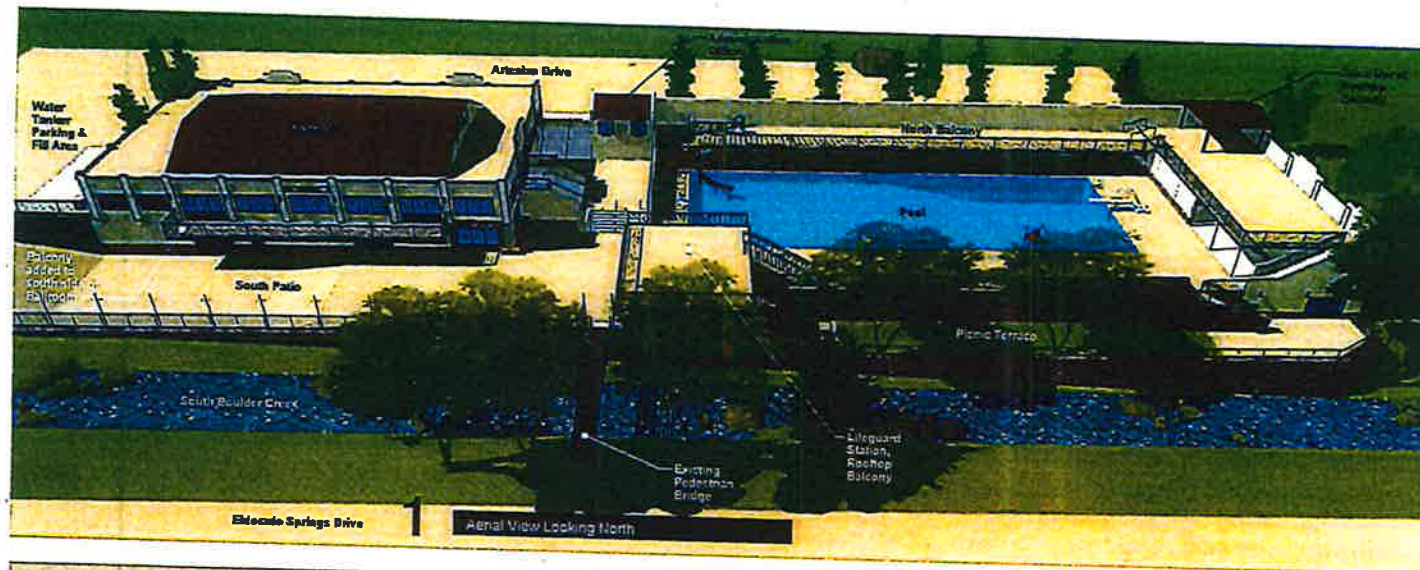
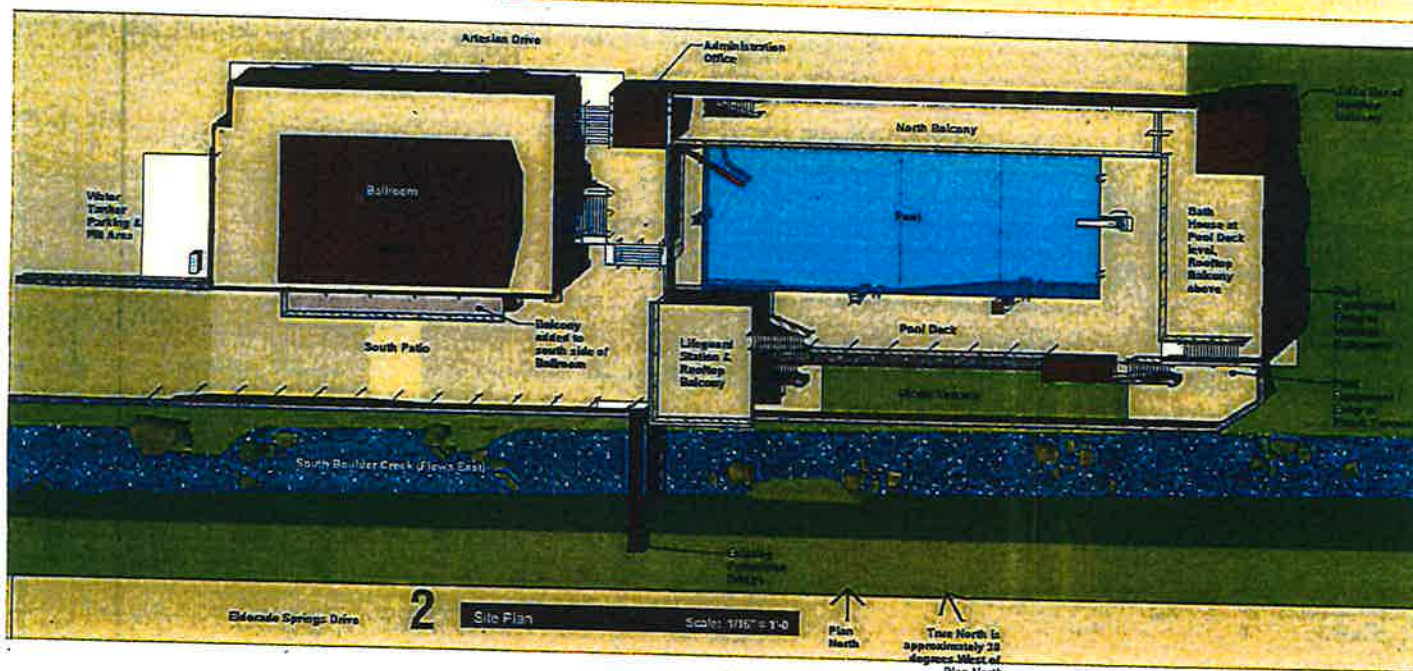
PROPOSED SITE PLAN 2018

Project Name & Location  
Eldorado Springs Resort  
Limited Impact Special Use Review  
235 Eldorado Springs Dr  
Eldorado Springs, CO 80025

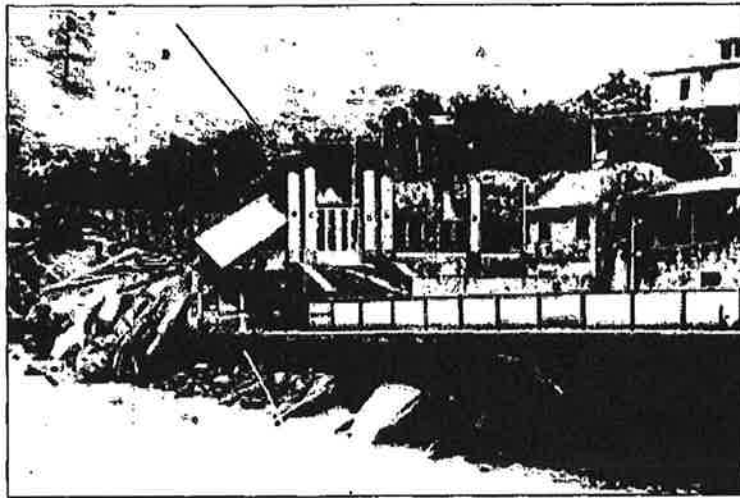
*Photograph depicting the ballroom in the aftermath of the 1938 flood. Note the larger collapsed parapet (indicated by arrow) above the entrance that was not reconstructed. Photograph courtesy of the Urban Drainage & Flood Control District website.*

The ballroom and associated structures were repaired, however a large collapsed parapet above the main entrance of the ballroom was not reconstructed. WPA workers were reportedly employed to build a large stone retaining wall (still visible today) along the banks of the creek to prevent future damage. The following year, in 1939, the New Eldorado hotel burned down. The resort experienced 19 years of calm, after which a 1958 fire destroyed the resort bath house, pool office, and men's locker room. A few small floods and fires have continued to occur since the 1950s, but none of them have had the devastating effects of previous disasters. (Photographs available online at [www.photoswest.org](http://www.photoswest.org) provide a visual reference for the flood damage over time. Individual photograph call numbers can be found on field 45 of the attached Management Data Form.)

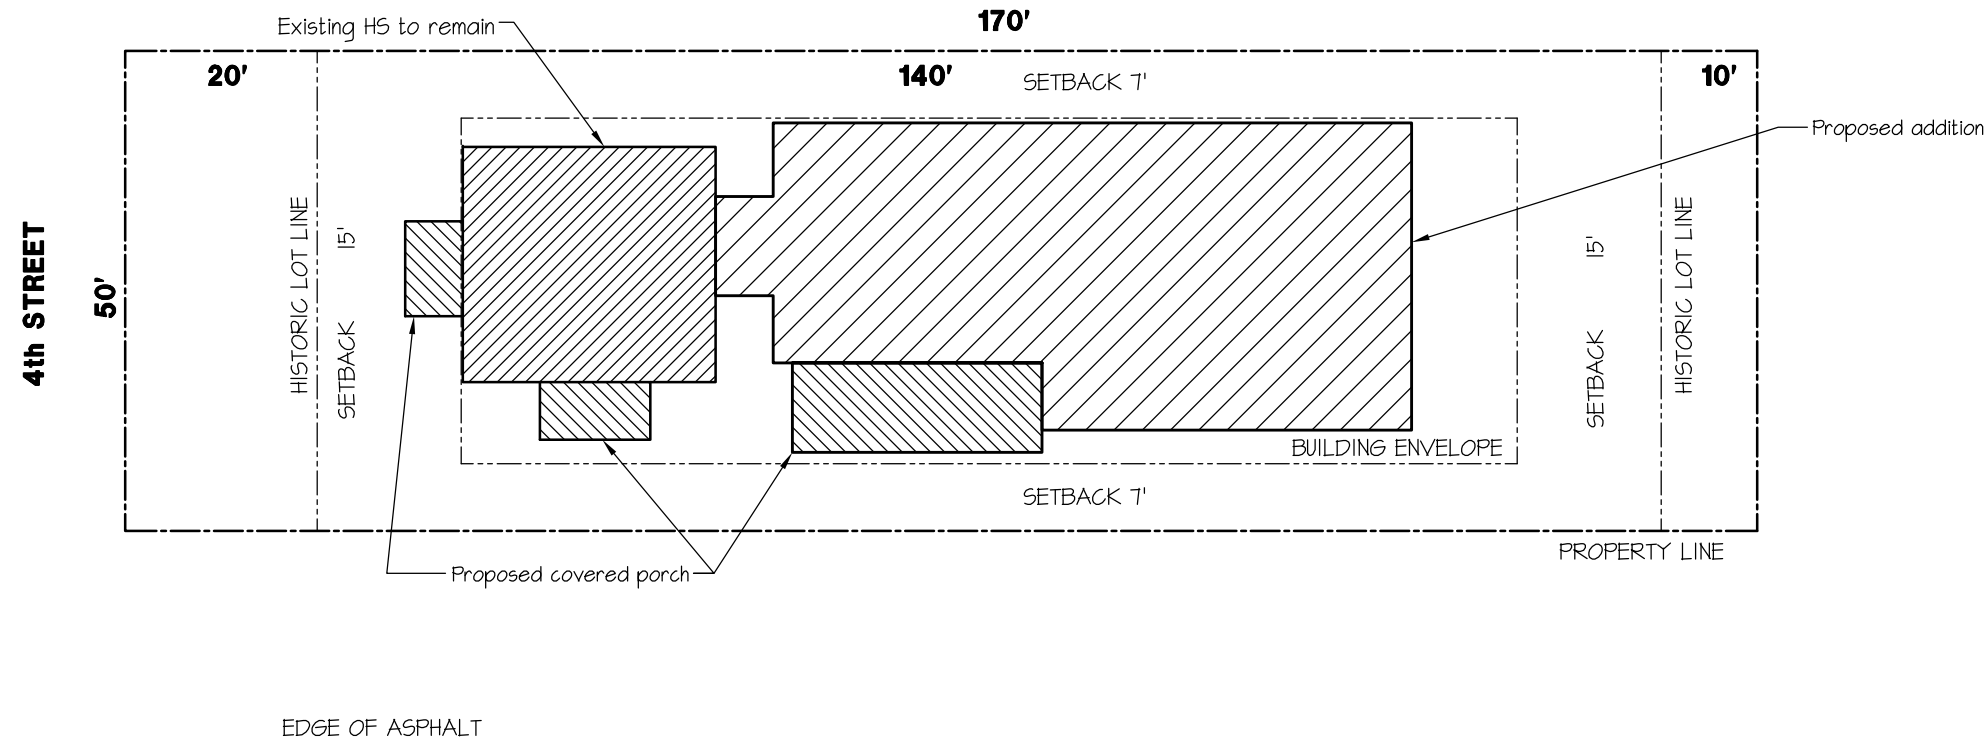
**SITE PLAN**

**EXISTING STRUCTURE and ONE STORY ADDITION**

1. This Narrative.
2. Two Architectural 11x17 sheets;
  - A100 Site Plan
  - A300 Elevations

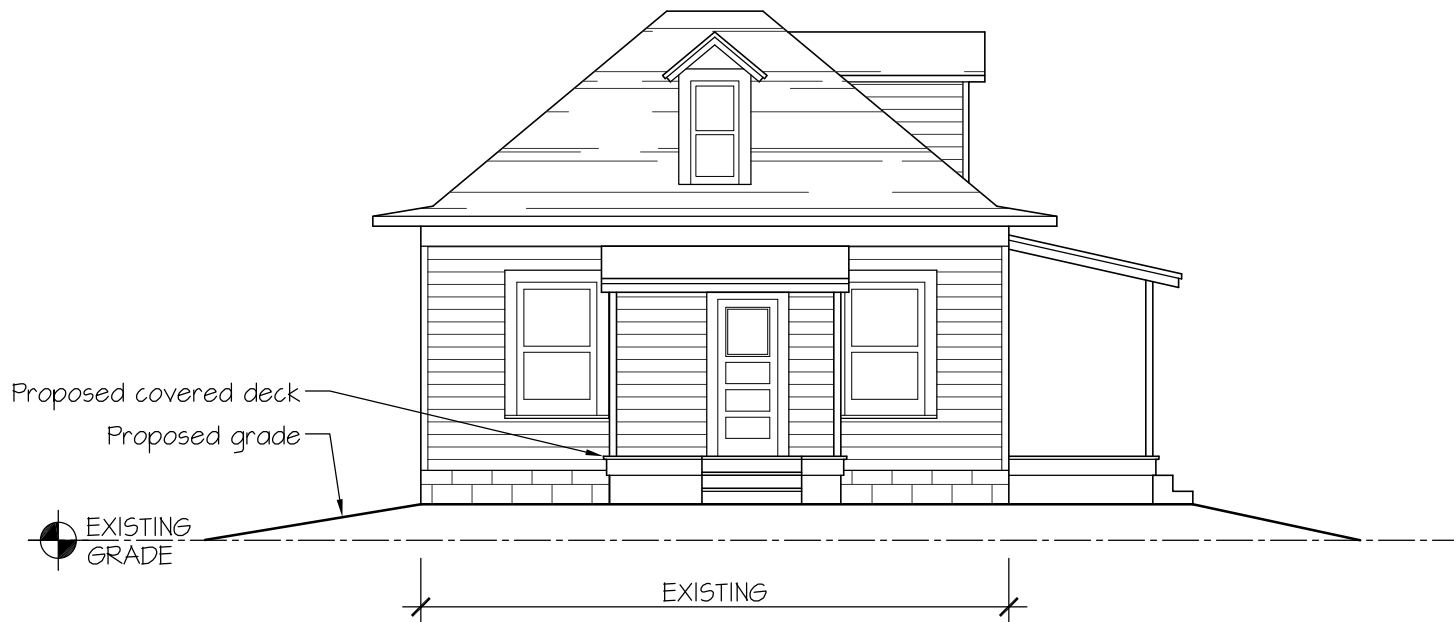
**FRONT / 4th STREET / WEST ELEVATION**

SCALE: 1/8"=1'-0"
