RE: Final Report: Influence of Crack Willow on Stream Geomorphology, Wildlife, and Native Plant Community Composition.

ABSTRACT

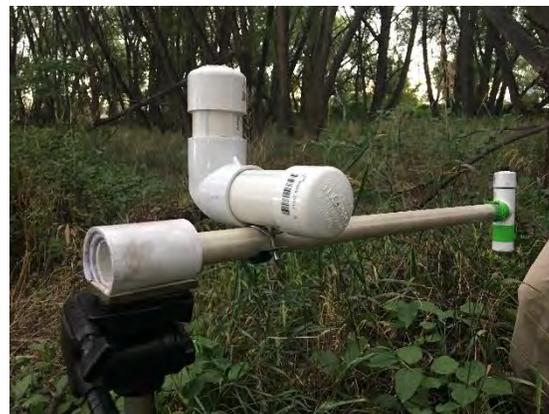
Line-point Intercept Survey Tool:
periscope (for canopy cover) mounted on arm with laser (for ground cover)

Vegetation Surveys: We conducted line-point intercept monitoring (Herrick et al. 2005) using lasers (ground cover) and periscopes (canopy cover) in 100-meter transects to measure vegetation cover (species cover, diversity, structure). The original research design aimed to collect a minimum of 10 randomly located transects in each study reach, within a 25-foot buffer of the canopy edge to reduce influence of non-target conditions on the desired understory measurements. However, due to the geometry of selected study reaches (i.e., crack willow and cottonwood stands were narrow and long rather than long and wide), we instead used four 200-meter long transects at each site, two in each overbank zone (**Figure 2**). Presence absence data was also recorded within a 2m wide belt along the 100m long transect. Vegetation was recorded in the following categories:

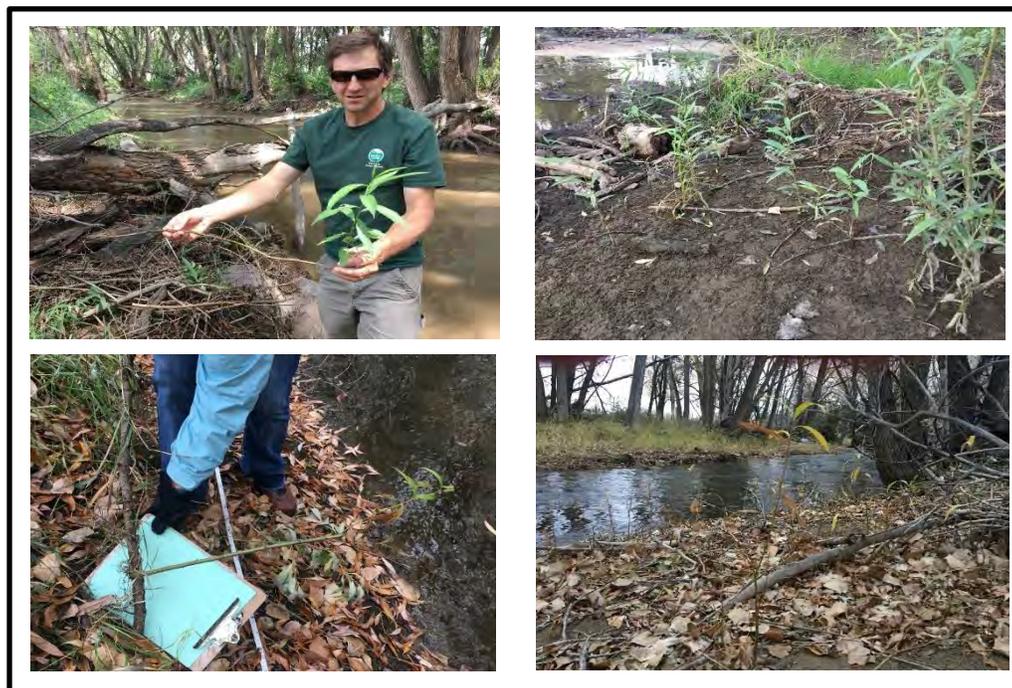
Image 2. Crack Willow Regeneration Photos (upper left = re-sprout from fallen branch, Peck; lower left = re-sprout from fallen branch, Jorgensen; upper right = re-sprout from branch, Peck; lower right = apparent re-sprout from seed, Jorgensen)

During the SSA and Vegetation surveys, observers documented the occurrence of crack willow (**Image 2**) and cottonwood saplings/seedlings via photographs and presence/absence data. Additionally, the principal investigator has observed numerous reaches on the Big Thompson River, Little Thompson River, Poudre River, and other Font Range streams where crack willow is growing from cuttings following the 2013 flood. These results are corroborated in at least one paper by Budde et. al. (2011), who documented high rates of asexual reproduction of *Salix fragilis* in Argentina.

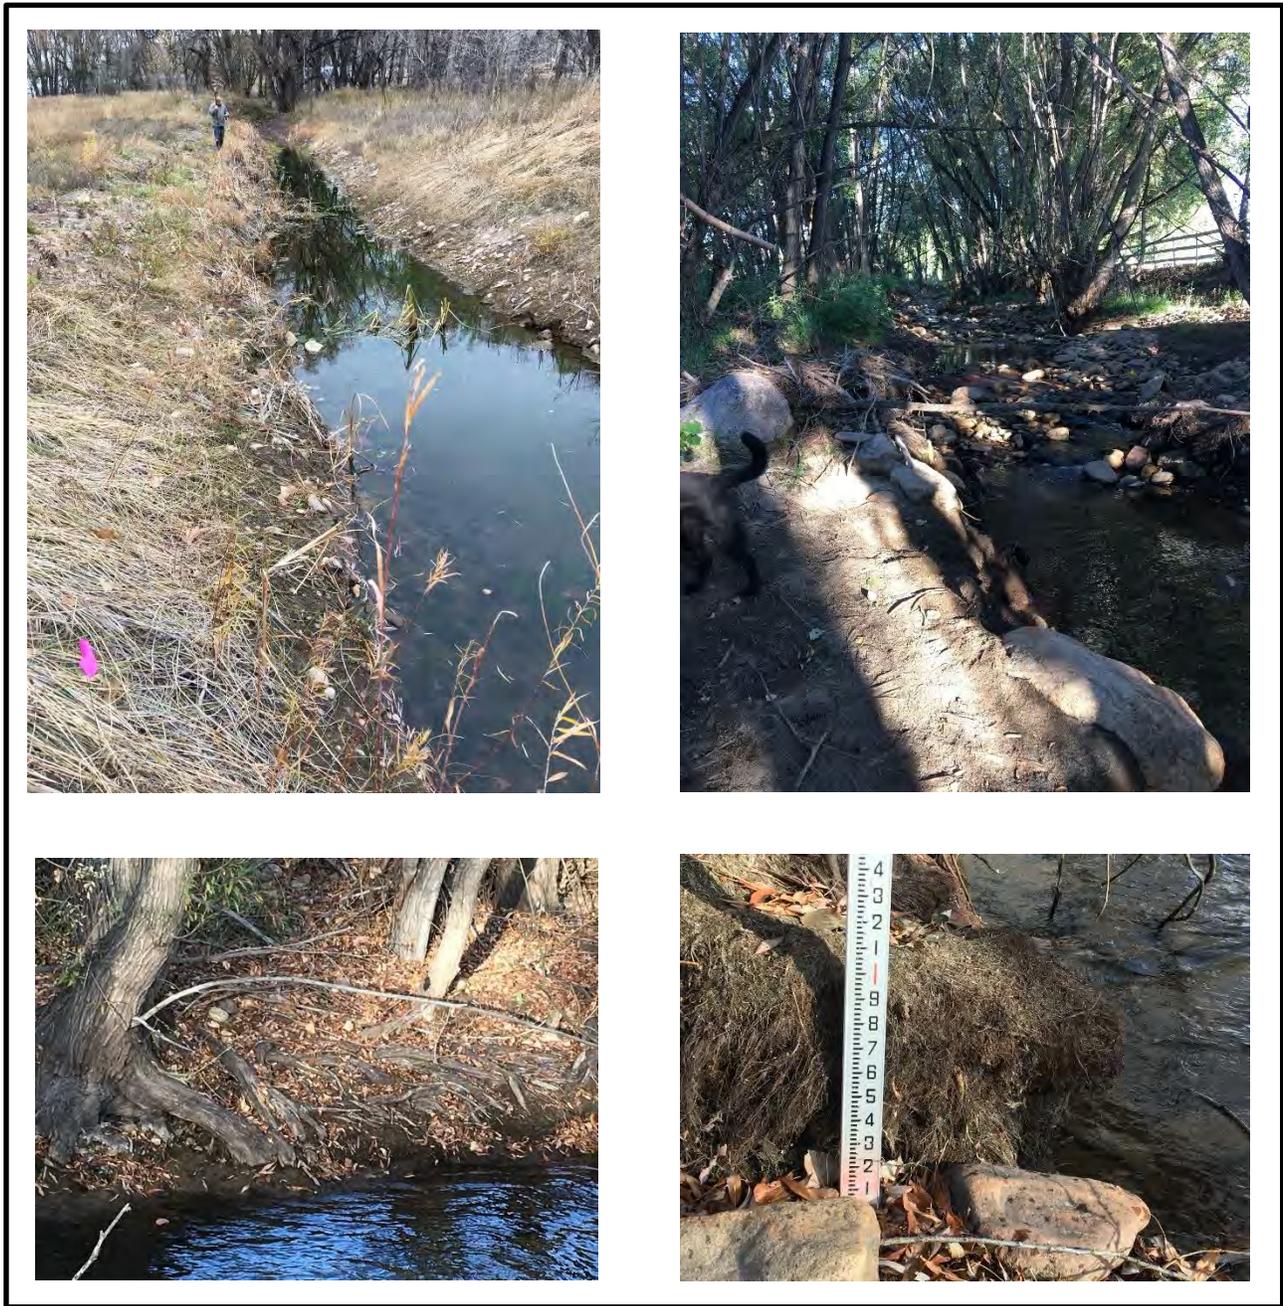
Image 3. High Cover of Surficial Crack Willow Roots (upper left = ditch on Jorgensen, roots reaching over 30 ft from source tree; lower left = woody and fibrous roots, Jorgensen; upper right = toe and inner berm hardened by roots, Jorgensen; lower right = 1' high mass of fibrous roots, Jorgensen)

Table 6 provides a summary of the streambank stability assessment (SSA) data for all sites. For each transect and site, the reference sites have a higher composite bank erosion hazard score, as compared to the crack willow sites. The higher scores were in part a result primarily of a high density of surficial crack willow roots, which in effect armor the banks. These areas of very high surficial roots also exhibited a low cover of herbaceous vegetation (**Image 3**). The dense surficial roots occurred primarily between the toe of the bank and the ordinary high water mark elevation, the zone of a streambank which undergoes some of the most significant erosion on an annual basis. With such armoring, it is possible to expect an increased risk of streambed incision (i.e., downcutting), thus disconnecting the overbank zone from annual floodwaters. Refer to the cross-section data for additional regarding evidence of incision in the reference and crack willow sites. The crack willow sites also exhibited higher overbank cover, lower active bank erosion, a more stable bank composition, and lower vegetation cover on banks, as compared to the reference sites.
