## Existing Conditions

# Boulder County Fairgrounds Park

Longmont, Colorado

K/O Fairground Planners

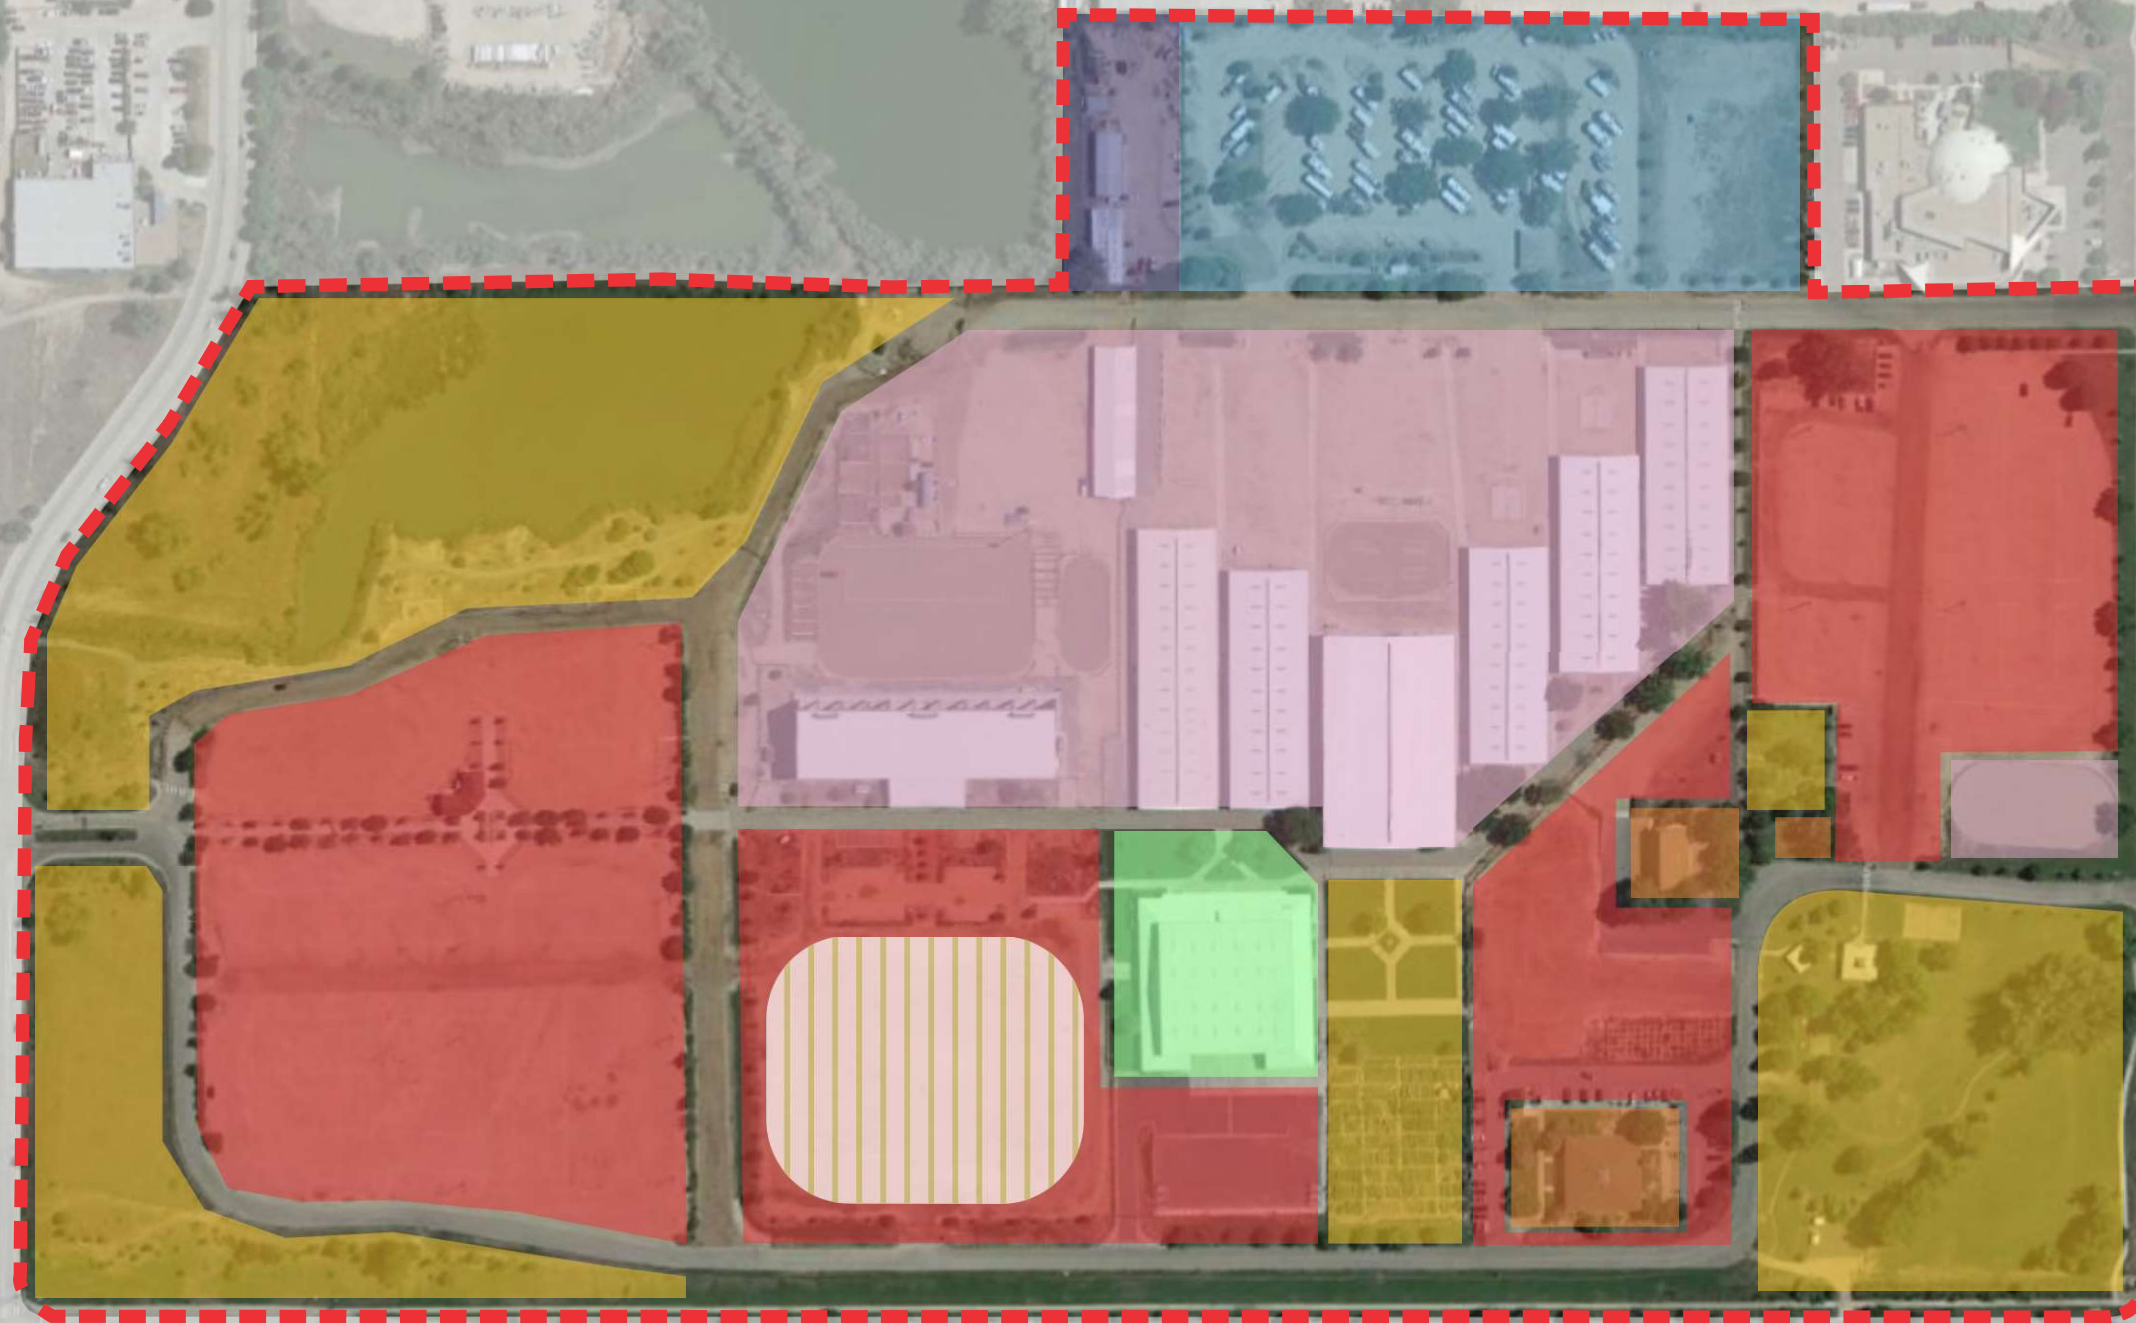
- 1 South Parking Lot
- 2 Public Practice Arena
- 3 Fairgrounds  
Management Office
- 4 Clover Building
- 5 Fairgrounds Parking Lot
- 6 Natural Resources  
Bldg./CSU Extension
- 7 Exhibit Building
- 8 Exhibitor Parking Lot
- 9 Midway Parking Lot
- 10 North Parking Lot
- 11 Farmer's Market
- 12 North East Parking Lot
- 13 Cattail Pond
- 14 Outdoor Arena &  
Contestant Parking
- 15 Outdoor Arena
- 16 Warm-Up Arena
- 17 Jack Murphy Arena
- 18 Maintenance Shop
- 19 Pole Barn
- 20 Barn A
- 21 Barn B
- 22 Indoor Arena
- 23 Warm-up Arena
- 24 East Parking Lot
- 25 RV Campground
- 26 Trailer Parking Lot
- 27 Barn C
- 28 Barn D
- 29 Barn E
- \* Site Entrance
- - - Fairgrounds Border

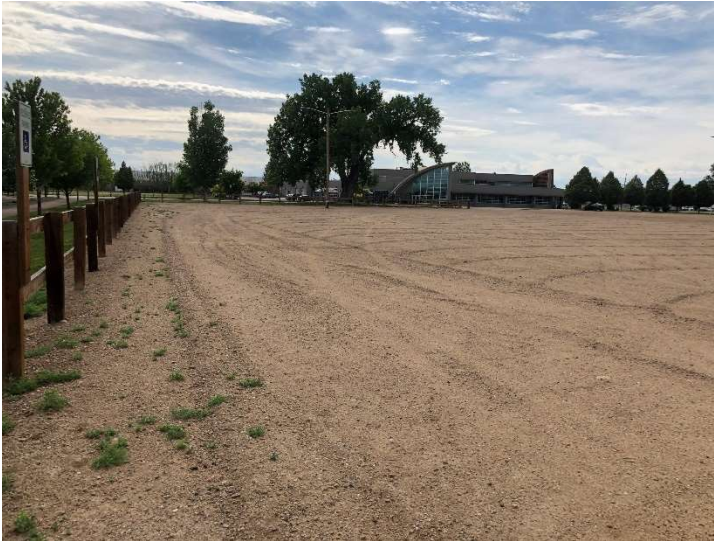
### 1. South Parking Lot

The South Parking Lot is located near the site's two access points along Nelson Road and contains approximately 5 acres of gravel surface parking found in fair and acceptable conditions. Located near the fair management office, practice arena and southern barns, the parking area has clear external boundaries but lacks any internal wayfinding. Paved drive areas or aisle markers should be considered to improve utilization.

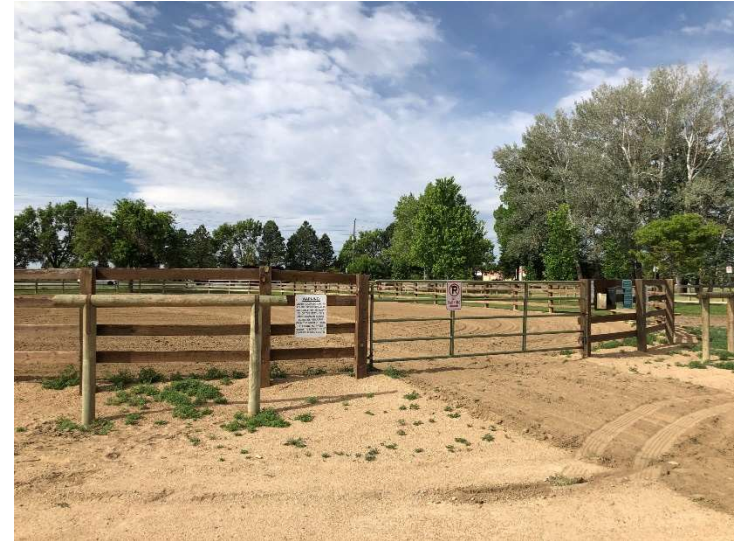
### 2. Public Practice Arena

Located adjacent the South Parking Lot, the Public Practice Arena is 100' x 200' in size, free for public use, and found to be in good condition with firm fencing and adequate riding surface. No shade is near this arena, a built shade cover should be considered.

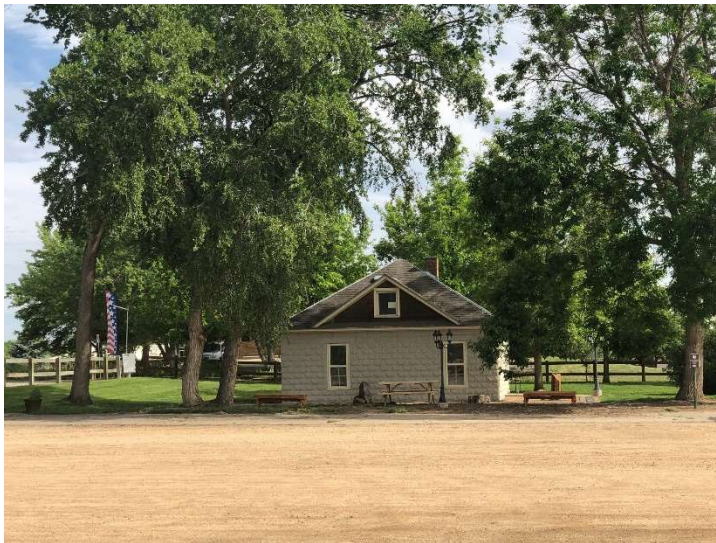
### 3. Fairgrounds Management Office

The Fairgrounds Management Office houses the administrative functions of the fairgrounds in a historic house original to the site, previously known as the Affolter Corner Farm or Affolter Place. Dating from depression era, the residence was historically used to house hired help on the farm. The house exhibits maintenance issues like residential structures of advanced age like energy inefficiency and water infiltration/prevention struggles but is found in acceptable condition. From a current function standpoint, the office should consider relocation to a structure that is better suited to the day to day operations of receiving public visits.

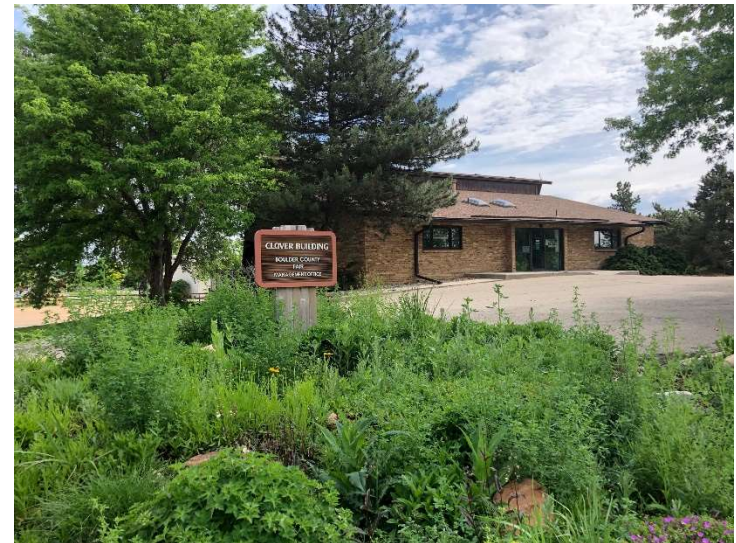
### 4. Clover Building

The Clover Building is a meeting facility utilized by numerous groups and constructed of typical wood residential means in 1984. It appears in good condition. Updates might include better access from the walk-out lower level to the upper level. This building might be a good candidate for relocation of the Fair's administrative offices.

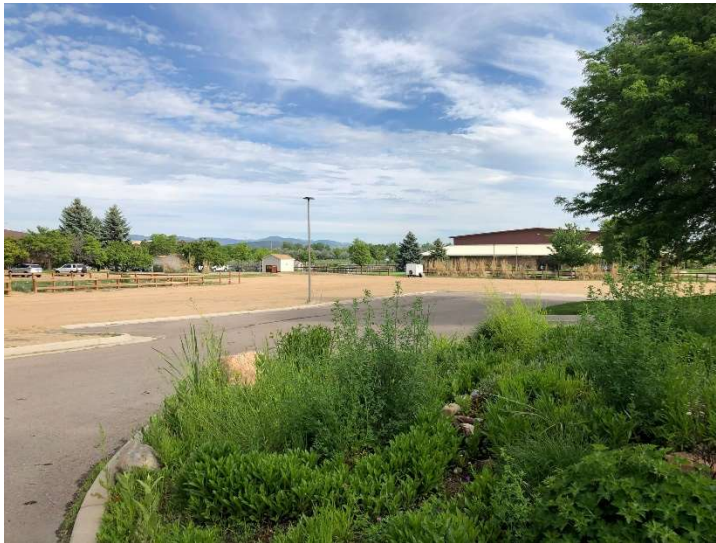
### 5. Fairgrounds Parking Lot

This is a dirt gravel fairgrounds parking lot is 1-1/4 acres. It is located in between the Exhibit and Clover Buildings near the fairground site's center. The site conditions of this lot are adequate for its intended use. However, as improvements are made to the grounds, paving this lot would be beneficial from an accessibility standpoint for year-round events.

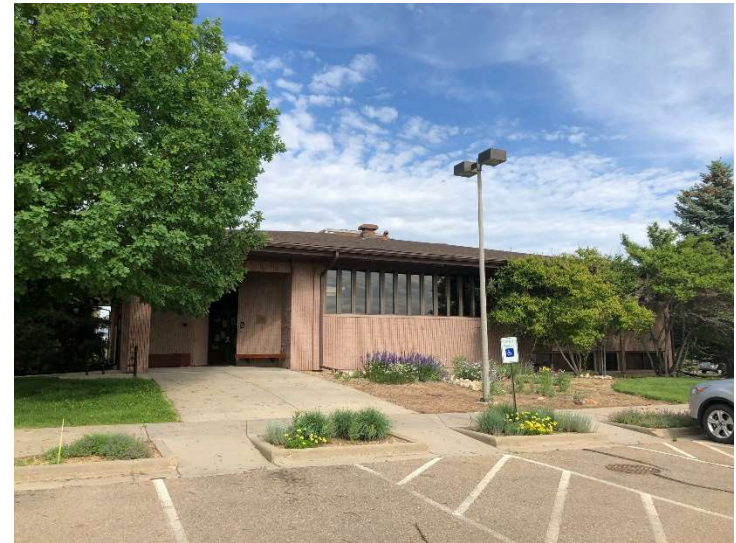
### 6. Natural Resources Building / CSU Extension

Located in the fairgrounds southwest area, adjacent Hover Road, the Natural Resources Building appears in good condition with good public access and parking. This structure is not used by the fairgrounds during the fair event or even during the off-season. Access to the interior was not available at the time of this report so no commentary will be made as such at this time.

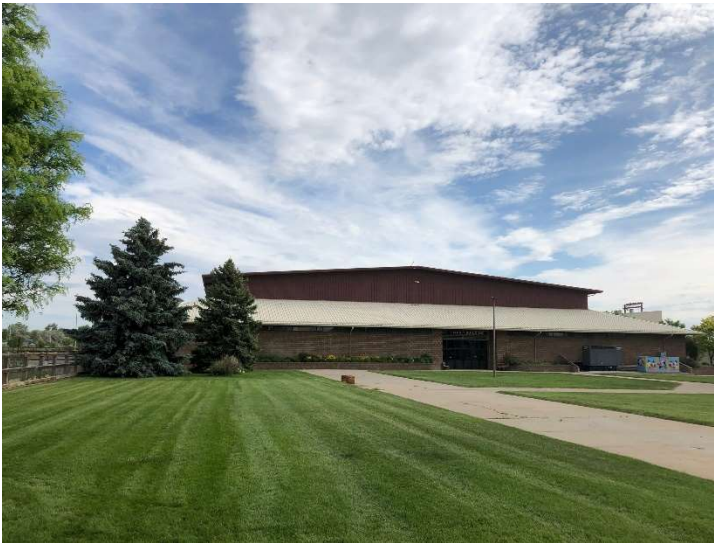
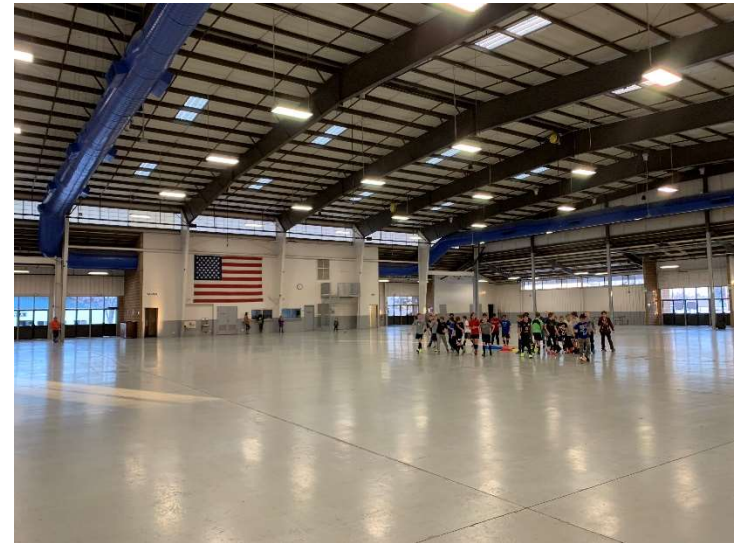
### 7. Exhibit Building

The Exhibit Building contains approximately 40,000 square feet of multipurpose open space used throughout the year. One of the original structures constructed on the site in 1979, the modern steel framed structure is found in good to excellent condition. Reconfiguration of the storage areas should be considered to better accommodate events. Other updates should include enhancements to the kitchen, updates to the restrooms, the addition of a show office, and refinishing of the floor.

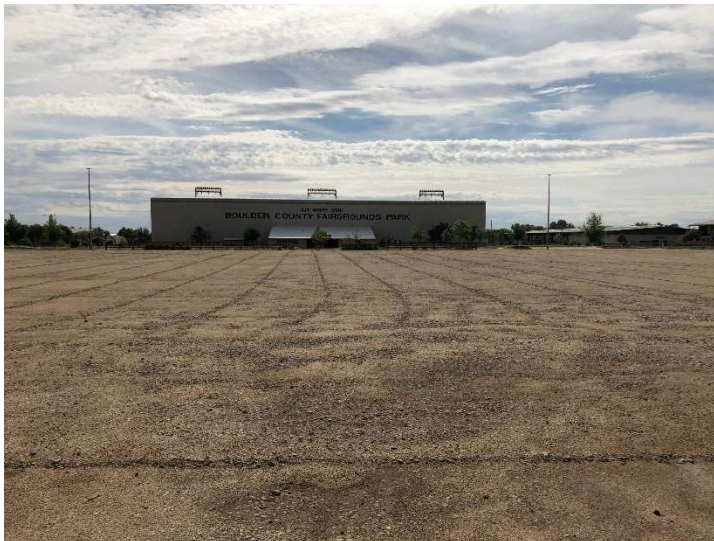
### 9. Midway Parking Lot

Containing roughly 4.3 acres dirt and gravel surface parking, the Midway Parking Lot is located just west of the Jack Murphy Arena. Like all gravel parking areas near built structures on site paving should be considered to allow for accessibility for events.

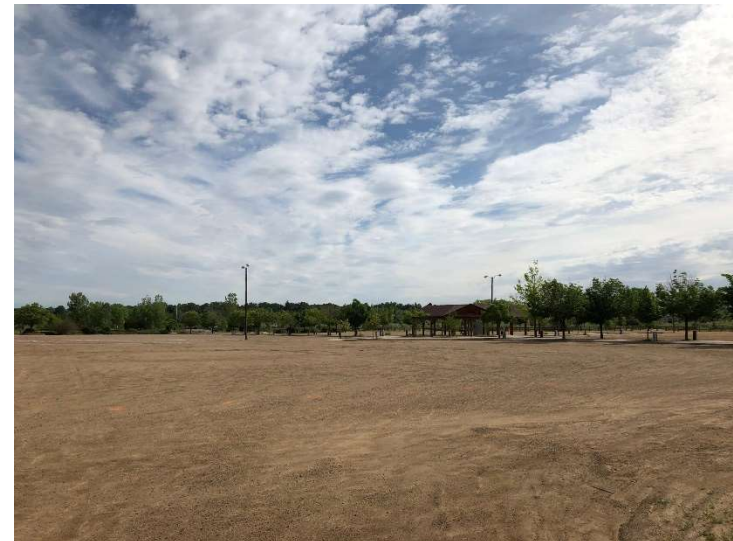
### 10. North Parking Lot

Also located along Hover Road, in the far Northwest of the fairgrounds, the North Parking Lot contains 5.9 acres of gravel surfaced parking found in acceptable conditions like the other large parking areas at the site. Paved drive areas or aisle markers should be considered to improve utilization.

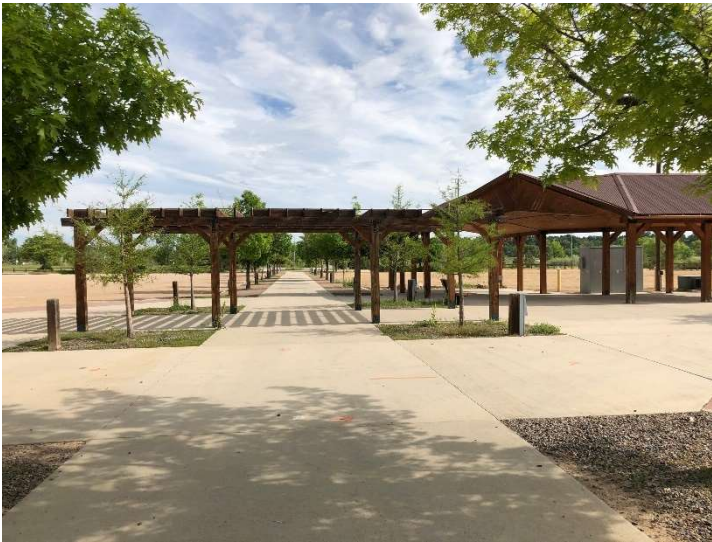
### 11. Farmer's Market

Constructed in 2011/12, the Farmer's Market provides shelter to a small area and tree shade to a much larger area and is found to be in excellent condition. This is a nice amenity and should continue to be enhanced with additional associated greenspace and trees as allowable to maintain its current use.

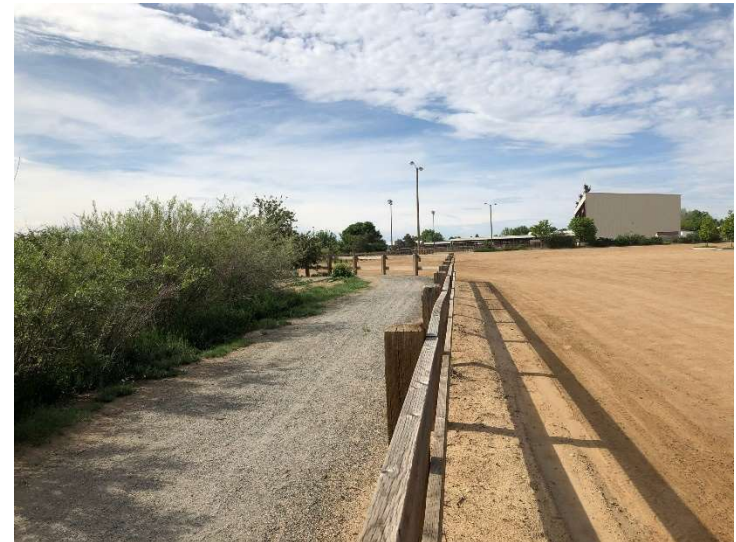
### 12. North East Parking Lot

Found nestled in between Cattail Pond and the Farmer's Market, the 2.75 acres of open gravel parking of the North East Parking Lot is found in acceptable conditions with clear boundaries and firm fencing. Like other gravel parking lots on the grounds, paved drive areas or aisle markers should be considered to improve utilization.

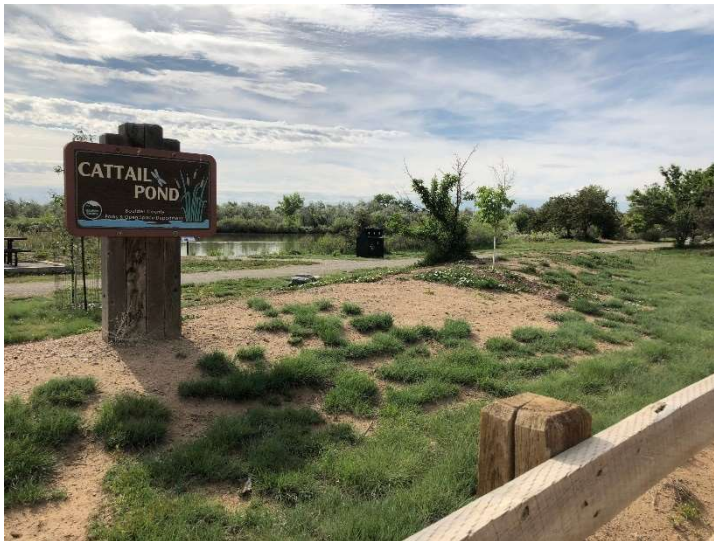
### 13. Cattail Pond

Cattail Pond outdoor area is in the site's far Northeast area and provides pleasant outdoor space and recreation opportunities for the public. No changes or improvements are anticipated to this area of the grounds.

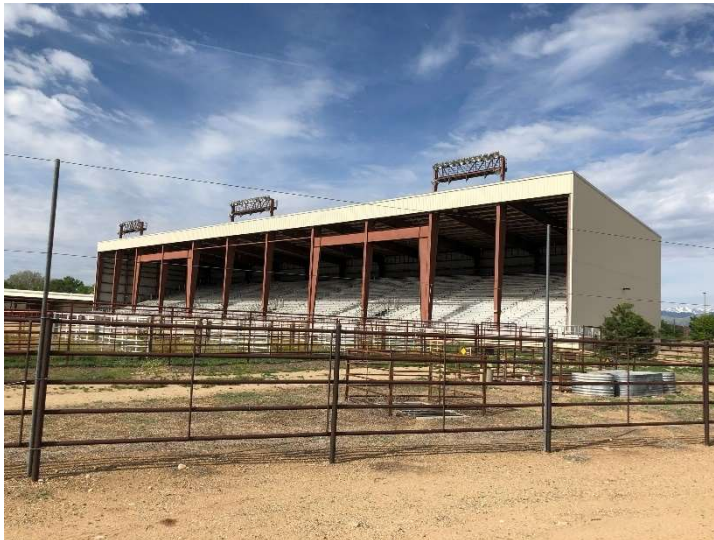
### 17. Jack Murphy Arena

Constructed in 1978 and named after County Commissioner and new fairgrounds advocate, the Jack Murphy Arena grandstand seats approximately 4,500 spectators for various entertainment acts including animal and auto themed events and is found in satisfactory conditions – although there are several structural updates that should be considered to the walk surfaces. Not necessarily part of this study but building and accessibility codes should be reviewed prior to any improvements to this structure. Kitchen and restroom facilities appear adequate, yet enhancements would improve user experiences.

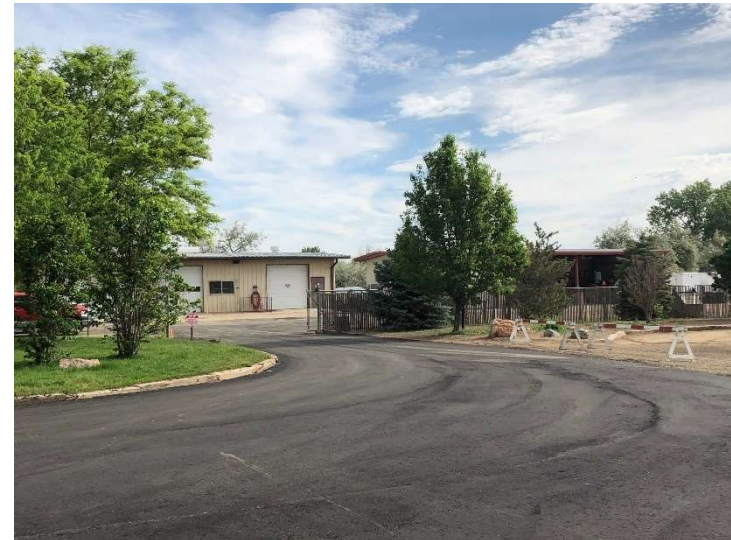
### 8. Maintenance Shop

The fairgrounds' maintenance area contains two buildings, totaling approximately 5,600 square feet of space, including machine and parts storage, work areas and restrooms. The surrounding area consists of dirt and gravel and totals roughly .85 acre. Sheltered storage space appears inadequate for the large maintenance machines. Additional enclosed and covered space is recommended, and additional paving is needed to assist in drainage, and maintain and store equipment that cannot be placed under cover.

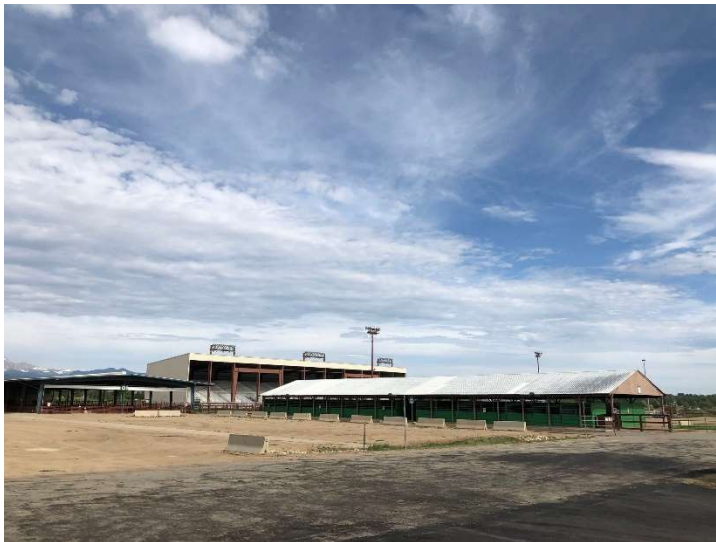
### 19. Pole Barn

At 9,000 square feet of column free space, the Pole Barn provides additional stalling room for animals near the warm-up and outdoor arenas. The wood structure is found in a poor condition, lacking an efficient size and lay out and exhibiting deteriorated materials and finishes. Due to elevation differences and the conditions of all elements this structure would be better served removed than spending any money towards improvements.

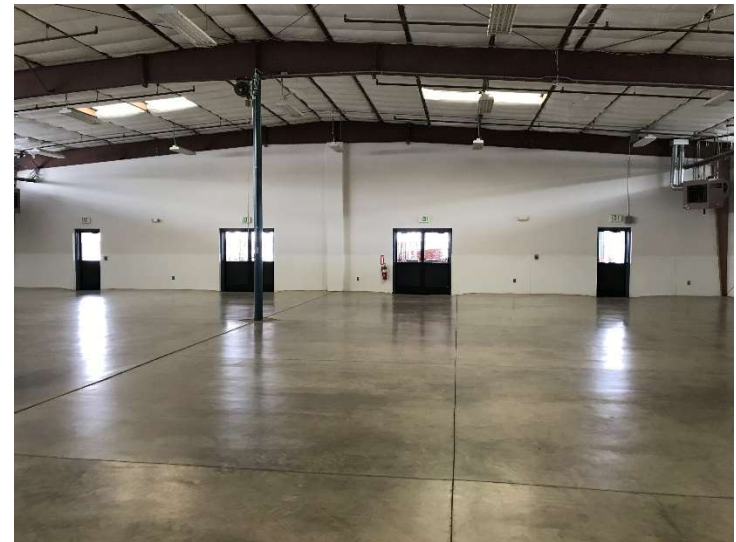
### 20. Barn A

Containing approximately 8,000 square feet of enclosed space and 18,000 sf of open sided stalling containing

small animal pens, Barn A was constructed in 1979/1980, exhibiting low slope roofs with large overhangs resting on a steel structure with gravel surfaces. Barn A's enclosed space contains two separate areas: an entrance hall and back space shown below. The enclosed area appears to be in acceptable condition. The barn structure and roof itself have several areas that should be considered for improvements. Paving within the barn would aid in drainage and safety. Stalling should be updated to a safer and more portable style, overhead fans should be added to assist in ventilation,

and lighting updates should be made to increase visibility for evening use. Water hook-ups should be updated for wash areas and scattered throughout the barn general livestock use.

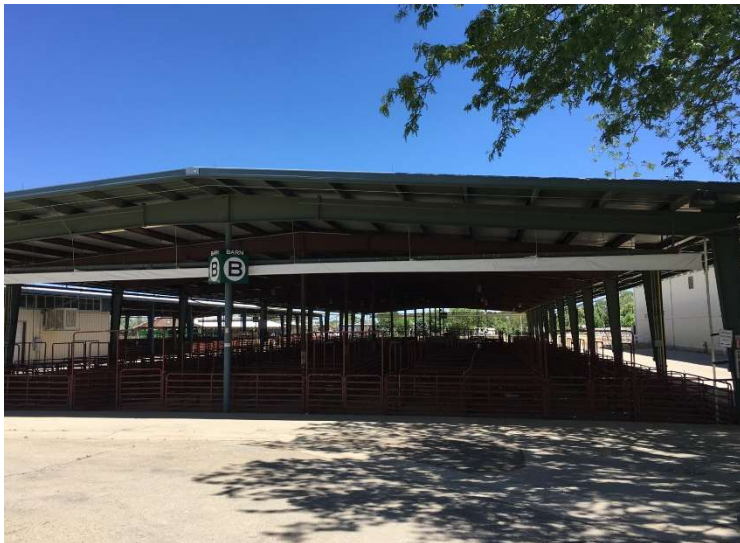
### 21. Barn B

At 21,600 square feet of covered stalling, Barn B lies just north of the Indoor Arena. Similar in character and condition to the other barns, Barn B is open on all sides and houses small animal pens on rough ground. Like Barn A the barn structure and roof itself have several areas that should be considered for improvements. Paving within the barn would aid in drainage and safety. Stalling should be updated to a safer and more portable style, overhead fans should be added to assist in ventilation, and lighting updates should be made to increase visibility for evening use. Water hook-ups should be updated for wash areas and scattered throughout the barn general livestock use.

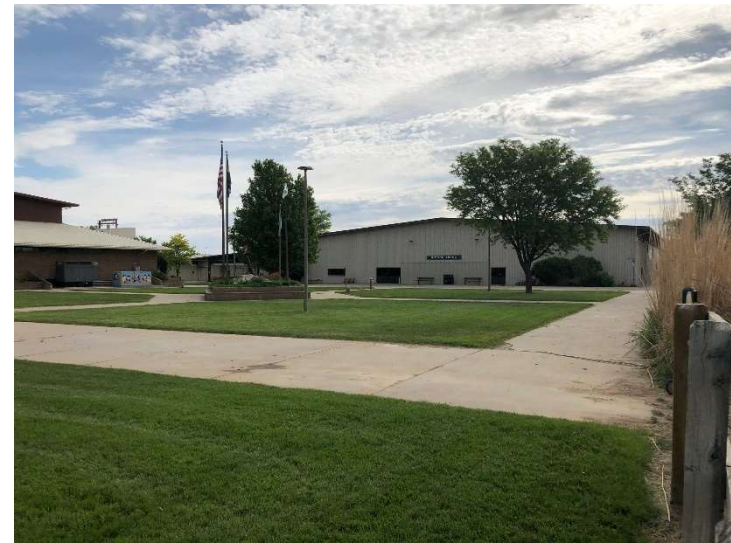
### 22. Indoor Arena

Containing approximately 37,000 square feet of covered riding and spectator viewing, the Indoor Arena is a frequently used and centrally located performance and demonstration facility. Concession areas and restroom facilities require updating to provide adequate sanitation and cleanliness. Layout of the arena is tight and should be reconfigured/expanded, additional lighting and ventilation should be added. If improvements are made, removal of the west portion of the building should be strongly considered to allow better alignment of the main north/south axis of the grounds. The removed space should be added to the east end as well as any expansion necessary.

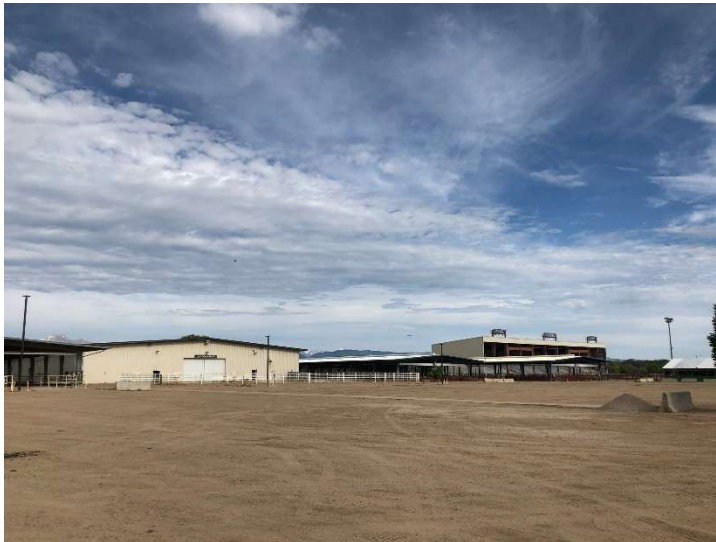
### 23. Warm-Up Arena

The Warm-Up Arena found just east of the Indoor Arena provides riders with a 95' x145' practice area found in acceptable conditions. To better support events in the Indoor arena this space should be covered. If the Indoor Arena building is expanded east this warm-up area will need to move further east into the East Parking Lot.

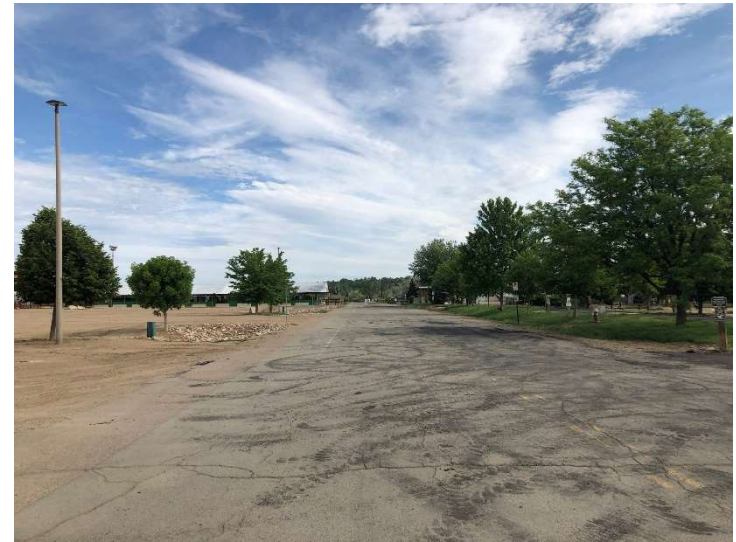
### 24. East Parking Lot

Containing just over 2.9 acres of open space on the fair's eastern side, the east parking lot accommodates vehicle access and storage for various animal users and provides area for animal waste management. Reconfiguration of the animal waste are should be part of any future work in this area to conform to code standards. Because of the use of this lot for large trailers and haulers and existing drainage issues in this area, it would make sense to pave as much of this lot as reasonable and control water flow.

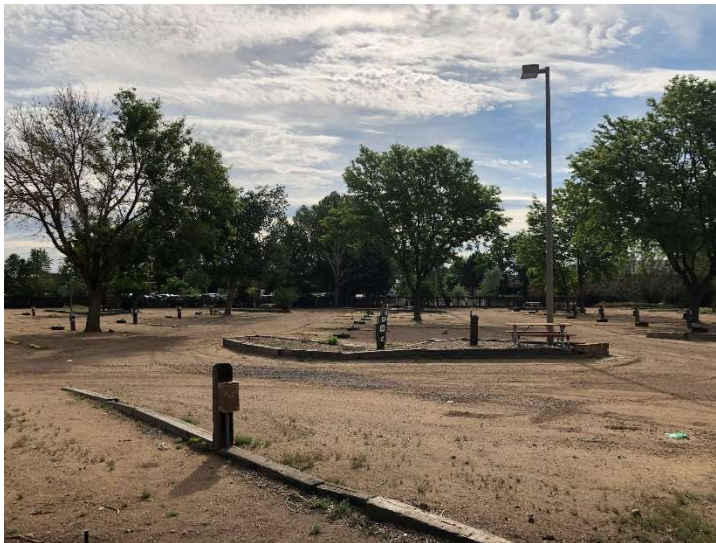
### 25. RV Campground

At roughly 4 acres, the 96 spaces of RV camping are located on the site's eastern edge, adjacent the maintenance area. Various water and power configurations are available, and a modern campground office and shower facility is found in good condition. Over half of the camp sites only have 30-amp power hook-ups available. These should all be upgraded to 50-amp. Paved drive aisles are desirable and should be added as budget allows. More trees and greenspace within the campground would make it more desirable from an aesthetic point of view and add much needed shade. Park shelters and walk paths throughout connecting to the fairgrounds would make it safer and useable for both fairgoers and campers.

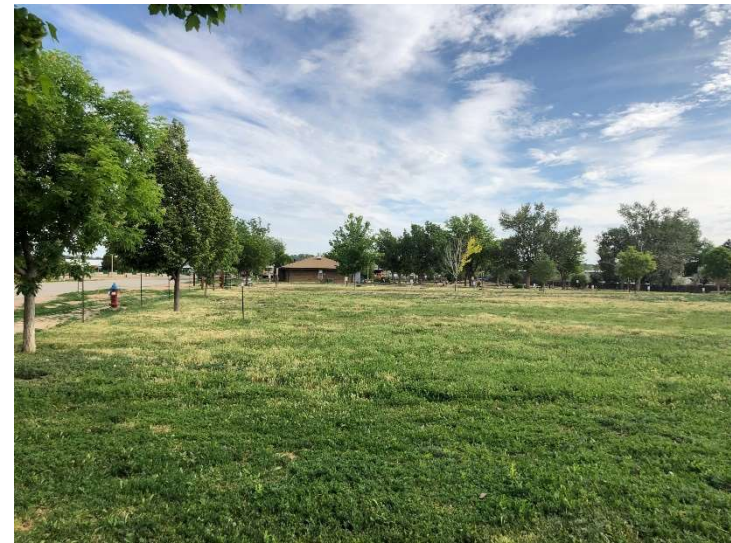
### 26. Trailer Parking Lot

Containing just over 1.25 acres gravel and grass surface parking, the Trailer Parking Lot is located between the RV Campgrounds and the Humane Society on the site eastern boundary. The green space is an asset that should not be overlooked in this area. However, the same comment applies here as that to the nearby South Parking Lot - Paved drive areas or aisle markers should be considered to improve utilization.

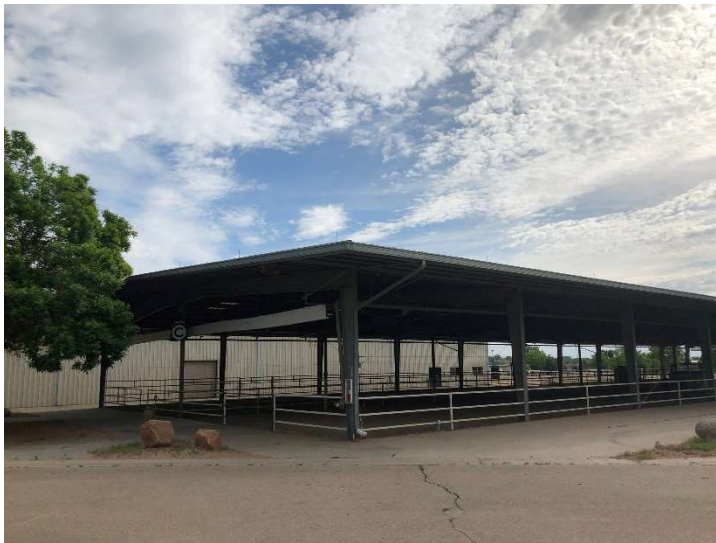
### 27. Barn C

At 20,000 square feet of covered stalling, Barn C lies just south of the Indoor Arena. Similar in character and condition to the other barns, Barn C is open on all sides and contains large pens over rough ground and gravel. The barn structure and roof itself have several areas that should be considered for improvements. Paving within the barn would aid in drainage and safety. Stalling should be updated to a safer and more portable style, overhead fans should be added to assist in ventilation, and lighting updates should be made to increase visibility for evening use. Water hook-ups should be updated for wash areas and scattered throughout the barn general livestock use.

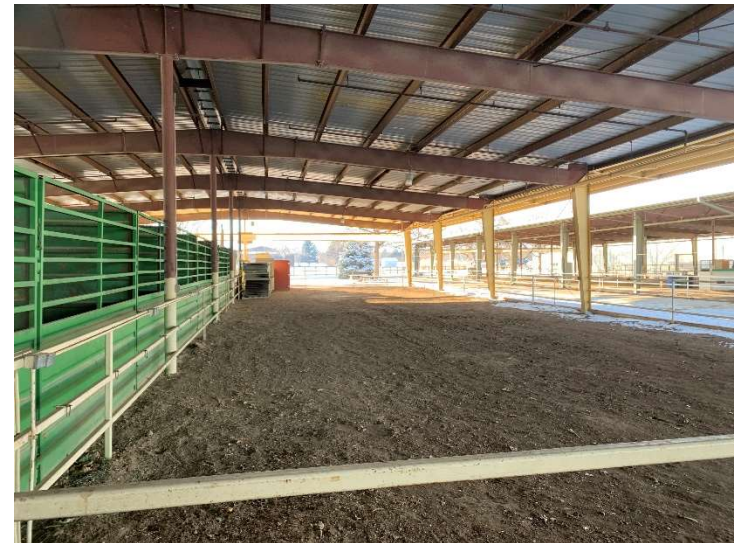
### 28. Barn D

Containing 20,000 square feet of overhead sheltered space, Barn D continues the low sloped, steel structure qualities of the other barns. Inflexible stalling and suboptimal floor quality is found throughout. The barn structure and roof itself have several areas that should be considered for improvements. Paving within the barn would aid in drainage and safety. Stalling should be updated to a safer and more portable style, overhead fans should be added to assist in ventilation, and lighting updates should be made to increase visibility for evening use. Water hook-ups should be updated for wash areas and scattered throughout the barn general livestock use.

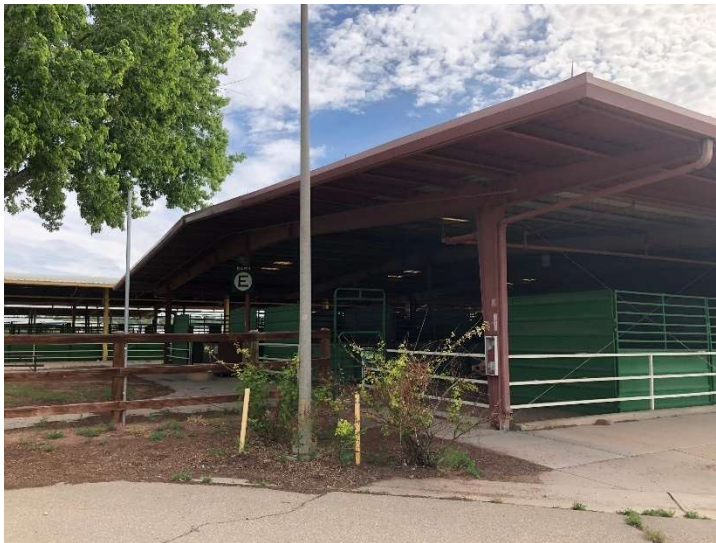
### 29. Barn E

Also containing 20,000 square feet of covered space, Barn E holds large equine stalls, unsuitable for rearrangement. As with the other barns on site the ground is of deficient quality with large pebble and small stones found throughout, necessitating continual flooring maintenance. The barn structure and roof itself have several areas that should be considered for improvements. Paving within the barn would aid in drainage and safety. Stalling should be updated to a safer and more portable style, overhead fans should be added to assist in ventilation, and lighting updates should be made to increase visibility for evening use. Water hook-ups should be updated for wash areas and scattered throughout the barn general livestock use.

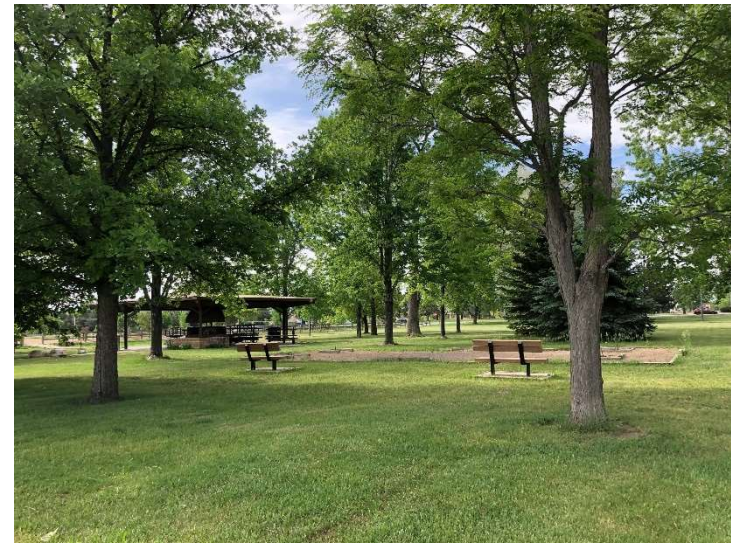
### 30. Picnic Area

Located in the southwest area of the fairgrounds, the 40'x40' Picnic Area is nestled among trees and vegetation and is found in good condition. The greenspace is a nice contrast to the dirt and gravel of the fairgrounds and should be maintained to keep this balance. The walkways and pathways through this area should be kept to further enhance this amenity and better tie it into the fairgrounds proper.
