South St. Vrain Creek Restoration at Hall Ranch

REACH 4b RECOMMENDED ALTERNATIVE: CHANNEL REALIGNMENT & SITE-SPECIFIC PROJ. MAP 3 OF 3

e. Appendix E – SRH 2D Hydraulic Model Output

f. Appendix F – Stream Power Maps

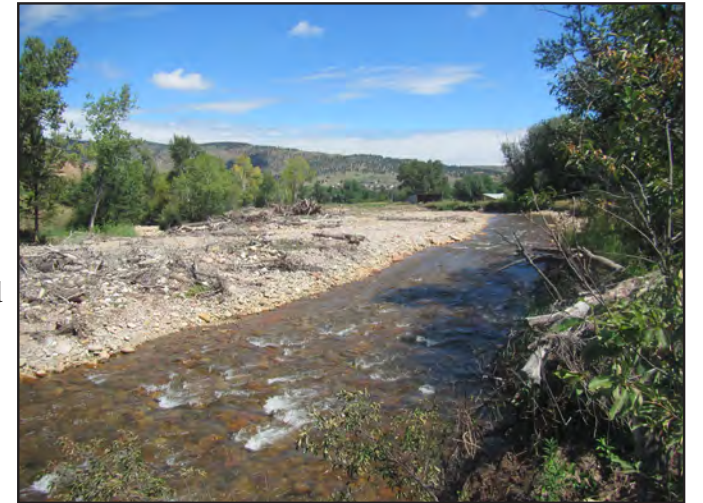
The recommended plan for Reach 4b is shown on the following Figures. The purpose of this alternative is to implement a channel alignment that will optimize the interaction with completed, ongoing, and funded projects while being sensitive to the constraints presented by the presence of numerous private residences throughout this river corridor. The implementation of this alternative will expedite the maturation of this reach by re-establishing a natural channel, repairing erosion scars, re-establishing floodplain benches, building point-bars and excavating pools, re-vegetating denuded areas, and stabilizing channel banks. The Baker Team conducted a feasibility analysis during the planning process to evaluate the potential for detention in the vicinity of Andesite Quarry as outlined in PDG 10. The analysis showed a lack of significant reduction in downstream flood risk and concluded that such a facility would not be cost beneficial as a result of the large cost of designing, building, maintaining, and operating such a facility with limited public benefit. Thus, the study did not recommend this flood control measure. If desired by the Town of Lyons and others, additional analysis could be undertaken to further evaluate the feasibility of detention at this location and whether it could be made more cost beneficial. Any further analysis would require additional engineering studies, cost-benefit analysis, and environmental investigations including an evaluation of the potential impacts to in-stream and riparian habitats that such a facility would create both upstream and downstream. See Appendix D and G for more information.

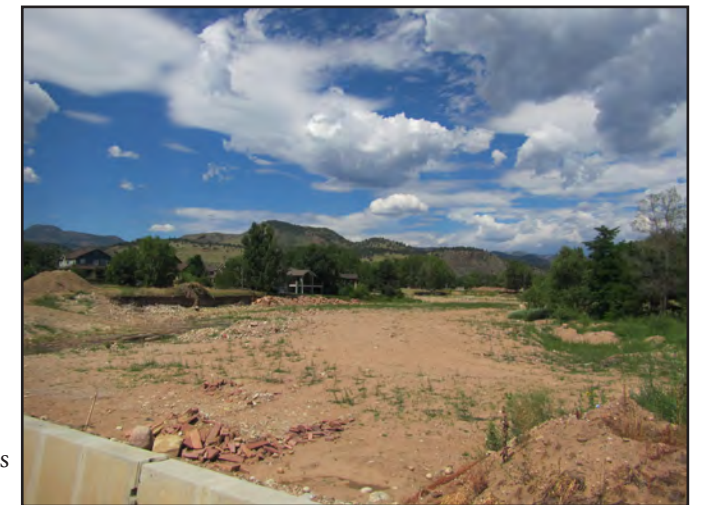
The focus of the improvements for this reach is at the site of the McConnell ponds. The reconstruction of these ponds is important to the community because of the social, recreational, and aesthetic benefit that they provided to the community. There has been ongoing discussion within the Lyons community about where the McConnell Ponds should be reconstructed in their pre-flood location on the south side of St. Vrain Creek or a new location on the north side. The qualitative analysis for the two alternative locations yielded very close results. The recommendation is to perform a more in-depth analysis as additional information (survey and hydraulic modeling) become available to further inform the pros and cons of the location of the McConnell Ponds. Note that the qualitative scoring in Appendix D has been redacted so as not to influence this future analysis.

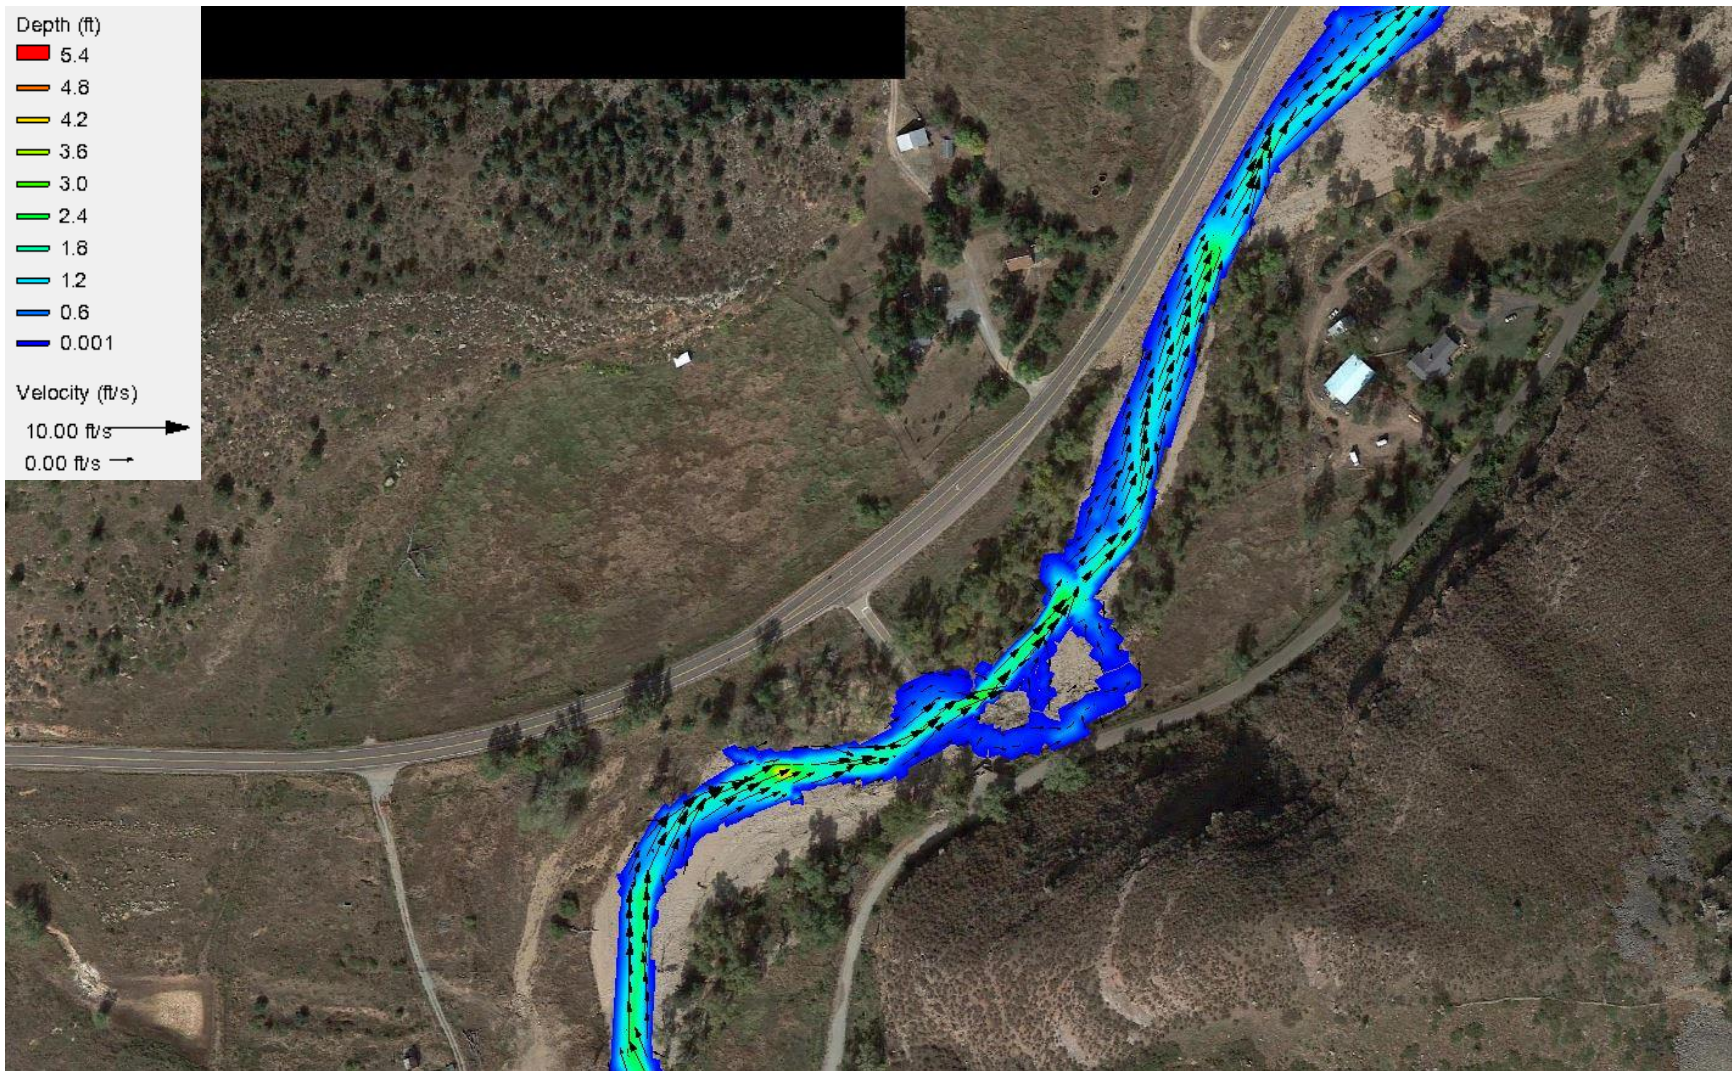
Existing Conditions – $Q_{1.5}$ – Upper Section (Map 1)

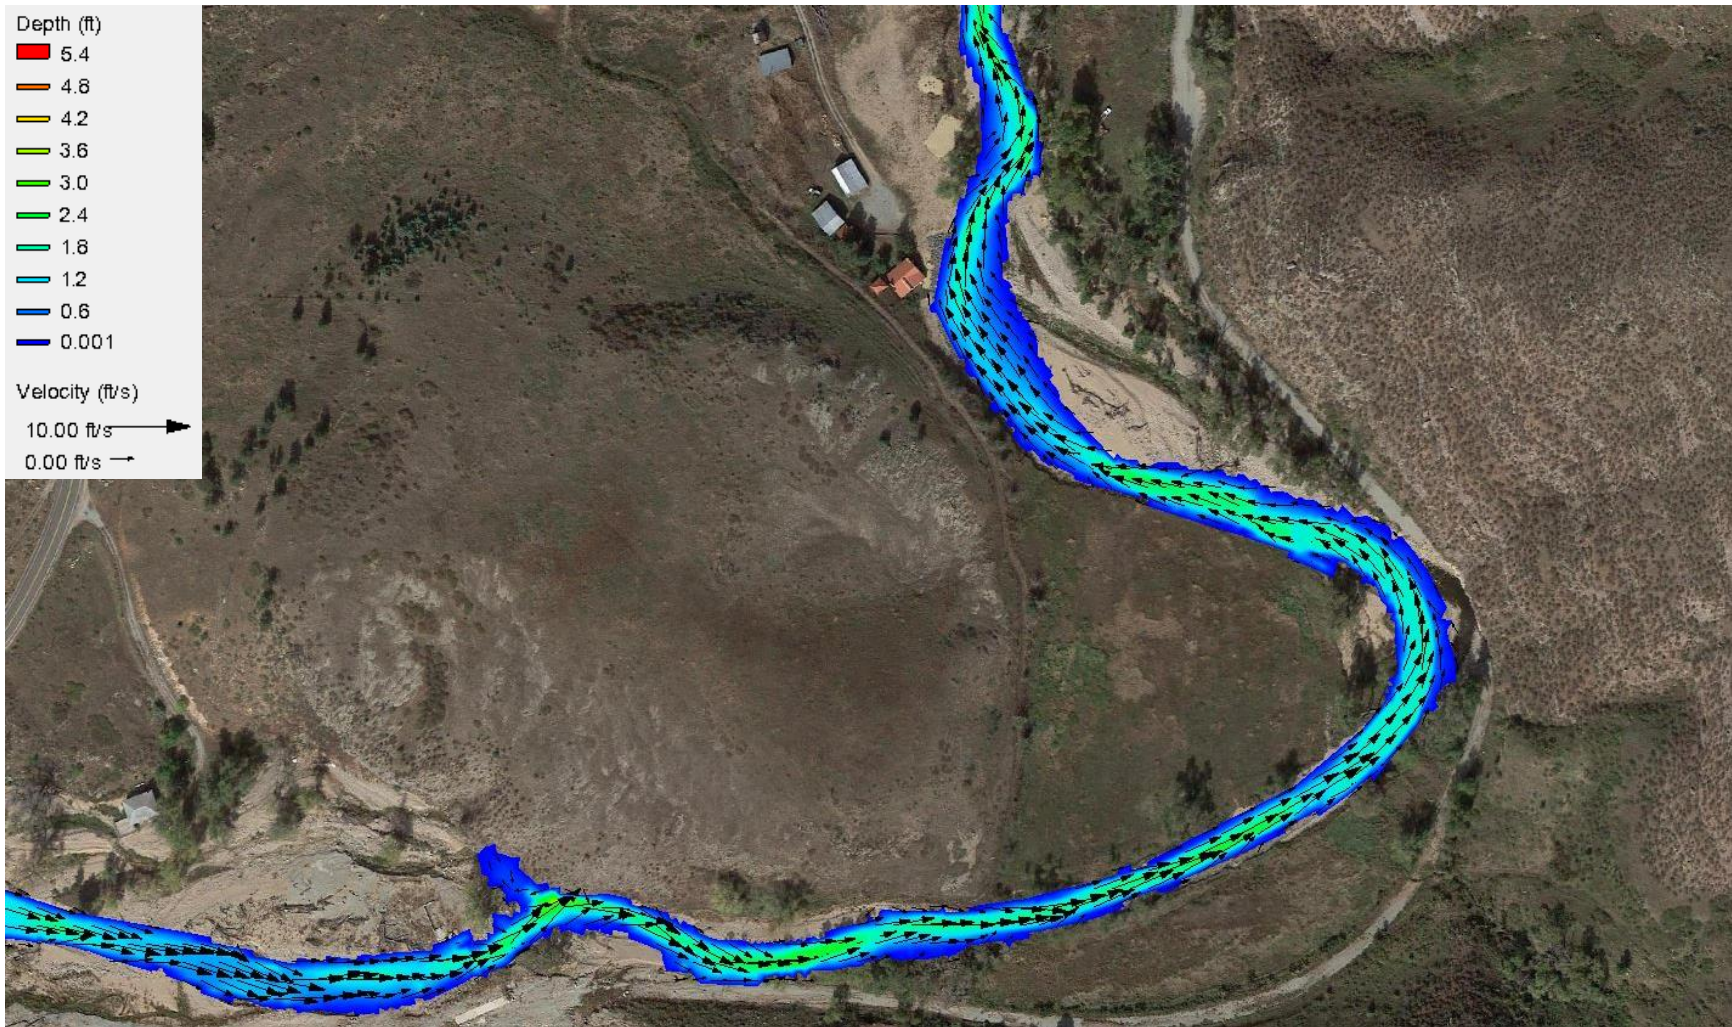
Existing Conditions – $Q_{1.5}$ – Upper Section (Map 2)

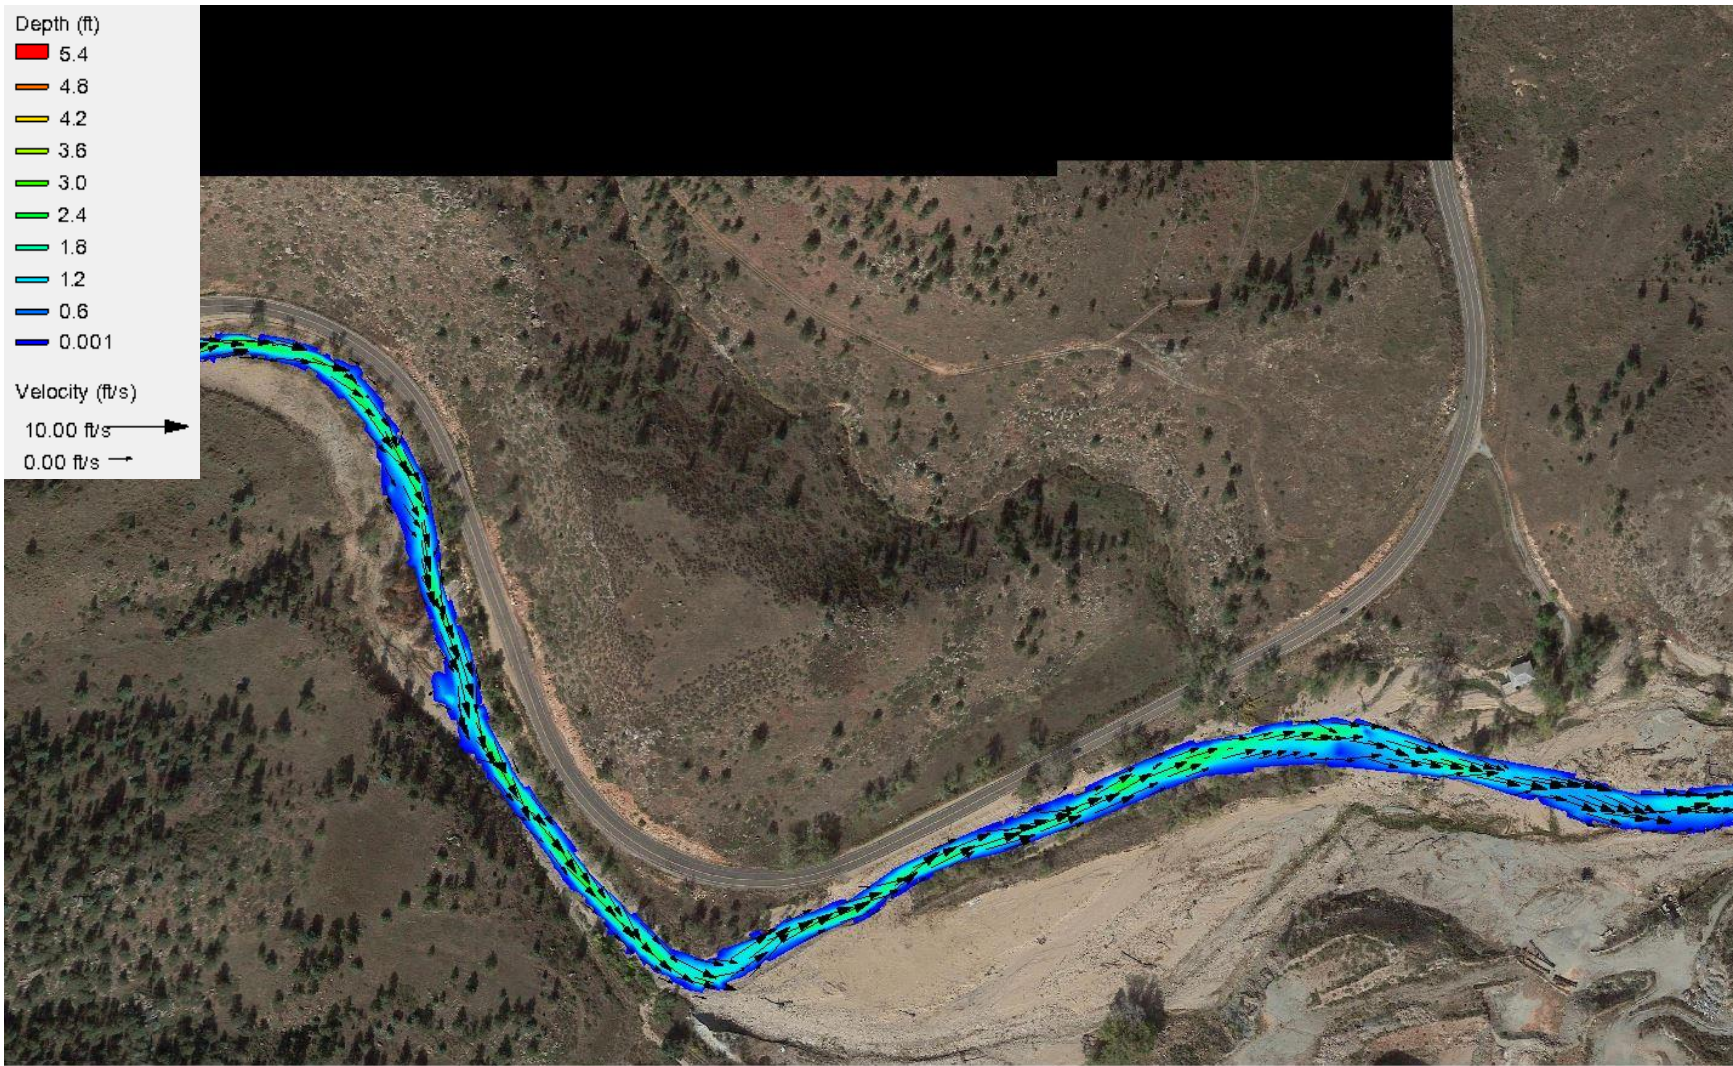
Existing Conditions – $Q_{1.5}$ – Upper Section (Map 3)

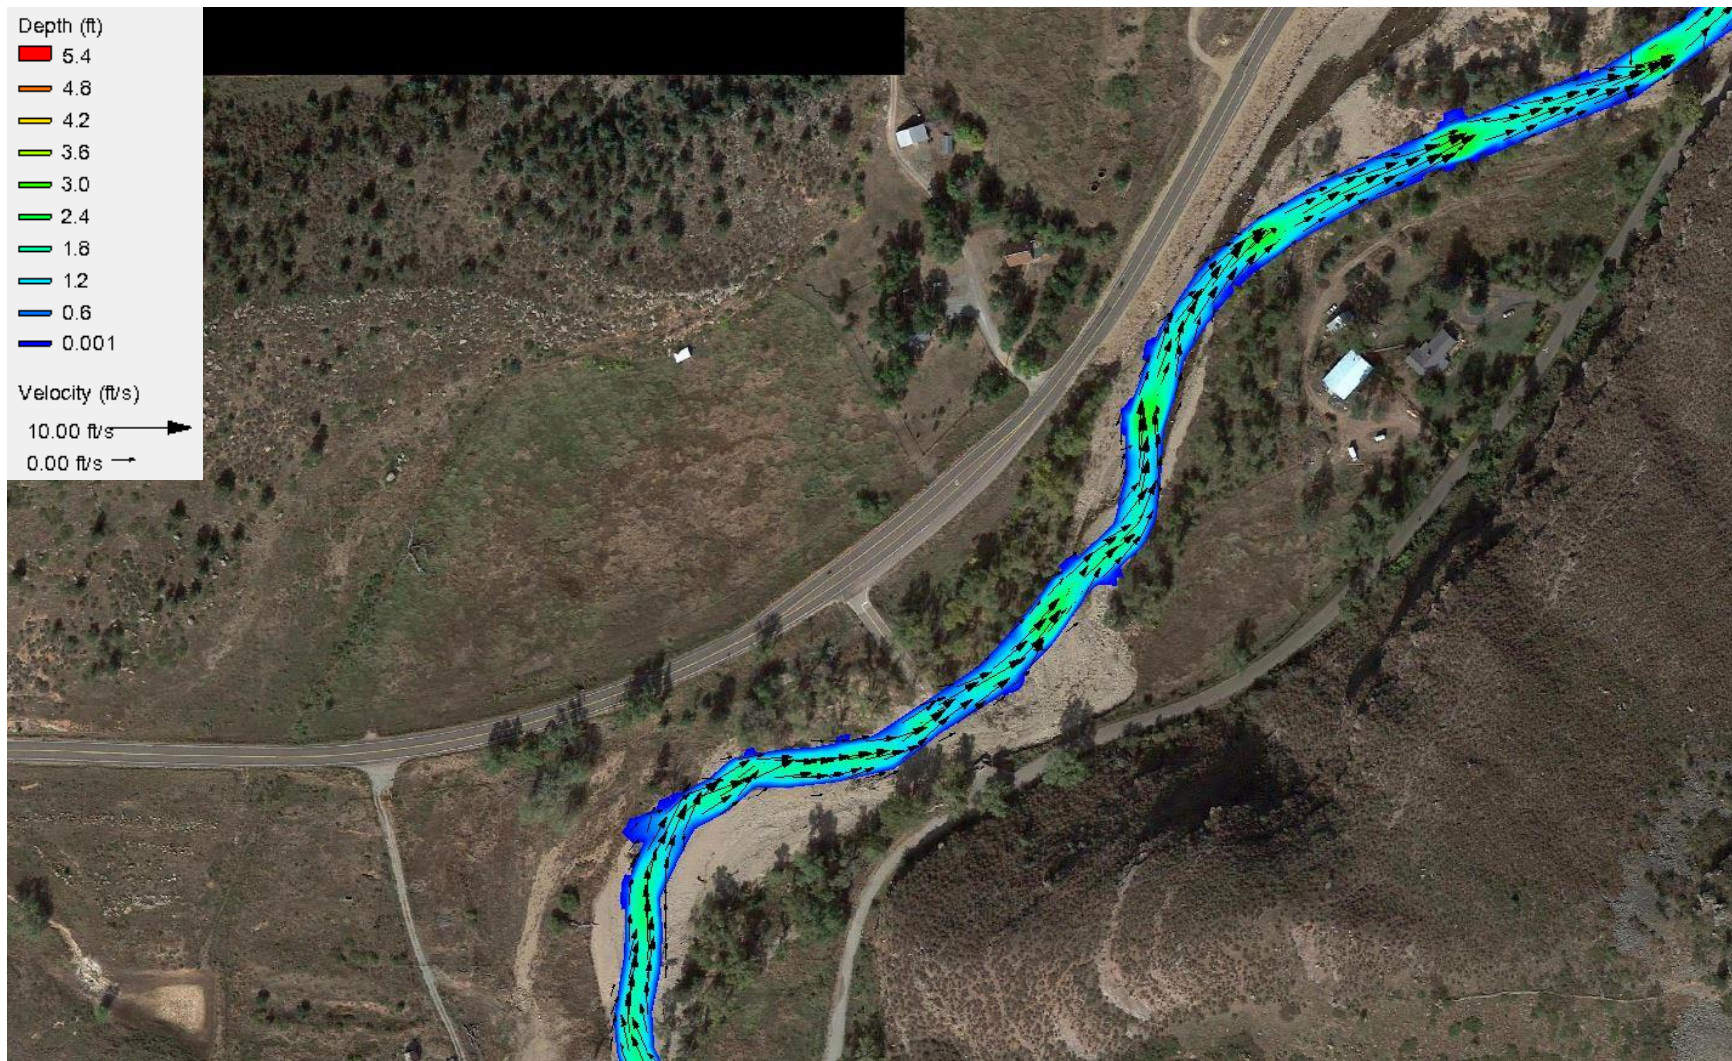
Proposed Conditions – $Q_{1.5}$ – Upper Section (Map 1)

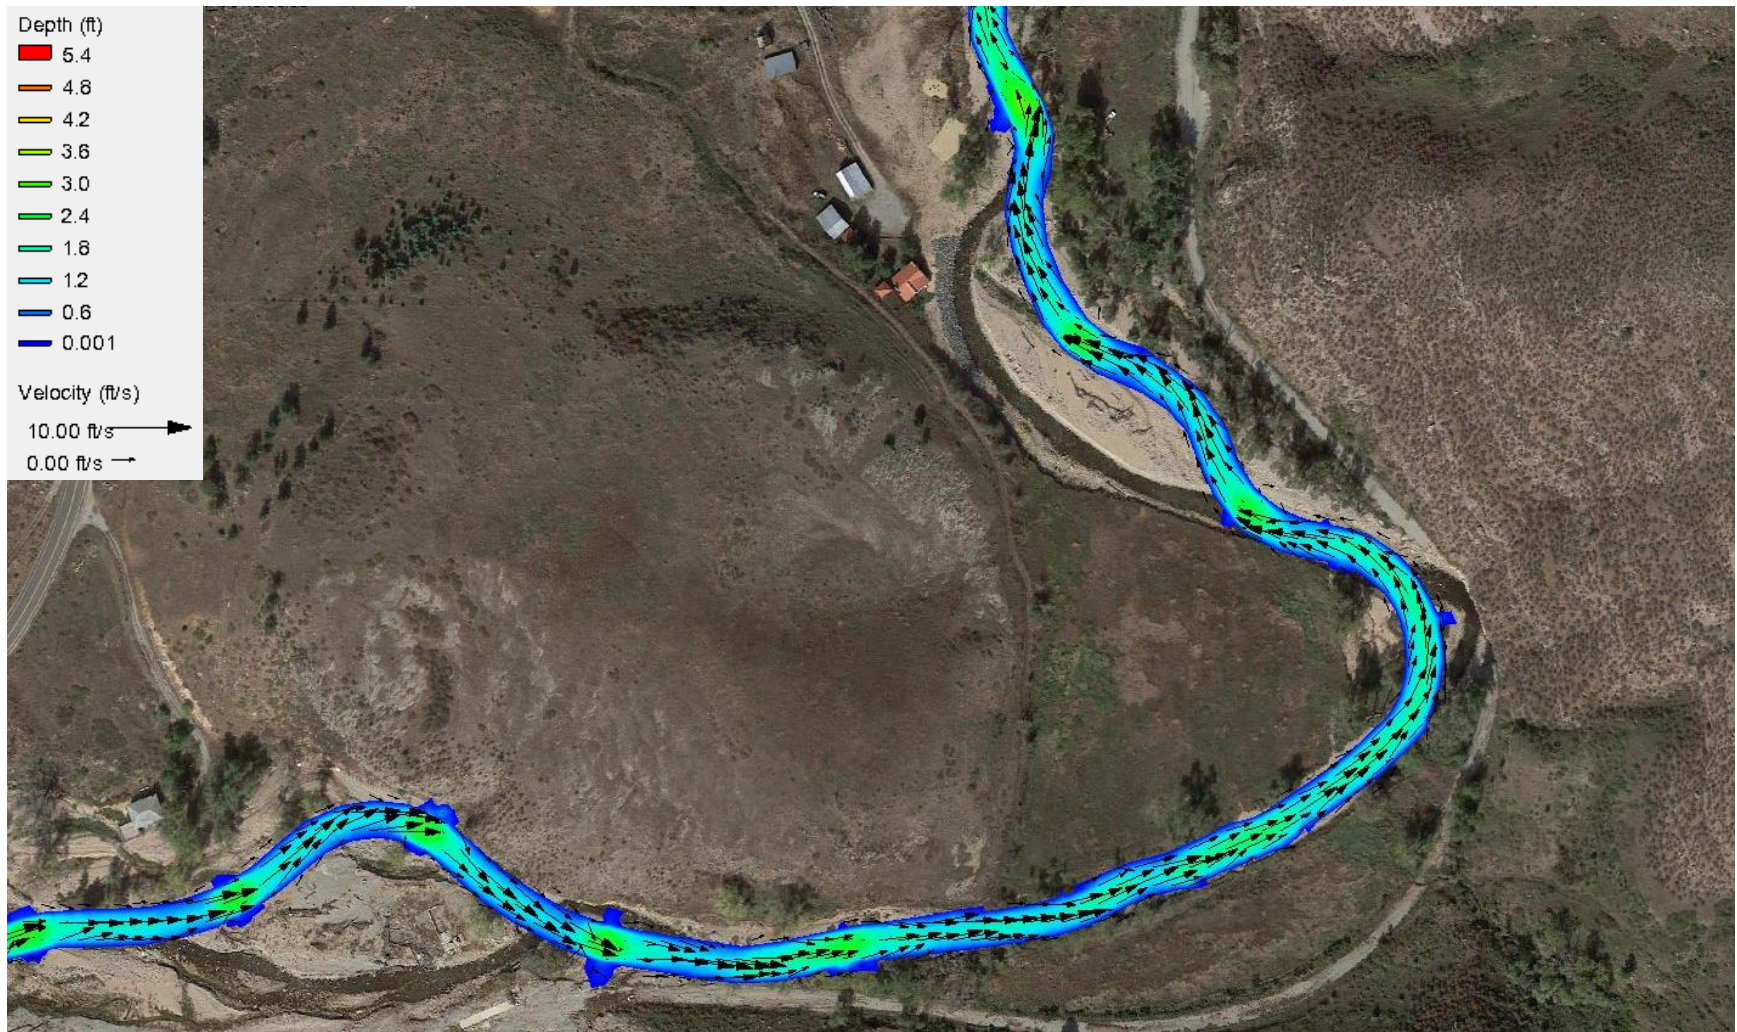
Proposed Conditions – $Q_{1.5}$ – Upper Section (Map 2)

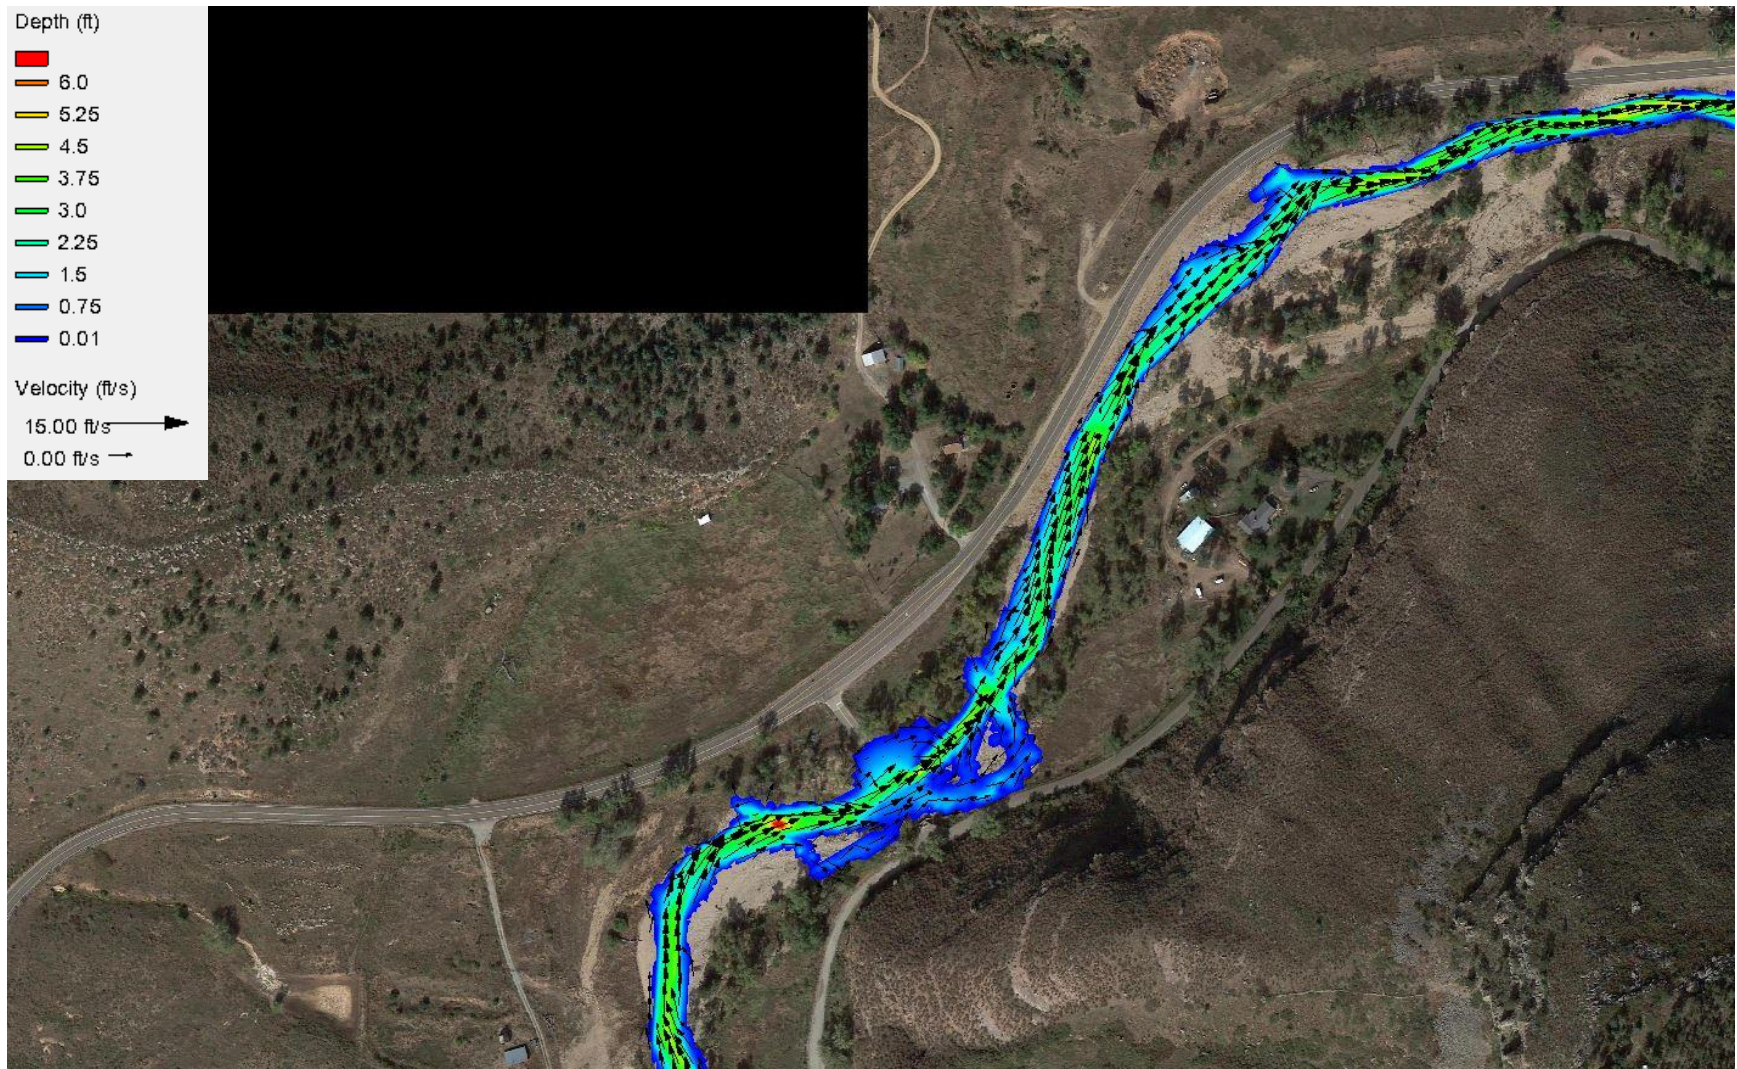
Existing Conditions – Q₅ – Upper Section (Map 1)

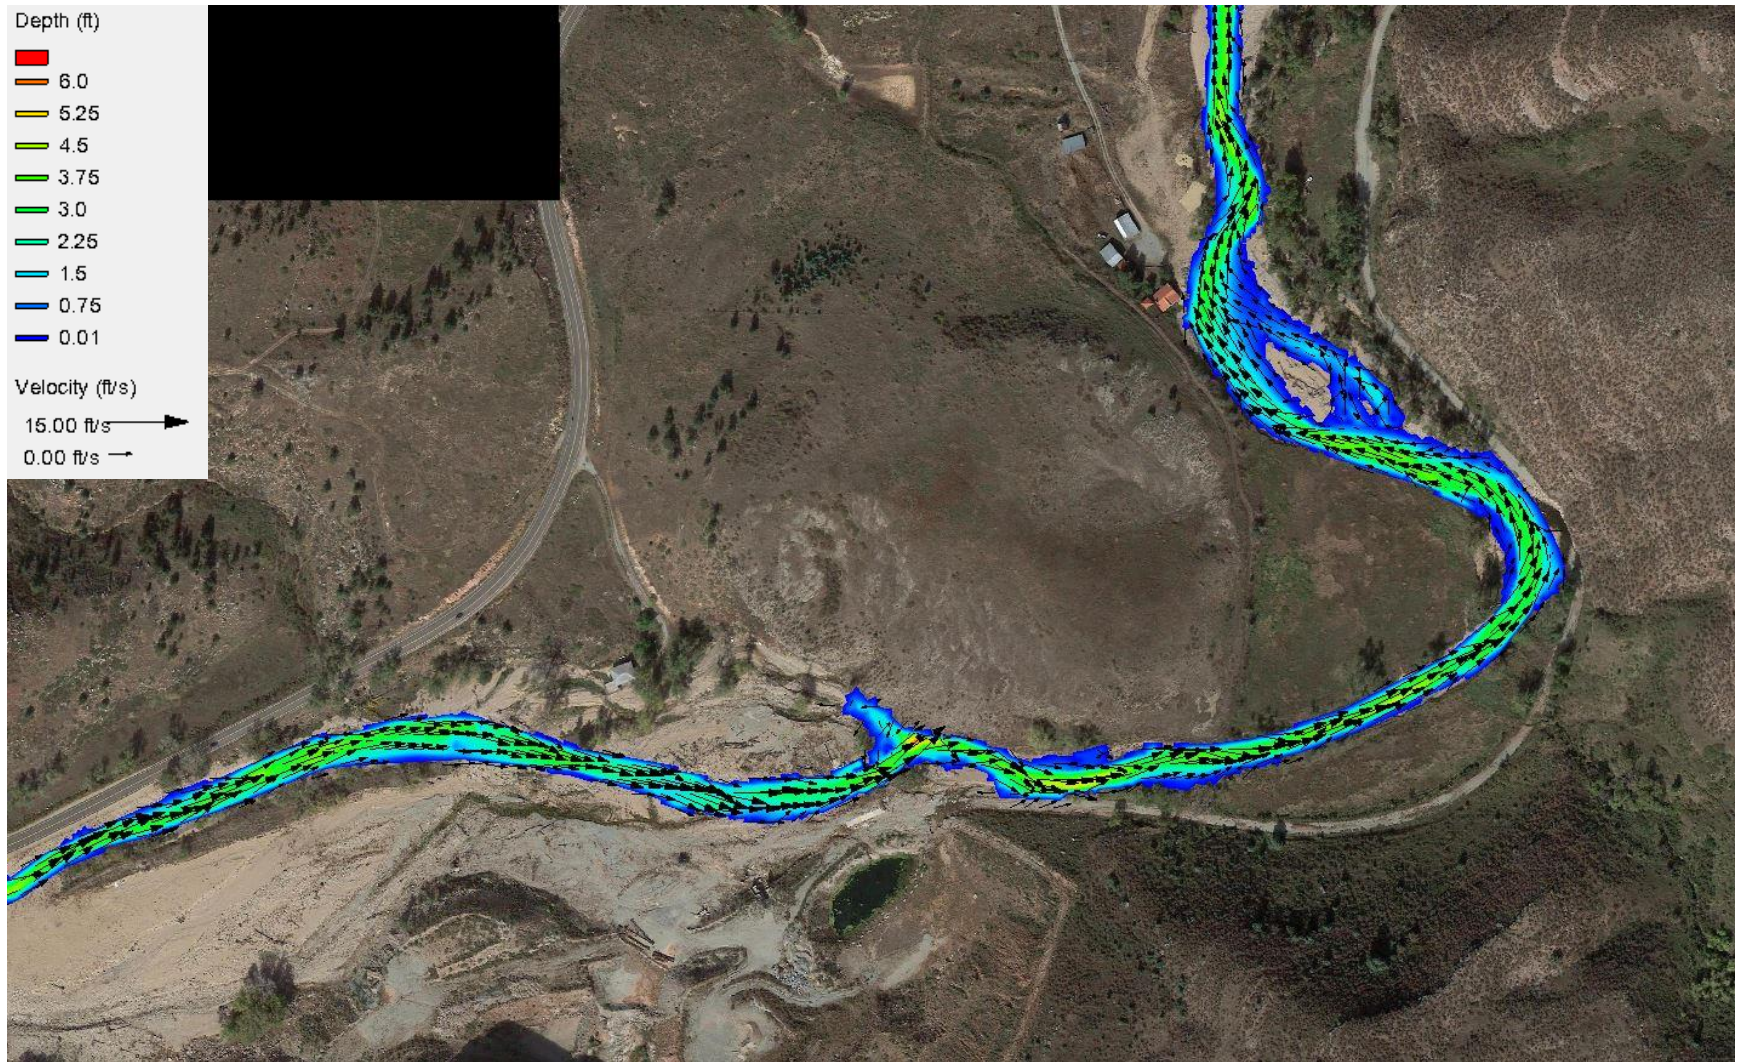
Existing Conditions – Q₅ – Upper Section (Map 2)

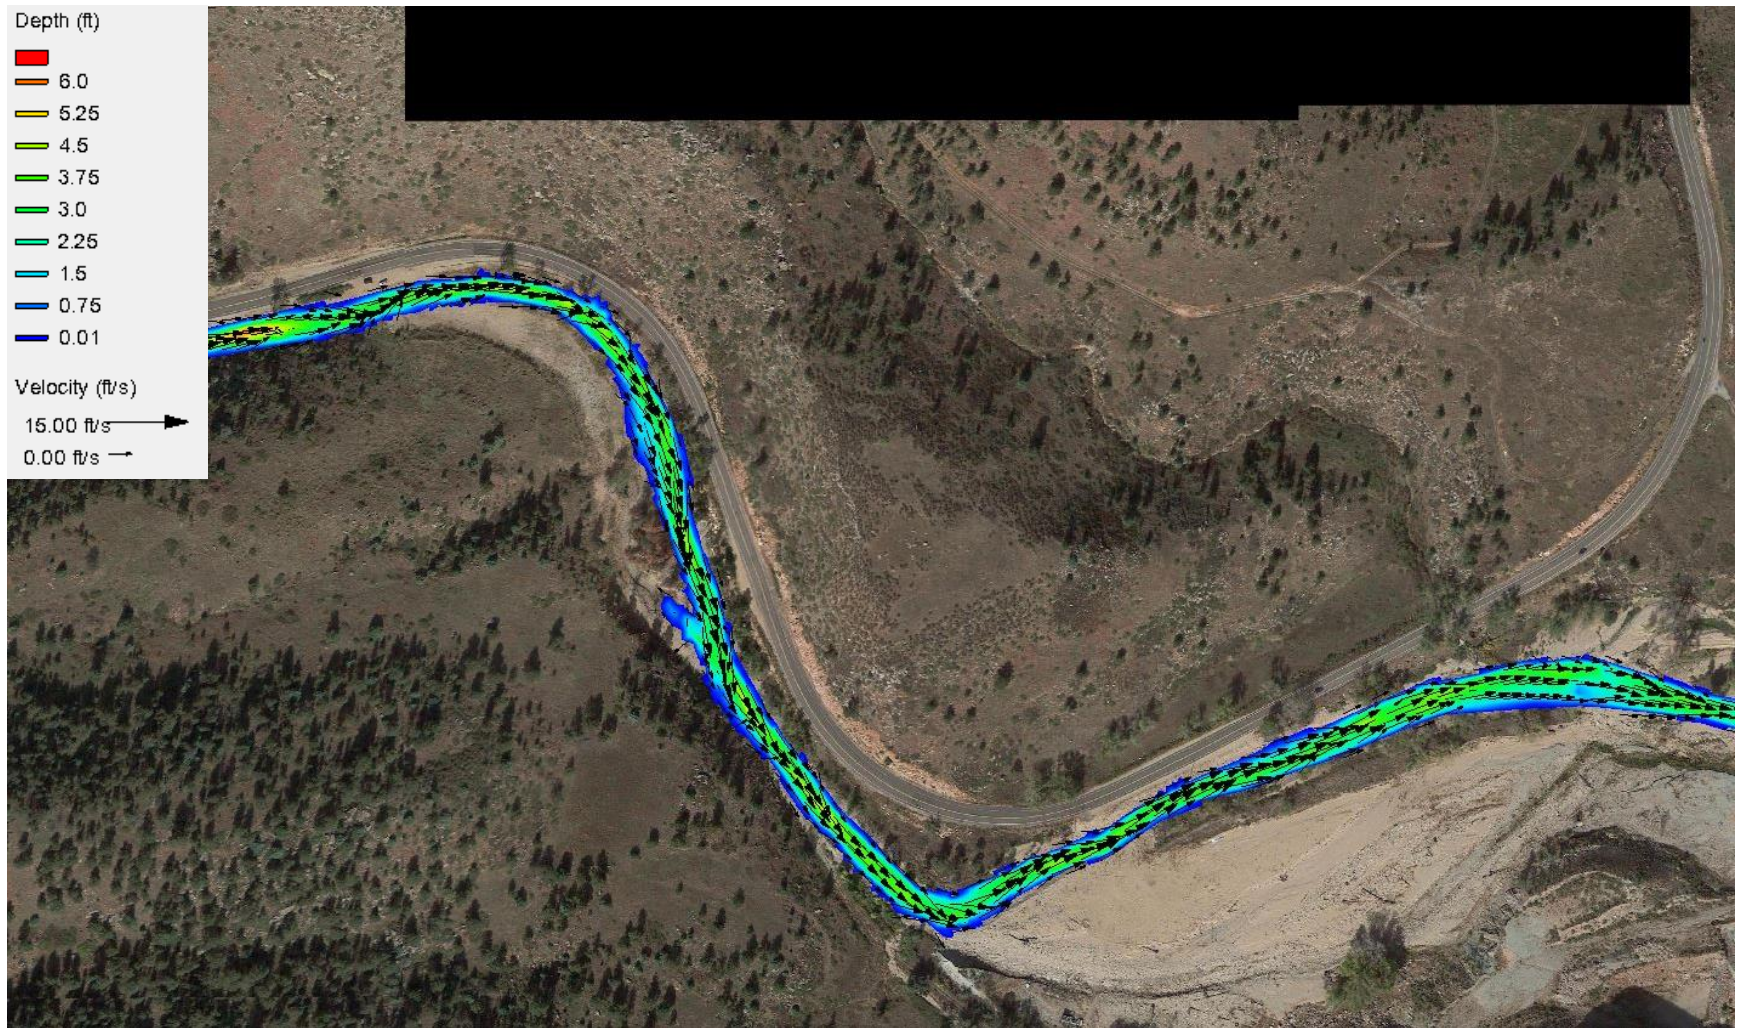
Existing Conditions – Q₅ – Upper Section (Map 3)

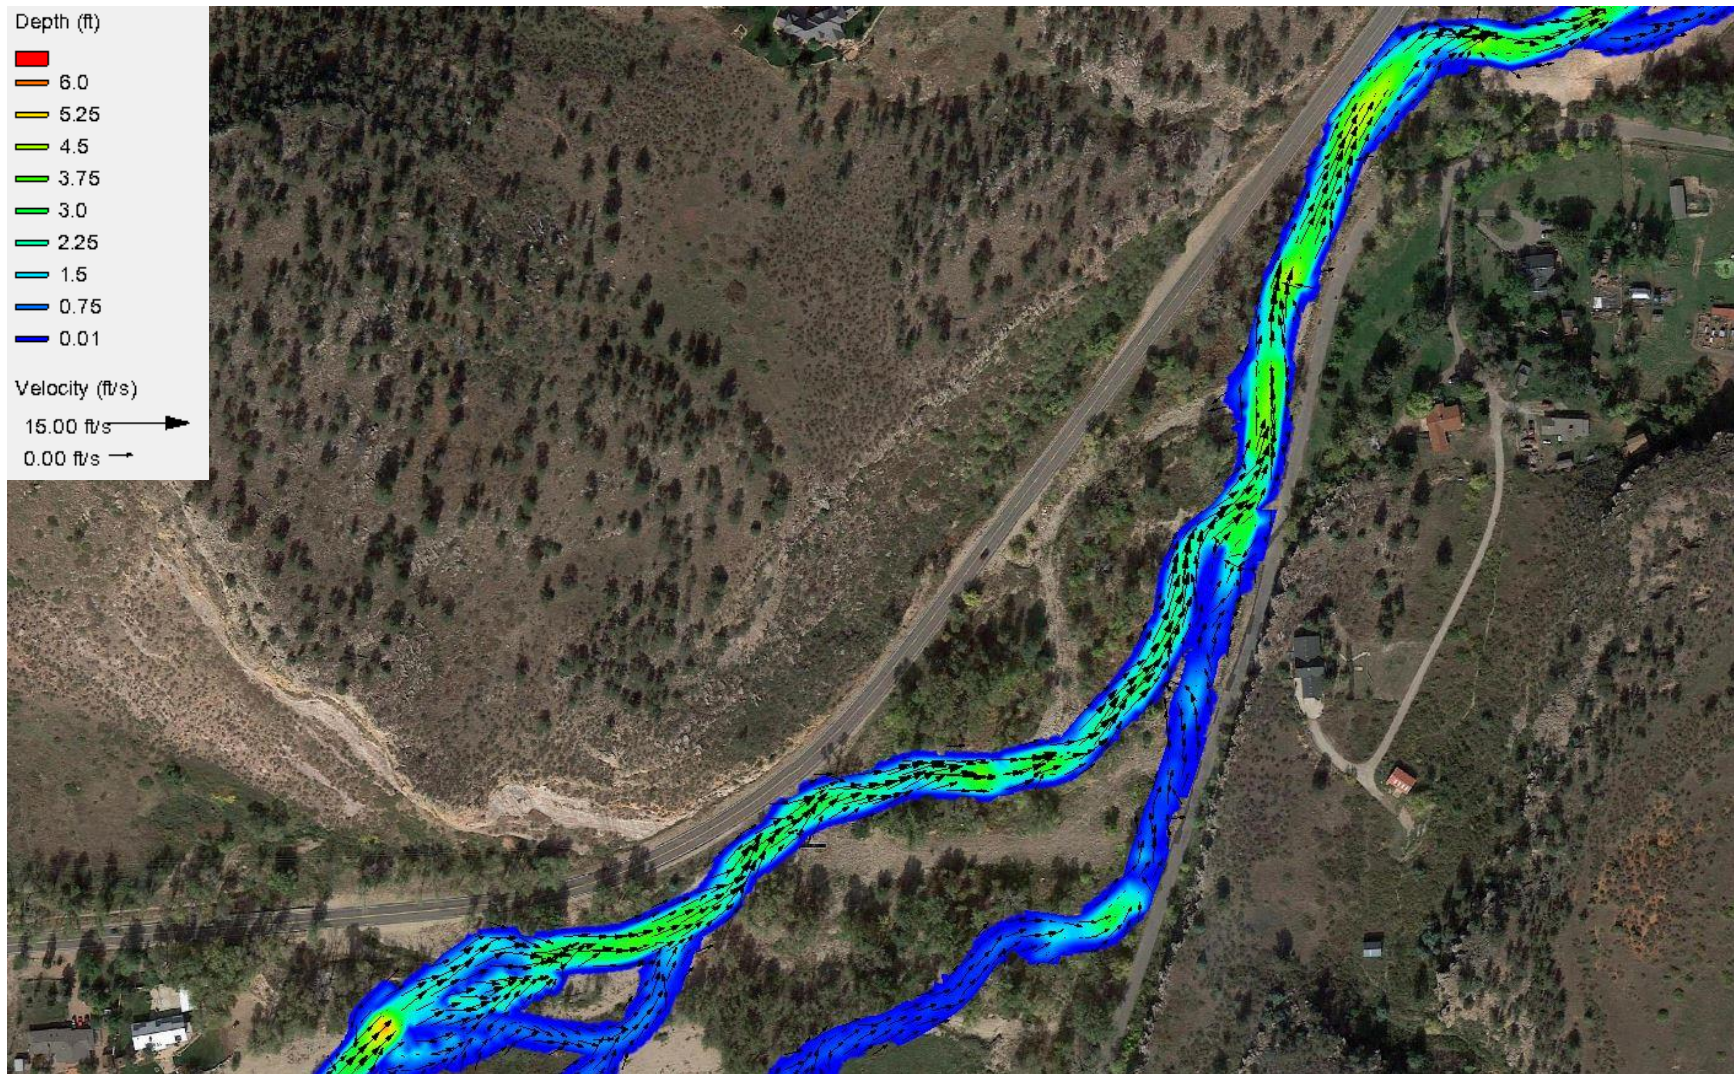
Proposed Conditions – Q₅ – Lower Section (Map 2)

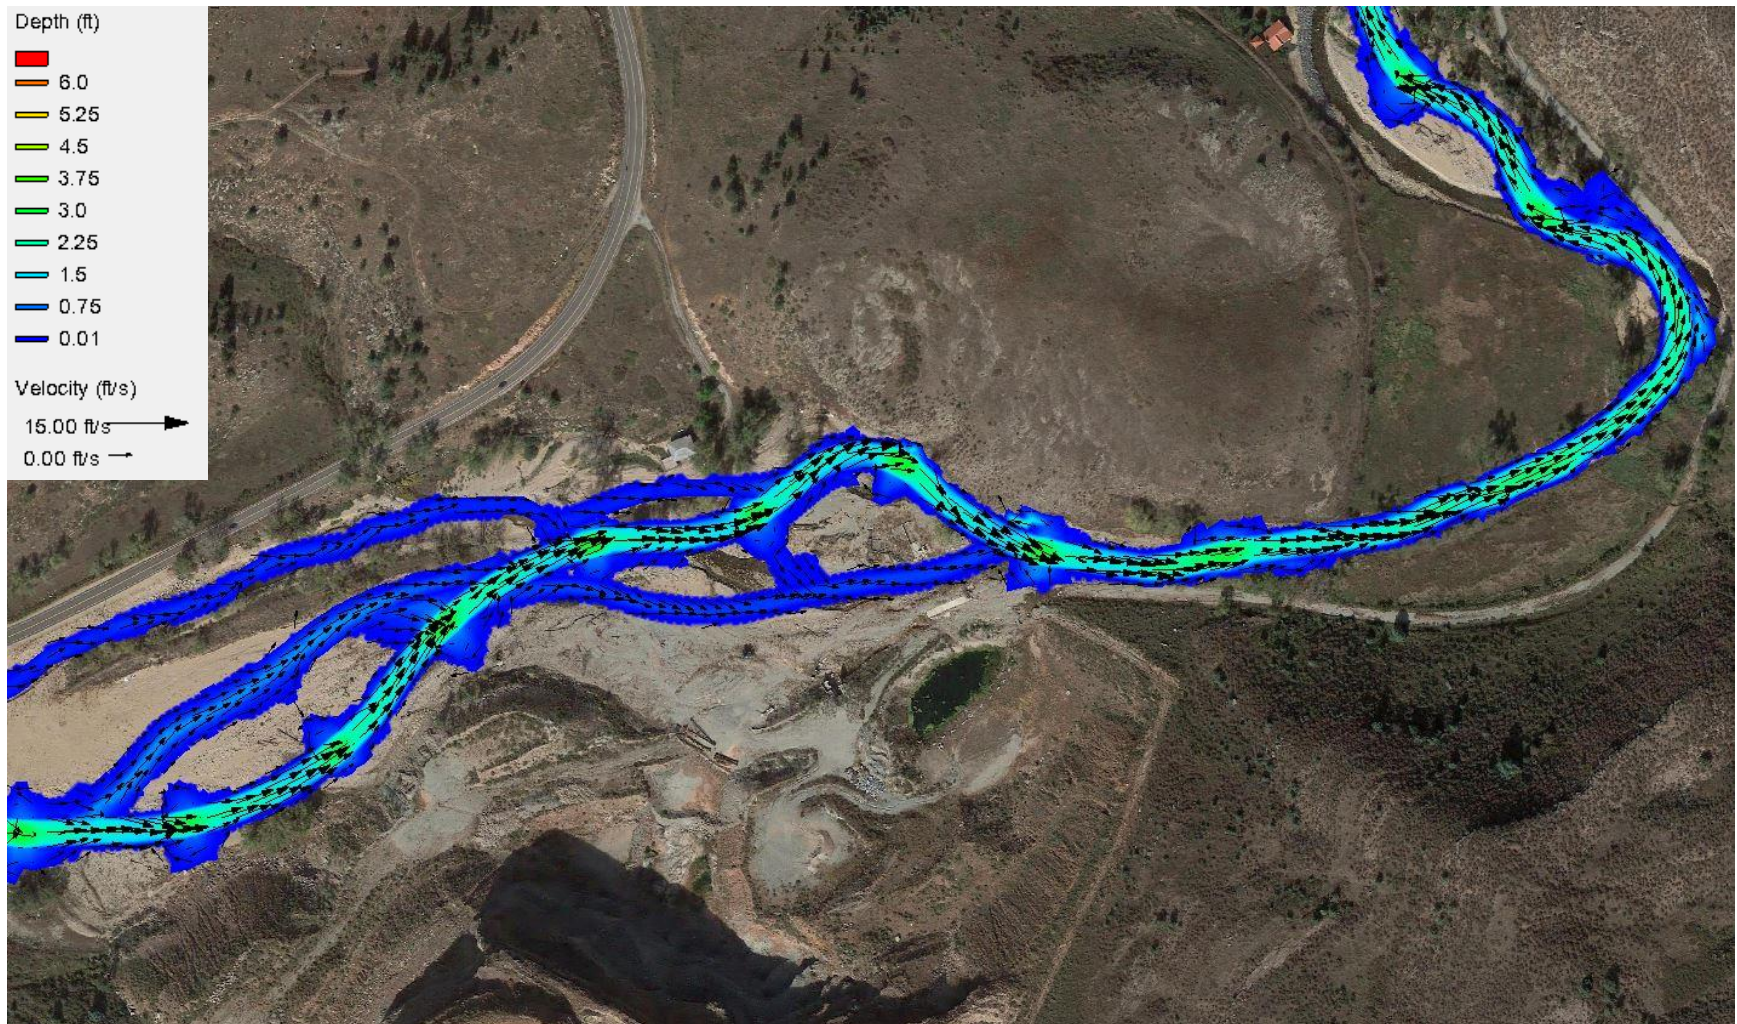
Proposed Conditions – Q_5 – Upper Section (Map 2)

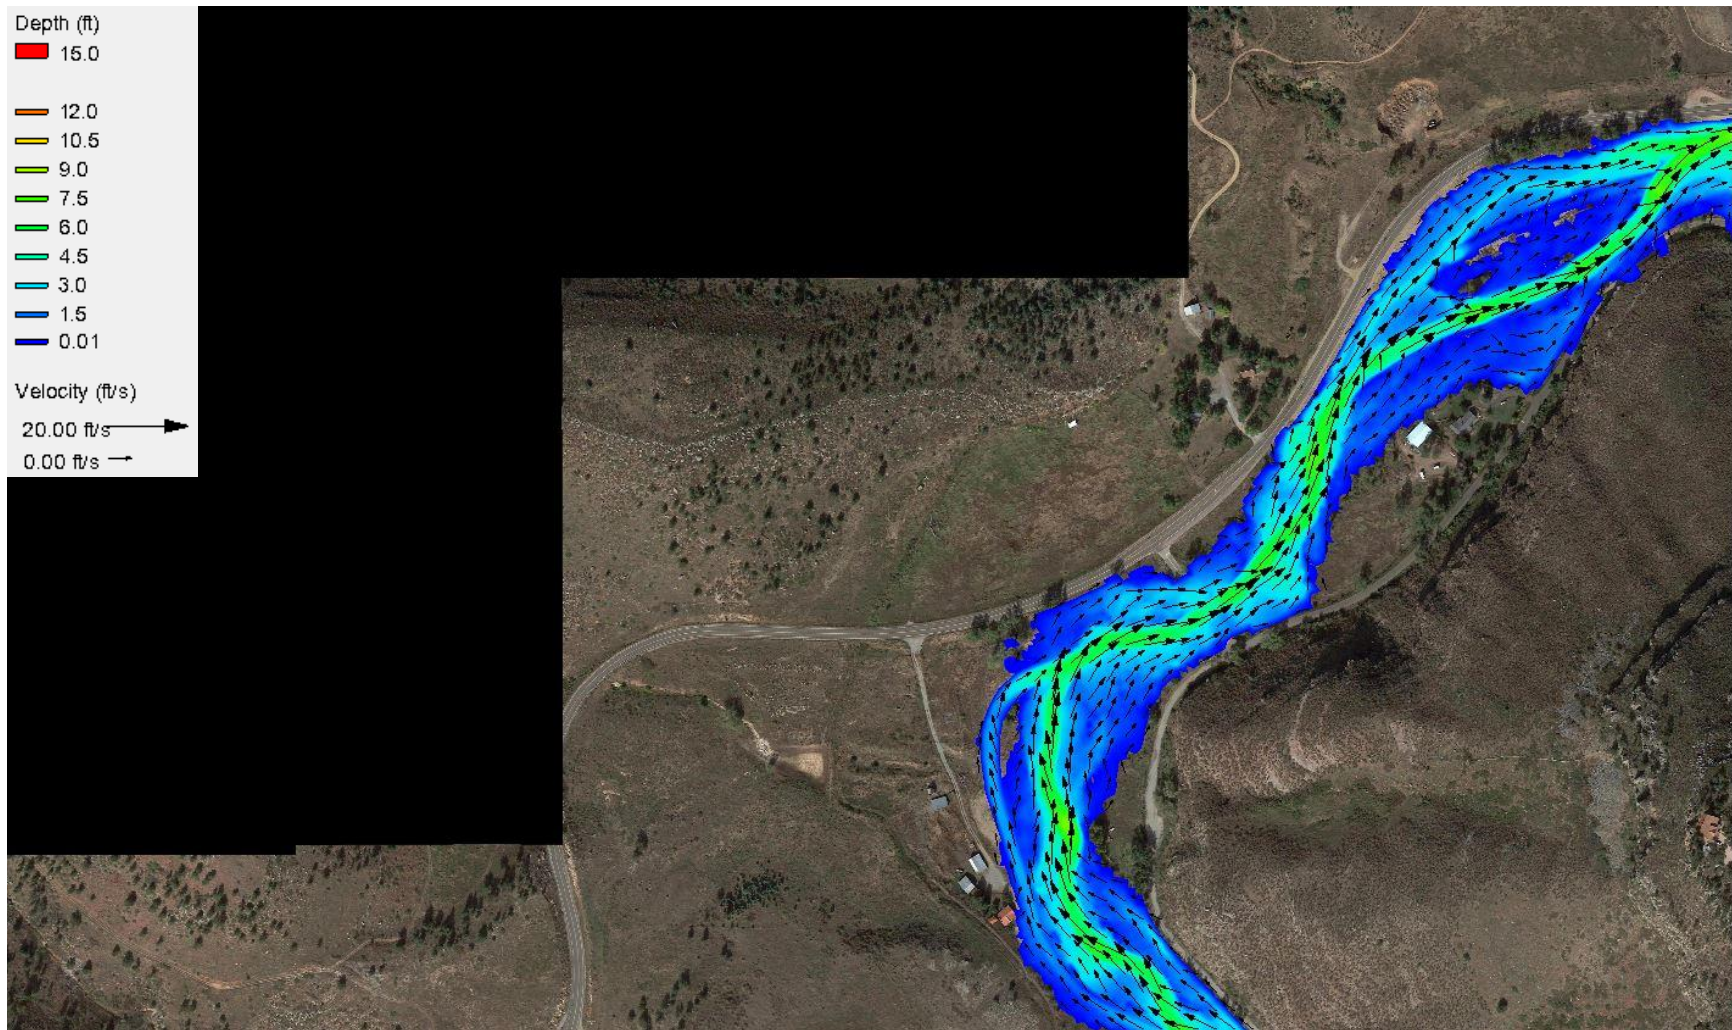
Proposed Conditions – Q_{100} – Upper Section (Map 1)
