South St. Vrain Creek Restoration at Hall Ranch

REACH 4b RECOMMENDED ALTERNATIVE: CHANNEL REALIGNMENT & SITE-SPECIFIC PROJ. MAP 3 OF 3

e. Appendix E – SRH 2D Hydraulic Model Output

f. Appendix F – Stream Power Maps

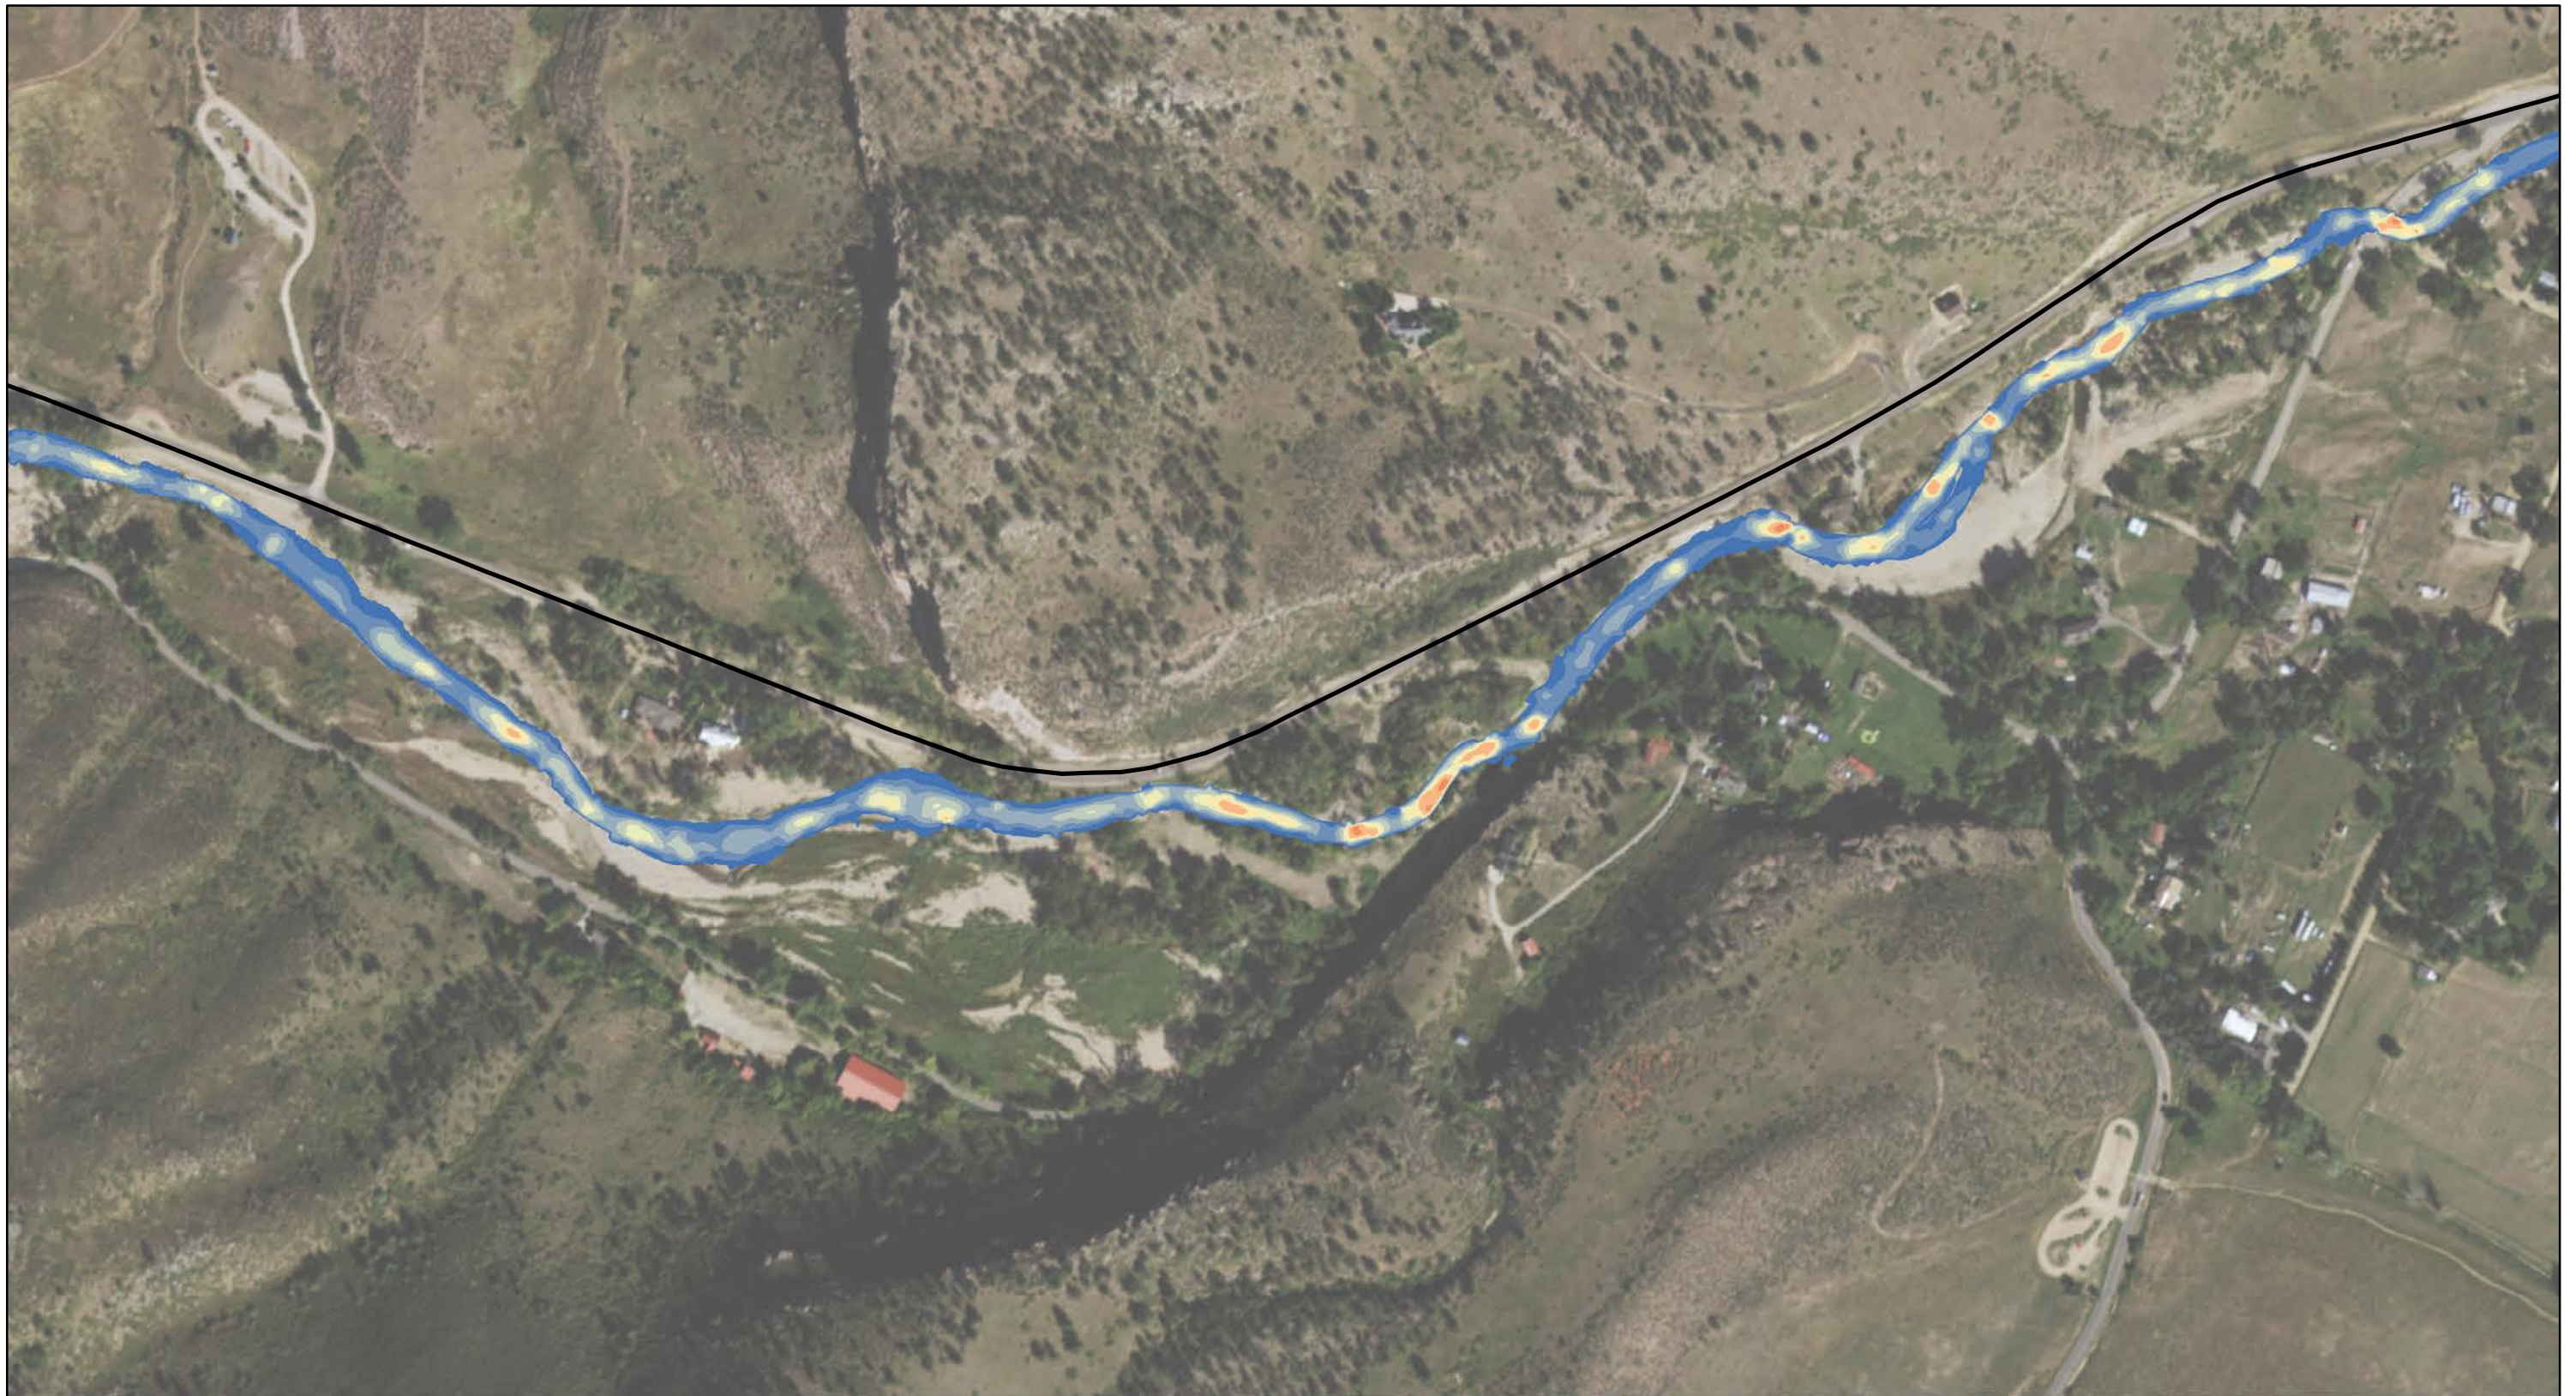
1.5 YEAR FLOW
**MAP
1**

**EXISTING CONDITIONS
STREAM POWER MAPBOOK
1.5 YEAR FLOW**

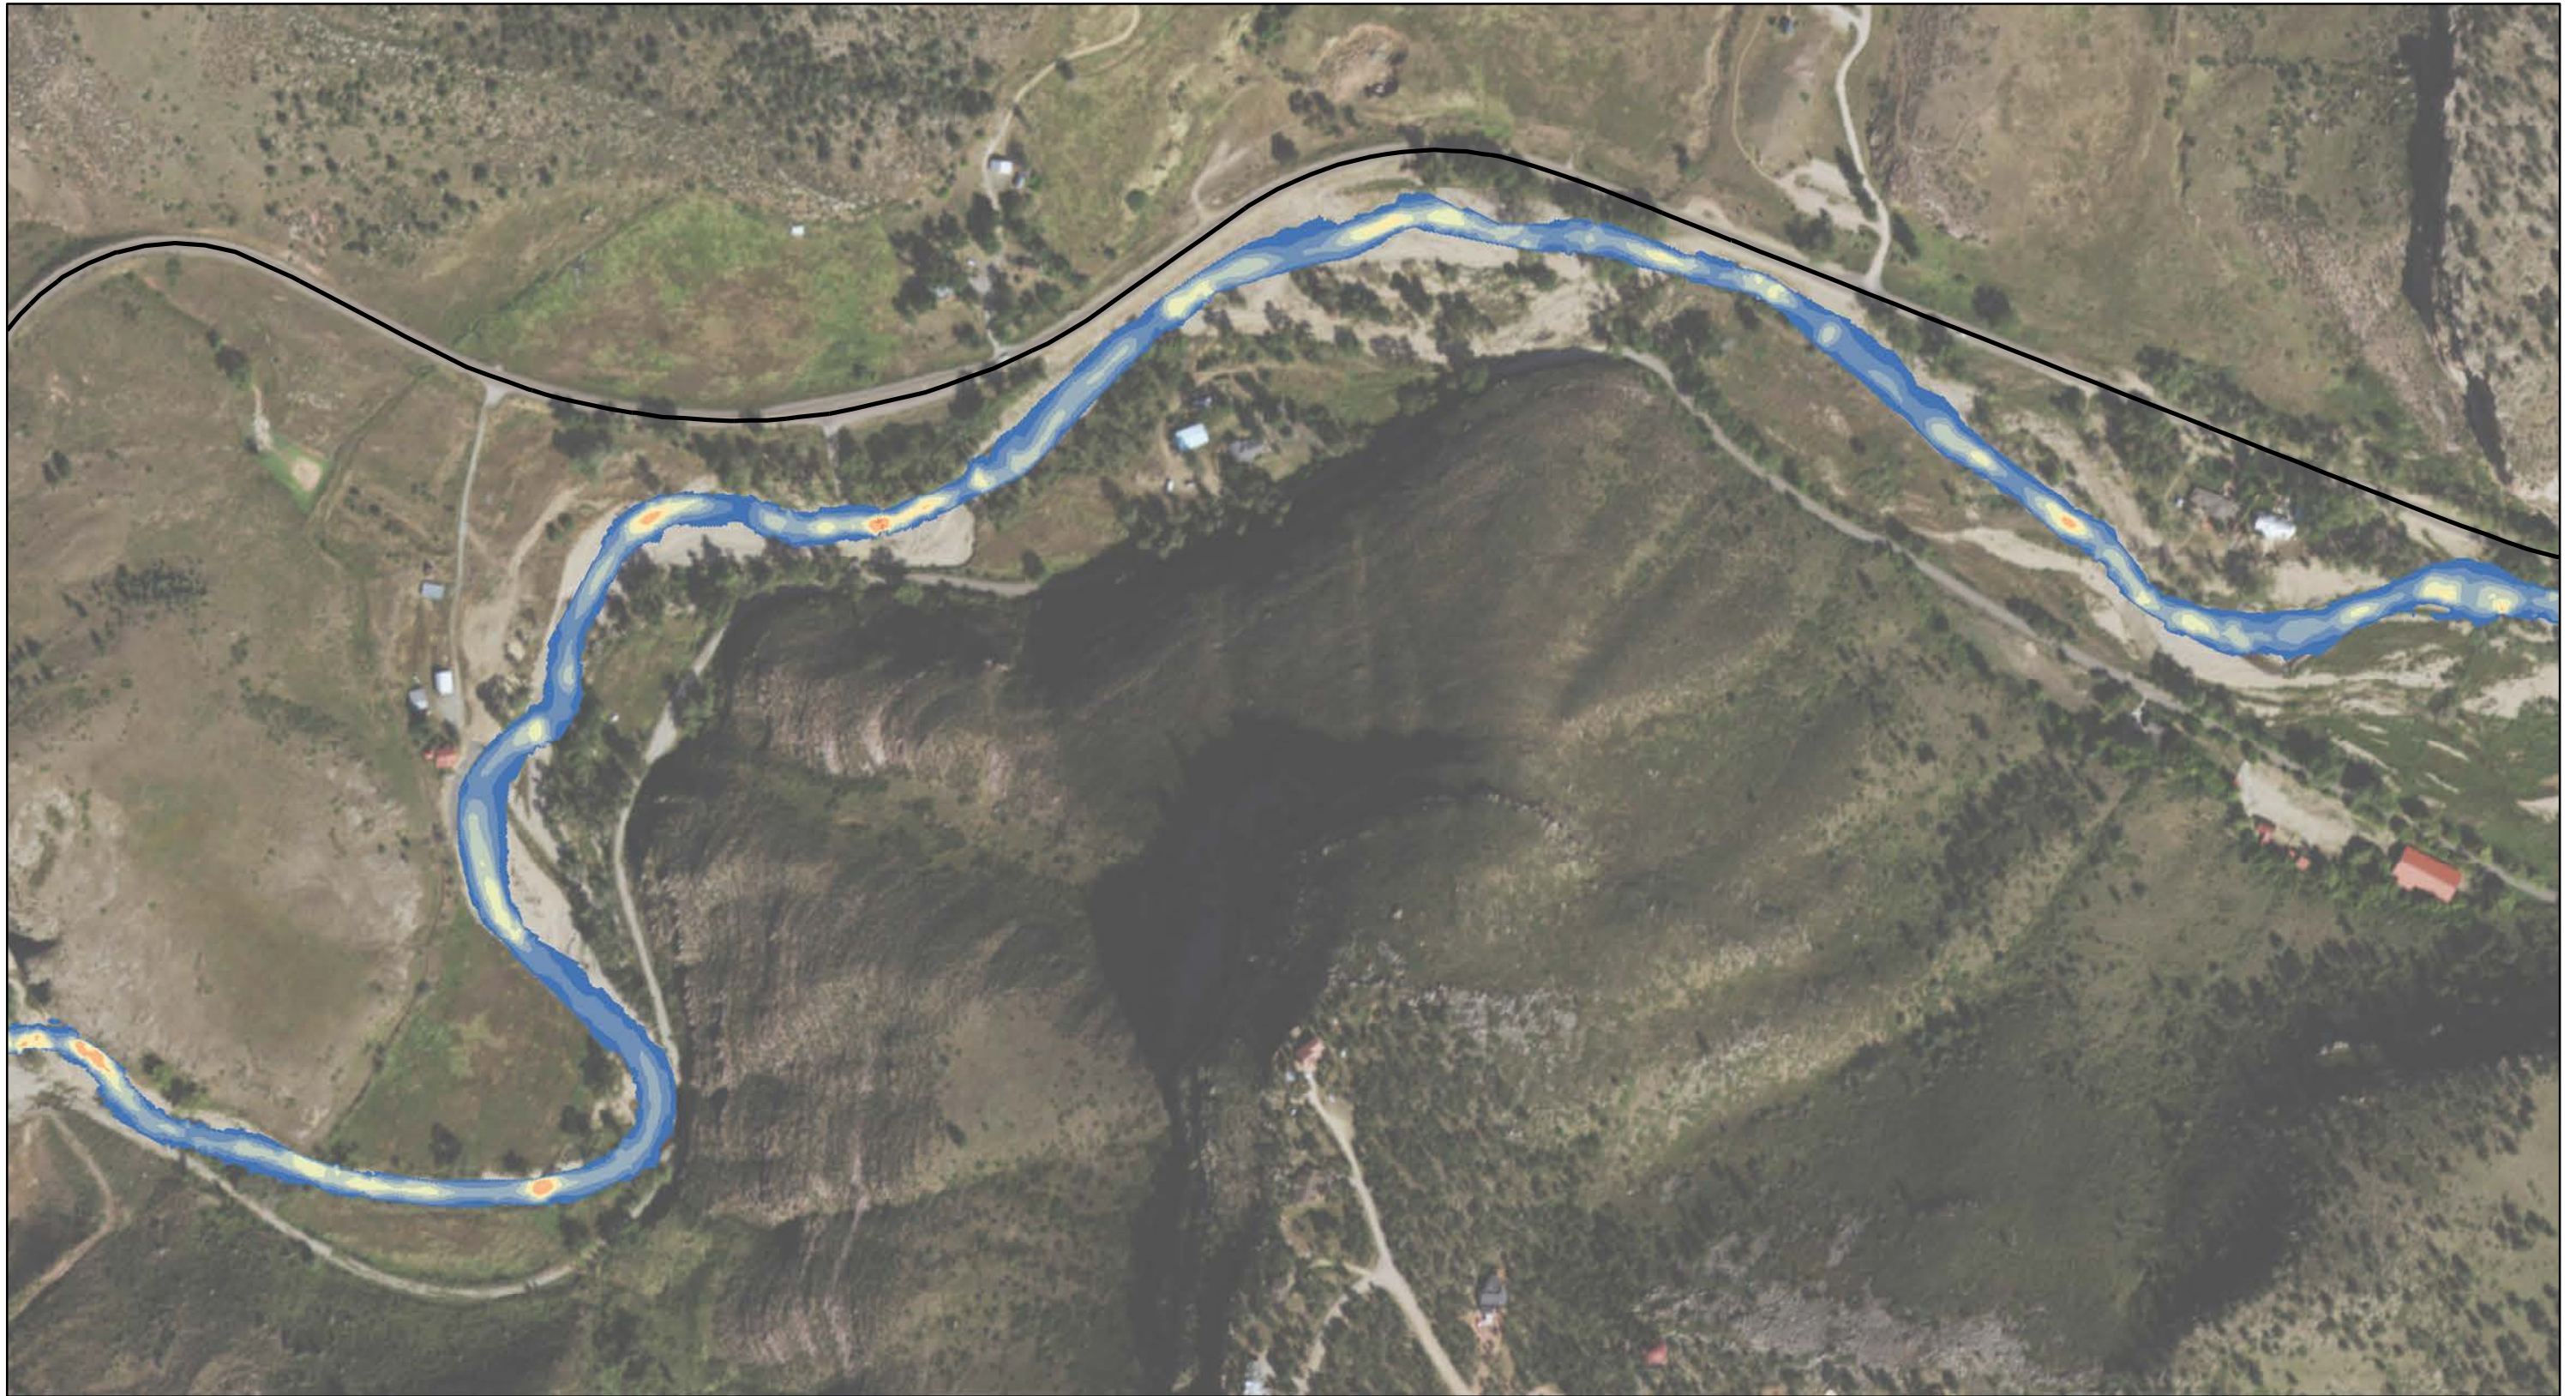
1.5 YEAR FLOW
**MAP
2**

**EXISTING CONDITIONS
STREAM POWER MAPBOOK
1.5 YEAR FLOW**

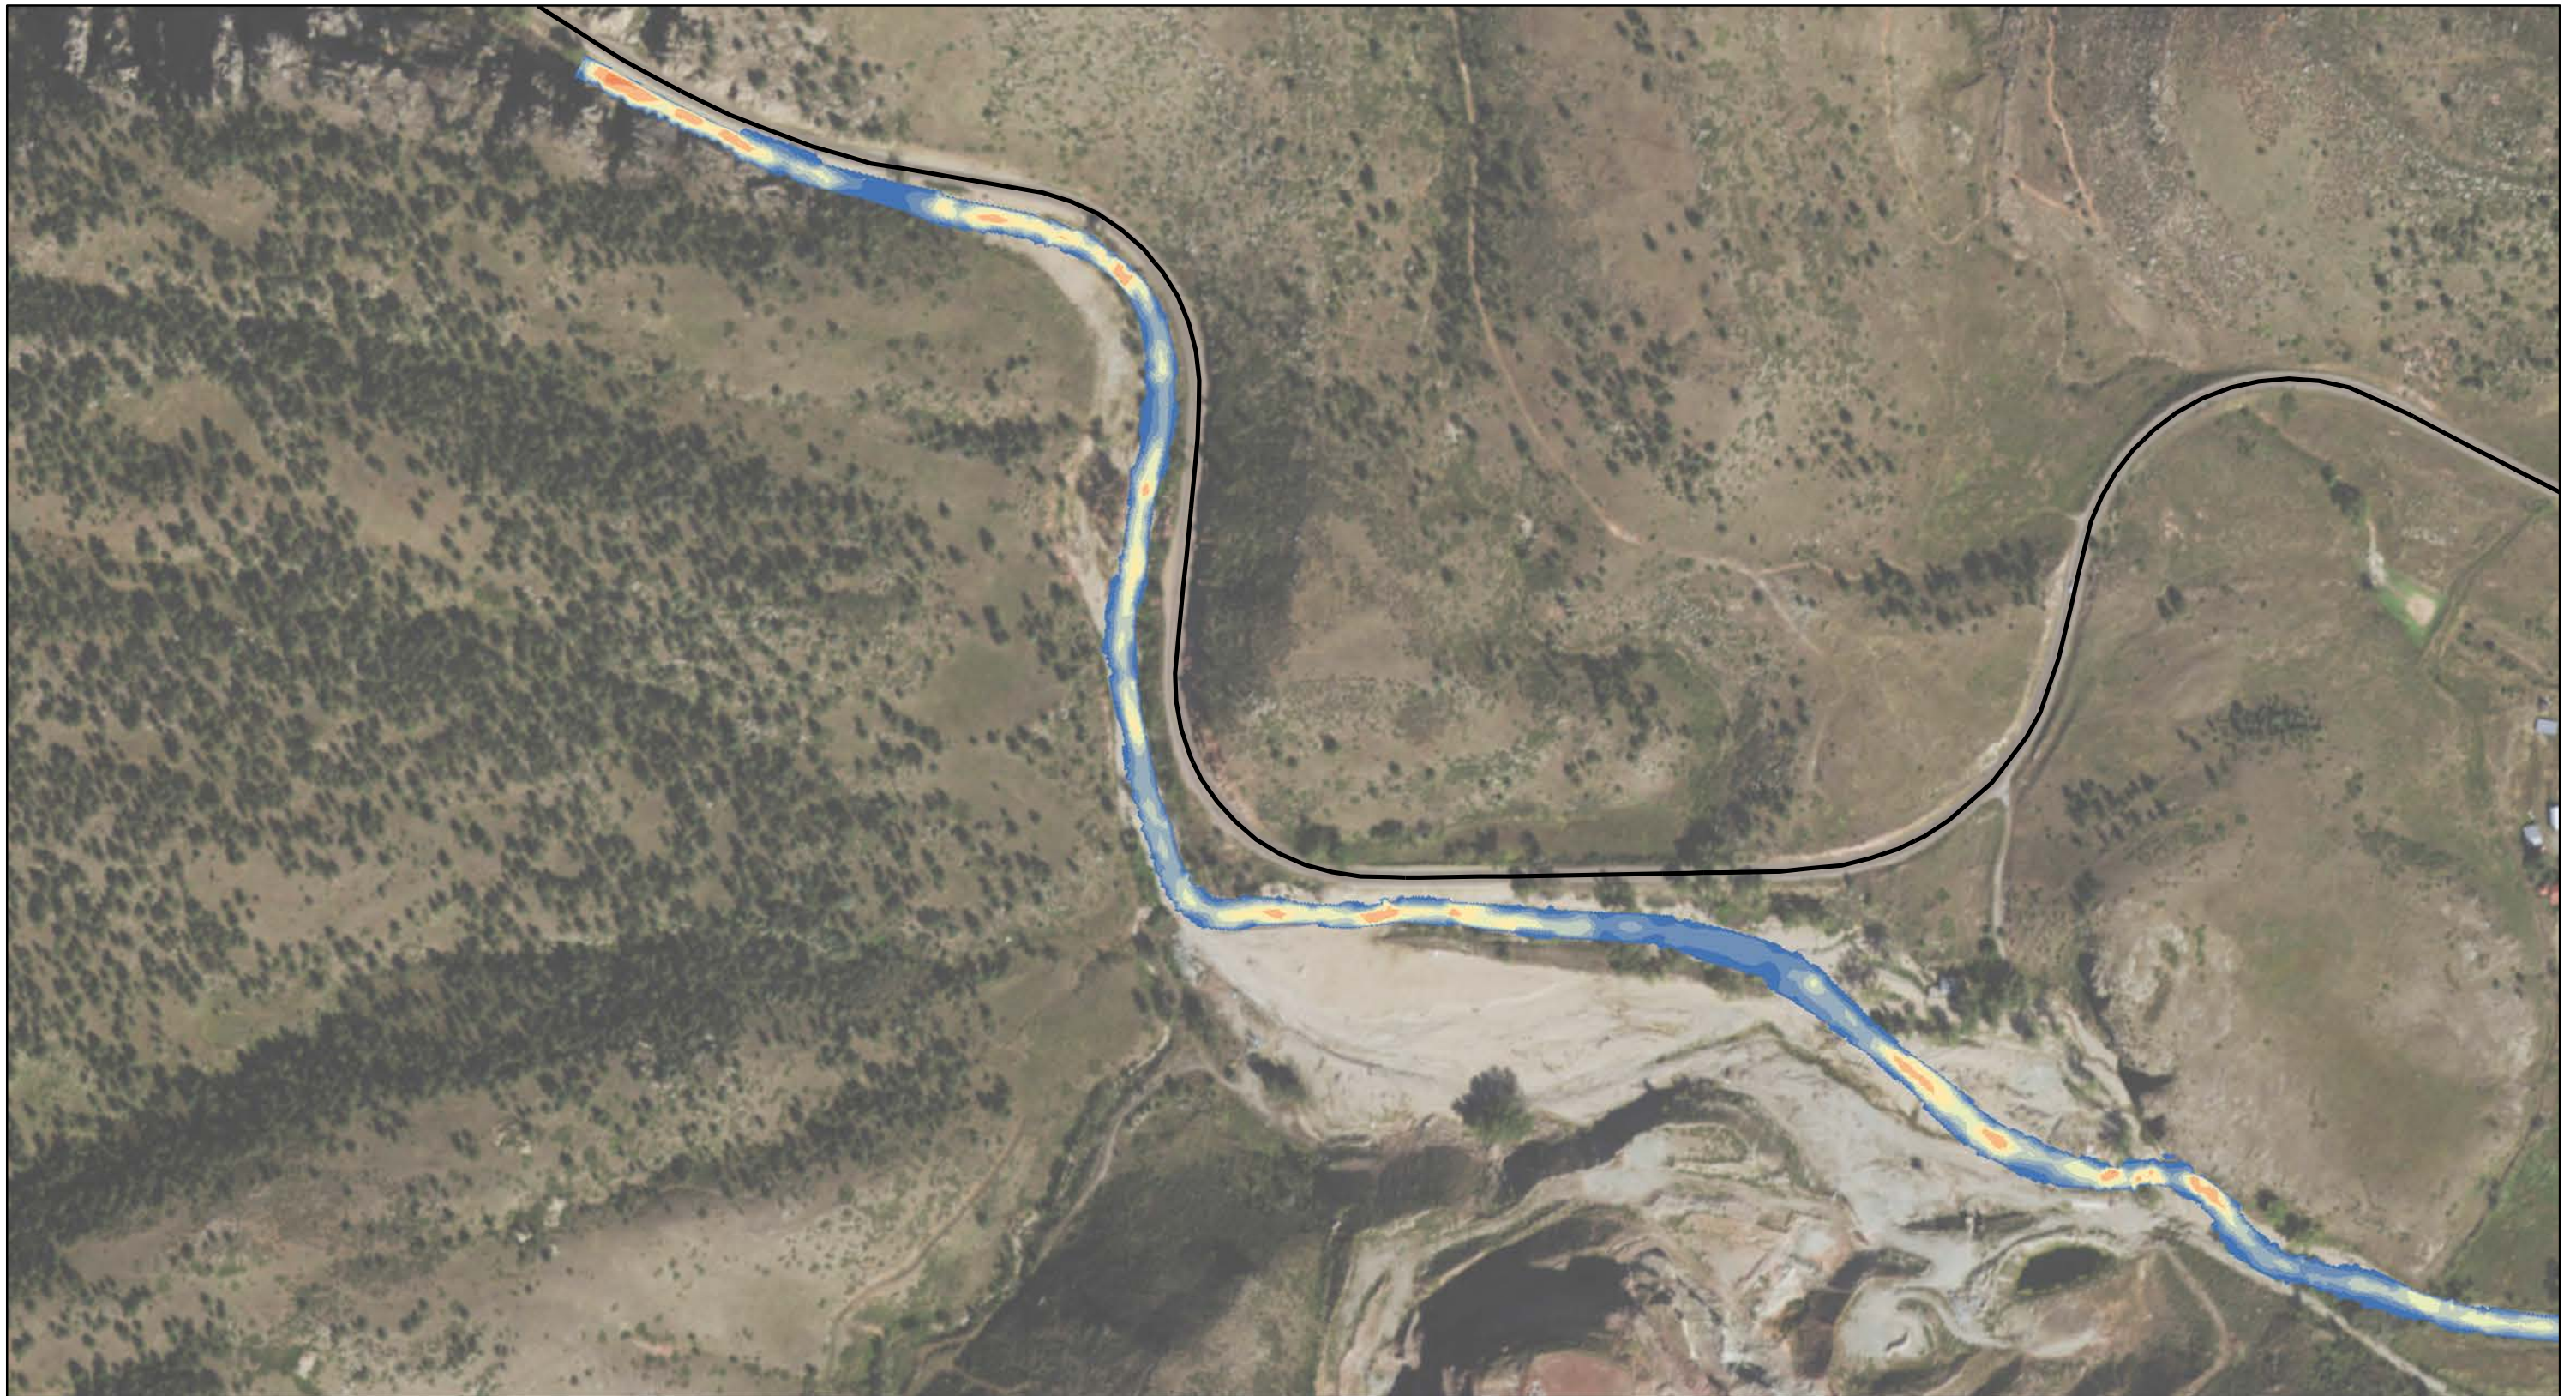
1.5 YEAR FLOW
**MAP
3**

**EXISTING CONDITIONS
STREAM POWER MAPBOOK
1.5 YEAR FLOW**

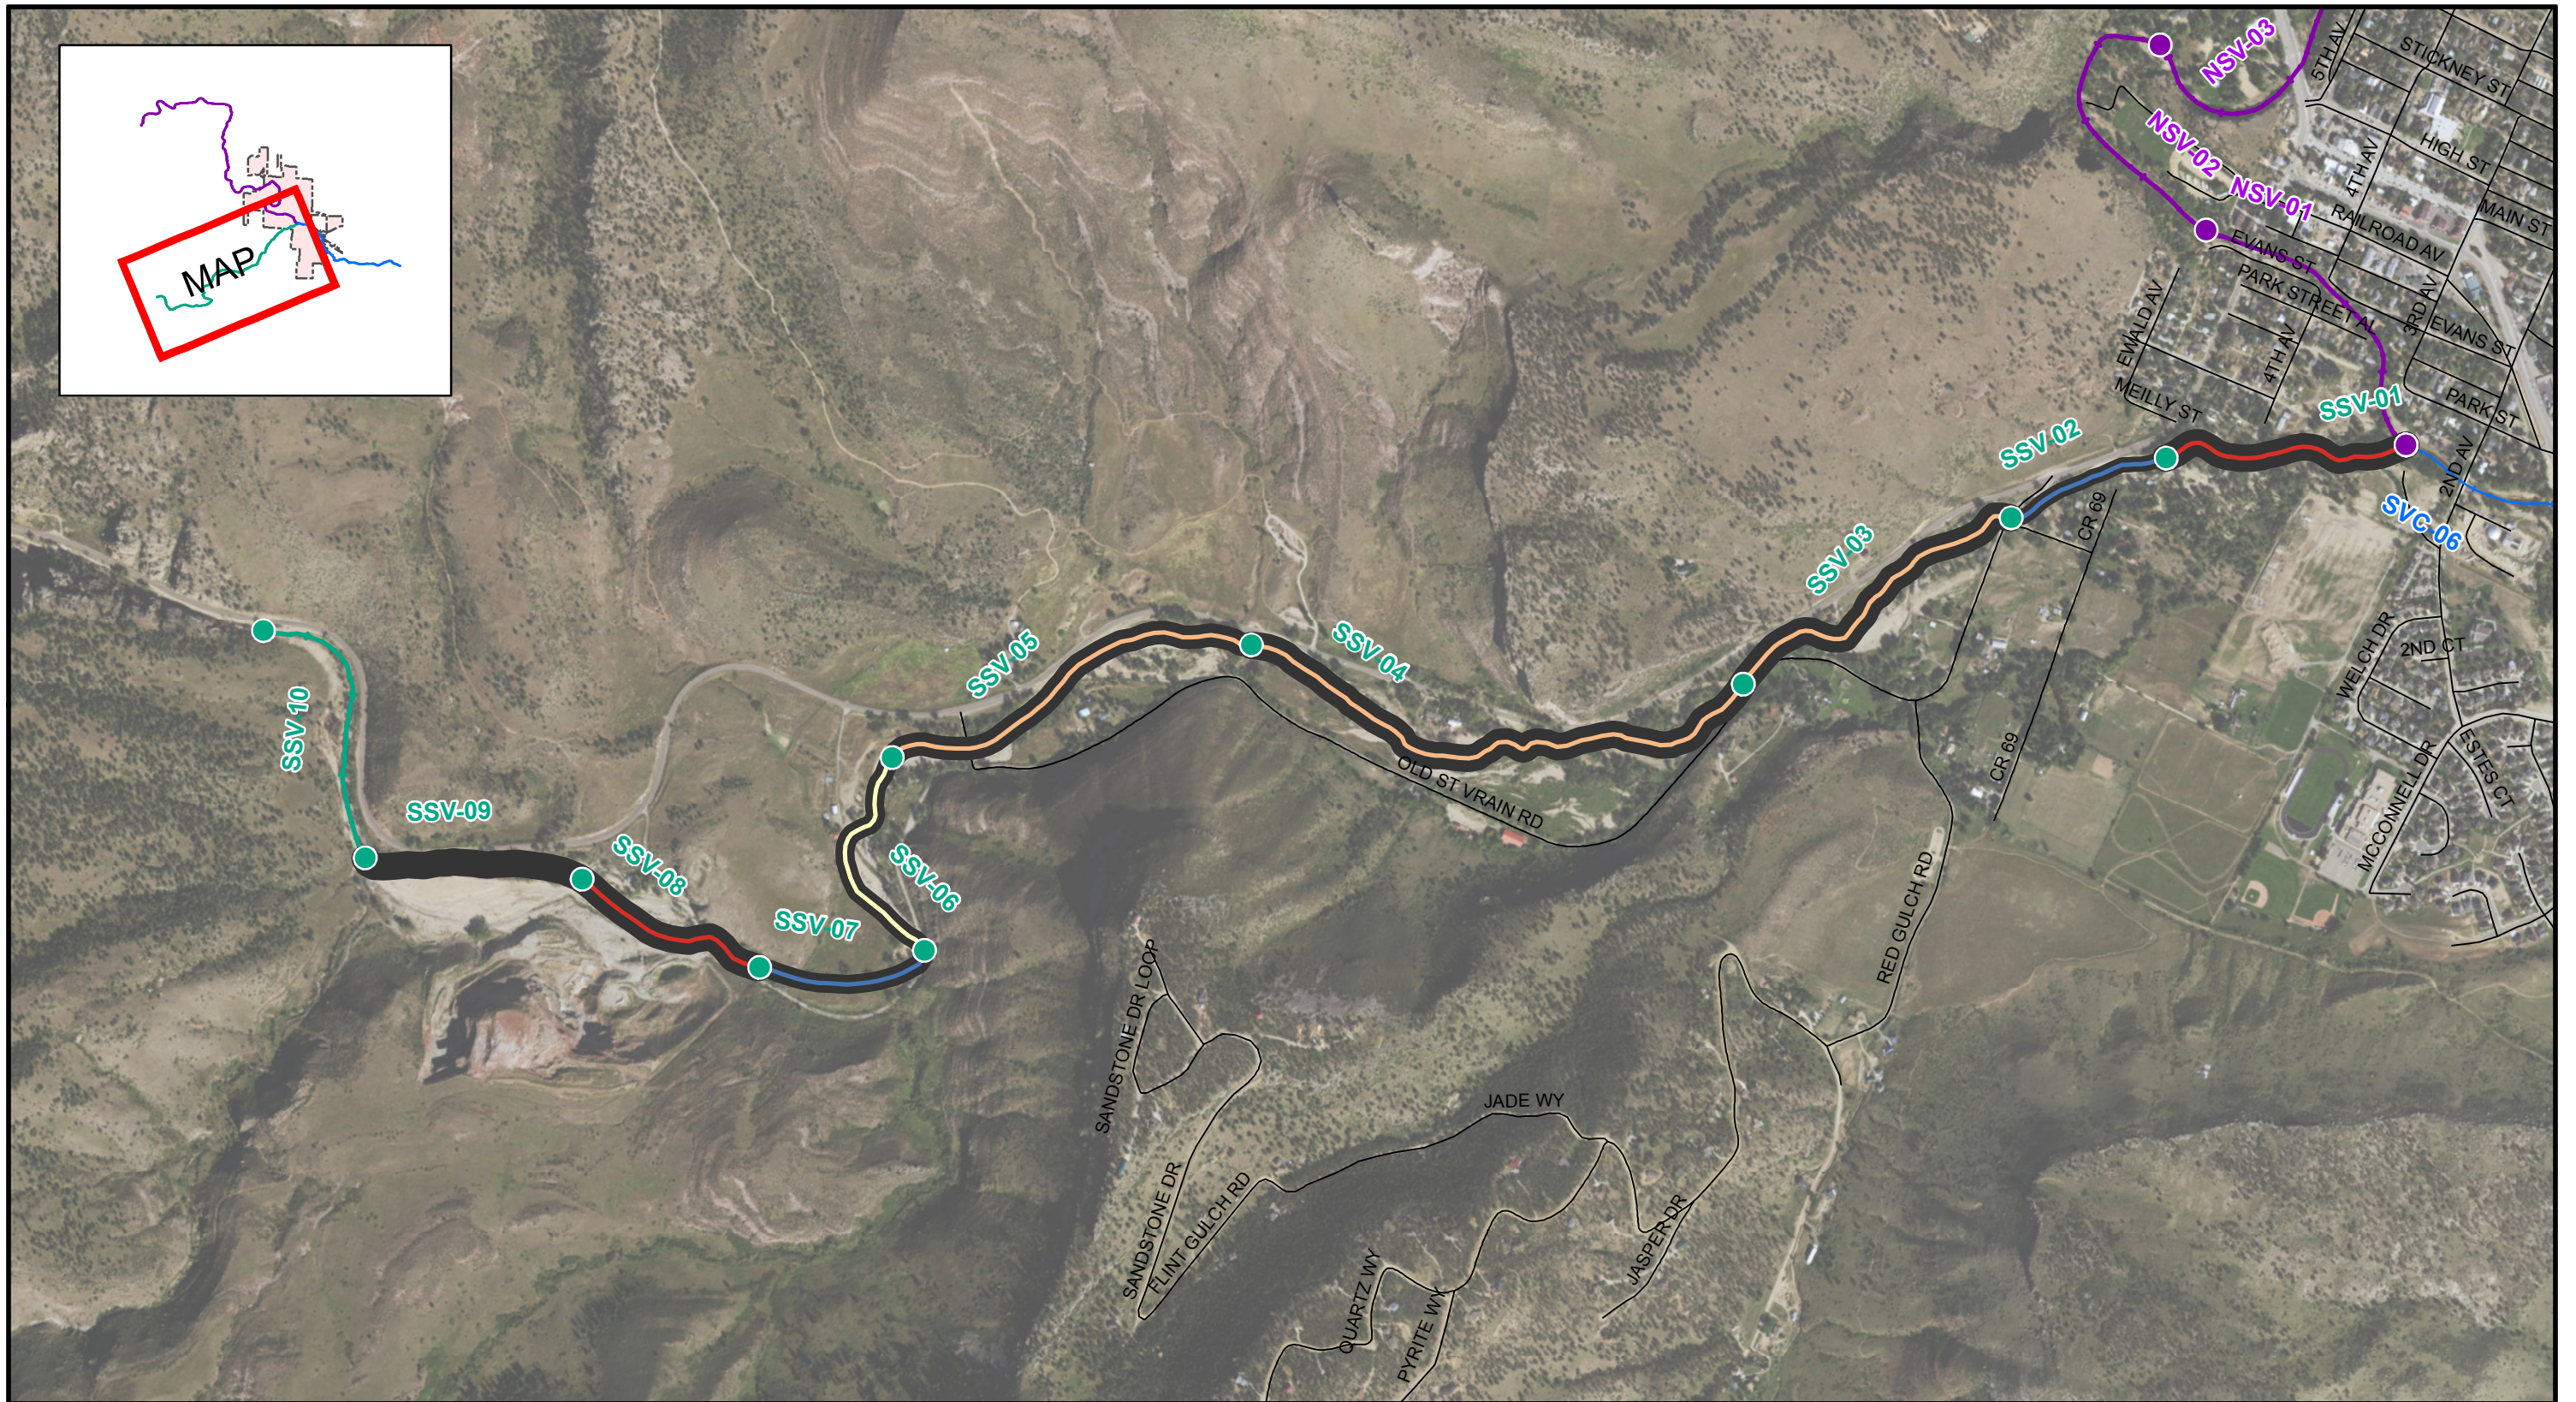
PROPOSED CONDITIONS
SEDIMENT TRANSPORT CAPACITY AND BALANCE

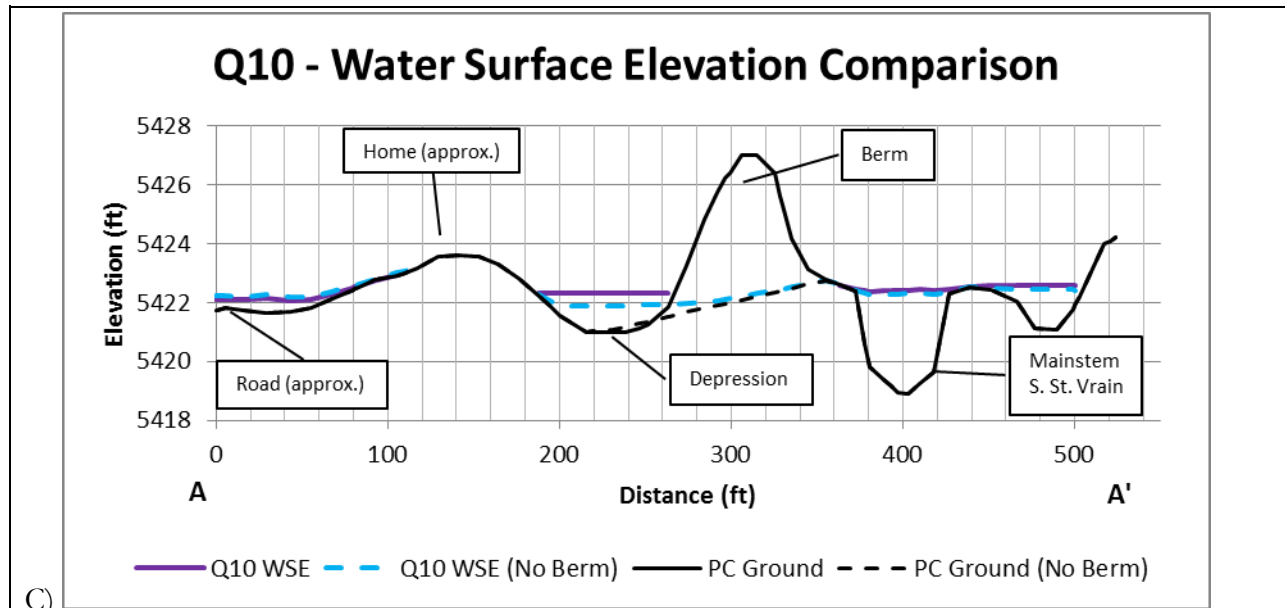
Figure 7. Water surface elevations sampled along cross section A-A' shown in (A). Velocity plot in 7(G) sampled along the main channel, B-B' shown in (A). Removal of the berm lowers WSEs behind the berm at Q5, as shown in (B), largely due to the severe reduction in available floodplain width caused by the berm.

The no-berm scenario was developed on the proposed conditions (PC) terrain model by removing the berm from the data. Removal of the berm was accomplished by identifying points on flat ground adjacent to the berm and straight-grading between them (Figure 1). Therefore, the terrain does not represent a designed condition. In the event that a decision is made to remove the berm, the bank and adjacent will undergo a design process aimed to reconfigure the area to align with the project goals. Simulation boundary conditions in SRH-2D (Lai, 2008) were setup following the methods outlined in the Preliminary Basis of Design Report (Matrix, 2016). Design flows were run to a stable solution for both berm and no-berm scenarios. Results from selected flows are presented below.
