US 287 Vision Zero Safety & Mobility Study

December 2023

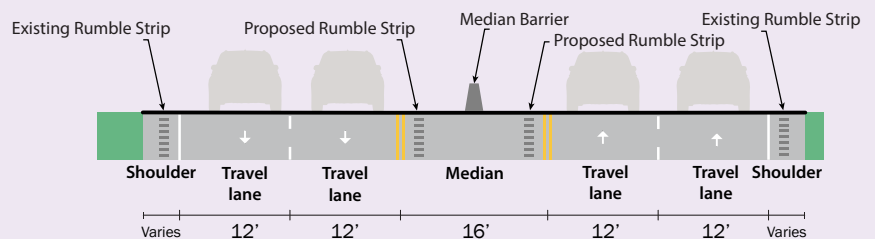
Figure 1. Proposed US 287 Center Median Barrier Cross Section

These crash types are occurring along rural areas where the highway is undivided with high posted speed limits, including the areas from (1) Pike Road to Arapahoe Road and (2) Park Ridge Avenue to the Boulder County/Larimer County border. A center median barrier is recommended in these two segments to improve safety and mitigate crossover crashes.

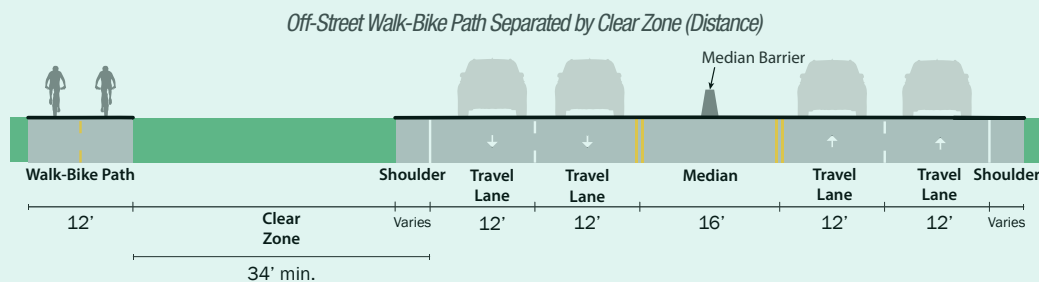
Figure 2. Recommended Off-Street Walk-Bike Path Cross Sections

A clear zone is an unobstructed area that allows a driver to stop safely or regain control of a vehicle that has left the road.

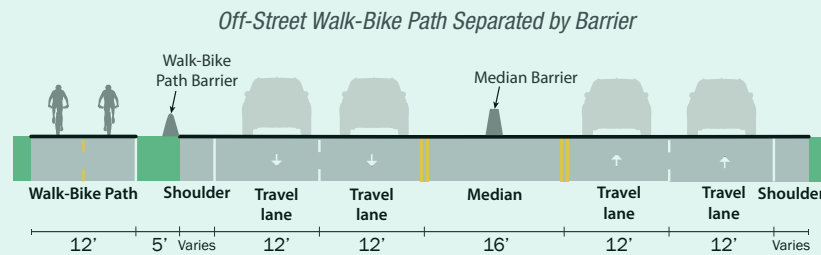
This cross section is necessary when there is not adequate right-of-way to accommodate a Walk-Bike Path separated by adequate distance.

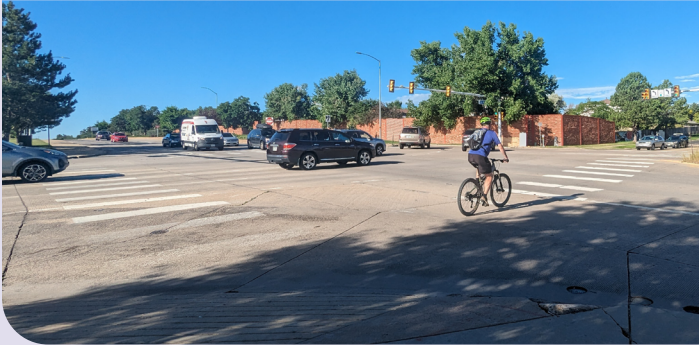
Bicyclists crossing US 287 at Miramonte Boulevard are vulnerable to collisions with turning vehicles.

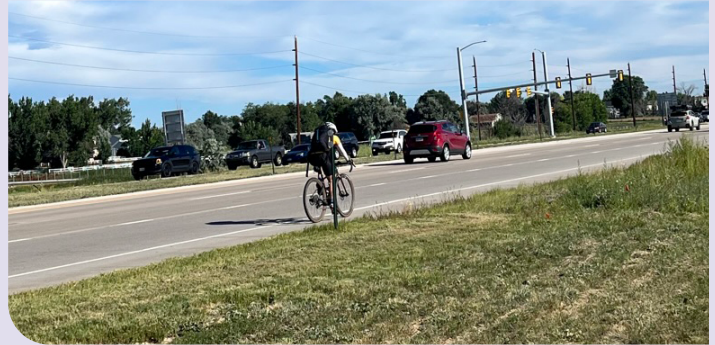
Bicyclists on US 287 at W Dillon Road are forced to ride on the shoulder, unprotected.

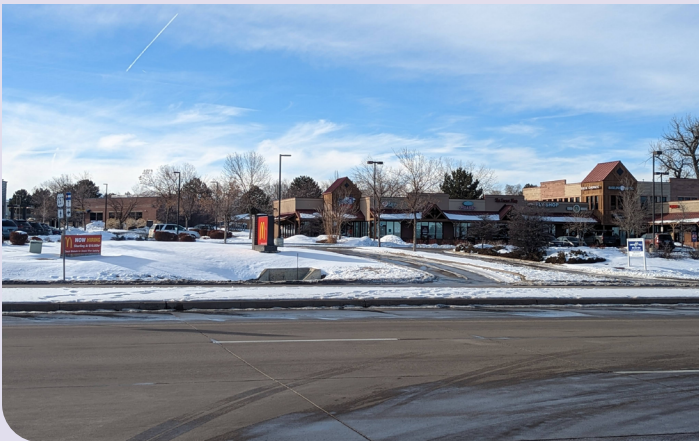
Pedestrians crossing 287 midblock north of Baseline lack adequate crossing infrastructure.

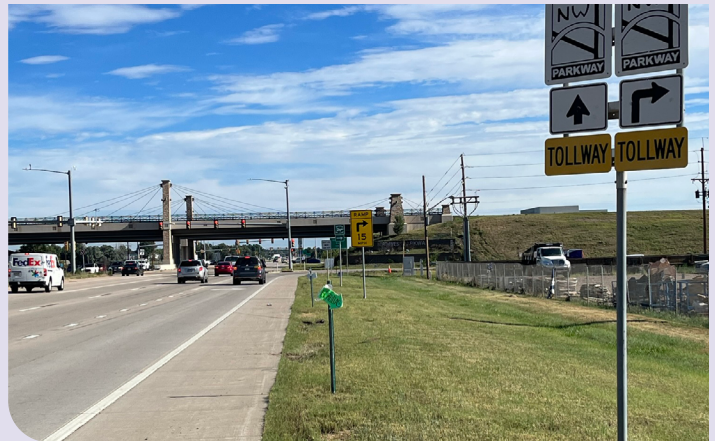
US 287 and Dillon Road is a complicated interchange.

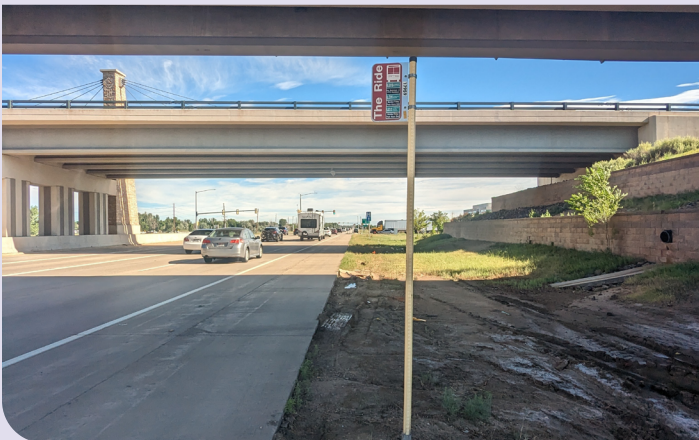
The bus stop at US 287 and Dillon Road is very inhospitable and has no supporting infrastructure.

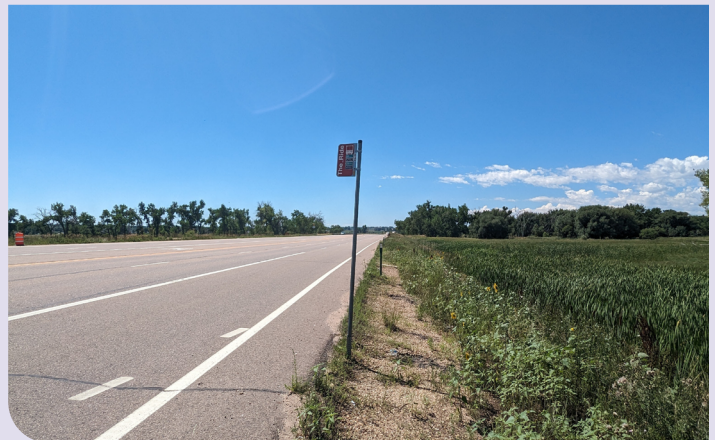
The bus stop at US 287 and Dawson Drive has no supporting pedestrian infrastructure.

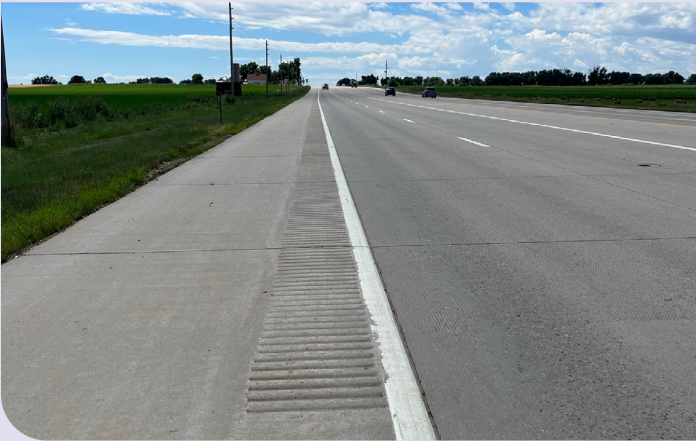
US 287 has edgeline rumble strips.

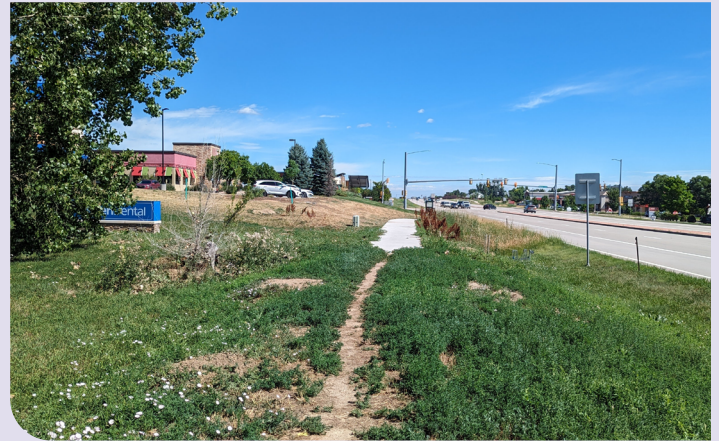
US 287 has a sidewalk gap near Arapahoe Road, which creates a lack of connectivity.

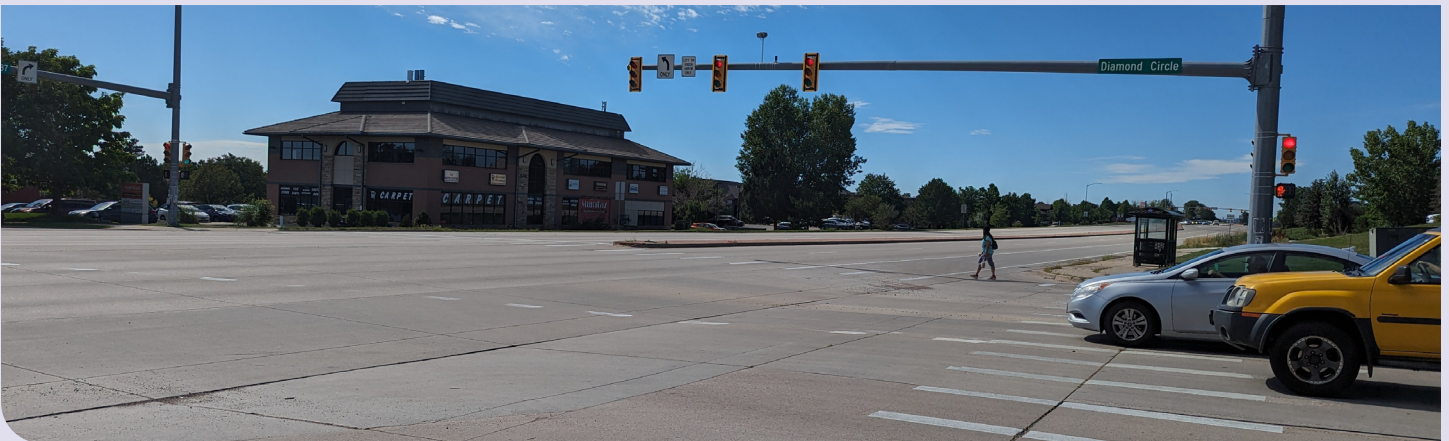
US 287 has long pedestrian crossing distances which increases pedestrian vulnerability.

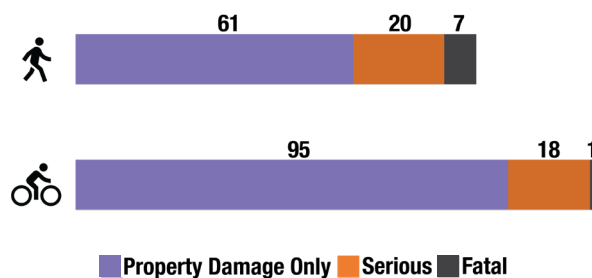
Figure 5. US 287 Number of Pedestrian and Bicycle Crashes

Figure 5 displays the pedestrian and bicyclist involved crashes along the corridor. **Figure 7** through **12** display the locations of all crashes and pedestrians and bicyclist crashes along the corridor.

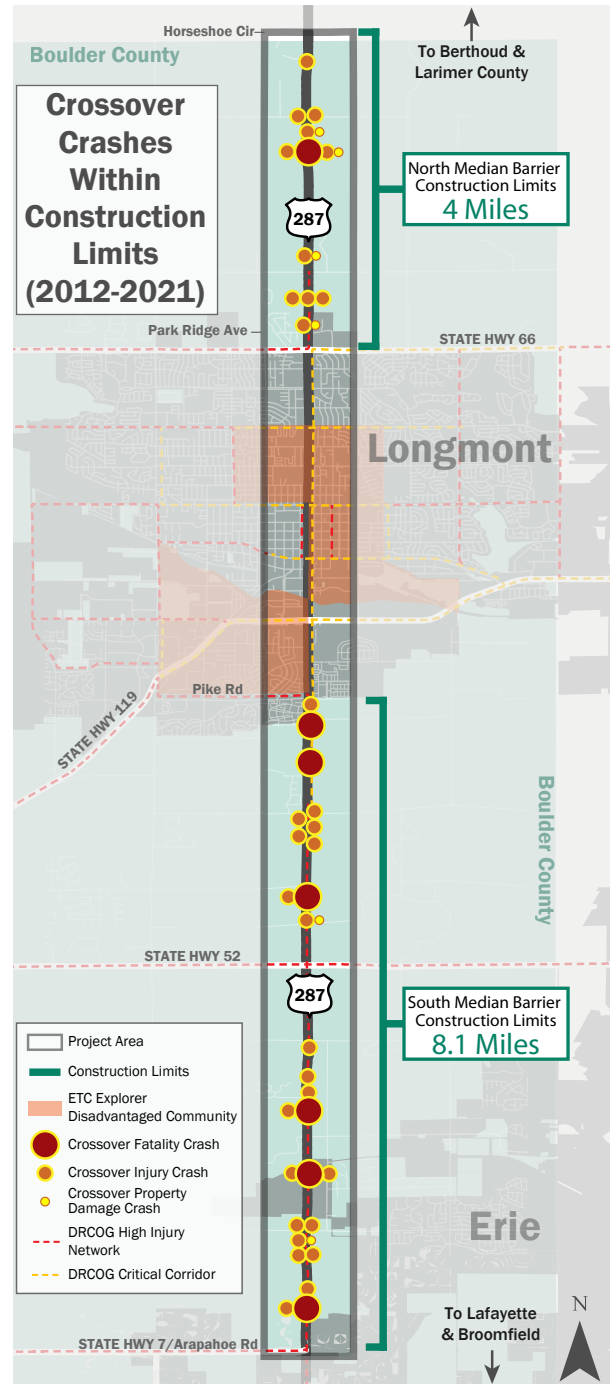
Figure 20. Center Median Extents and Crossover Crashes

The crash analysis revealed two segments that had an overrepresented amount of fatal and serious injury crashes. Most of the fatal and serious crashes were caused by drivers crossing over the centerline into the opposite direction of traffic resulting in head-on crashes or sideswipe (opposite direction) crashes. These crash types are occurring along rural areas where the highway is undivided with high posted speed limits. **Figure 20** displays the two segments including the areas from (1) Pike Road to Arapahoe Road and (2) Park Ridge Avenue to the Boulder County/Larimer County border. A center median barrier is recommended in these two segments to improve safety and mitigate crossover crashes. **Appendix E** displays the conceptual design and cost estimate for the two segments identified for installing a center median barrier.

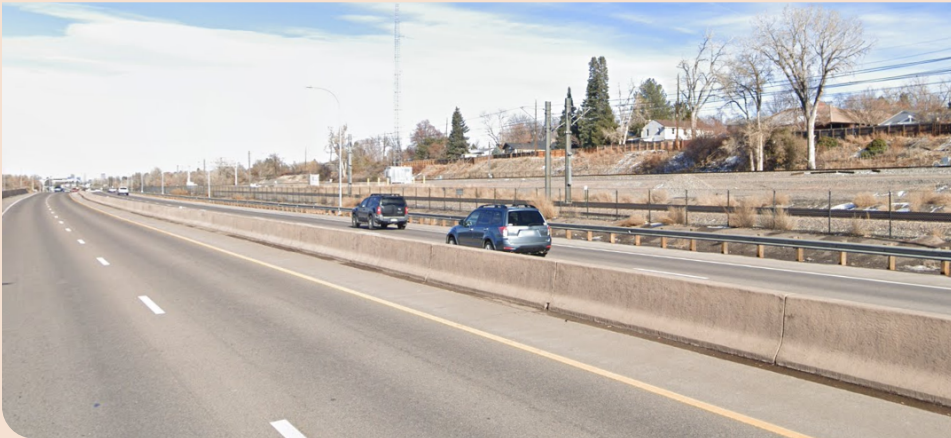
Example of a Cast-In-Place Concrete Barrier, US 85 (Santa Fe) between Aspen Grove and Sumner

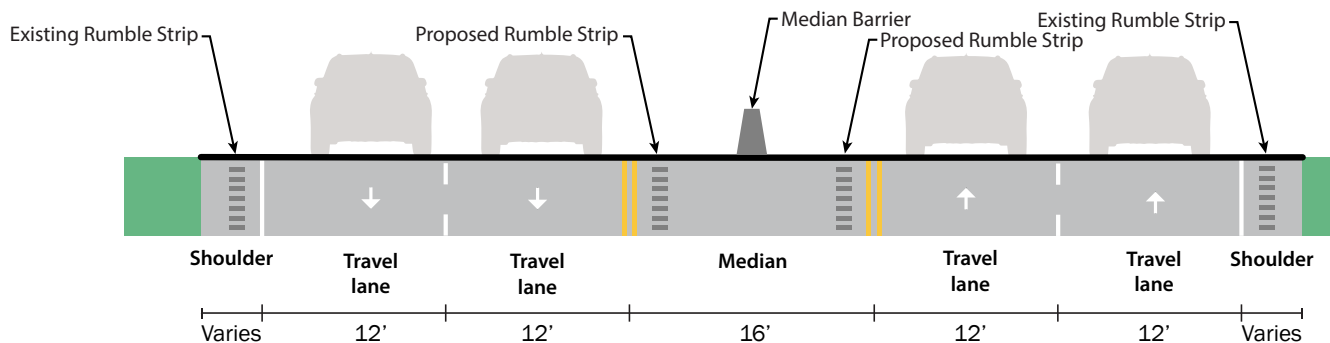
Figure 21. US 287 Proposed Median Barrier Cross Section

Several types of median barriers were analyzed, and an alternatives analysis was performed to recommend the preferred type of median barrier. Discussion of the alternatives analysis can be found in the Median Barrier Alternatives Analysis Memorandum located in **Appendix D**. From the analysis and conversations with Boulder County and CDOT, it was determined that cast-in-place concrete (example shown in the image below) was the preferred median barrier selection. **Figure 21** displays the proposed median barrier cross section on US 287.

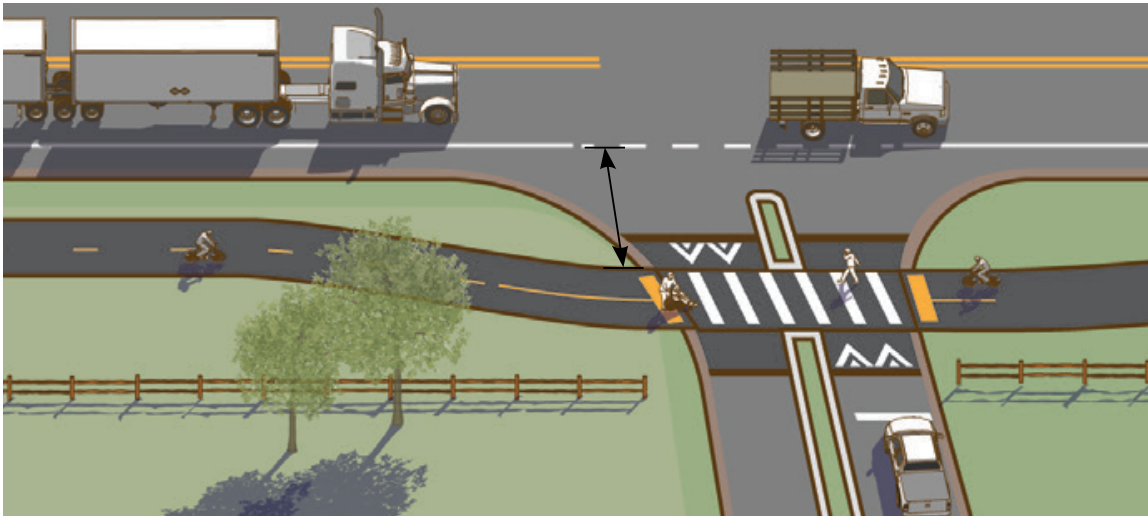
Figure 32. Walk-Bike Path Crossing at Minor Street and Driveways

The bend out displayed in **Figure 32** slows bicycle speeds approaching the intersection. **Figure 33** displays the recommended side path separation distance at crossings.
