**ADDENDUM #2
Parks and Open Space
Cardinal Mill Environmental Remediation Project
RFP-083-24**

This report presents the results of a geotechnical study conducted to provide recommendations for the proposed remedial construction of a wall on the west side of the New Cardinal Mill building near Nederland, Colorado. This study also addresses stability of a steep slope adjacent to the proposed wall construction, and provides recommendations for mitigating water seepage in the lower level of the mill building. The investigation was performed in general accordance with our proposal to Loris & Associates, Inc., dated May 16, 2003.

New Cardinal Mill Retaining Wall Reconstruction
Near Nederland, Boulder, County Colorado
By Angus Campbell, CDPHE Project Manager
March 17, 2006

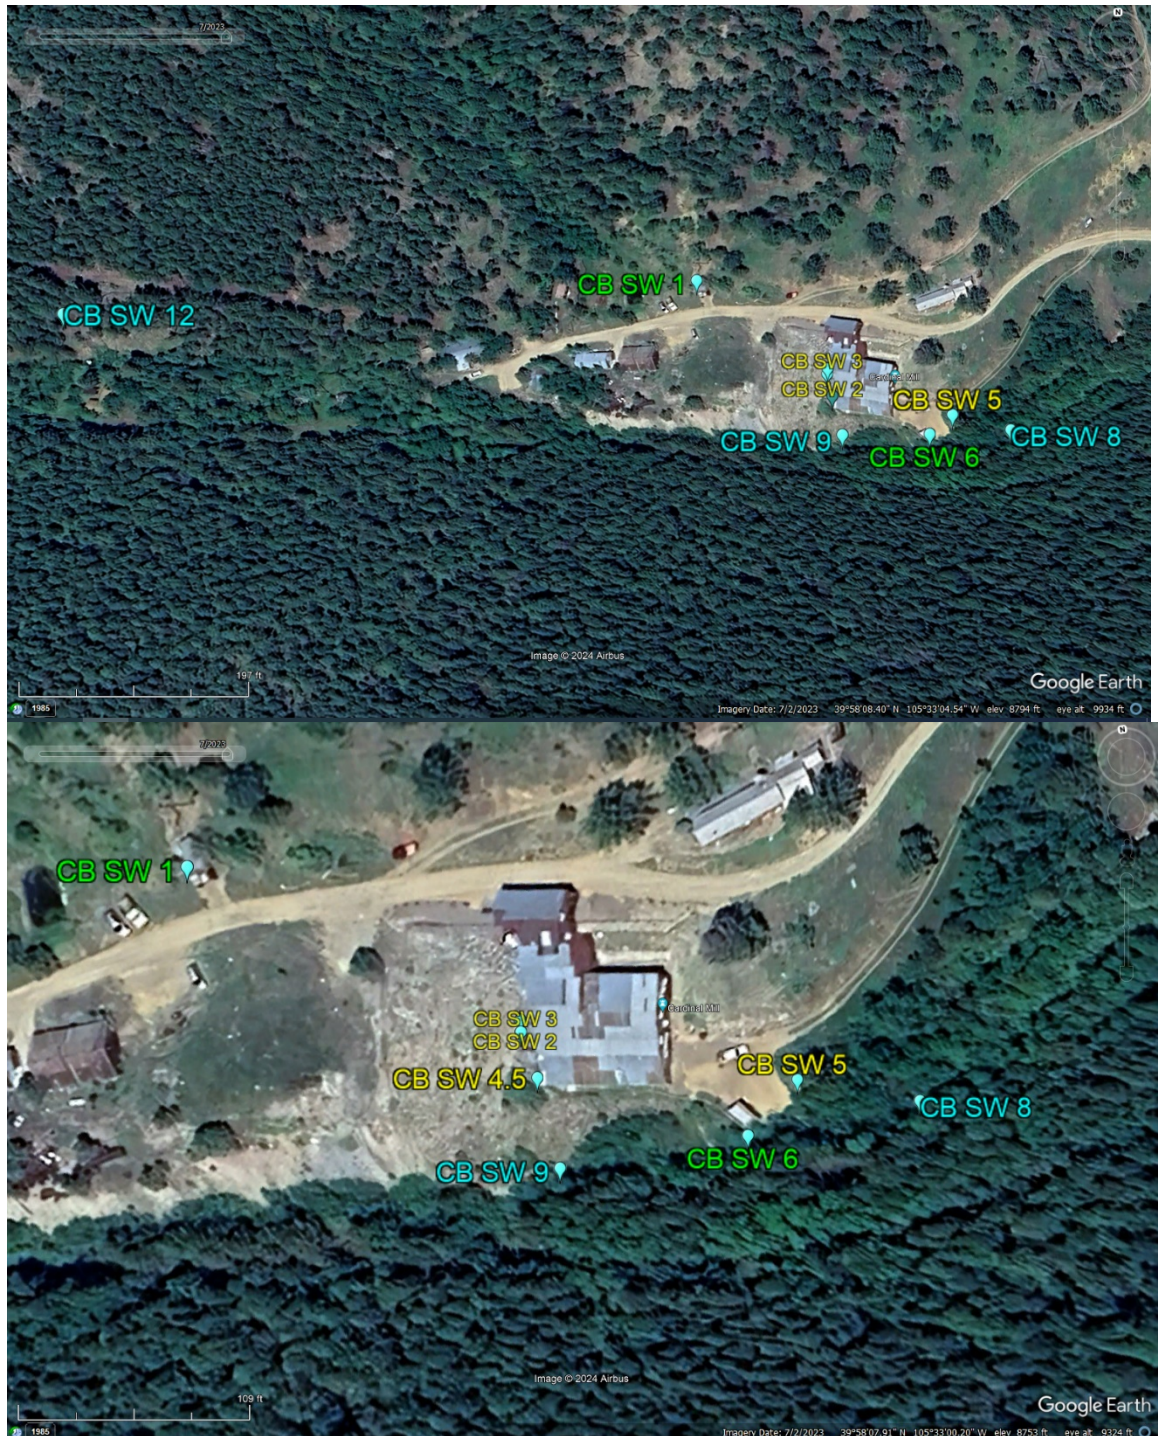
ANSWER: We have recently performed a pollutant load analysis, approximate sampling locations shown below in the Google Earth images, with the data to be received later this week. We will provide this data at the pre-bid meeting on July 10th. Most of our sampling data over the years is located at the toe drainpipe outlet labeled "CB SW 6" in this Google Earth picture. We have limited water quality data from other dates and times at "CB SW 1" the mine adit. "CB SW 8, CB SW 9 and CB SW 12 are all points in Coon Track Creek, for which there is also additional data available through other municipal and state sources that we are currently trying to collect. We have an additional date for which data was collected at the hill slope seeps "CB SW 2", "CB SW 3", and a third seep to the south, and this can be provided to the selected Contractor. "CB SW 4.5" is a surface water location for seep water not collected into the toe drain pipe. "CB SW 5" is an additional seep location.

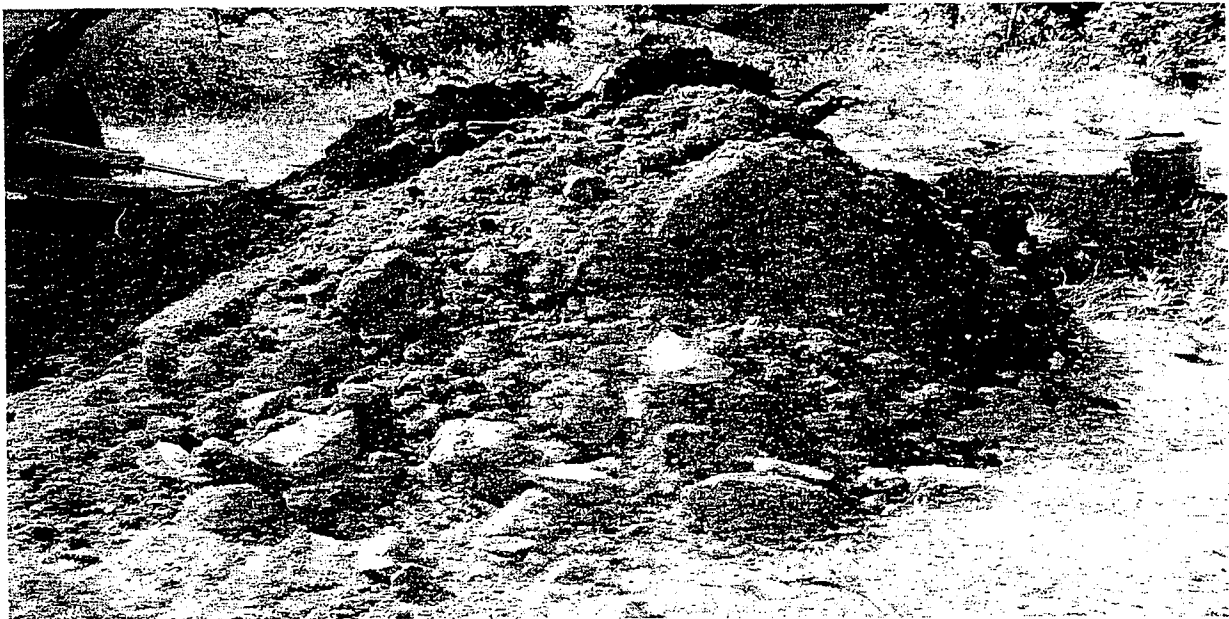
Excavated Materials from Test Pit TP-5

Test Pit TP-4 contained significant gravel, cobbles and small, angular boulders with maximum size estimated at approximately 18 inches. Boulder size materials were estimated at approximately 30 percent of the volume. In addition to soil, cobbles, and boulders, fill materials encountered in TP-4 included wood, brick, and metal debris, estimated to comprise up to 30 percent of the fill volume. Test Pit TP-5 contained significantly less cobbles than TP-4 and no boulders were observed; however, the type of fill materials and estimated quantity was similar to TP-4. Photos of the test pits are shown on Figures 4 and 5.

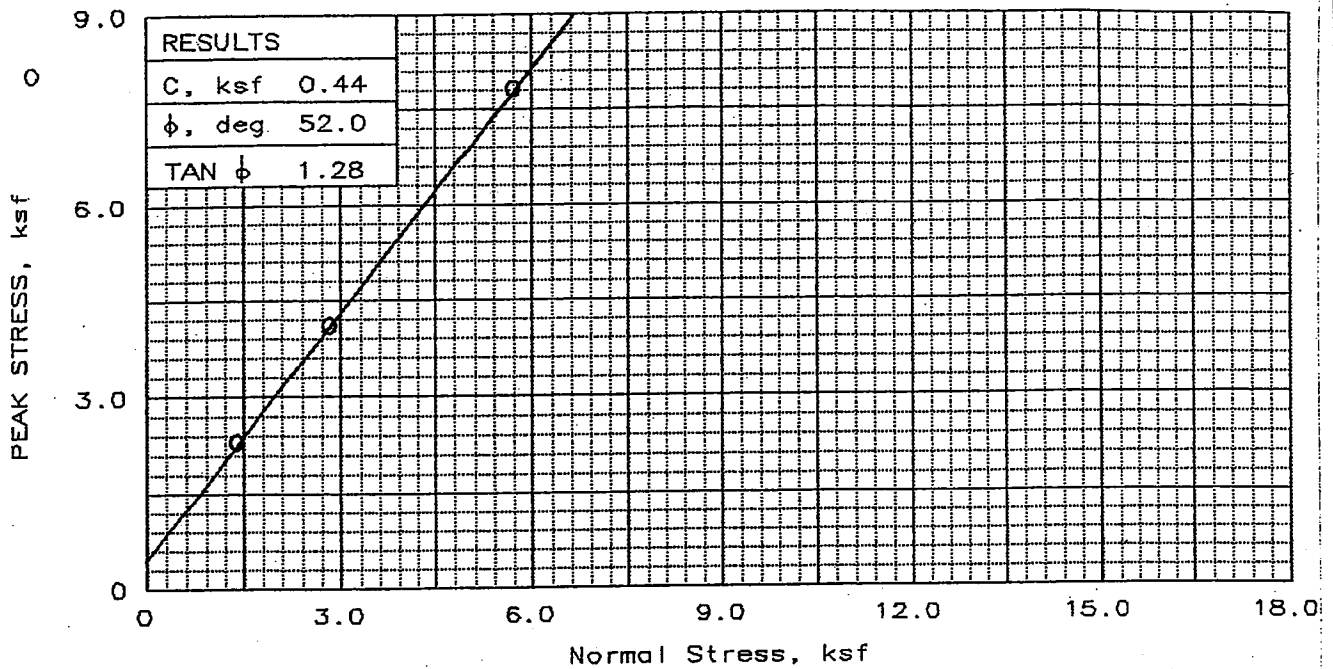
FIGURE 10

SAMPLE NO.:		1	2	3
INITIAL	WATER CONTENT, %	8.0	8.0	8.0
	DRY DENSITY, pcf	110.6	110.6	110.6
	SATURATION, %	42.7	42.7	42.7
	VOID RATIO	0.496	0.496	0.496
	DIAMETER, in	2.50	2.50	2.50
	HEIGHT, in	1.00	1.00	1.00
AT TEST	WATER CONTENT, %	6.6	6.6	6.6
	DRY DENSITY, pcf	110.6	110.6	110.6
	SATURATION, %	35.2	35.2	35.2
	VOID RATIO	0.496	0.496	0.496
	DIAMETER, in	2.50	2.50	2.50
	HEIGHT, in	1.00	1.00	1.00
NORMAL STRESS, ksf		1.44	2.88	5.76
PEAK STRESS, ksf		2.29	4.10	7.81
STRAIN, %		25.1	24.9	24.1
ULTIMATE STRESS, ksf				
STRAIN, %				
Strain rate, %/min		0.14	0.14	0.14

Sample Type: Remolded.
 Sample Location: B-2@15'-20'
 Description: SAND, gravelly, clayey.
 Specific Gravity = 2.65
 Date: 8/28/2003

Gradation test results are shown on Figures 7 and 8, and moisture-density relationship results are presented on Figure 9. Direct shear test results are shown on Figures 10 through 12. A summary of laboratory test results is included in Table 1, and test results for corrosion potential are presented on Table 2.

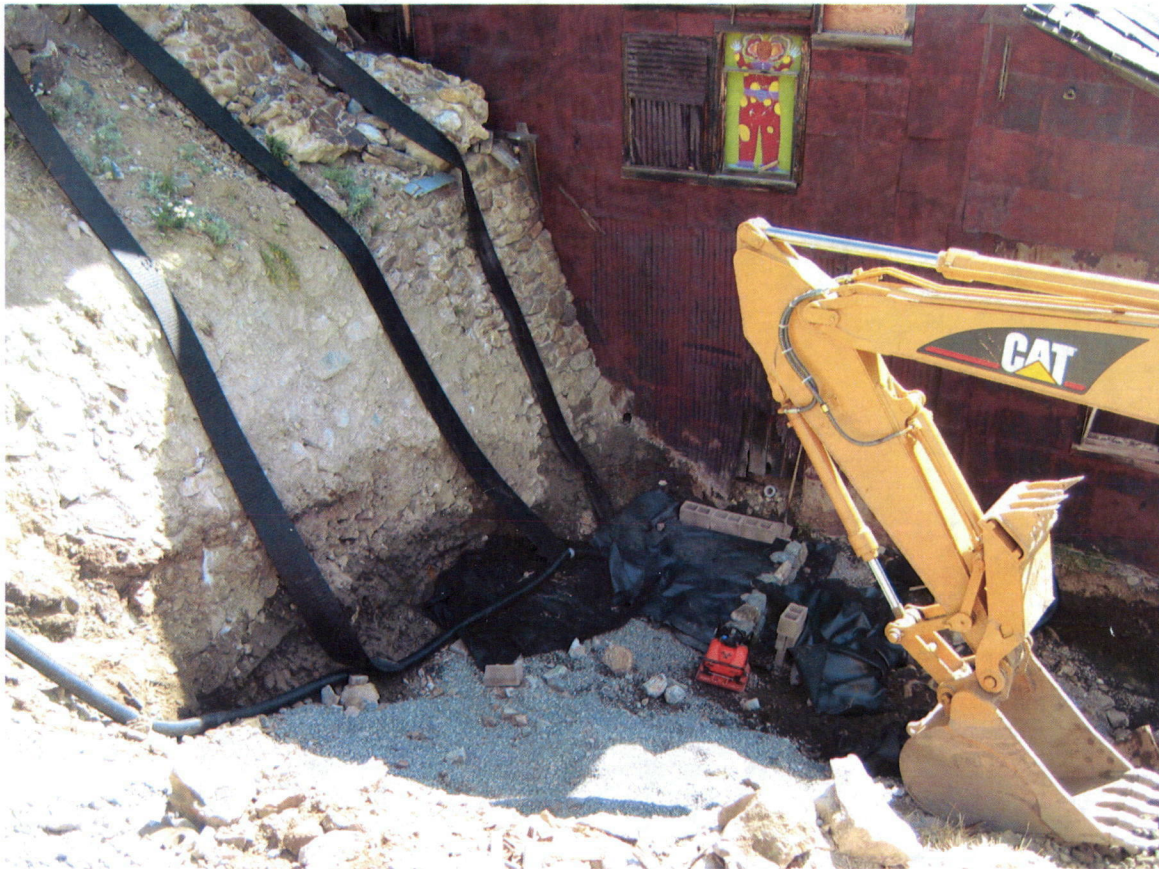
After cleaning and grubbing, drainage system was installed collection channels going up the back of the fill area and perforated pipe which collected the drainage in a manifold system which discharged the collected water at the base of the wall.

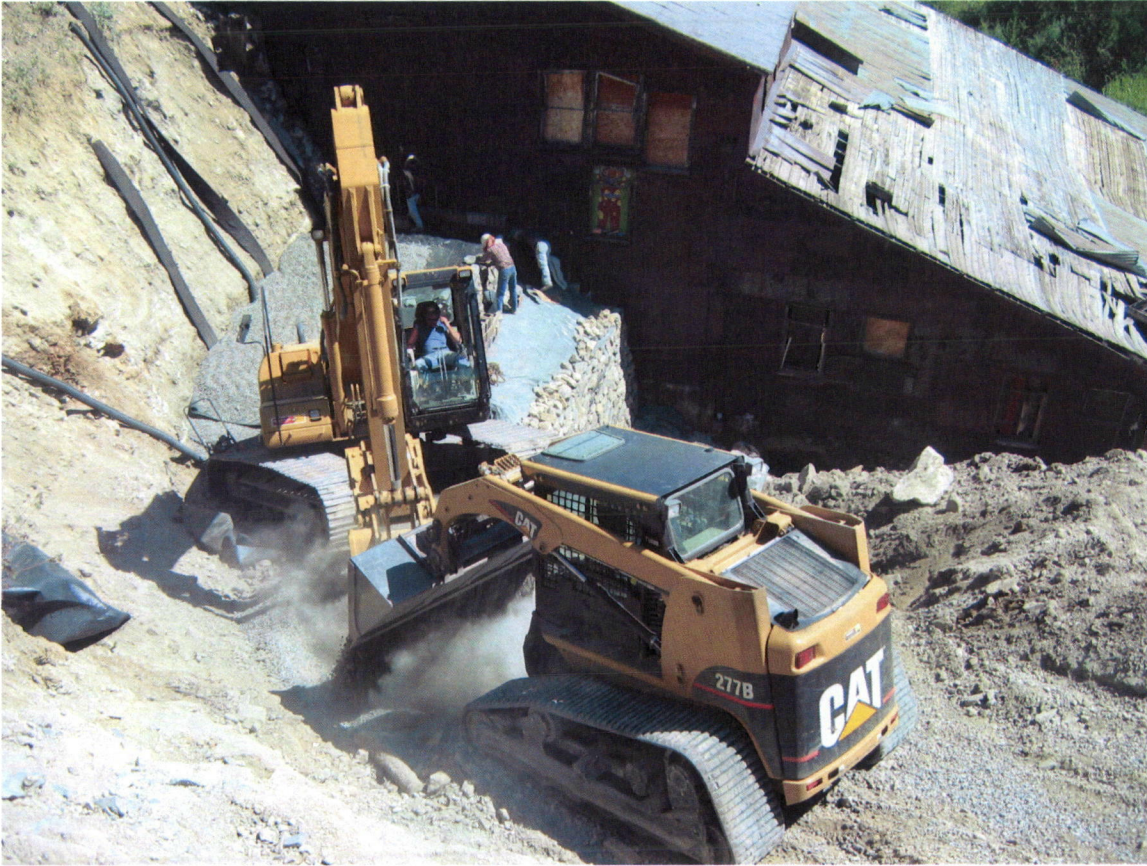
Construction of the MSE wall. Gravel is hauled to the construction site by a small tracked vehicle the material is placed in the wall fill by an excavator.

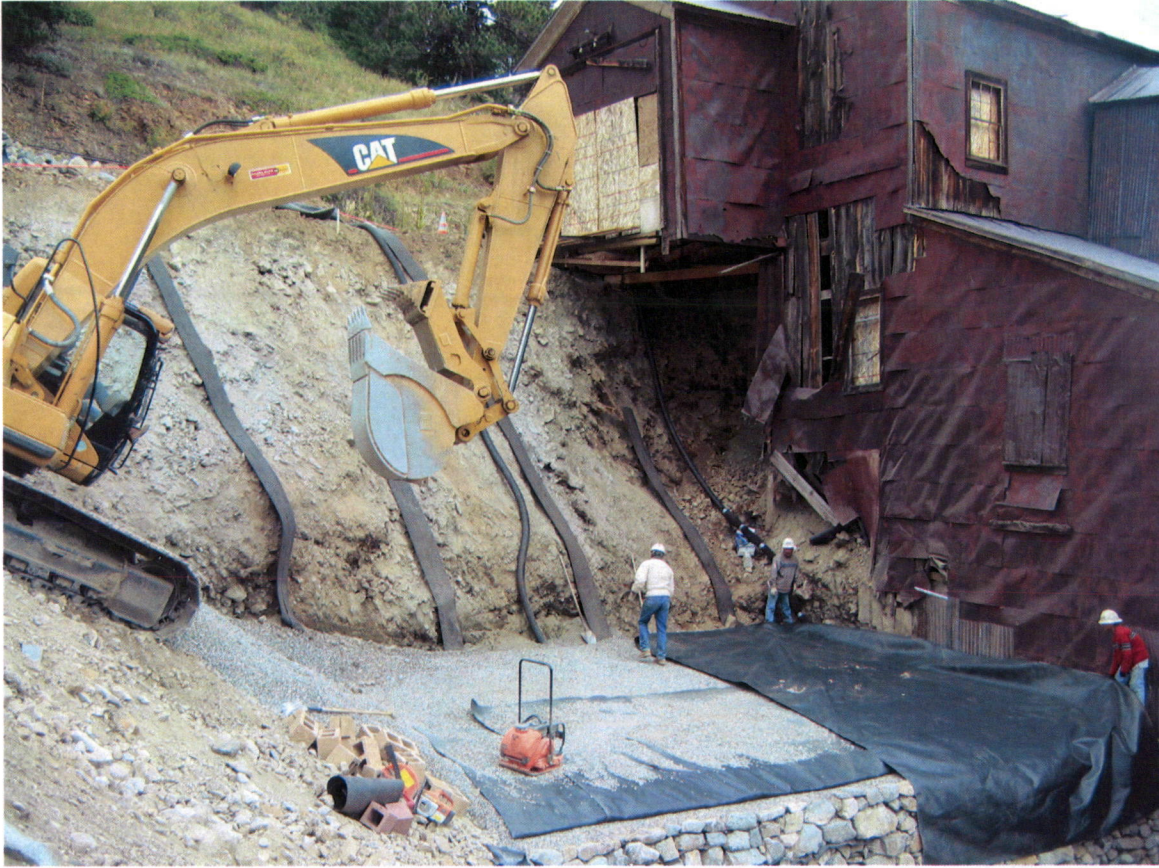
Once placed, the gravel was tamped with a hand held compactor (orange machine in foreground) then a geo-fabric was placed on the gravel fill material by workmen.

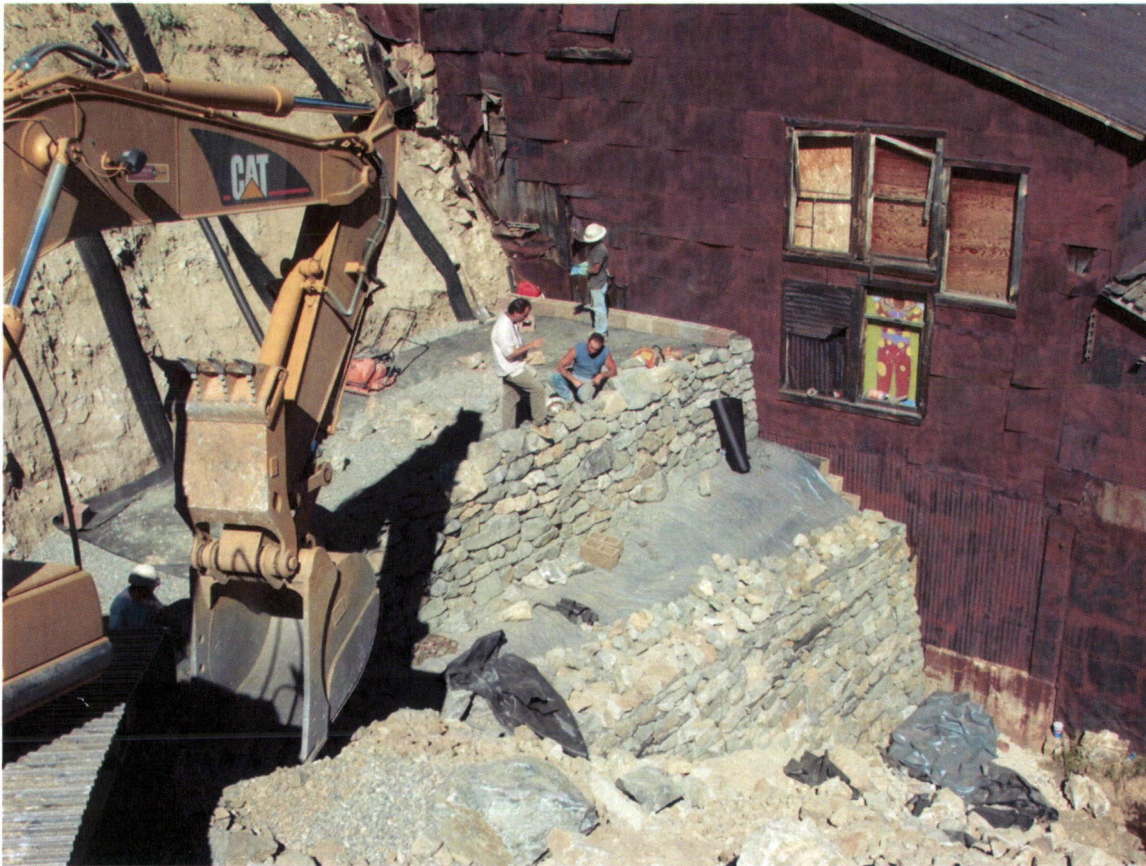
After the fabric is placed, a new course of stone is lain by workers for the face of the wall.

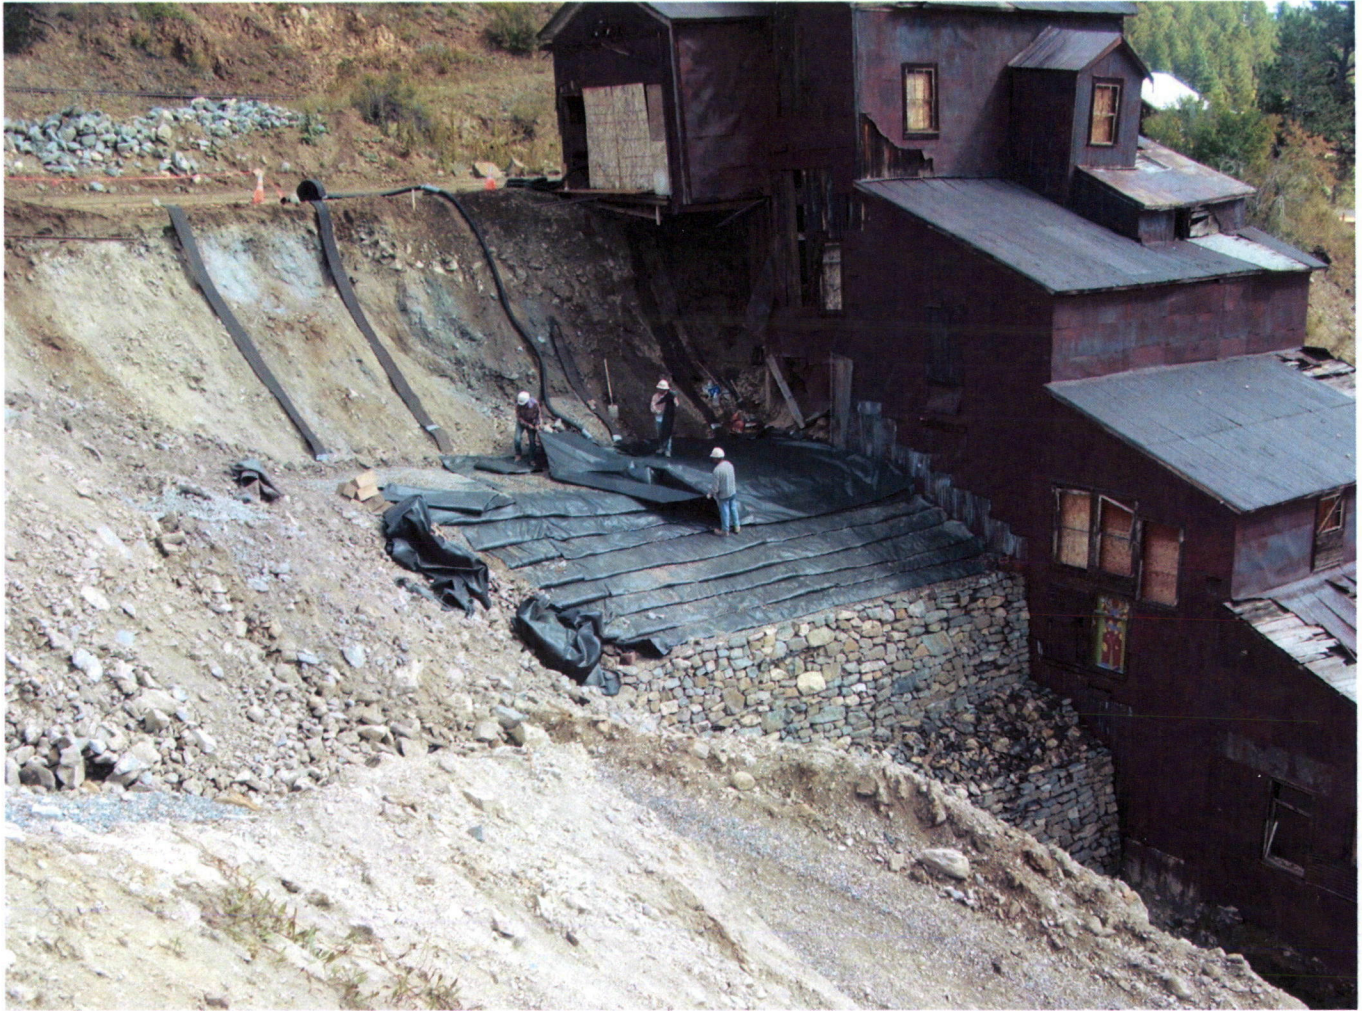
The MSE wall was constructed in 6-inch lifts throughout the entire wall. This photo of one of the Terraces shows the completed lifts with fabric material enclosing the 6-inch gravel lift. This sloped back area is being covered with a final fabric layer that will have a final cover of rock for the face.

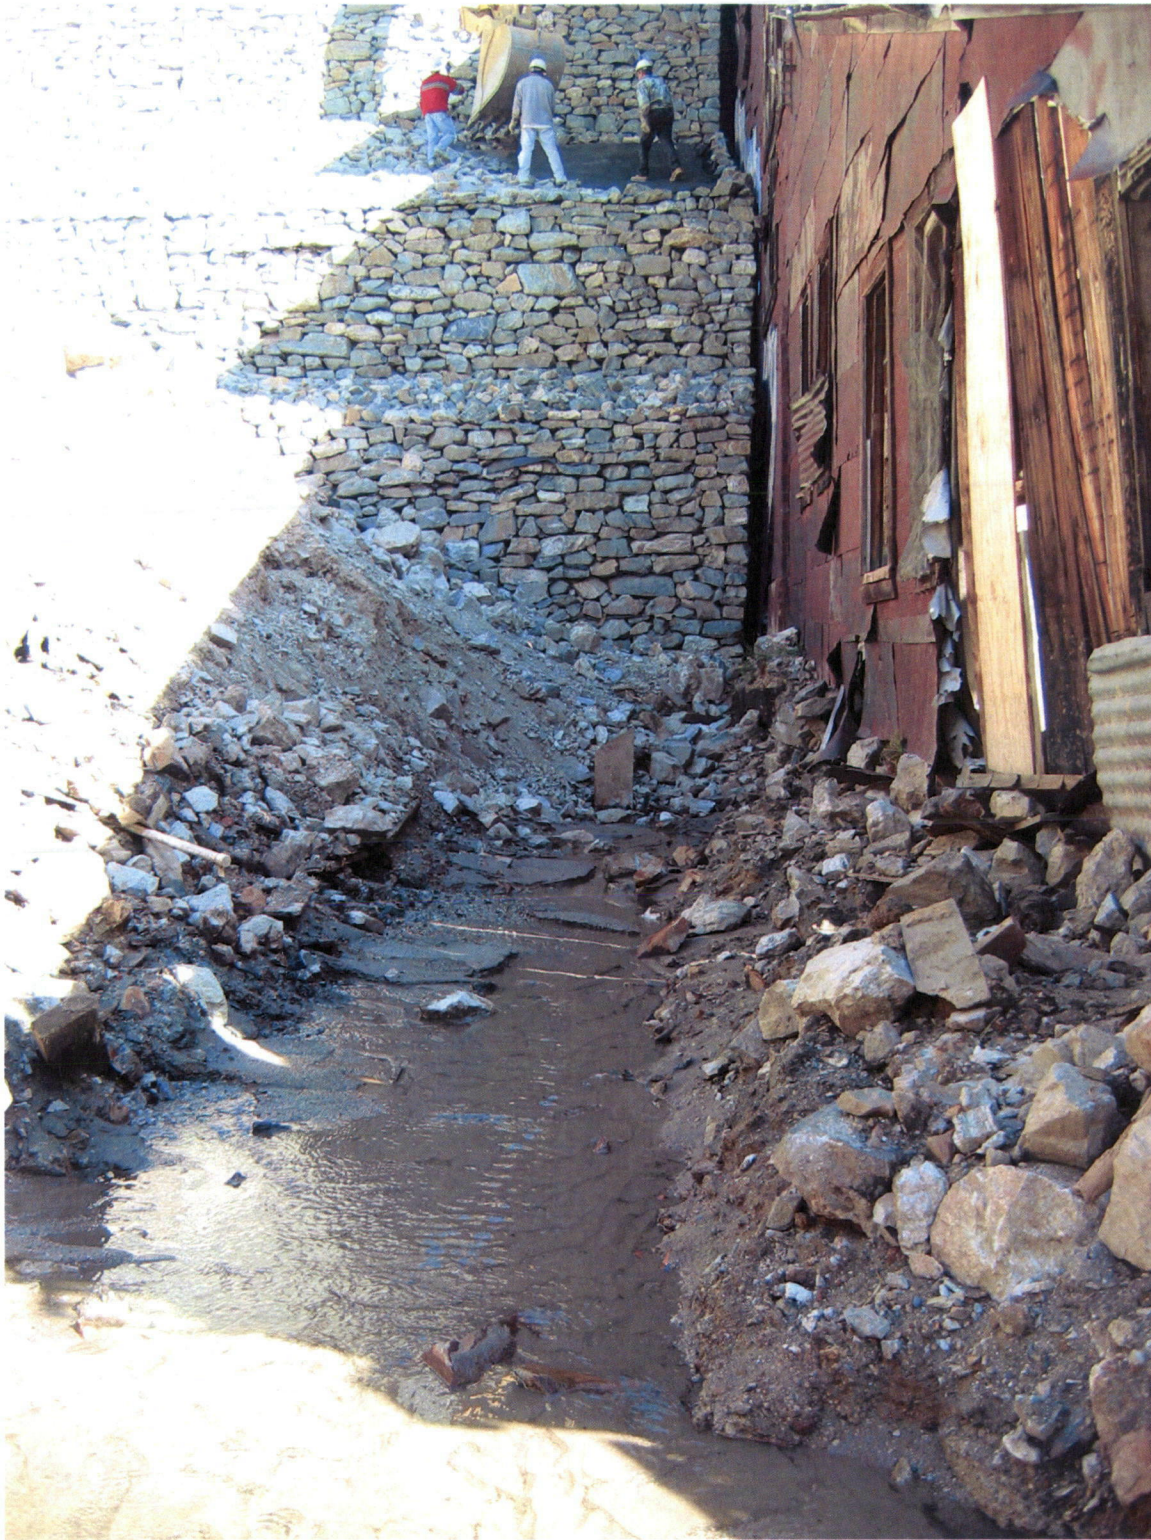
On the terraces, workers place a final rock face. Groundwater seeping out of toe of mine waste pile

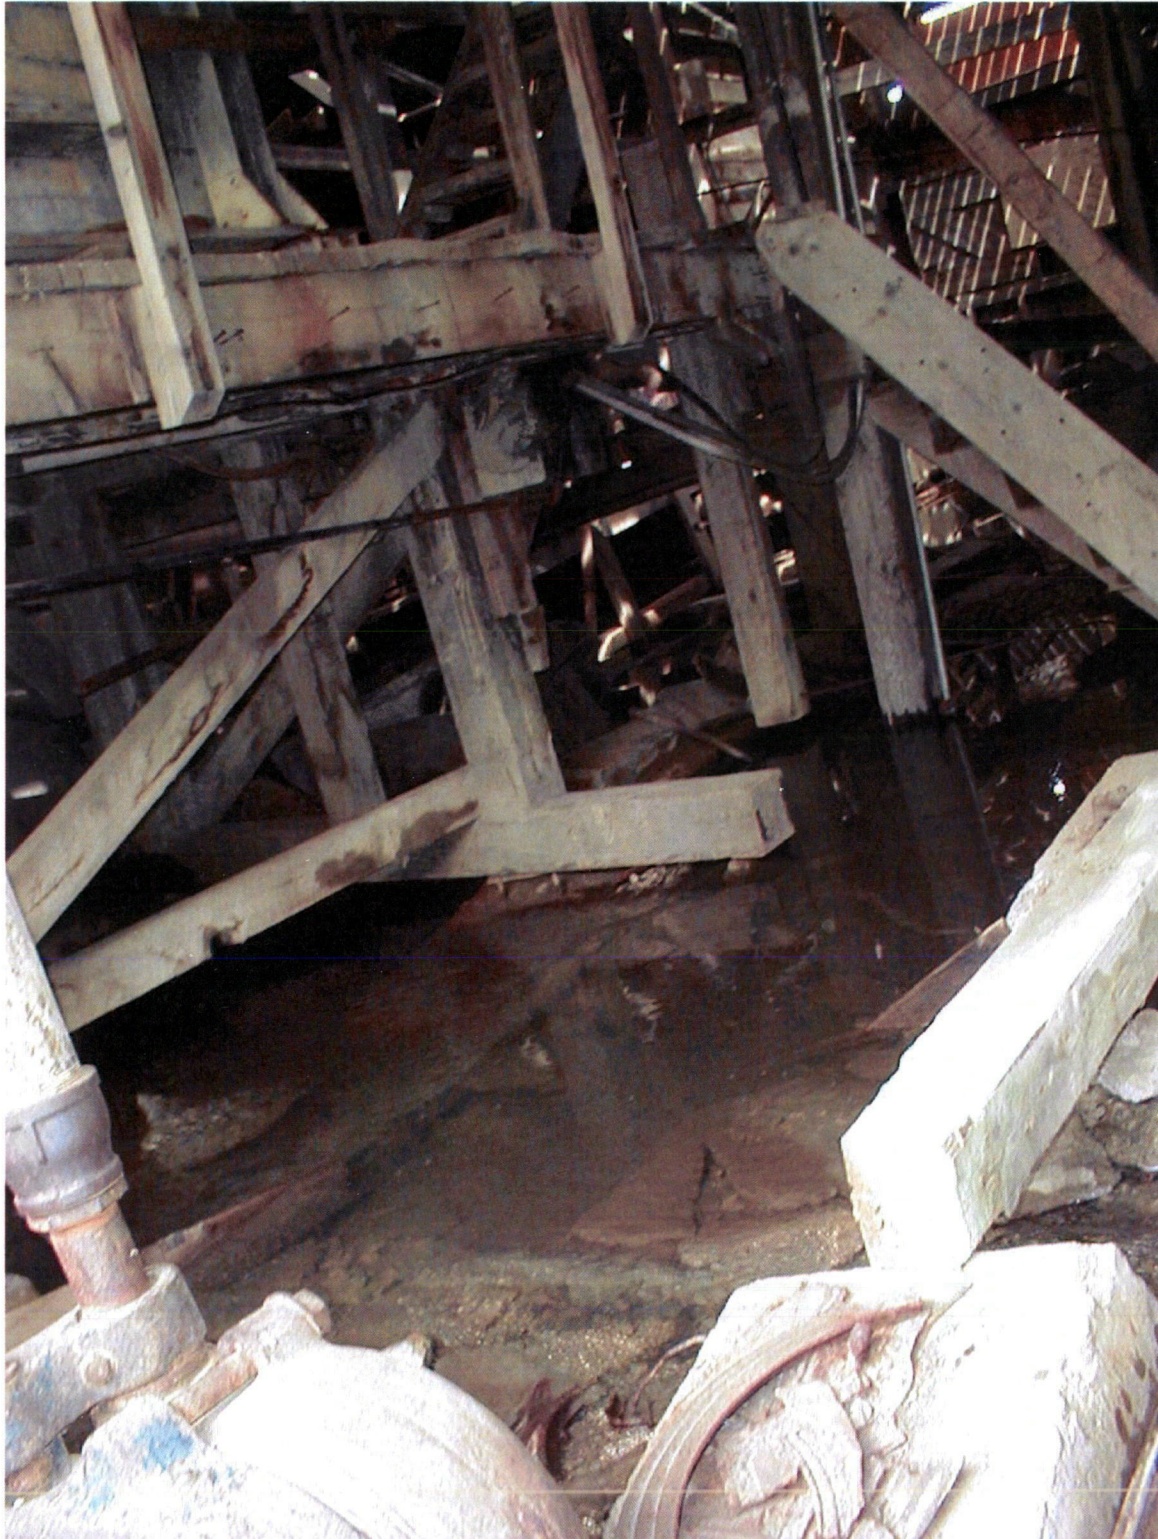
Groundwater seeped into the mill building and pool up in 2-4 foot deep pools in places.

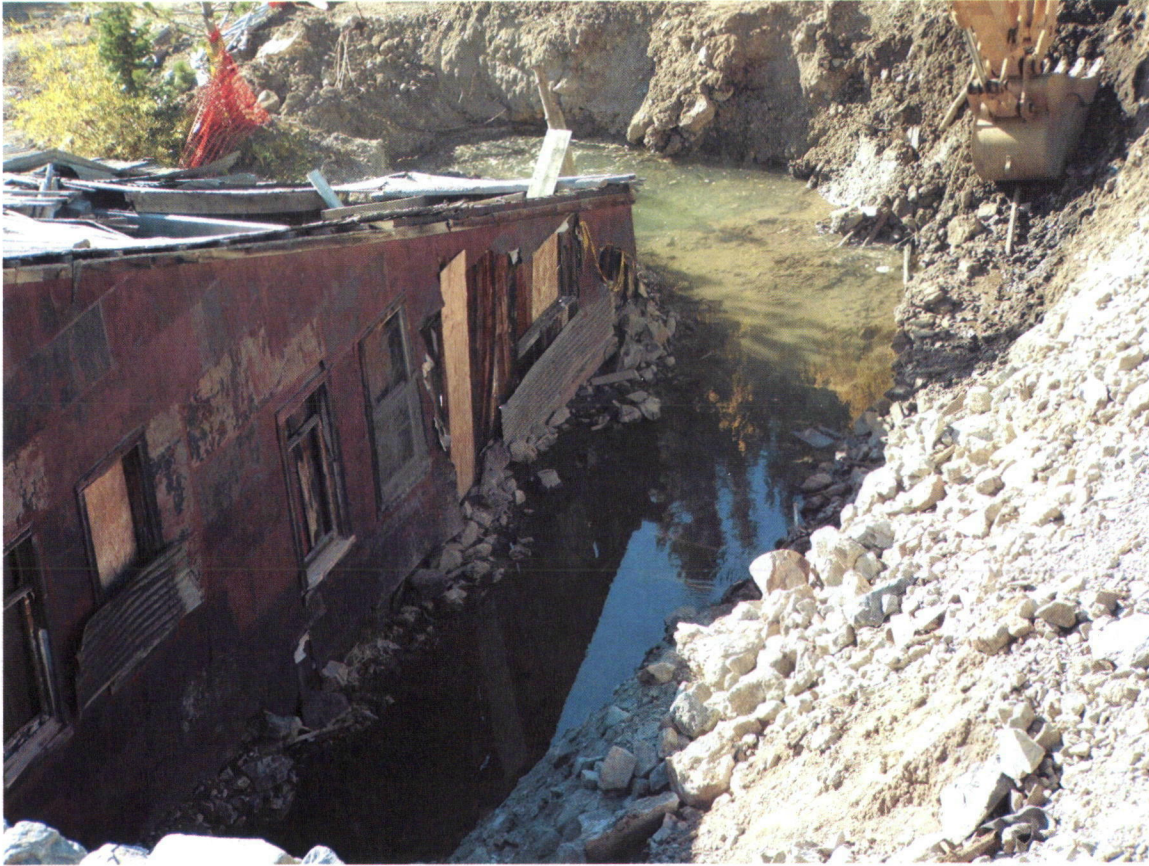
Groundwater collecting in cleaned trench prior to construction of interceptor drain

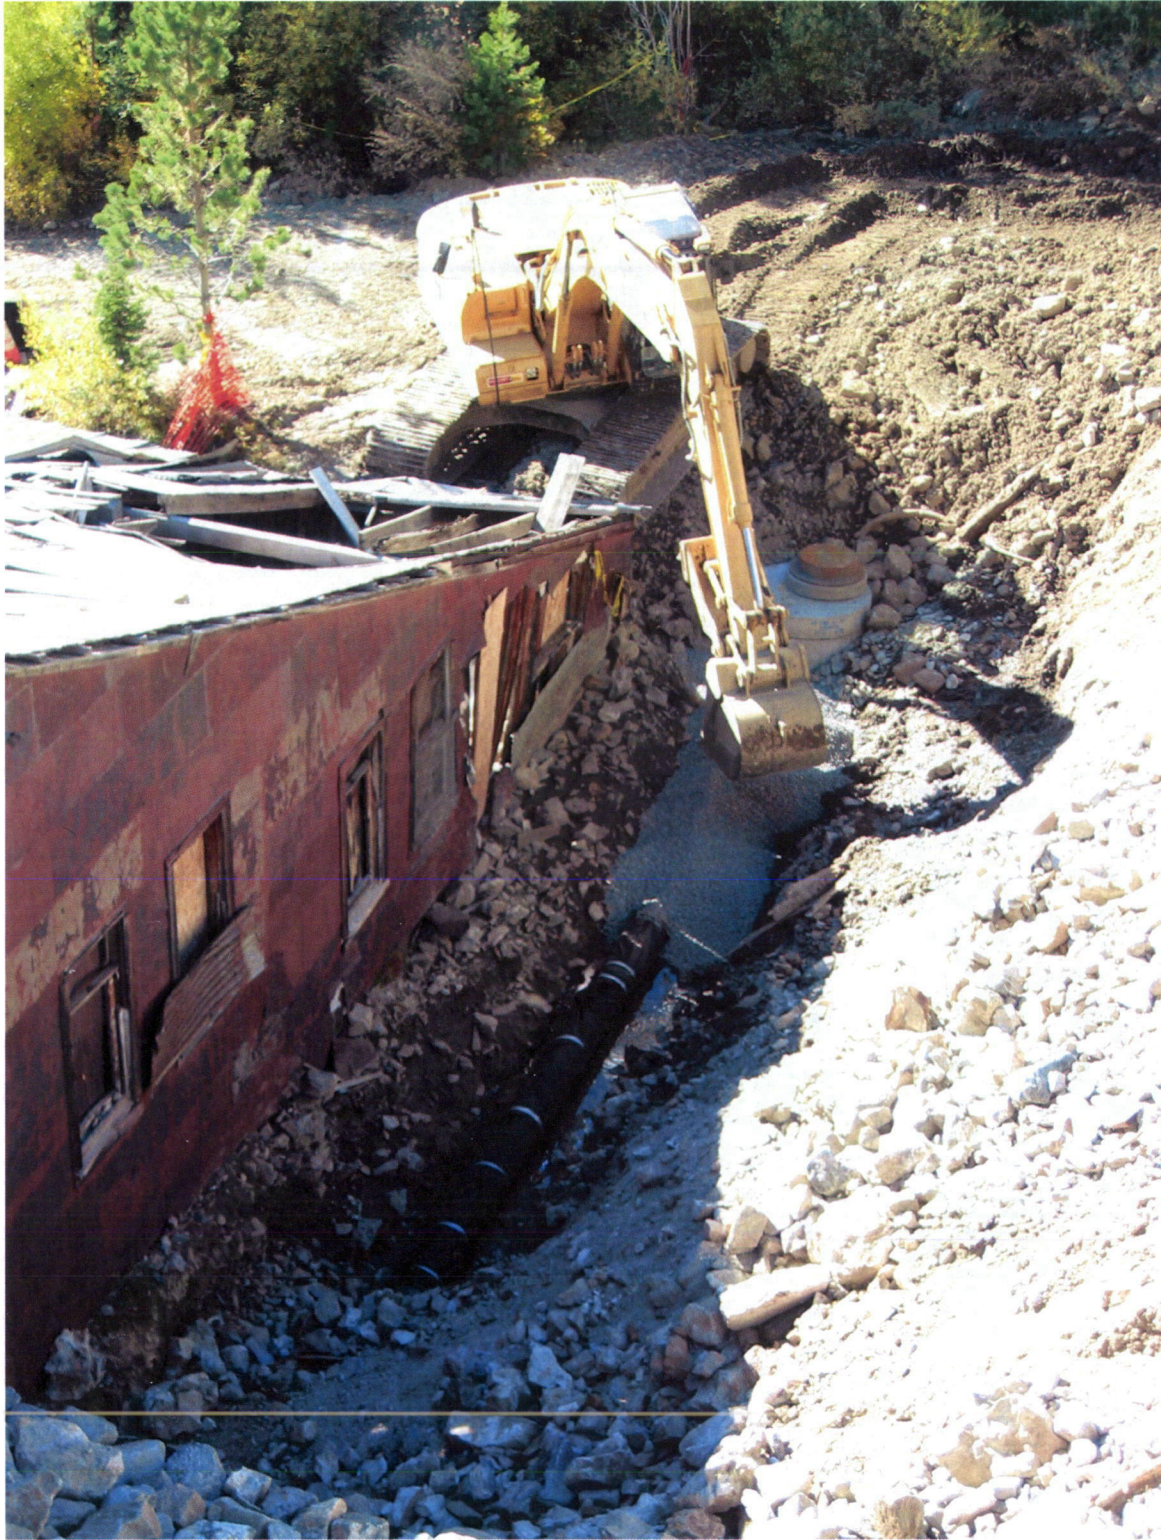
Groundwater inceptor trench with collection pipe being backfilled with gravel, not manhole clean out, next to excavator.

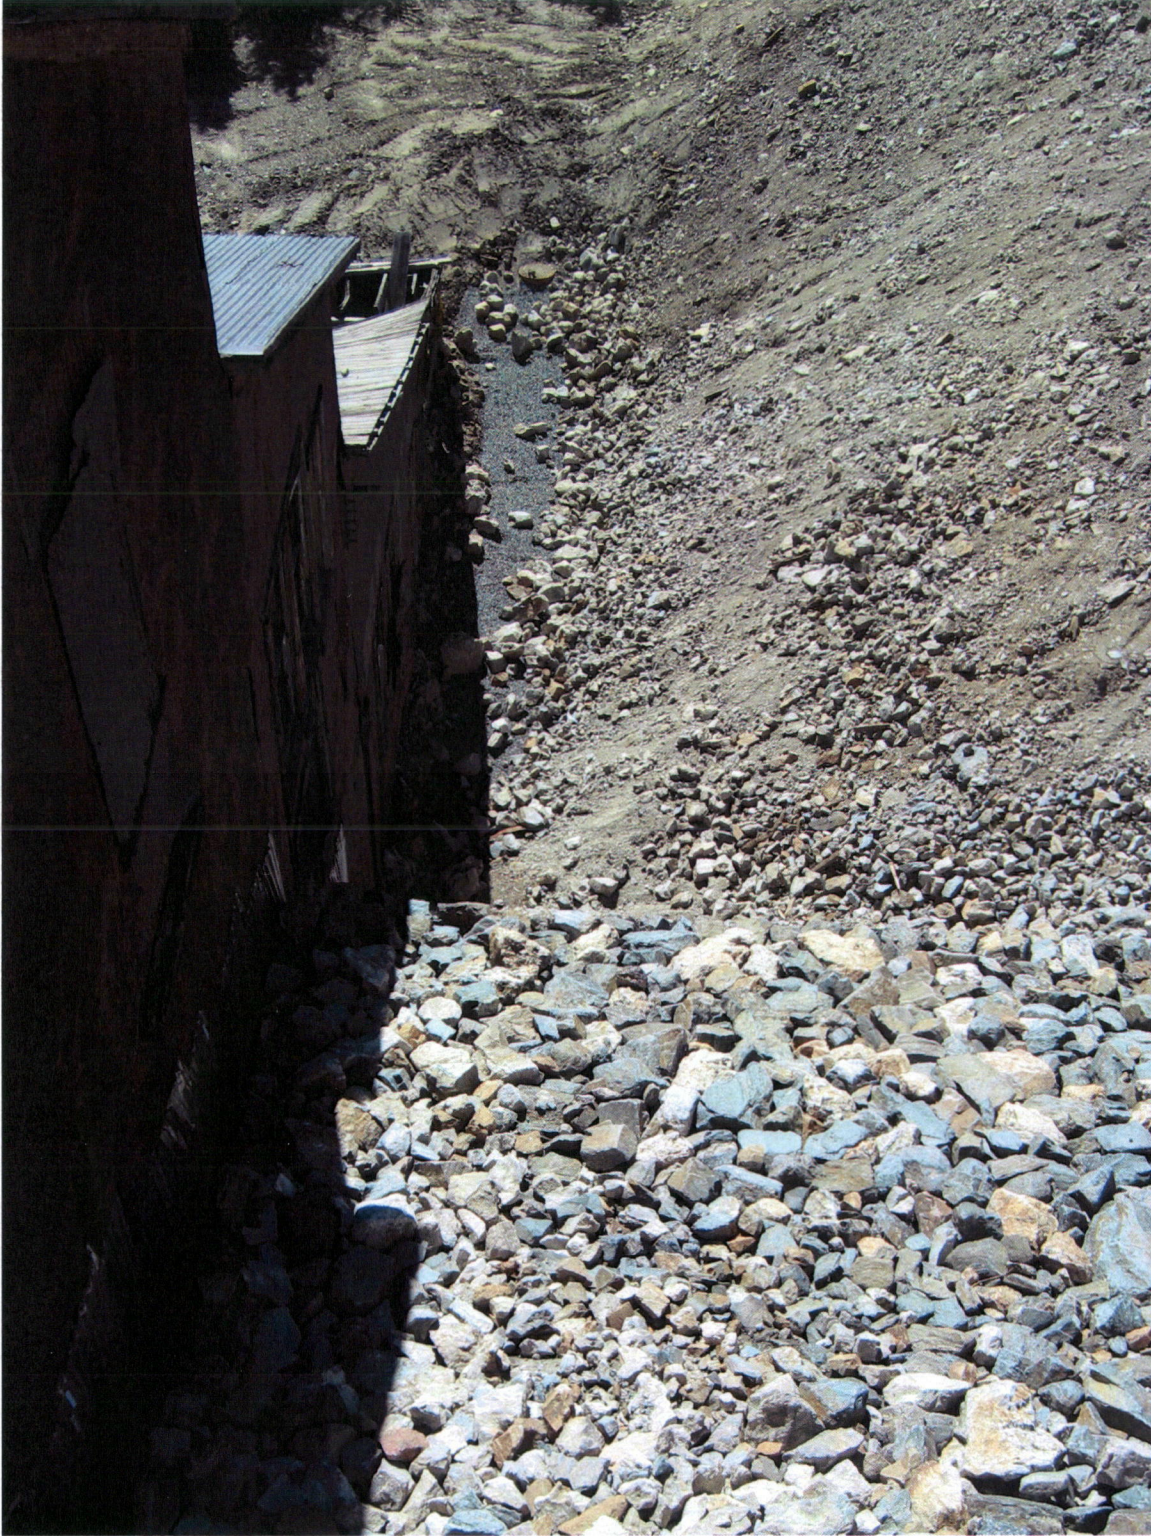
Completed groundwater inceptor drain note light colored gravel next to building.

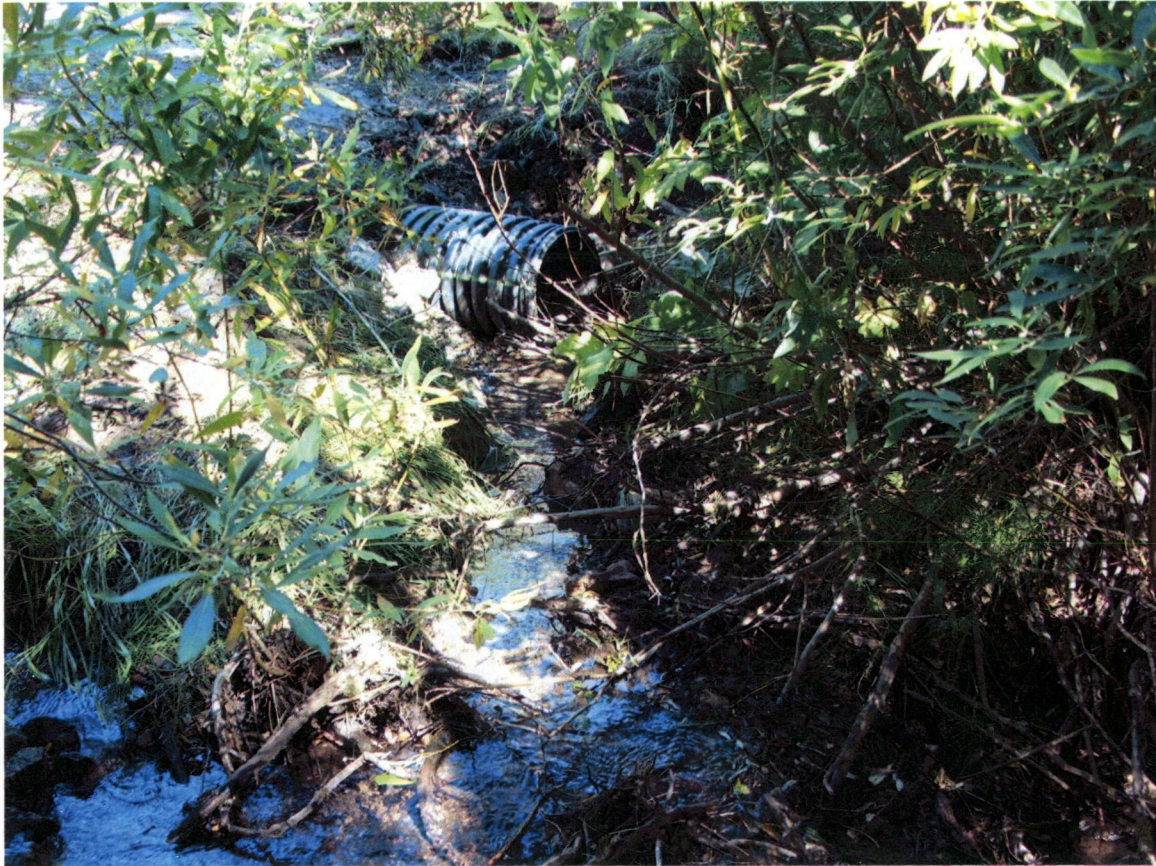
Discharge point from groundwater collection trench.

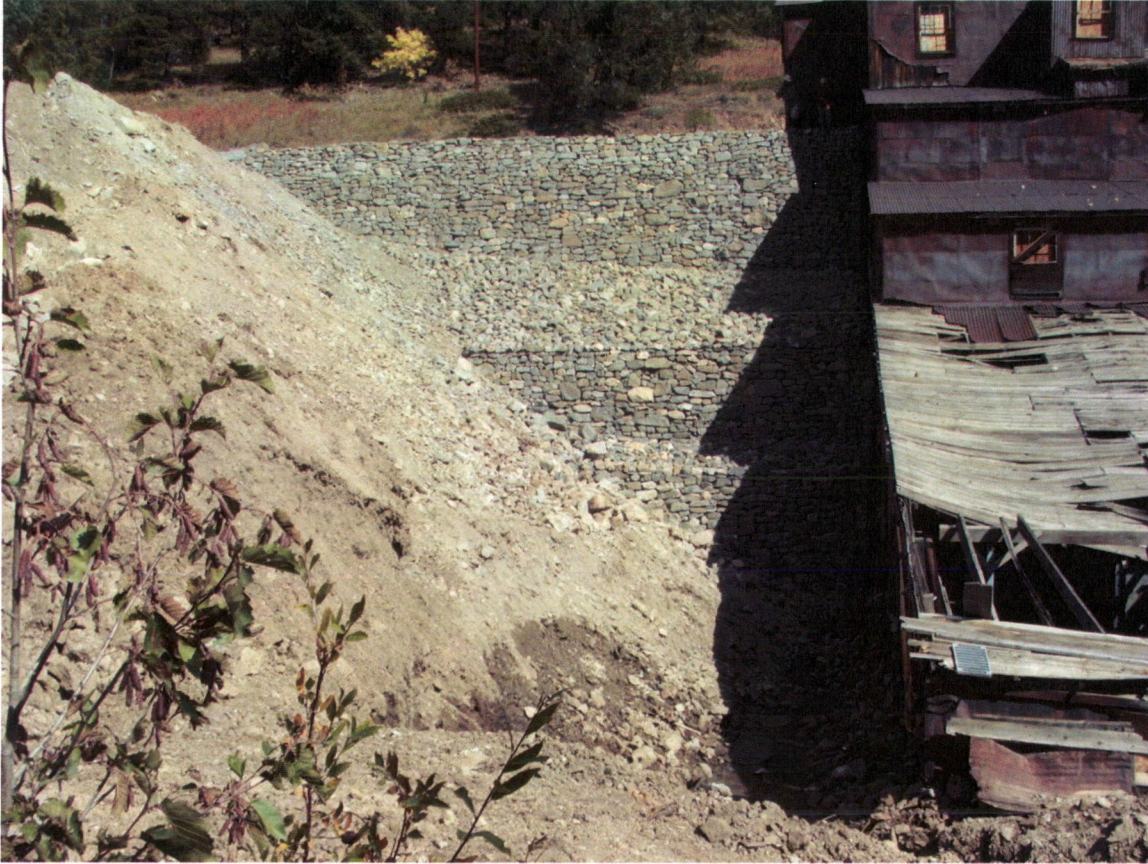
Completed MSE wall.
