# U.S. 36 Wildlife Crossing Assessment, Prioritization, & Cost Estimation Study

AUGUST 2024

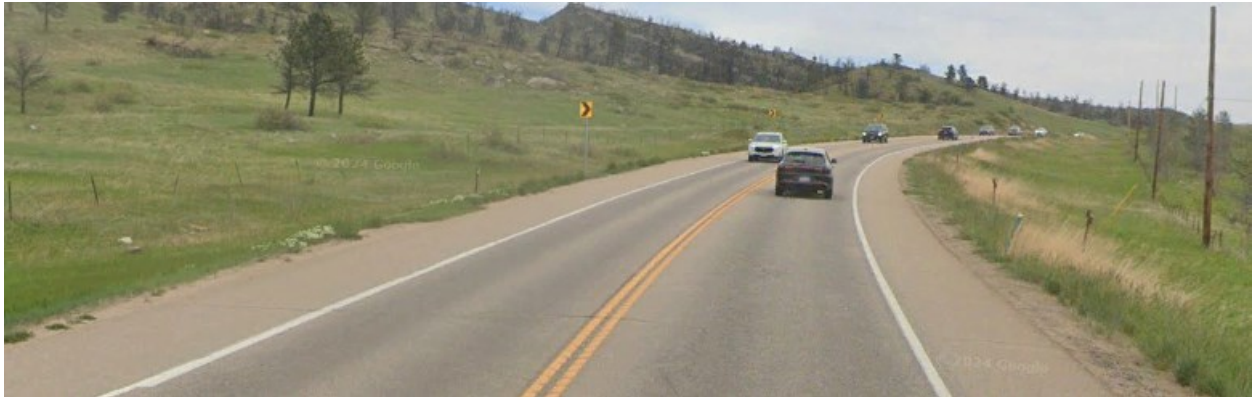
**Photo 1. View of US 36 near MP 25.5**

US 36 between Nelson Road and SH 66 generally consists of a single vehicular travel lane in both directions and shoulders with turn-lanes at the intersections with SH 66, Hygiene Road, Saint Vrain Road, and Nelson Road. US 36 between Nelson Road and SH 66 has portions that occur within cuts (i.e., favorable for overpasses), fills (i.e., favorable for underpasses), and both flat and high-gradient topography. The topography surrounding US 36 was considered during the screening process and is further discussed in Chapter 4.

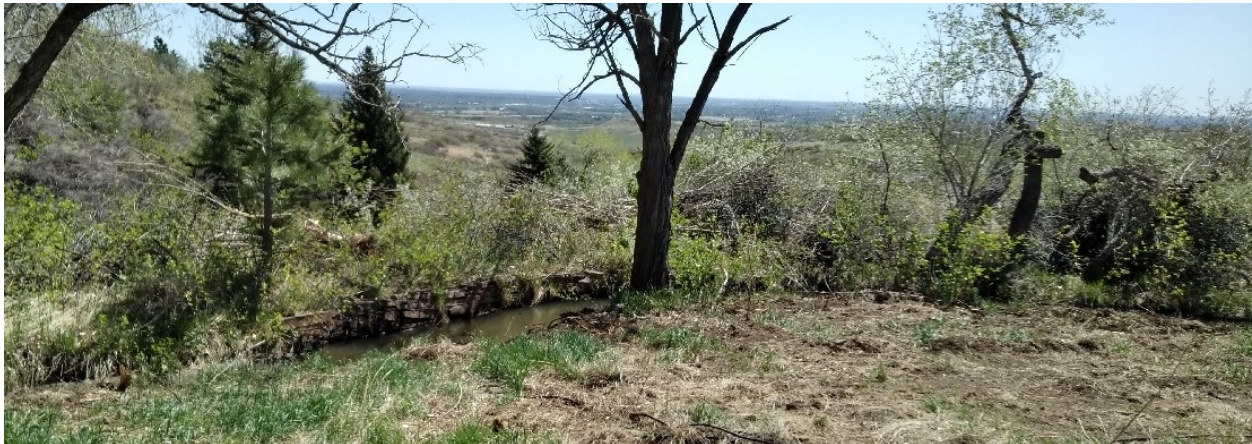
**Photo 2. View of Lake Ditch near MP 24.5**

Lake Ditch meanders along the east side of US 36 from roughly MP 24.5 to 26.5 (Figure 8). At some areas of the project corridor, the ditch and its associated infrastructure (e.g., access roads) are close enough to the highway so that it would pose challenges to the construction feasibility of proposed underpasses and/or overpasses. Considerations of Lake Ditch and other ditch features during the screening processes are further discussed in Chapter 4.

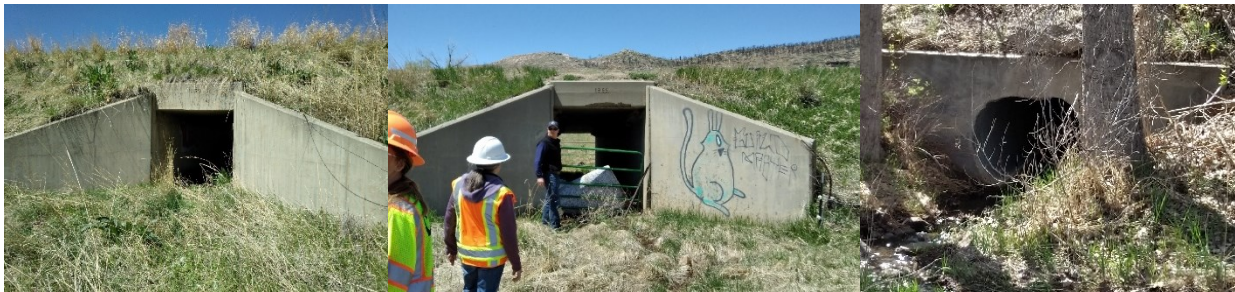
**Photo 3. View of Existing Drainage Structures near MP 25.5 (Left), MP 26.8 (Middle), and MP 24.4 (Right)**

Drainage structures (e.g., concrete box culverts, corrugated metal pipes) were identified in the CDOT OTIS database and are shown in Figure 8. Currently, there are few structures along the project corridor large enough to be used by ungulates. Some medium-to-small sized culverts in the area may provide safe passage for bears and smaller mammals (e.g., coyotes, rabbits, mice). Although bears are large mammals, they frequently use smaller structures for passage; however, there is a size limit where small culverts are not usable by bears. These existing structures may be cleaned and integrated with wildlife fencing to increase usage by bears and smaller mammals or upsized to increase usage by ungulates. Chapter 4 screens the existing drainage structures and provides recommendations for which to upsize for use by ungulates.

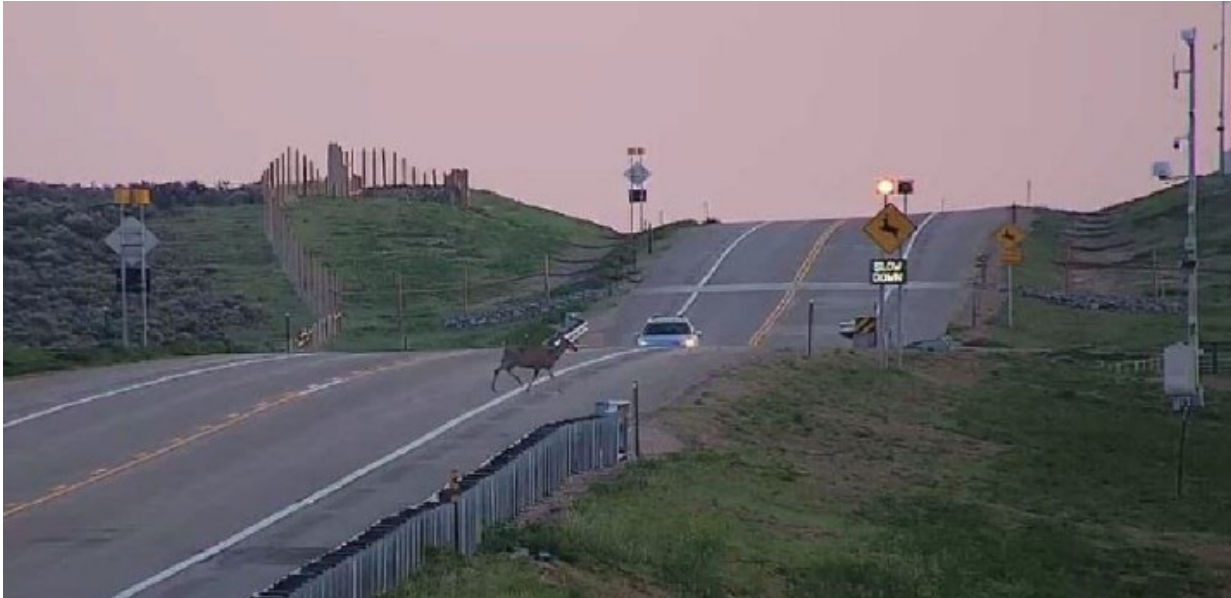
**Photo 5. Example of a Wildlife Detection Zone**

zone is recommended on Nelson Road on the straightaway between Triple Creek Ranch and North 51st Street, where most elk crossings occur.

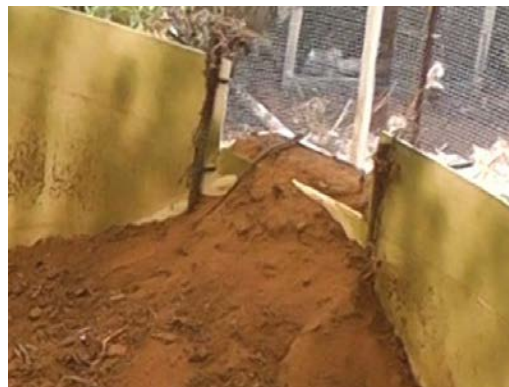
**Example of a Small Animal Jump Out**

**Small Animal Jump Outs:** These would be installed in conjunction with the herptile barrier. They are similar to escape ramps for ungulates but smaller, allowing small animals that get trapped on the roadway side of the fence to jump out. Documentation shows them to be effective. Additional information: <https://dot.ca.gov/-/media/dot-media/programs/environmental-analysis/documents/final-caltrans-usgs-report-herproadresearch-rev.pdf>. Approximate Cost: **\$500**

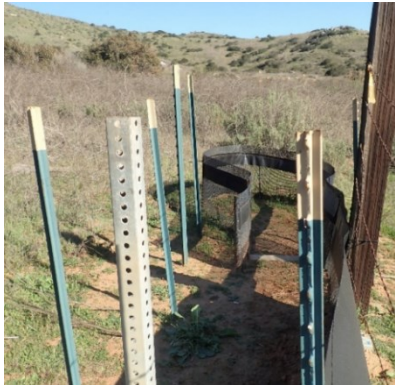
**Example of a Turnaround**

**Turnarounds:** This would also be installed in conjunction with herptile barrier. Turnarounds involve adding blocks along fences near crossings to encourage animals to turn around back toward the crossing. Documentation shows them to be effective. Additional information: <https://dot.ca.gov/-/media/dot-media/programs/environmental-analysis/documents/final-caltrans-usgs-report-herproadresearch-rev.pdf>. Approximate Cost: **\$250**

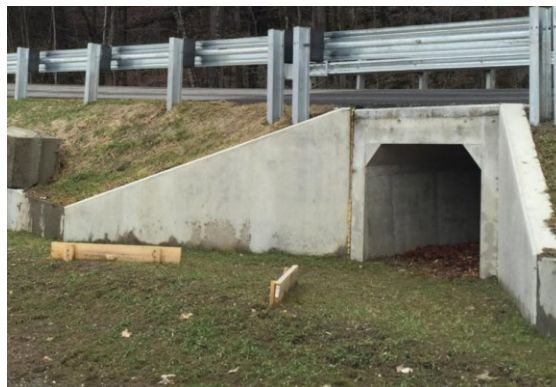
**Example of Guide Walls**

**Guide Walls:** Angled concrete or wooden walls that promote funneling smaller animals into a culvert. The walls are offset a few feet away from the culvert and are around 6 inches to 1 foot tall. Additional information: <https://storymaps.arcgis.com/stories/84e9c986d22e4864b4c3b78660ca442e>. Approximate Cost: **Nominal to \$250 if constructed from wood**

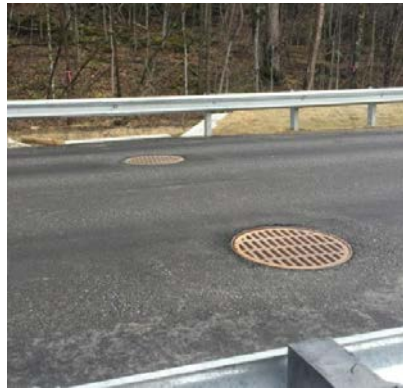
### Example of a Lighting Grate

**Lighting Grate:** Grates added to the pavement surface above the culvert to allow light, moisture and air circulation into the culverts, making it more likely animals may use it by reducing the tunnel effect. These are like drainage grates but could be smaller. The grates should be installed to avoid the typical wheel paths of the traffic above (such as in the shoulder, on the centerline stripe, or exactly in the middle of the lane). Additional information: [https://files.ontario.ca/bmp\\_herp\\_2016\\_final\\_final\\_resized.pdf](https://files.ontario.ca/bmp_herp_2016_final_final_resized.pdf). Approximate Cost: **\$10,000/grate**

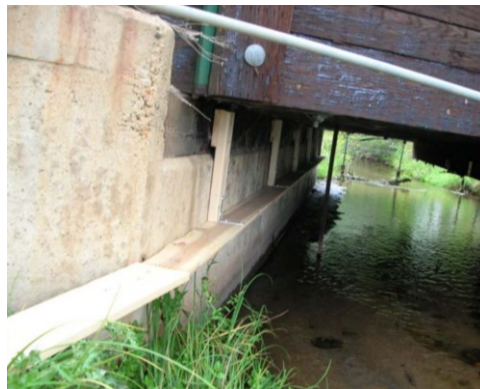
### Example of a Catwalk

**Catwalks:** An elevated ledge or walkway ("catwalk") through a culvert. The catwalk should be high enough to be above the normal water elevation and have ramps at the culvert ends to allow animals to get up to it. The catwalks can be cast into the side of new concrete culverts or added to existing culverts with metal grating or lumber. The width of the catwalk will depend on the species targeted. If a catwalk were to be installed in a culvert conveying irrigation, it would need to be coordinated with the owner of the irrigation ditch. Additional information: <https://www.codot.gov/programs/research/reports/2007/smallmammal.pdf>. Approximate Cost: **\$100/linear foot**. Culverts along US 36 are in the range of 100 feet long, so this would cost around \$10,000 per culvert

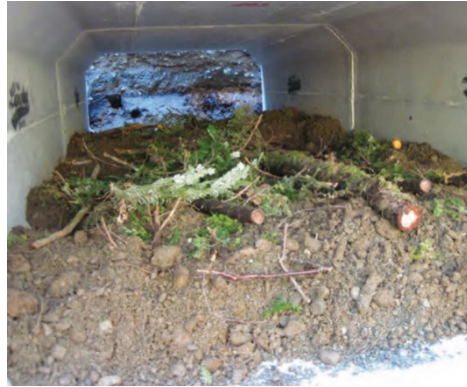
### Example of Backfill

**Backfilling a portion of the culvert:** Soil or smooth rocks may be used. Hydraulic requirements may preclude this option in some culverts. Backfilling a portion of the culvert serves two functions. 1) It makes the opening smaller to match the dimensions of smaller animals. 2) It creates a natural bottom. Additional information: [https://files.ontario.ca/bmp\\_herp\\_2016\\_final\\_final\\_resized.pdf](https://files.ontario.ca/bmp_herp_2016_final_final_resized.pdf). Approximate Cost: **\$2500 or more, depending on the size of the culvert.**

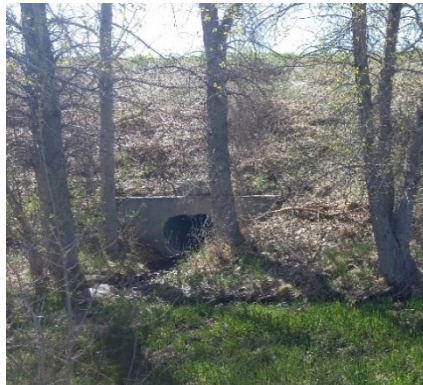
### Example of Vegetation

**Adding Vegetation:** Some research suggests simply adding vegetation of any kind to the bottom of a culvert and near the entrance to a culvert would make it more likely for small animals to cross. Lighting grates must be added to support vegetation in culverts. Specific plants can be selected to entice a particular species to use the crossing, or to repel certain species to keep them away from the roadway. This tactic of repelling is mentioned in literature but is unconventional and untested. Additional information: [https://files.ontario.ca/bmp\\_herp\\_2016\\_final\\_final\\_resized.pdf](https://files.ontario.ca/bmp_herp_2016_final_final_resized.pdf). Approximate Cost: **\$5000 or more depending on types and quantities of plants.**

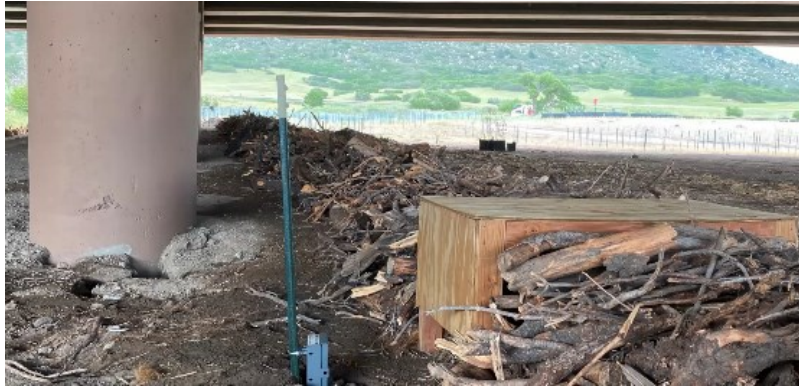
### Example of Vegetation and Brush Windrows

**Vegetation and Brush Windrows on an Ungulate Overpass:** To make an overpass attractive to smaller species, add shrubs, trees, and grass to the top. Tunnels made of sticks can be built to provide shelter for smaller species. Additional information: [https://files.ontario.ca/bmp\\_herp\\_2016\\_final\\_final\\_resized.pdf](https://files.ontario.ca/bmp_herp_2016_final_final_resized.pdf). Approximate Cost: **\$1000 per tree; \$150 per shrub; \$30/linear foot brush windrow**

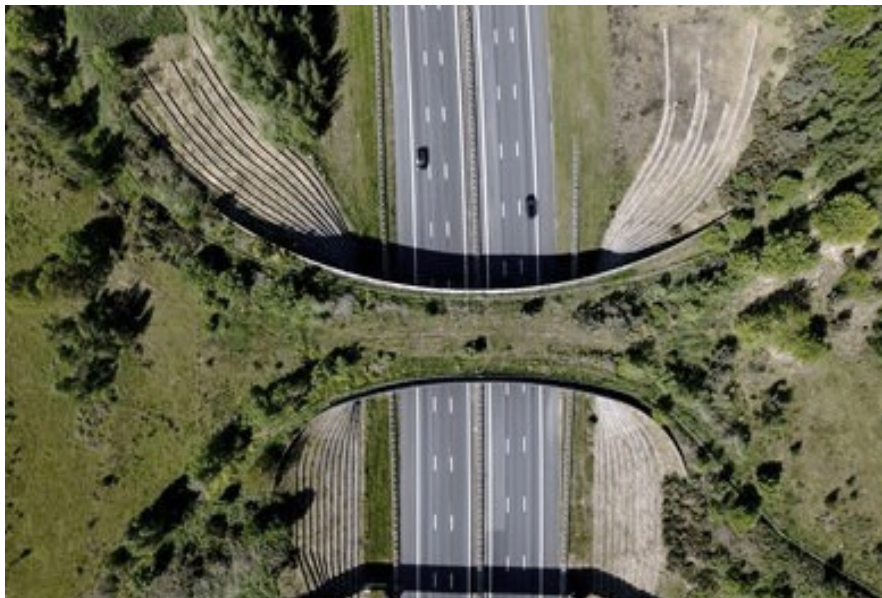
**Photo 6. Example of hourglass-shaped overpass**

For each of the three wildlife crossings, the structure, earthwork, and pavement work were drawn and modeled in conceptual Civil 3D models using aerial imagery and existing terrain data from the Denver Regional Council of Governments.

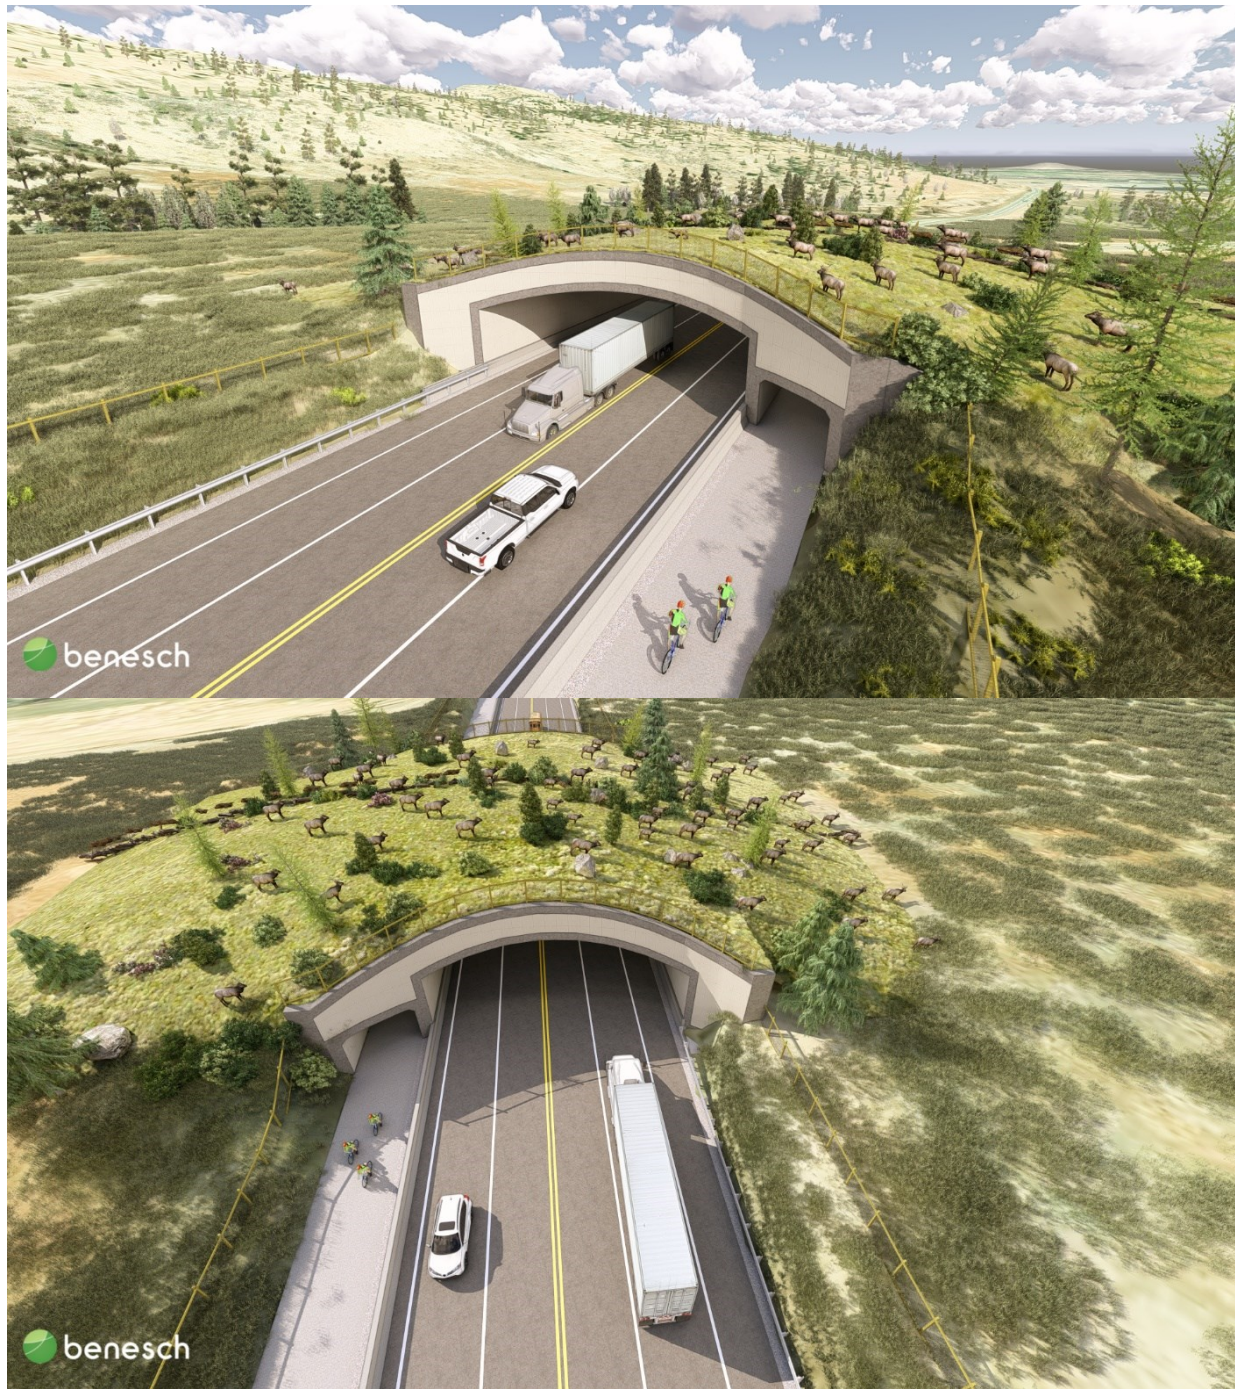
**Photo 8. Conceptual Renderings of the Overpass at MP 24.6**

The images below are conceptual renderings of the overpass at MP 24.6. There will be a berm or opaque fence in the final design.

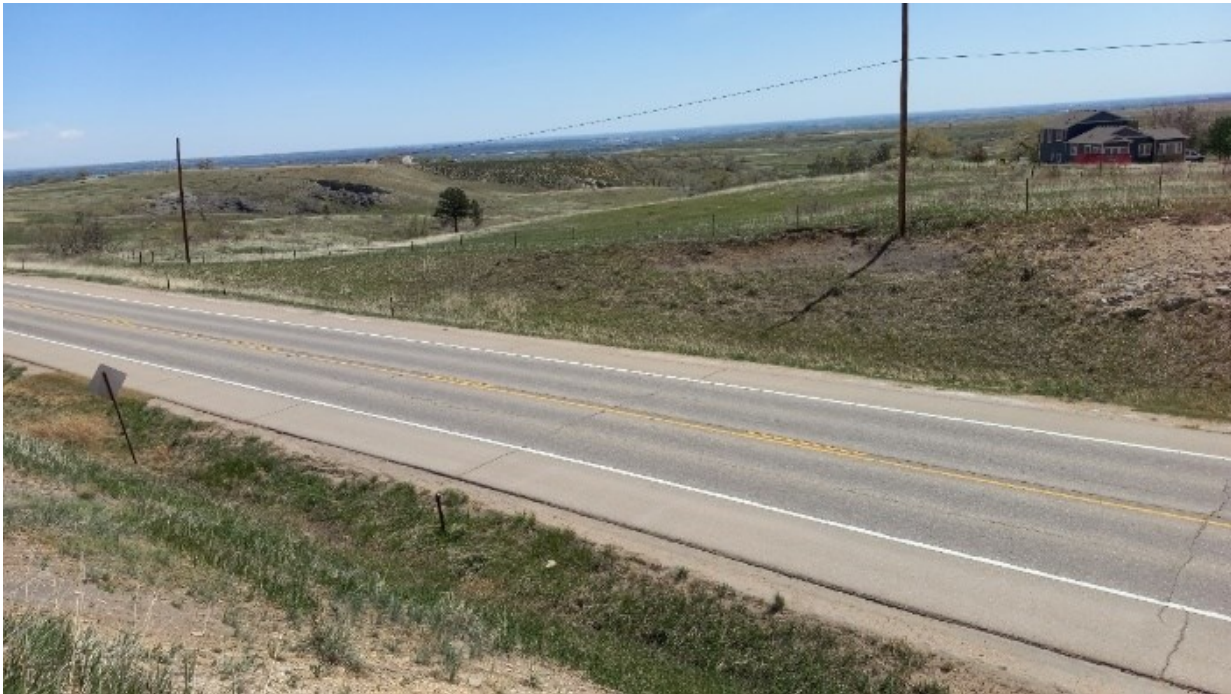
**Photo 9. View of MP 26.4**

The overpass at MP 26.4 was ranked 2nd. It costs approximately the same as the overpass at MP 24.6, but the benefit is much lower because the number of WVCs in this segment is much lower. It ranks above the crossing at MP 22.4 because the land on both sides of MP 26.4 is open space and it has fewer potential environmental resources than MP 22.4.

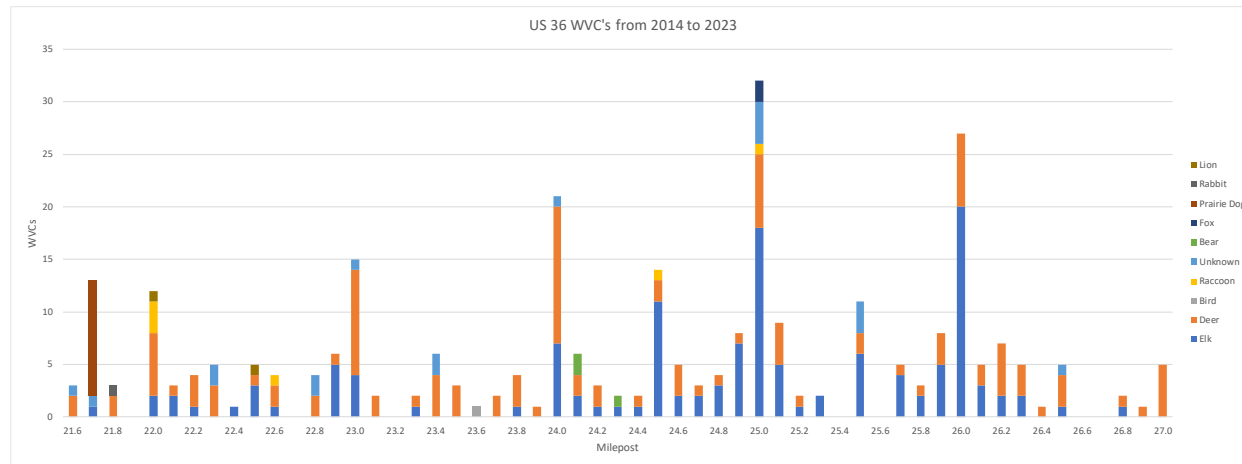
**Figure B-16. U.S. 36 WVCs from 2014 to 2023**

- The non-ungulate species include raccoon, skunk, cat, prairie dog (11 prairie dog WVCs at MP 21.7), rabbit, mountain lion, and a bird.
- The spikes at each milepost are most likely attributed to rounding when the data was collected.
- The deer WVCs are more uniformly spread throughout the corridor, whereas the elk have significant bumps around MP 25 and MP 26.

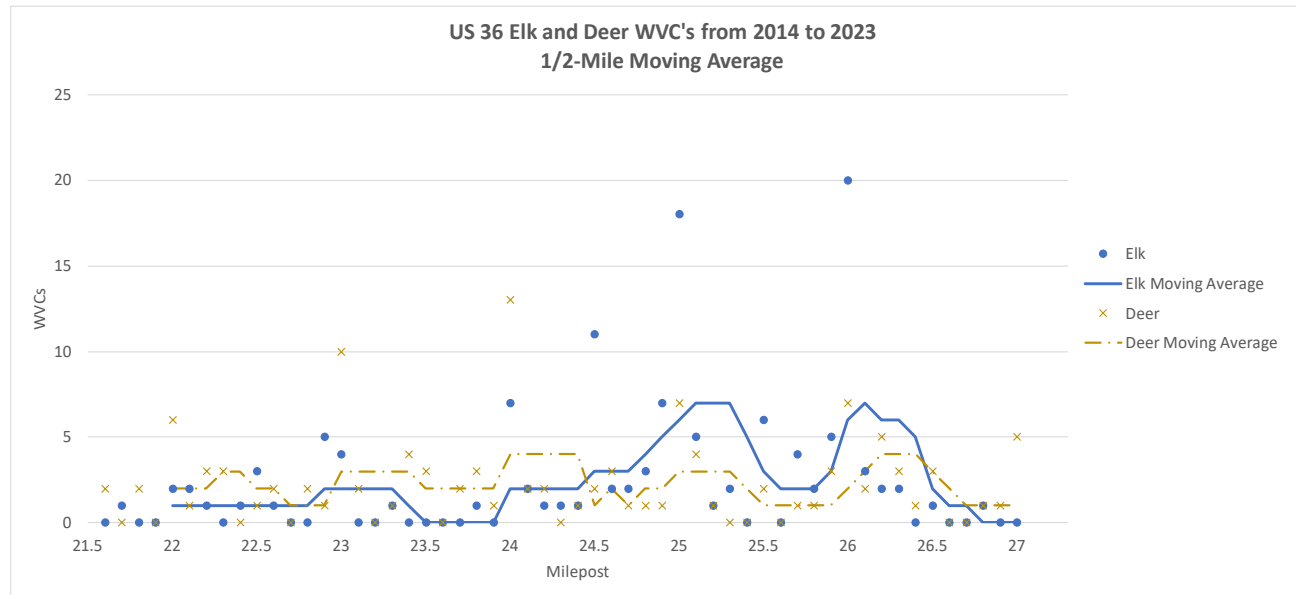
**Figure B-17. U.S. 36 Elk and Deer WVCs from 2014 to 2023 1.2-Mile Moving Average**

WVC data was supplemented by collar data and the knowledge of BCPOS and CPW staff. A 0.5-mile moving average of the WVCs was used to smooth out spikes at each milepost caused by rounding during data collection. The scoring considers only elk because deer WVCs are fairly uniform across the entire corridor with moderate increases at the same locations where the elk have increases. See Appendix B for details about the WVC data and analysis.

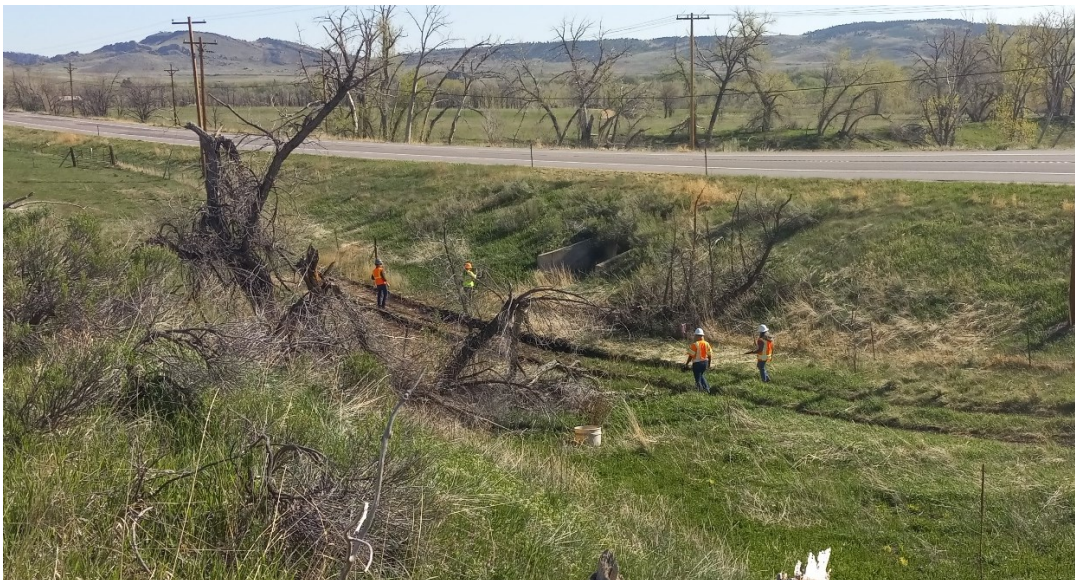
**Photo D-10. Milepost 22.9**

There is a stock pond on the west, and Jon said there used to be one on the east, but it is dry now.

22.9	Underpass. Replace existing 48" CMP drainage culvert	1	2	2	2	7	15	WVCs: Moving average = 1 elk, 2 deer Site feasibility: US 36 is on about 12 feet of embankment. The area could be dug out and graded to drain to accommodate an elk crossing, but the grading would be extensive. ROW/Leveraging investments: West - BCPOS. East - Private Environmental Clearances: Potential PMJM habitat. Likely wetlands/waters. No cultural resources beyond US 36 5BL.7529.6.	No. The overpass to the north is more favorable. This is an existing drainage crossing 4 feet in diameter. The area to the east used to be a stock pond until the flood in 2013 changed the hydrology of the Ledge Ditch; now the area is vegetated.

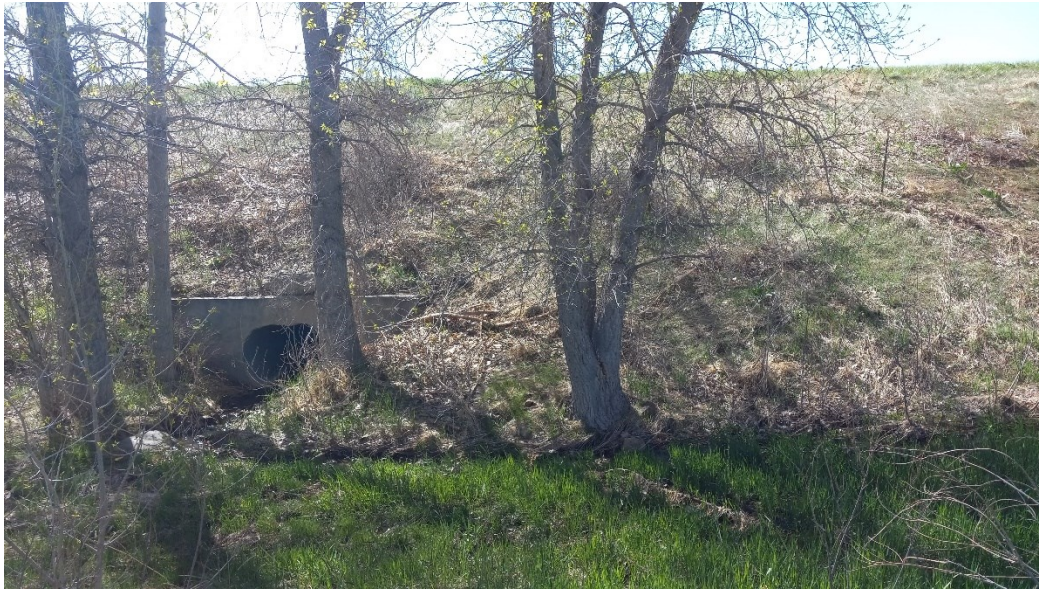
**Photo D-11. Milepost 24.4**

Jon mentioned that there are many elk WVCs in this location. He also mentioned that a crossing here could be less favorable, as it would direct wildlife into an area where they would still have to cross St. Vrain Road to get to Table Mountain.

24.4	Underpass. Replace existing 48" CMP drainage culvert	2	2	2	1	7	17	WVCs: Moving average = 2 elk, 4 deer Site feasibility: Animals have to cross Saint Vrain Road to get to Table Mountain. Irrigation ditch may be in the way ROW/Leveraging investments: Public to west. Private to east Environmental Clearances: Potential PMJM habitat. Likely wetlands/waters. Potentially eligible ditch (5BL.6934) to the southwest and northwest of the crossing.	No. The drainage ditch to the west would make construction of an underpass complicated. Wildlife would have to cross Saint Vrain Road to get to Table Mountain.

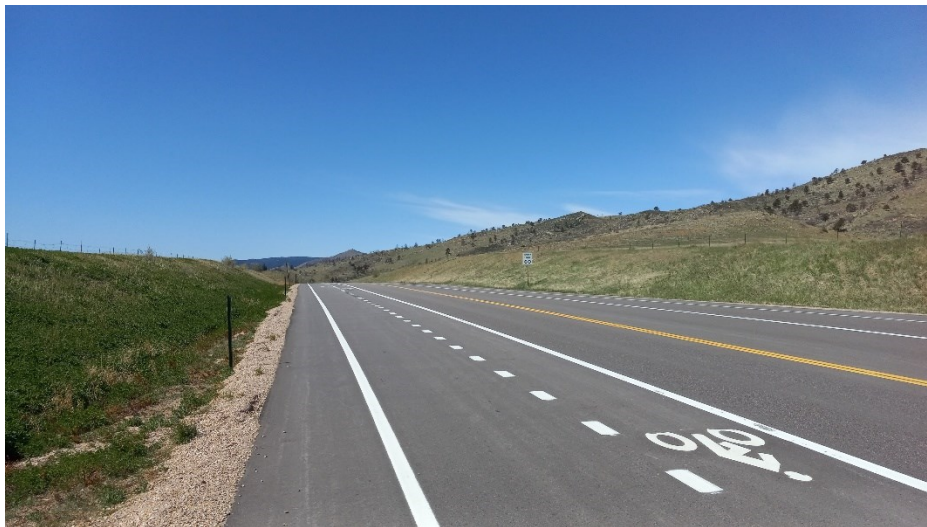
**Photo D-12. Milepost 24.6**

This site was not identified in the ESPWPS. Jon, Joe, and Ben all agreed that more elk cross here than at MP 24.4. Both resident and migratory elk herds utilize this area. Because of the flat topography on either side of US 36, they have a better line of sight to Table Mountain, which is where they want to graze. Elk cross US 36 back and forth daily here, especially during the winter and spring. Joe prefers a crossing here rather than the drainageway because at this location, the elk do not have to cross St. Vrain Road to get to Table Mountain.

US 36 is in a cut at this location, so a wildlife overpass would fit well here. The topography is flat to the east and west of US 36 here at the top of the roadway cut. The irrigation ditch is far from US 36 and would not interfere with the crossing.

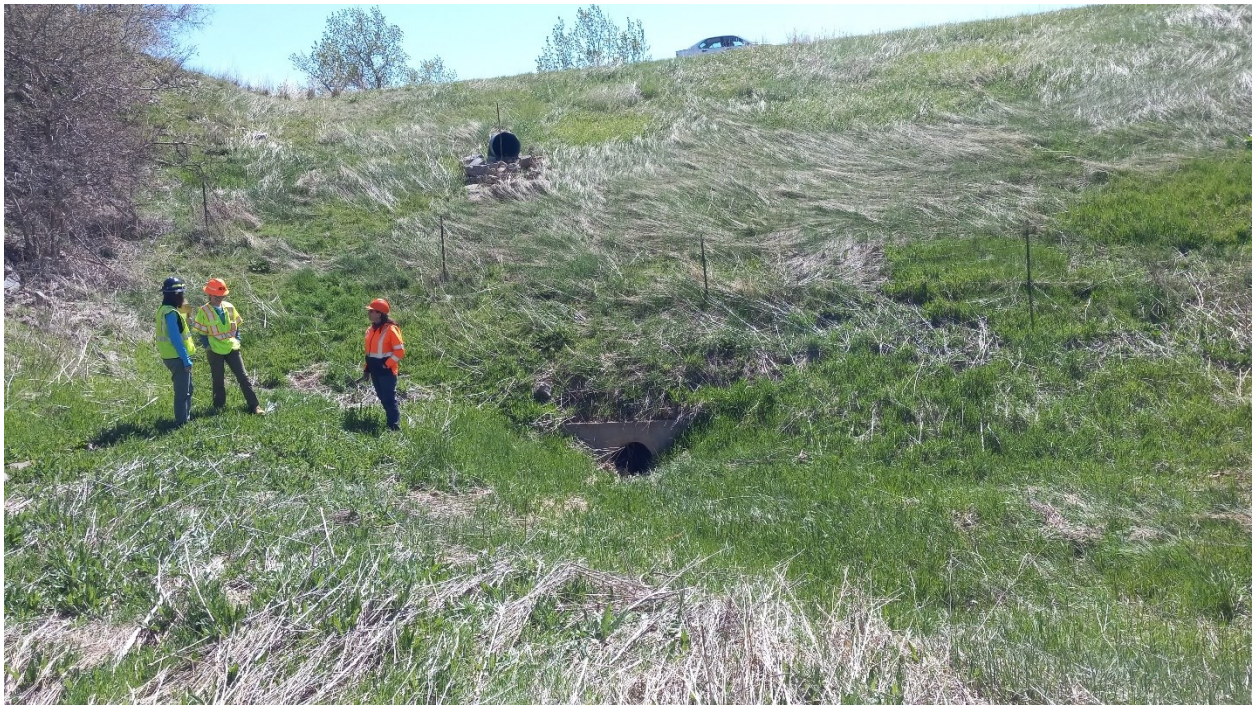
**Photo D-13. Milepost 25.0**

The irrigation ditch to the east is about 30 feet down vertically from the roadway surface and the culvert is further down below the ditch. The floor of the wildlife underpass would have to be above the elevation of the ditch.

25.0	Underpass. Replace existing drainage culvert	3	2	2	1	8	20	WVCs: Moving average = 6 elk, 3 deer Site feasibility: 19' between US 36 surface and top of irrigation ditch limits the structure type options ROW/Leveraging investments: Private land with a conservation easement on east side, east of fence. West is open space. Environmental Clearances: Potential PMJM habitat. Likely wetlands/waters. Potentially eligible ditch (5BL.6934) to the southwest and northwest of the crossing.	No. This location may be a feasible alternative to 24.6. See paragraph above.

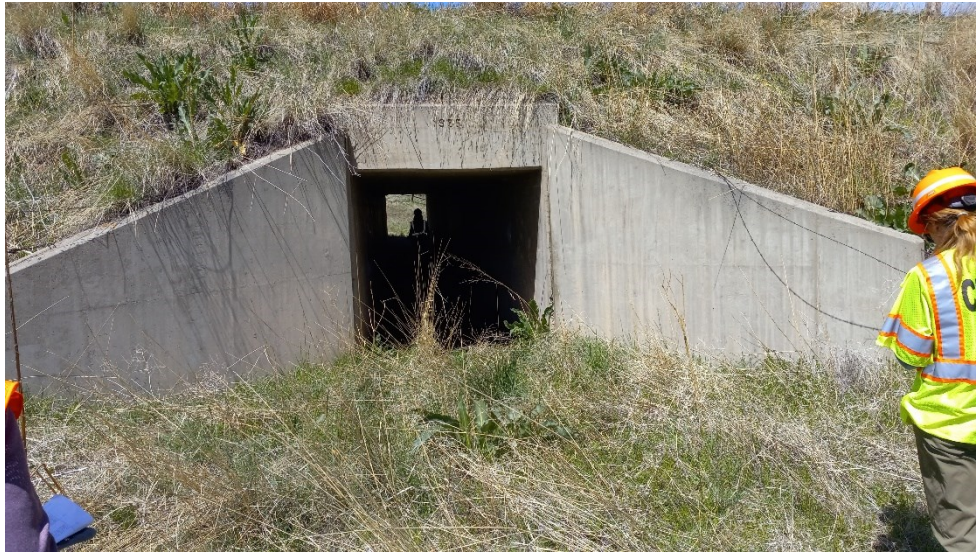
**Photo D-14. Milepost 25.5**

The irrigation ditch to the east may be at a higher elevation than the floor of the elk underpass. Further investigation would be needed to determine how the irrigation ditch and wildlife underpass would interact.

25.5	Underpass. Replace existing 6x7 CBC	2	2	2	2	8	18	WVCs: Moving average = 3 elk, 1 deer Site feasibility: 21' between US 36 and top of irrigation ditch leaves 6' structure depth ROW/Leveraging Investments: Public to west. Private to east Environmental Clearances: Potential PMJM habitat. Likely wetlands/waters. No cultural resources beyond US 36 5BL.7529.6.	No. This box culvert goes public to private. Improvements should be considered.

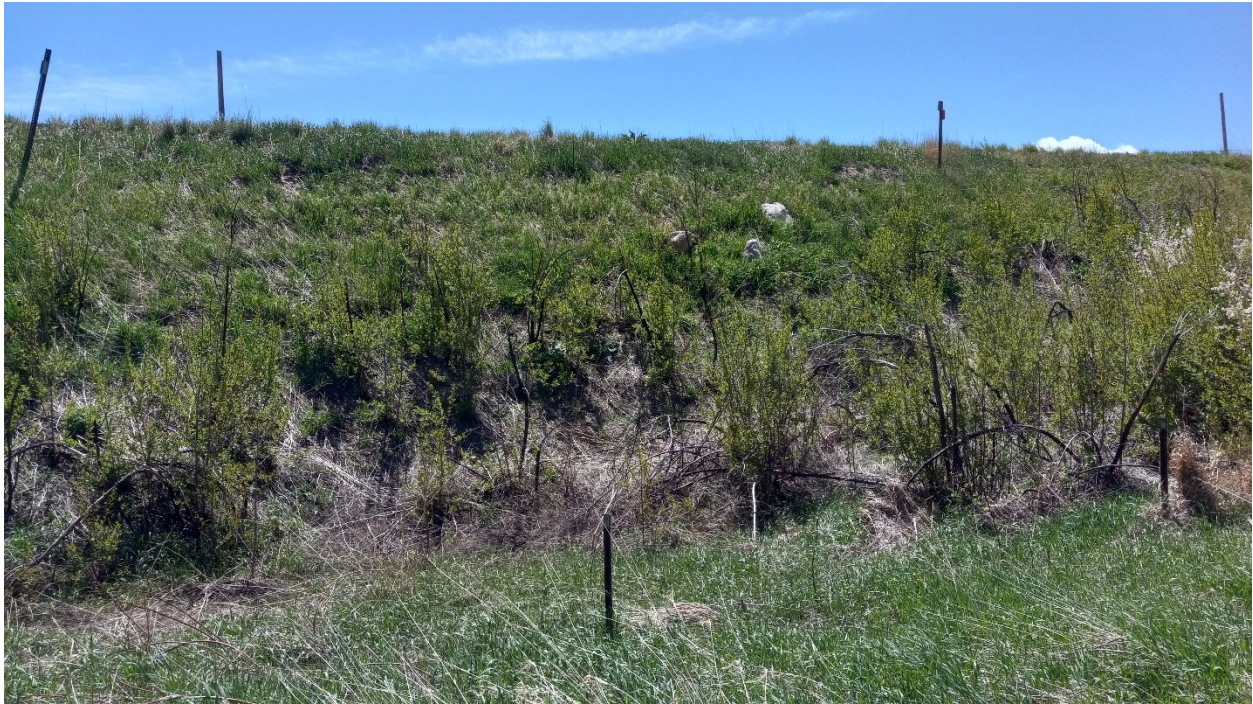
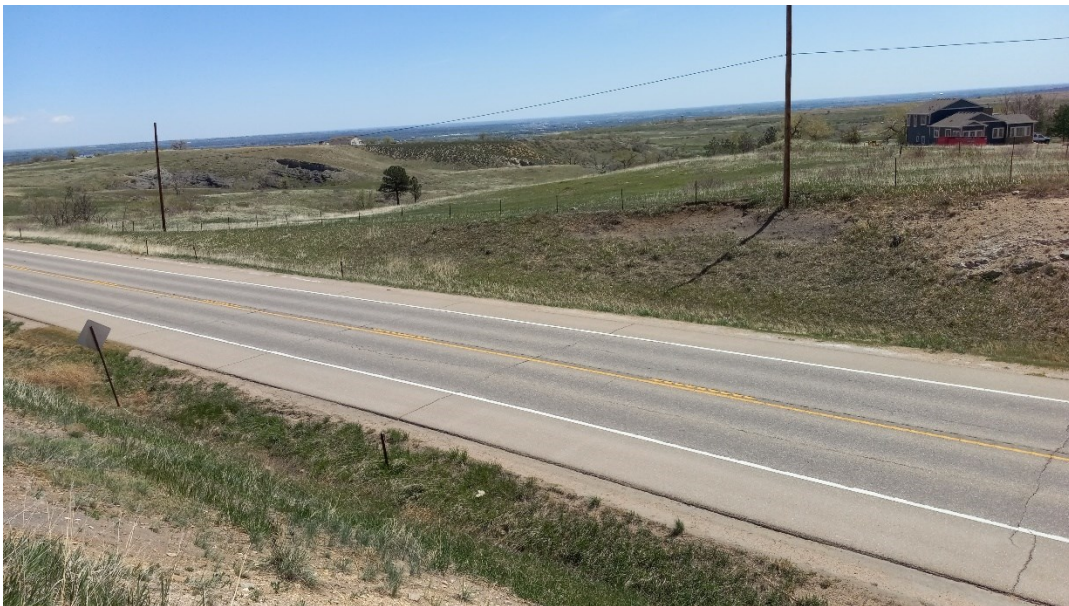
**Photo D-15. Milepost 26.4**

This location was not identified in the ESPWPS. US 36 is in a cut here, and this is at the southern limit of Boulder County Parks and Open Space property to the east, so it may be a good location for an overpass.

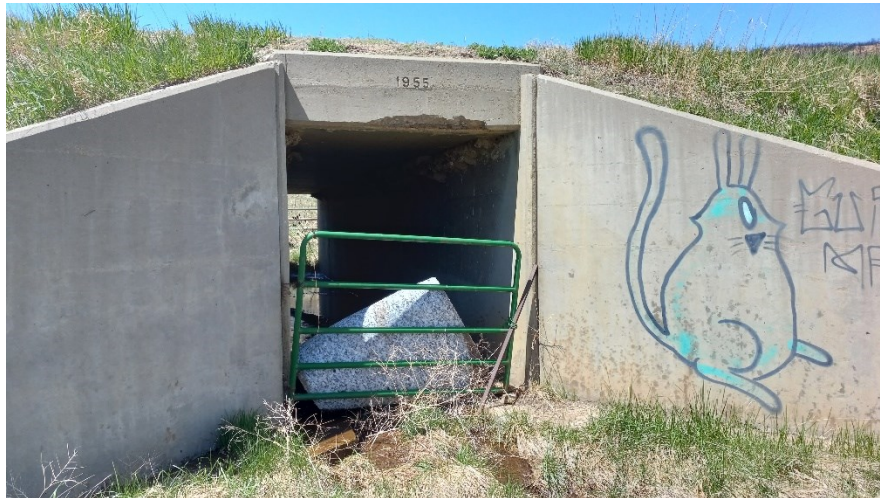
**Photo D-17. Milepost 26.8**

The ESPWPS says that this existing underpass does not have enough cover and cannot feasibly be modified to have more height. The gate can be removed, and wildlife fence can be tied to this structure to serve as a crossing for smaller species and bears.

Jon mentioned that elk do not cross here very often.

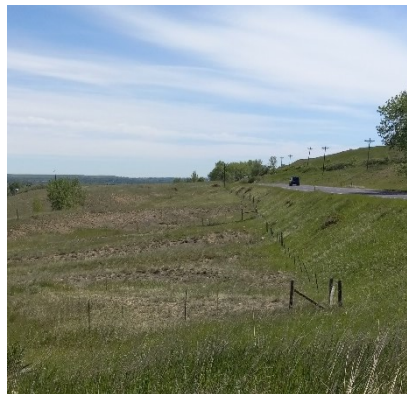
**Photo D-19. Nelson Road**

The curves on Nelson Road, west of N 51<sup>st</sup> St, have high WVCs because drivers travel at high speeds and there is limited sight distance. Fencing along Nelson Road from US 36 to N 51<sup>st</sup> Street would help reduce the WVCs.

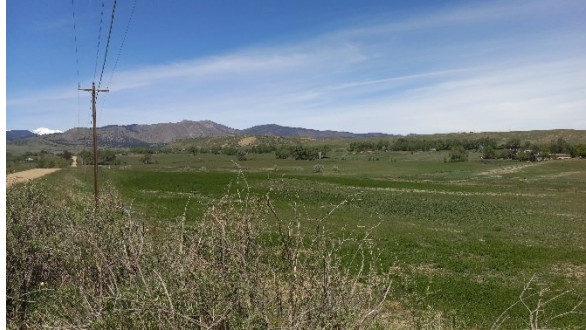
**Photo D-20. Table Mountain Area**

Jon said that elk come down from the southeast corner of Table Mountain to the north of Oxford Road. The area is shown in the photo to the right.

Jon said that about 120 elk spend winters on the Imel property, which is east of N 63<sup>rd</sup> St between Oxford Rd and Plateau Rd. Elk calve in Left Hand Creek to the southeast of the Imel property.

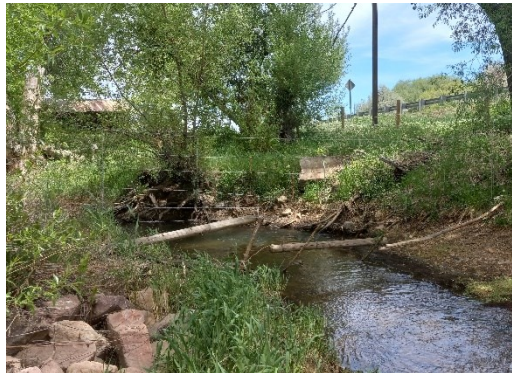
**Photo D-21. Left Hand Creek under State Highway 119 and Airport road**

We walked along Left Hand Creek where it crosses under SH 119 and Airport Road. There is an electric fence crossing Left Hand Creek, just east of Airport Road, as shown in the photo. Its purpose appears to be to restrict wildlife movement through the creek bed, which conflicts with the idea of allowing wildlife to use the bridges as crossings.
