APPENDIX E

HIGH-PRIORITY HIGH-INJURY NETWORK (HIN) PROJECT RECOMMENDATION FACT SHEETS

HIGH-PRIORITY HIN PROJECT RECOMMENDATION FACT SHEETS

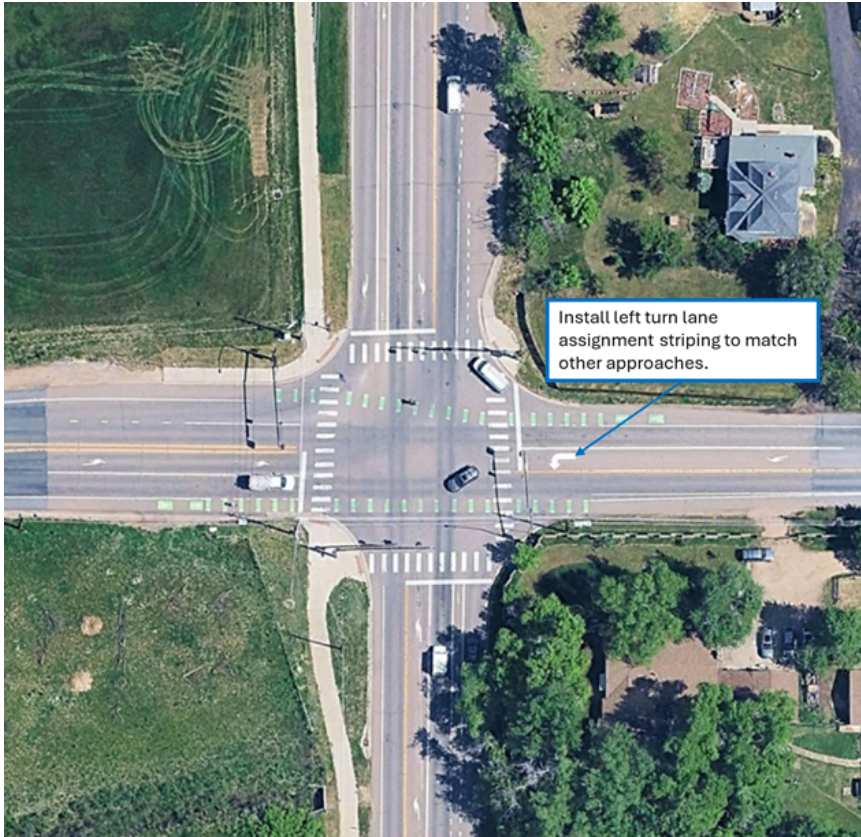
- ✓ Install luminaire with modern LED light with shielding on northeast and southwest corner of intersection (lighting) \$
- ✓ Evaluate curb radii on all four intersection corners (traffic calming, crossing distances) \$\$\$
 - Reduce northwest curb radius, tie into removing second westbound receiving lane
 - Reduce southeast curb radius to improve pedestrian landing size and pull pedestrian push button away from private fence
 - Reduce northeast curb radius to slow westbound right-turn speeds

- ✓ Reconstruct pedestrian ramps to be directional and evaluate pedestrian push button locations (pedestrian facilities) \$\$\$
- ✓ Install green pavement markings in northbound and southbound directions (bicycle facilities) \$
- ✓ Align westbound green pavement markings on east leg and west leg (bicycle facilities) \$
 - This recommendation is contingent on the reduction of the west leg to one receiving lane
