# **APPENDIX D**

## PROJECT ANALYSIS SHEETS

# Location-Specific Projects

The subsequent Project Sheets detail the recommendations at each location identified in Safer Roads Strategy 1 and Strategy 3. A crash analysis was completed and is presented as part of the Project Sheets for each location on the High Injury Network.

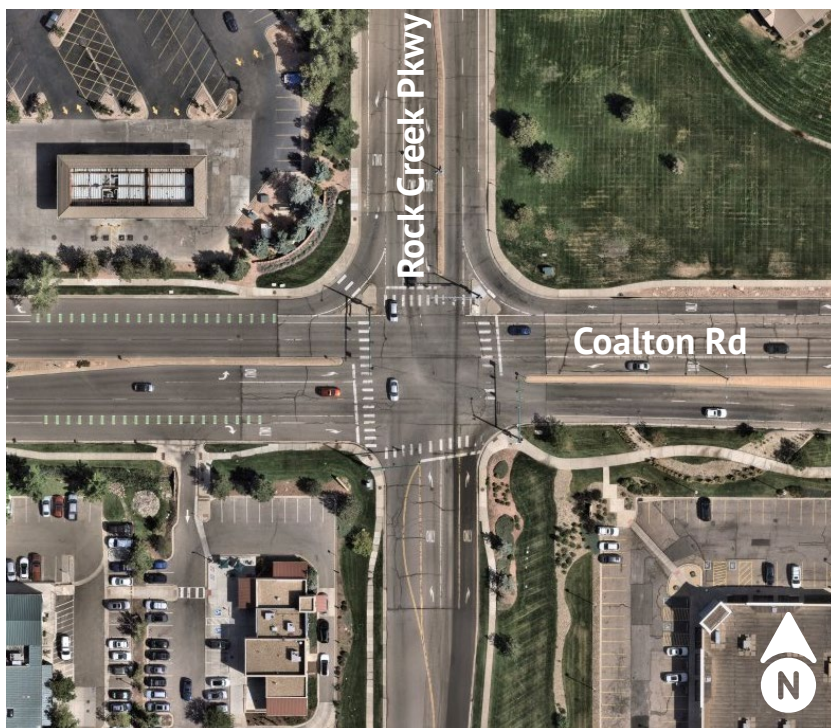
# SR1.2 Rock Creek Parkway & Coalton Road

*Traffic Control: Signal*

- **Northbound – three lane approach**
  - Left-turn lane
  - Thru lane
  - Right-turn lane
- **Southbound – four lane approach**
  - Dual left-turn lane
  - Thru lane
  - Right-turn lane
- **Eastbound – five lane approach**
  - Left-turn lane
  - Two thru lanes
  - Right-turn lane
- **Westbound – five lane approach**
  - Left-turn lane
  - Two thru lanes
  - Right-turn lane

1. Upgrade eastbound and westbound "doghouse" style signal heads to 4-section FYA
2. Install left-turn (R3-5) signage on eastbound, westbound, and southbound approaches
3. Install raised crossings at channelized right-turn islands in northeast and northwest corners
4. Evaluate protected-only by time of day for dual southbound left-turn
5. Install ADA-compliant and directional curb ramps
6. Analyze location for potential systemwide safety improvements, such as treatments to enhance bicycle and pedestrian comfort, and implement applicable countermeasures

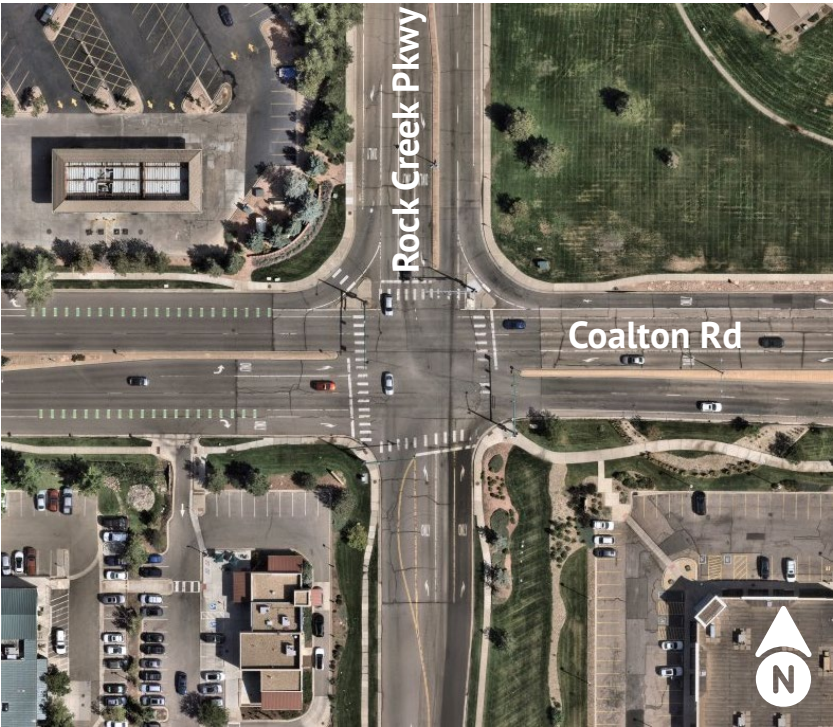
Traffic Control: Signal

Total Crashes: 26  
Serious Injury Crashes: 0  
Minor Injury Crashes: 4

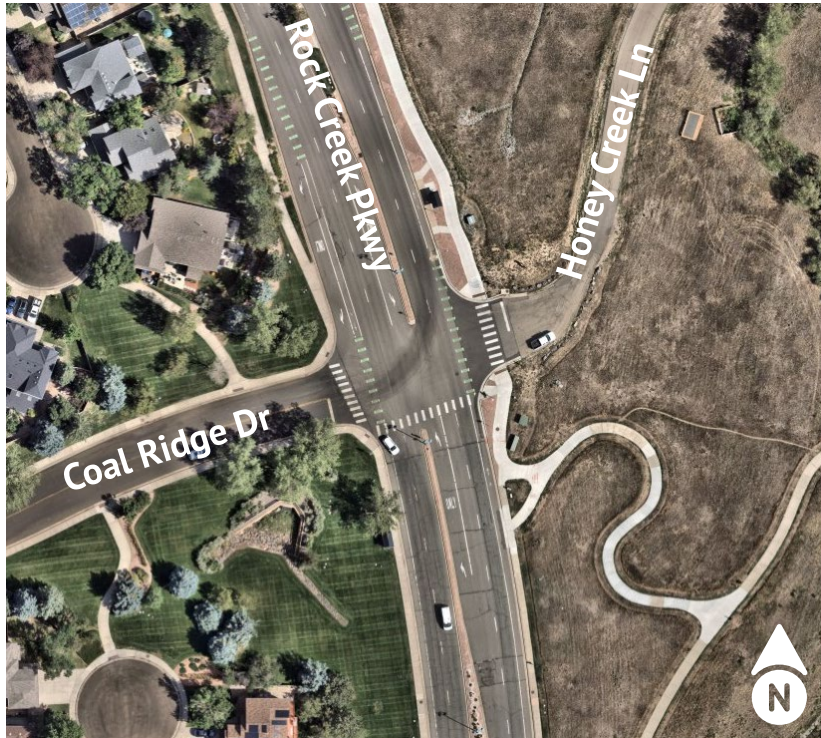
# SR1.3 Rock Creek Parkway & Honey Creek/Coal Ridge

*Traffic Control: Unsignalized with Rectangular Rapid Flashing Beacon (RRFB)*

- **Northbound – three lane approach**

- Left-turn lane
- Thru lane
- Thru/right

- **Westbound – one lane approach**

- Left/thru/right

- **Southbound – three lane approach**

- **Eastbound – one lane approach**

1. Remove "State Law Yield" signs and install W11-15 (combined bicycle/pedestrian warning sign) with W16-7PL/W16-7PR (down left/down right warning sign) at Rectangular Rapid Flashing Beacon crossing location
2. Install ADA-compliant curb ramps on the northwest and southwest corners
3. Analyze location for potential systemwide safety improvements, such as treatments to enhance bicycle and pedestrian comfort, and implement applicable countermeasures

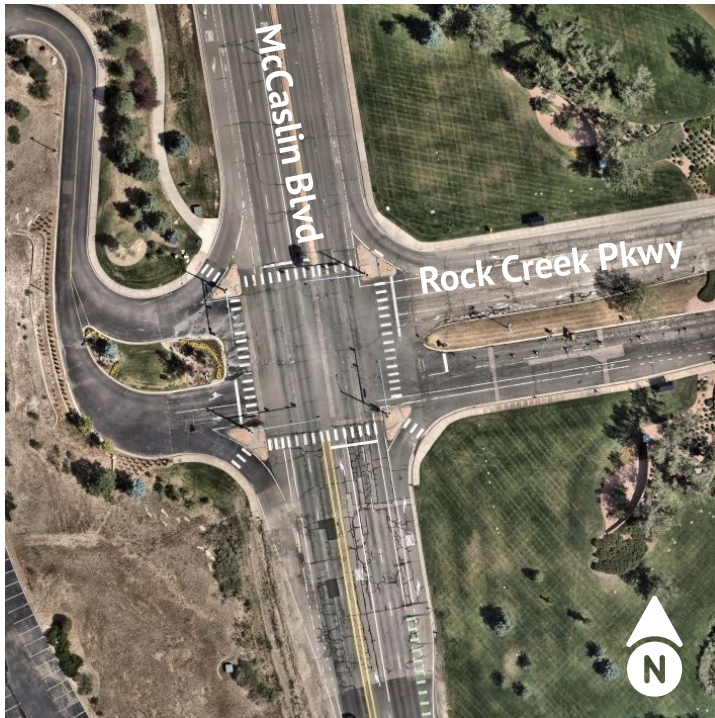
# SR1.4 McCaslin Boulevard & Rock Creek Parkway

*Traffic Control: Signal*

- **Northbound – 3 lane approach**
  - Left-turn lane
  - Two dual lanes
  - Right-turn lane
- **Southbound – 3 lane approach**
  - Left-turn lane
  - Two dual lanes
  - Right-turn lane
- **Eastbound – 3 lane approach**
  - Left-turn lane
  - Thru lane
  - Right-turn slip lane
- **Westbound – 3 lane approach**
  - Left-turn lane
  - Thru lane
  - Right-turn lane

1. Update "doghouse" style signal heads to 4-section FYA
2. Install raised crossings at channelized right-turn islands on northeast, northwest, southeast, and southwest corners
3. Install additional traffic signal head to northbound through lane
4. Analyze location for potential systemwide safety improvements, such as treatments to enhance bicycle and pedestrian comfort, and implement applicable countermeasures

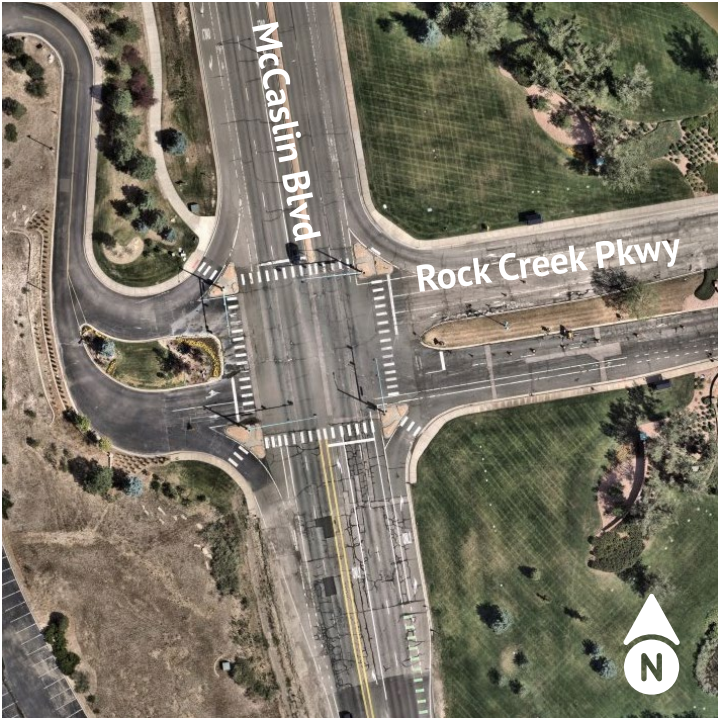
Rock Creek Parkway Design Plans

Traffic Control: Signal

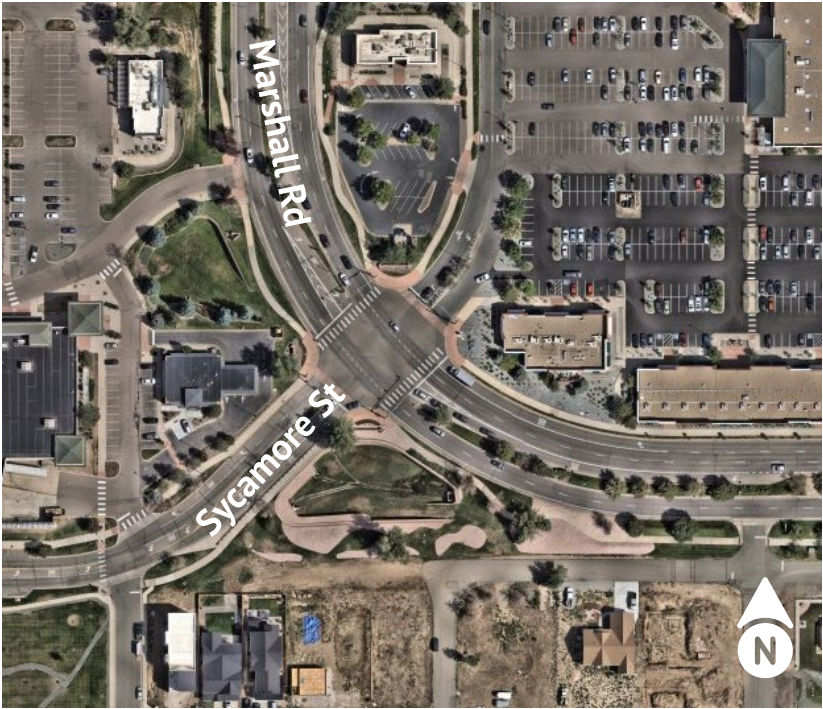
# SR1.5 Sycamore Street & Marshall Road

Traffic Control: Signal

- ### Crash Type Directionality
- Northbound (Sycamore) – two lane approach**
    - Left/thru lane
    - Right only lane
  - Southbound (Sycamore) – two lane approach**
    - Left only lane
    - Thru/right lane
  - Eastbound (Marshall) – three lane approach**
    - Left only lane
    - Through lane
    - Through/right lane
    - Bike lane
  - Westbound (Marshall) – four lane approach**
    - Left only lane
    - Two thru lanes
    - Right only lane

1. Update southbound, eastbound, and westbound left-turn "doghouse" style signal heads to 4-section FYA
2. Add left-only signage for westbound
3. Shift traffic signal indications to be over the center of the northbound receiving lanes
4. Analyze location for potential systemwide safety improvements, such as treatments to enhance bicycle and pedestrian comfort, and implement applicable countermeasures

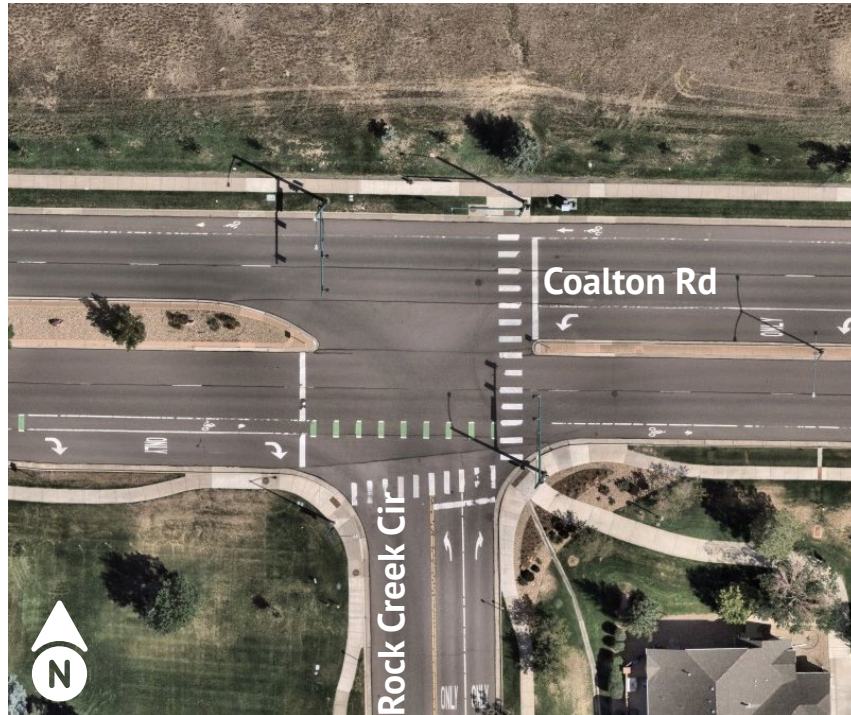
# SR1.7 Rock Creek Circle & Coalton Road

*Traffic Control: Signal*

- **Northbound – two approach lanes**
  - Left-turn lane
  - Right-turn lane
- **Eastbound – three approach lanes**
  - Two thru lanes
  - Right-turn lane
- **Westbound – three approach lanes**
  - Left-turn lane
  - Two thru lanes

1. Install directional and ADA-compliant ramps
2. Analyze location for potential systemwide safety improvements, such as treatments to enhance bicycle and pedestrian comfort, and implement applicable countermeasures

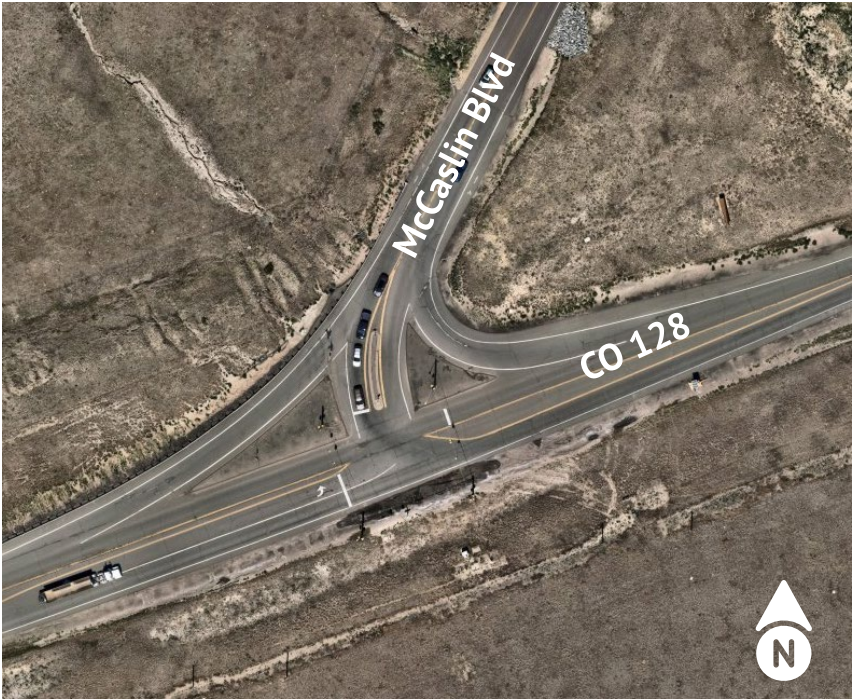
# SR1.8 McCaslin Boulevard & CO 128

Traffic Control: Signal

- **Southbound – two lane approach**
  - 128 WB slip lane
  - Left-turn lane
- **Eastbound – two lane approach**
  - Left-turn lane
  - Thru lane
- **Westbound – two lane approach**
  - McCaslin NB slip lane
  - Through lane

1. Update "doghouse" style signal head to 4-section FYA
2. Update mast arm signal
3. Change geometry of southbound slip lane to 30-60-90
4. Analyze location for potential systemwide safety improvements, such as treatments to enhance bicycle and pedestrian comfort, and implement applicable countermeasures

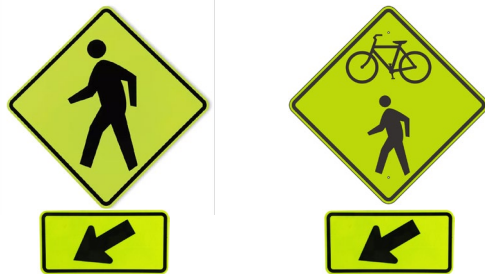
1. Install median refuge island and crossing markings at location of existing midblock pedestrian ramps
2. Install W11-15 sign at the crosswalk
