APPENDIX A

ASSESSMENT PROTOCOL

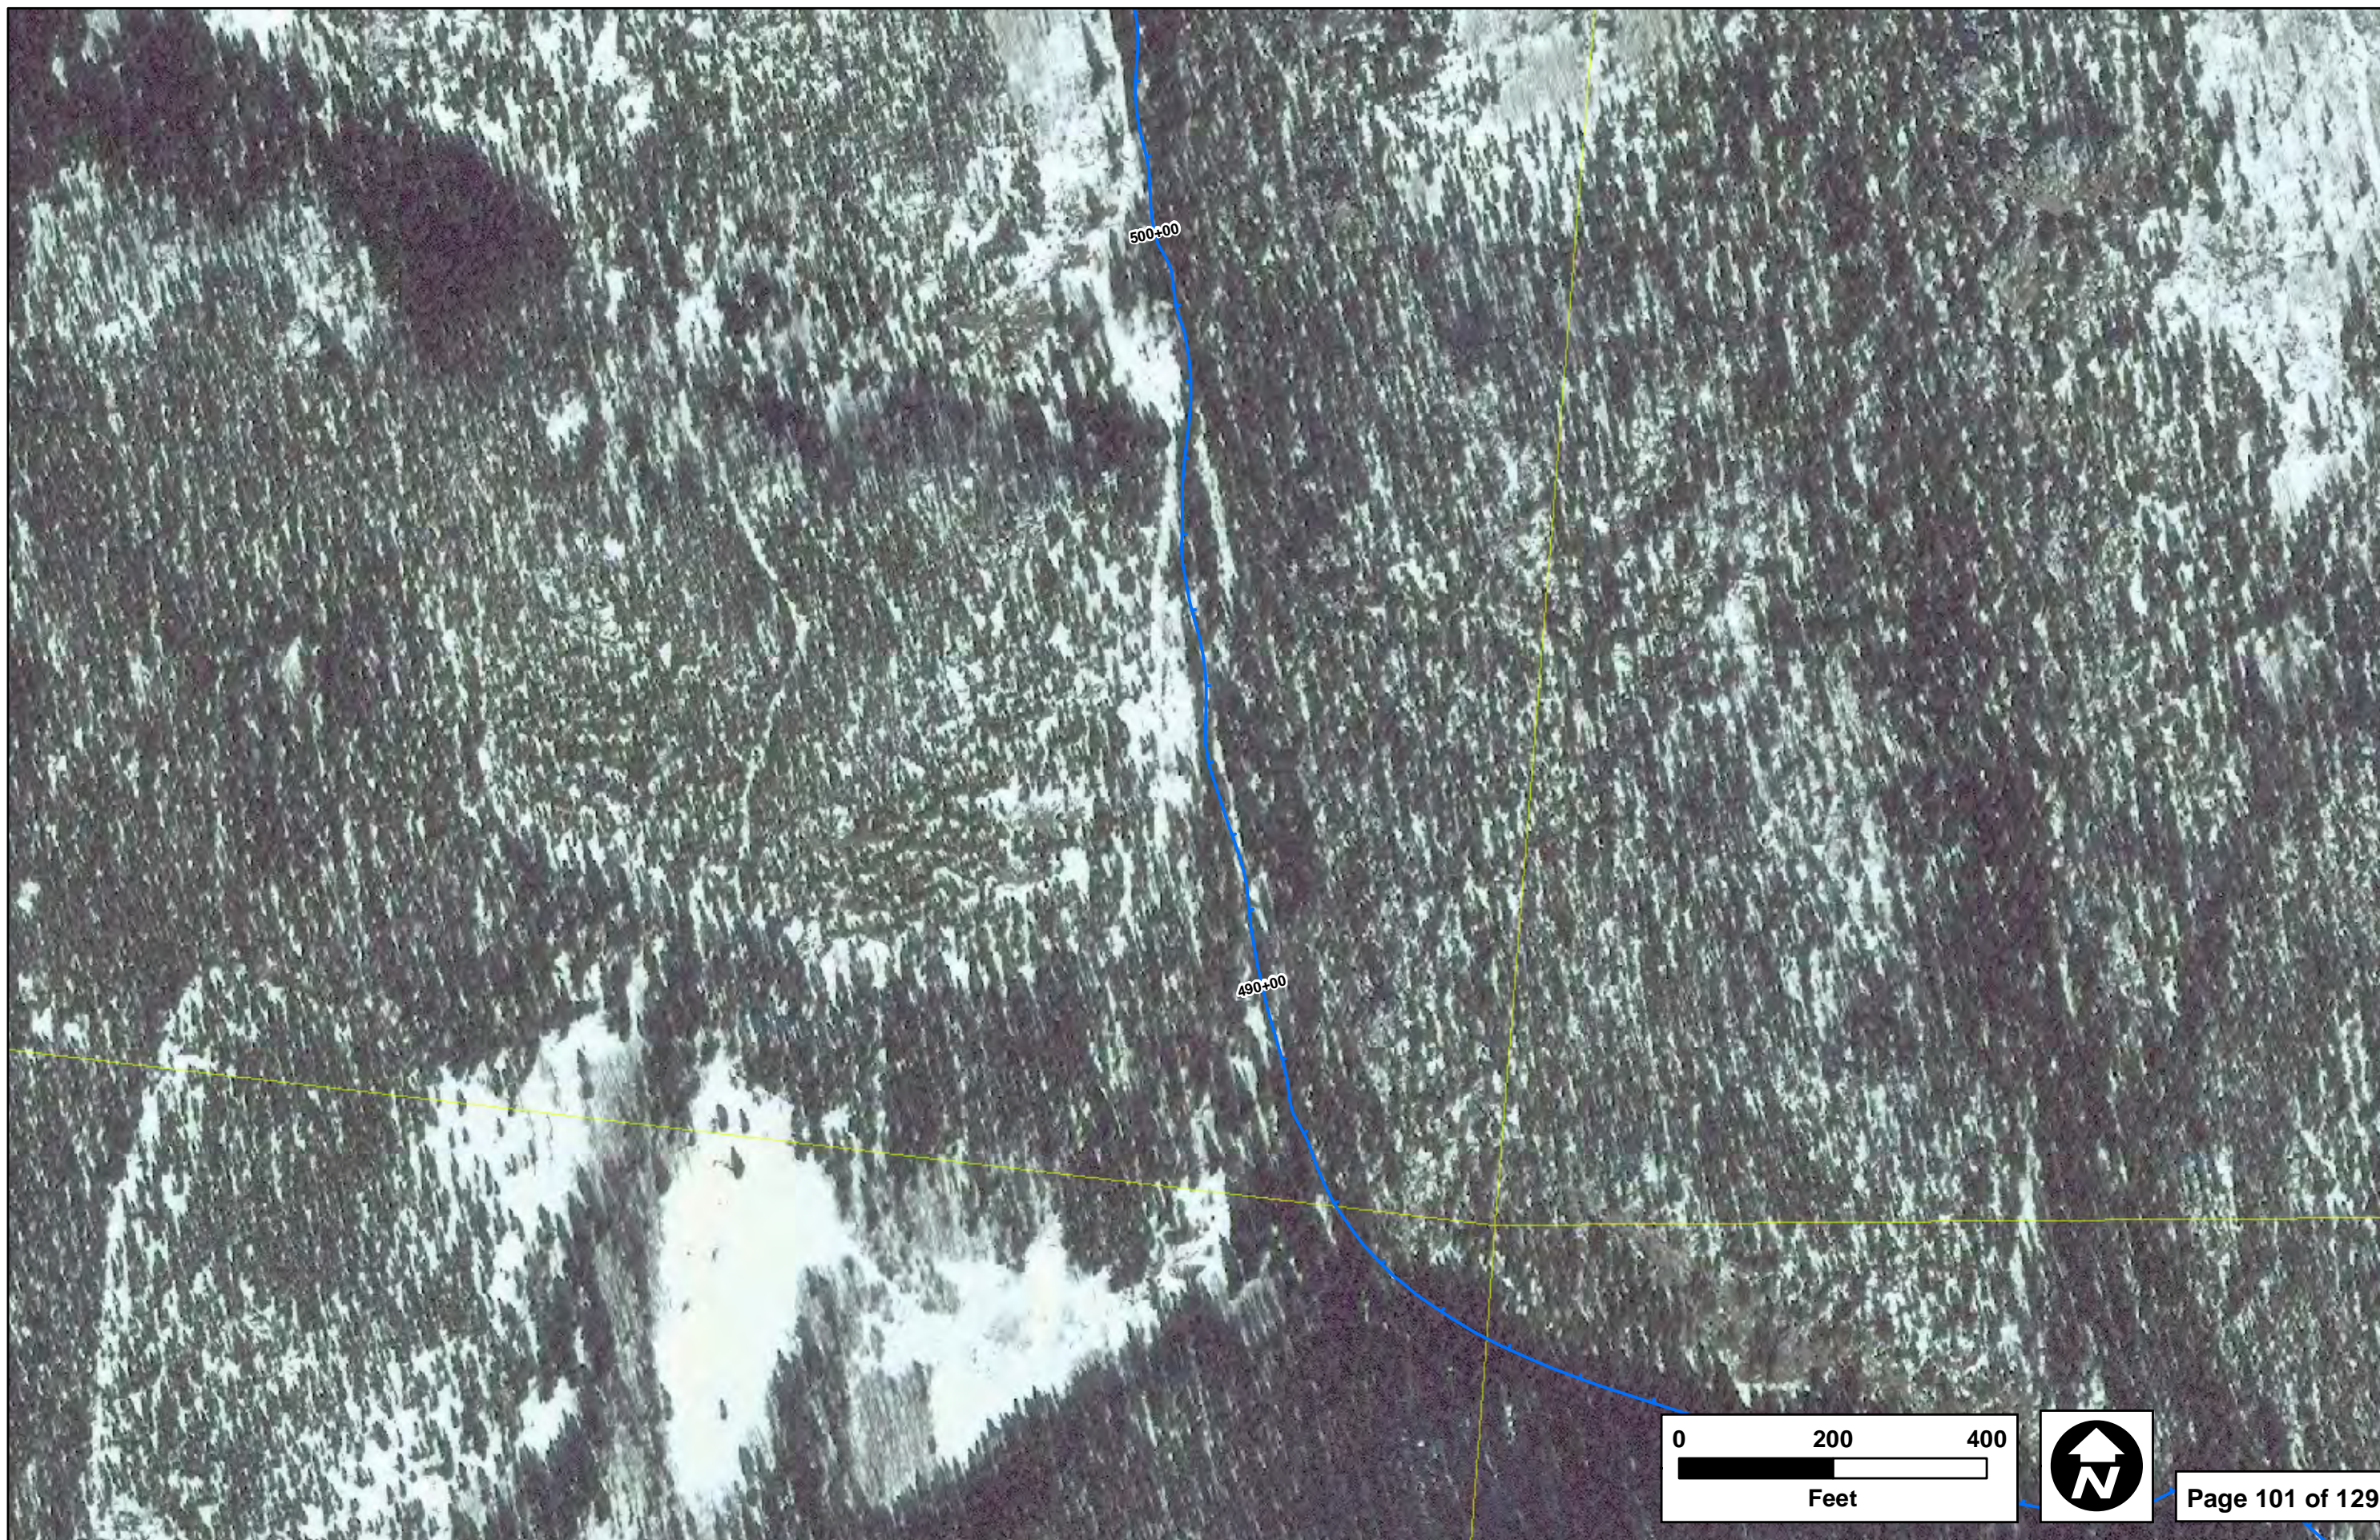
NEIGHBORHOOD: Big Elk Meadows
SHEET: 102
STATION: West Fork above Big Elk Meadows

The West Fork upstream of Big Elk Meadows is generally canyon-bound with rock outcrop and walls. This reach is isolated with very limited encroachment on the river corridor. Aerial images indicate a potential debris flow in the upper watershed that may have contributed to the deposition observed in the portions of the West Fork in and near Big Elk Meadows. However, the river appears relatively stable and expected to recover without restoration activities. The USFS has no plans for debris removal or restoration activities.

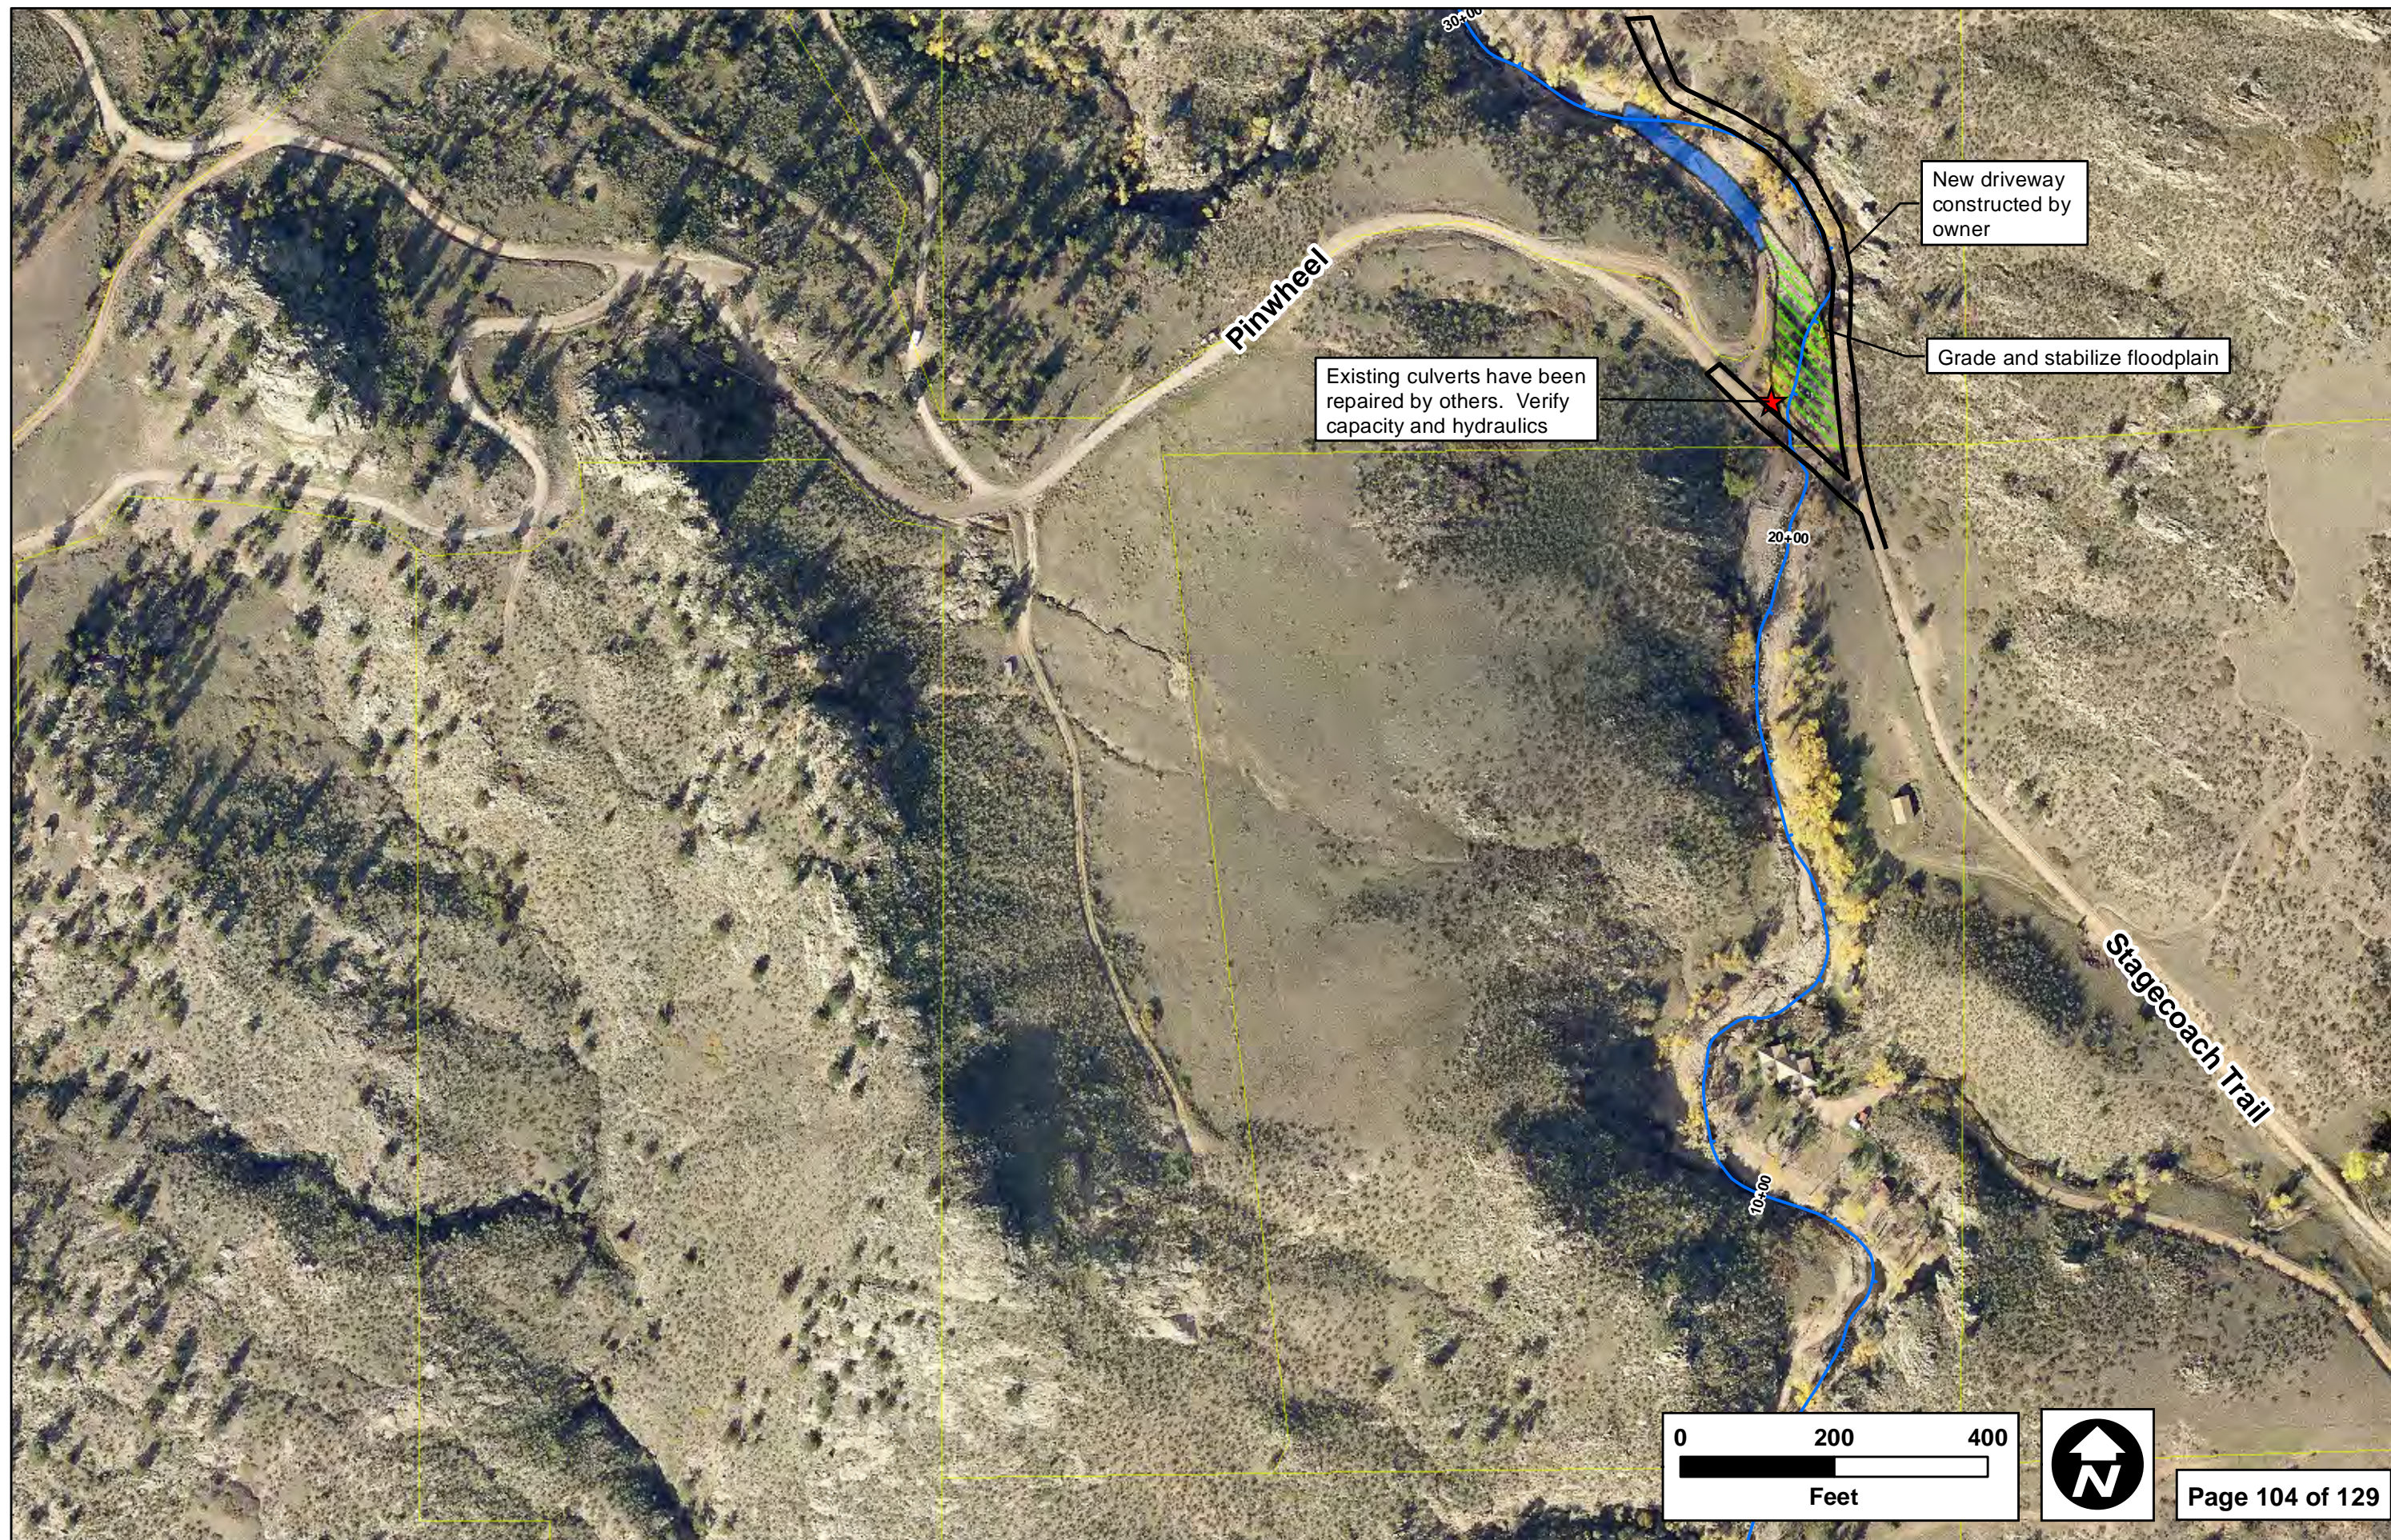
New driveway
constructed by
owner

Existing culverts have been
repaired by others. Verify
capacity and hydraulics

Grade and stabilize floodplain

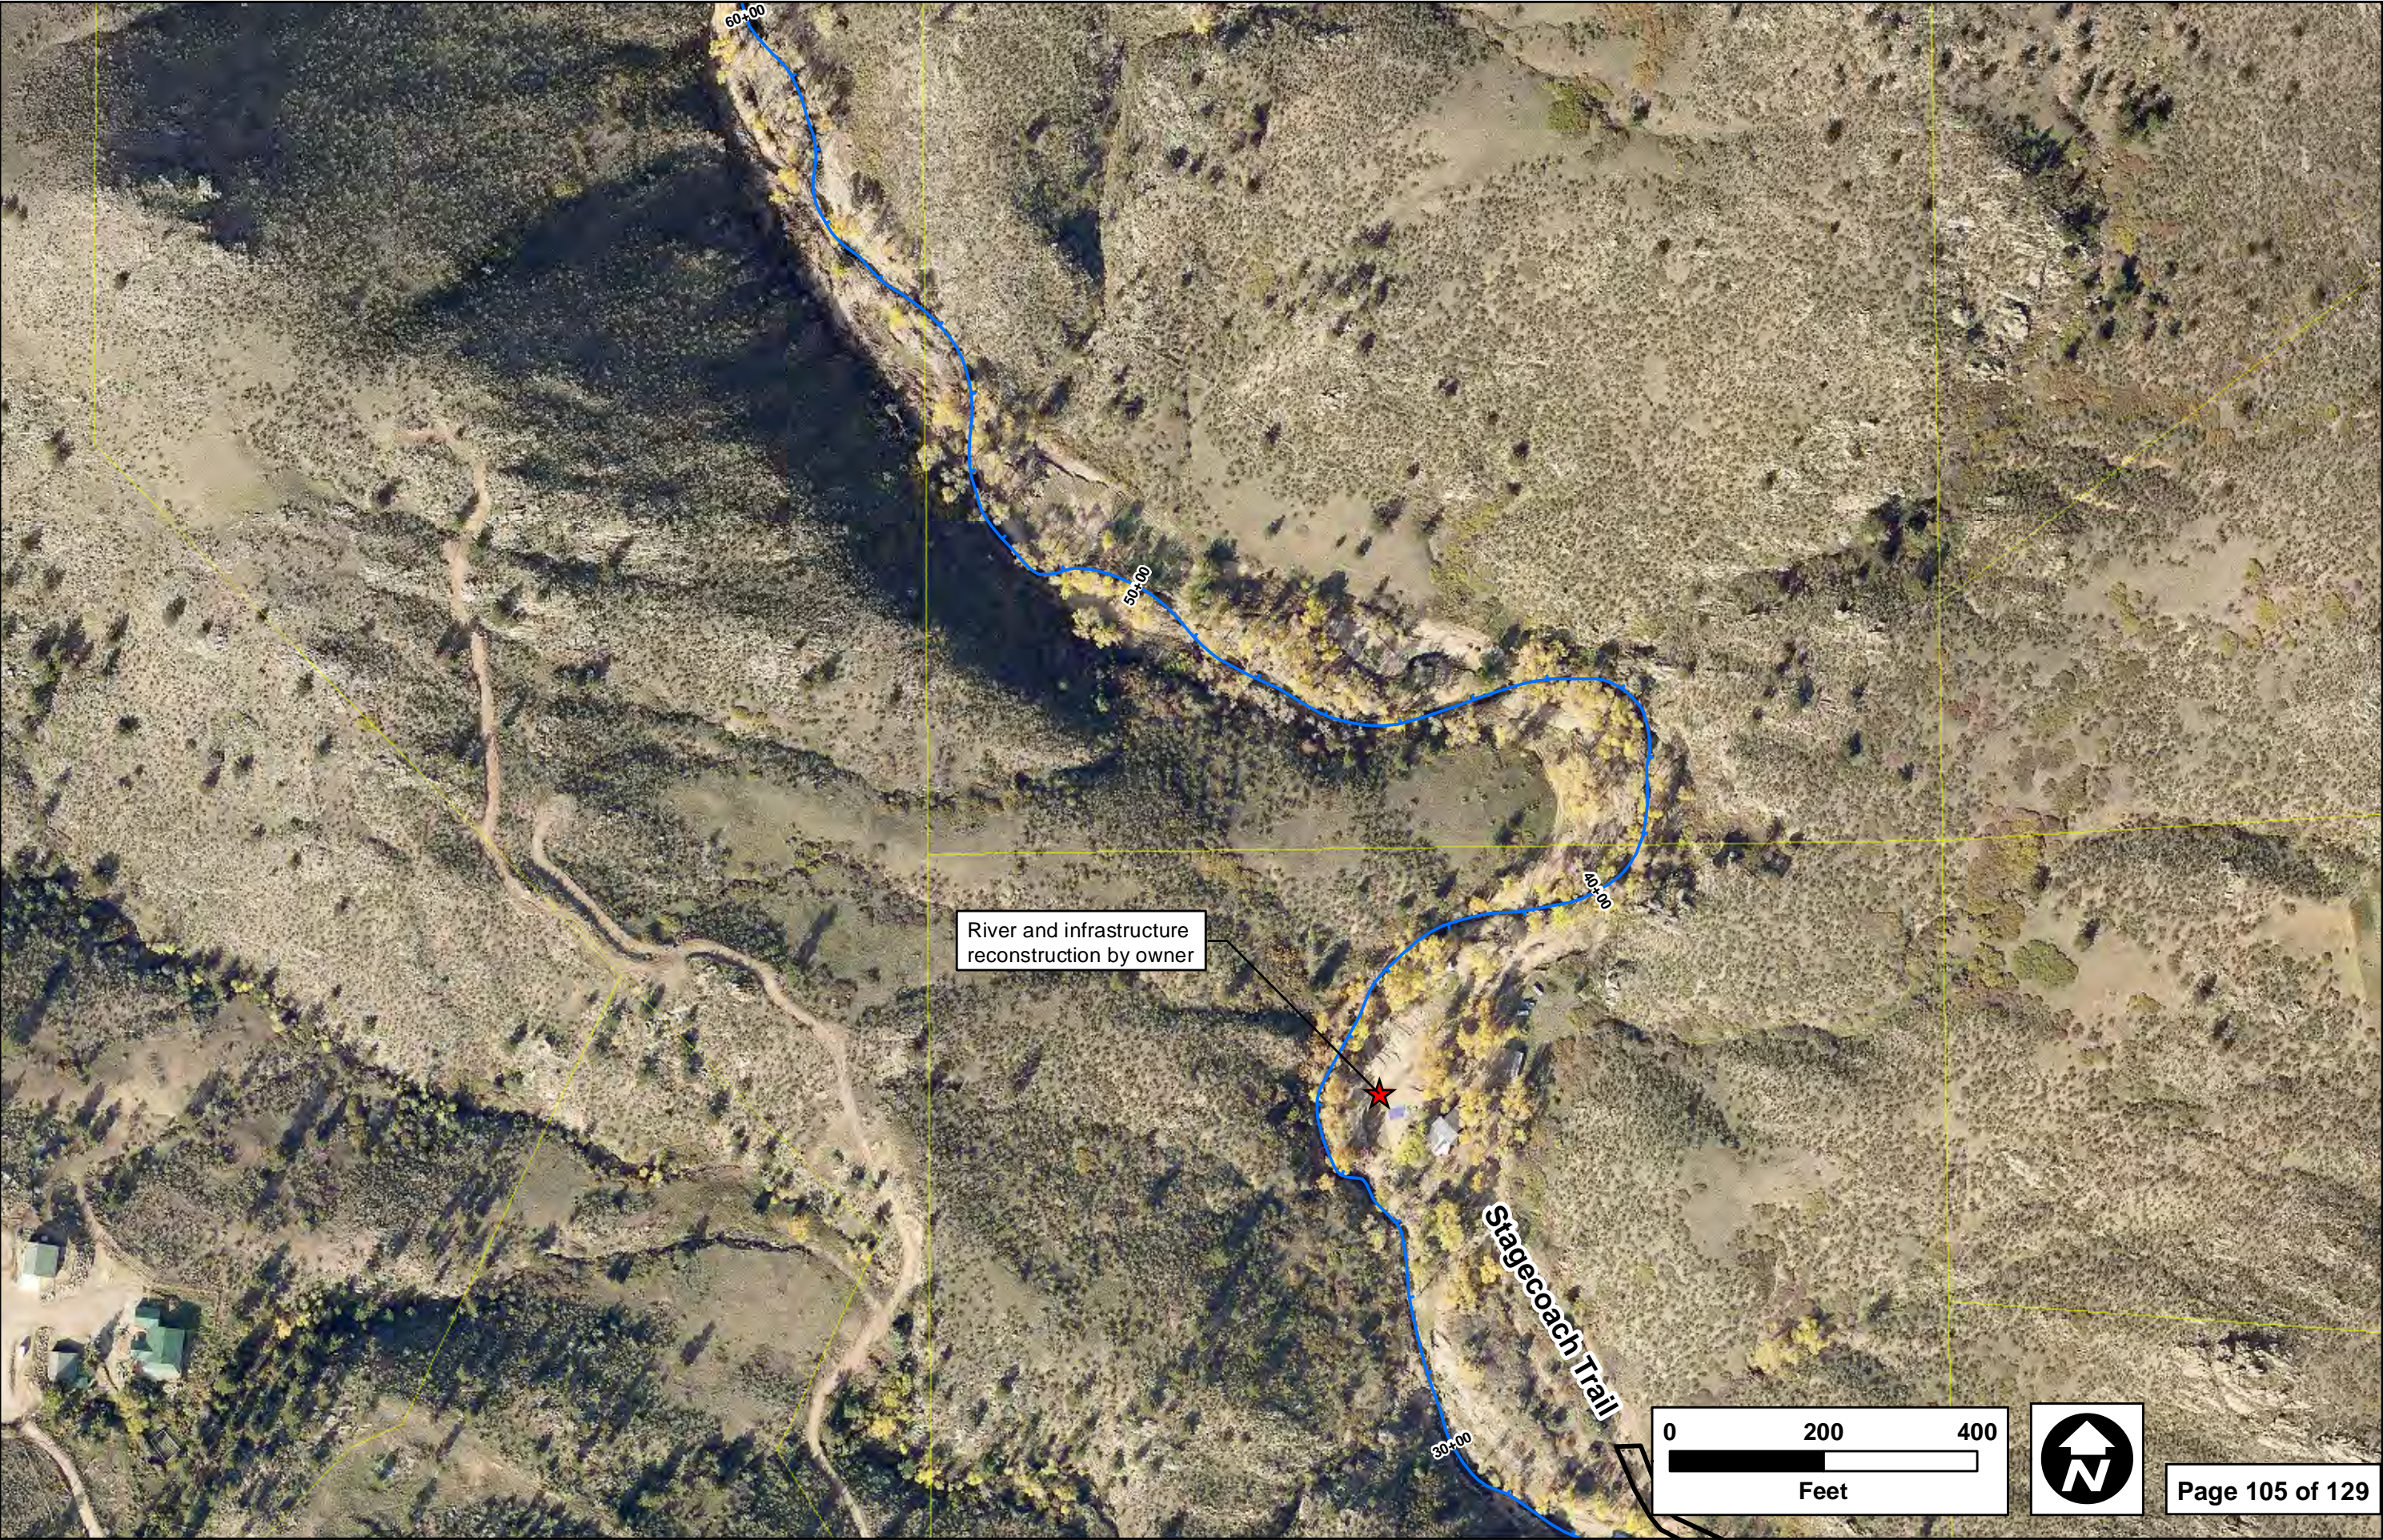
NEIGHBORHOOD: Blue Mountain
SHEET: 106
STATION: North Fork upstream of Stagecoach

Aerial photos of pre-flood conditions and anecdotal information indicate this reach had a densely vegetated riparian corridor, approximately 100 feet wide, comprised primarily of cottonwoods and willows, some of which were torn out during the flood. The river is generally bound by hillsides and some rock outcrops, setting the riparian corridor alignment. The North Fork is a relatively small stream system that often goes dry by late summer.

Geomorphic functions of this reach is likely sufficient to allow for the natural regeneration of cottonwood, willow, and other riparian species through seeding and cloning without active restoration. No further actions are suggested at this time.

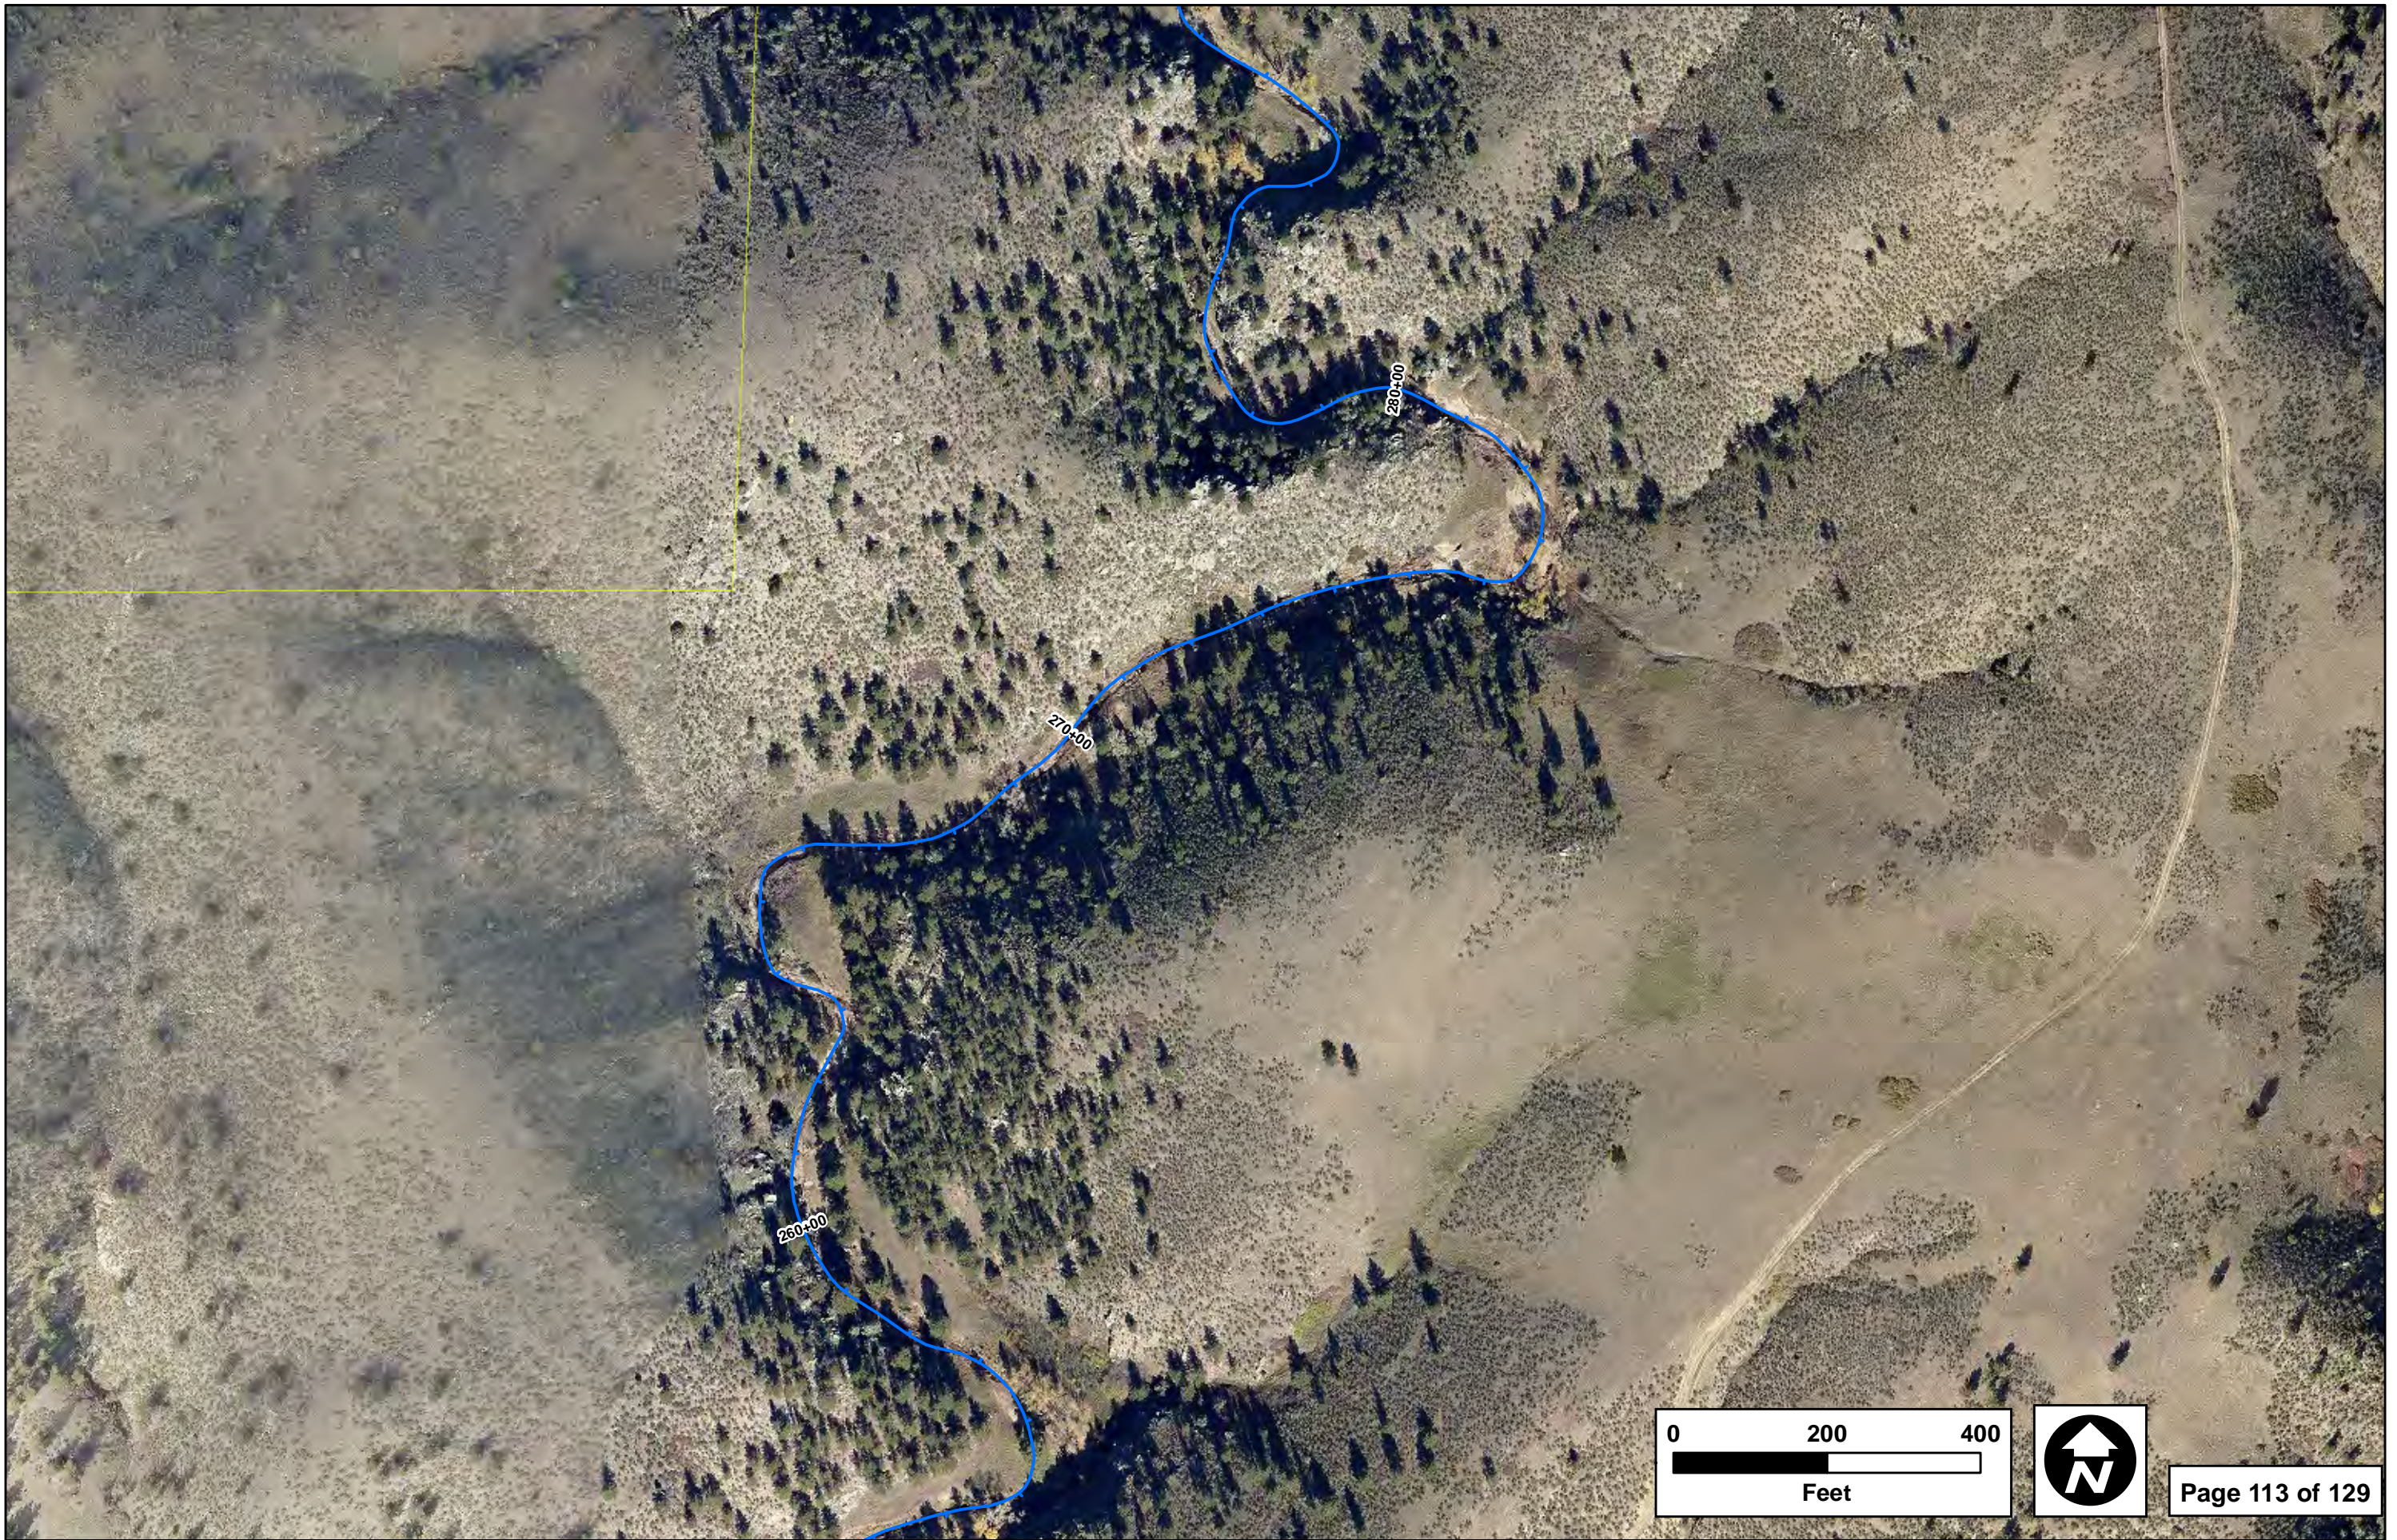
NEIGHBORHOOD: Blue Mountain
SHEET: 114
STATION: North Fork—upstream of Stagecoach

Aerial photos of pre-flood conditions and anecdotal information indicate this reach had a densely vegetated riparian corridor, approximately 50 feet wide, comprised primarily of cottonwoods and willows, some of which were torn out during the flood. The river is generally bound by hillsides and some rock outcrops, setting the riparian corridor alignment. The North Fork is a relatively small stream system that often goes dry by late summer.

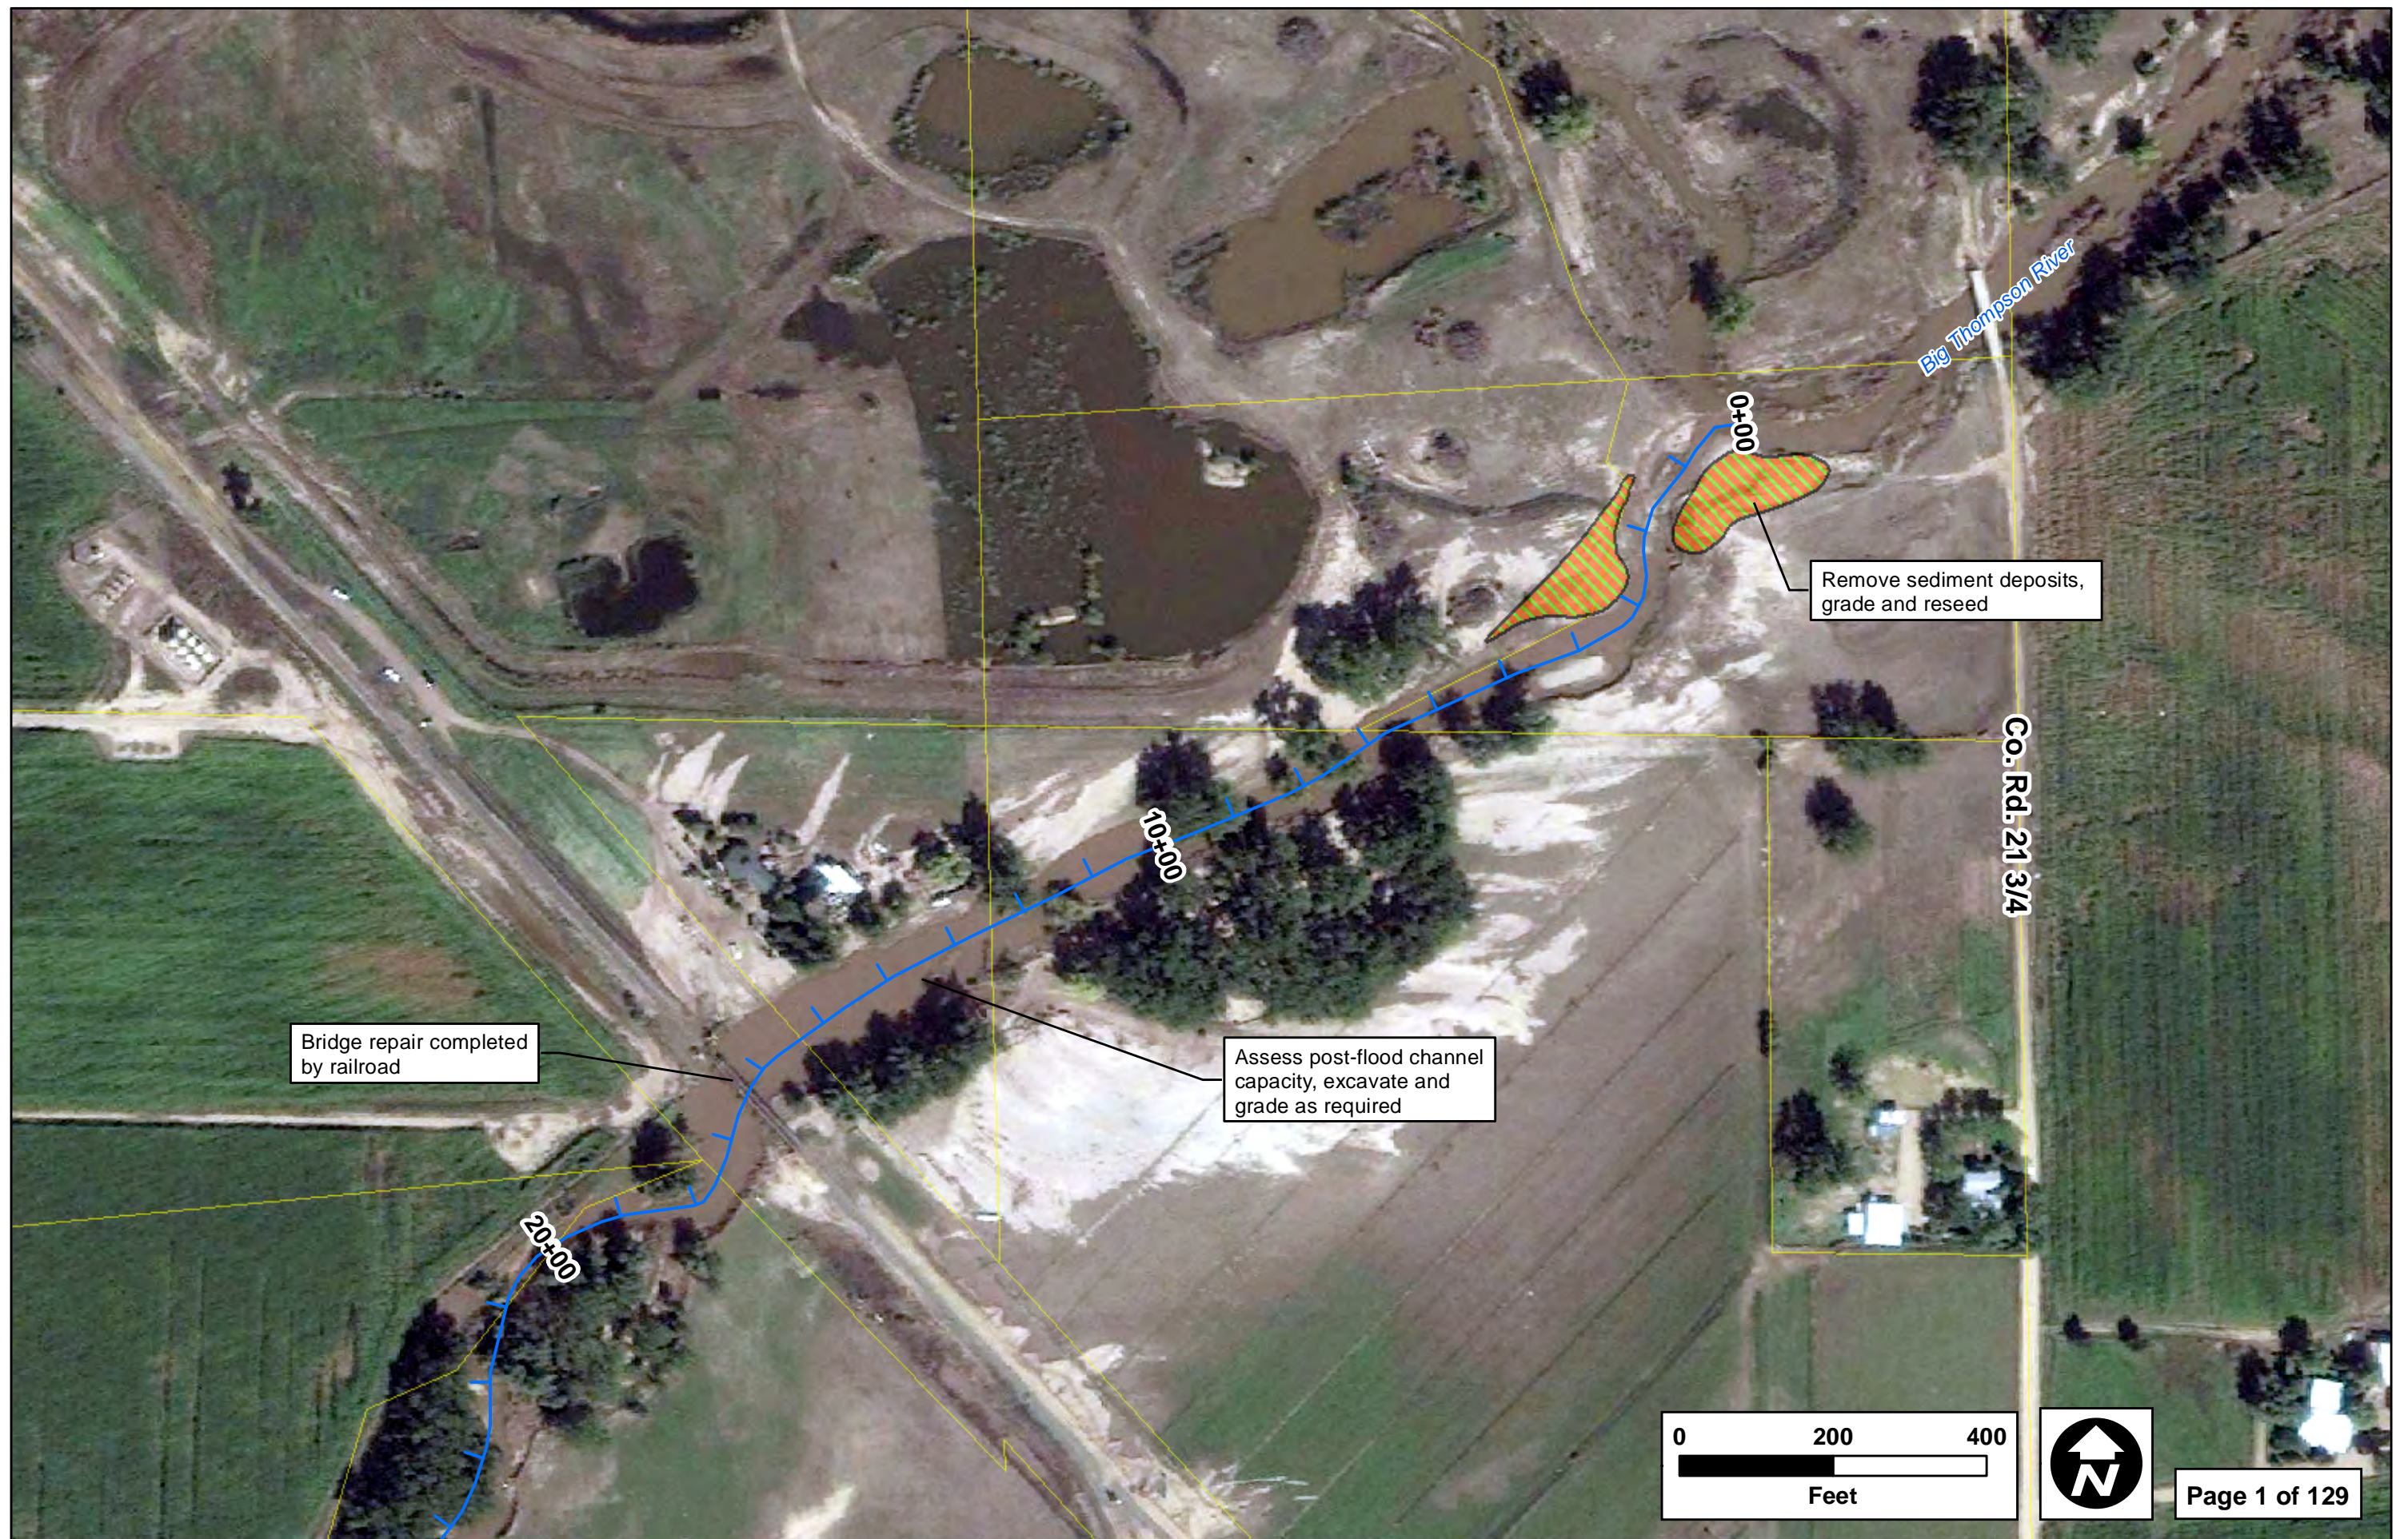
Bridge repair completed
by railroad

Remove sediment deposits,
grade and reseed

Assess post-flood channel
capacity, excavate and
grade as required

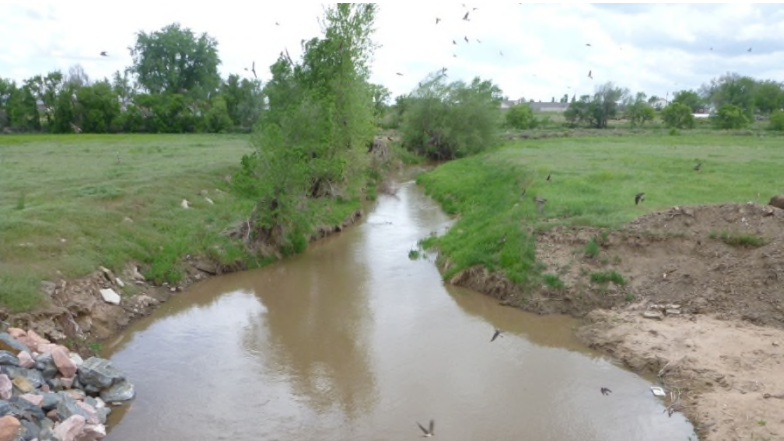
Highway 60 bridge received some repair following the 2013 flood, and is currently being assessed by CDOT for additional potential improvements. At Sta 72+00 is the headgate of the Bee Line ditch. This feature is being reviewed as part of a drainage master plan being prepared by the Town of Milliken. It is likely this feature will need repair from damage due to the 2013 flood.

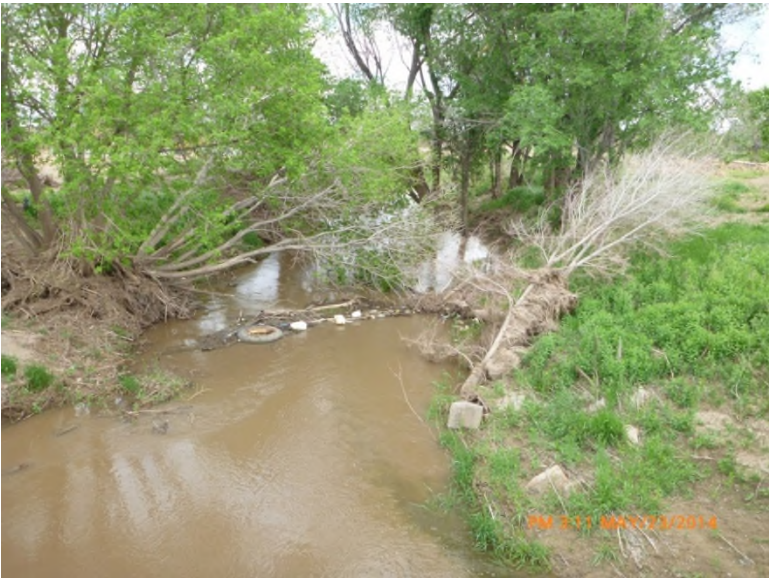
The extent of flooding is not well defined so it is not possible to determine exactly how many structures were flooded. It is likely several properties were flooded with clusters of buildings in each property. Most of the impacted area appears to be rural and agricultural. Flood-related impacts to the river include deposition and channel widening. As the channel begins to recover and reset itself, it is likely that over time, the geomorphic tendency will be to reestablish its equilibrium slope, and planform. Much of this reach is relatively stable and expected to recover without restoration activities. Deposition in the floodplain is evident although does not appear to be significant and limited to the cottonwood understory. A review should be conducted to assess the channel elevations and impacts on the floodplain and its elevations. If required, some excavation may be required to return the channel to pre-flood elevations.

1. Removal of debris is recommended along the channel and overbanks in areas where the debris could affect flood conveyance. Assess the channel elevations and impacts of floodplain elevations and excavate and grade if required to return the channel to pre-flood elevations.
2. Geomorphic functions of this reach are likely sufficient to allow for the natural regeneration of willow, and other riparian species through seeding and cloning without active revegetation.
3. Incorporate additional recommendations from the Town's Master Plan.

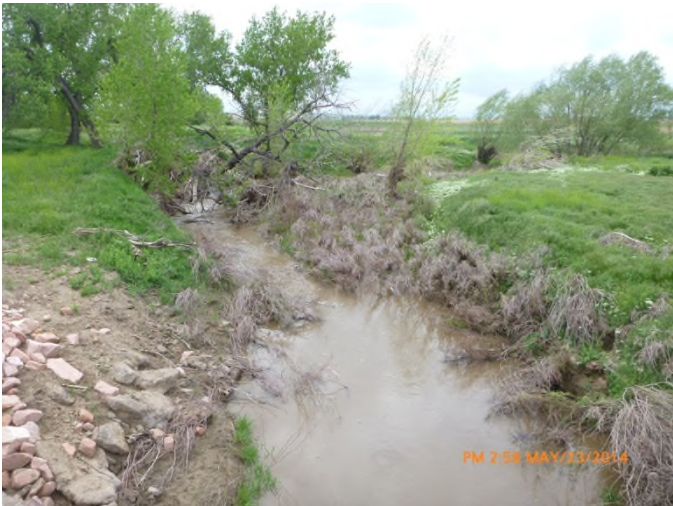
For the most part, the general channel planform appears to have remained relatively stable during the 2013 flood event. Some bank erosion was observed in localized areas, such as near bridge crossing. Minor sediment deposition along the channel margins and floodplains also occurred. The extent of flooding is not well defined so it is not possible to determine exactly how many structures were flooded. Most of the impacted area appears to be rural and agricultural. Much of this reach is relatively stable and expected to recover without restoration activities. There are two road crossings here, County Road 46½ and the Railroad between Sta 175+00 and Sta 177+00. Some riprap replacement was evident at the railroad bridge, but it was not clear if anything had been done at County Road 46 ½, which appeared to experience some toe scour. A review should be conducted to assess the channel elevations and impacts on the floodplain and its elevations. If required, some excavation may be required to return the channel to pre-flood elevations.

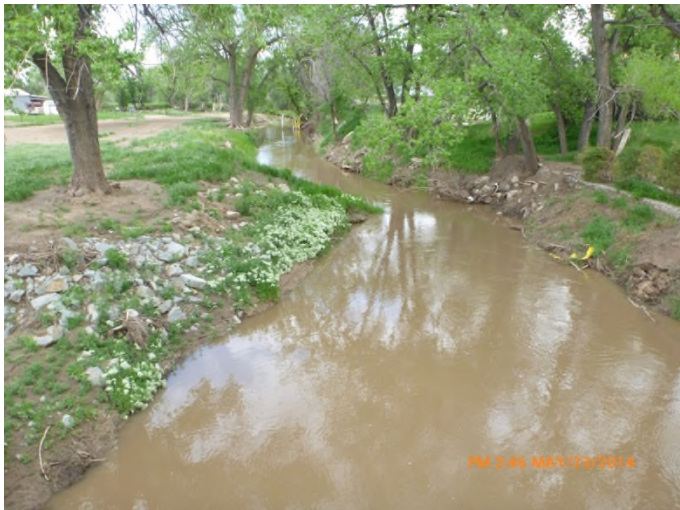
For the most part, the general channel planform appears to have remained relatively stable during the 2013 flood event. Some bank erosion was observed in localized areas, and minor sediment deposition along the channel margins and floodplains also occurred. The extent of flooding is not well defined so it is not possible to determine exactly how many structures were flooded. It is likely several properties were flooded with clusters of buildings in each property. Most of the impacted area appears to be rural and agricultural. Much of this reach is relatively stable and expected to recover without restoration activities. A review should be conducted to assess the channel elevations and impacts on the floodplain and its elevations. If required, some excavation may be required to return the channel to pre-flood elevations.

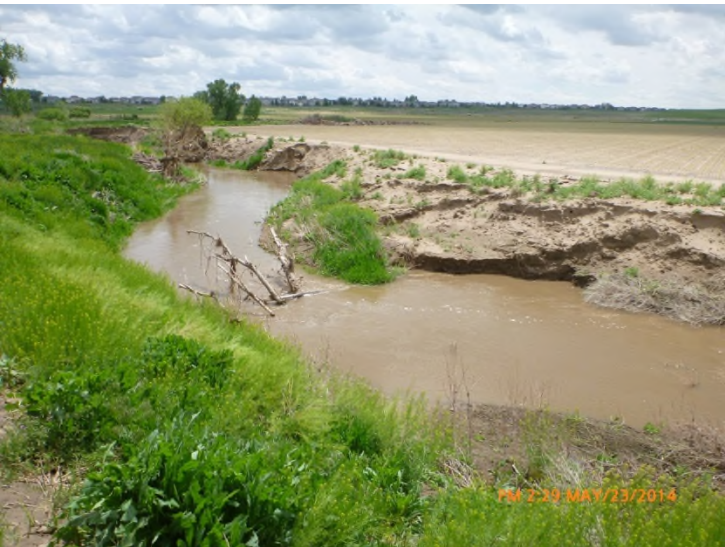
For the most part, the general channel planform was maintained during the 2013 flood event. Some bank erosion did occur in localized areas. In addition, general aggradation, and moderate levels of localized sediment deposition along the channel margins and floodplains also occurred.

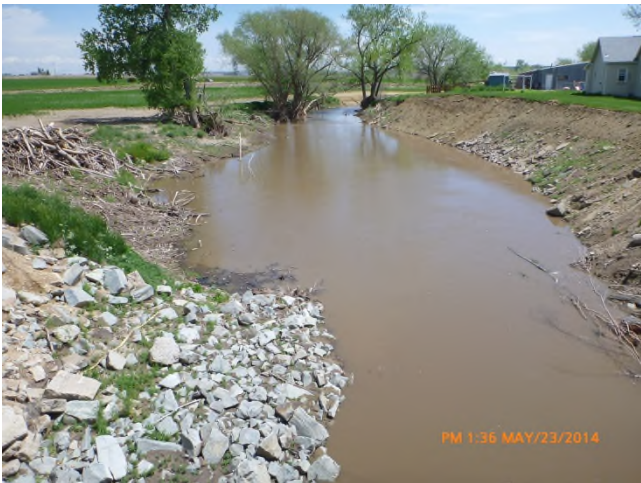
For the most part, the general channel planform was maintained during the 2013 flood event. Significant localized bank erosion did occur, especially along the right bank along the bend near Sta 301+50 and at County Road 15 Bridge. In addition, general aggradation, and moderate levels of localized sediment deposition along the channel margins and floodplains also occurred. A considerable amount of channel bank and overbank erosion threatens residential structures and property that are in close proximity to the river. Some work was performed at the County Road 15 Bridge, but no riprap was evident.
