APPENDIX A

ASSESSMENT PROTOCOL

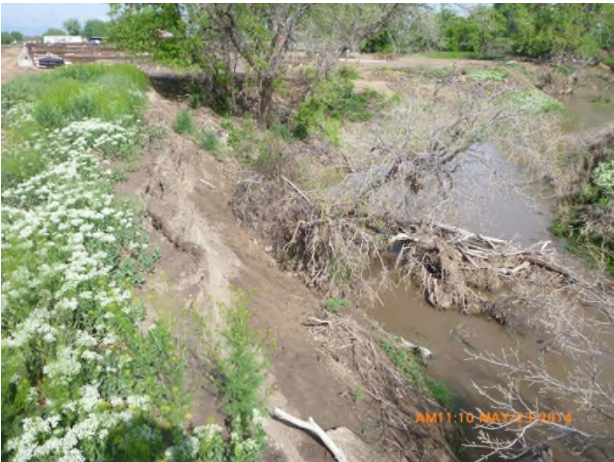
NEIGHBORHOOD: Johnstown & Milliken
SHEET: 10
STATION: 317+00 to 361+00
RESTORATION RECOMMENDATIONS: 317+00 to 361+00

Aerial photos of pre-flood conditions and anecdotal information indicate this reach had a dense riparian vegetation corridor, with average widths of about 250 feet. The vegetation was comprised of cottonwoods, willows, and other riparian species, some of which were torn out during the flood. Some of the vegetation that is still intact is somewhat buried with sediment. Adjacent land use primarily includes agriculture, with some rural development, and roads.

For the most part, the general channel planform was maintained during the 2013 flood event. Localized bank erosion did occur, and a few significant scour holes developed in conjunction with the bank scour in this reach. In addition, some generalized aggradation, and moderate levels of localized sediment deposition along the channel margins and floodplains also occurred. Significant ag-infrastructure was severely damaged during the flood along this reach. This reach also contains at least one utility pipeline buried below the channel bed near Sta 319+50, but the channel is relatively stable and does not appear to currently pose a threat to the pipeline.

- 1. Removal of debris is recommended along the channel and overbanks in areas where the debris could affect flood conveyance. Assess the channel elevations and impacts of floodplain elevations and excavate and grade if required to return the channel to pre-flood elevations.
- 2. Geomorphic functions of this reach are likely sufficient to allow for the natural regeneration of willow, and other riparian species through seeding and cloning without active revegetation.
- 3. Stabilize right bank between Sta 324+00 and Sta 330+00 to protect frequent use area.
- 4. Stabilize right channel banks between Sta 340+00 and Sta 343+50 to protect property, infrastructure, and access road.
- 5. Stabilize left channel banks near Sta 353+50 and Sta 345+50 to protect access road.
- 6. Stabilize banks near Sta 359+00 and Sta 361+00.

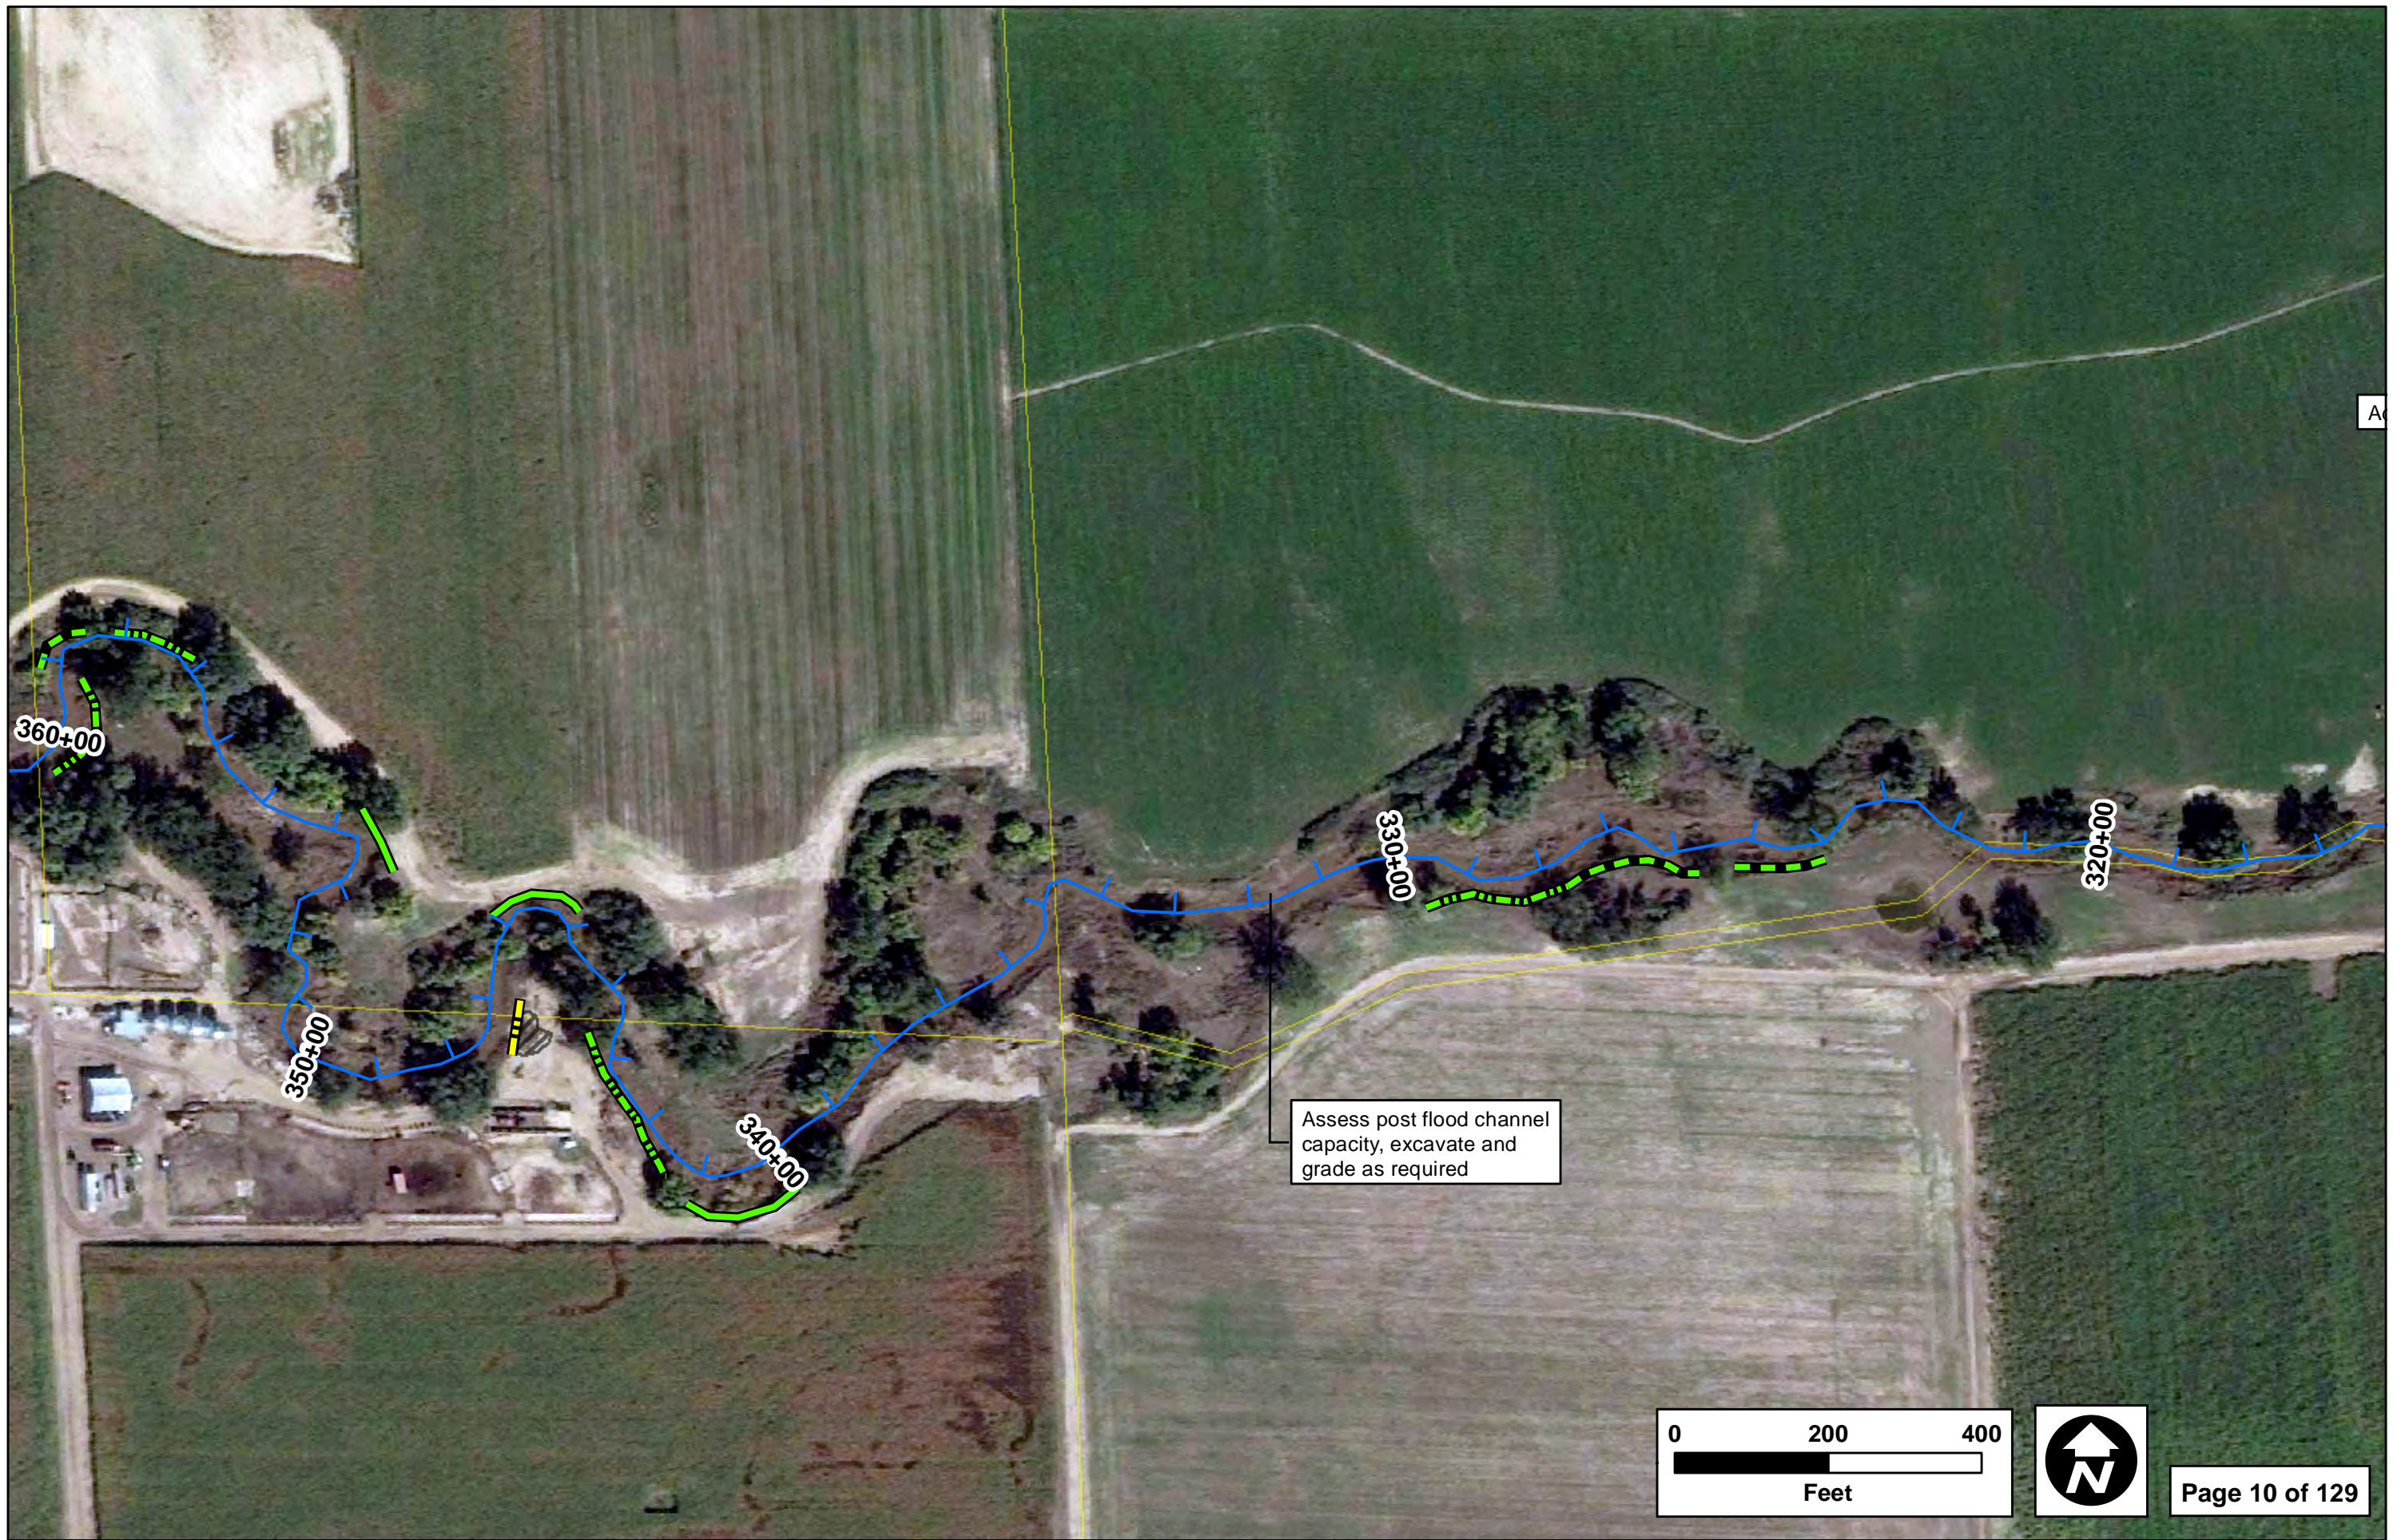
Assess post flood channel
capacity, excavate and
grade as required

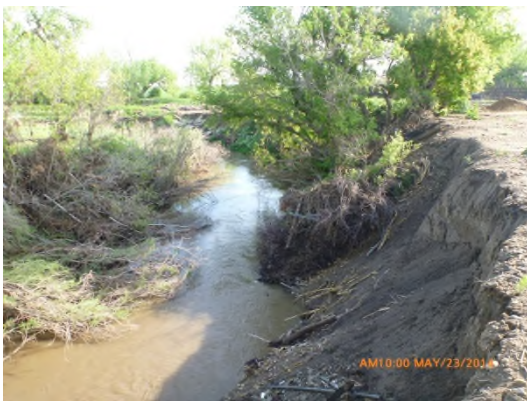
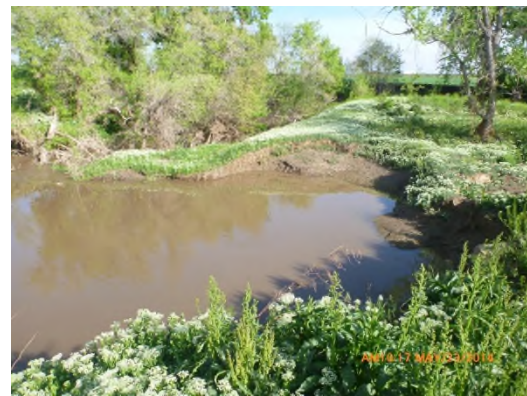
NEIGHBORHOOD: Johnstown & Milliken
SHEET: 11
STATION: 361+00 to 403+00
RESTORATION RECOMMENDATIONS: 361+00 to 403+00

For the most part, the general channel planform was maintained during the 2013 flood event. Localized bank erosion did occur along this reach, and a few significant scour holes developed in conjunction with the bank scour in this reach. In addition, some generalized aggradation, and moderate levels of localized sediment deposition along the channel margins and floodplains also occurred. The County Road 13 Bridge was significantly damaged during the flood, and most of the repairs are already complete. Two known houses were damaged, and those repairs were largely already complete at the time of the field reconnaissance, but significant ag-infrastructure was also severely damaged. This reach contains at least one utility pipeline hung above the channel near Sta 375+00, but the channel is relatively stable and does not appear to pose a threat to the pipeline.

- 1. Removal of debris is recommended along the channel and overbanks in areas where the debris could affect flood conveyance. Assess the channel elevations and impacts of floodplain elevations and excavate and grade if required to return the channel to pre-flood elevations.
- 2. Geomorphic functions of this reach are likely sufficient to allow for the natural regeneration of willow, and other riparian species through seeding and cloning without active revegetation.
- 3. Stabilize left bank near Sta 364+00 to protect access road.
- 4. Reclaim right overbank near Sta 366+00.
- 5. Grade floodplain near Sta 370+00 to improve conveyance.
- 6. Stabilize right bank near Sta 371+00 and Sta 368+00 to protect access road.
- 7. Stabilize upper bank near Sta 373+00.
- 8. Stabilize right bank to protect access road near Sta 400+00 and Sta 391+00.

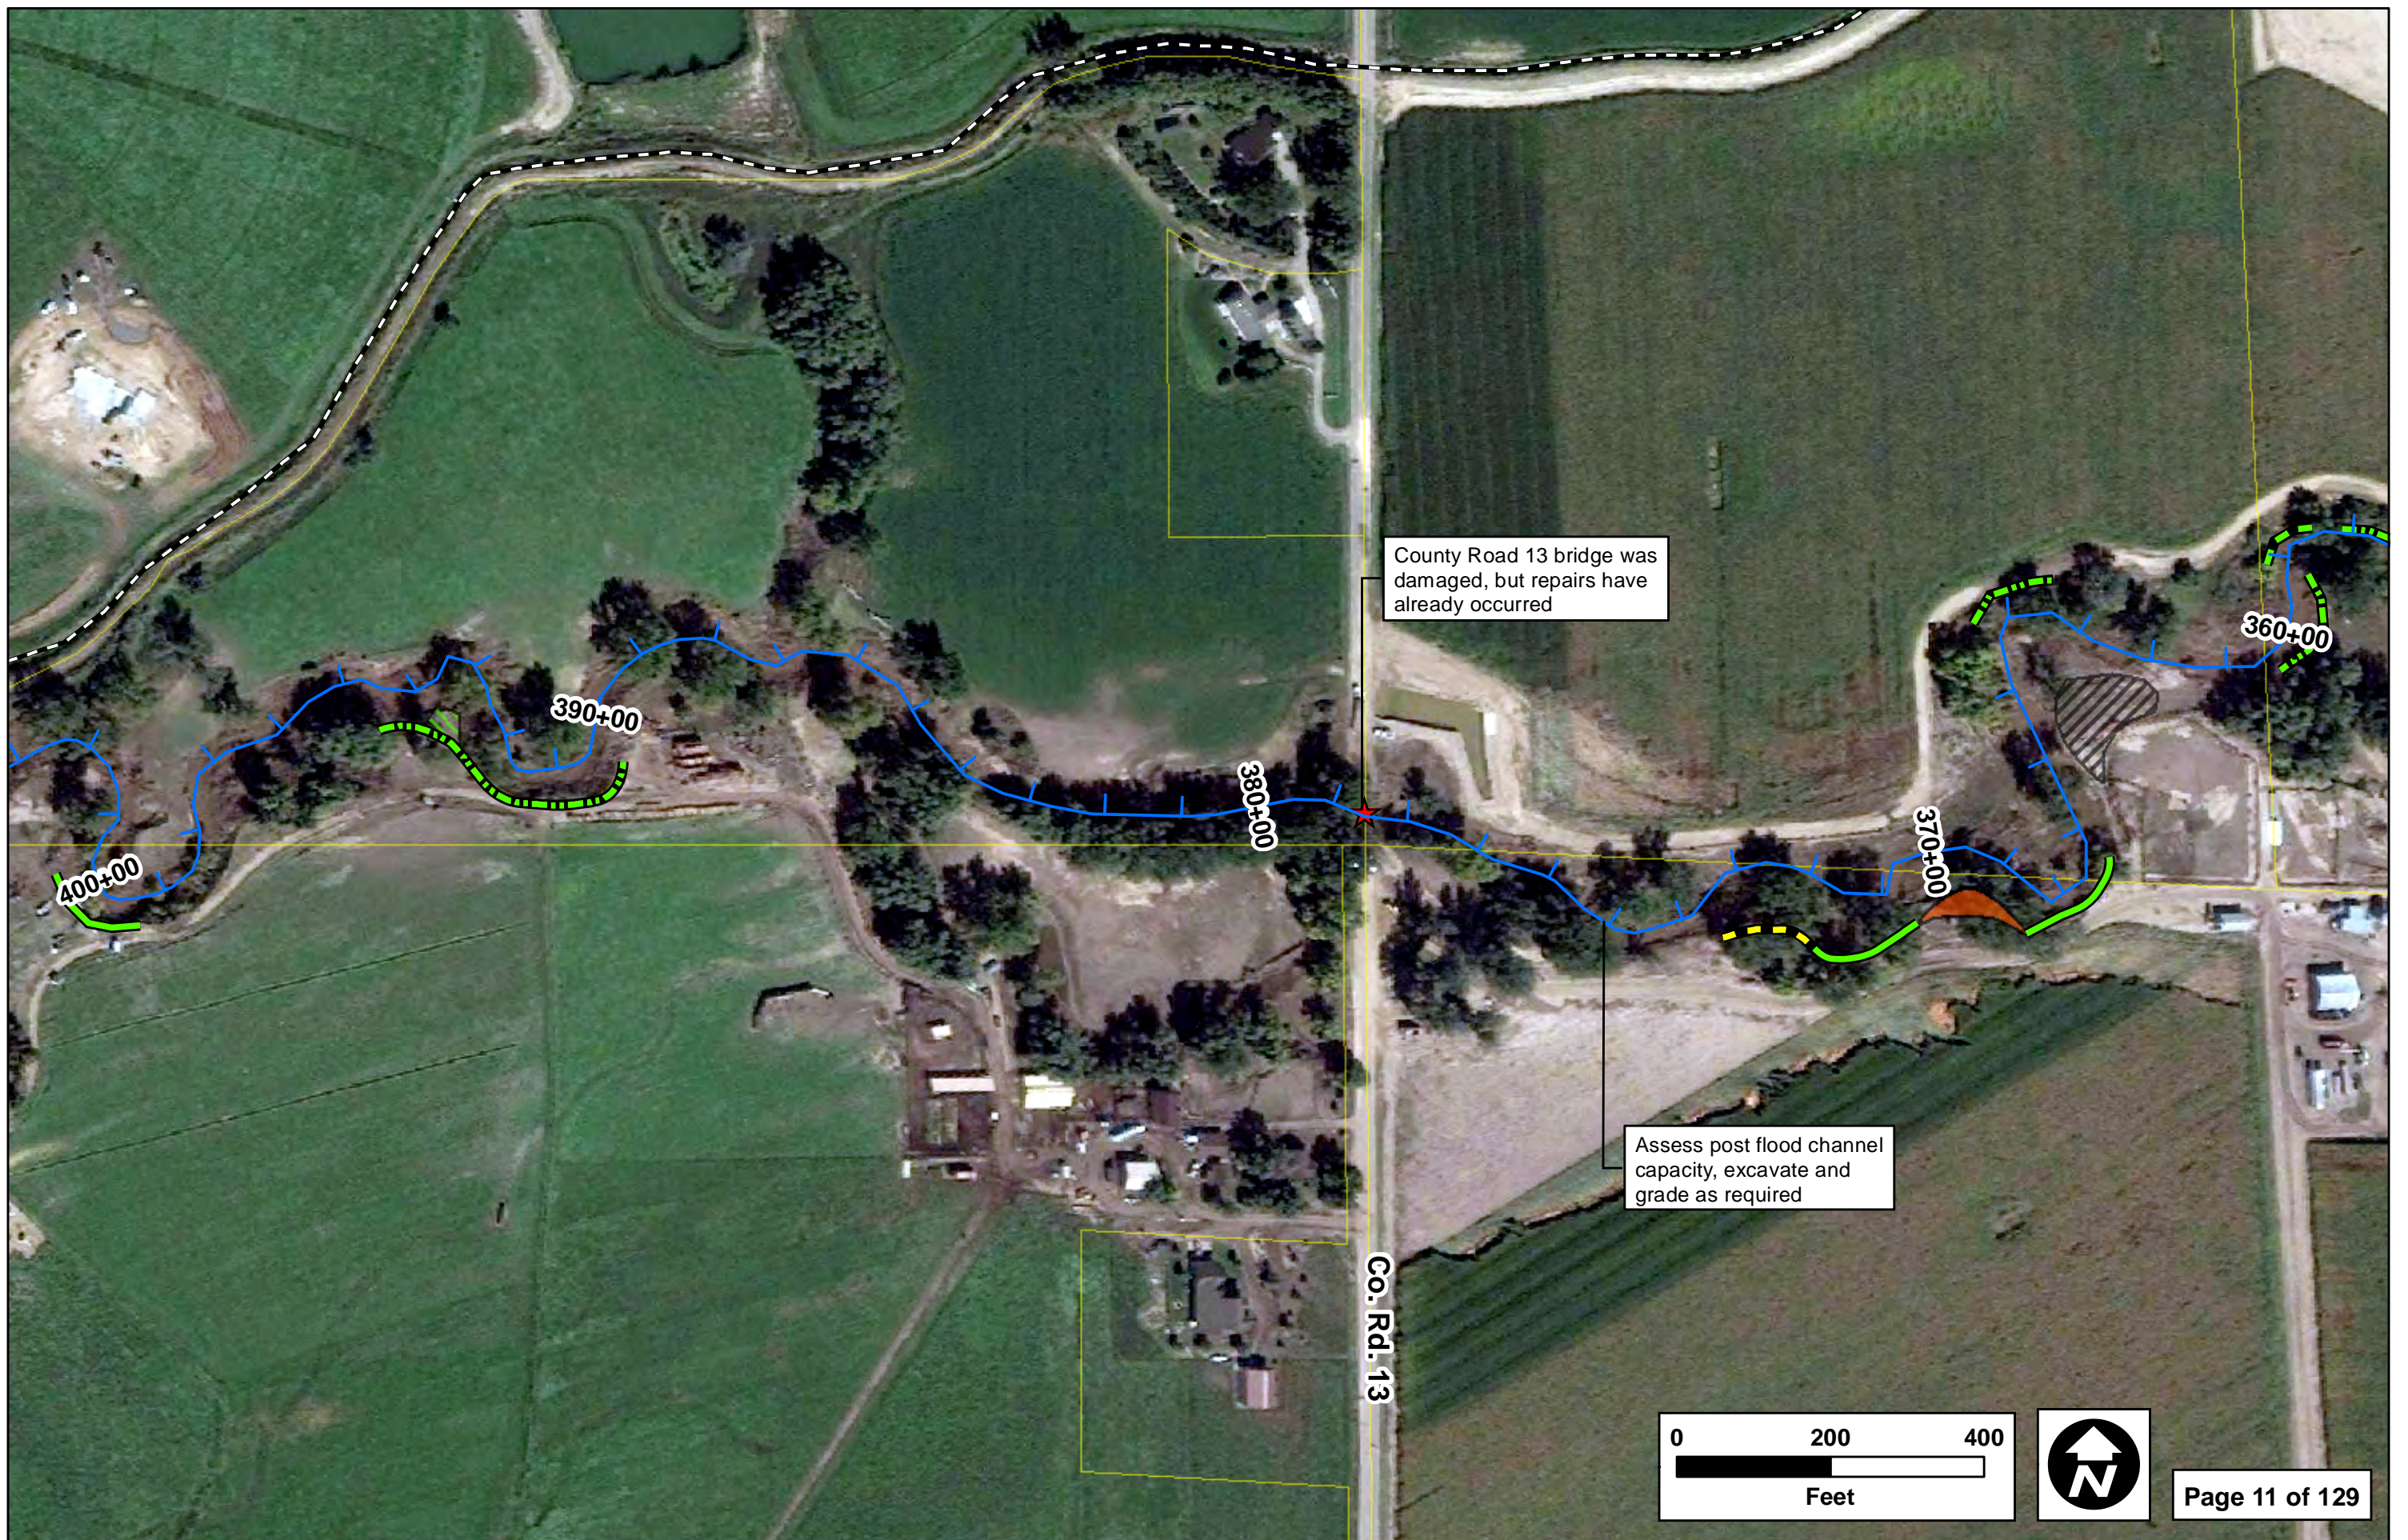
County Road 13 bridge was damaged, but repairs have already occurred

Assess post flood channel capacity, excavate and grade as required

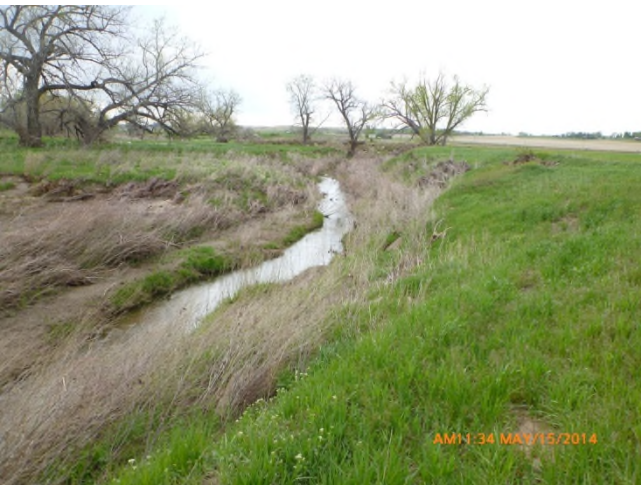
NEIGHBORHOOD: Johnstown & Milliken
SHEET: 12
STATION: 403+00 to 456+00
RESTORATION RECOMMENDATIONS: 403+00 to 456+00

Aerial photos of pre-flood conditions and anecdotal information indicate this reach had relatively dense riparian vegetation corridor, ranging in widths between about 50 and 250 feet. The vegetation consists largely of willows, riparian grasses (e.g., sedges), and cottonwoods. Much of the vegetation is still intact, but often somewhat buried with sediment. Adjacent land use primarily includes agriculture, with some rural development, and roads.

For the most part, the general channel planform was maintained during the 2013 flood event. Minor localized bank erosion did occur along this reach, and a few significant scour holes developed in conjunction with the bank scour in this reach. One scour hole is located near the inverted siphon crossing of the Hillsborough Ditch near Sta 441+00. In addition, some generalized aggradation, and moderate levels of localized sediment deposition along the channel margins and floodplains also occurred.

1. Removal of debris is recommended along the channel and overbanks in areas where the debris could affect flood conveyance. Assess the channel elevations and impacts of floodplain elevations and excavate and grade if required to return the channel to pre-flood elevations.
2. Geomorphic functions of this reach are likely sufficient to allow for the natural regeneration of willow, and other riparian species through seeding and cloning without active revegetation.
3. Stabilize left bank near Sta 418+50.
4. Remove substantial in-channel debris plugs near Sta 439+00 and Sta 437+00.
5. Stabilize right bank near Sta 441+00.

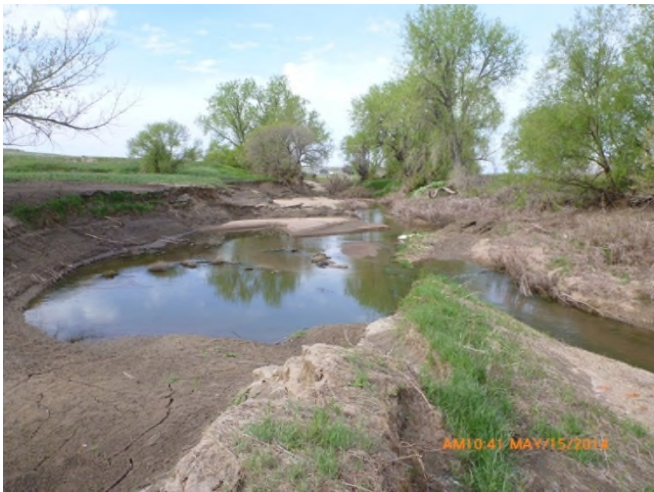
NEIGHBORHOOD: Johnstown & Milliken
SHEET: 13
STATION: 456+00 to 493+00
RESTORATION RECOMMENDATIONS: 456+00 to 493+00

Aerial photos of pre-flood conditions and anecdotal information indicate this reach had a somewhat limited riparian corridor, consisting primarily of riparian grasses (e.g., sedges), willows, and a few cottonwoods. Much of the vegetation is still intact, but considerably buried with sediment. Adjacent land use primarily includes agriculture, with some rural development, and roads.

For the most part, the general channel planform was maintained during the 2013 flood event. Minor localized bank erosion did occur along this reach, and a few significant scour holes developed in conjunction with the bank scour in this reach. In addition, some generalized aggradation, and moderate levels of localized sediment deposition along the channel margins and floodplains also occurred.

1. Removal of debris is recommended along the channel and overbanks in areas where the debris could affect flood conveyance. Assess the channel elevations and impacts of floodplain elevations and excavate and grade if required to return the channel to pre-flood elevations.
2. Geomorphic functions of this reach are likely sufficient to allow for the natural regeneration of willow, and other riparian species through seeding and cloning without active revegetation.
3. Stabilize right bank near Sta 458+00.
4. Stabilize upper right bank near Sta 471+00.
5. Stabilize left bank near Sta 485+50.
6. Stabilize right channel bank near Sta 491+00.
7. Floodplain grading near Sta 492+00 to improve conveyance and reduce future scour potential.

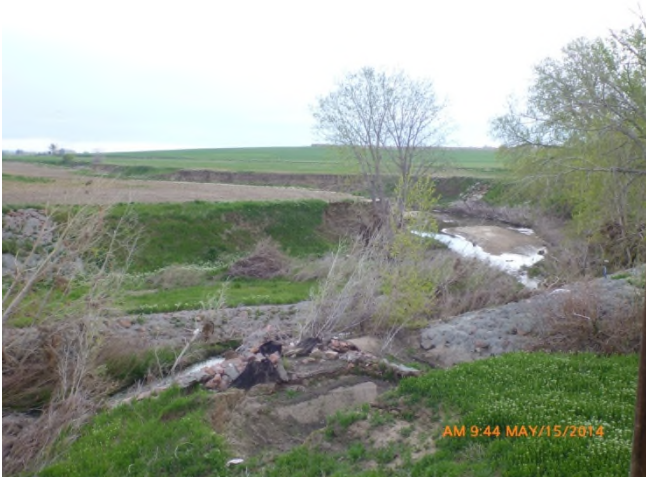
NEIGHBORHOOD: Johnstown & Milliken
SHEET: 15
STATION: 512+00 to 535+00
RESTORATION RECOMMENDATIONS: 512+00 to 535+00

For the most part, the general channel planform was maintained during the 2013 flood event. Only minor localized bank erosion occurred along this reach. In addition, moderate levels of sediment deposition along the channel margins and floodplains also occurred.

- 1. Removal of debris is recommended along the channel and overbanks in areas where the debris could affect flood conveyance. Assess the channel elevations and impacts of floodplain elevations and excavate and grade if required to return the channel to pre-flood elevations.
- 2. Geomorphic functions of this reach are likely sufficient to allow for the natural regeneration of willow, and other riparian species through seeding and cloning without active revegetation.

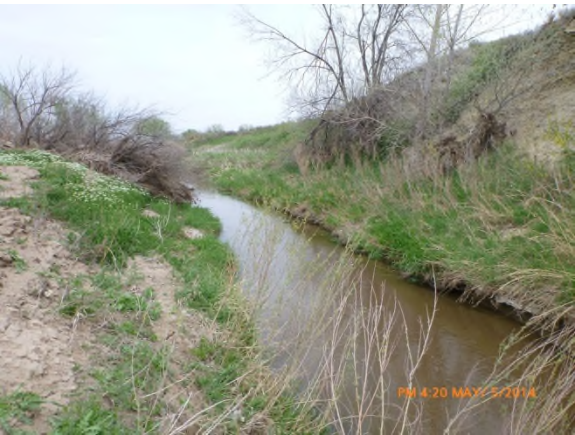
NEIGHBORHOOD: Berthoud
SHEET: 16
STATION: 535+00 to 574+00
RESTORATION RECOMMENDATIONS: 535+00 to 574+00

For the most part, the general channel planform was maintained during the 2013 flood event. Only minor localized bank erosion occurred along this reach. In addition, moderate levels of sediment deposition along the channel margins and floodplains also occurred.

Channel erosion and downcutting did expose many of the pier footings at the I-25 Bridge. Since the time of field assessments, CDOT has reportedly returned to repair and protect footings.

1. Removal of debris is recommended along the channel and overbanks in areas where the debris could affect flood conveyance. Assess the channel elevations and impacts of floodplain elevations and excavate and grade if required to return the channel to pre-flood elevations.
2. Geomorphic functions of this reach are likely sufficient to allow for the natural regeneration of willow, and other riparian species through seeding and cloning without active revegetation.
3. Bank stabilization in vicinity and below I-25 Bridge near Sta 543+00.
4. Overbank fill and reclamation along left side of channel near Sta 551+50 and Sta 545+00.
5. Refinement of low flow channel downstream of the Miner and Longan Ditch diversion structure near Sta 555+00.

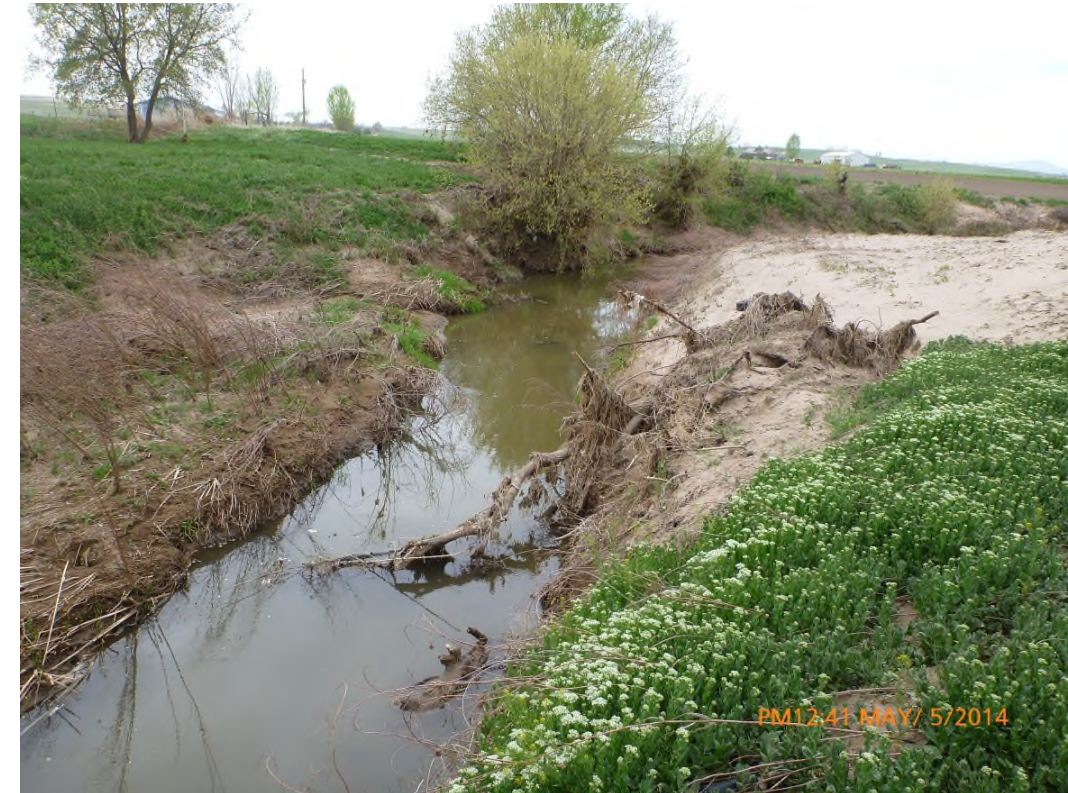
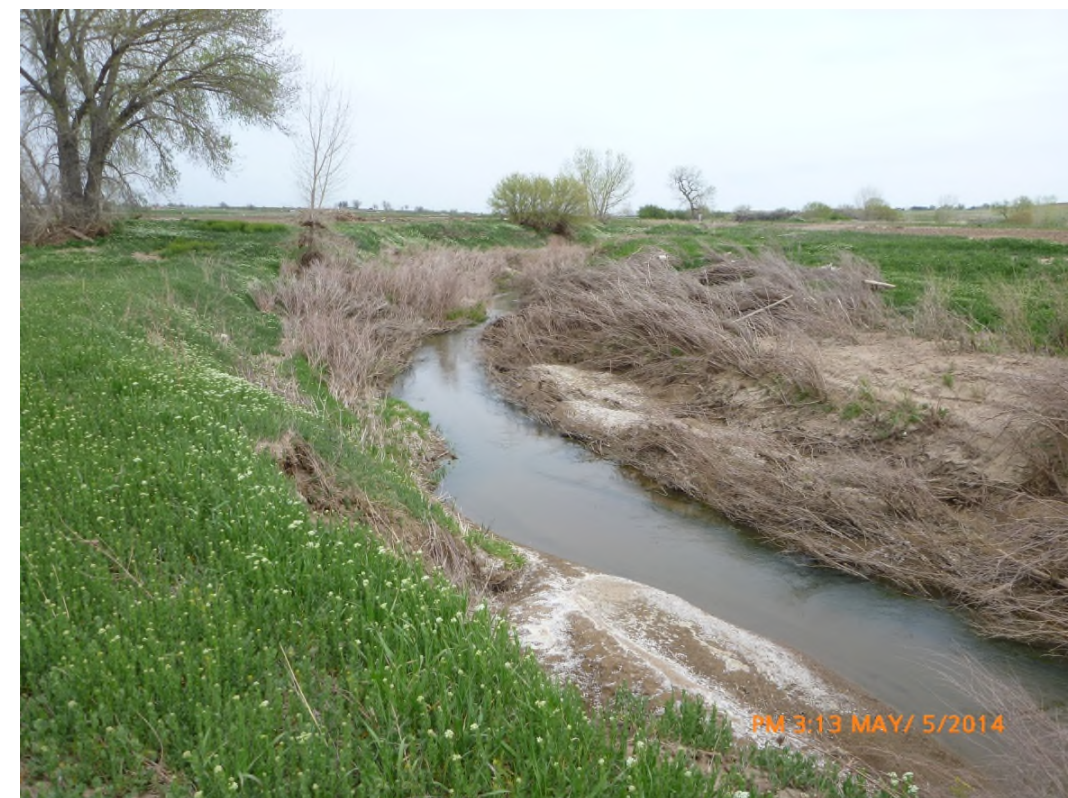
NEIGHBORHOOD: Berthoud
SHEET: 17
STATION: 571+00 to 622+00

For the most part, the general channel planform was maintained during the 2013 flood event. Only minor localized bank erosion occurred along this reach. In addition, moderate levels of sediment deposition along the channel margins and floodplains also occurred. Beyond that, only limited damages occurred.

1. Geomorphic functions of this reach are fairly sufficient to convey flow and sediment, and to allow for the regeneration of riparian species through natural seeding and cloning without any further restoration. However, removal of debris is recommended along the channel and overbanks in areas where the debris could affect flood conveyance.
2. No further actions are suggested at this time.

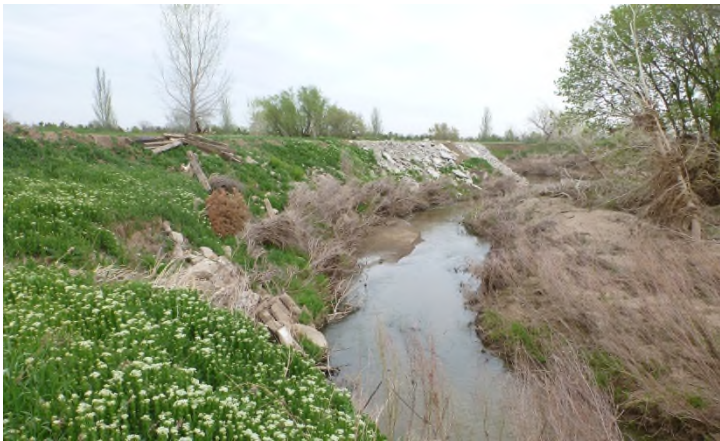
NEIGHBORHOOD: Berthoud
SHEET: 18
STATION: 622+00 to 668+00
RESTORATION RECOMMENDATIONS: 630+00 to 668+00

For the most part, the general channel planform was maintained during the 2013 flood event. However, significant bank erosion and lateral migration did occur along this reach, especially near Sta 654+00 where lateral erosion severely damaged an access road, and near Sta 660+00 resulting in a pond breach. In addition to localized bank erosion, a significant and consistent problem through this reach appears to have been generalized aggradation and severe sediment deposition along the channel margins and floodplains, as well as accumulation of debris.

7. Stabilize left bank near Sta 660+00 to protect bank/berm shared by irrigation pond.
8. Stabilize left bank near Sta 668+00.
9. Removal of debris is recommended along the channel and overbanks in areas where the debris could affect flood conveyance. Some of the woody debris could be used as bank and slope stabilization measures where recommended. Removal of the sandy material deposited in the overbanks may also be necessary at a number of locations to reclaim farmland.

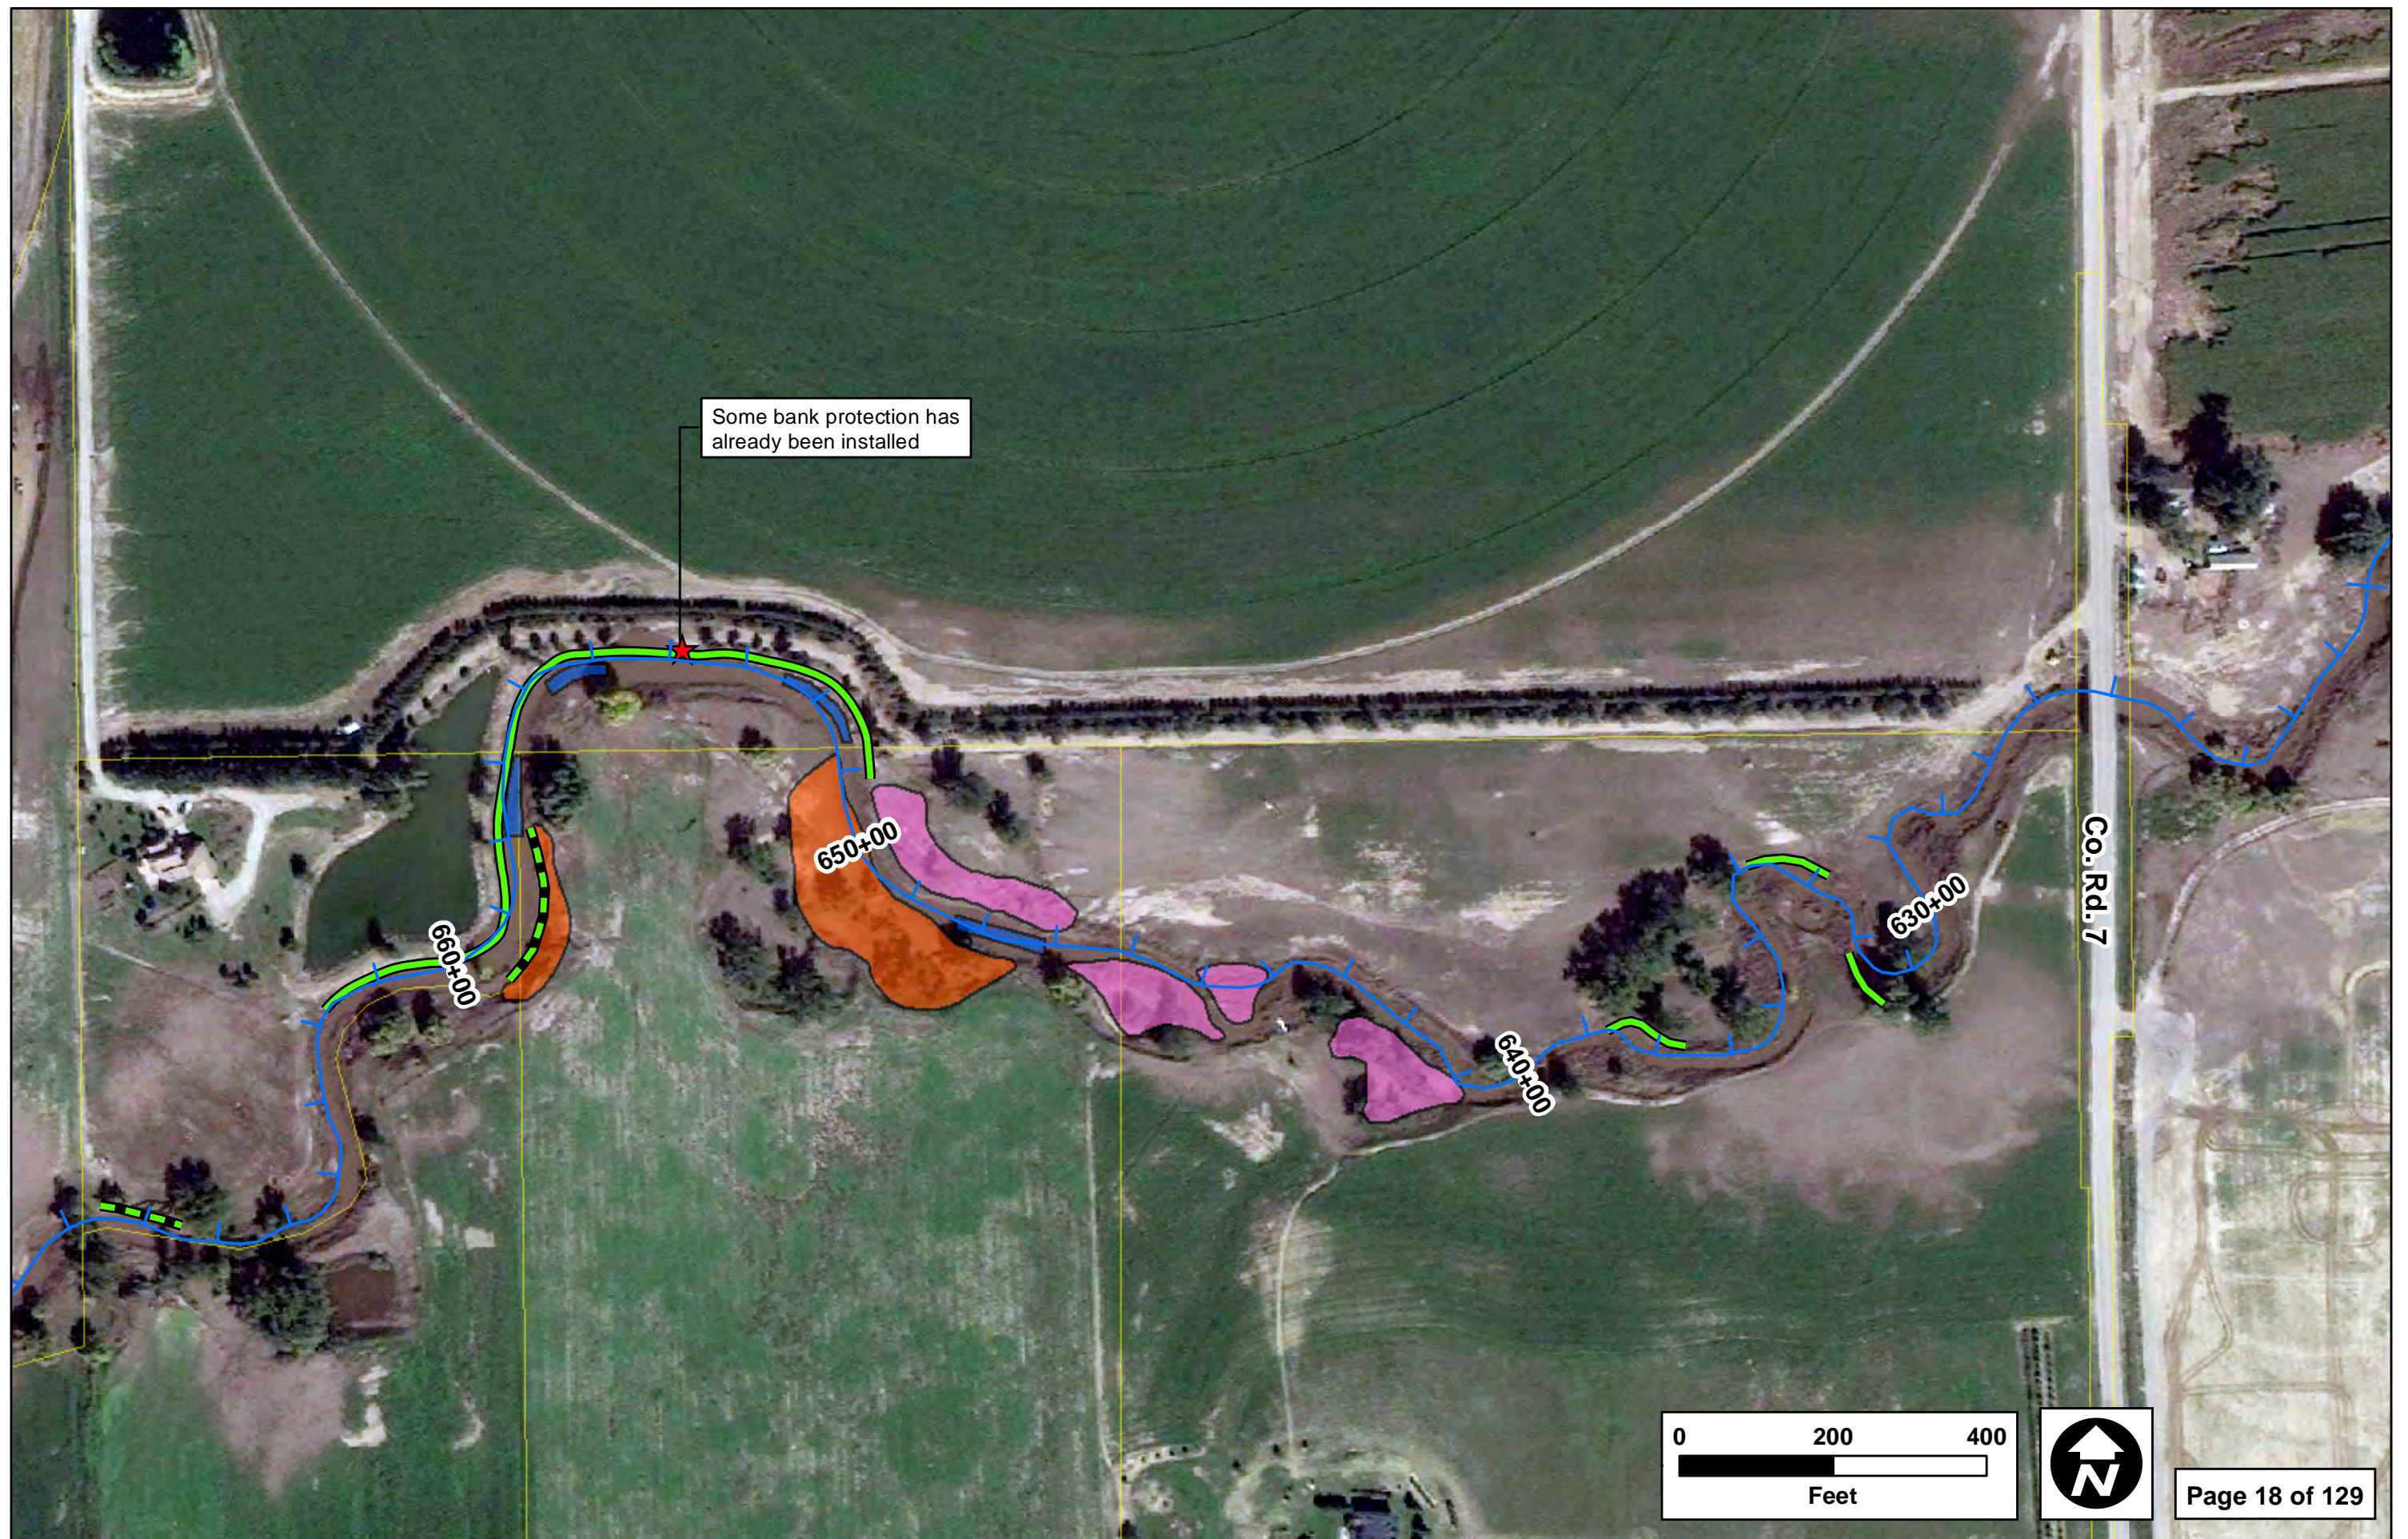
Some bank protection has
already been installed

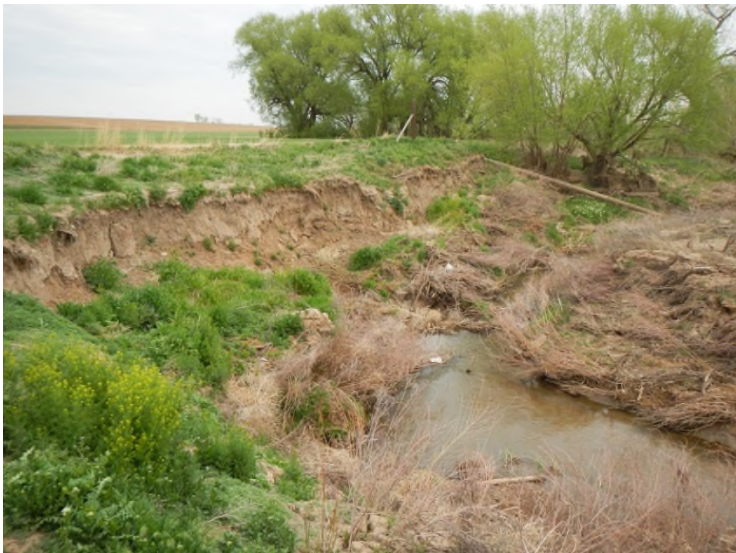
NEIGHBORHOOD: Berthoud
SHEET: 19
STATION: 661+00 to 708+00
RESTORATION RECOMMENDATIONS: 671+00 to 700+00

For the most part, the general channel planform was maintained during the 2013 flood event. Lateral migration, significant bank erosion, and channel downcutting are limited, although localized areas showing evidence of each of these items were observed. The most significant and consistent problem through this reach appears to have been aggradation in the main channel, along the channel margins, and in the overbanks, as well as accumulation of debris.

Bank erosion and lateral migration were limited due to the presence of historical bank protection (concrete rubble, automobiles, etc.). Some localized bank erosion that extended from toe to top of bank was observed locally. Upper bank erosion was observed in areas where overbank flows returned to the channel, but the bank toes in these areas appear stable. Downstream from County Road 5, the sharp bends did not erode significantly due to relief provided by flood conveyance over the inside bend, although the more moderate bends experienced some bank erosion that could threaten private drives and access roads.

1. Stabilize left bank near Sta 698+00, Sta 693+00, Sta 685+00, Sta 675+00, Sta 673+00, and Sta 667+00.
2. Stabilize right bank near Sta 705+00.
3. Removal of debris is recommended along the channel and overbanks in areas where the debris could affect flood conveyance. Some of the woody debris could be used as bank and slope stabilization measures where recommended. Removal of the sandy material deposited in the overbanks may also be necessary at a number of locations to reclaim farmland.

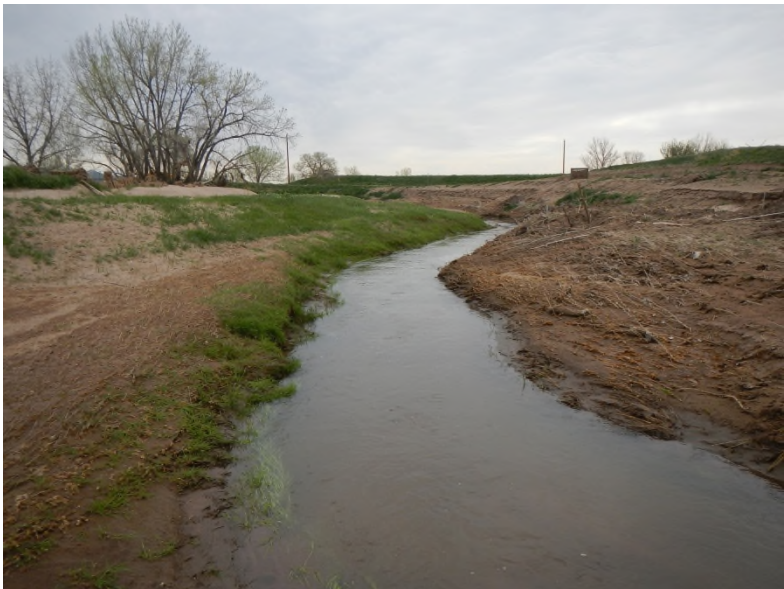
For the most part, the general channel planform was maintained during the 2013 flood event. Lateral migration, significant bank erosion, and channel downcutting are limited, although localized areas showing evidence of each of these items were observed. The most significant and consistent problem through this reach appears to have been aggradation in the main channel, along the channel margins, and in the overbanks, as well as accumulation of debris.

Bank erosion and lateral migration were limited due to the presence of historical bank protection (concrete rubble, automobiles, etc.). Some localized bank erosion that extended from toe to top of bank was observed. Upper bank erosion was observed in areas where overbank flows returned to the channel, but the bank toes in these areas appear stable. Some remedial action has occurred at County Road 5 with the placement of riprap on the upper bank of the left abutment. Downstream from County Road 5, the sharp bends did not erode significantly due to relief provided by flood conveyance over the inside bend, although the more moderate bends experienced some bank erosion that could threaten private drives and access roads.

- 1. Stabilize right bank near Sta 705+00.
- 2. Bank stabilization near Sta 741+00.
- 3. Removal of debris is recommended along the channel and overbanks in areas where the debris could affect flood conveyance. Some of the woody debris could be used as bank and slope stabilization measures where recommended. Removal of the sandy material deposited in the overbanks may also be necessary at a number of locations to reclaim farmland.

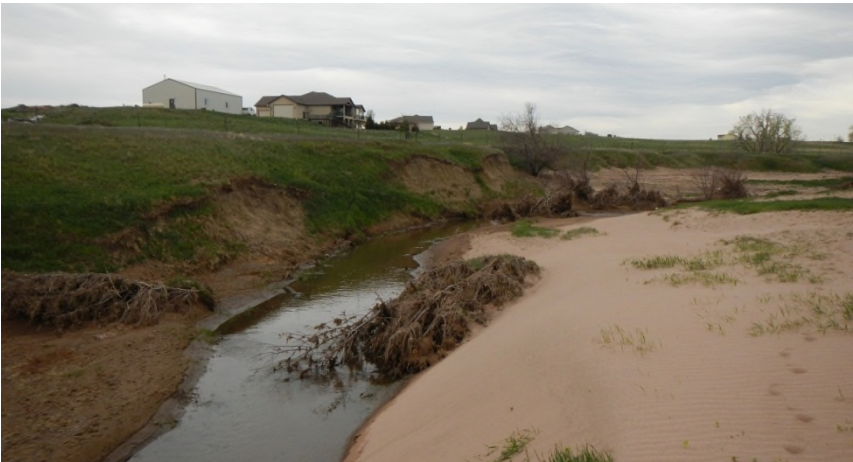
For the most part, the general channel planform was maintained during the 2013 flood event. Lateral migration, significant bank erosion, and channel downcutting are limited, although localized areas showing evidence of each of these items were observed. The most significant and consistent problem through this reach appears to have been aggradation in the main channel, along the channel margins, and in the overbanks, as well as accumulation of debris.

Bank erosion and lateral migration were limited due to the presence of historical bank protection (concrete rubble, automobiles, etc.). Some localized bank erosion that extended from toe to top of bank was observed locally. Upper bank erosion was observed in areas where overbank flows returned to the channel, but the bank toes in these areas appear stable.

1. Bank stabilization near Sta 741+00.
2. Stabilize right bank near Sta 773+00.
3. Bank stabilization and grading and lowering near Sta 779+00.
4. Removal of sediment deposition (grading and lowering) along the left overbanks between Sta 740+00 to Sta 762+00.
5. Removal of debris is recommended along the channel and overbanks in areas where the debris could affect flood conveyance. Some of the woody debris could be used as bank and slope stabilization measures where recommended. Removal of the sandy material deposited in the overbanks may also be necessary at a number of locations to reclaim farmland.

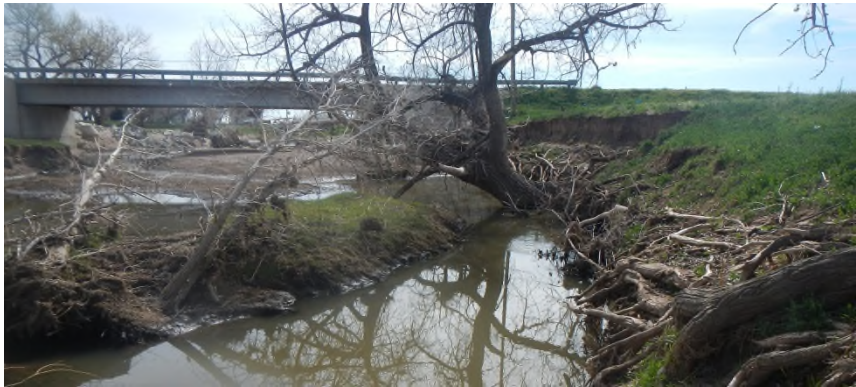
For the most part, the general channel planform was maintained during the 2013 flood event. Lateral migration, significant bank erosion, and channel downcutting are limited, although localized areas showing evidence of each of these items were observed. The most significant and consistent problem through this reach appears to have been aggradation in the main channel, along the channel margins, and in the overbanks, as well as accumulation of debris.

Bank erosion and lateral migration were limited due to the presence of historical bank protection (concrete rubble, automobiles, etc.). Some localized bank erosion that extended from toe to top of bank was observed locally, including in the vicinity of County Road 3. Upper bank erosion was observed in areas where overbank flows returned to the channel, but the bank toes in these areas appear stable. The most significant bank erosion was observed in the vicinity of County Road 3, especially in the reach between Sta 787+00 and Sta 796+00 and just upstream from County Road 3. Some repair work has occurred at the County Road 3 Bridge, including the placement of riprap on the upper banks of the right abutment and placement of riprap in a scour hole.

- 1. Stabilize banks in vicinity of County Road 3 Bridge to protect against flanking of the structure.
- 2. Siphon crossing below County Road 3 currently protected only by concrete rubble and may require additional stabilization.
- 3. Removal of debris is recommended along the channel and overbanks in areas where the debris could affect flood conveyance. Some of the woody debris could be used as bank and slope stabilization measures where recommended. Removal of the sandy material deposited in the overbanks and grading may also be necessary at a number of locations to reclaim farmland.
- 4. Stabilize right bank near Sta 773+00.
- 5. Fill and stabilize upper banks near Sta 779+00.
- 6. Fill and stabilize upper banks between Sta 788+00 and Sta 801+00 and at Sta 798+00.

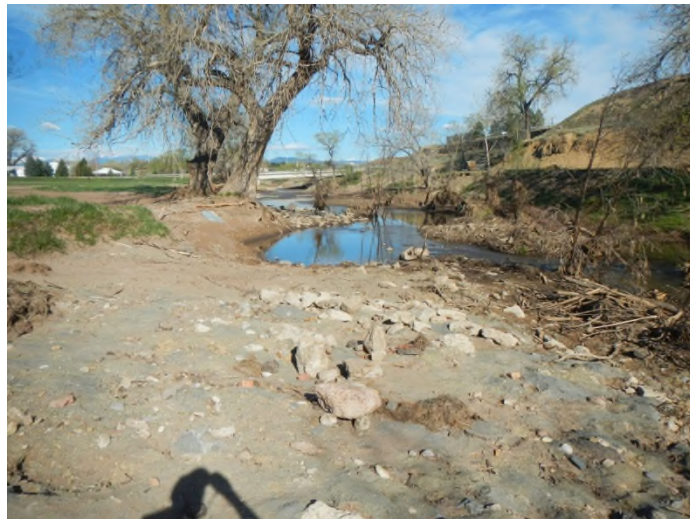
For the most part, the general channel planform was maintained during the 2013 flood event. Lateral migration, significant bank erosion, and channel downcutting are limited, although localized areas showing evidence of each of these items were observed. The most significant and consistent problem through this reach appears to have been aggradation in the main channel, along the channel margins, and in the overbanks, well as accumulation of debris.

Bank erosion and lateral migration were limited due to the presence of historical bank protection (concrete rubble, automobiles, etc.). Upper bank erosion was observed in areas where overbank flows returned to the channel, but the bank toes in these areas appear stable.

1. Geomorphic functions of this reach are fairly sufficient to convey flow and to allow for the regeneration of riparian species through natural seeding and cloning without any further restoration. However, removal of debris is recommended along the channel and overbanks in areas where the debris could affect flood conveyance.
2. No further actions are suggested at this time.
