APPENDIX A

ASSESSMENT PROTOCOL

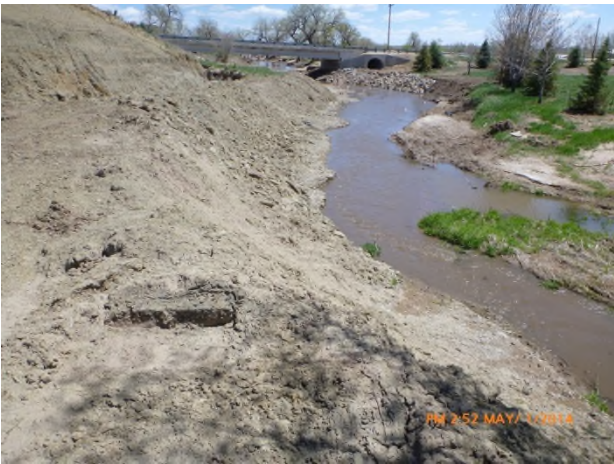
For the most part, the general channel planform was maintained during the 2013 flood event. The issues along this reach primarily consist of localized bank erosion, some generalized aggradation, localized deposition (primarily in small floodplain surfaces on inside of bends), and debris jams. Bank erosion along reach is limited in many areas by the presence of concrete rubble and other buried bank protection measures that were installed prior to the flood (concrete rubble, automobiles, etc.). Some localized bank erosion that extended from toe to top of bank was observed locally, including an area just below County Road 1. Significant channel clean up, excavation, and reconstruction has occurred upstream of Sta 888+50. Seeding or planting of any reshaped channel banks would help accelerate vegetation recruitment.

The right abutment of County Road 1 was undermined during the 2013 flood event. This has been repaired with the placement of riprap. It is unknown at this time if any remedial work was performed at County Road 6.

1. Geomorphic functions of this reach are fairly sufficient to allow for the regeneration of riparian species through natural seeding and cloning without any further restoration. However, seeding or planting of riparian vegetation along any bare or reconstructed channel banks and floodplain surfaces is recommended to accelerate revegetation and stability.
2. Stabilize right bank near Sta 854+00.
3. Stabilize left bank near Sta 876+00.
4. Stabilize banks near Sta 880+00 to protect and stabilize the Rockwell Ditch and the upstream side of the County Road 1 Bridge.
5. Lower and grade left floodplain surface near Sta 882+50.

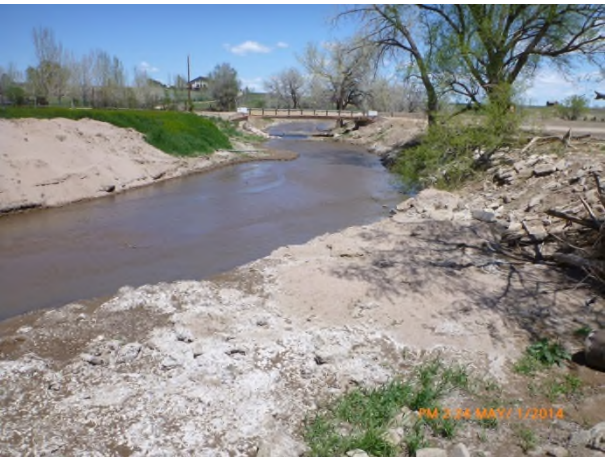
For the most part, the general channel planform was maintained during the 2013 flood event. The issues along this reach primarily consist of localized bank erosion, some generalized aggradation, localized deposition (primarily in small floodplain surfaces on inside of bends), and debris jams. Bank erosion along reach is limited in many areas by the presence of concrete rubble and other buried bank protection measures that were installed prior to the flood. Seeding or planting of any reshaped channel banks would help accelerate vegetation recruitment.

- 1. Stabilize channel banks in vicinity of County Road 6c Bridge.
- 2. Up-and downstream of County Road 6c, the channel width is likely too wide to maintain transport of sediment through the system or possibly even efficient water conveyance at lower flows. It is likely that over time, the channel will adjust through either minor downcutting and/or more likely deposition along the wider channel bottom to naturally narrow the low flow channel. This process could be expedited via mechanical earthwork. Providing some low level vegetated benches will also improve environmental aspects of the channel.

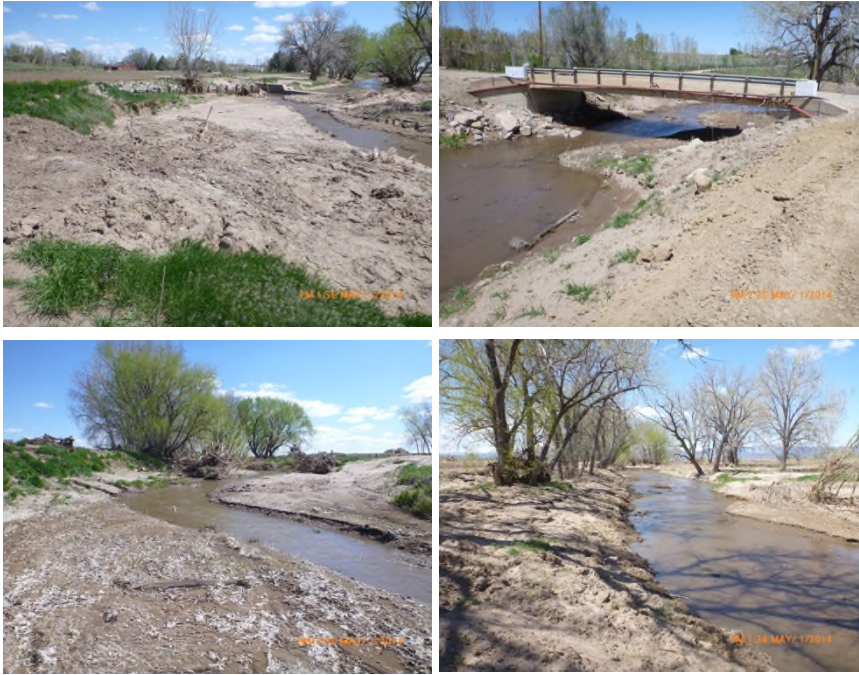
For the most part, the general channel planform was maintained during the 2013 flood event. The issues along this reach primarily consist of localized bank erosion, some generalized aggradation, localized deposition (primarily in small floodplain surfaces on inside of bends), and debris jams. Bank erosion along reach is limited in many areas by the presence of concrete rubble and other buried bank protection measures that were installed prior to the flood. Significant channel clean up, excavation, and reconstruction has occurred downstream of Sta 915+50. Seeding or planting of any reshaped channel banks would help accelerate vegetation recruitment.

1. Geomorphic functions of this reach are fairly sufficient to allow for the regeneration of riparian species through natural seeding and cloning without any further restoration. However, seeding or planting of riparian vegetation along any bare or reconstructed channel banks and floodplain surfaces is recommended to accelerate revegetation and stability.

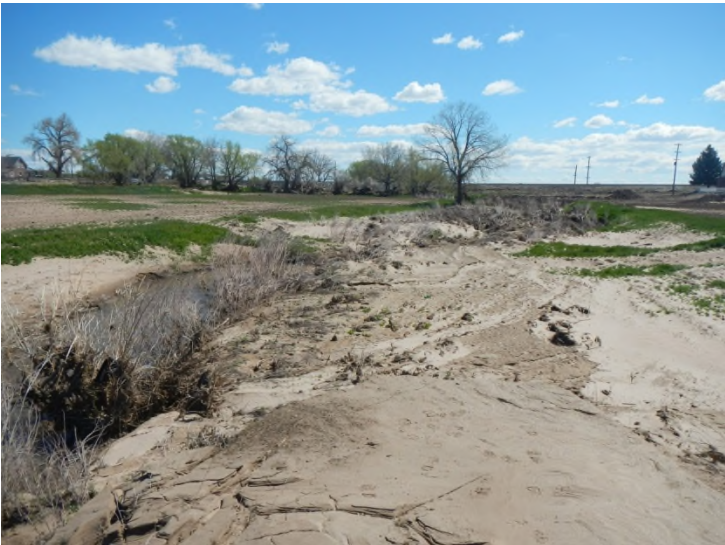
For the most part, the general channel planform was maintained during the 2013 flood event. Local scour along channel banks and debris and sediment deposition along the floodplain occurred during the flood. Seeding or planting of any reshaped channel banks would help accelerate vegetation recruitment.

The landowner has placed riprap and graded along the right bank downstream of the bridge at 1st Street. Riprap on the right abutment has also been placed since the 2013 flood.

- 1. Geomorphic functions of this reach are fairly sufficient to allow for the regeneration of willow and other riparian species through natural seeding and cloning without any further restoration. However, seeding or planting of riparian vegetation along any bare channel banks and floodplain surfaces is recommended to accelerate revegetation and stability.
- 2. Restore low-flow channel in several sections by removing debris and reconstructing single thread channel.
- 3. Stabilize left bank near Sta 929+00, Sta 935+00 and Sta 939+00.
- 4. Stabilize right bank near Sta 934+00
- 5. Stabilize right bank and reclaim right overbank near Sta 941+00.

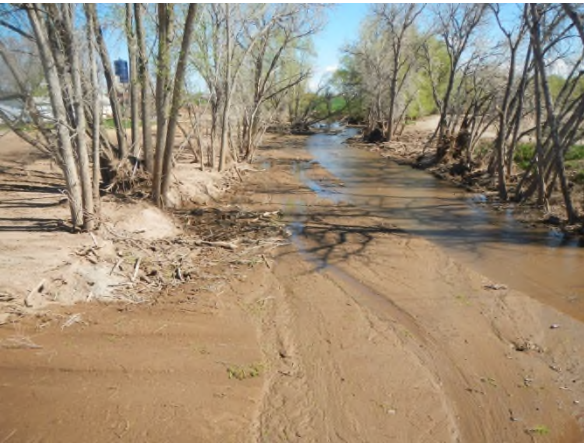
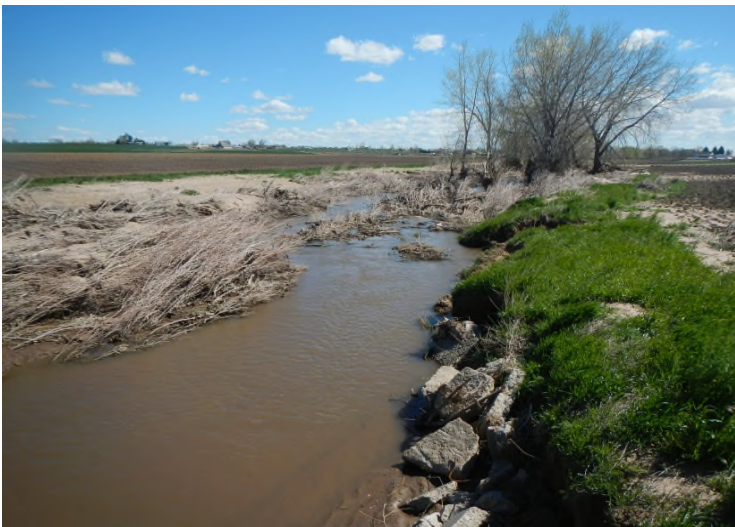
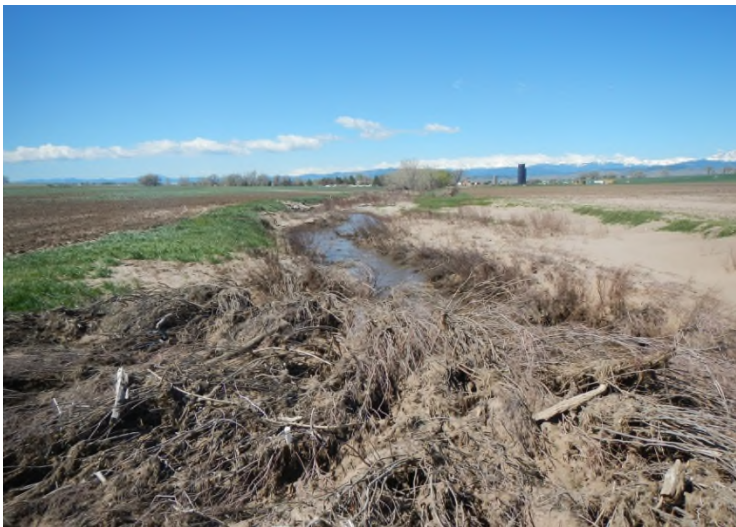
NEIGHBORHOOD: Berthoud
SHEET: 28
STATION: 952+00 to 985+00
RESTORATION RECOMMENDATIONS: 952+00 to 984+00

Aerial photos of pre-flood conditions and anecdotal information indicate this reach had a densely vegetated riparian corridor, with an average width of about 100 feet. The vegetation was comprised of cottonwoods, willows, and other riparian species, some of which were torn out during the flood. Cottonwoods are primarily the only remaining vegetation at this time. Adjacent land use includes agriculture, rural development, and roads.

For the most part, the general channel planform was maintained during the 2013 flood event. Local scour along channel banks and debris and sediment deposition along the floodplain occurred during the flood. Seeding or planting of any reshaped channel banks would help accelerate vegetation recruitment. Dry Creek confluences with the Little Thompson River at Sta 972+00.

- 1. Geomorphic functions of this reach are likely sufficient to allow for the regeneration of willow, and other riparian species through natural seeding and cloning without any further restoration. However, seeding or planting of riparian vegetation along any bare channel banks and floodplain surfaces is recommended to accelerate revegetation and stability.
- 2. Monitor the river in the vicinity of Dry Creek to ensure that future sediment loads do not impact flood-conveyance capacity.
- 3. No further actions are suggested at this time.

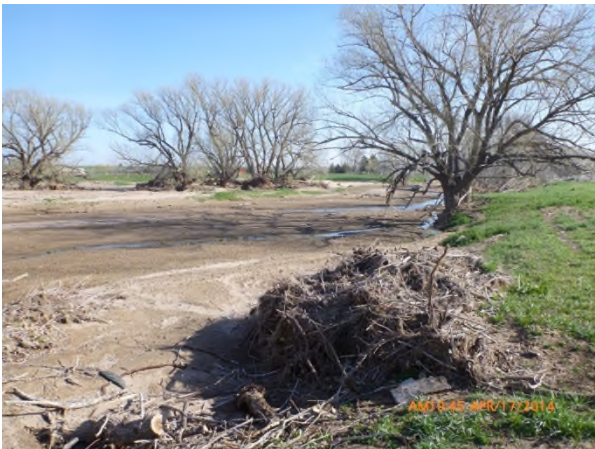
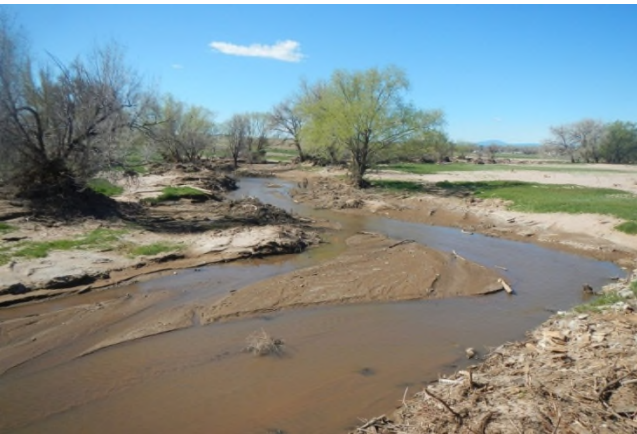
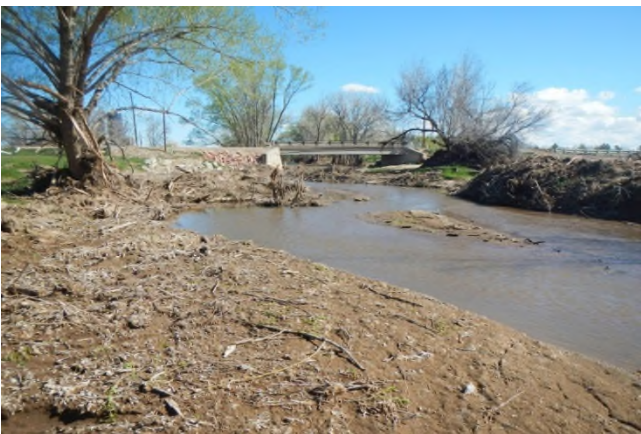
NEIGHBORHOOD: Berthoud
SHEET: 29
STATION: 982+00 to 1011+00
RESTORATION RECOMMENDATIONS: 985+00 to 994+00

Aerial photos of pre-flood conditions and anecdotal information indicate this reach had scattered areas of moderately dense riparian vegetation. The vegetation was comprised of cottonwoods, willows, and other riparian species, many of which were torn out during the flood. Cottonwoods are primarily the only remaining vegetation at this time. Adjacent land use includes agriculture, rural development, and roads.

For the most part, the general channel planform was maintained during the 2013 flood event. Local scour along channel banks and debris and sediment deposition along the floodplain occurred during the flood. The most significant overbank sediment deposition occurred upstream (south) of the County Road 4E Bridge due to the constricting effects of the bridge, and was on the order of 4 to 6 feet. Riprap has been placed on the upper banks of this bridge.

1. Geomorphic functions of this reach are likely sufficient to allow for the regeneration of willow, and other riparian species through natural seeding and cloning without any further restoration. However, seeding or planting of riparian vegetation along any bare channel banks and floodplain surfaces is recommended to accelerate revegetation and stability.
2. Lower and grade left floodplain near Sta 990+00 and the right overbank between Sta 990+00 to Sta 1000+00.
3. Stabilize right bank near Sta 1006+00, including fill/reclamation of right over bank.
4. Refinement of low-flow channel and stabilization of banks near Sta 1010+00.

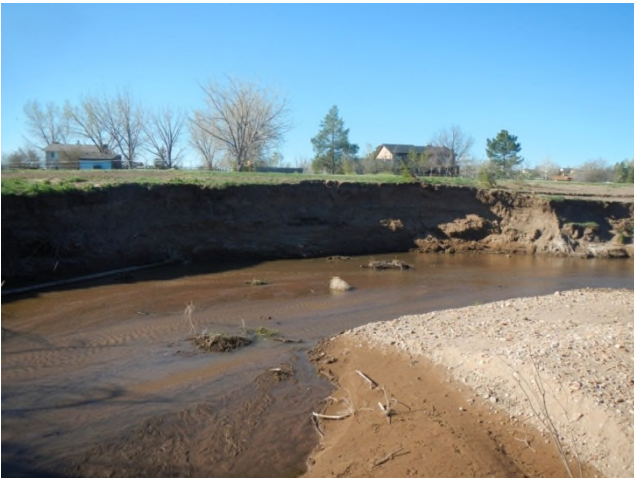
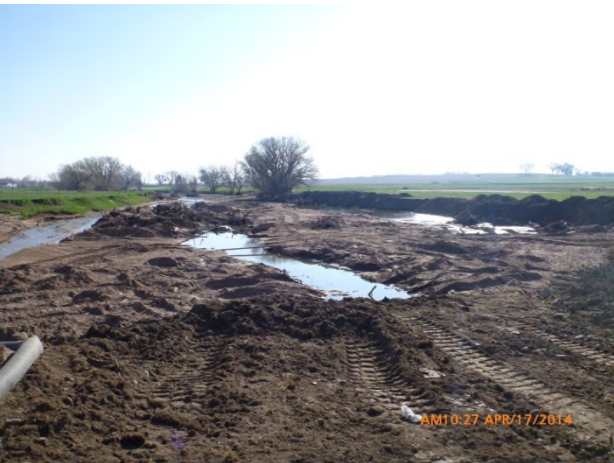
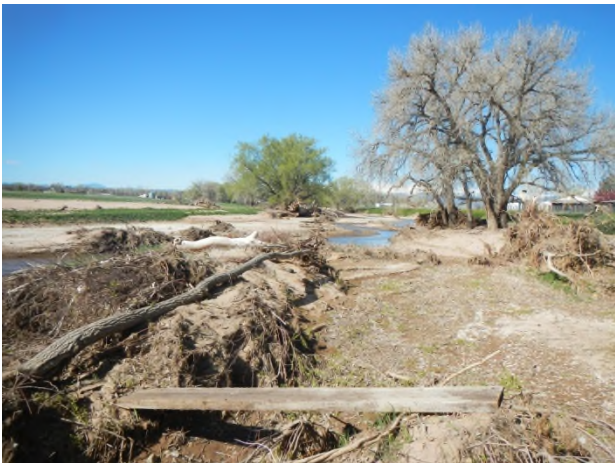
NEIGHBORHOOD: Berthoud
SHEET: 30
STATION: 997+00 to 1029+00
RESTORATION RECOMMENDATIONS: 1000+00 to 1017+00

Aerial photos of pre-flood conditions and anecdotal information indicate this reach had scattered areas of moderately dense riparian vegetation. The vegetation was comprised of cottonwoods, willows, and other riparian species, many of which were torn out during the flood. Adjacent land use includes agriculture, rural development, and roads. Flood flows caused significant bank erosion in certain locations, such as along the left bank near Sta 1025+00. Significant bank erosion also occurred along the right bank near Sta 1013+00, which was largely due to scour that flanked the Osborne Caywood Ditch Diversion Structure and directed flows directly at the right overbank. Flood flows also deposited significant amounts of sediment and debris along the channel and floodplain. Overbank and floodplain sedimentation and channel bank erosion are the dominant flood impacts in this reach.

The County Road 17 Bridge and the Osborne Caywood Ditch Diversion Structure was severely damaged during the flood. To date, most of the repairs have been made to both structures.

- 1. Stabilize right bank near Sta 1006+00.
- 2. Stabilize the banks in the vicinity of the Osborne Caywood Ditch Diversion Structure to reduce potential for future failure due to flanking of the structure. Extend left bank stabilization, (level 1) between the Osborne Caywood Diversion Structure at Sta 1018+00 to the bridge at County Road 17.

- 9. In general, clearing of primary low flow channel, removal of significant sediment deposits along the floodplain, and grading of floodplain surfaces to ensure proper connectivity and drainage with river is recommended.

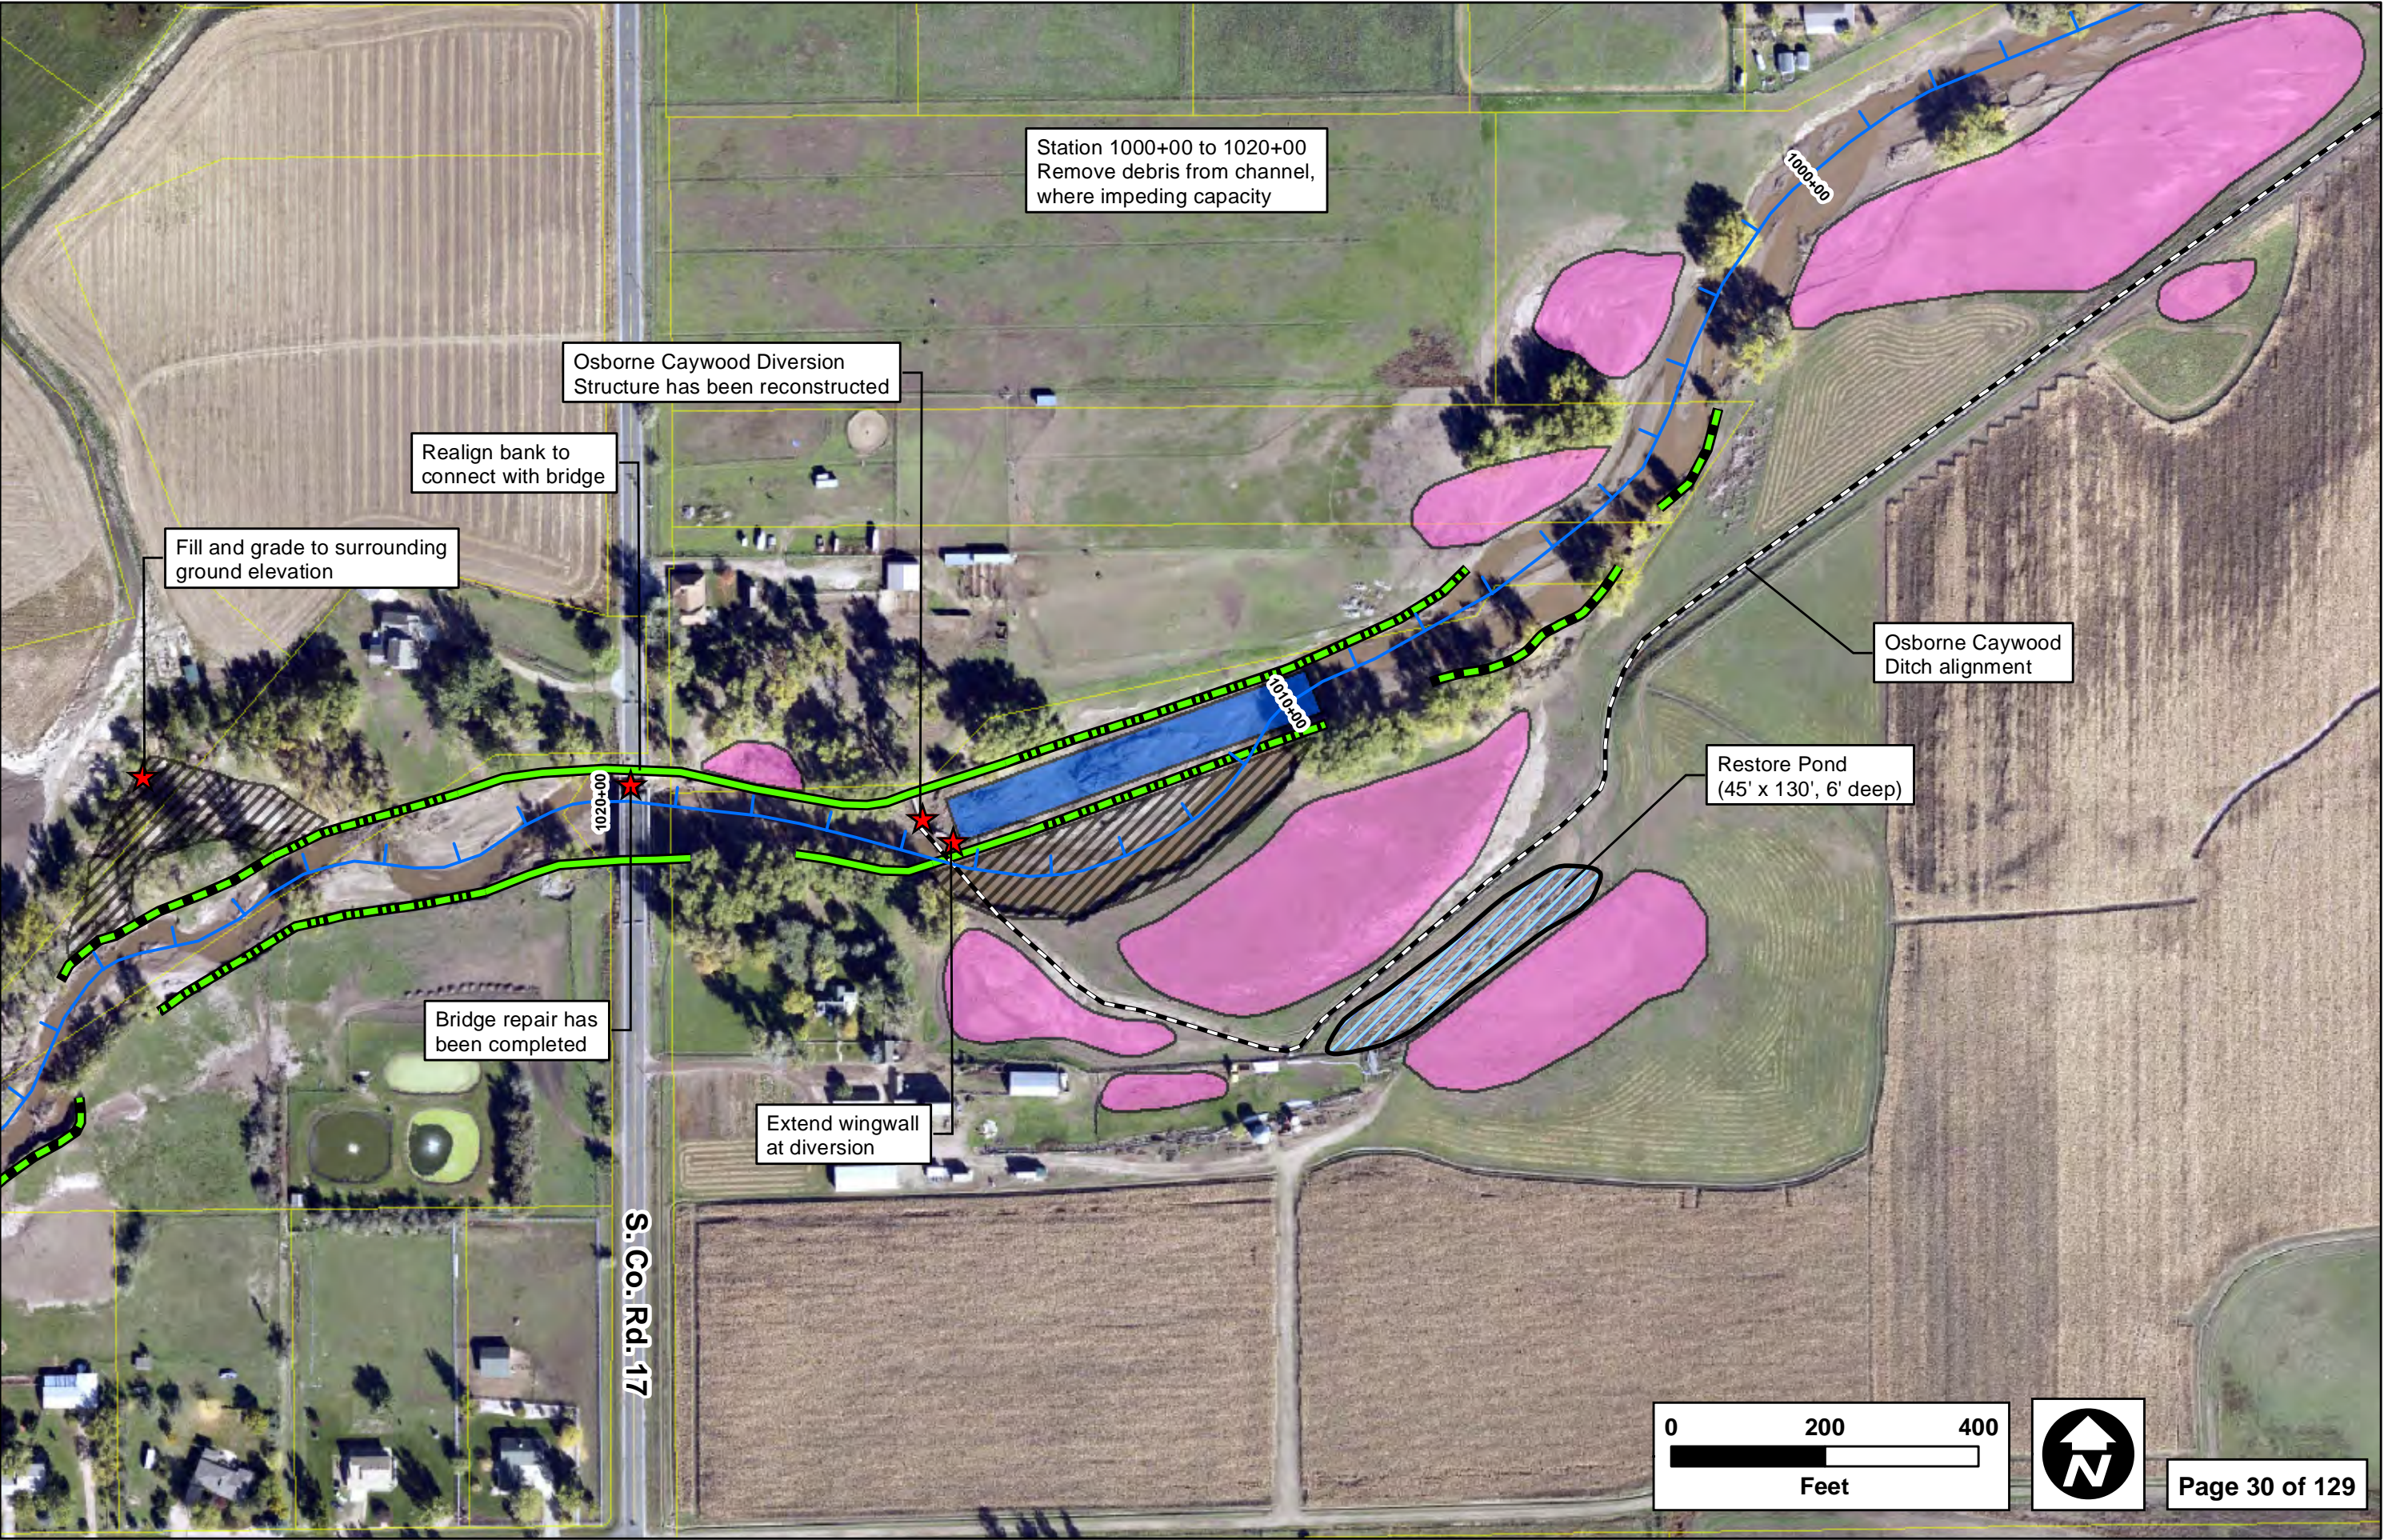
Osborne Caywood Diversion
Structure has been reconstructed

Bridge repair has
been completed

Station 1000+00 to 1020+00
Remove debris from channel,
where impeding capacity

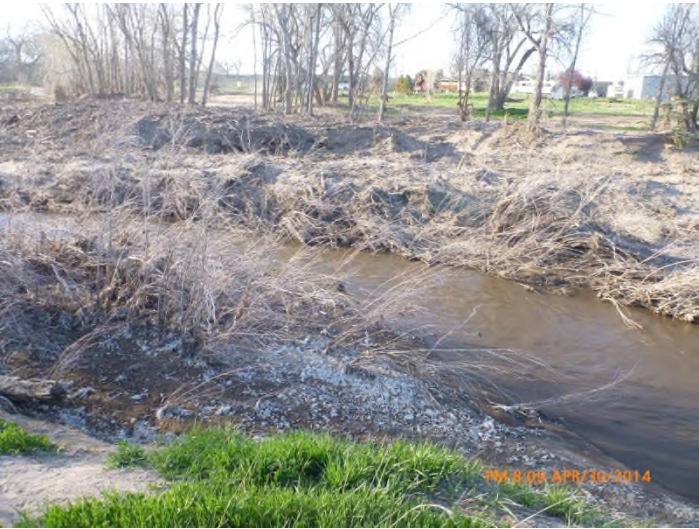
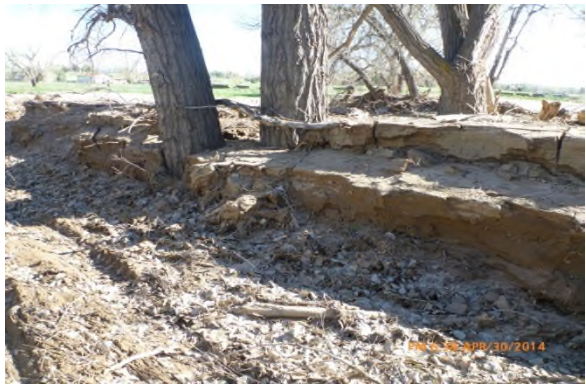
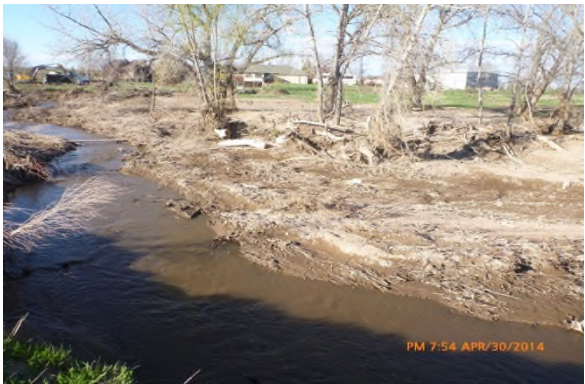
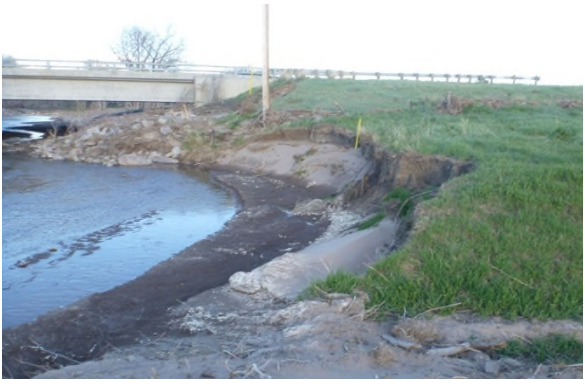
NEIGHBORHOOD: Berthoud
SHEET: 31
STATION: 1028+00 to 1063+00
RESTORATION RECOMMENDATIONS: 1028+00 to 1060+00

Aerial photos of pre-flood conditions and anecdotal information indicate this reach had a moderately dense vegetated riparian corridor, ranging from 100 to 300 feet wide. The vegetation was comprised of cottonwoods, willows, and other riparian species, many of which were torn out during the flood. Flood flows caused some significant bank scour in certain locations. Flood flows also deposited significant amounts of sediment and debris along the channel and floodplain. Sedimentation and bank erosion are the dominant flood impacts in this reach. Adjacent land use includes agriculture, rural development, and roads.

Riprap has been placed on the upper banks adjacent to State Highway 287.

- 1. Stabilize right bank near Sta 1038+00 and Sta 1032+00.
- 2. Lowering and grading of the floodplain near Sta 1055+00.
- 3. Stabilize right bank near Sta 1055+00, including immediately upstream of State Highway 287 Bridge.
- 4. In general, clearing of primary low-flow channel, removal of significant sediment deposits along the floodplain, and grading of floodplain surfaces to ensure proper connectivity and drainage with river is recommended.

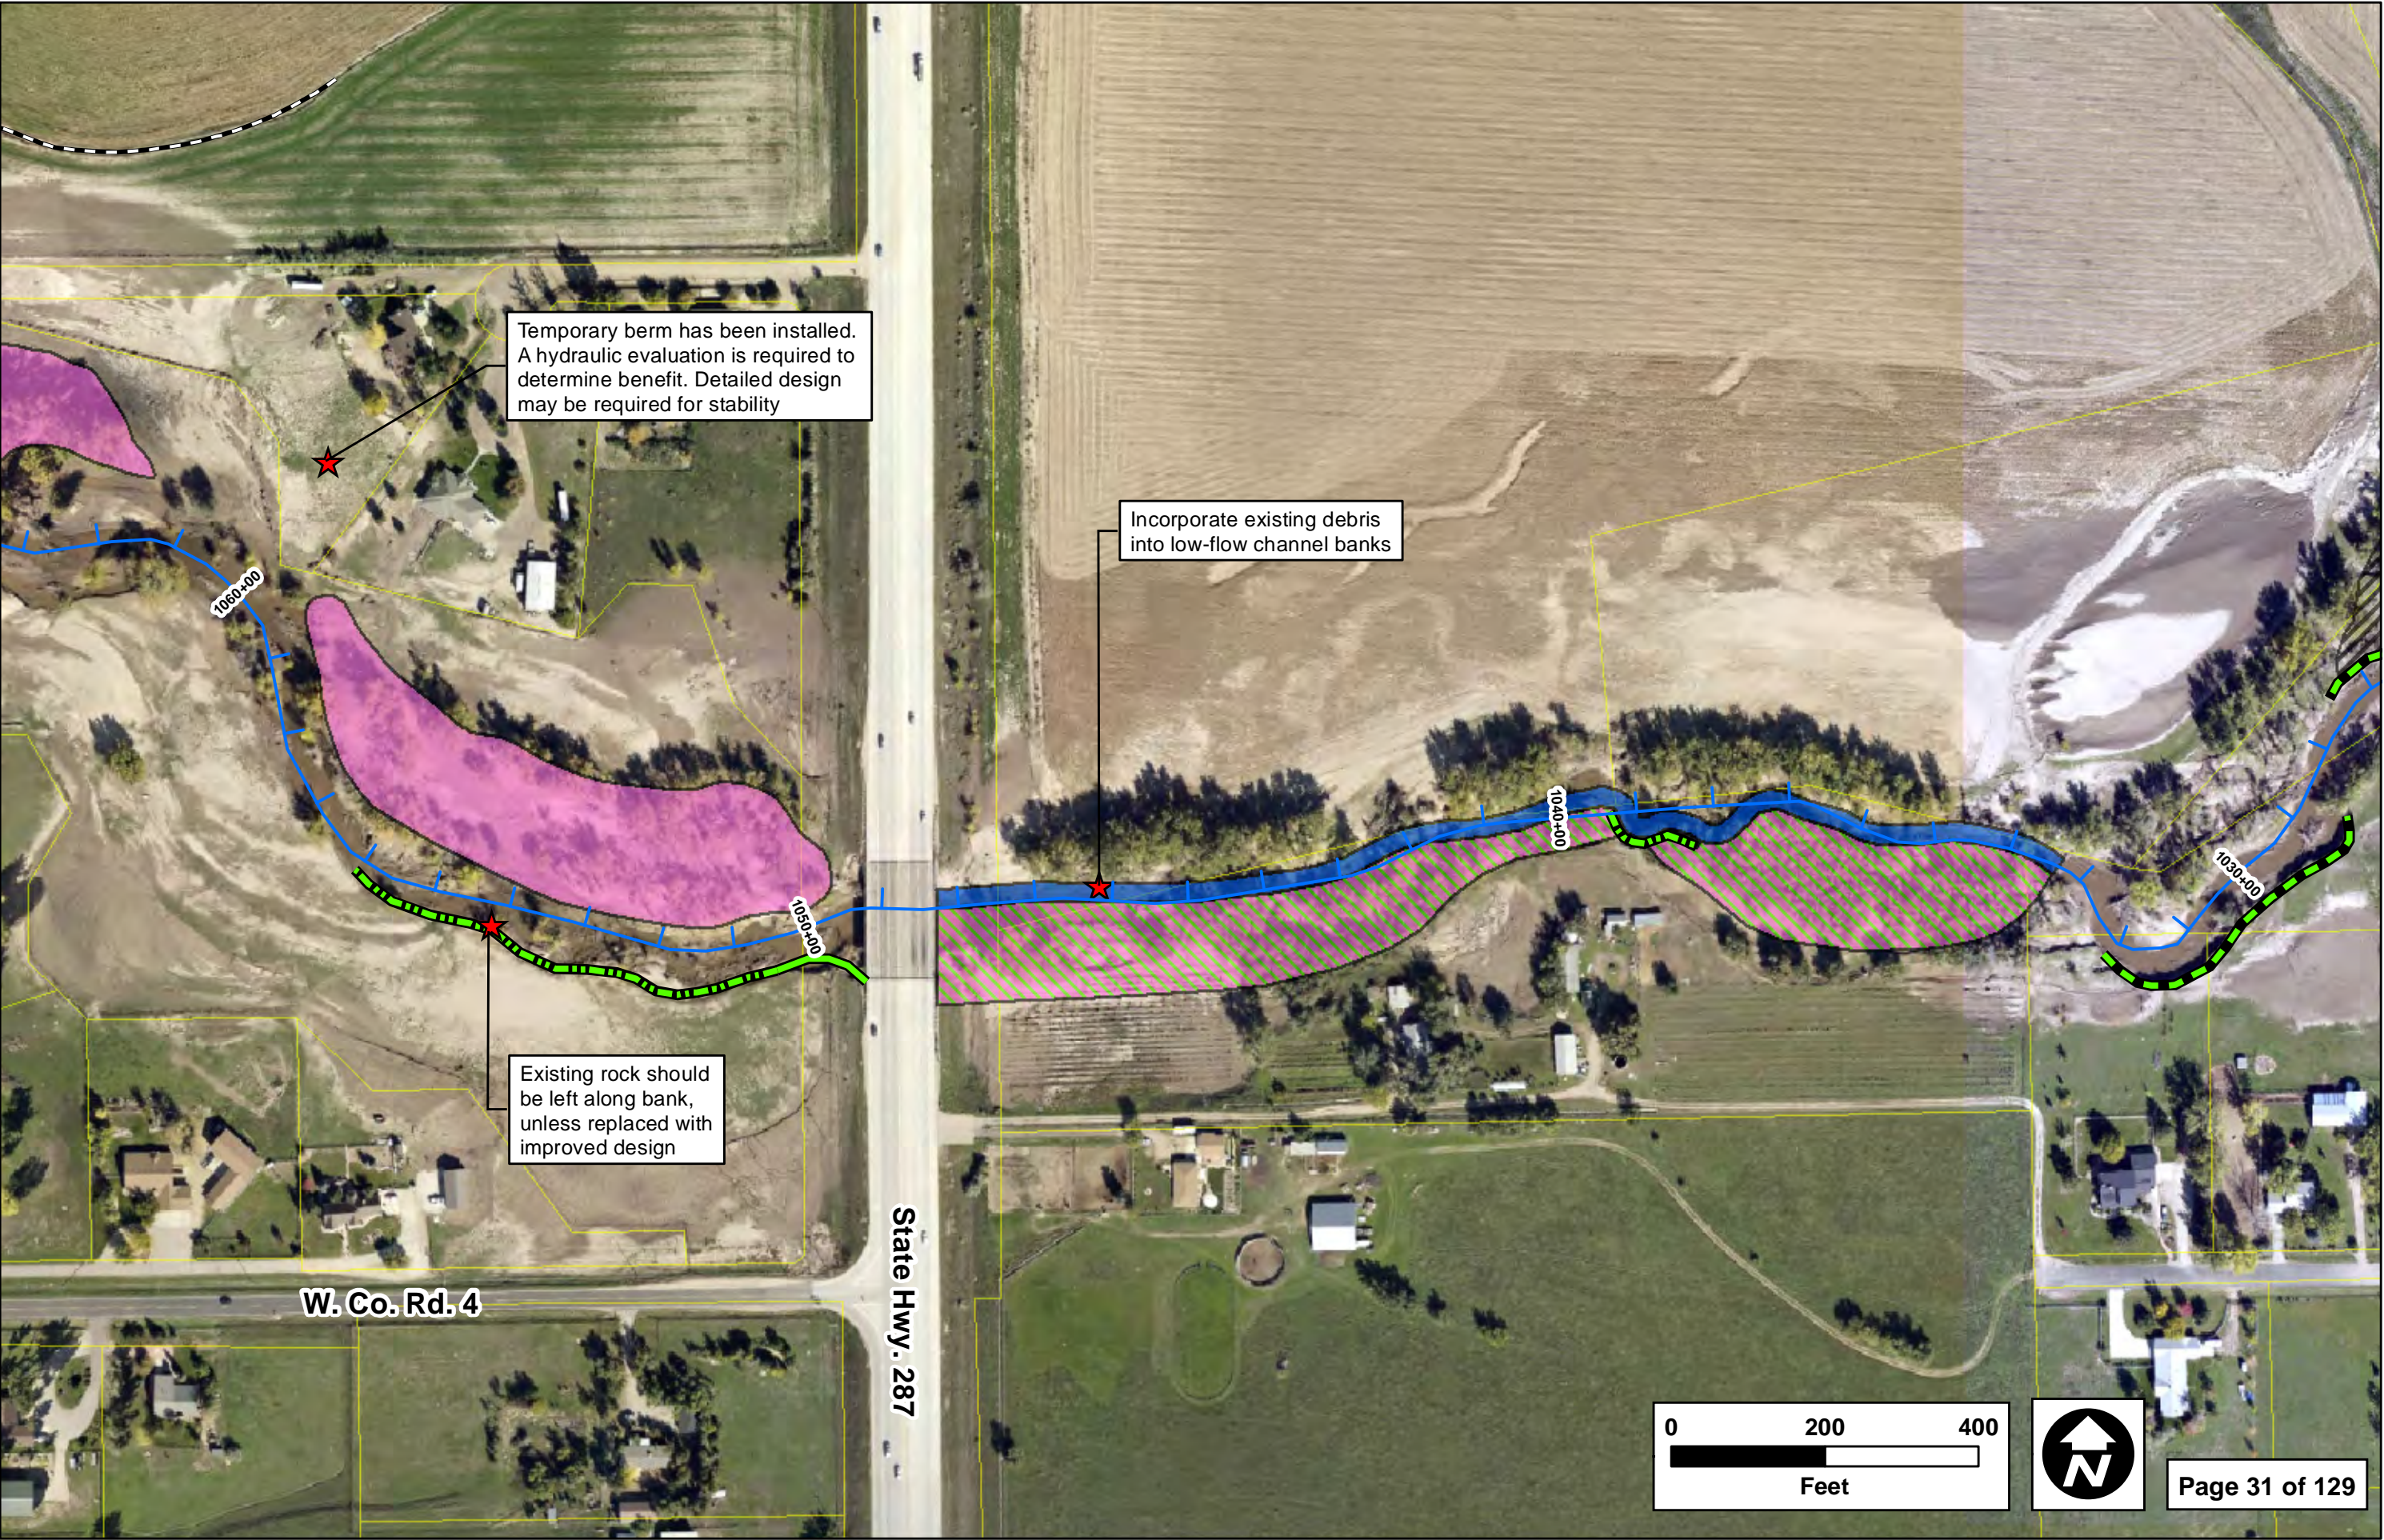
Temporary berm has been installed. A hydraulic evaluation is required to determine benefit. Detailed design may be required for stability

Incorporate existing debris into low-flow channel banks

Existing rock should be left along bank, unless replaced with improved design

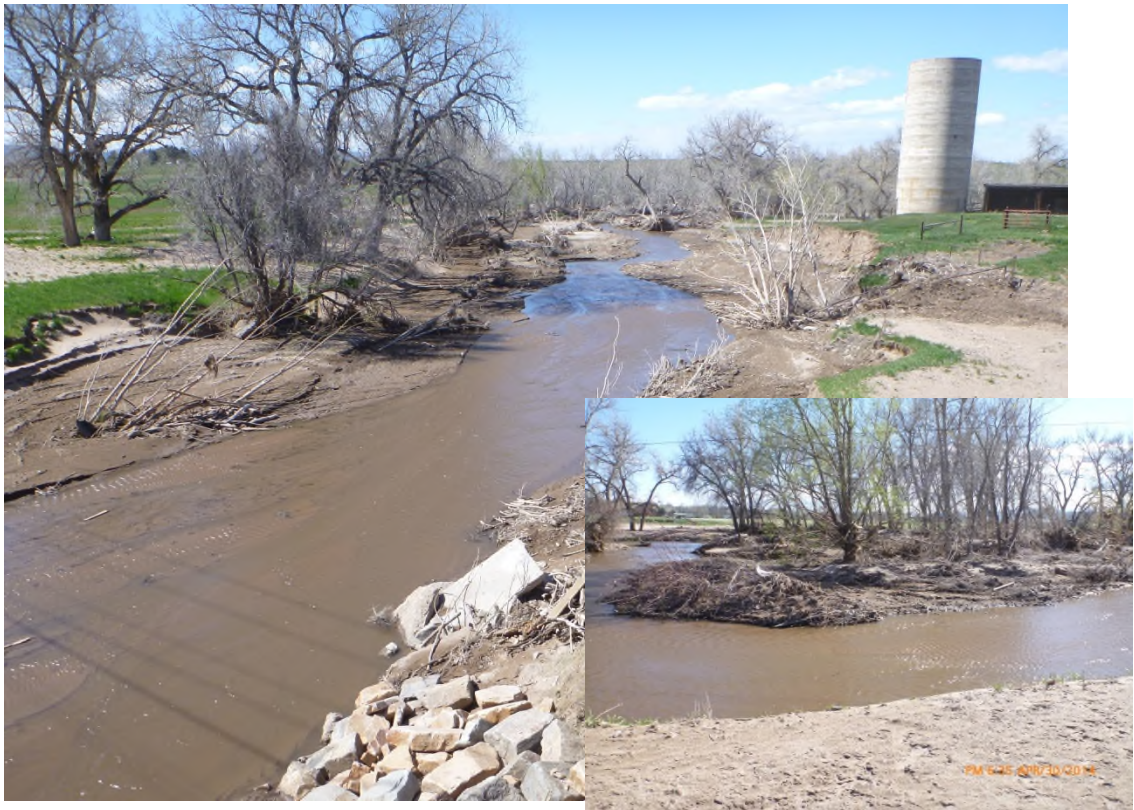
NEIGHBORHOOD: Berthoud
SHEET: 32
STATION: 1057+00 to 1094+00
RESTORATION RECOMMENDATIONS: 1060+00 to 1094+00

Aerial photos of pre-flood conditions and anecdotal information indicate this reach had a moderately dense vegetated riparian corridor, ranging from 100 to 250 feet wide, but with local floodplain areas expanding the width to as much as 400 feet. The vegetation was comprised of cottonwoods, willows, and other riparian species, many of which were torn out during the flood. Flood flows caused some significant bank scour in certain locations, such as along the right bank downstream from County Road 4 near Sta 1091+00. Flood flows also deposited significant amounts of sediment and debris along the channel and floodplain. Sedimentation and bank erosion are the dominant flood impacts in this reach. Adjacent land use includes agriculture, rural development, and roads.

- 1. Stabilize right bank near Sta 1091+00 and extend to County Road 4.
- 2. Grading along wide floodplain adjacent to left channel bank downstream from Sta 1088+00.
- 3. Stabilize right bank near Sta 1078+00.
- 4. Lowering and grading of the floodplain near Sta 1065+00.
- 5. In general, clearing of primary low-flow channel (including removal of large tree at Sta 1091+00), removal of significant sediment deposits along the floodplain, and grading of floodplain surfaces to ensure proper connectivity and drainage with river is recommended.

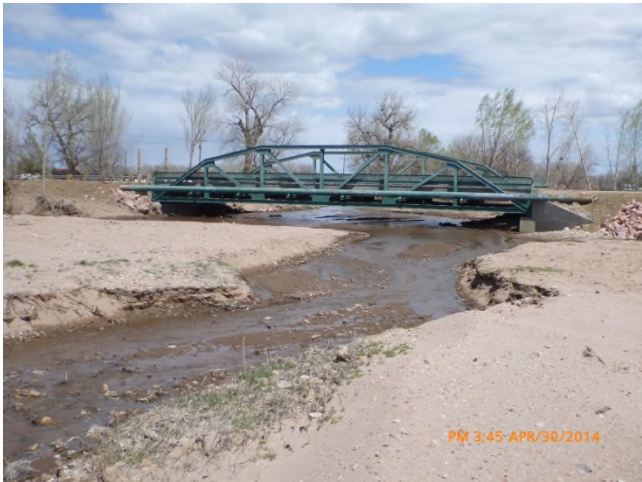
NEIGHBORHOOD: Berthoud
SHEET: 33
STATION: 1178+00 to 1120+00
RESTORATION RECOMMENDATIONS: 1094+00 to 1120+00

Aerial photos of pre-flood conditions and anecdotal information indicate this reach had a sparsely vegetated riparian corridor, with average widths of less than about 100 feet. The alignment appears highly altered due to roads and buildings with the river running parallel and south of County Road 4, then turning 90 degrees to the north, crossing under County Road 4. The vegetation was comprised of cottonwoods, willows, and other riparian species, many of which were torn out during the flood. Flood flows caused some localized scour of the floodplain and overbank surfaces in some areas. Flood flows also deposited significant amounts of sediment and debris along the channel and floodplain. Sedimentation and bank erosion are the dominant flood impacts in this reach. Adjacent land use includes agriculture, rural development, and roads.

Significant flooding issues associated, in part, by the limited capacity of the Mountain River Road Bridge, and the 90-degree turn the river makes at County Road 4 occurred within the area. This resulted in significant infrastructure and residential damages. Sedimentation caused the channel to avulse, drastically changing the planform. Low-flow channel upstream of Sta 1103+00 does not have adequate sediment transport capacity at low to moderate flows, and flood flow capacity in this area is severely diminished.

Between Sta 1085+00 and Sta 1110+00, the FIS effective floodplain and floodway follow a straight alignment rather than paralleling County Road 4 and turning 90° at the bridge. The alignment and road overtopping are likely both contributing to the very wide floodplain in this area, which is at least 1,250 feet spanning northward to about the Eglin Ditch. Field observations and aerial images indicate the flood pattern from the 2013 event followed a similar alignment.

1. A detailed hydraulic and sediment transport evaluation of this area is recommended to analyze and develop a design that would improve sediment transport capacity at low to moderate flows, increase flood capacity (including through Mountain River Road Bridge), and improve functionality of Eglin Ditch diversion structure.

1. Construct a new bridge under W. County Road 4 with greater capacity and to the west of the existing bridge to help alleviate the sharp bend in the river at the bridge.
2. Modify the channel alignment between Sta 1085+00 to Sta 1105+00 by moving the channel westerly (to the new bridge location) and reducing the bend at the bridge to potentially improve conveyance and reduce the lateral extent of flood flows (and potentially the lateral extent of the FIS effective floodplain and floodway). This realignment would also alleviate the scour pressures noted at the silo located at Sta 1091+00.
3. Consider modifying the elevation profile of West County Road 4 by shifting rise in road elevations farther east than existing in order to reduce potential for overtopping of road under flood conditions.
4. Modify or replace Mountain River Road Bridge to increase flow capacity.

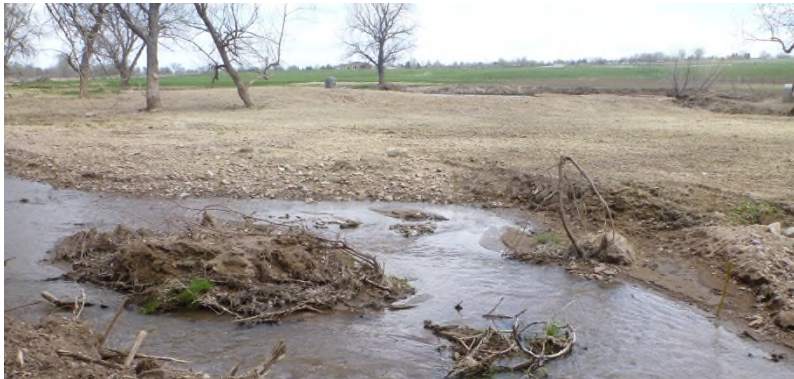
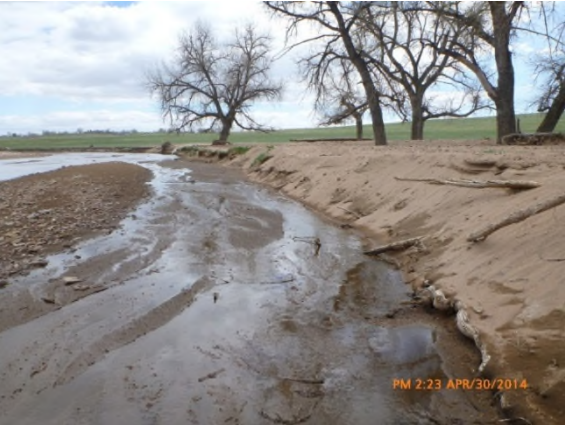
NEIGHBORHOOD: Berthoud
SHEET: 34
STATION: 1120+00 to 1150+00
RESTORATION RECOMMENDATIONS: 1120+00 to 1164+00

Aerial photos of pre-flood conditions and anecdotal information indicate this reach had a moderately dense vegetated riparian corridor, ranging up to about 150 feet in width. The vegetation was comprised of cottonwoods, willows, and other riparian species, some of which were torn out during the flood. Flood flows caused some localized scour of the floodplain and overbank surfaces in some areas, including significant lateral channel migration in the bends near Sta 1126+00 and Sta 1138+00. Flood flows also deposited large amounts of sediment and debris along the channel and floodplain. Adjacent land use includes agriculture, rural development, and roads.

Upstream of about Sta 1130+00, except for the channel erosion at the bend at Sta 1138+00, the channel planform did not change significantly during the 2013 flood event. General scour enlarged the channel size, local bank scour occurred, and debris and sediment deposition impacted both the channel, floodplain, and overbank areas. Seeding or planting of any reworked channel banks would help accelerate vegetation recruitment.

Downstream of Sta 1130+00, significant flooding issues associated, in part, by the limited capacity of the Mountain River Road Bridge, occurred within the area. This resulted in significant infrastructure and residential damages. Sedimentation caused the channel to avulse, drastically changing the planform. Low-flow channel does not have adequate sediment-transport capacity at low to moderate flows, and flood-flow capacity in this area is severely diminished.

- 1. See sheet 33 for recommendations downstream of Sta 1120+00.
- 2. Stabilize left channel bank from Sta 1120+00 to Sta 1127+00.
- 3. Floodplain stabilization between Sta 1120+00 and Sta 1130+00.
- 4. Stabilize right bank between Sta 1132+00 and Sta 1150+00.
- 5. Realign river to pre-flood alignment between Sta 1134+00 to Sta 1140+00.
- 6. Overbank reclamation near Sta 1136+00.
- 7. Stabilize left bank near Sta 1149+00.
- 8. Seeding or planting of any reworked channel banks would help accelerate vegetation recruitment.

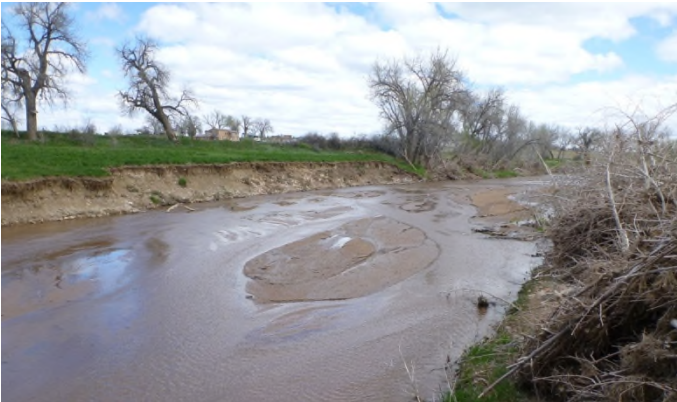
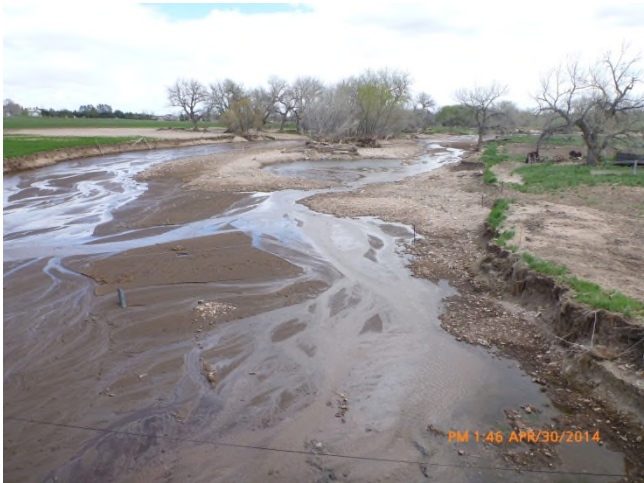
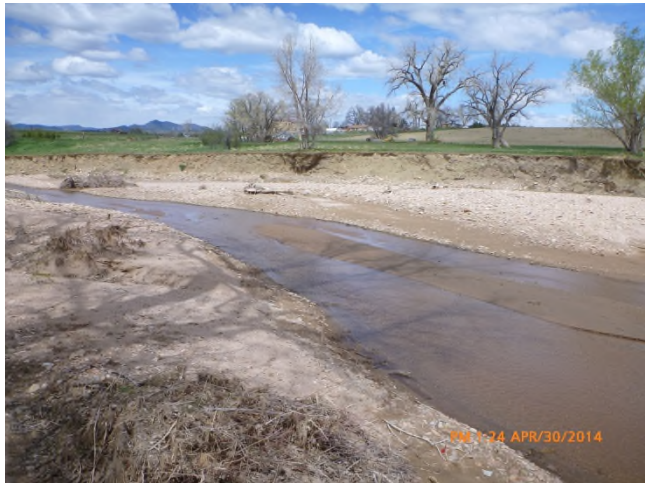
NEIGHBORHOOD: Berthoud
SHEET: 35
STATION: 1144+00 to 1180+00
RESTORATION RECOMMENDATIONS: 1168+00 to 1179+00

Aerial photos of pre-flood conditions and anecdotal information indicate this reach had a moderately dense vegetated riparian corridor, ranging from 150 to 250 feet wide, but with local floodplain areas expanding the width to as much as 400 feet. The vegetation was comprised of cottonwoods, willows, and other riparian species, some of which were torn out during the flood. Flood flows caused some localized scour of the floodplain and overbank surfaces in some areas, including significant lateral channel migration in the large bend near Sta 1162+00. Flood flows also deposited large amounts of sediment and debris along the channel and floodplain. Adjacent land use includes agriculture, rural development, and roads.

Except for the channel erosion at the bend near Sta 1162+00, the channel planform did not change significantly during the 2013 flood event. General scour enlarged the channel size, local bank scour occurred, and debris and sediment deposition impacted both the channel, floodplain, and overbank areas. The channel avulsed immediately downstream of County Road 21 due to debris blockage. Seeding or planting of any reworked channel banks would help accelerate vegetation recruitment. Significant channel widening occurred downstream of County Road 21. The bridge at County Road 21 was significantly damaged during the flood and is being repaired as of early Summer 2014.

1. Geomorphic functions of this reach are likely sufficient to allow for the regeneration of willow, and other riparian species through natural seeding and cloning without any further restoration. However, seeding or planting of riparian vegetation along the bare reworked channel banks is recommended to accelerate revegetation and stability of the banks and floodplain.

5. Left channel bank near Sta 1162+00 eroded approximately 130 feet to the north. Current channel geometry has an improved conveyance capacity, and should also provide adequate surface for regeneration of riparian vegetation. It is, however, recommended that the left channel bank be stabilized to reduce chance for further erosion.

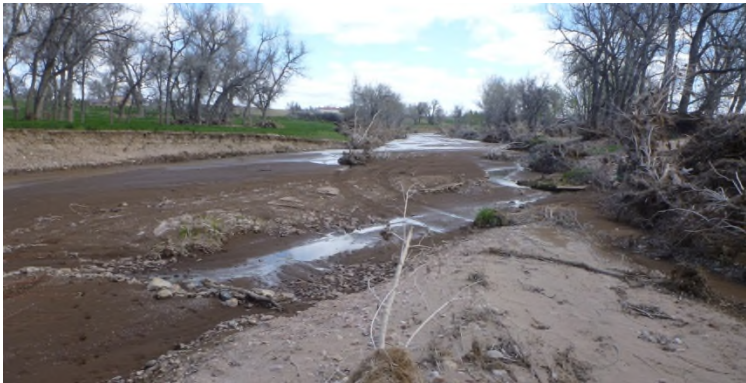
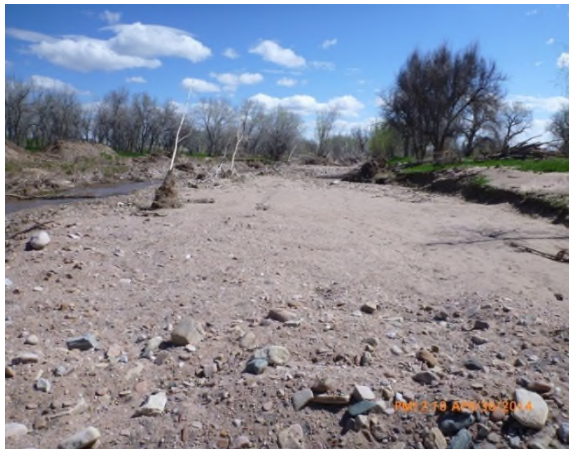
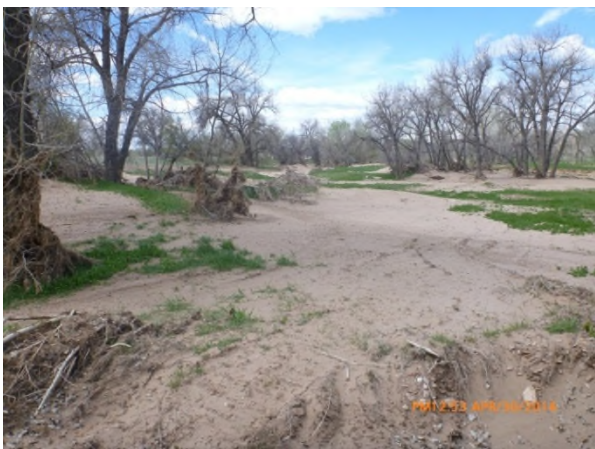
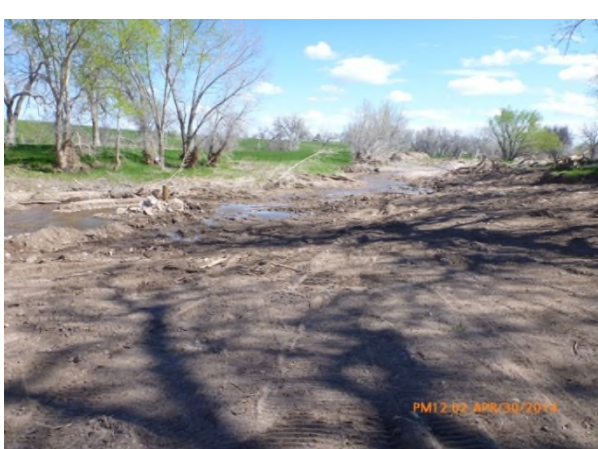
NEIGHBORHOOD: Berthoud
SHEET: 36
STATION: 1169+00 to 1195+00
RESTORATION RECOMMENDATIONS: 1179+00 to 1199+00

Aerial photos of pre-flood conditions and anecdotal information indicate this reach had a moderately dense vegetated riparian corridor, ranging from 200 to 300 feet wide, but with local areas containing additional vegetation somewhat set back from the channel. The vegetation was comprised of cottonwoods, willows, and other riparian species, a few of which were torn out during the flood. Significant channel and floodplain reconstruction has already occurred, and cottonwoods are primarily the only remaining vegetation at this time. Adjacent land use includes agriculture, rural development, and roads.

For the most part, the general channel planform was maintained during the 2013 flood event. General scour that enlarged the channel, local scour and bank retreat, and debris and sediment deposition occurred during the flood, but due to channel reconstruction, some post-flood impacts were not identifiable. Seeding or planting of the reworked channel banks would help accelerate vegetation recruitment.

- 1. Geomorphic functions of this reach are likely sufficient to allow for the regeneration of willow, and other riparian species through natural seeding and cloning without any further restoration. However, seeding or planting of riparian vegetation along the bare reworked channel banks is recommended to accelerate revegetation and stability of the banks and floodplain.
- 2. Stabilize left bank near Sta 1175+00.
- 3. Floodplain grading near Sta 1175+00.
- 4. Stabilize floodplain in areas where channel has been reconstructed.
