APPENDIX A

ASSESSMENT PROTOCOL

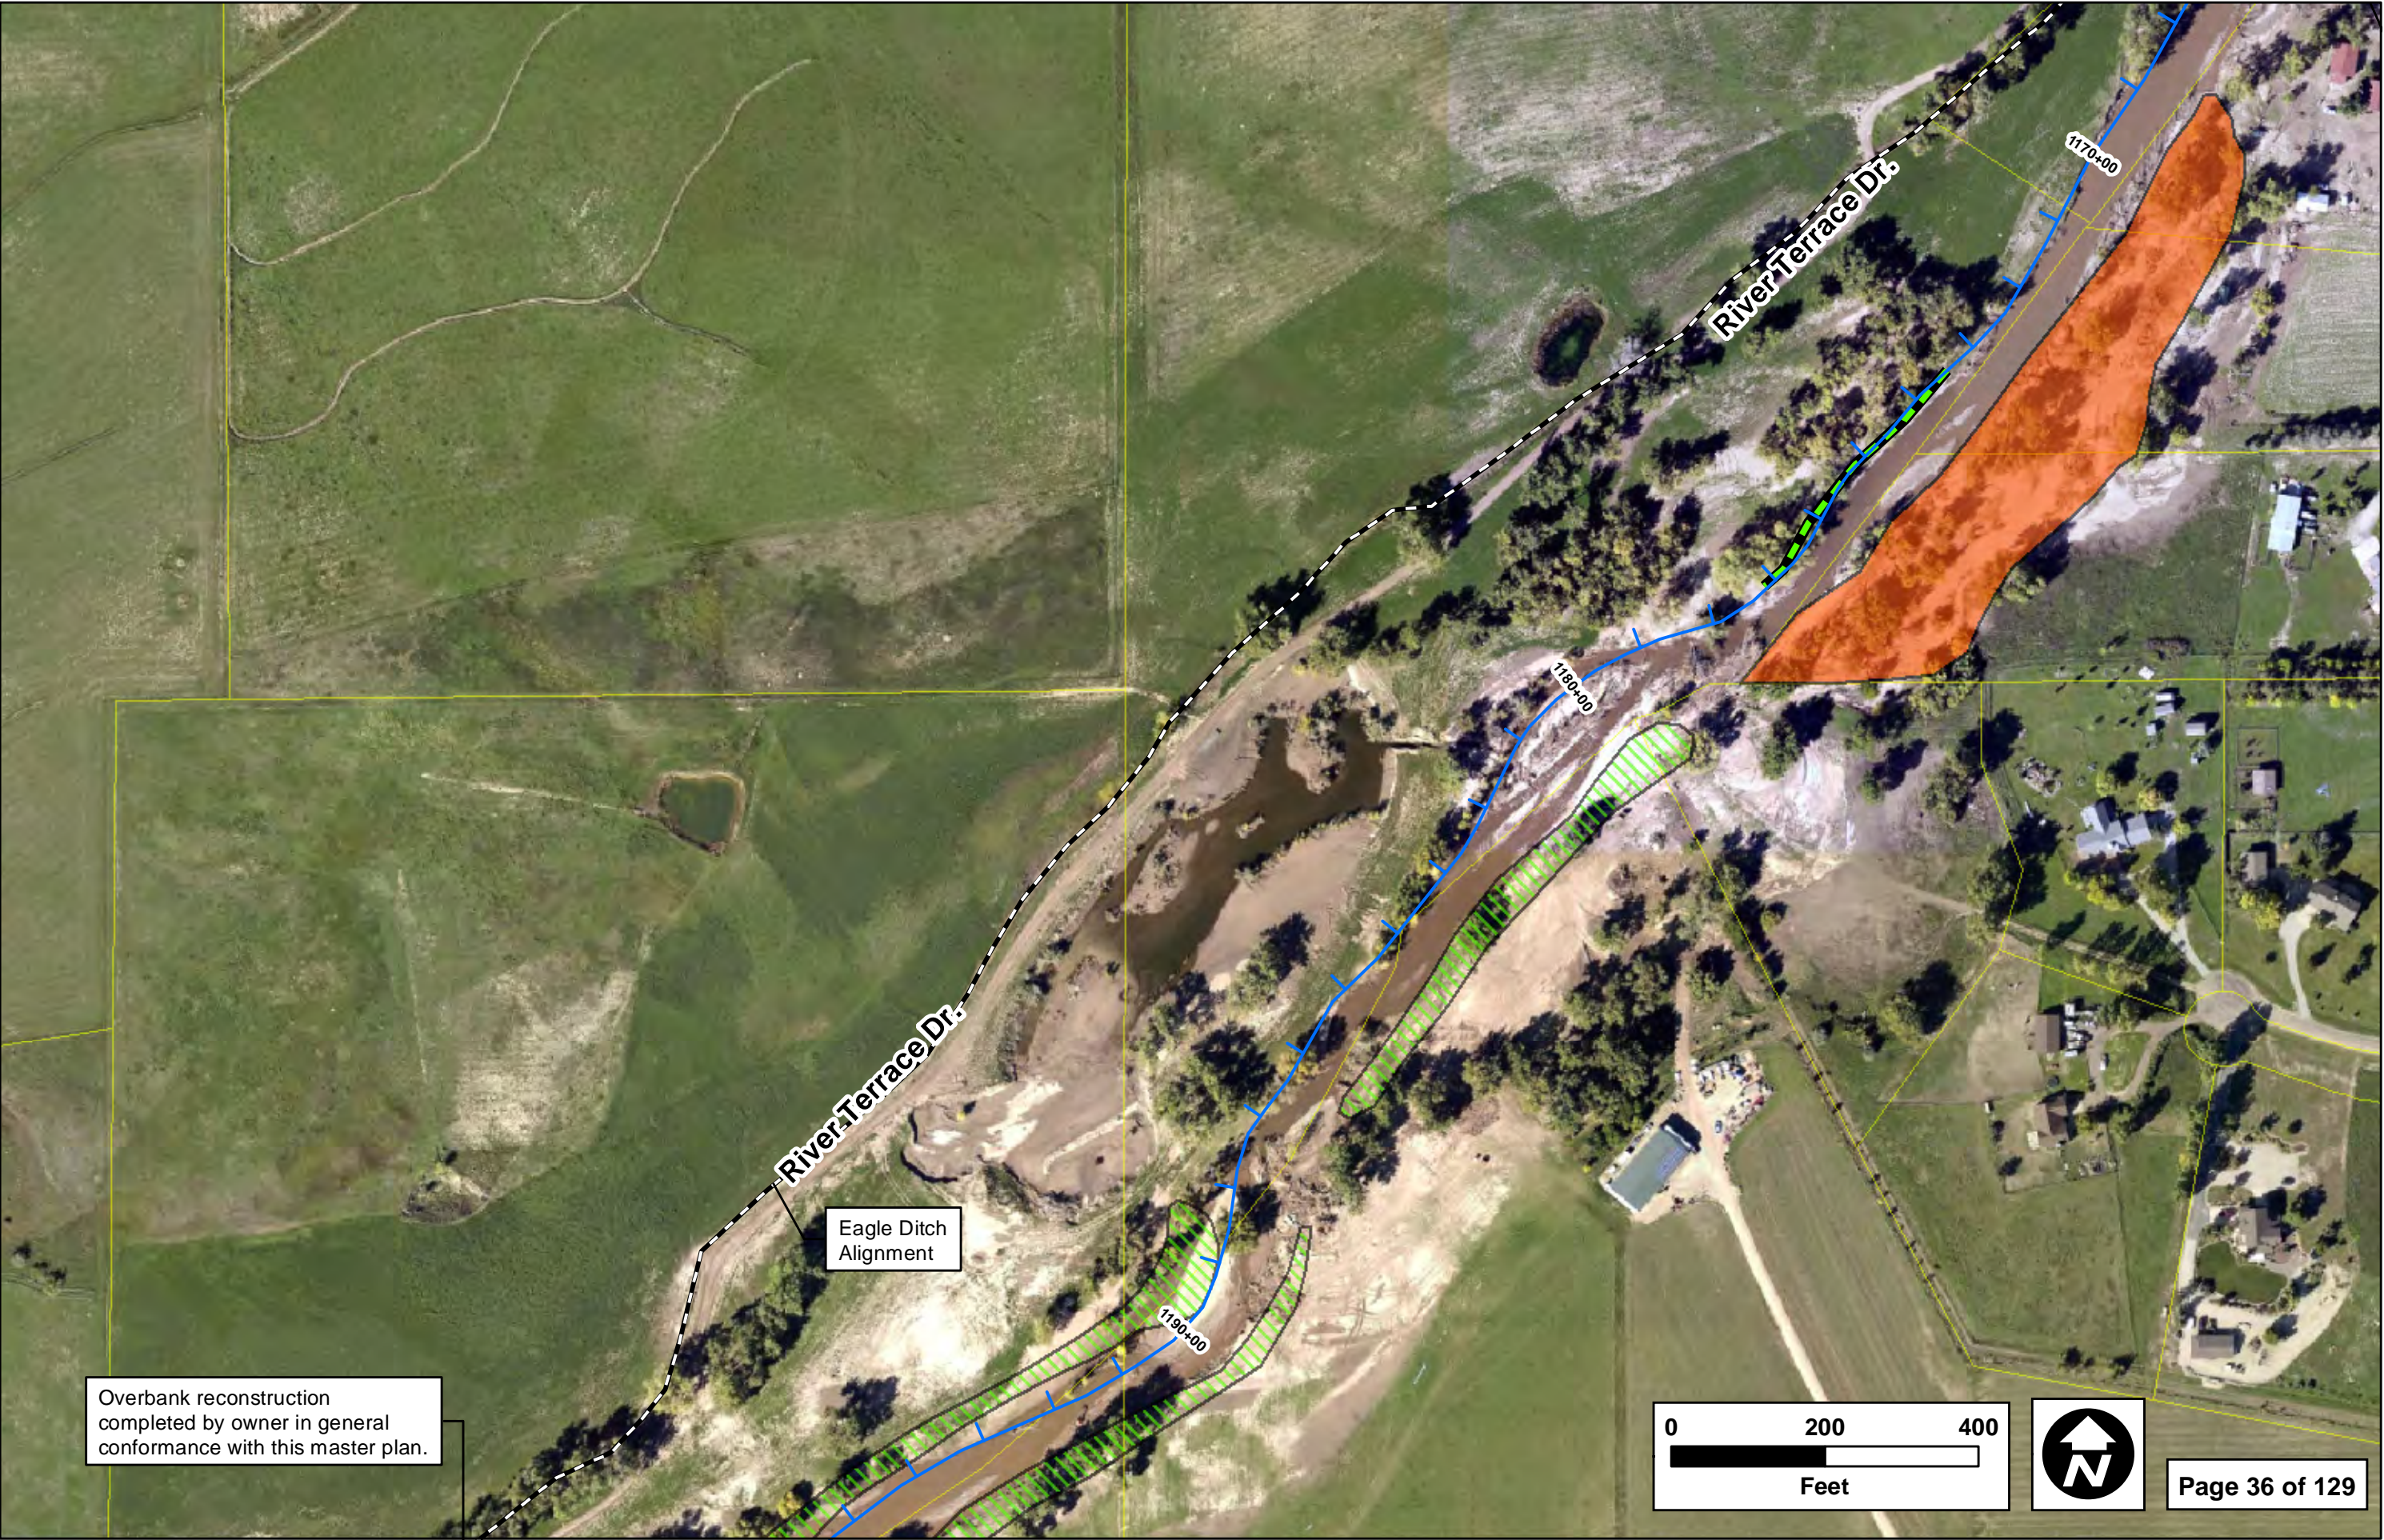
Overbank reconstruction
completed by owner in general
conformance with this master plan.

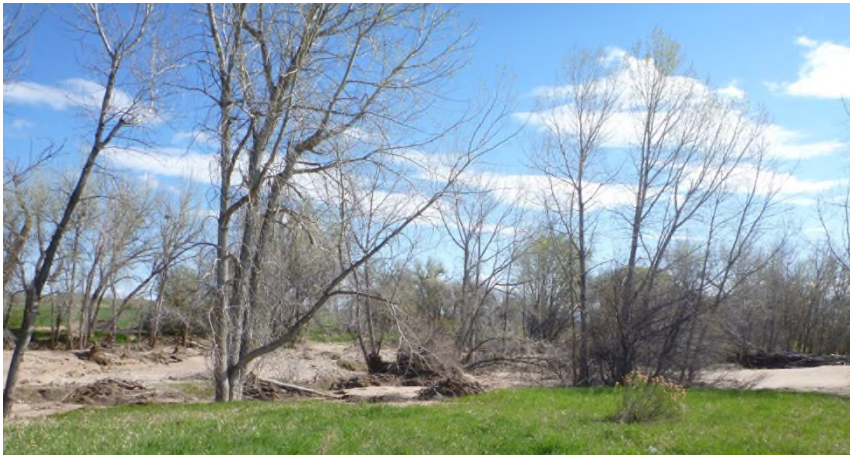
NEIGHBORHOOD: Berthoud
SHEET: 37
STATION: 1184+00 to 1220+00
RESTORATION RECOMMENDATIONS: 1199+00 to 1211+00

Aerial photos of pre-flood conditions and anecdotal information indicate this reach had a moderately dense vegetated riparian corridor, approximately 200 feet wide, with localized areas of vegetation somewhat set back from the channel. The vegetation was comprised of cottonwoods, willows, and other riparian species, only a few of which were torn out during the flood. Adjacent land use includes agriculture, rural development, and roads. For the most part, the general channel planform was maintained during the 2013 flood event. Local scour, bank retreat, and debris and sediment deposition occurred during the flood, but due to channel reconstruction, some post-flood impacts were not identifiable.

Significant work has been accomplished by the landowner, with input and guidance from the NRCS. This work included the removal of significant amounts of debris, grading the overbanks, bank stabilization and reseeding, all in general conformance with this Master Plan. Additional seeding or planting of the reworked channel banks would help accelerate vegetation recruitment.

- 1. Geomorphic functions of this reach are likely sufficient to allow for the regeneration of willow, and other riparian species through natural seeding and cloning without any further restoration. However, seeding or planting of riparian vegetation along the bare reworked channel banks is recommended to accelerate revegetation and stability of the banks and floodplain.
- 2. Stabilize banks in vicinity of diversion near Sta 1201+50. Diversion structure should also be tied into the bank an adequate distance to reduce the chance of erosion that could flank the structure.
- 3. Floodplain grading near Sta 1208+00.
- 4. Stabilize floodplain in areas where channel has been reconstructed.

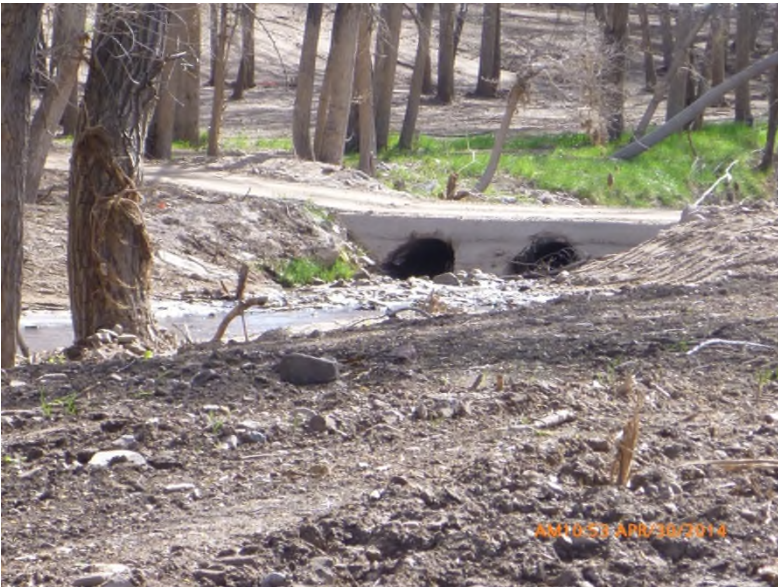
NEIGHBORHOOD: Berthoud
SHEET: 38
STATION: 1212+00 to 1245+00
RESTORATION RECOMMENDATIONS: 1218+00 to 1239+00

Aerial photos of pre-flood conditions and anecdotal information indicate this reach had a densely vegetated riparian corridor, with a relatively consistent width of almost 400 feet. The vegetation was comprised of cottonwoods, willows, and other riparian species, a few of which were torn out during the flood. Adjacent land use includes agriculture, rural development, and roads.

For the most part, the general channel planform was maintained during the 2013 flood event. Some local scour and debris and sediment deposition occurred during the flood, but due to the channel reconstruction, detailed post-flood impacts were not identifiable. County Road 2, a low water culvert crossing, reportedly plugged and overtopped.

- 1. Geomorphic functions of this reach are likely sufficient to allow for the regeneration of willow, and other riparian species through natural seeding and cloning without any further restoration. However, seeding or planting of riparian vegetation along the bare reworked channel banks is recommended to accelerate revegetation and stability of the banks and floodplain.
- 2. Stabilize floodplain.
- 3. Stabilize banks along channel bends near Sta 1224+00.
- 4. Assess and consider improvements to the culvert/bridge at County Road 2.

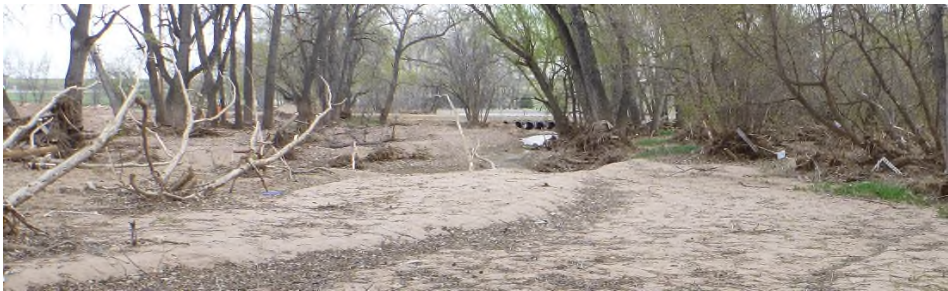
NEIGHBORHOOD: Boulder County
SHEET: 39
STATION: 1238+00 to 1273+00
RESTORATION RECOMMENDATIONS: 1239+00 to 1282+00

Aerial photos of pre-flood conditions and anecdotal information indicate this reach had a densely vegetated riparian corridor, ranging in widths up to about 200 feet. The vegetation is comprised primarily of cottonwoods, some willows, and other riparian species, some of which were torn out during the flood. Flood flows caused considerable scour and shifting of the floodplain and overbank surfaces in some areas. Localized sediment and debris deposits are considerable in this area.

During the 2013 flood, the original channel breached to the north near Sta 1272+00, and a secondary channel developed along that north side and somewhat parallel to the original channel, which ultimately filled in with sediment. This new channel ultimately eroded into and undercut a house near Sta 1266+00. Just upstream of the 83rd Street Bridge, the flood channel turns abruptly to the south, rejoining the original channel.

The 83rd Street Bridge failed during the 2013 flood, and high flows were also directed over the lowest section of the road profile, which is about 200 feet north of the bridge. These road overtopping flows entered the overbank surface on the downstream side of the road, which resulted in a significant headcut channel that developed along the full length of the channel between 83rd Street and West County Line Road. Significant damage occurred to property and houses both upstream and downstream of 83rd Street.

- 6. Stabilize right bank between Sta 1239+00 and Sta 1247+00 to protect newly constructed bank.
- 7. Specific areas are not shown, but seeding or planting of riparian vegetation along the bare reworked channel banks is recommended to accelerate revegetation and stability of the banks.
- 8. All recommendations for areas near 83rd Street may need to be refined in coordination with future Boulder County Bridge designs.

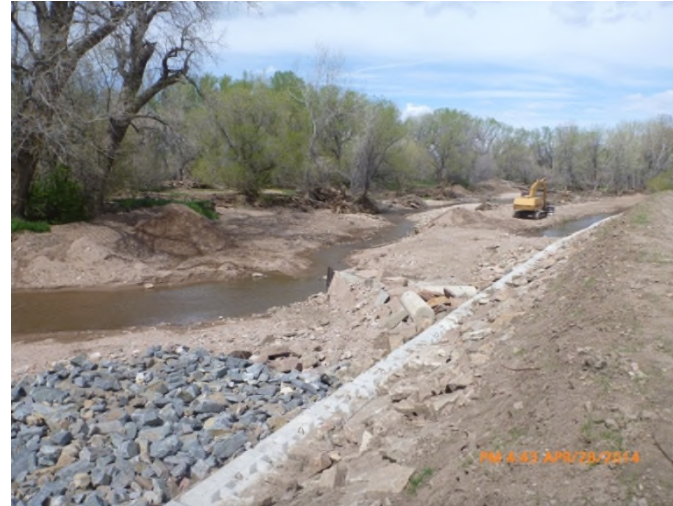
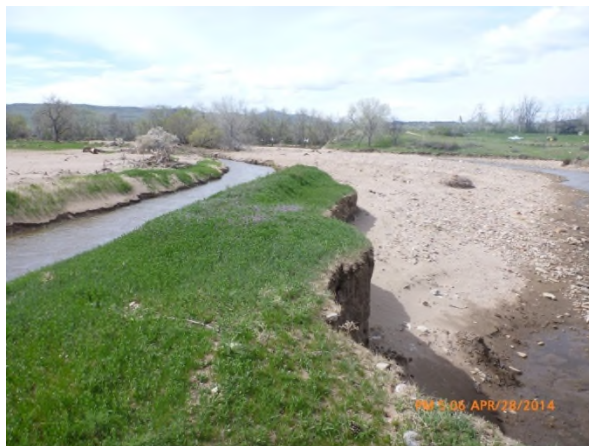
NEIGHBORHOOD: Boulder County**SHEET: 40****STATION: 1267+00 to 1304+00****RESTORATION RECOMMENDATIONS: 1284+00 to 1308+00**

Significant overbank flows breached the left channel bank near about Sta 1296+00, which primarily reentered the channel corridor near Sta 1284+00. Significant bank scour and severe damage occurred to the Blower Ditch and associated diversion structure at Sta 1284+00.

The 2013 flood event caused some of the larger channel bends to erode laterally into overbank surfaces that have primarily been used as cropland, and sinuosity of the channel was also generally reduced as flood flows scoured a more direct flowpath along the floodplain. However, relatively high overbank and terrace surfaces limited the amount of lateral channel erosion.

Although significant geomorphic changes have occurred in this reach as a result of the 2013 flood, much of the current channel and floodplain is relatively stable, and expected to recover without significant restoration activities. However, there are some notable overbank areas that require some fill and reclamation along with some bank stabilization. Seeding or planting of the reworked channel banks would help accelerate vegetation recruitment.

4. Left bank between Sta 1290+00 and Sta 1300+00 experienced significant overtopping flows during the 2013 flood. This may have been primarily due to the significant amount of debris and backwater conditions along this portion of the river. Removal of large sediment and debris deposits as well as possible rising of left bank elevation may help prevent future overtopping. Furthermore, the Blower Ditch diversion structure also acts as a grade control for upstream flows. A more detailed study of the bed profile, hydraulic channel capacity, and potential alternatives for relocating the Blower Ditch diversion is recommended. Relocation of the Blower Ditch diversion would also help reduce future damages to this structure and associated ditch infrastructure.

5. Bank stabilization near Sta 1279+00.
6. Lowering and grading of floodplain surfaces to improve conveyance capacity and drainage.
7. A detailed hydraulic analysis of channel and floodplain capacity is recommended for this area.

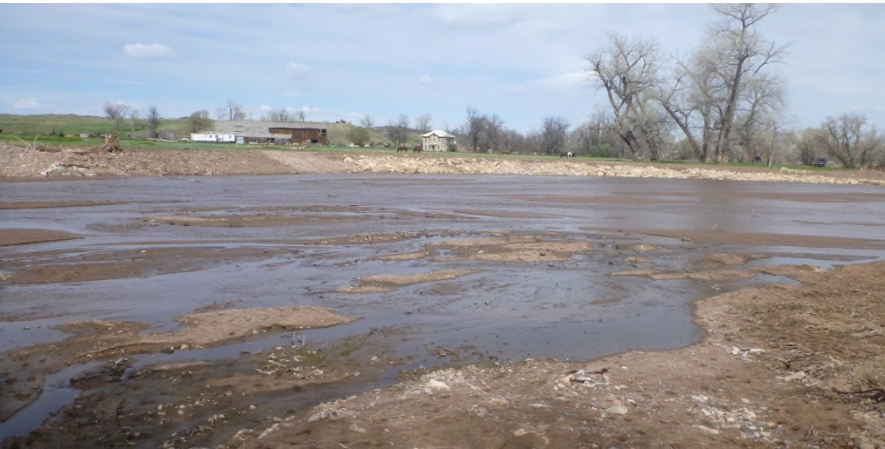
RESTORATION RECOMMENDATIONS: 1308+00 to 1326+00

Aerial photos of pre-flood conditions and anecdotal information indicate this reach had a moderately dense vegetated riparian corridor, ranging from 150 feet directly along the river corridor to more than 550 feet wide in areas with expanded floodplain surfaces. The vegetation is comprised primarily of cottonwoods, some willows, and other riparian species, many of which were torn out during the flood. Flood flows caused considerable scour of the floodplain and overbank surfaces in some areas, including significant lateral channel migration in the large bend near Sta 1325+00 and Sta 1302+00. Due to the significant scour upstream, including significant sediment and debris transported through the upstream canyon, large sediment deposits, including coarse material, also exist in this area.

The 2013 flood caused many of the significant channel bends to erode laterally into overbank surfaces that have primarily been used as cropland. Sinuosity of the channel was also generally reduced as flood flows scoured a more direct flow path along the floodplain.

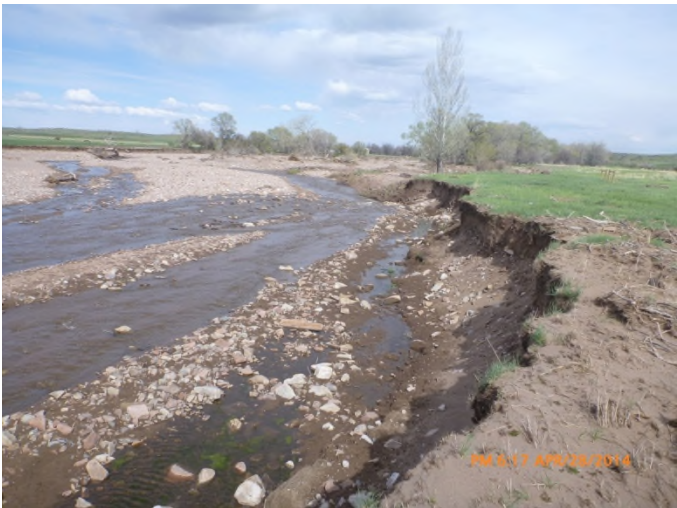
NEIGHBORHOOD: Boulder County
SHEET: 42
STATION: 1331+00 to 1365+00
RESTORATION RECOMMENDATIONS: 1339+00 to 1346+00

Aerial photos of pre-flood conditions and anecdotal information indicate this reach had a densely vegetated riparian corridor, ranging up to 500 feet wide, comprised primarily of cottonwoods and other riparian species, many of which were torn out during the flood. This section of the river is located about one mile downstream of the canyon mouth. High-velocity flows exiting the canyon mouth caused considerable scour of the floodplain and overbank surfaces in some areas, including significant lateral channel migration in the large bend near Sta 1354+00. Flood flows exiting the canyon also carried significant amounts of sediment and debris, which were deposited in large quantities throughout this area.

The valley along this section of the river is slightly wider than the canyon upstream, which has allowed the channel sinuosity to increase (pre-flood). The 2013 flood event caused many of the significant channel bends to erode laterally into overbank surfaces that have primarily been used as cropland, changing the channel planform, and typically reducing the sinuosity.

Although significant changes have occurred in this reach as a result of the 2013 flood, much of the current channel and floodplain is relatively stable, and expected to recover without significant restoration activities. However, there are some overbank areas that require some fill and reclamation along with some bank stabilization. Seeding or planting of the reworked channel banks would help accelerate vegetation recruitment.

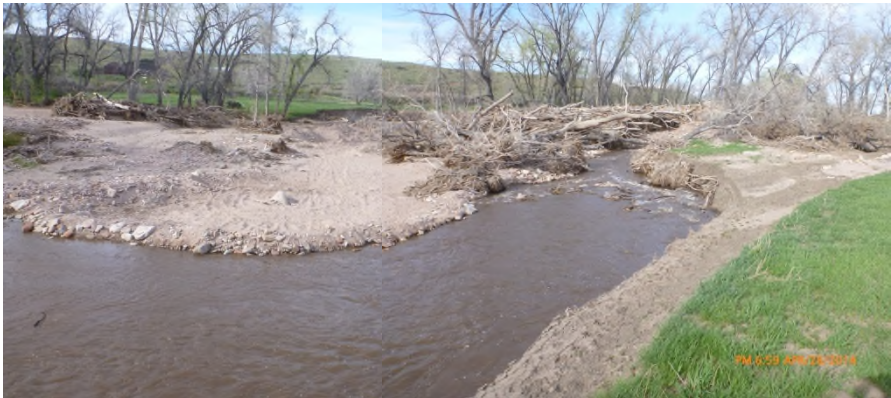
NEIGHBORHOOD: Boulder County
SHEET: 43
STATION: 1363+00 to 1399+00
RESTORATION RECOMMENDATIONS: 1375+00 to 1385+00

Aerial photos of pre-flood conditions and anecdotal information indicate this reach had a densely vegetated riparian corridor, ranging from 150 to 350 feet wide, comprised primarily of cottonwoods and other riparian species, many of which were torn out during the flood. This section of the river is located immediately downstream of the canyon mouth. High-velocity flows exiting the canyon mouth caused significant scour of the floodplain and overbank surfaces in some areas, including significant lateral channel migration in the large bend near Sta 1387+00. Flood flows exiting the canyon also carried significant amounts of sediment and debris, which were deposited in large quantities throughout this area.

The valley along this section of the river is slightly wider than the canyon upstream, which has allowed the channel sinuosity to increase (pre-flood). The 2013 Flood caused many of the significant channel bends to erode laterally into overbank surfaces that have primarily been used as cropland, changing the channel planform, and typically reducing the sinuosity.

There is a low water or ‘dip’ crossing with culverts in this reach, located on the Parrish Ranch property. The crossing is used to access the south side of Boulder County Open Space (under contract to the Parrish Ranch for agricultural use) and by the Northern Colorado Water Conservancy District to access the CBT system at the St. Vrain Supply canal. The crossing suffered minor damage during the 2013 flood, requiring debris removal and bank stabilization. However, overall the crossing is in good condition and did not appear to cause significant degradation or aggradation, when compared to the conditions overall in this reach, indicating that it functioned adequately under flood conditions. No further recommendations are made for modifying the dip crossing.

- 4. Provide bank stabilization at the dip crossing structure near Sta 1384+00. Work will need to be coordinated or conducted by Northern Colorado Water Conservancy District, as they maintain this road crossing.
- 5. Numerous rock vanes were constructed along the channel downstream of the Culver Ditch headgate. Tying these structures farther back into the bank to prevent erosion from flanking the structures is recommended.
- 6. Specific areas are not shown, but seeding or planting of riparian vegetation along the bare reworked channel banks is recommended to accelerate revegetation and stability of the banks.

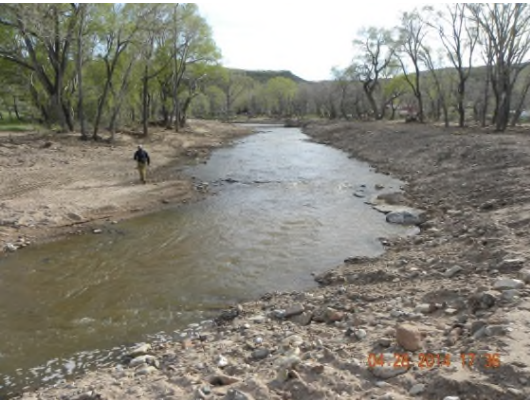
NEIGHBORHOOD: Boulder County
SHEET: 44
STATION: 1383+00 to 1428+00
RESTORATION RECOMMENDATIONS: 1394+00 to 1405+00

Aerial photos of pre-flood conditions and anecdotal information indicate this reach had a densely vegetated riparian corridor, up to 350 feet wide in some areas, comprised primarily of cottonwoods and other riparian species, many of which were torn out during the flood. This section of the river borders, and is immediately downstream of, the mouth of the canyon. High-velocity flows exiting the canyon mouth caused significant scour of the floodplain and overbank surfaces in some areas, including significant lateral channel migration in the large bend near Sta 1405+00. Flood flows exiting the canyon also carried significant amounts of sediment and debris, which were deposited in large quantities throughout this area. The severe deposition that occurred also completely buried the weir, headgate, and irrigation canal for the Culver Irrigation Ditch.

The valley along this section of the river is slightly wider than the canyon upstream, which has allowed the channel sinuosity to increase. The 2013 Flood caused many of the significant channel bends to erode laterally, slightly changing the channel planform.

Although significant changes have occurred in this reach as a result of the 2013 Flood, much of the current channel and floodplain is relatively stable, and expected to recover without significant restoration activities. However, there are some notable areas that require some stabilization, especially in the vicinity of the campground and ranch buildings, and seeding or planting of the reworked channel banks would help accelerate vegetation recruitment.

- 1. Realign short section of channel to reduce threat to campground and facilities area.
- 2. Elevate and stabilize the left channel bank between Sta 1396+00 and Sta 1404+00.
- 3. Provide bank stabilization at the dip crossing structure near Sta 1384+00.
- 4. Numerous rock vanes were constructed along the channel downstream of the Culver Ditch headgate. Tying these structures farther back into the bank to prevent erosion from flanking the structures is recommended.
- 5. Specific areas are not shown, but seeding or planting of riparian vegetation along the bare reworked channel banks is recommended to accelerate revegetation and stability of the banks.

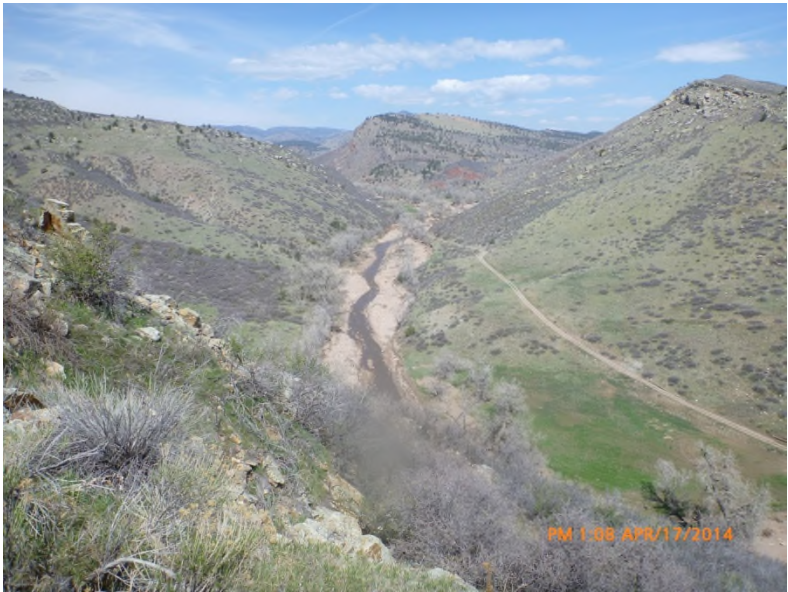
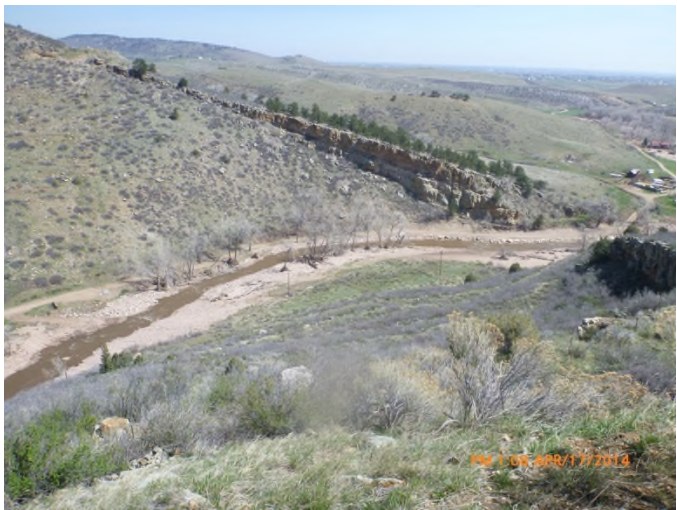
NEIGHBORHOOD: Boulder County
SHEET: 45
STATION: 1421+00 to 1452+00
RESTORATION RECOMMENDATIONS: 1444+00 to 1450+00

Aerial photos of pre-flood conditions and anecdotal information indicate this reach had a moderately dense vegetated riparian corridor, 100 to 200 feet wide, comprised primarily of cottonwoods and other riparian species, many of which were torn out during the flood. The river is generally canyon bound, which controls the sinuosity and river corridor alignment. Aerial mapping and field reconnaissance reveals observable areas of riffle pool complexes.

Based on field observations it appears this reach experienced significant scour from the 2013 Flood and velocities were high as evidenced by the loss of riparian vegetation.

Because of the canyon bound valley formation, much of this reach is relatively stable and expected to recover without restoration activities.

- 1. Stabilize the left channel bank between Sta 1444+00 and Sta 1460+00. A level 3 bank protection is recommended except along upstream portion of bank where a level 2 is recommended due to the close proximity of the bank to access road, which was lost during the 2013 Flood.

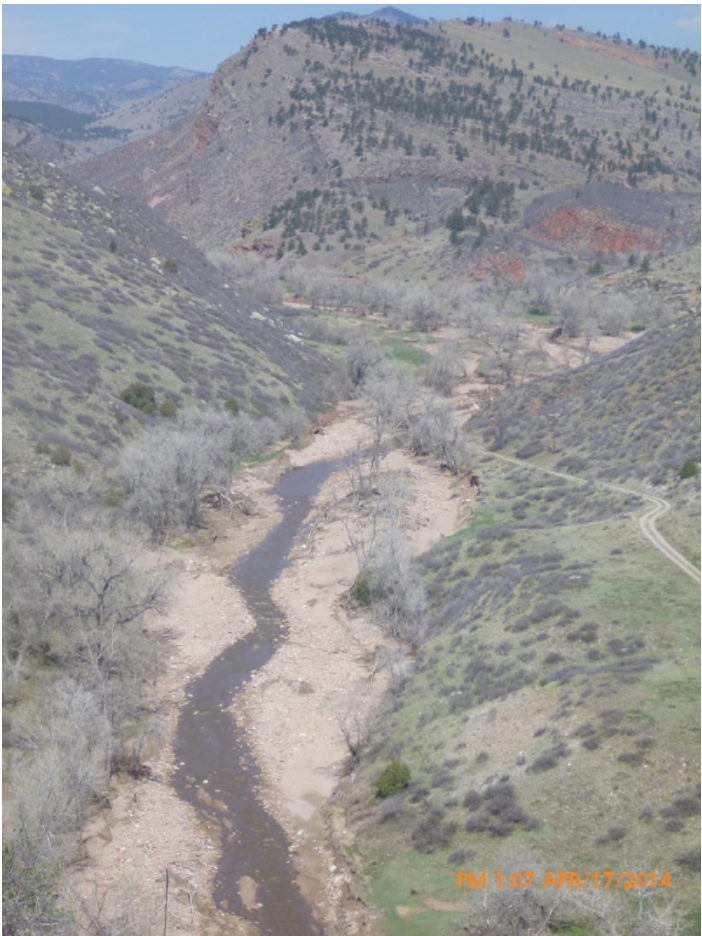
NEIGHBORHOOD: Boulder County
SHEET: 46
STATION: 1444+00 to 1465+00
RESTORATION RECOMMENDATIONS: 1450+00 to 1461+00

Aerial photos of pre-flood conditions and anecdotal information indicate this reach had a moderately dense vegetated riparian corridor, 100 to 200 feet wide, comprised primarily of cottonwoods and other riparian species, many of which were torn out during the flood. The river is generally canyon bound, which controls the sinuosity and river corridor alignment. Aerial mapping and field reconnaissance reveals observable areas of riffle pool complexes.

- 1. Stabilize the left channel bank between Sta 1444+00 and Sta 1460+00. A level 3 bank protection is recommended except along upstream portion of bank where a level 2 is recommended due to the close proximity of the bank to access road, which was lost during the 2013 Flood.

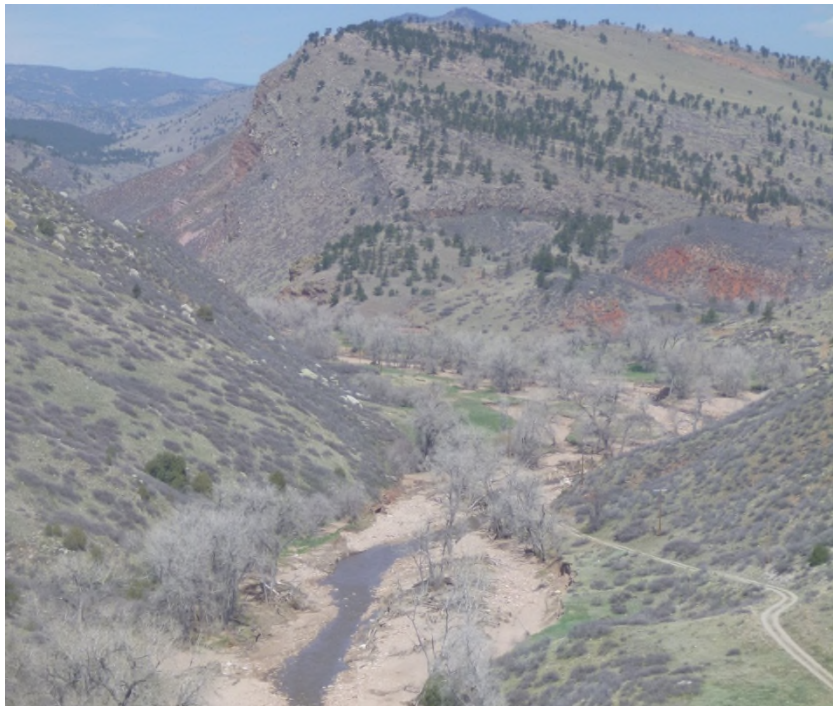
NEIGHBORHOOD: Boulder County
SHEET: 47
STATION: 1465+00 to 1497+00
RESTORATION RECOMMENDATIONS: 1474+00 to 1483+00

Aerial photos of pre-flood conditions and anecdotal information indicate this reach had a moderately dense vegetated riparian corridor, 100 to 200 feet wide, comprised primarily of cottonwoods and other riparian species, many of which were torn out during the flood. The river is generally canyon bound, which controls the sinuosity and river corridor alignment. Aerial mapping and field reconnaissance reveals observable areas of riffle pool complexes.

Geomorphic function of this reach is likely sufficient to allow for the natural regeneration of cottonwood, willow, and other riparian species through seeding and cloning without active restoration. Except for the following recommendation, no further actions are suggested at this time:

- 1. Stabilize the left channel bank between Sta 1474+00 and Sta 1483+00 to protect the house.

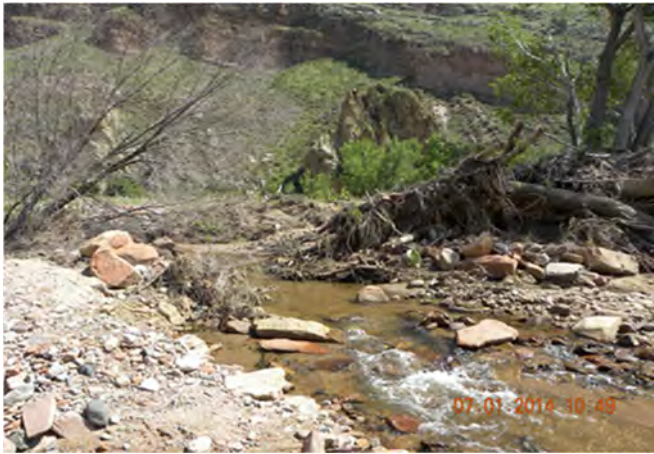
NEIGHBORHOOD: Blue Mountain
SHEET: 48
STATION: 1497+00 to 1531+00
RESTORATION RECOMMENDATIONS: 1501+00 to 1528+00

This is a single family home site with multiple buildings all which were flooded from the 2013 flood. Pasture and/or farm land overbanks eroded vertically where the floodwaters extended beyond the riparian corridor and there were damages incurred to the irrigation system. The driveway was also destroyed. Deposition of sediments is significant at this site and recommendations include stabilization or removal of some of these sediments to (1) minimize the excessive transport of sediment downstream, and (2) aid in the vegetative recovery of the exposed banks. Debris was also relatively significant. As of July 1, 2014, western Wheatgrass appears to be colonizing the sand areas very effectively.

As the channel begins to recover and reset itself from the 2013 flood, it is likely that over time, the geomorphic tendency will be to reestablish its equilibrium slope and meander. Because of the property-related issues here, and potential for movement of sediment, recommendations include stabilization and grading of the floodplain areas, bank stabilization, and floodplain reconstruction, grading and stabilization.

- 1. Bank stabilization along the left bank at Sta. 1504+00 and left overbank stabilization at Sta 1510+00.
- 2. Lowering and grading the channel at Sta 1513+00.
- 3. Floodplain stabilization and grading.
- 4. Overbank fill and reclamation.
- 5. Raise driveway and replace low-water crossing driveway.
- 6. Replace irrigation headgate/well.
- 7. Remove debris.

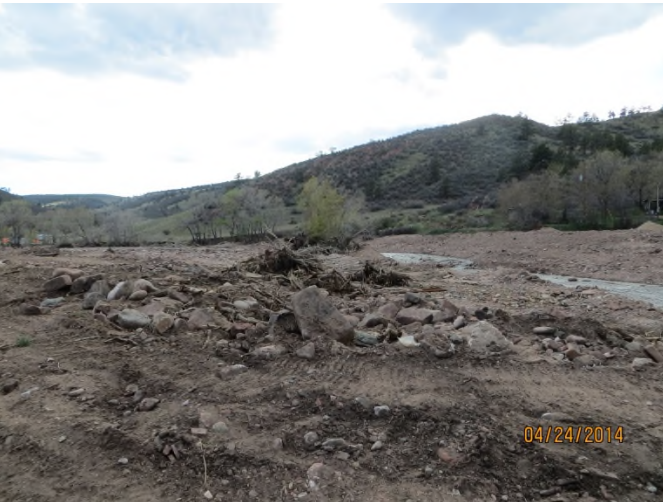
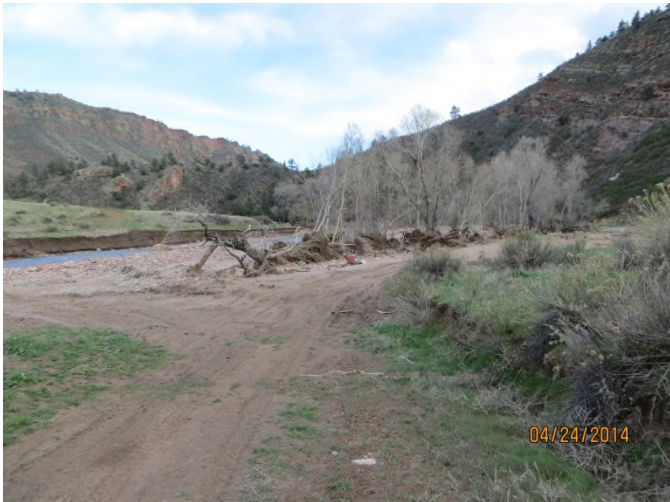
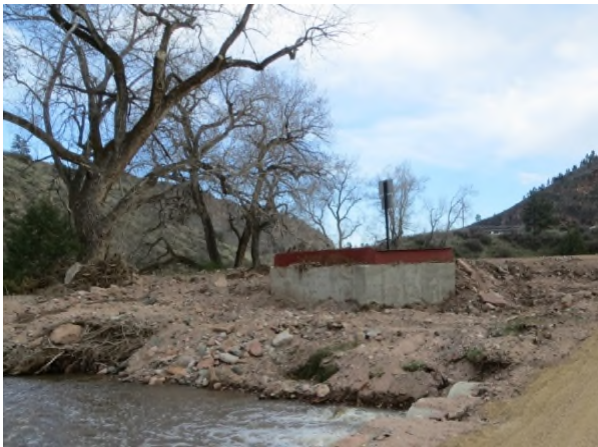
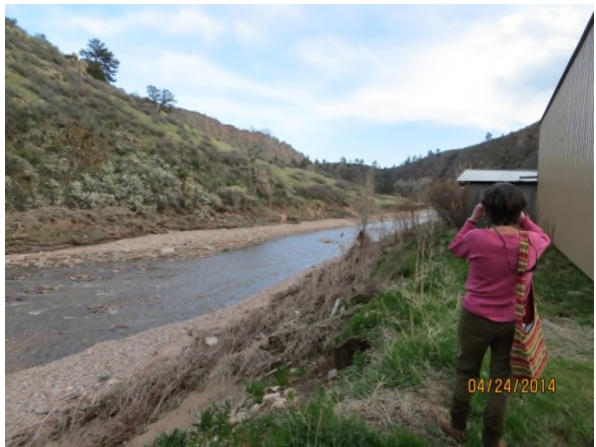
NEIGHBORHOOD: Blue Mountain
SHEET: 52
STATION: 1616+00 to 1648+00
RESTORATION RECOMMENDATIONS: 1624+00 to 1639+00

This is a family home site with multiple buildings, many of which were flooded from the 2013 Flood. The property included a bridge, which was totally destroyed from the 2013 Flood, reportedly from debris jams. Vegetation was scoured and torn out along the inside of the large bend. Deposition of large size debris was observed.

As the channel begins to recover and reset itself from the 2013 Flood, it is likely that over time, the geomorphic tendency will be to reestablish its equilibrium slope and meander. Because of the property-related issues here, and potential for additional damages should additional scour and bank erosion occur, recommendations include the reconstruction of the pre-flood channel alignment, including bank stabilization, and floodplain reconstruction, grading and stabilization. The floodplain benches will likely require fill material as the entire channel valley experienced scour.

- 1. Bank stabilization along the left bank at Sta. 1627+00.
- 2. Overbank stabilization along the left bank at Sta 1628+00.
- 3. Floodplain stabilization and grading.
- 4. Replace bridge (driveway crossing).

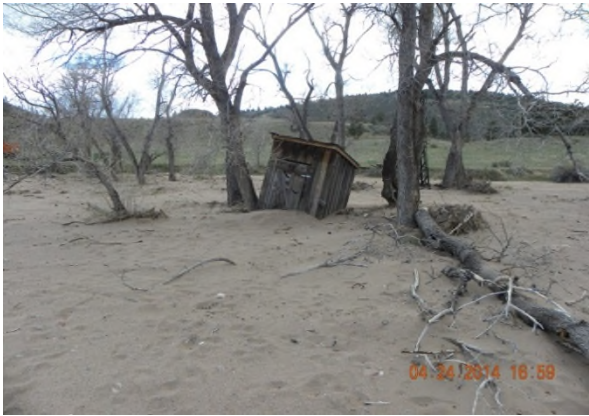
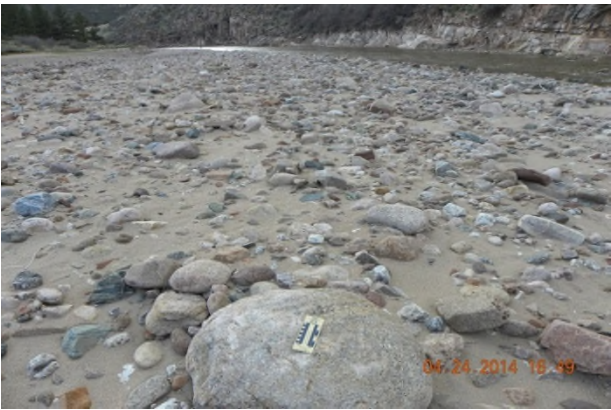
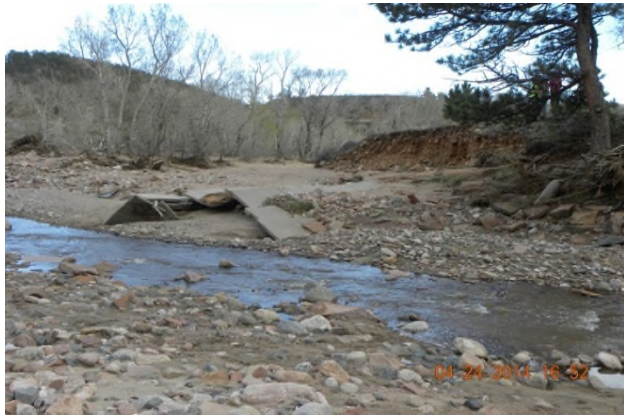
NEIGHBORHOOD: Blue Mountain
SHEET: 53
STATION: 1648+00 to 1684+00
RESTORATION RECOMMENDATIONS: 1649+00 to 1664+00

This is a family home site with multiple buildings, some of which were flooded from the 2013 Flood. The property included a small on-line pond, which was totally destroyed from the 2013 Flood. The cottonwood gallery had less damage and many trees survived. Sediment deposition is evident along the right overbank in the area of the surviving cottonwood trees. Vegetation closer to the river was scoured and torn out. Deposition of large size debris and boulders were observed.

As the channel begins to recover and reset itself from the 2013 Flood, it is likely that over time, the geomorphic tendency will be to reestablish its equilibrium slope and meander. Because of the property-related issues here, and potential for additional damages should additional scour and bank erosion occur, recommendations include the construction of a low-flow channel, and floodplain grading and stabilization. Grading should also be performed on the floodplain bench to remove excess deposition from the root zone of the surviving cottonwood trees.

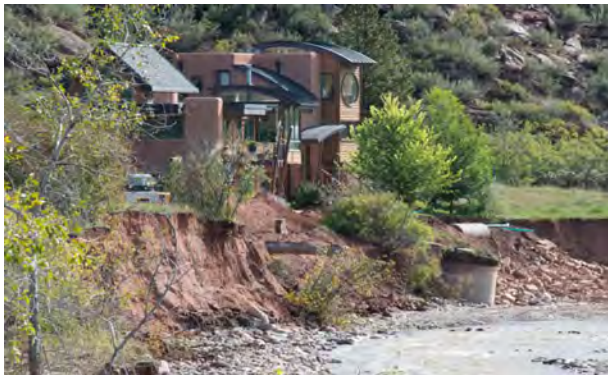
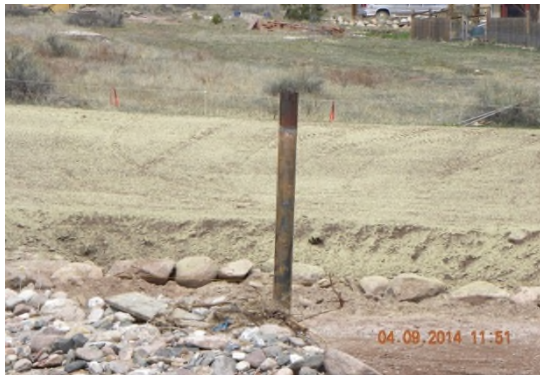
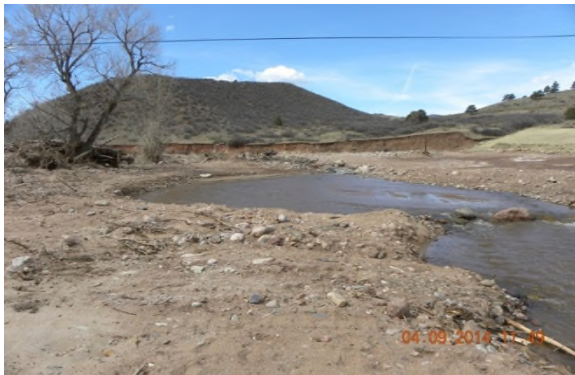
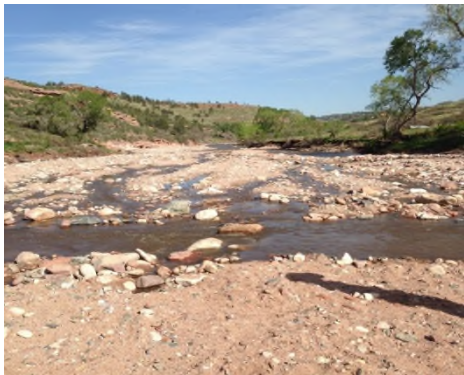
NEIGHBORHOOD: Blue Mountain
SHEET: 57
STATION: 1732+00 to 1772+00
RESTORATION RECOMMENDATIONS: 1742+00 to 1761+00

Aerial photos of pre-flood conditions and anecdotal information indicate this reach had a densely vegetated riparian corridor, 100 to 200 feet wide, comprised primarily of cottonwoods and willows, most of which were torn out during the flood. The river corridor is wider here than up- and downstream allowing for lateral movement of the river at the bend centered at Sta 1754+00. The 2013 flood event moved the channel from the center of the bend to the far outer edge (river left) scouring material to an estimated 8 feet, as seen by an exposed water well (photo below). This resulted in the loss of multiple buildings at one property (Buster Property) at Sta 1758+00 and the near loss of the Hoag residence at Sta 1748+00.

As the channel begins to recover and reset itself from the 2013 flood, it's likely that over-time, the geomorphic tendency will be to reestablish its equilibrium slope and meander. Currently, however, the channel is perched above the left overbank/floodplain near Sta 1748+00. Thus, one recommendation is to elevate the left overbank and slope it back toward the river. Other recommendations include grading the overbank and upper bank to meet in a blended, gentle slopes for ease in landscaping, and the creation of a series of pools on the upstream channel approach, designed to mimic pre-flood beaver ponds and to provide energy dissipation as flows enter the canyon bend. Minor improvements in the low-flow channel banks are also recommended, however, the low-flow channel will not be reconfigured in this restoration effort.

In addition, bank protection is recommended along the upper banks at Station 1748+00 to protect the residence. Recommendations include the installation of launch-style buried riprap on the upper bank. This riprap will be buried and set back from the river by several hundred feet and should therefore not be seen or interfere with the biologic and geomorphic functions of the bank full channel and associated floodplain being restored.

- 1. Maintain existing (post flood) channel alignment; shape point bars on the inside bends.
- 2. Create low-laying floodplain overbank with gentle slope toward the river.
- 3. Create bank along the channel using level 3 bank protection including rootwads combined with coir lift/willow plug banks at the bends and native cobble with sedges along the channel banks in the straight sections.
- 4. Install and bury launch style riprap immediately adjacent to the intact, upper banks and bury.
- 5. Blend improvements with newly reconstructed bank (completed by owner) and blend upper and lower benches using slopes that are plant-able (3 horizontal to 1 vertical or flatter).
- 6. Create a series of pools on the upstream channel approach,

designed to mimic pre-flood beaver ponds and to provide energy dissipation as flows enter the canyon bend.

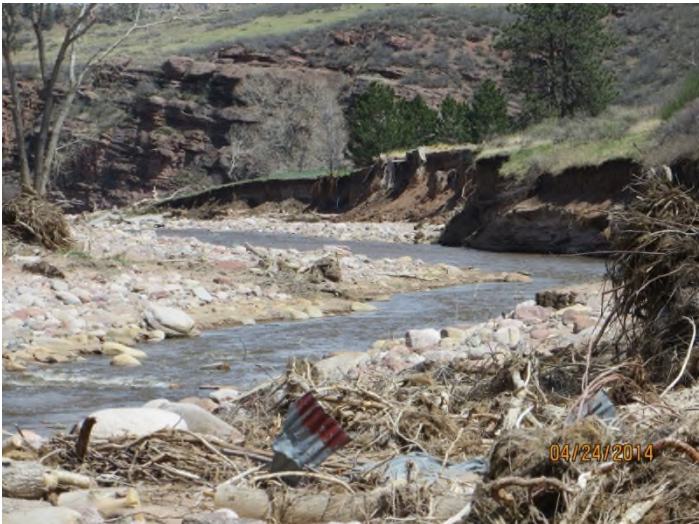
NEIGHBORHOOD: Blue Mountain
SHEET: 58
STATION: 1772+00 to 1799+00
RESTORATION RECOMMENDATIONS: 1776+00 to 1792+00

Aerial photos of pre-flood conditions and anecdotal information indicate this reach had a densely vegetated riparian corridor, 100 to 200 feet wide, comprised primarily of cottonwoods and willows, most of which were torn out during the flood. The river channel alignment had, pre-flood, two large bends centered at Sta 1780+00 and Sta 1788+00, respectively. The flood avulsed through both bends resulting in a straightening of the channel which moved the channel flow line alignments between 150 to 200 feet from its pre-flood alignment. This resulted in the total destruction of one home (Campassi residence) at Sta 1780+00, and the loss of river front property at the second home (Sandford residence) at Sta 1788+00.

As the channel begins to recover and reset itself from the 2013 Flood, it is likely that over-time the geomorphic tendency will be to reestablish its equilibrium slope and meander. However, because of the property-related issues here, and in particular the losses experienced at both residences, recommendations include the reconstruction of the pre-flood meanders, including bank stabilization, low-flow channel reconfiguration, and floodplain reconstruction, grading and stabilization. Both bends should be constructed together as the two bends work in concert in terms of conveyance and geomorphic impacts. The floodplain benches will likely require fill material as the entire channel valley experienced significant scour.

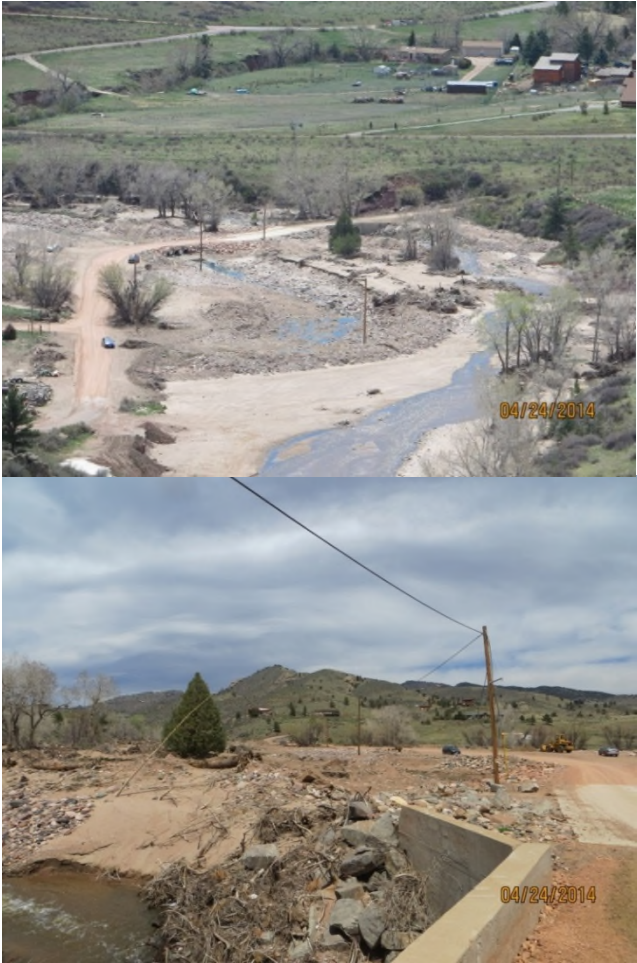
NEIGHBORHOOD: Blue Mountain
SHEET: 59
STATION: 1799+00 to 1836+00
RESTORATION RECOMMENDATIONS: 1810+00 to 1836+50

Based on field observations it appears this reach experienced significant scour from the 2013 flood event and velocities were high as indicated by the conveyance of an automobile over a half-mile in length from its pre-flood location and the total destruction a home (Lewis residence) at Sta 1820+00. The crossing on Stagecoach Trail, comprised of three concrete culverts, plugged with debris during the event causing water to overtop the road, rendering it unusable. A temporary culvert crossing was constructed immediately to the north of the existing bridge crossing. An existing concrete dip, installed by the NRCS in 1995, served to transport overtopping flows over the road. Flows overtopping the road scoured a secondary channel to the north of the main channel.

Because of the canyon-bound valley formation and limited encroachment on the river corridor, much of this reach is relatively stable and expected to recover without restoration activities. In the area of Stagecoach Trail crossing, however, there is some notable disturbance from the flood, including wide-spread riparian disturbance and loss of vegetation, channel avulsion, the destruction of a home (beyond repair), damage to three outbuildings and the total loss of four additional outbuildings that were completely washed away all on the Lewis property immediately downstream of the road crossing. Approximately 1000 feet upstream of the road crossing the existing fire station was also swept away, in its entirety (see Sheet 60).

Larimer County has indicated they will be repairing the existing crossing at Stagecoach Trail. The standards for repair are reportedly to return the crossing to pre-flood conditions. However, anecdotal information indicates this crossing has overtopped several times in recent history, indicating that it is undersized to meet current County criteria. In 1995, NRCS reportedly constructed a concrete dip over the top of the crossing to help channelize overtopping flows. Because this existing crossing is likely

undersized, and prone to plugging with debris, a bridge replacement is recommended, sized appropriately for current criteria and with provisions for blockage from debris.

1. Replace the existing culverts at Sta 1820+55 with a bridge to provide increased capacity and to reduce the potential for debris blockage.
2. Elevate Stagecoach Trail upstream of the bridge crossing from Sta 1820+55 to Sta 1830+80 to confine flood flows to the river corridor and to minimize overtopping flows and the passage of shallow flooding outside of the river corridor.

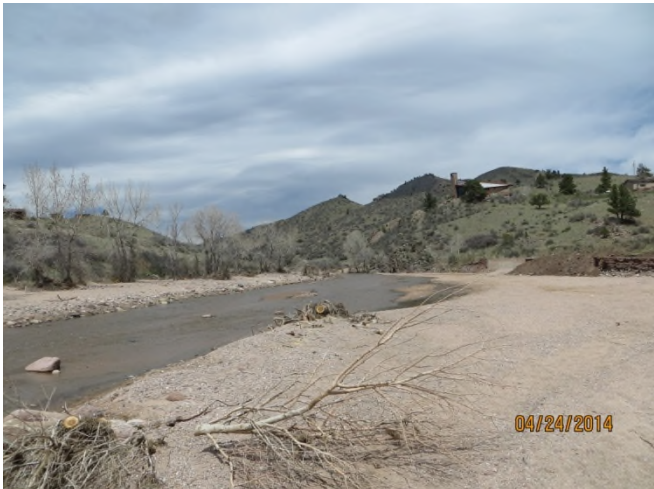
NEIGHBORHOOD: Blue Mountain
SHEET: 60
STATION: 1836+00 to 1848+00
RESTORATION RECOMMENDATIONS: 1836+50 TO 1839+00

Based on field observations it appears this reach experienced significant scour from the 2013 flood event and velocities were high as evidenced by the total destruction the fire station. What remains of the fire station includes the building pad and a cistern. The fire department will repair and maintain the cistern. Parking and access improvements are recommended as shown. The fire station has been relocated to the southwest of the river.

Because of the canyon bound valley formation and limited encroachment on the river corridor, much of this reach is relatively stable and expected to recover without restoration activities. In the area of Stagecoach Road crossing, however, there is some notable disturbance as shown on Sheet 59. Recommendations for Sheet 60 are noted below.
