APPENDIX A

ASSESSMENT PROTOCOL

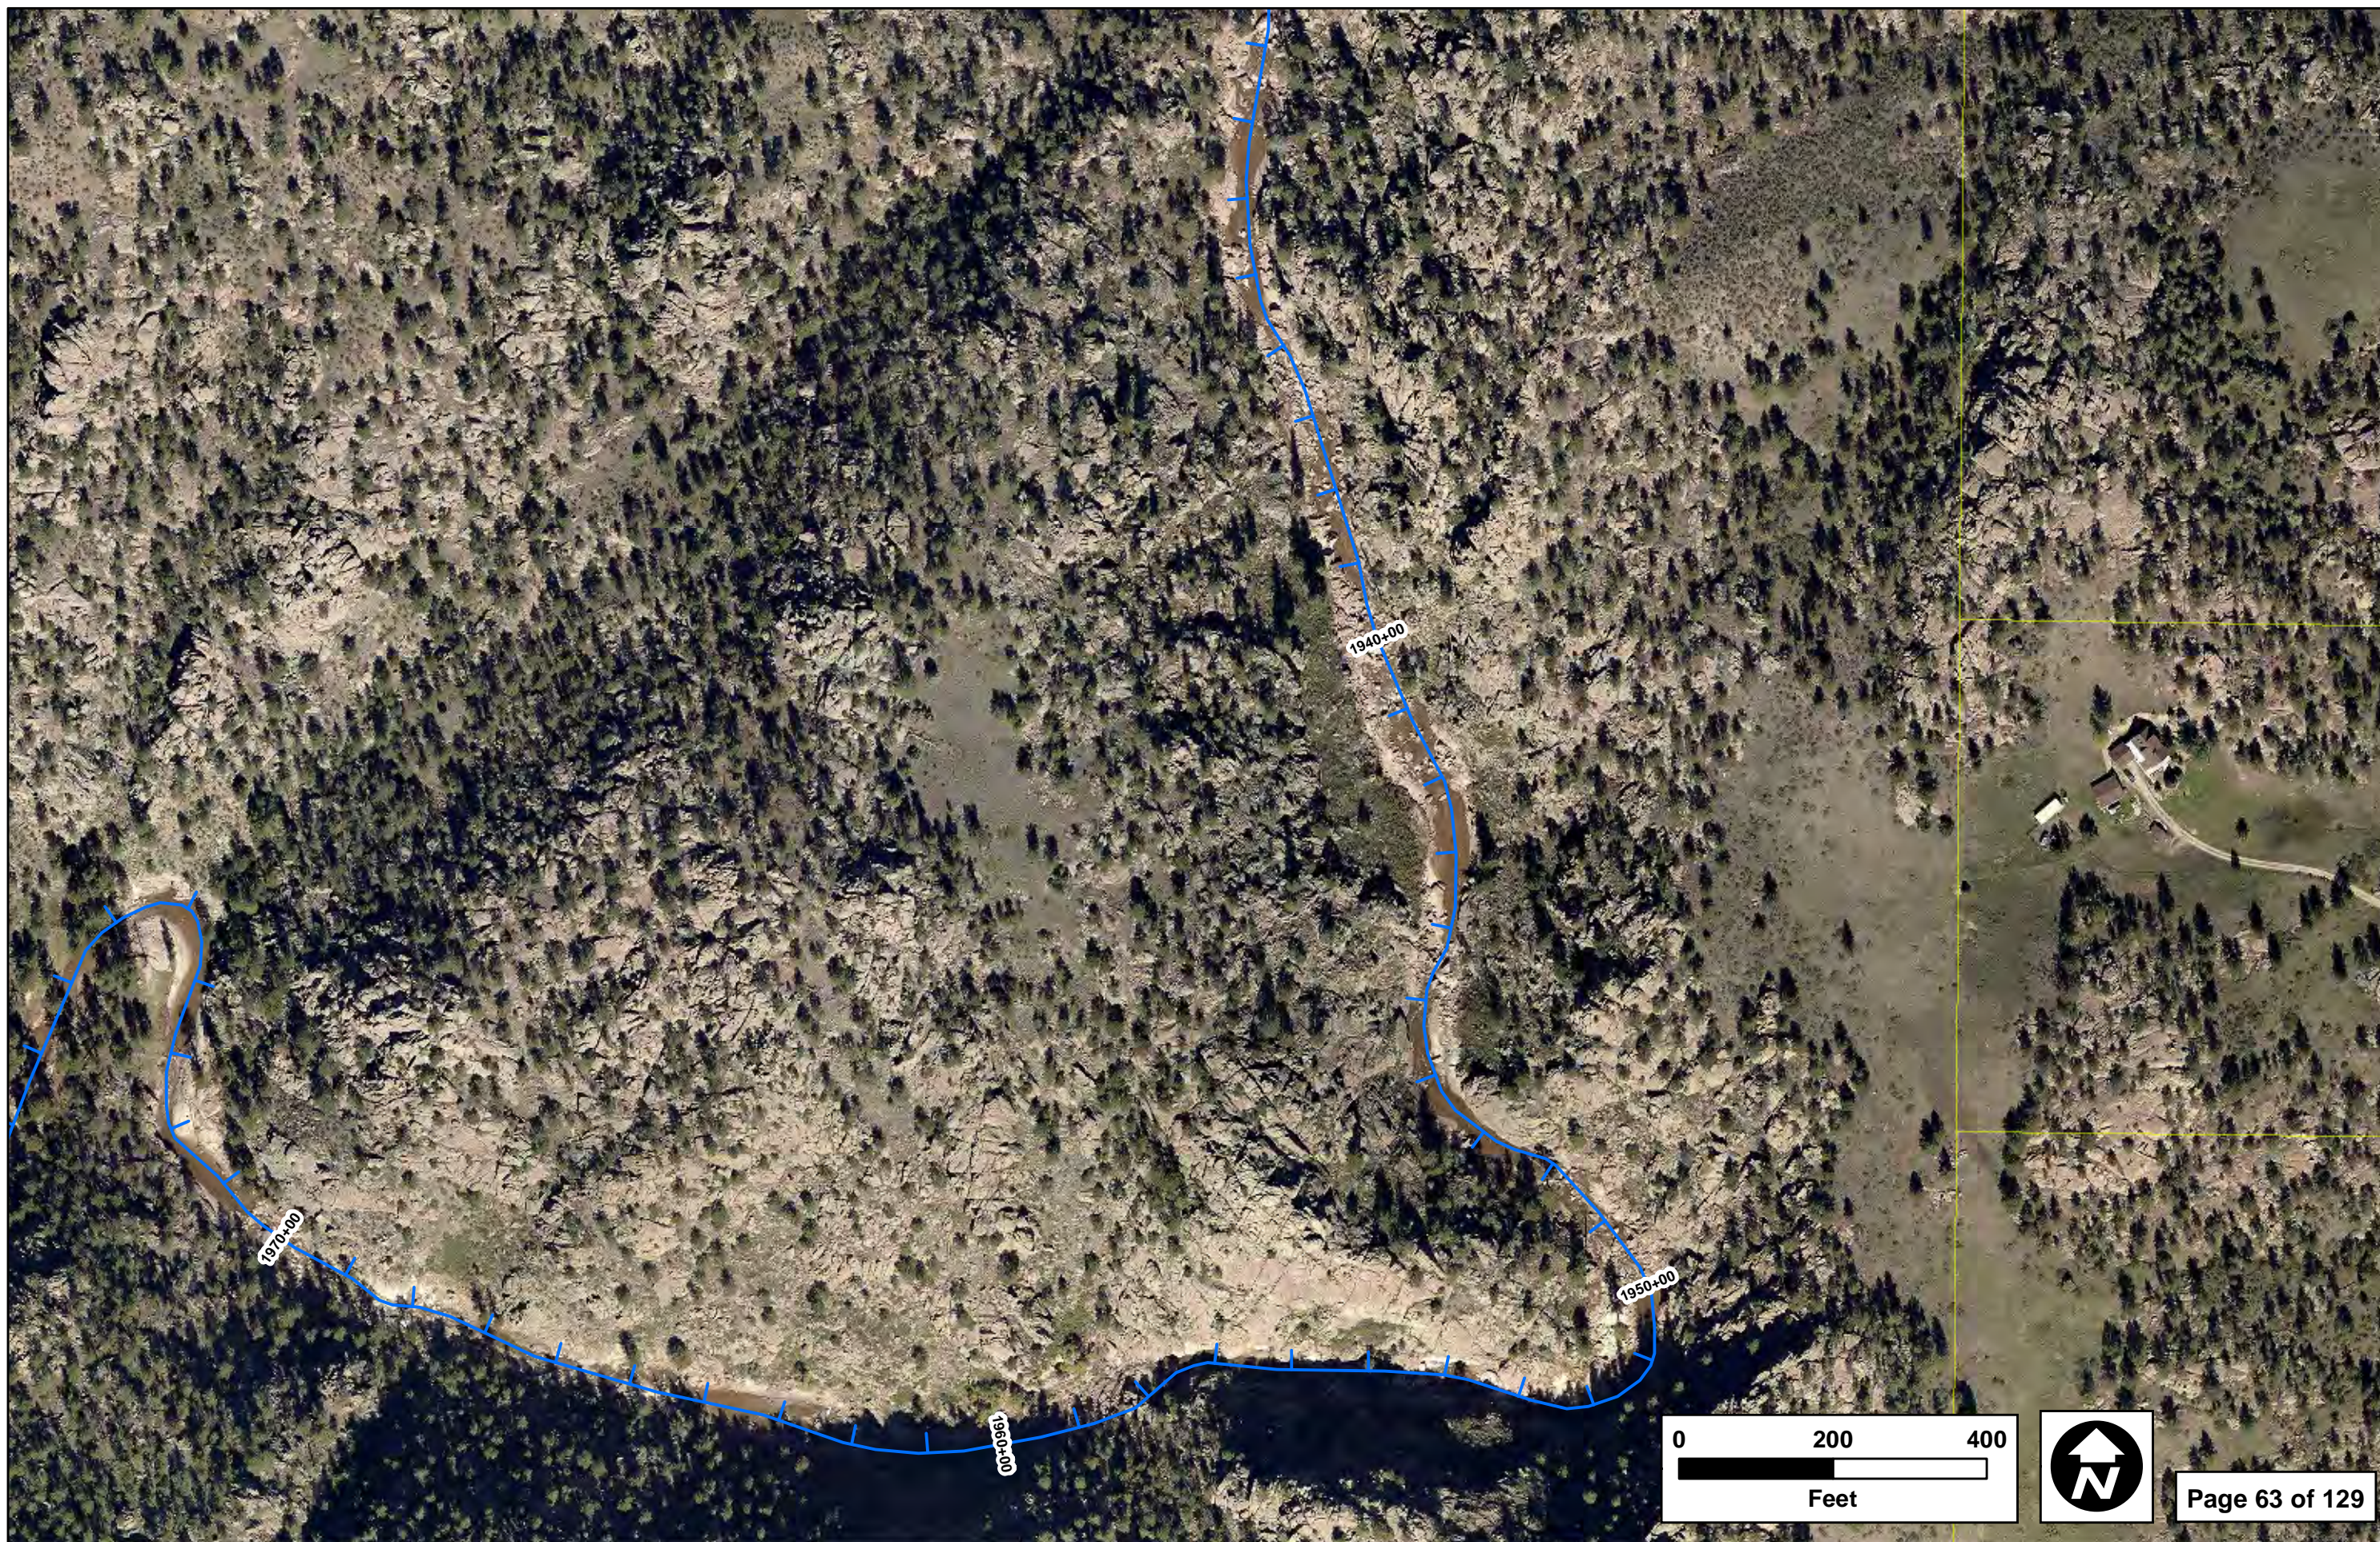
NEIGHBORHOOD: Pinewood Springs to Blue Mountain
SHEET: 64
STATION: 1973+00 to 2033+00

Aerial photos of pre-flood conditions and anecdotal information indicate this reach had a vegetated riparian corridor, 50 to 100 feet wide, comprised primarily of fir trees and willows, much of which were torn out during the flood. The river corridor is narrow and canyon bound, setting the sinuosity and river corridor alignment.

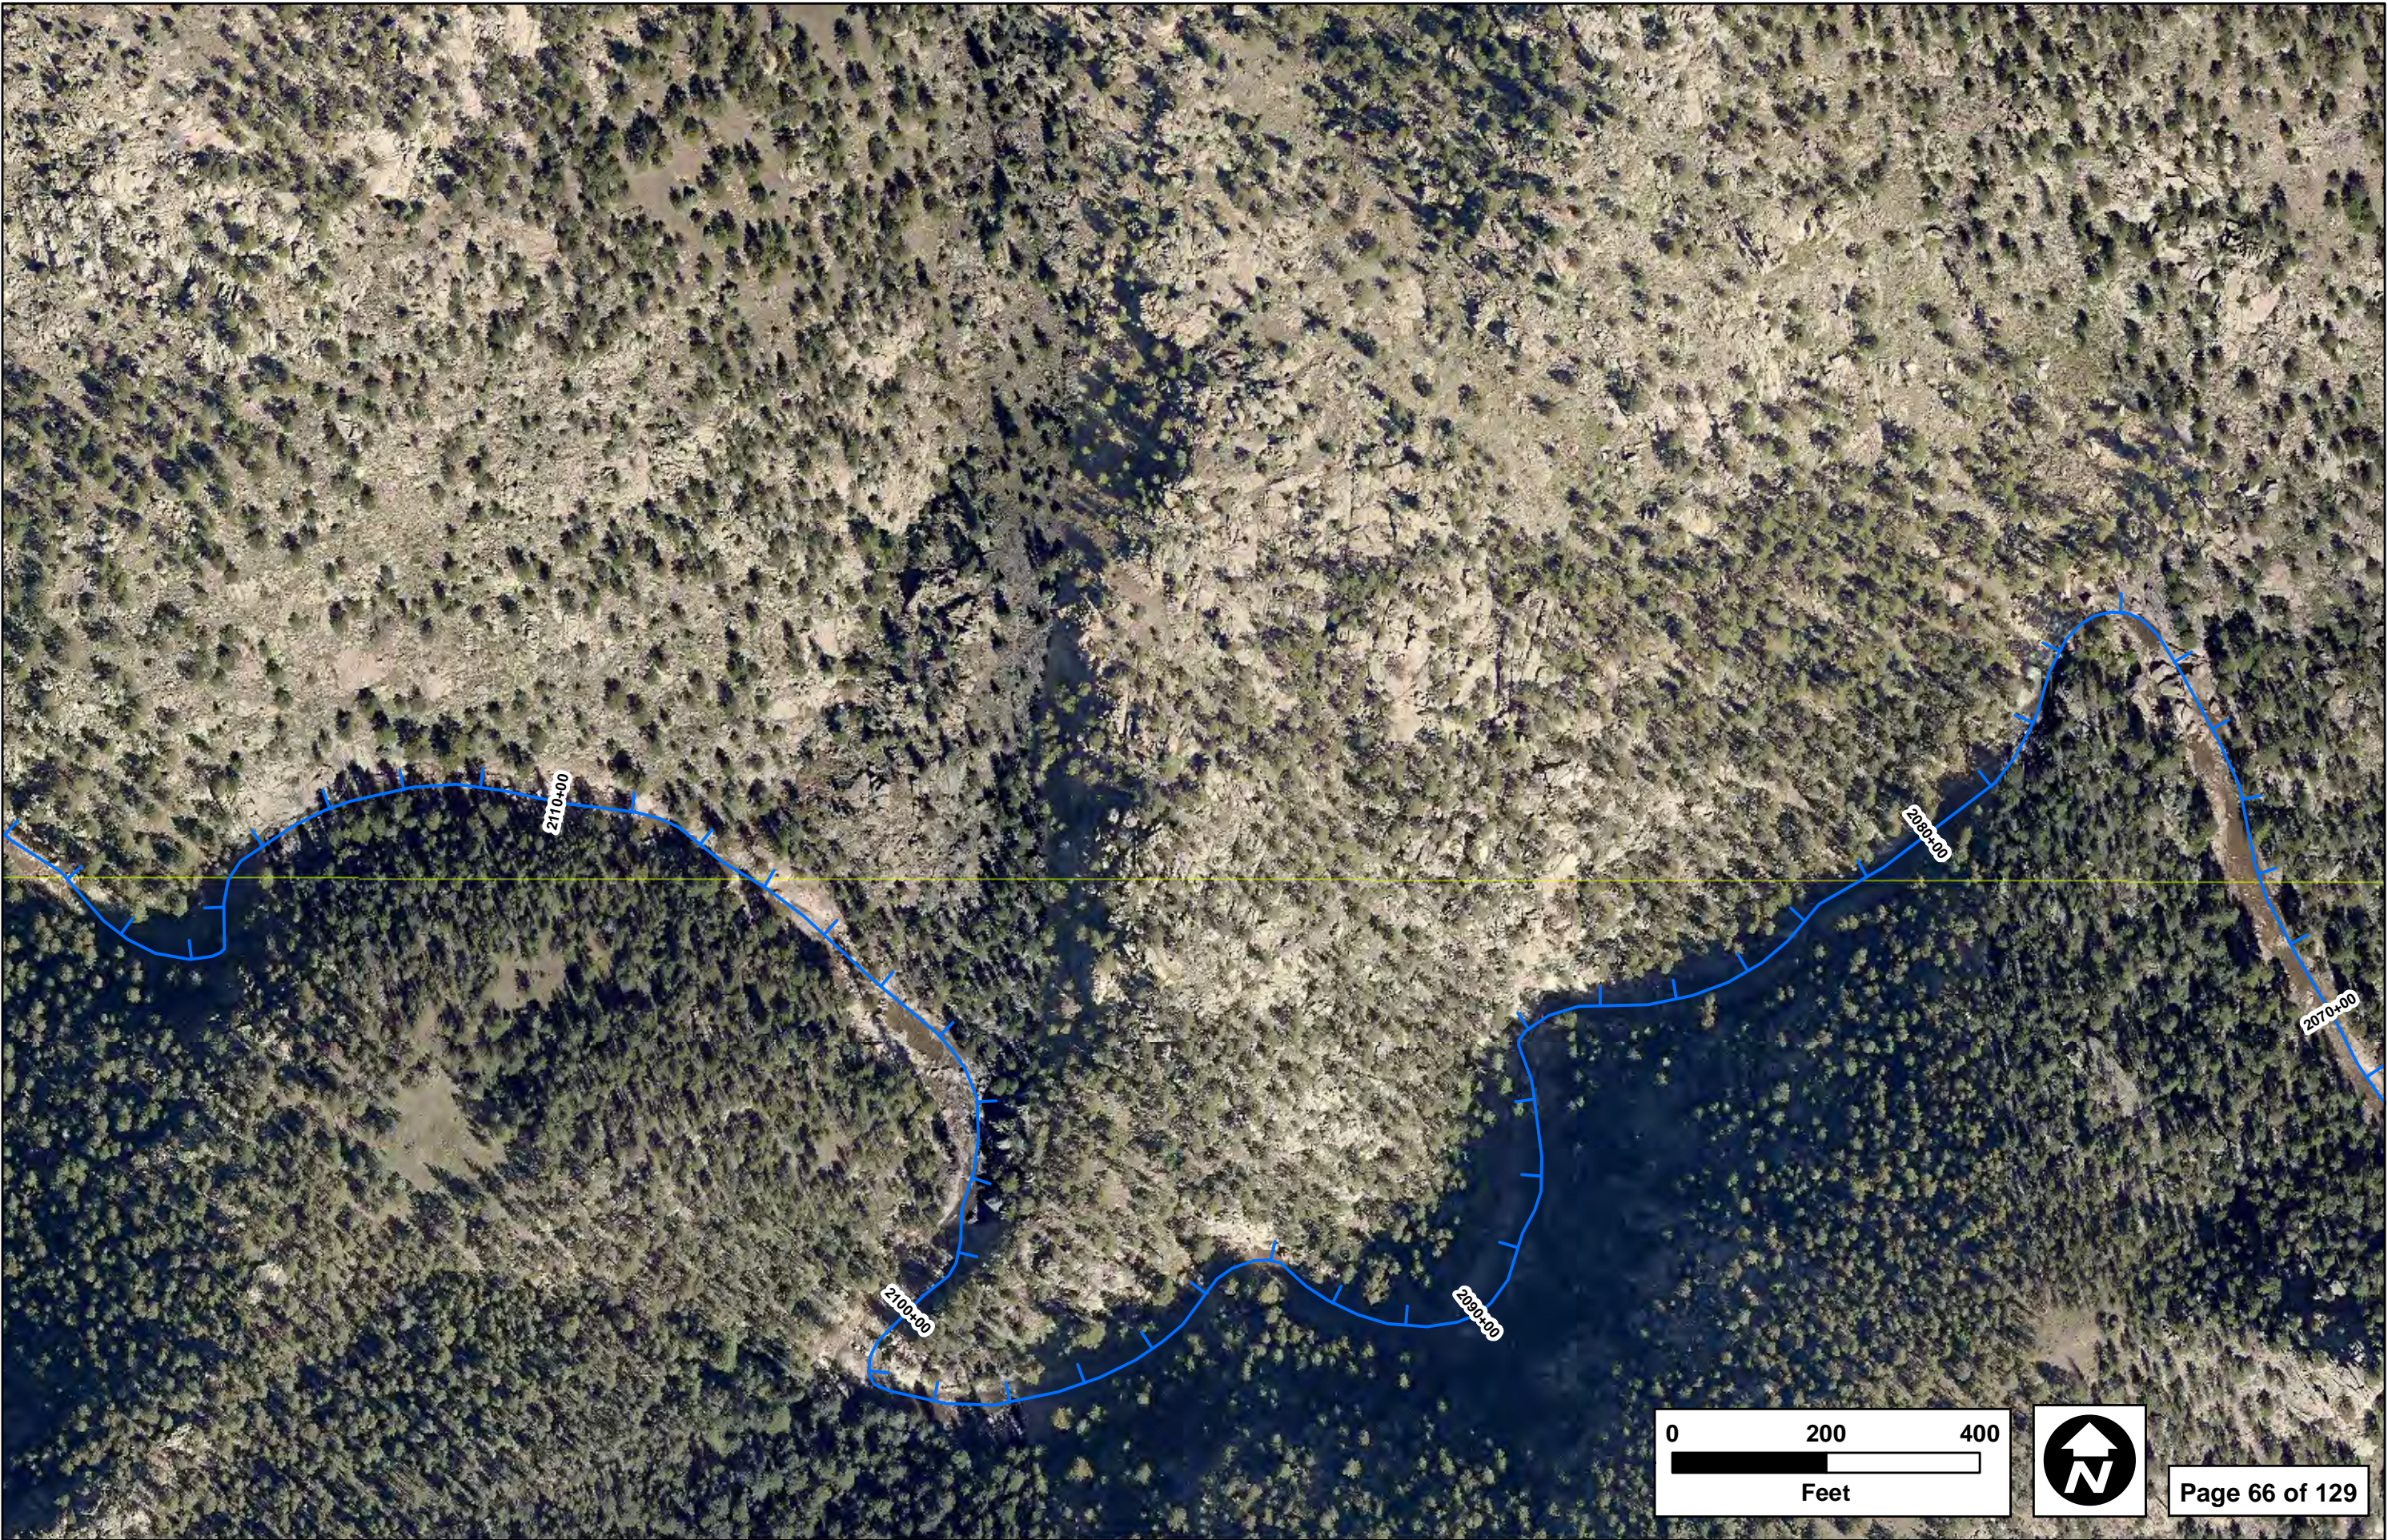
NEIGHBORHOOD: Pinewood Springs to Blue Mountain**SHEET: 67****STATION: 2110+00 to 2140+00**

Aerial photos of pre-flood conditions and anecdotal information indicate this reach had a vegetated riparian corridor, 50 to 100 feet wide, comprised primarily of fir trees and willows, much of which were torn out during the flood. The river corridor is narrow and canyon bound, setting the sinuosity and river corridor alignment.

Geomorphic functions of this reach is likely sufficient to allow for the natural regeneration of willow, and other riparian species through seeding and cloning without active restoration. No further actions are suggested at this time.

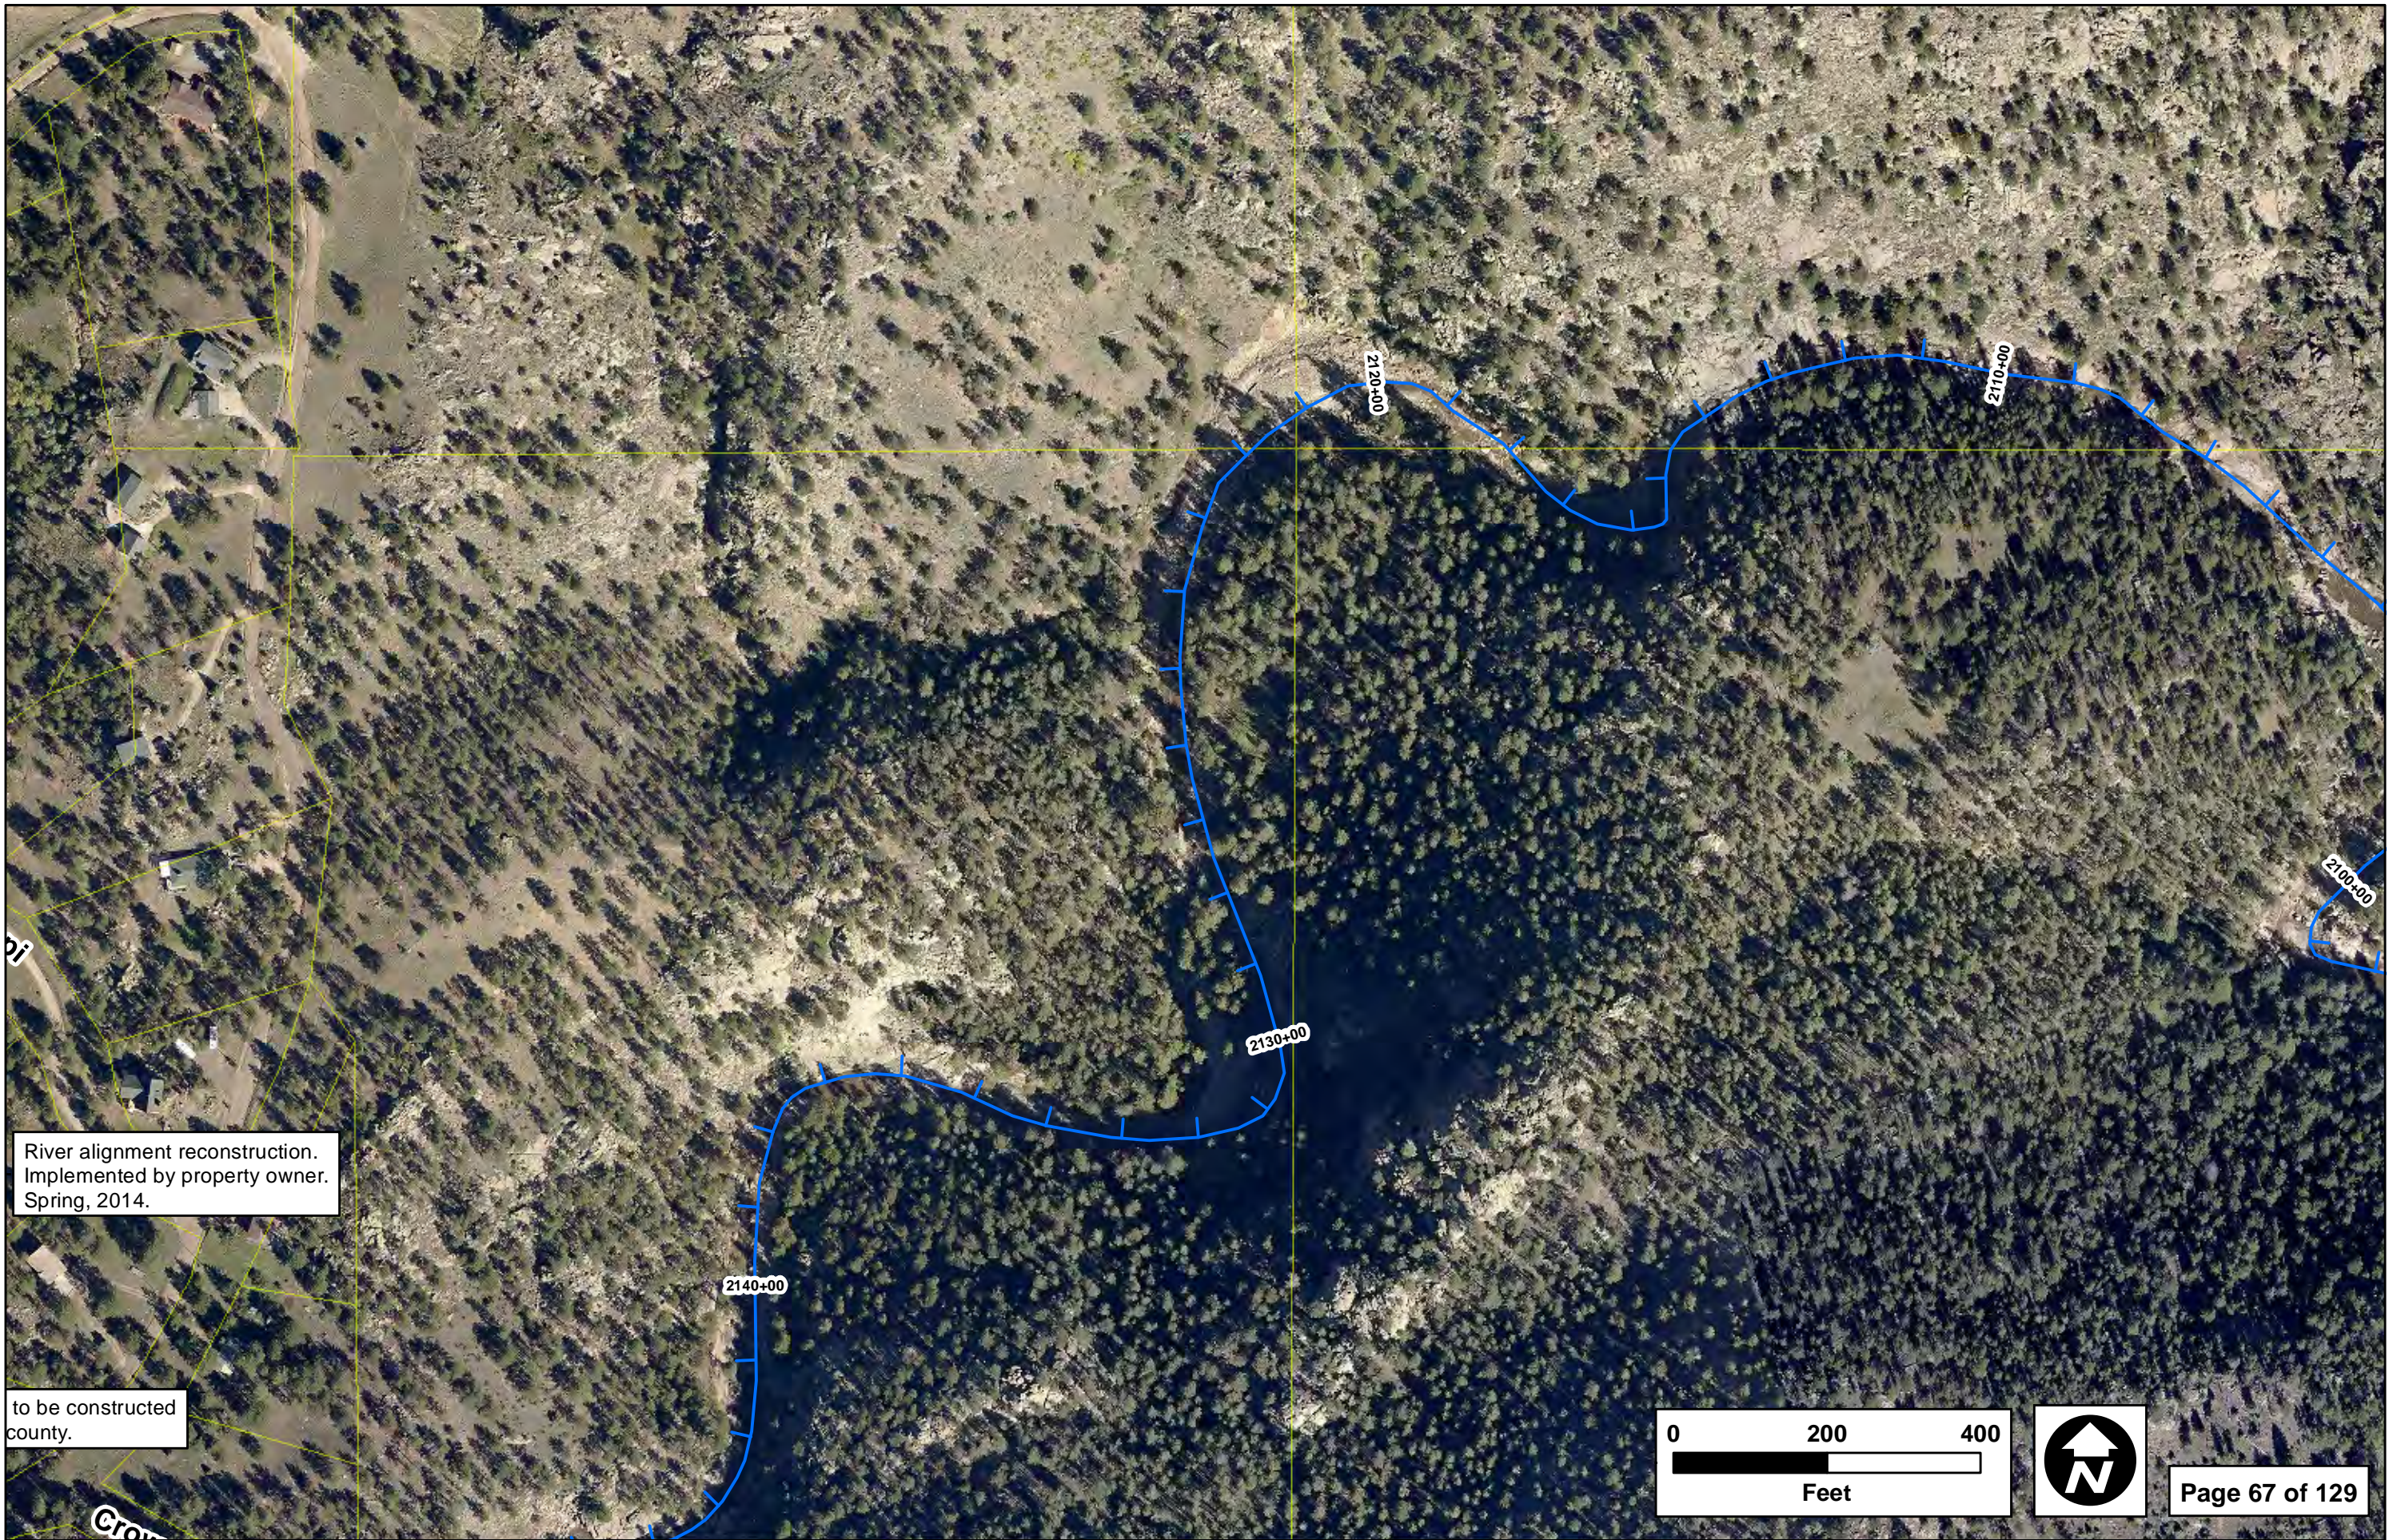
NEIGHBORHOOD: Pinewood Springs
SHEET: 68
STATION: 2140+00 to 2190+00
RESTORATION RECOMMENDATIONS: 2160+00 to 2175+00

Aerial photos of pre-flood conditions and anecdotal information indicate this reach had a vegetated riparian corridor, 50 to 150 feet wide, comprised primarily of fir trees and willows, much of which were torn out during the flood. The river corridor is narrow and canyon bound, setting the sinuosity and river corridor alignment.

Near the Kiowa Bridge crossing the river experienced significant scour from the 2013 flood. Velocities were high as evident by the loss of the bridge on Kiowa at Sta 2170+10, the significant loss of shrubs and grasses and the removal and transport of large fir trees. The crossing on Kiowa was a low-water crossing which failed as a result of flanking flows around the abutments. A temporary culvert crossing exists today and Larimer County is planning to replace the culverts with a new bridge in accordance with the County criteria. Upstream of Kiowa, there is a residence that was flooded with significant property damage. This property was restored by the owner prior to the field assessments conducted for this Master Plan.

During the 2013 flood, the channel thalweg moved to the outside, or right bend which through the center of Crescent Lake and as a result, created a lower flow line elevation as compared to the inside or left bend. Since the 2013 flood, the local residences have reconstructed the low-flow channel downstream of Kiowa to the USFS property line, along the inside or left bend, creating a perched-channel configuration could avulse under runoff or flood conditions without implementation of the additional recommendations presented here.

1. Coordinate with Larimer County on bridge alignment.
2. Reconstruct headgate and intake located upstream of Kiowa Bridge; investigate the possibility to move it closer to Crescent Lake.
3. Replace dry-hydrant and construct a parking platform for the fire department to access the lake and hydrant. Include parking for residences.
4. Reconstruct Crescent Lake. Include a flood overflow outlet on the downstream end to alleviate flood conditions from the lake. Consider an overflow from the currently configured channel to the outside flood overflow channel.
5. Assess channel stability and design the lake berm between the channel and lake for appropriate scour and overtopping.
6. Stabilize and vegetate floodplain below Crescent Lake.
7. Reconstruct low-flow channel as required to define the low-flow channel along the left valley.

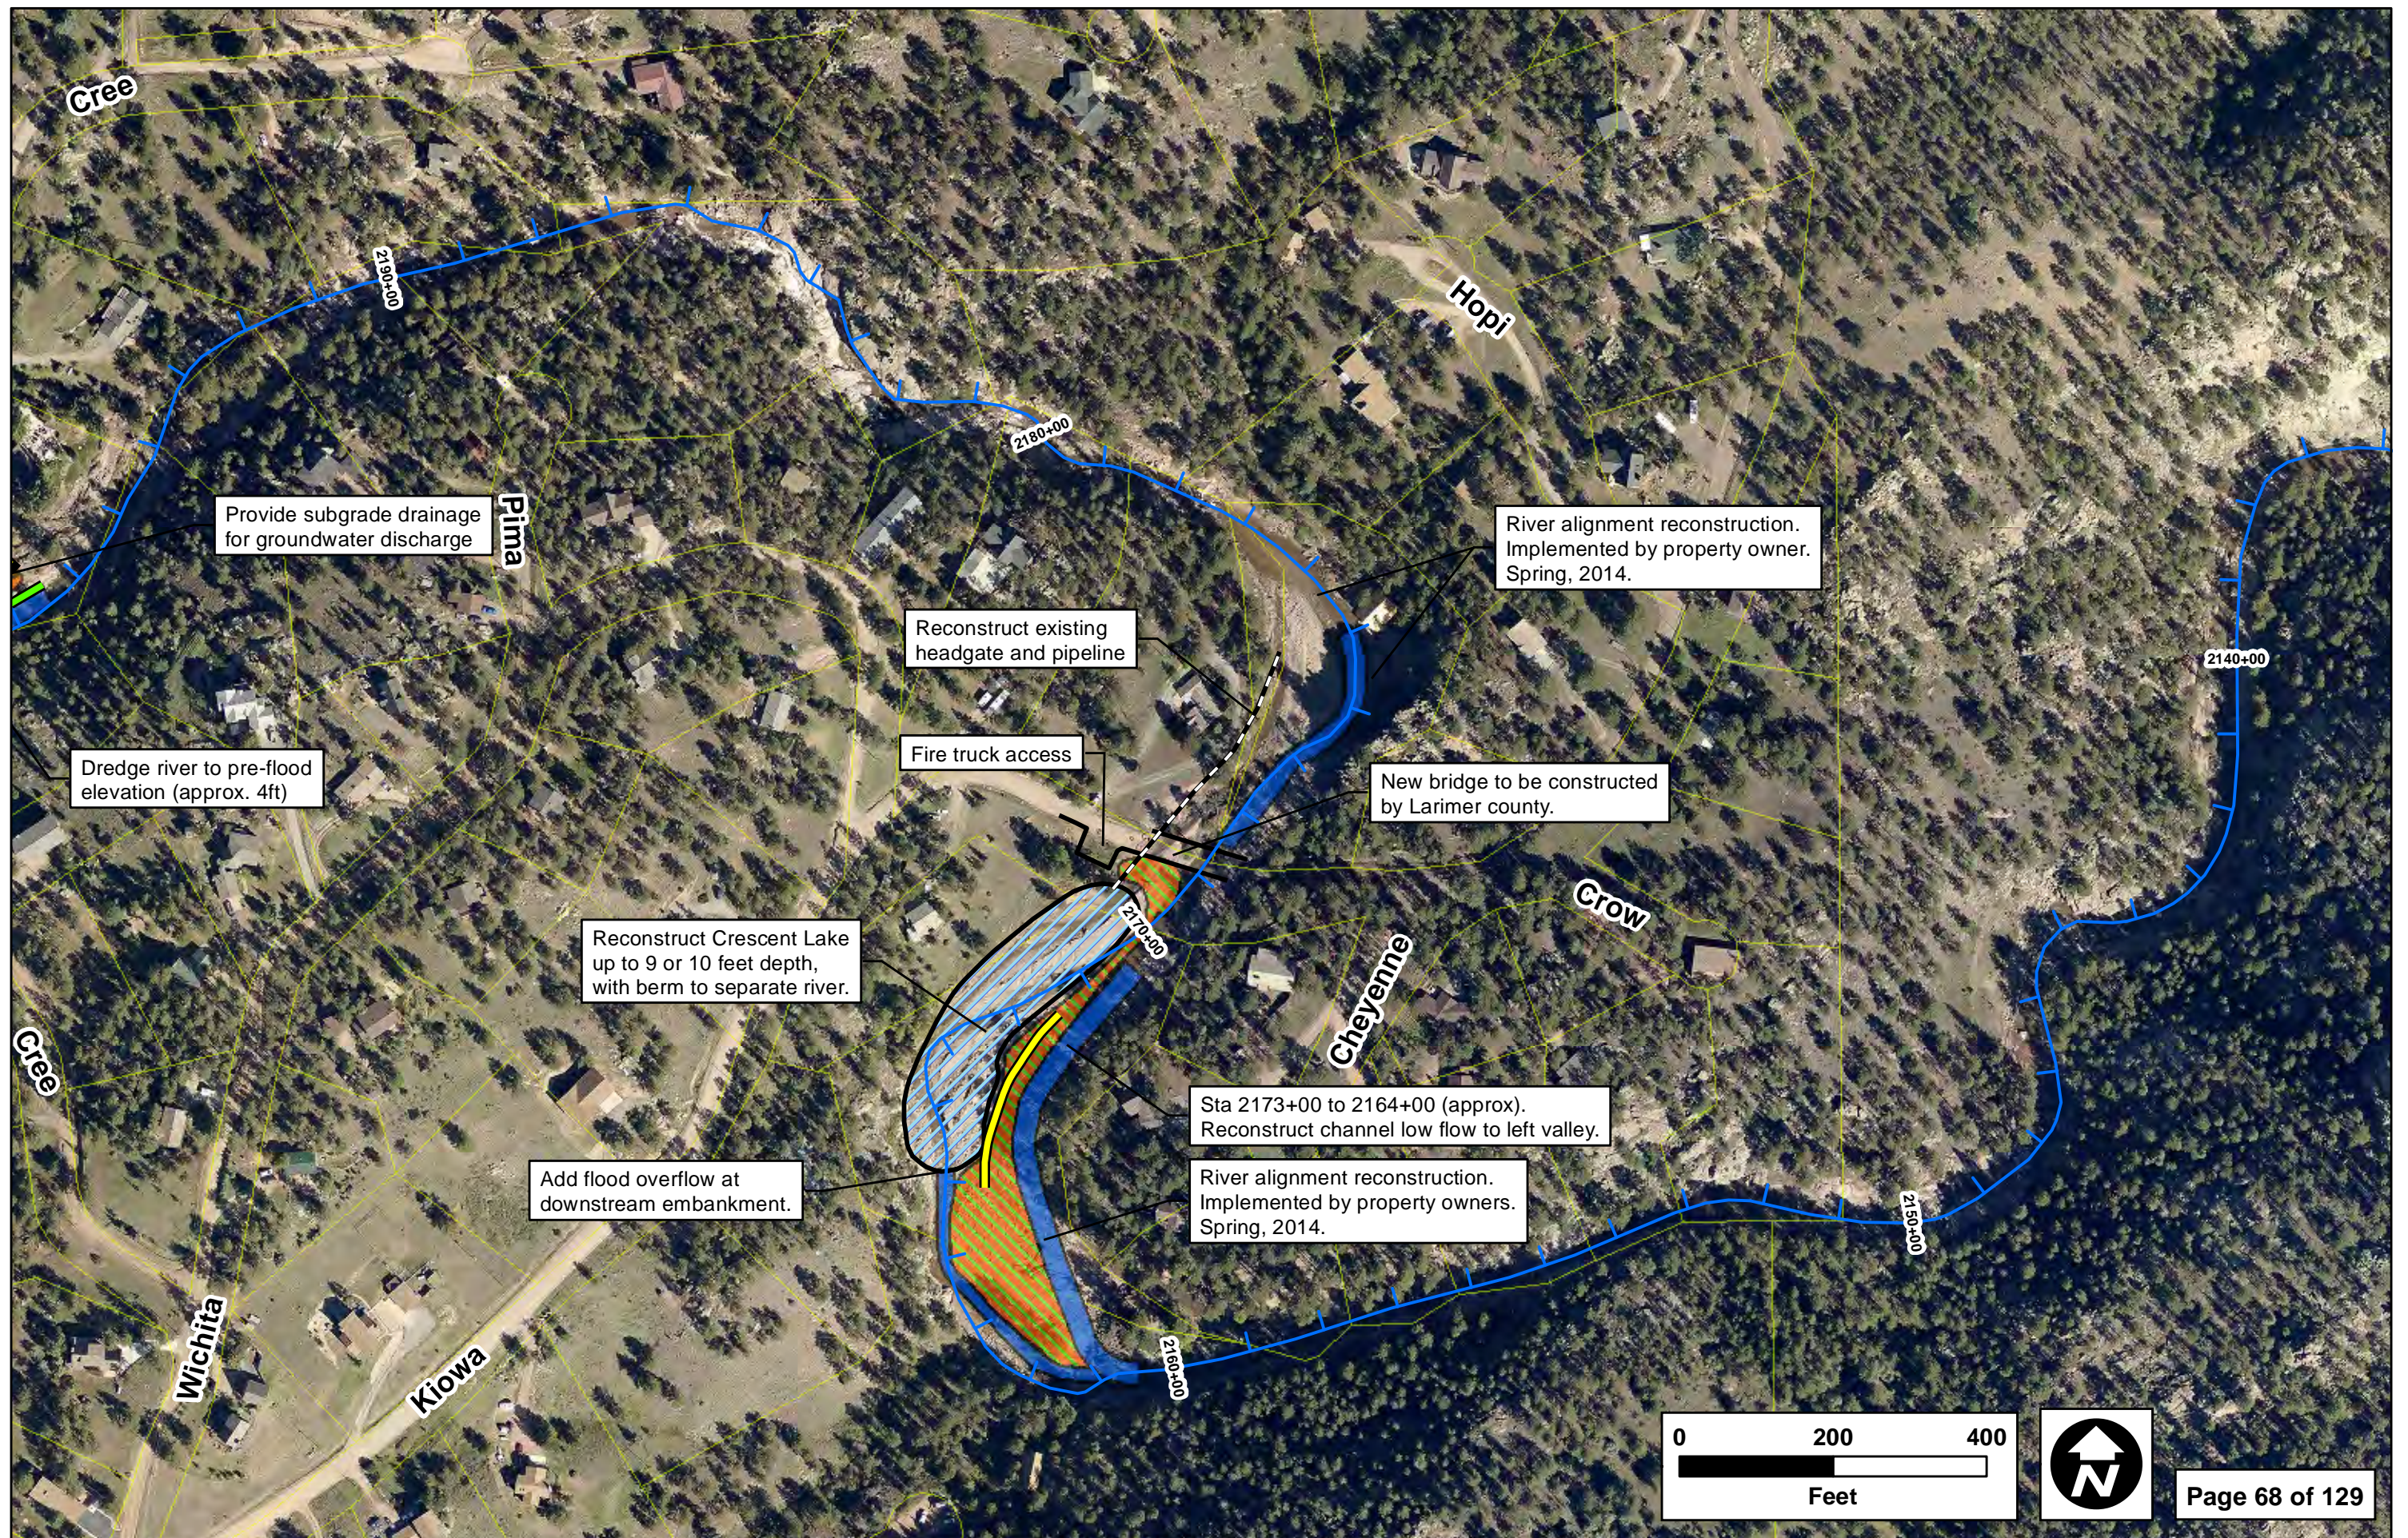
NEIGHBORHOOD: Pinewood Springs
SHEET: 69
STATION: 2190+00 to 2210+00
RESTORATION RECOMMENDATIONS: 2196+00 to 2204+00

Aerial photos of pre-flood conditions and anecdotal information indicate this reach had a vegetated riparian corridor, 50 to 100 feet wide, comprised primarily of fir trees and willows, much of which were torn out during the flood. The river corridor is narrow and canyon bound, setting the sinuosity and river corridor alignment.

Near the Cree Bridge crossing the river experienced significant lateral scour from the 2013 flood. Velocities were high as evidenced by the damage to the bridge on Cree (Sta 2190+90), the significant loss of vegetation, bank degradation at the Sherman residence, the channel avulsion at the water treatment plan and the transport and removal of large fir trees. The crossing on Cree was a single-span bridge, which reportedly failed as a result of debris plugging and subsequent flanking of flows around the northwest abutment. This flanking is also the likely cause of significant erosion and loss of river bank at the Sherman residence. Additional erosion or loss of bank at the Sherman residence will likely result in structural failure of the home. Downstream of the Cree Bridge immediately the river aggraded by an estimated four (4) feet based on anecdotal information from Jeff Sherman who lives immediately adjacent to the aggraded area. The elevated stream bed may be contributing to high groundwater condition that exists today.

- 1. Coordinate with Larimer County on bridge reconstruction. Evaluate for higher flows than the county design standard of 25 years and assess overtopping flow to ensure the bridge is not perched compared to the approach roads.
- 2. Coordinate with Pinewood Springs Water District to align river with vault location.
- 3. Assess channel stability immediately up- and downstream of the Cree Bridge.
- 4. Backfill and stabilize the banks adjacent to Sherman residence.
- 5. Verify channel elevations and to the extent possible, lower the channel reach immediately adjacent to Sherman residence to conform to pre-flood elevations. Verify adequacy of channel capacity.

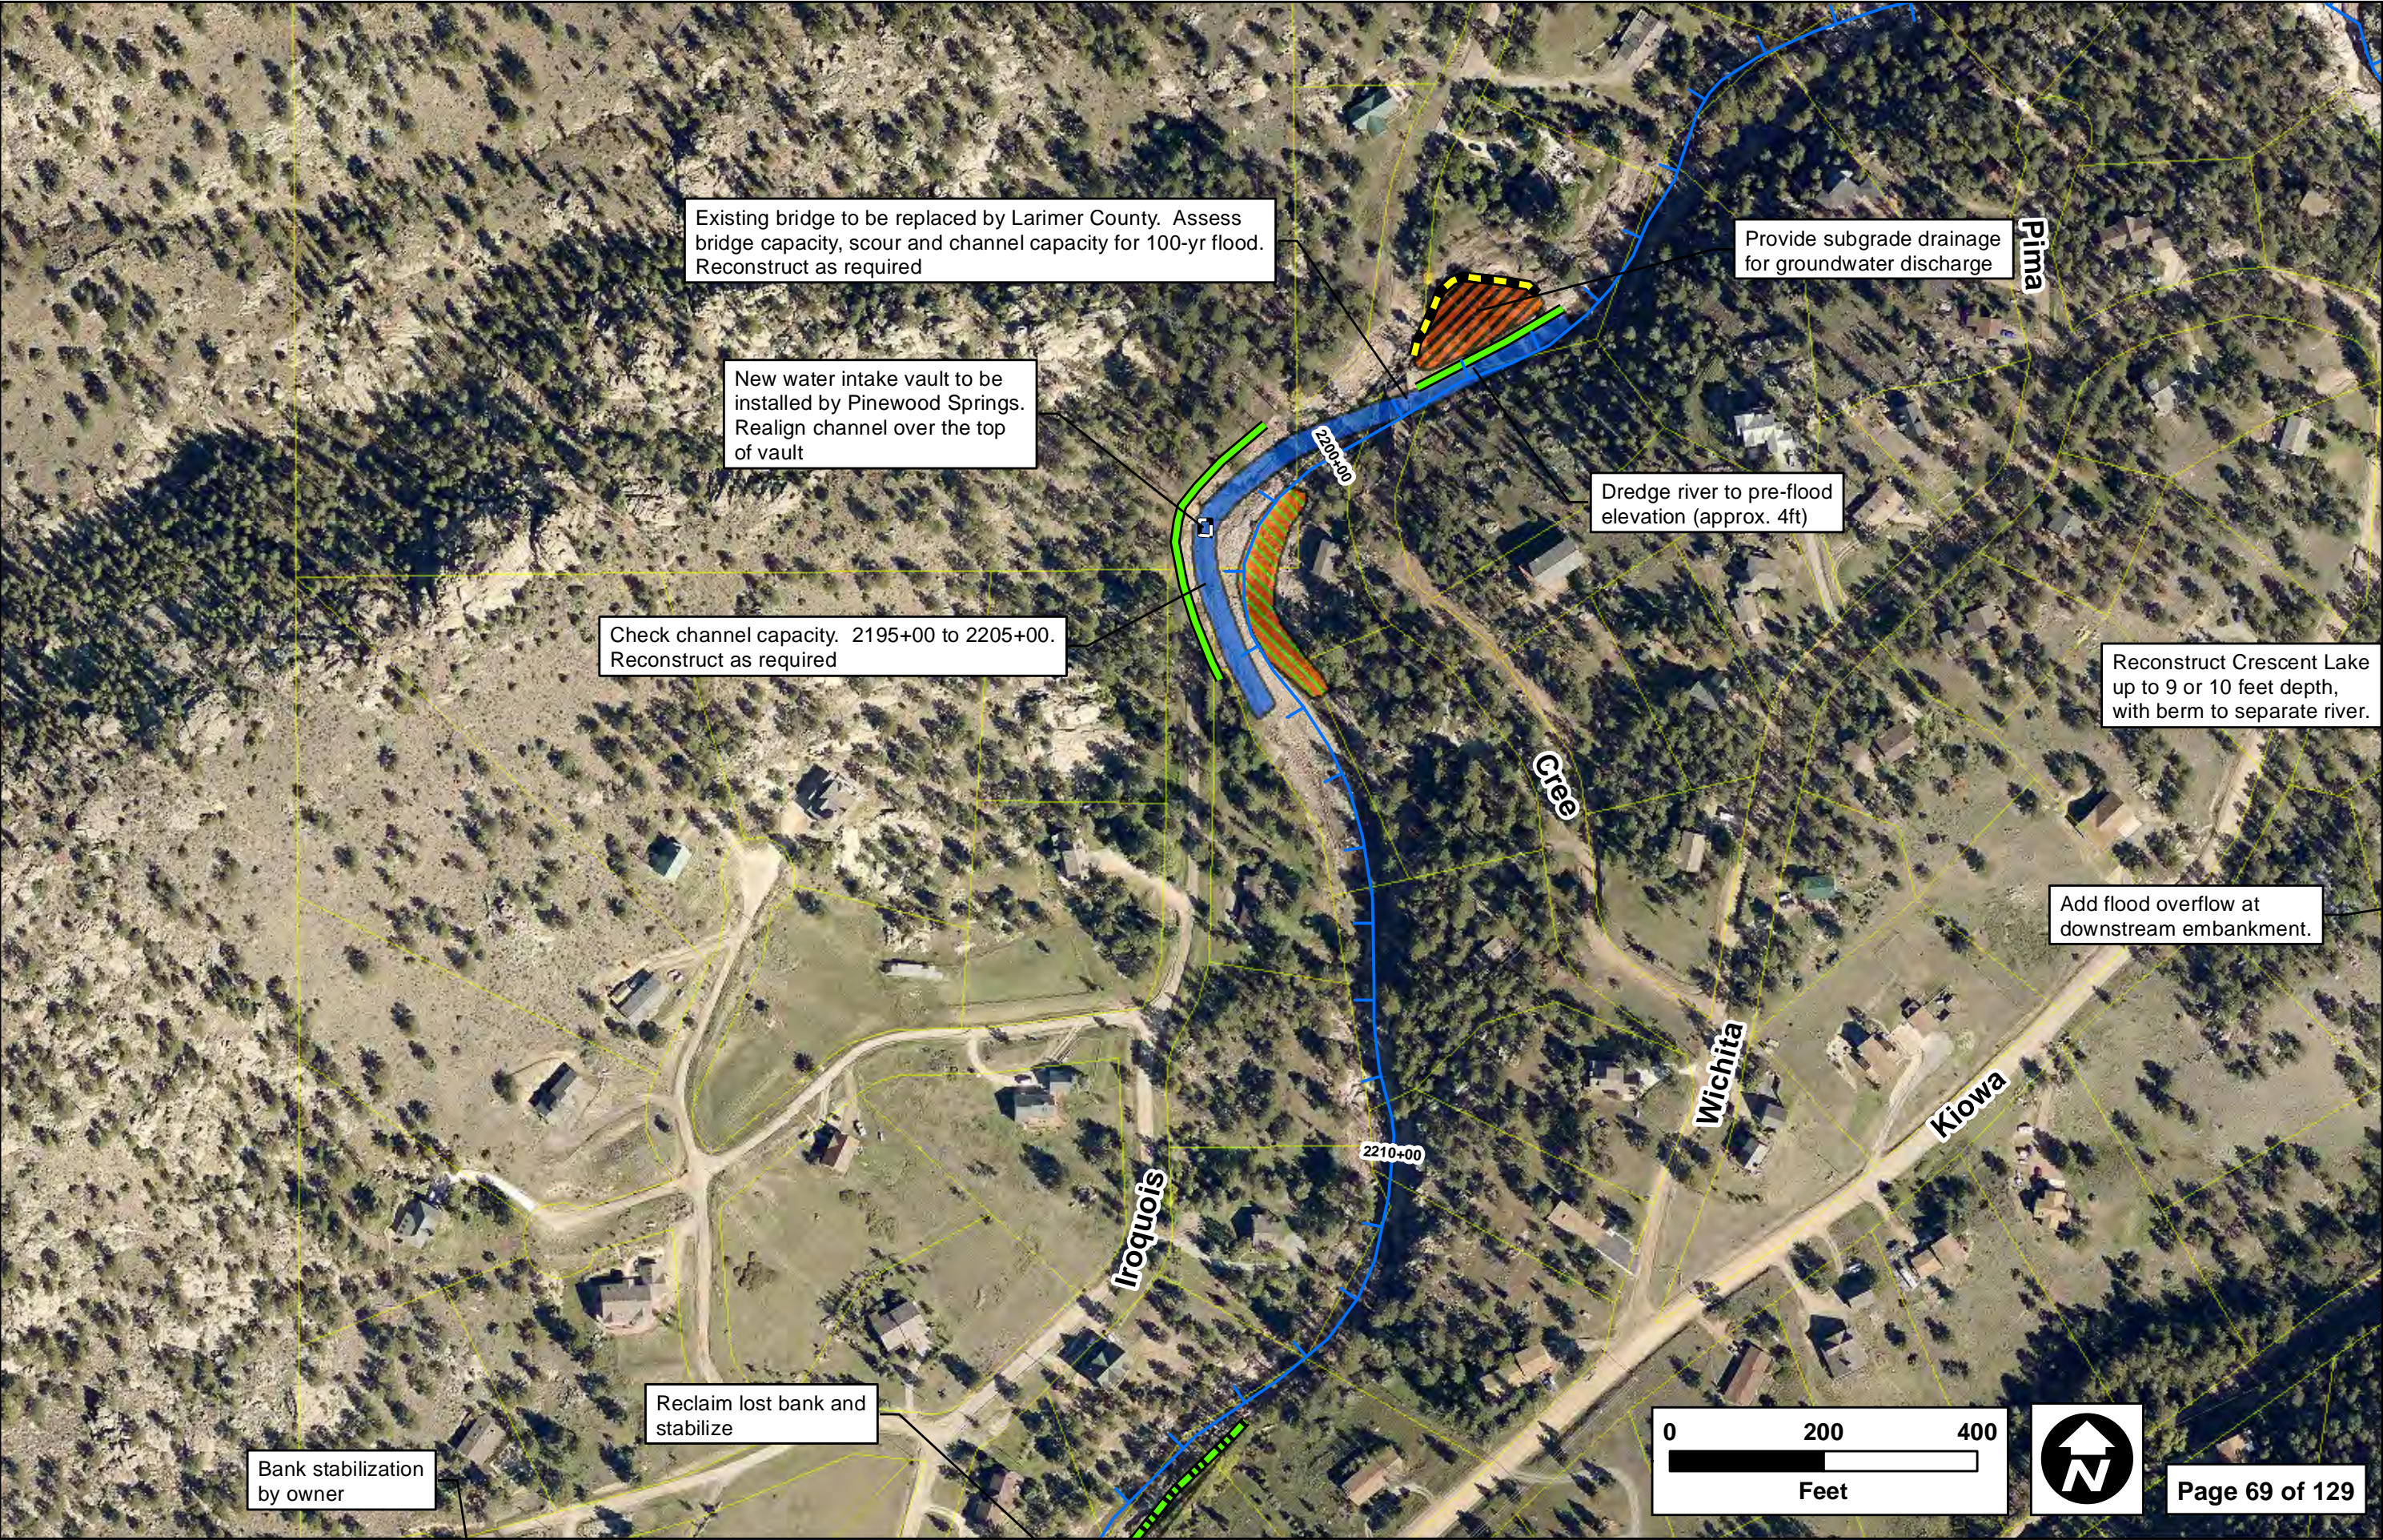
NEIGHBORHOOD: Pinewood Springs
SHEET: 70
STATION: 2210+00 to 2249+00
RESTORATION RECOMMENDATIONS: 2214+00 to 2230+00

Because of the rock outcrops, canyon bound valley formation, and limited encroachment on the river corridor, much of this reach is relatively stable and expected to recover without restoration activities except for the area near the Seneca bridge crossing and the area immediately up- and downstream area as described below. Debris removal by Larimer County, neighborhood residences and volunteer help has been extensive.

Near the Seneca Bridge the river experienced some scour from the 2013 flood, along with debris accumulation at the bridge, bank scour downstream and degradation along the channel flow line. Velocities were high as evidenced by the size and amount of debris that snagged in the bridge structure, the transport of large boulder and cobble material and loss of vegetation. The crossing on Seneca is a truss bridge with two spans both which experienced significant debris accumulation and some undermining of a mid-channel footing. Larimer County is planning to repair the bridge.

Upstream of the Seneca Bridge the channel makes a significant bend at Sta 2220+35. During the 2013 flood, flows reportedly overtopped the bar at this bend, alternating in waves of deposition and degradation. At the time of the site assessment the property owner had already removed debris and cleared the bar. The channel adjacent to the bar may have accumulated material and subsequently lost capacity. Immediately upstream, near Sta 2220+80 the property owner had already reconstructed the riverbanks, although channel deposition has likely reduced the capacity of this reach, which could result in increased frequency of bank overtopping.

- 1. Coordinate with Larimer County on bridge repair and debris removal.
- 2. Assess channel capacity and bank stabilization upstream of the Seneca Bridge along portions of the channel that have already been repaired and reconstructed. Also assess for reduced capacity due to deposition. Excavate and/or upsize the channel as required.
- 3. Stabilize the banks downstream of Seneca Bridge for 50 to 75 feet.
- 4. Reseed overbank areas particularly upstream of Seneca Bridge to help stabilize the large exposed bars.
