APPENDIX A

ASSESSMENT PROTOCOL

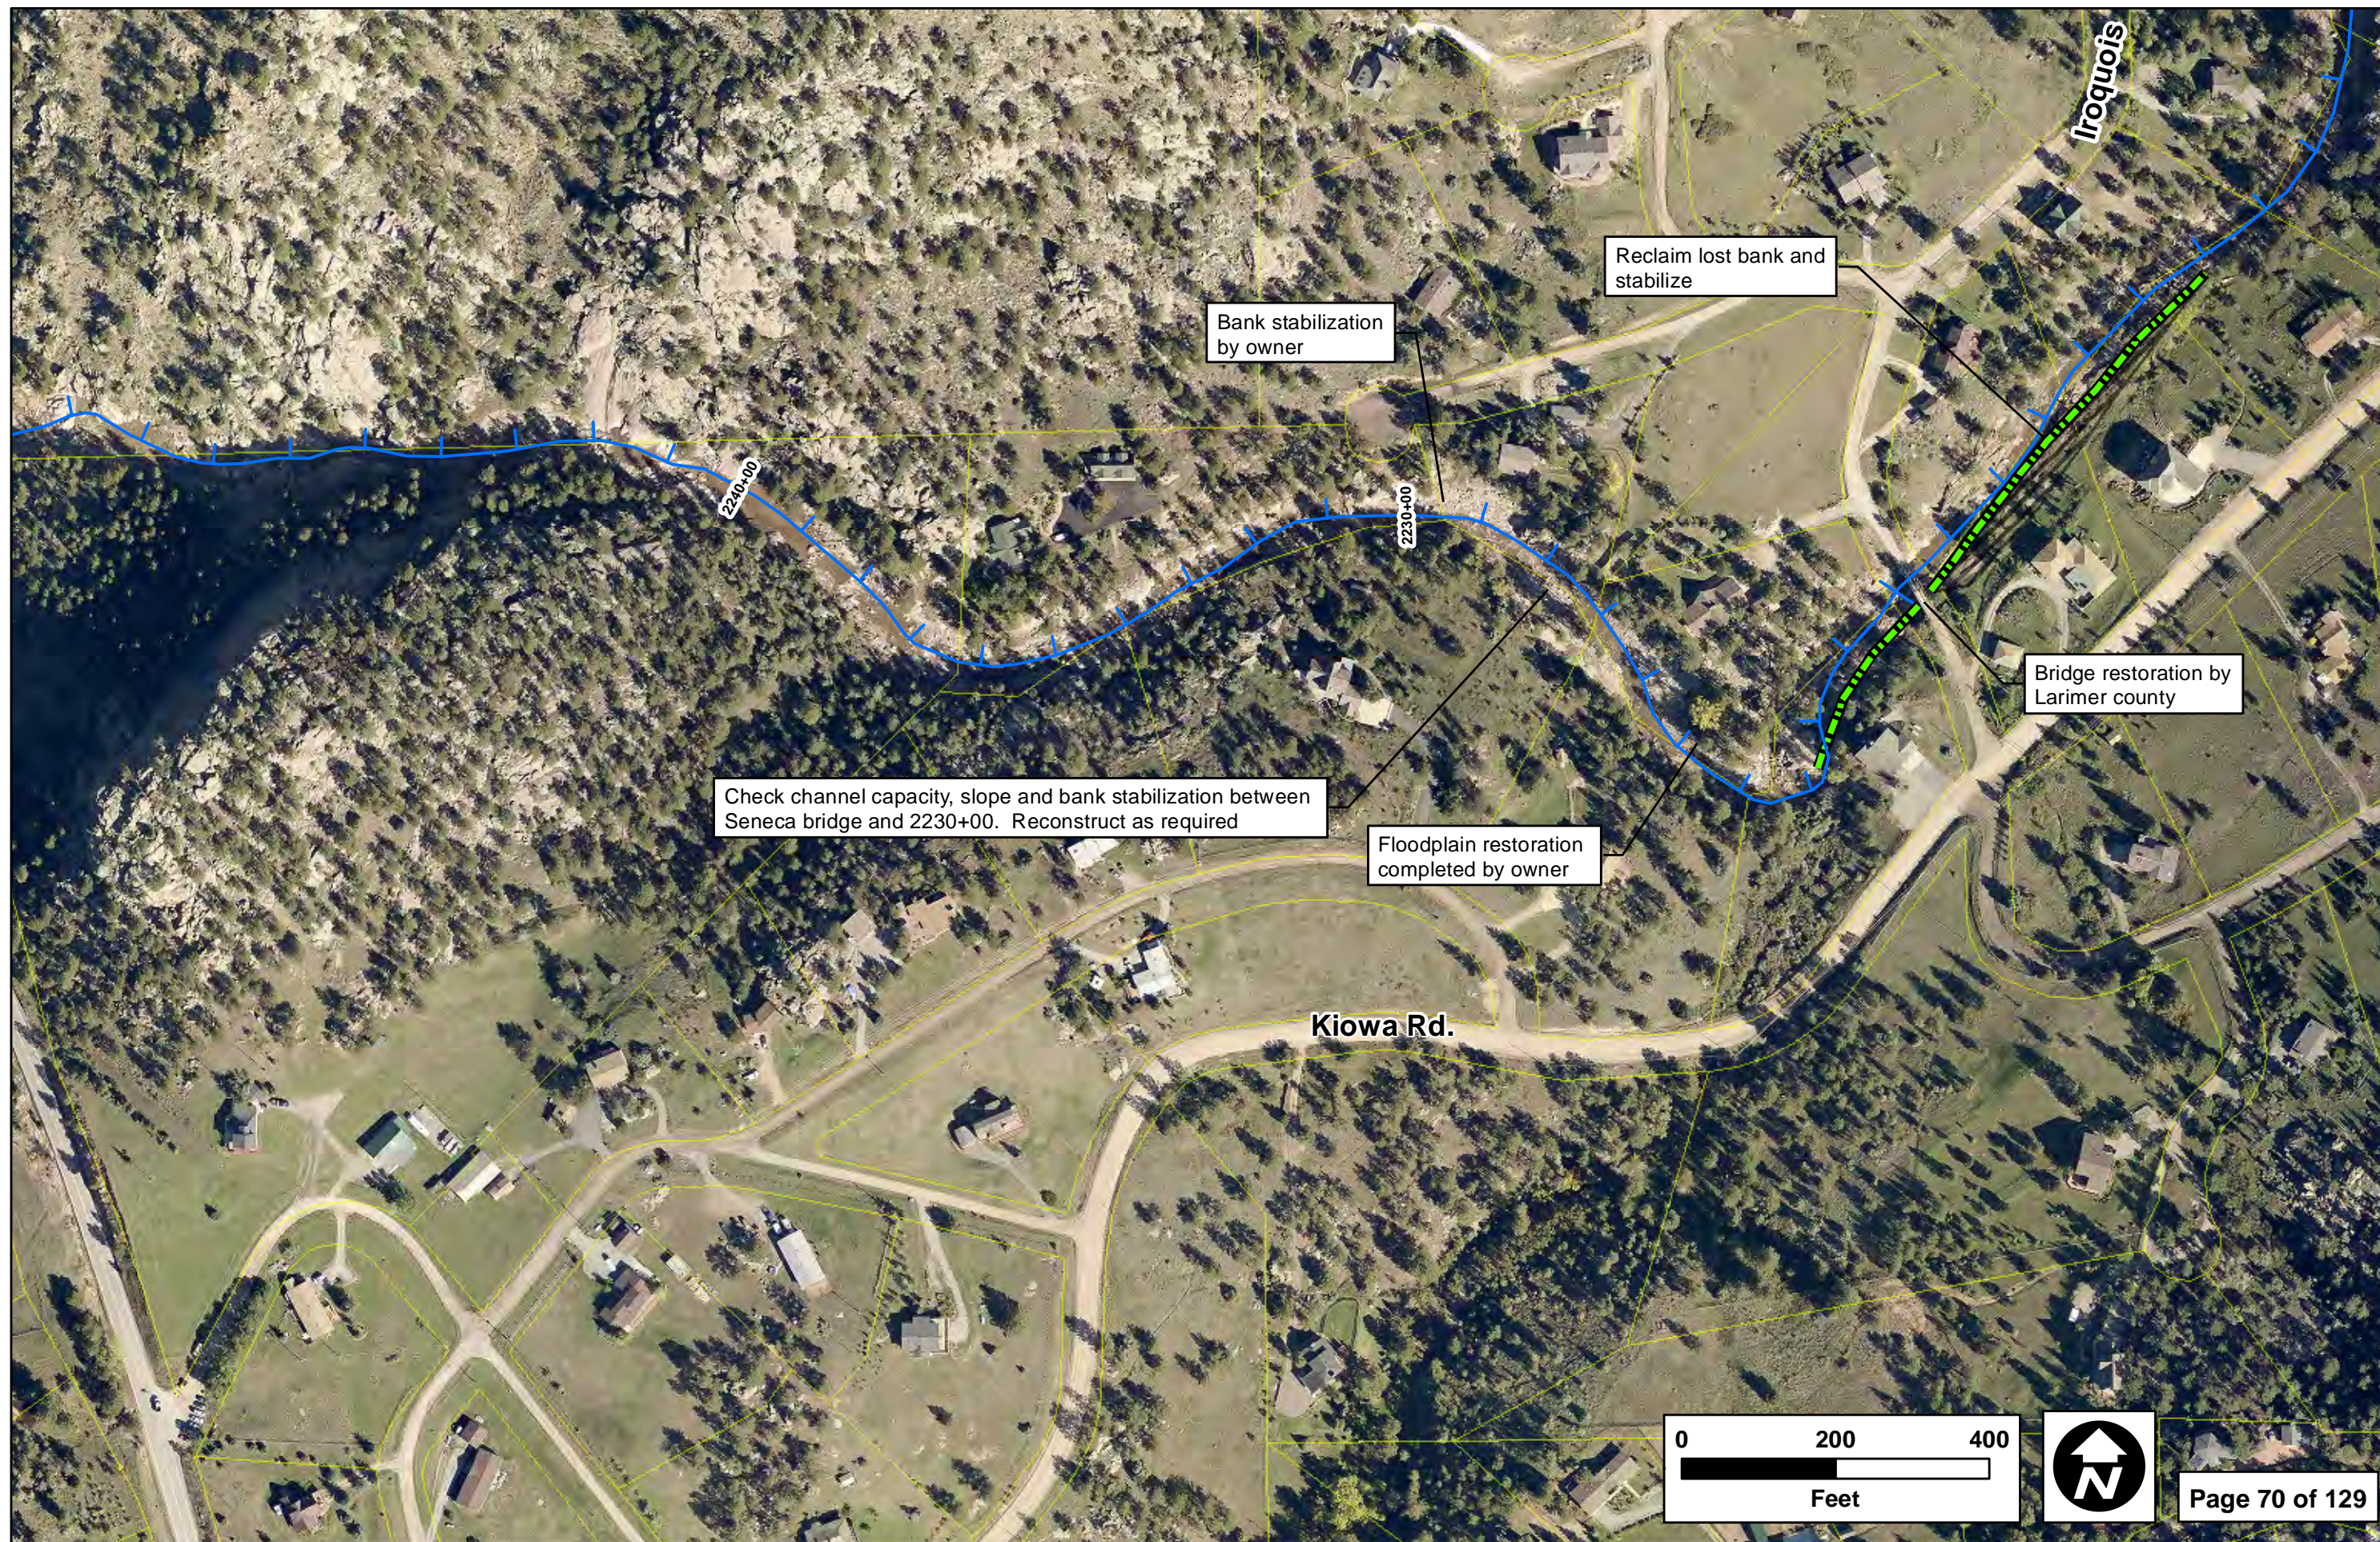
NEIGHBORHOOD: Pinewood Springs
SHEET: 71
STATION: 2249+00 to 2280+00
RESTORATION RECOMMENDATIONS: 2253+00 to 2255+00

Most of this reach runs immediately adjacent to U.S. Highway 36. The river traverses land owned by both CDOT and the USFS. Aerial photos of pre-flood conditions and anecdotal information indicate this reach had a vegetated riparian corridor, typically less than 50 feet wide, comprised primarily of fir trees and willows, much of which were torn out during the flood. The river corridor is narrow and canyon bound, setting the sinuosity and river corridor alignment.

Highway damage was extensive as well as property damage at the Lucero residence, including bank degradation, loss of a driveway and significant deposition in the field immediately south of the channel bend and inlet to the U.S. Highway 36 Bridge. Channel restoration is being undertaken by CDOT in conjunction with the U.S. Highway 36 reconstruction and in collaboration with the USFS. River improvements consist of the construction a low-flow channel, and the reconnection to the floodplain corridor. Restoration plans for the Lucero residence river bank property is unclear, but should include, as a minimum, bank stabilization and protection on the upstream banks of the U.S. Highway 36 Bridge (Sta 2250+30). Capacity of both the channel and bridge should also be assessed and considered in the reconstructed accordingly. Restoration not implemented as part of CDOT improvements should be considered in the master plan, except for the driveway, which was reconstructed by the Lucero's.

- 1. Coordinate with CDOT and the USFS on reconstruction at Lucero residence.
- 2. Assess channel capacity upstream of the U.S. Highway 36 Bridge and design restoration accordingly.
- 3. Stabilize the banks upstream of U.S. Highway 36 at Sta 2250+30 and, grade and stabilize floodplain.

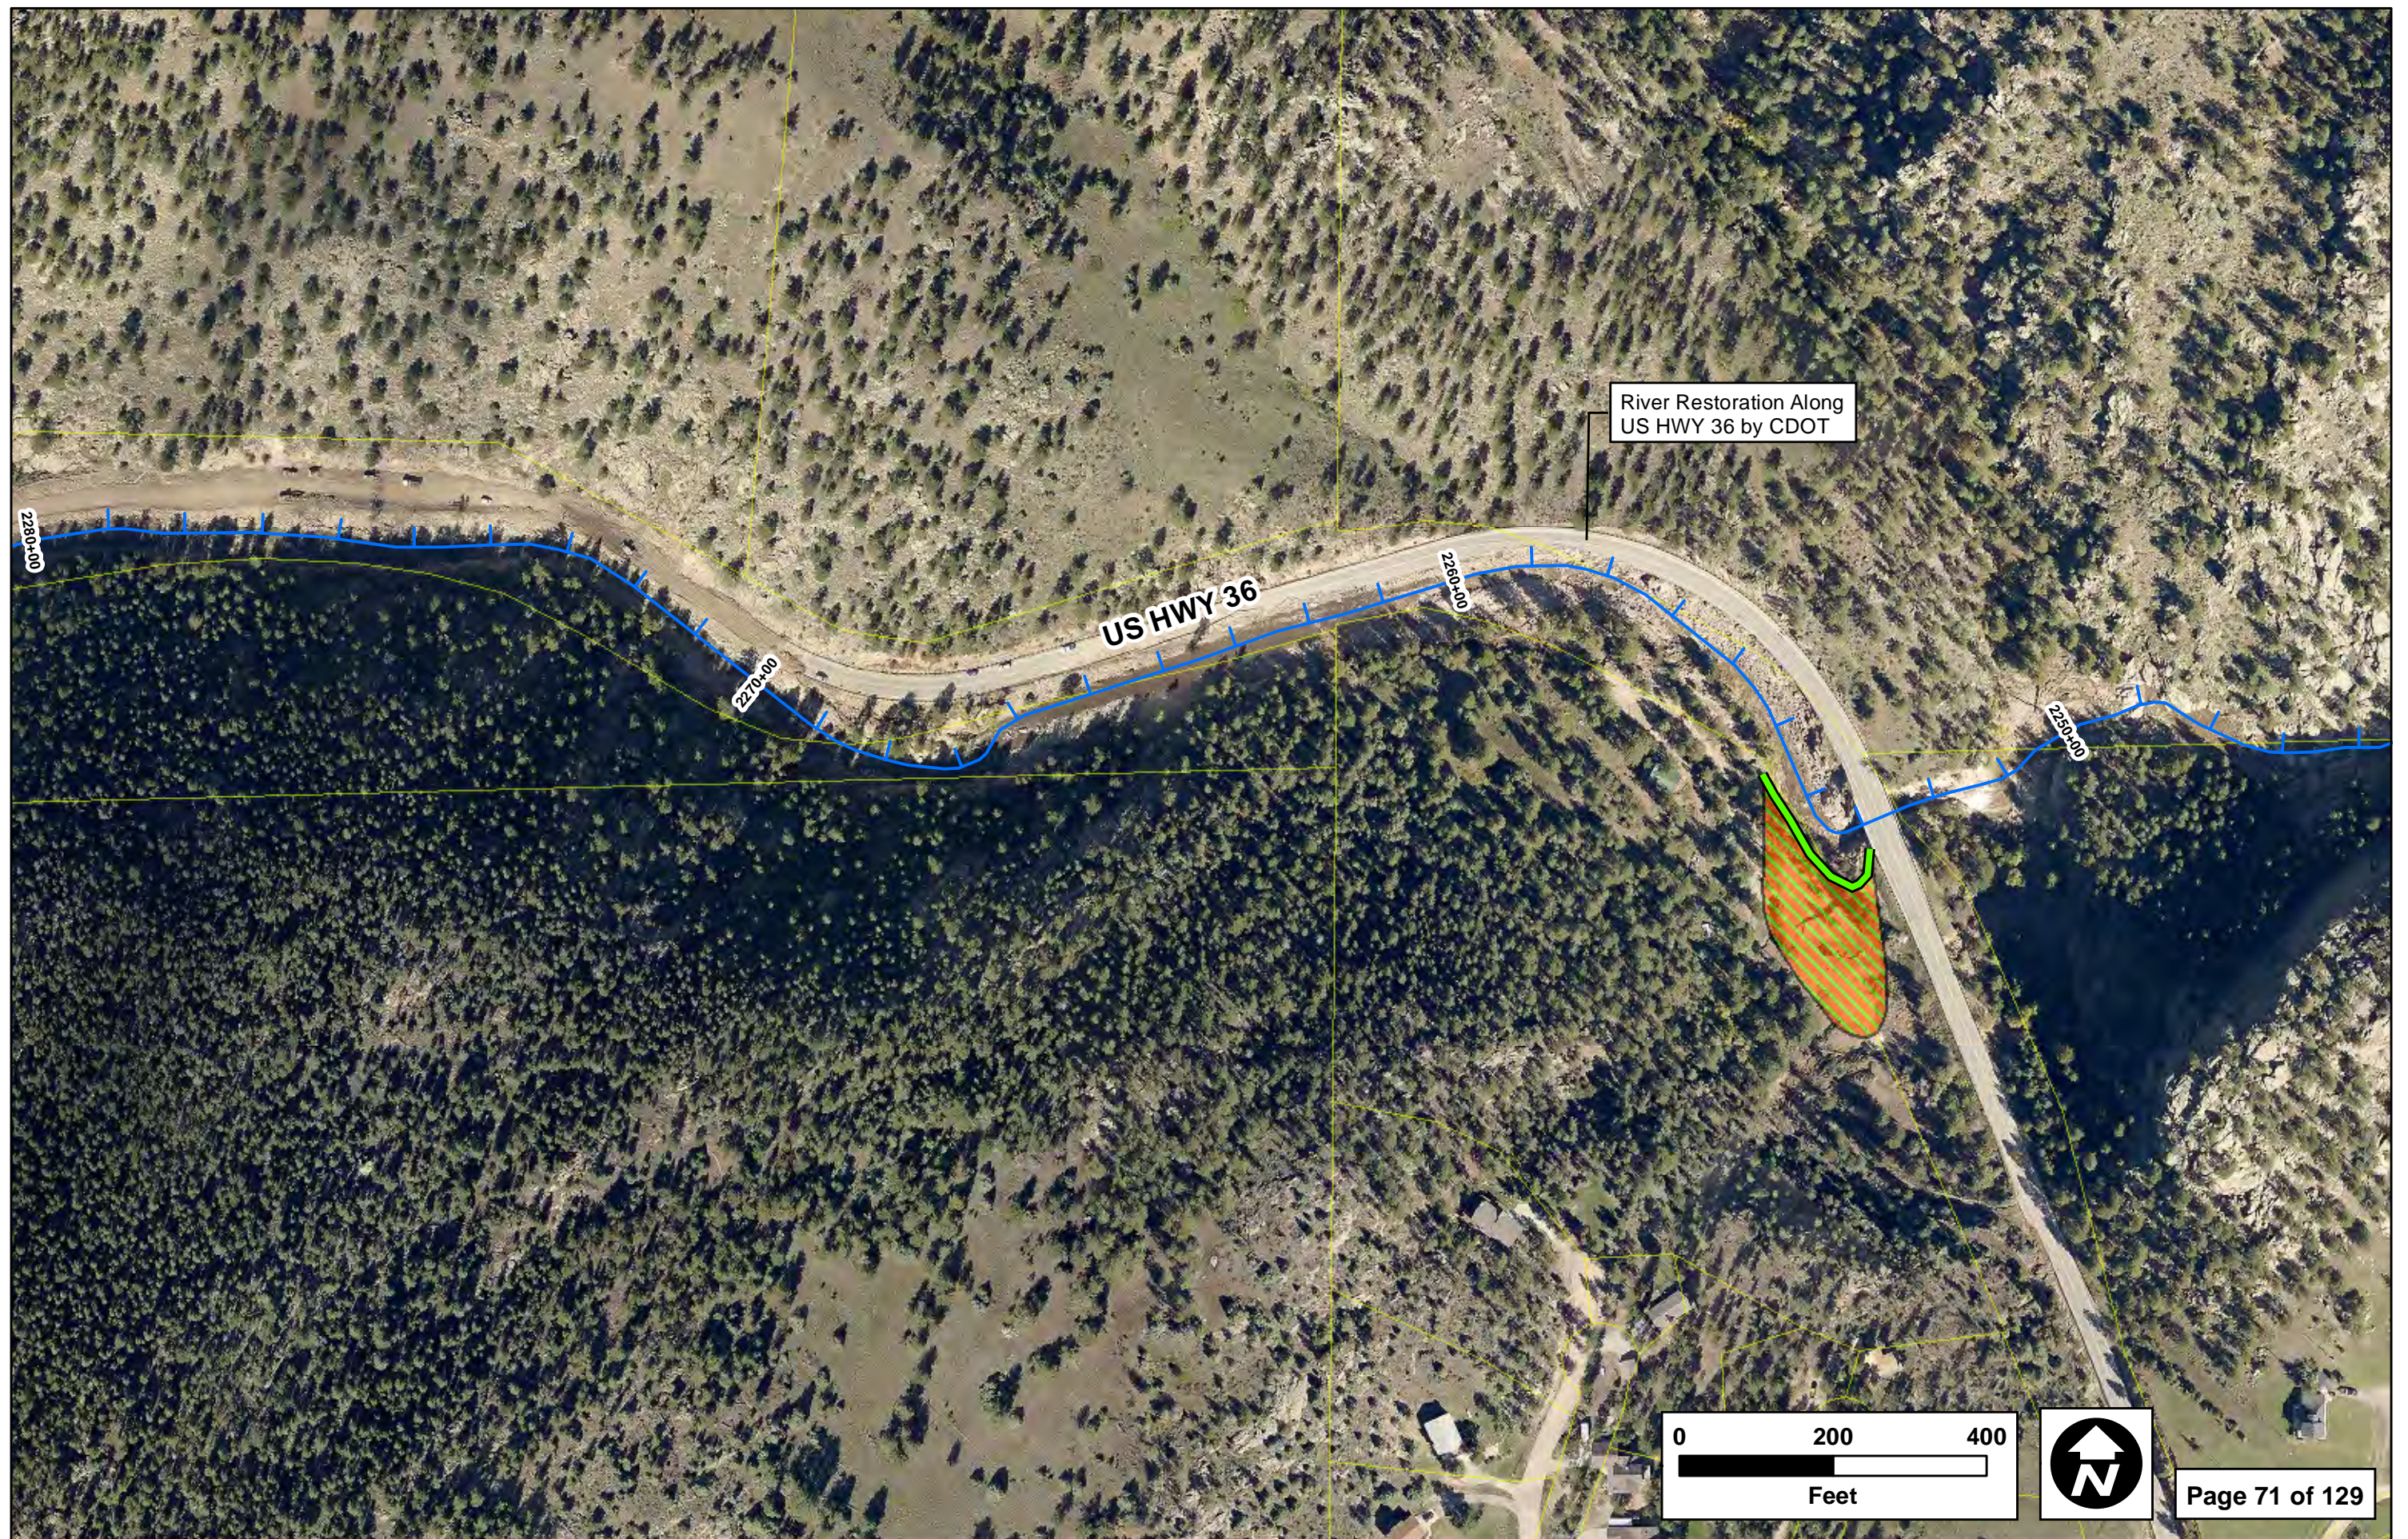
NEIGHBORHOOD: Pinewood Springs
SHEET: 72
STATION: 2280+00 to 2302+00 (Main Stem)
0+00 to 30+00 (West Fork)
RESTORATION RECOMMENDATIONS: 2286+00

Highway damage was extensive as well as bank damage and the loss of a driveway crossing at the Larson property. Channel restoration is being undertaken by CDOT in conjunction with the U.S. Highway 36 reconstruction and in collaboration with the USFS. River improvements consist of the construction a low-flow channel, and the reconnection to the floodplain corridor. Restoration plans by CDOT do not include access improvements to the Larson residence. Thus, a crossing to access the property is recommended herein. Capacity of both the channel and the crossing should also be assessed and considered in the culvert design

The West Fork runs immediately adjacent to County Road 47, crossing it five times in less than 2 miles. These crossing were all destroyed during the 2013 flood and field evidence indicates the road was likely overtopped, with the road and canyon walls conveying floodwater. Larimer County replaced the culverts shortly after the flood. The USFS has expressed an interest in replacing the culverts with culverts of increased capacity and culverts that can provide connectivity for aquatic species. As of the fall of 2014 Larimer County, FEMA, the USFS and Central Federal Lands are working to repair the road and permanently replace the culverts.

Field observations indicate that the channel size was insufficient for the flood event. As the event is estimated to be in excess of the 500-year flood, this is understandable the channel capacity was exceeded, however, a channel assessment for capacity as well as bank stability under design flood conditions may be warranted along with the implementation of site specific improvements where required.

- 1. Coordinate with CDOT and the USFS on reconstruction at Larson residence.
- 2. Coordinate with Larimer County, FEMA, the USFS and Central Federal Lands on culvert replacements along County Road 47.

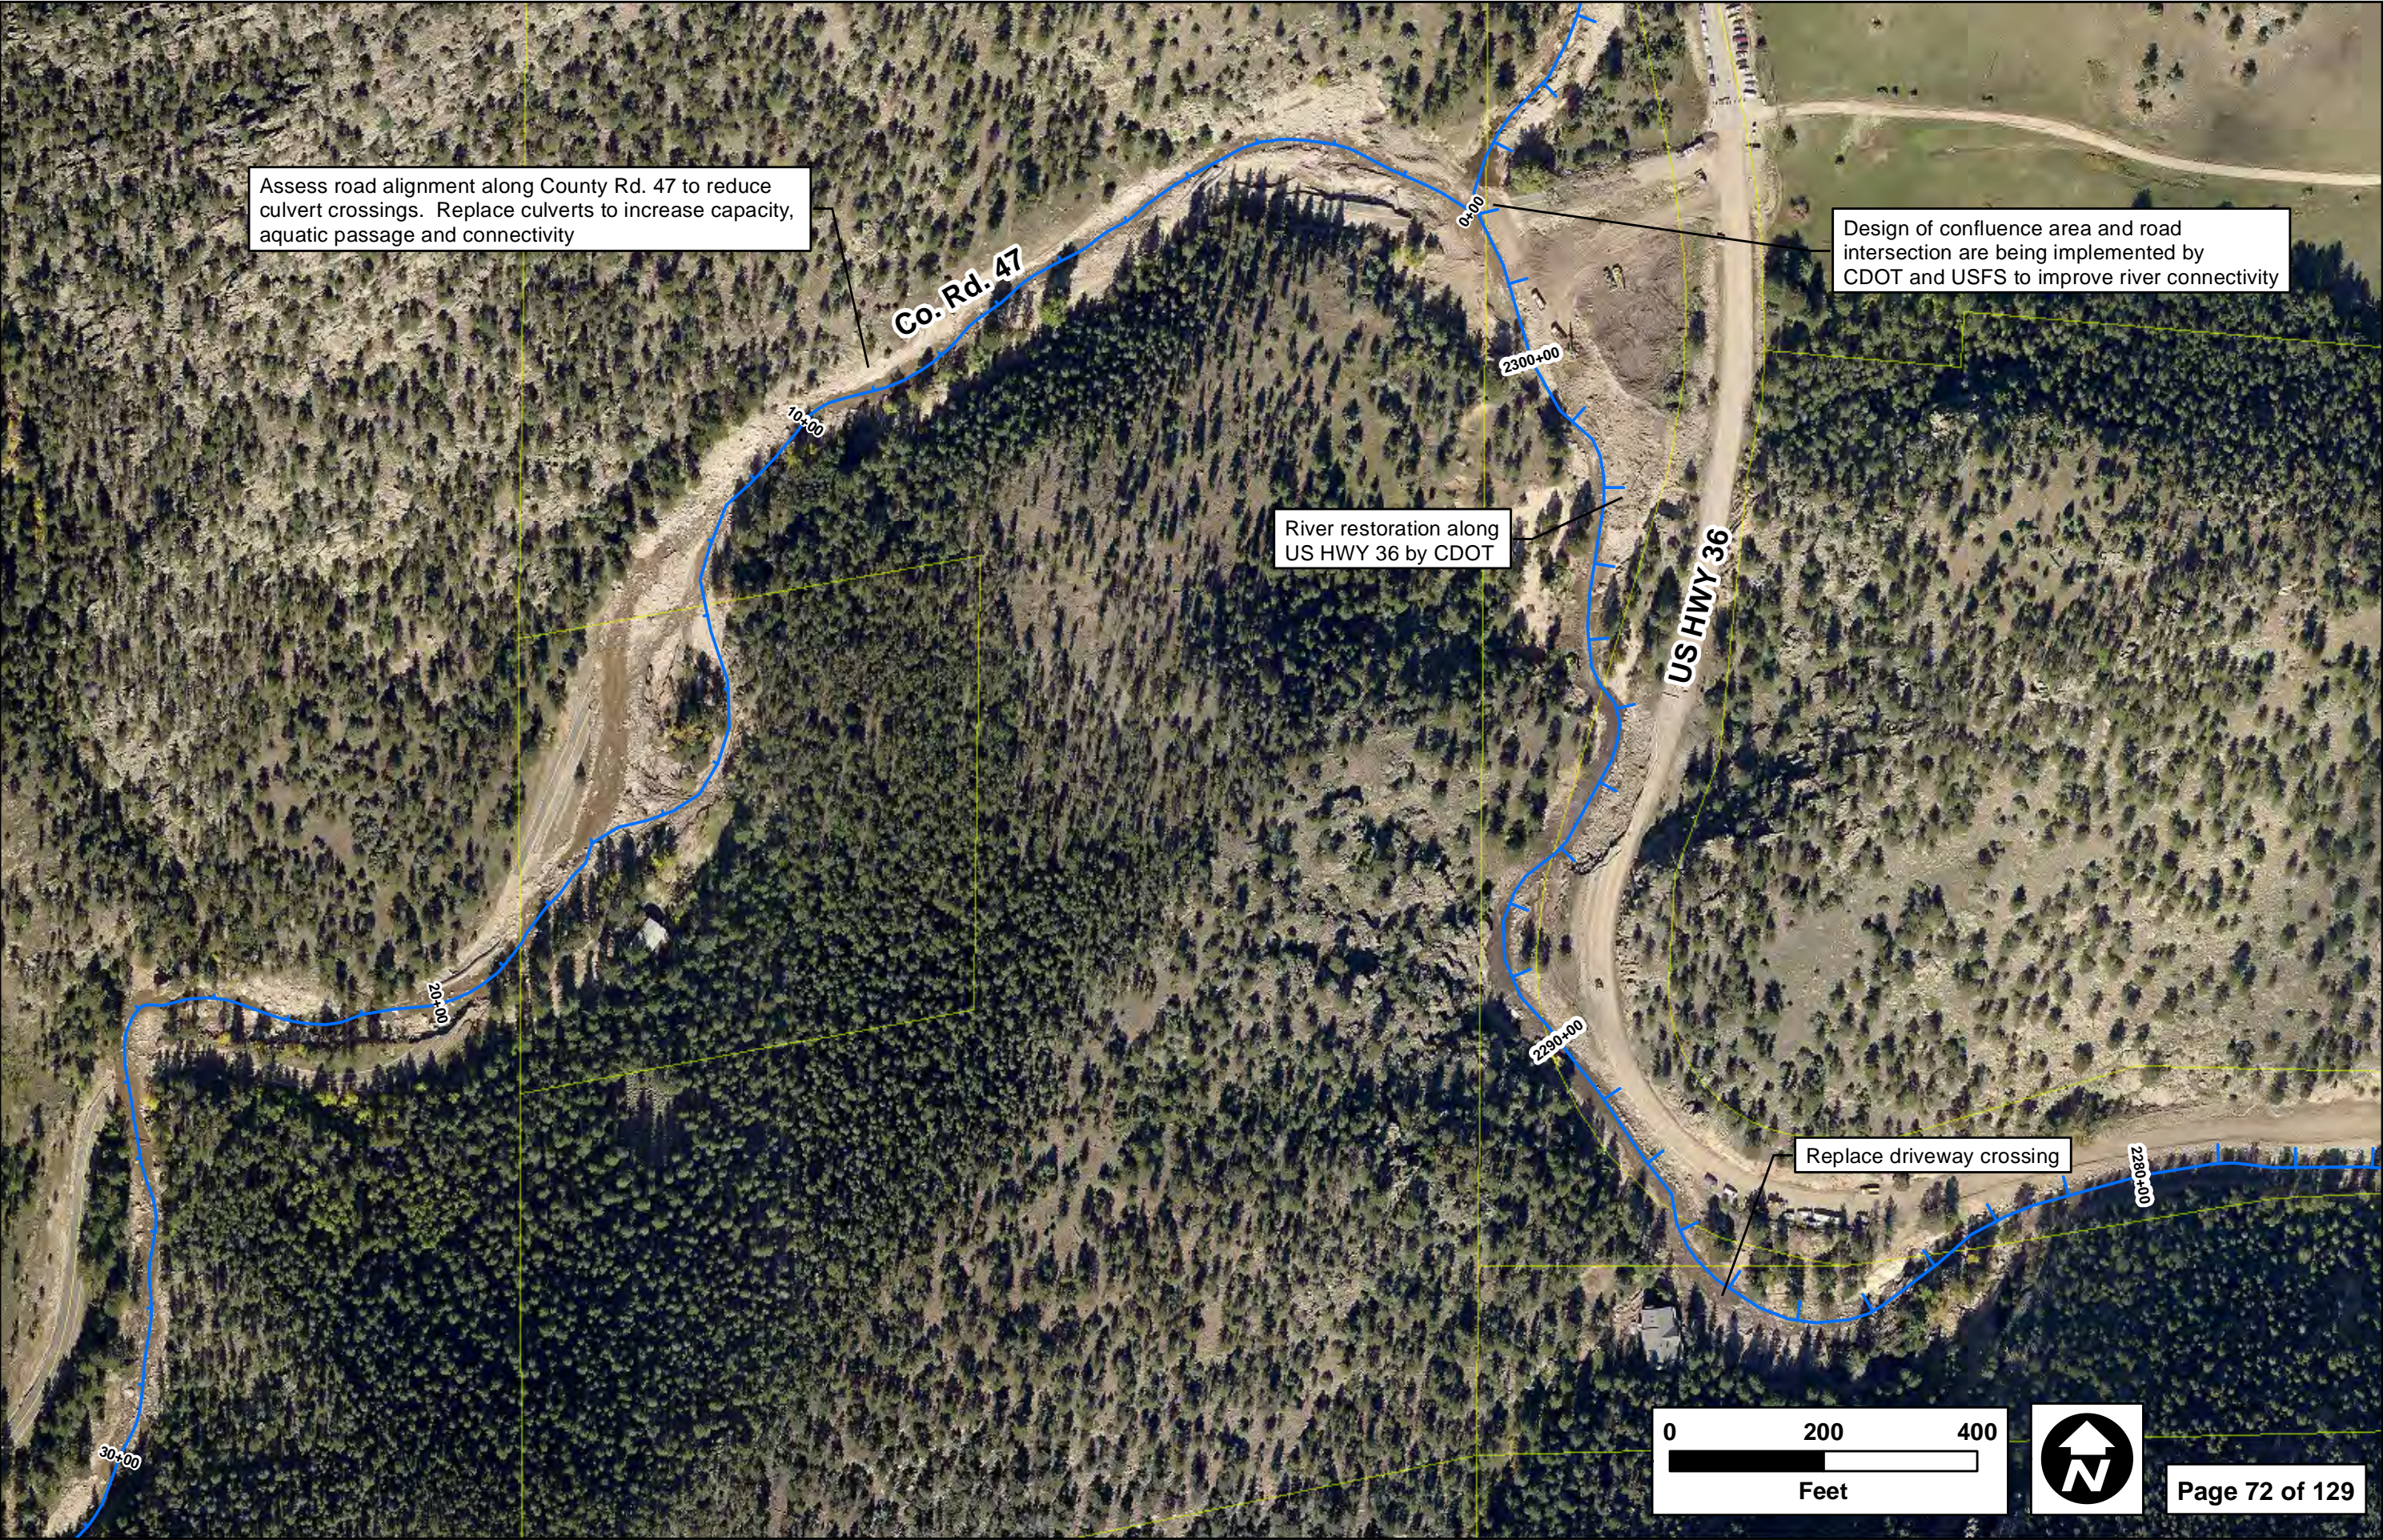
NEIGHBORHOOD: Headwaters**SHEET: 73****STATION: 2302+00 to 2334+00**

This portion of the LT runs immediately adjacent to U.S. Highway 36. The river traverses land owned privately and land managed by the USFS. Aerial photos of pre-flood conditions and anecdotal information indicate this reach had a vegetated riparian corridor, typically less than 50 feet wide, comprised primarily of fir trees and willows, much of which were torn out during the flood. The river corridor is steep (in excess of 3 percent), narrow, and canyon bound, setting the sinuosity and river corridor alignment.

This reach sustained flood-related damage primarily due to large debris and boulders moving through the system and significant scour and loss of soils and vegetation. The most severe damage appeared to occur at culvert crossings or where the floodplain had been encroached by anthropogenic activities. Neither the USFS nor private property owners have indicated any desire to restore or reconstruct this reach of the river.

Geomorphic functions of this reach is likely sufficient to allow for the natural regeneration of cottonwood, willow, and other riparian species through seeding and cloning without active restoration. No further actions are suggested at this time.

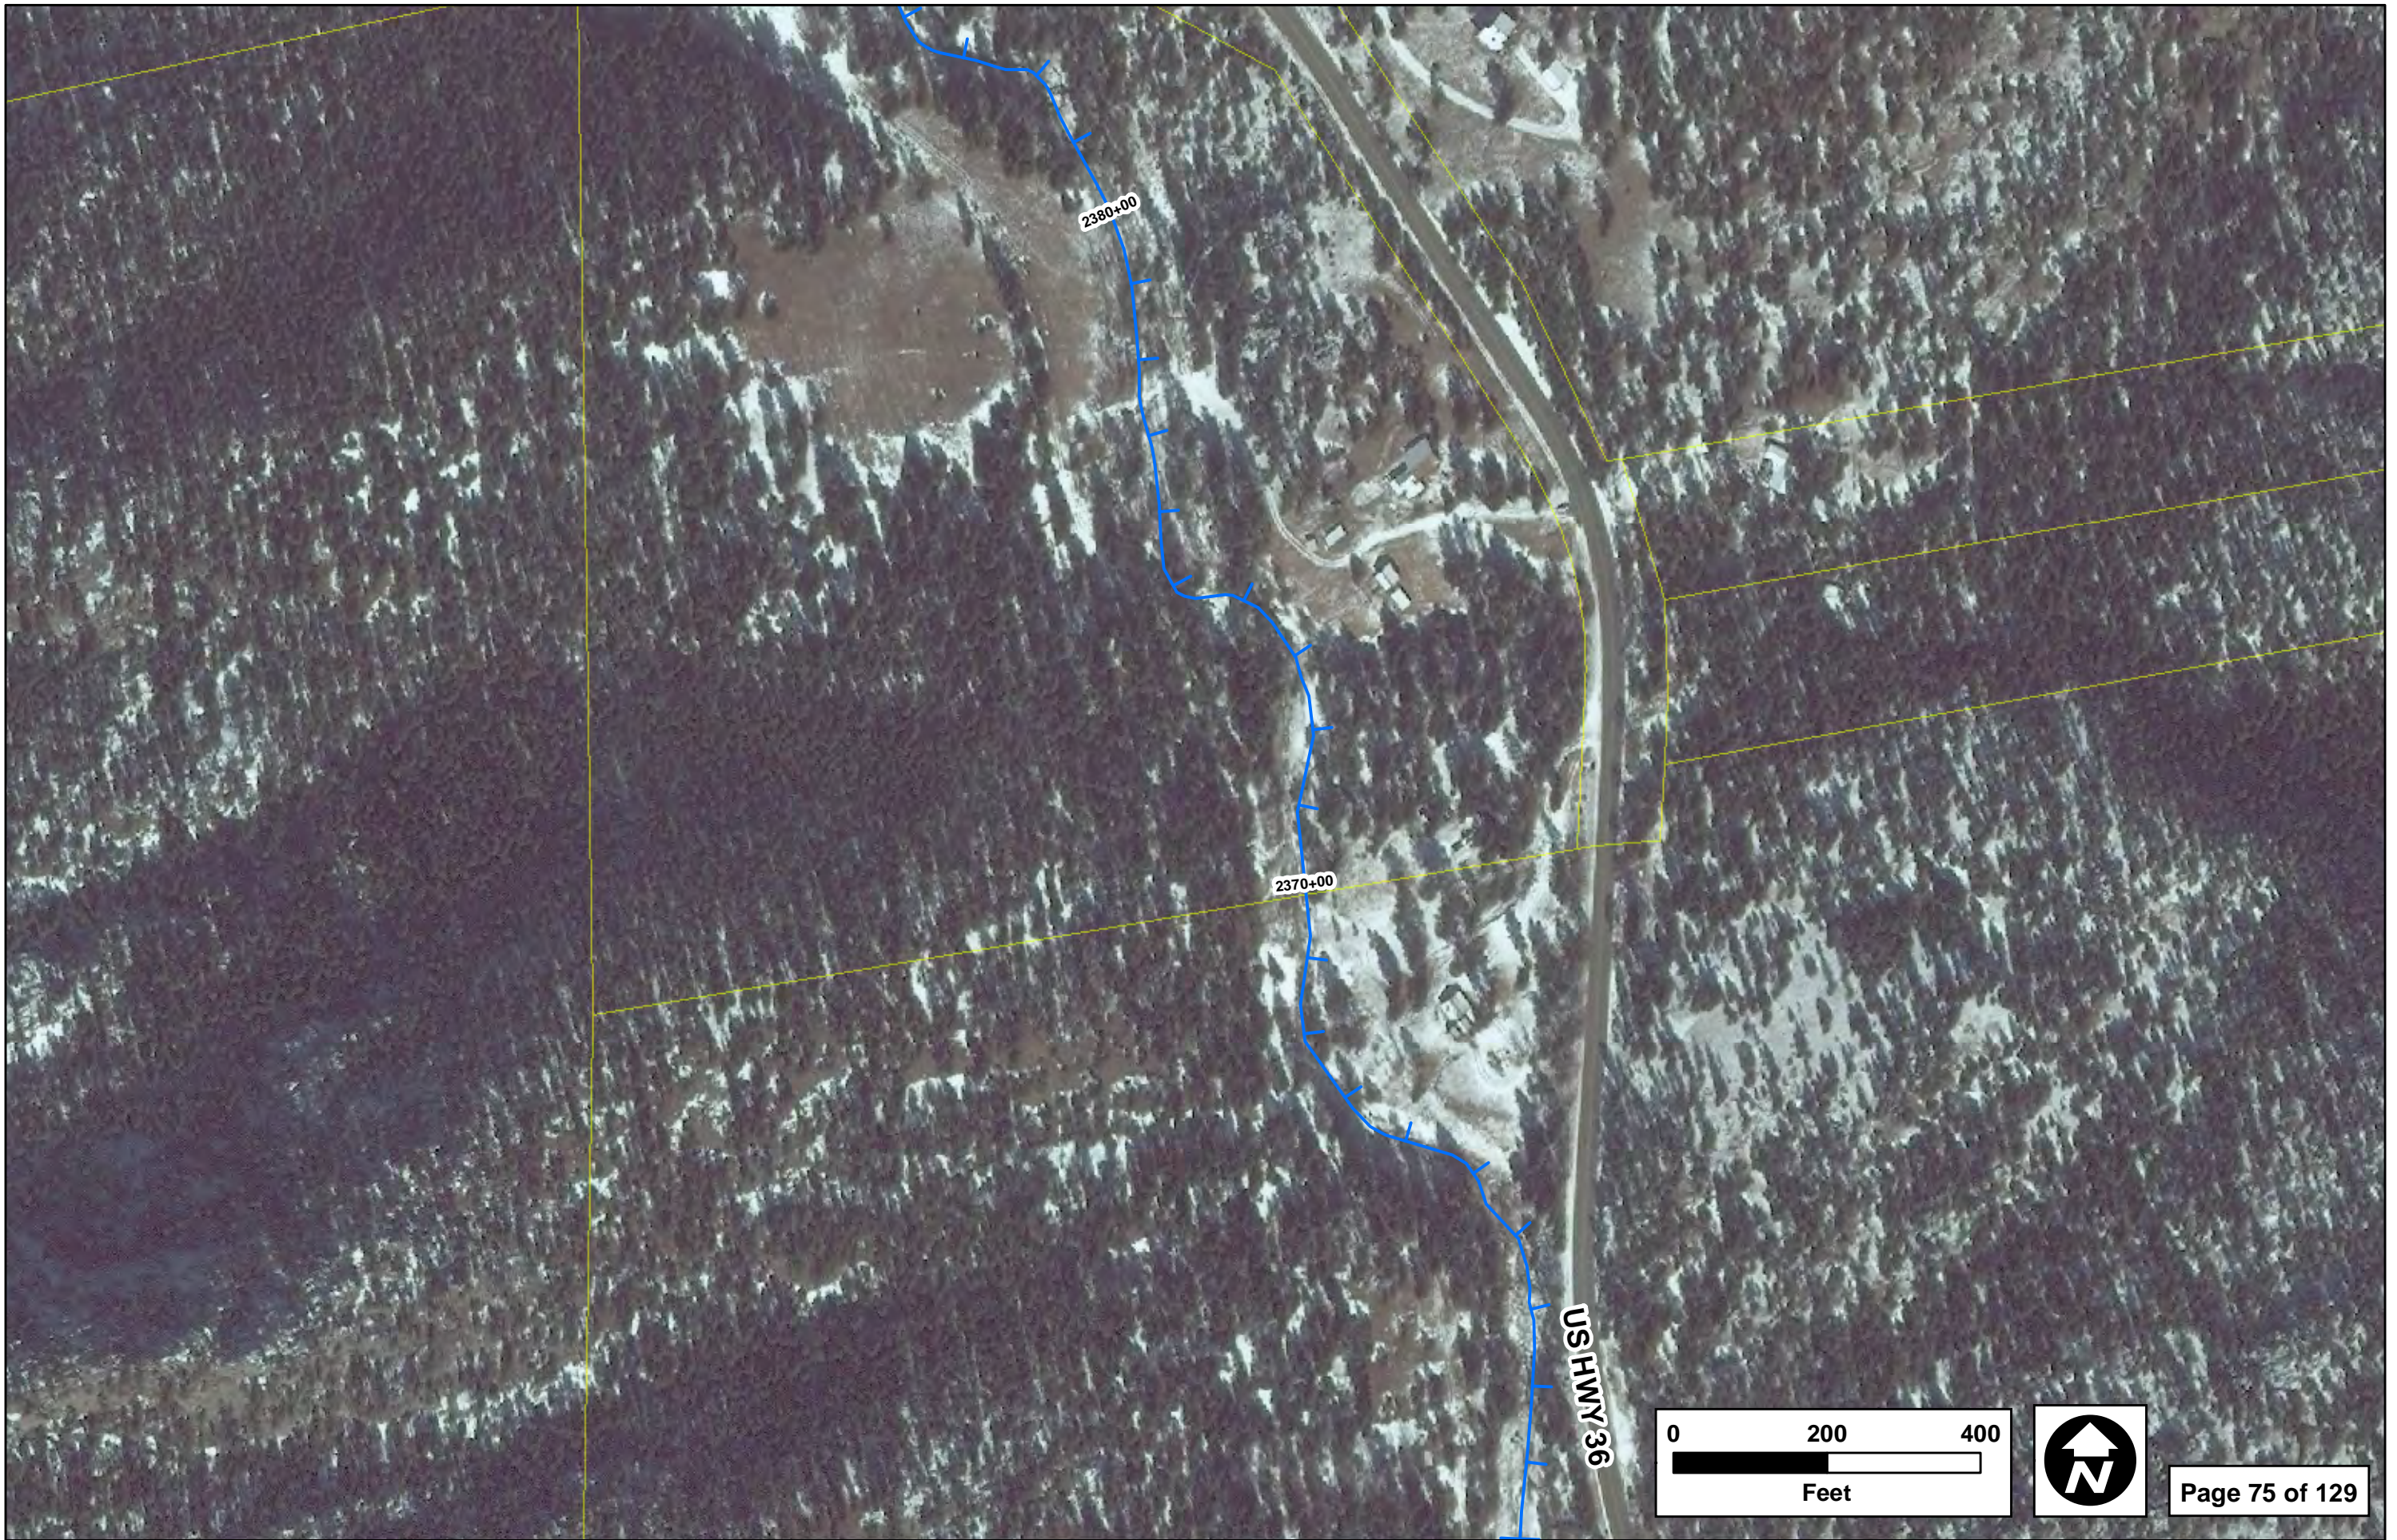
NEIGHBORHOOD: Headwaters
SHEET: 76
STATION: 2385+00 to 2419+00

This portion of the Little Thompson River runs parallel to U.S. Highway 36, approximately 200 to 400 feet south-southwest. The river traverses land owned privately. Aerial photos of pre-flood conditions and anecdotal information indicate this reach had a vegetated riparian corridor, typically less than 50 feet wide, comprised primarily of fir trees and willows, much of which were torn out during the flood. The river corridor is steep (in excess of 3 percent) narrow, and canyon bound, setting the sinuosity and river corridor alignment.

Geomorphic functions of this reach is likely sufficient to allow for the natural regeneration of cottonwood, willow, and other riparian species through seeding and cloning without active restoration. No further actions are suggested at this time.

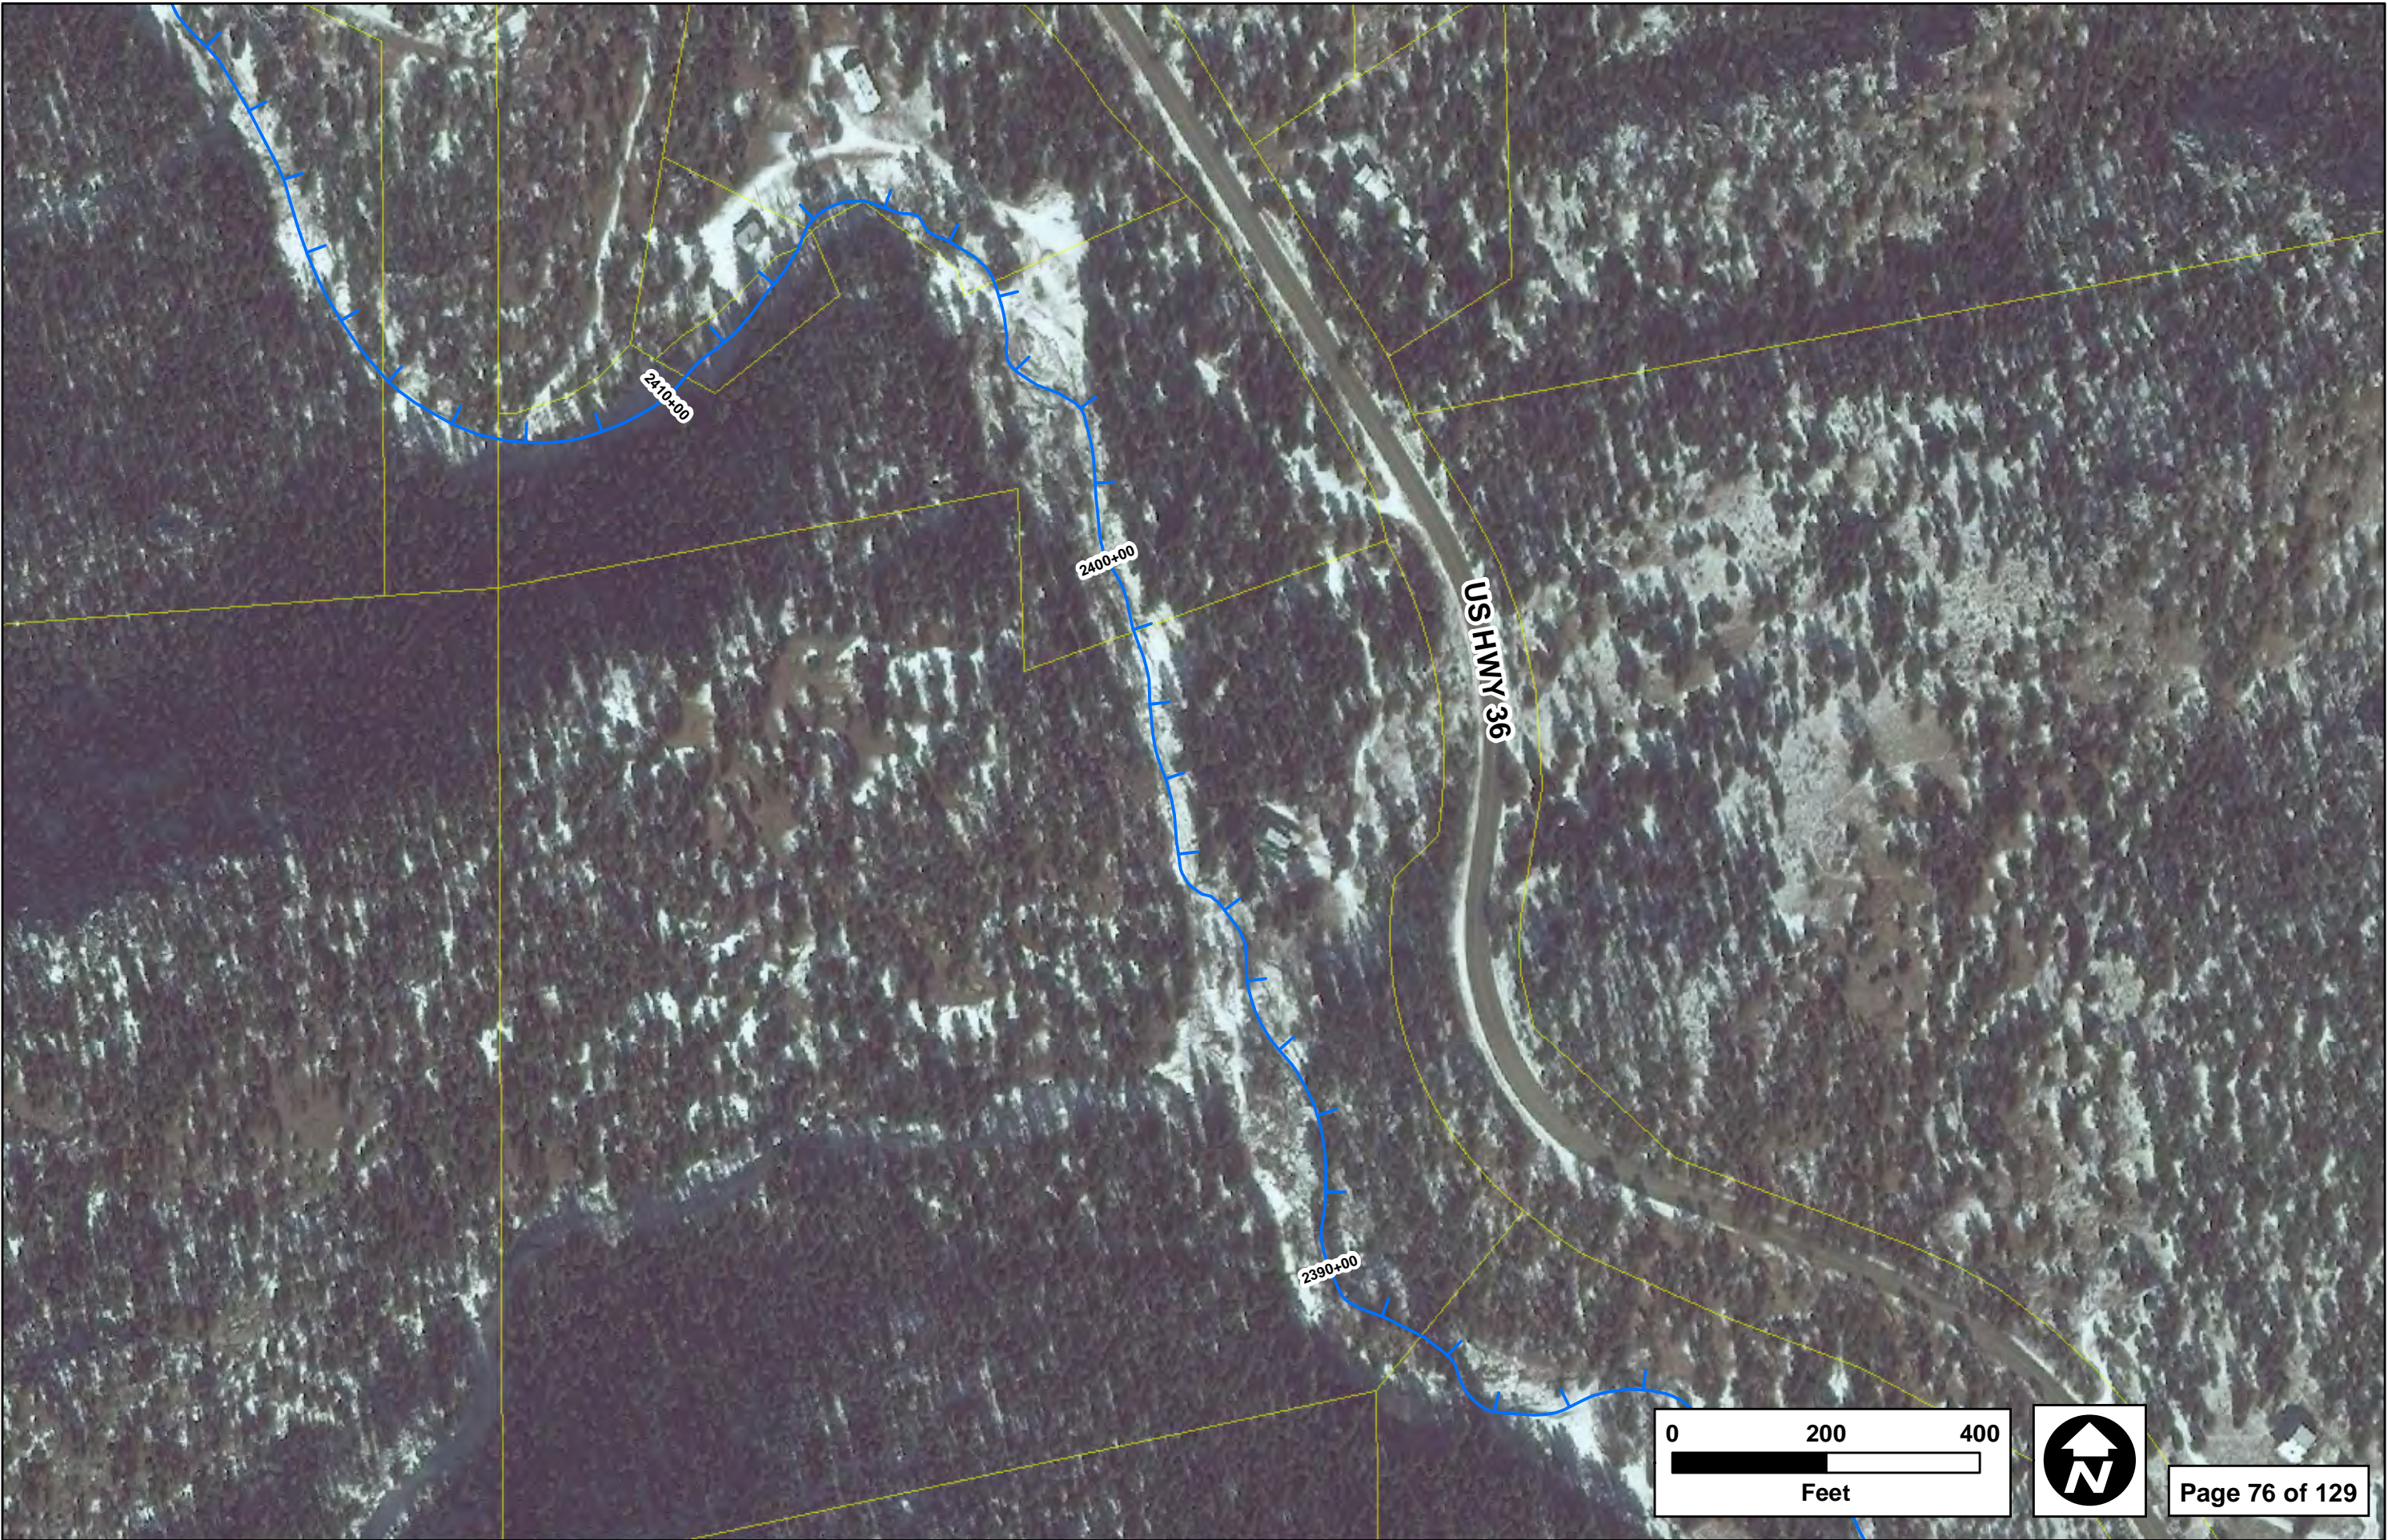
NEIGHBORHOOD: Headwaters
SHEET: 77
STATION: 2419+00 to 2454+00

Much of this reach is on property managed by USFS with some private land ownership. Neither the USFS nor private property owners have indicated any desire to restore or reconstruct this reach of the river.

Geomorphic functions of this reach is likely sufficient to allow for the natural regeneration of cottonwood, willow, and other riparian species through seeding and cloning without active restoration. No further actions are suggested at this time.
