APPENDIX A

ASSESSMENT PROTOCOL

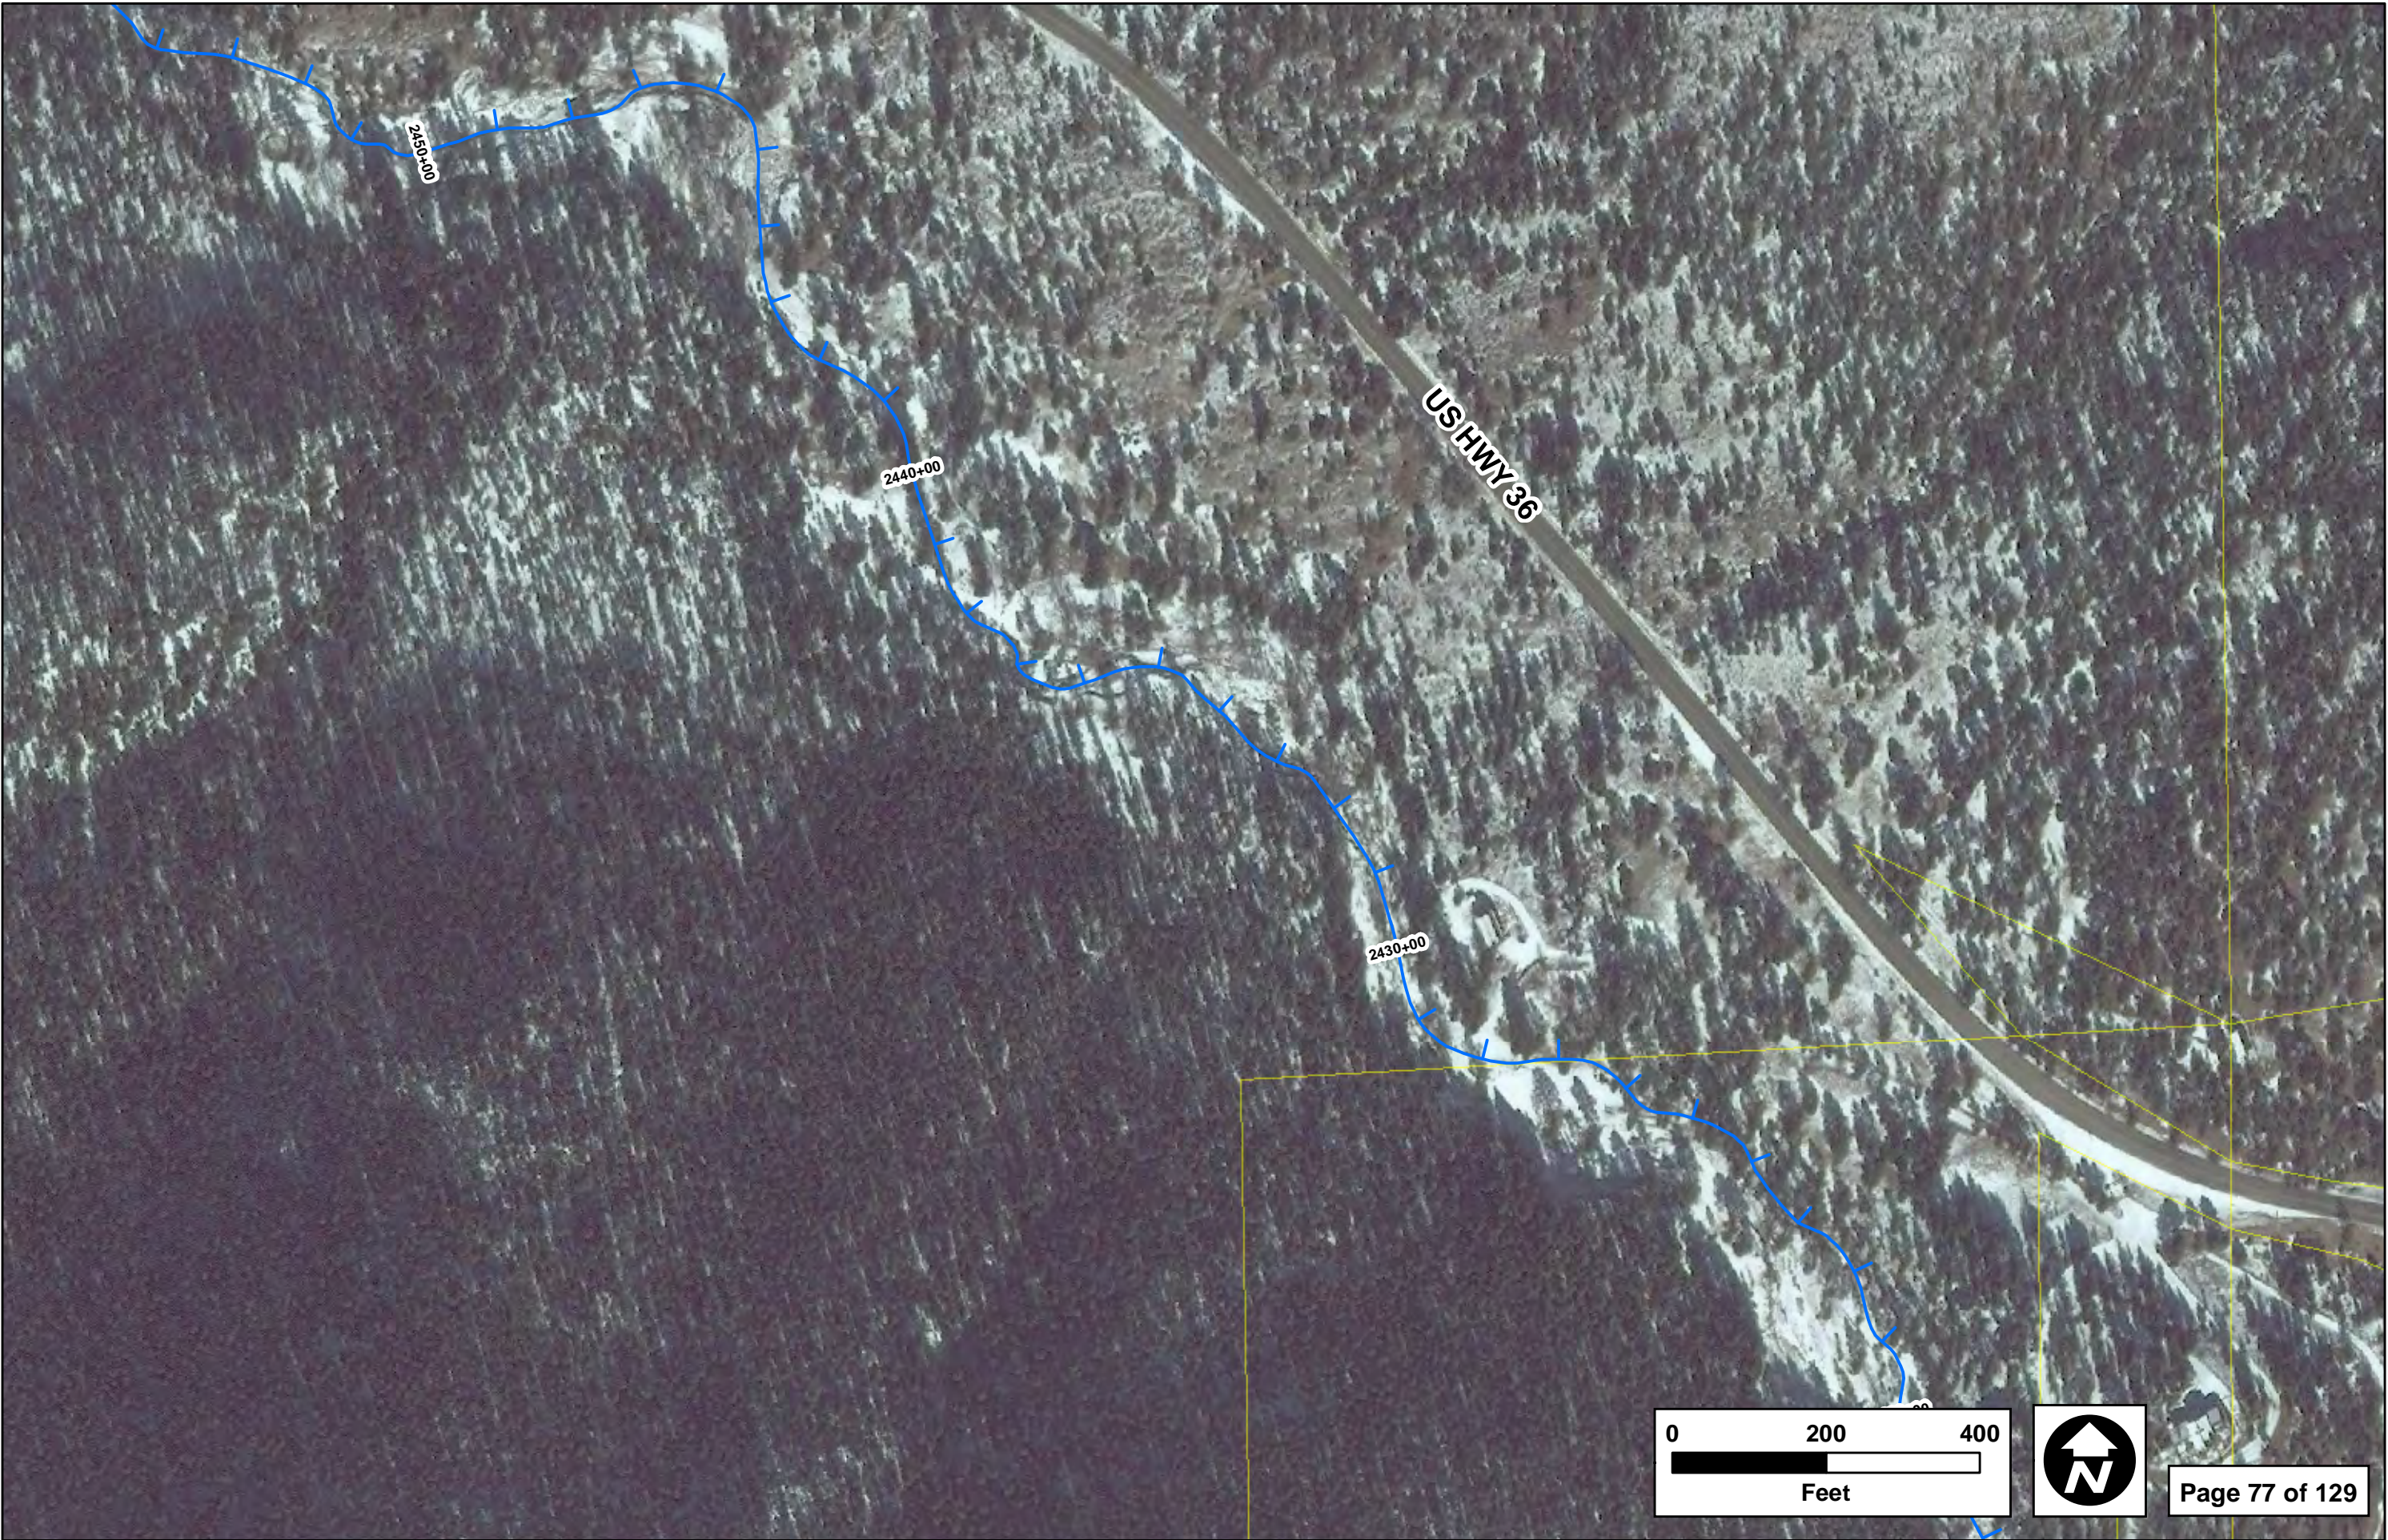
NEIGHBORHOOD: Headwaters**SHEET: 78****STATION: 2454+00 to 2487+00**

This portion of the Little Thompson River runs parallel to U.S. Highway 36, approximately 200 to 400 feet south-southwest until Sta 2475+00, after which the river returns to an alignment that is closer and adjacent to the highway. The river traverses land managed by the USFS. Lyons Gulch tributary confluences at approximately Sta 2470+00. The Lyons Gulch Trailhead is also in this reach. From Sta 2472+00 to Sta 2476+00, the channel drops an average of 0.4 percent with some sections nearly vertical.

Geomorphic functions of this reach is likely sufficient to allow for the natural regeneration of cottonwood, willow, and other riparian species through seeding and cloning without active restoration. No further actions are suggested at this time.

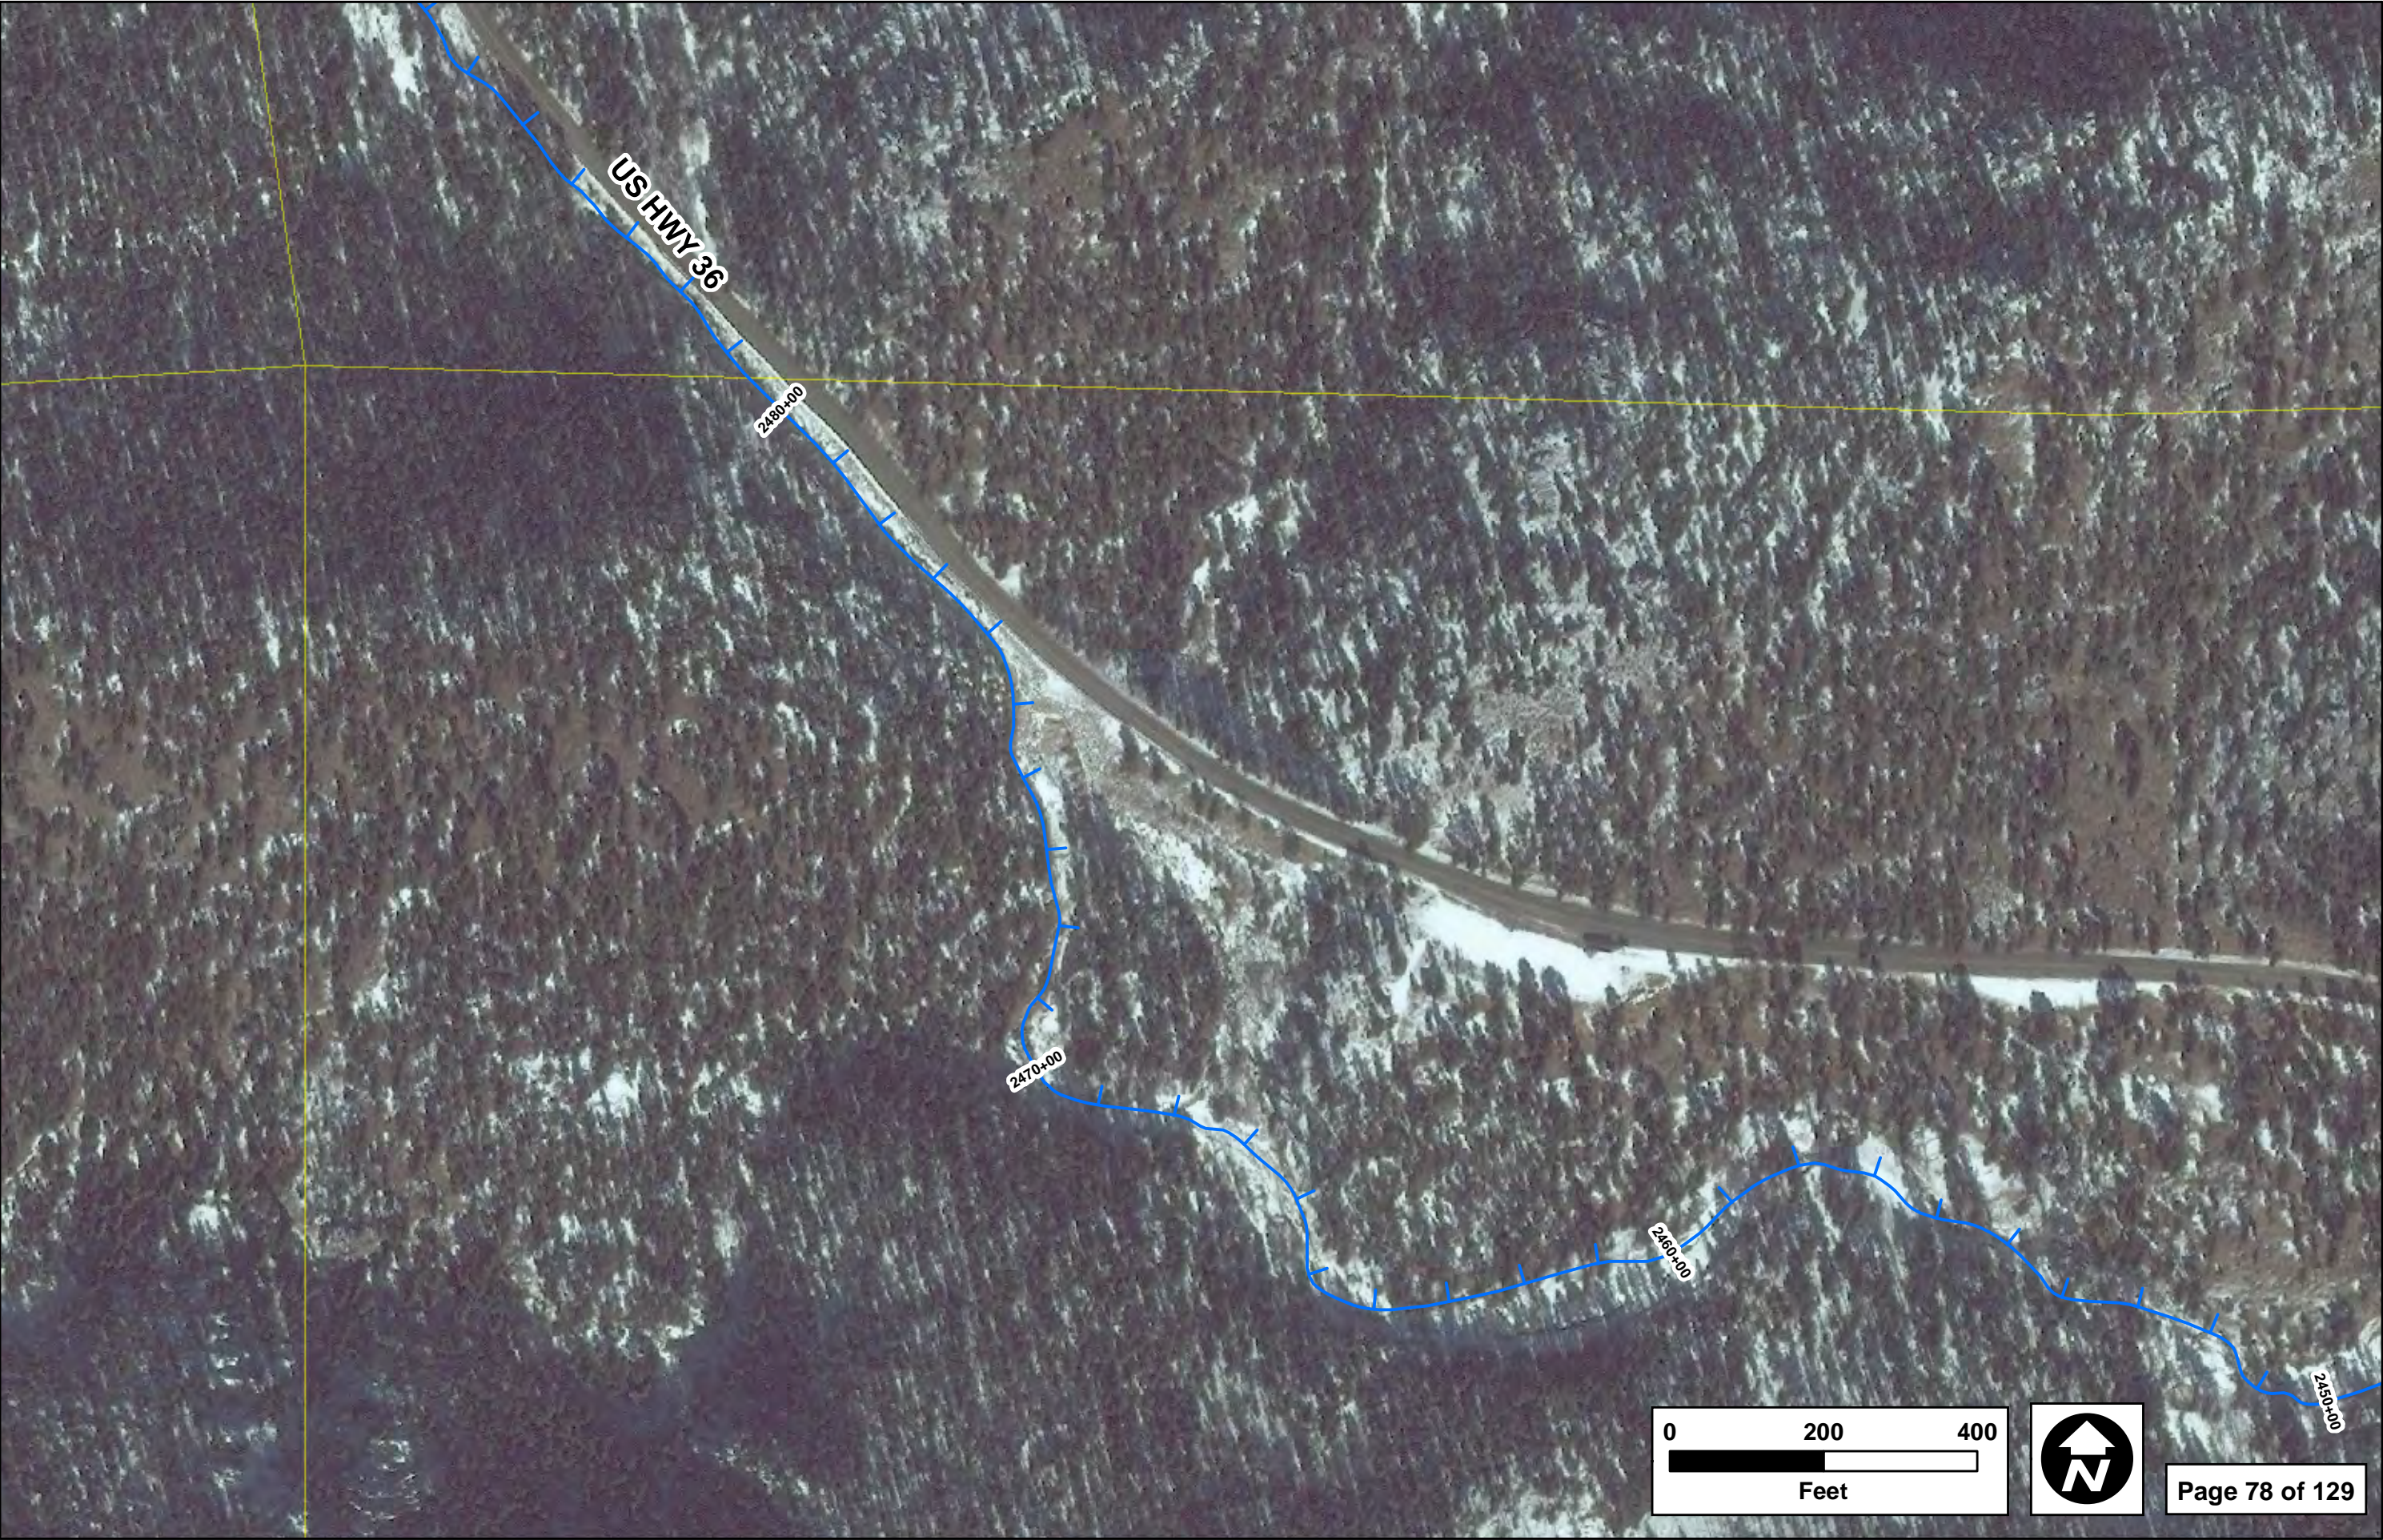
NEIGHBORHOOD: Headwaters**SHEET: 79****STATION: 2487+00 to 2523+00**

The river runs adjacent to U.S. Highway 36, approximately 100 to 400 feet south-southwest. The river traverses privately owned land and lands managed by the USFS. The river corridor is wider than the downstream sections, with less canyon and rock formations controlling the vertical and horizontal alignments. The average channel slope through this reach is 2 percent.

Geomorphic functions of this reach is likely sufficient to allow for the natural regeneration of cottonwood, willow, and other riparian species through seeding and cloning without active restoration. No further actions are suggested at this time.

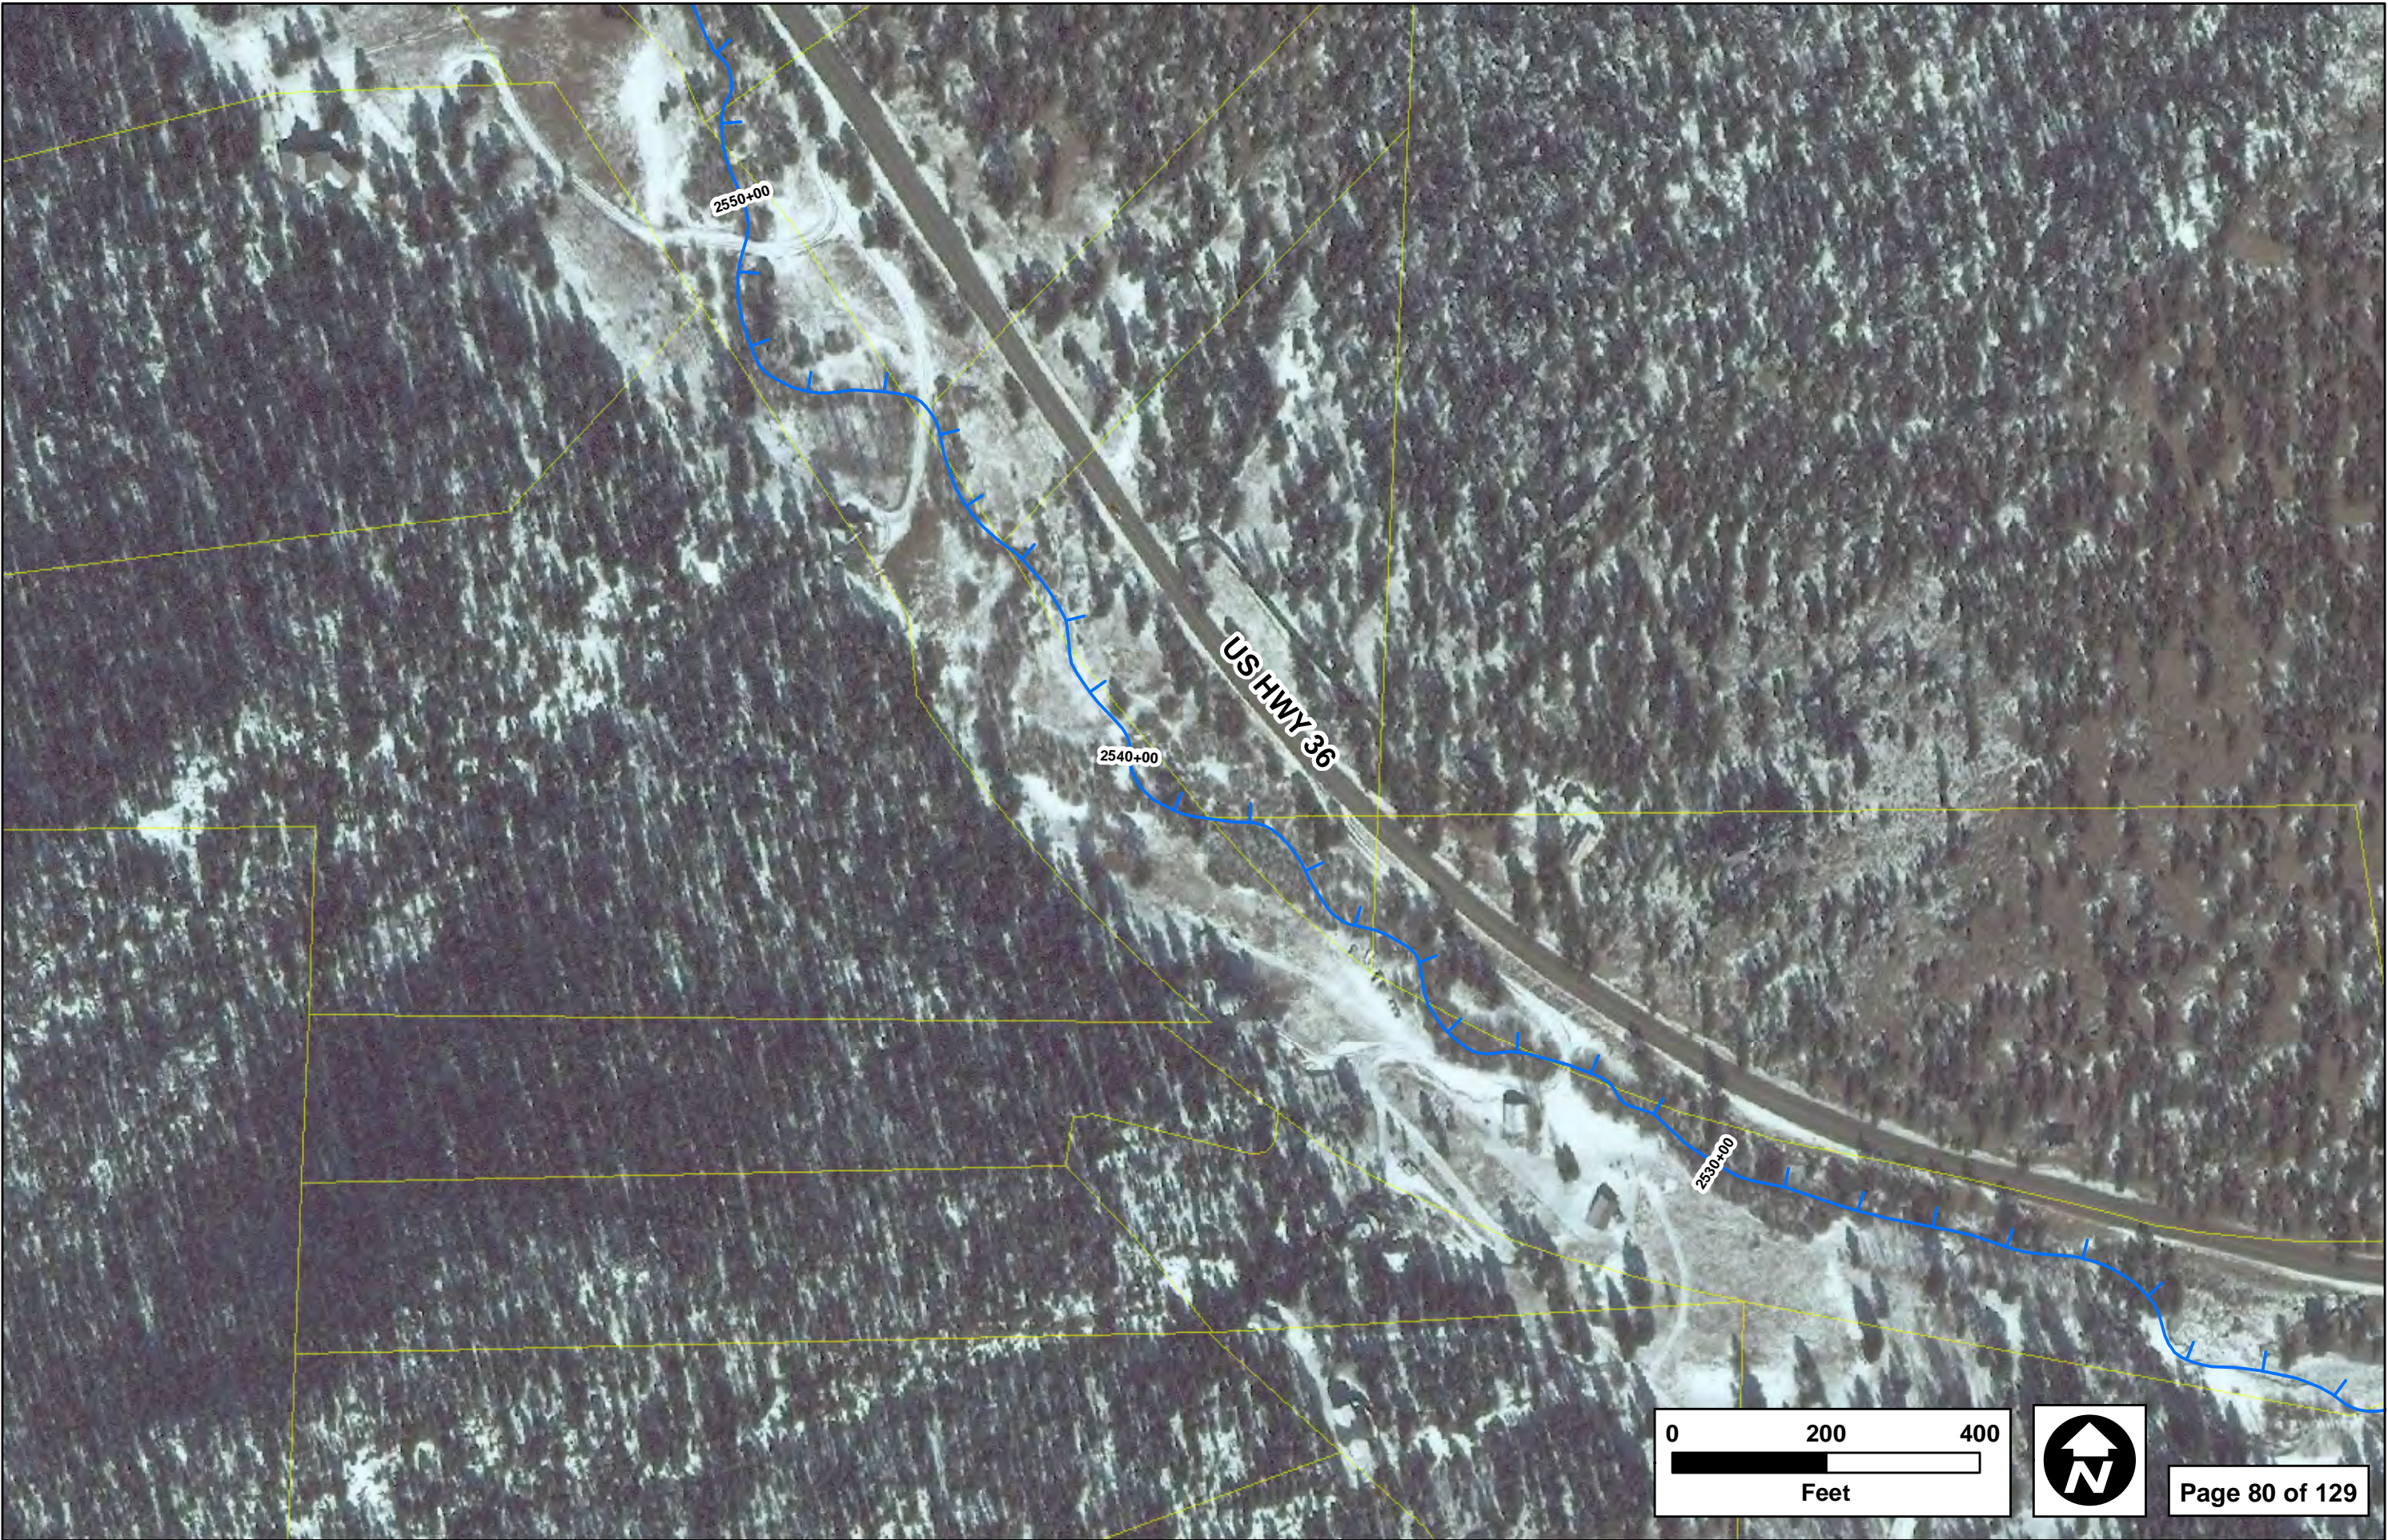
NEIGHBORHOOD: Headwaters**SHEET: 81****STATION: 2552+00 to 2574+00**

This is the headwaters of the Little Thompson. The river runs adjacent to U.S. Highway 36, approximately 50 to 400 feet south-southwest. The river traverses privately owned land. The river corridor is wider than the downstream sections, with less canyon and rock formations controlling the vertical and horizontal alignments. The average channel slope through this reach is 2 percent.

Geomorphic functions of this reach is likely sufficient to allow for the natural regeneration of cottonwood, willow, and other riparian species through seeding and cloning without active restoration. No further actions are suggested at this time.

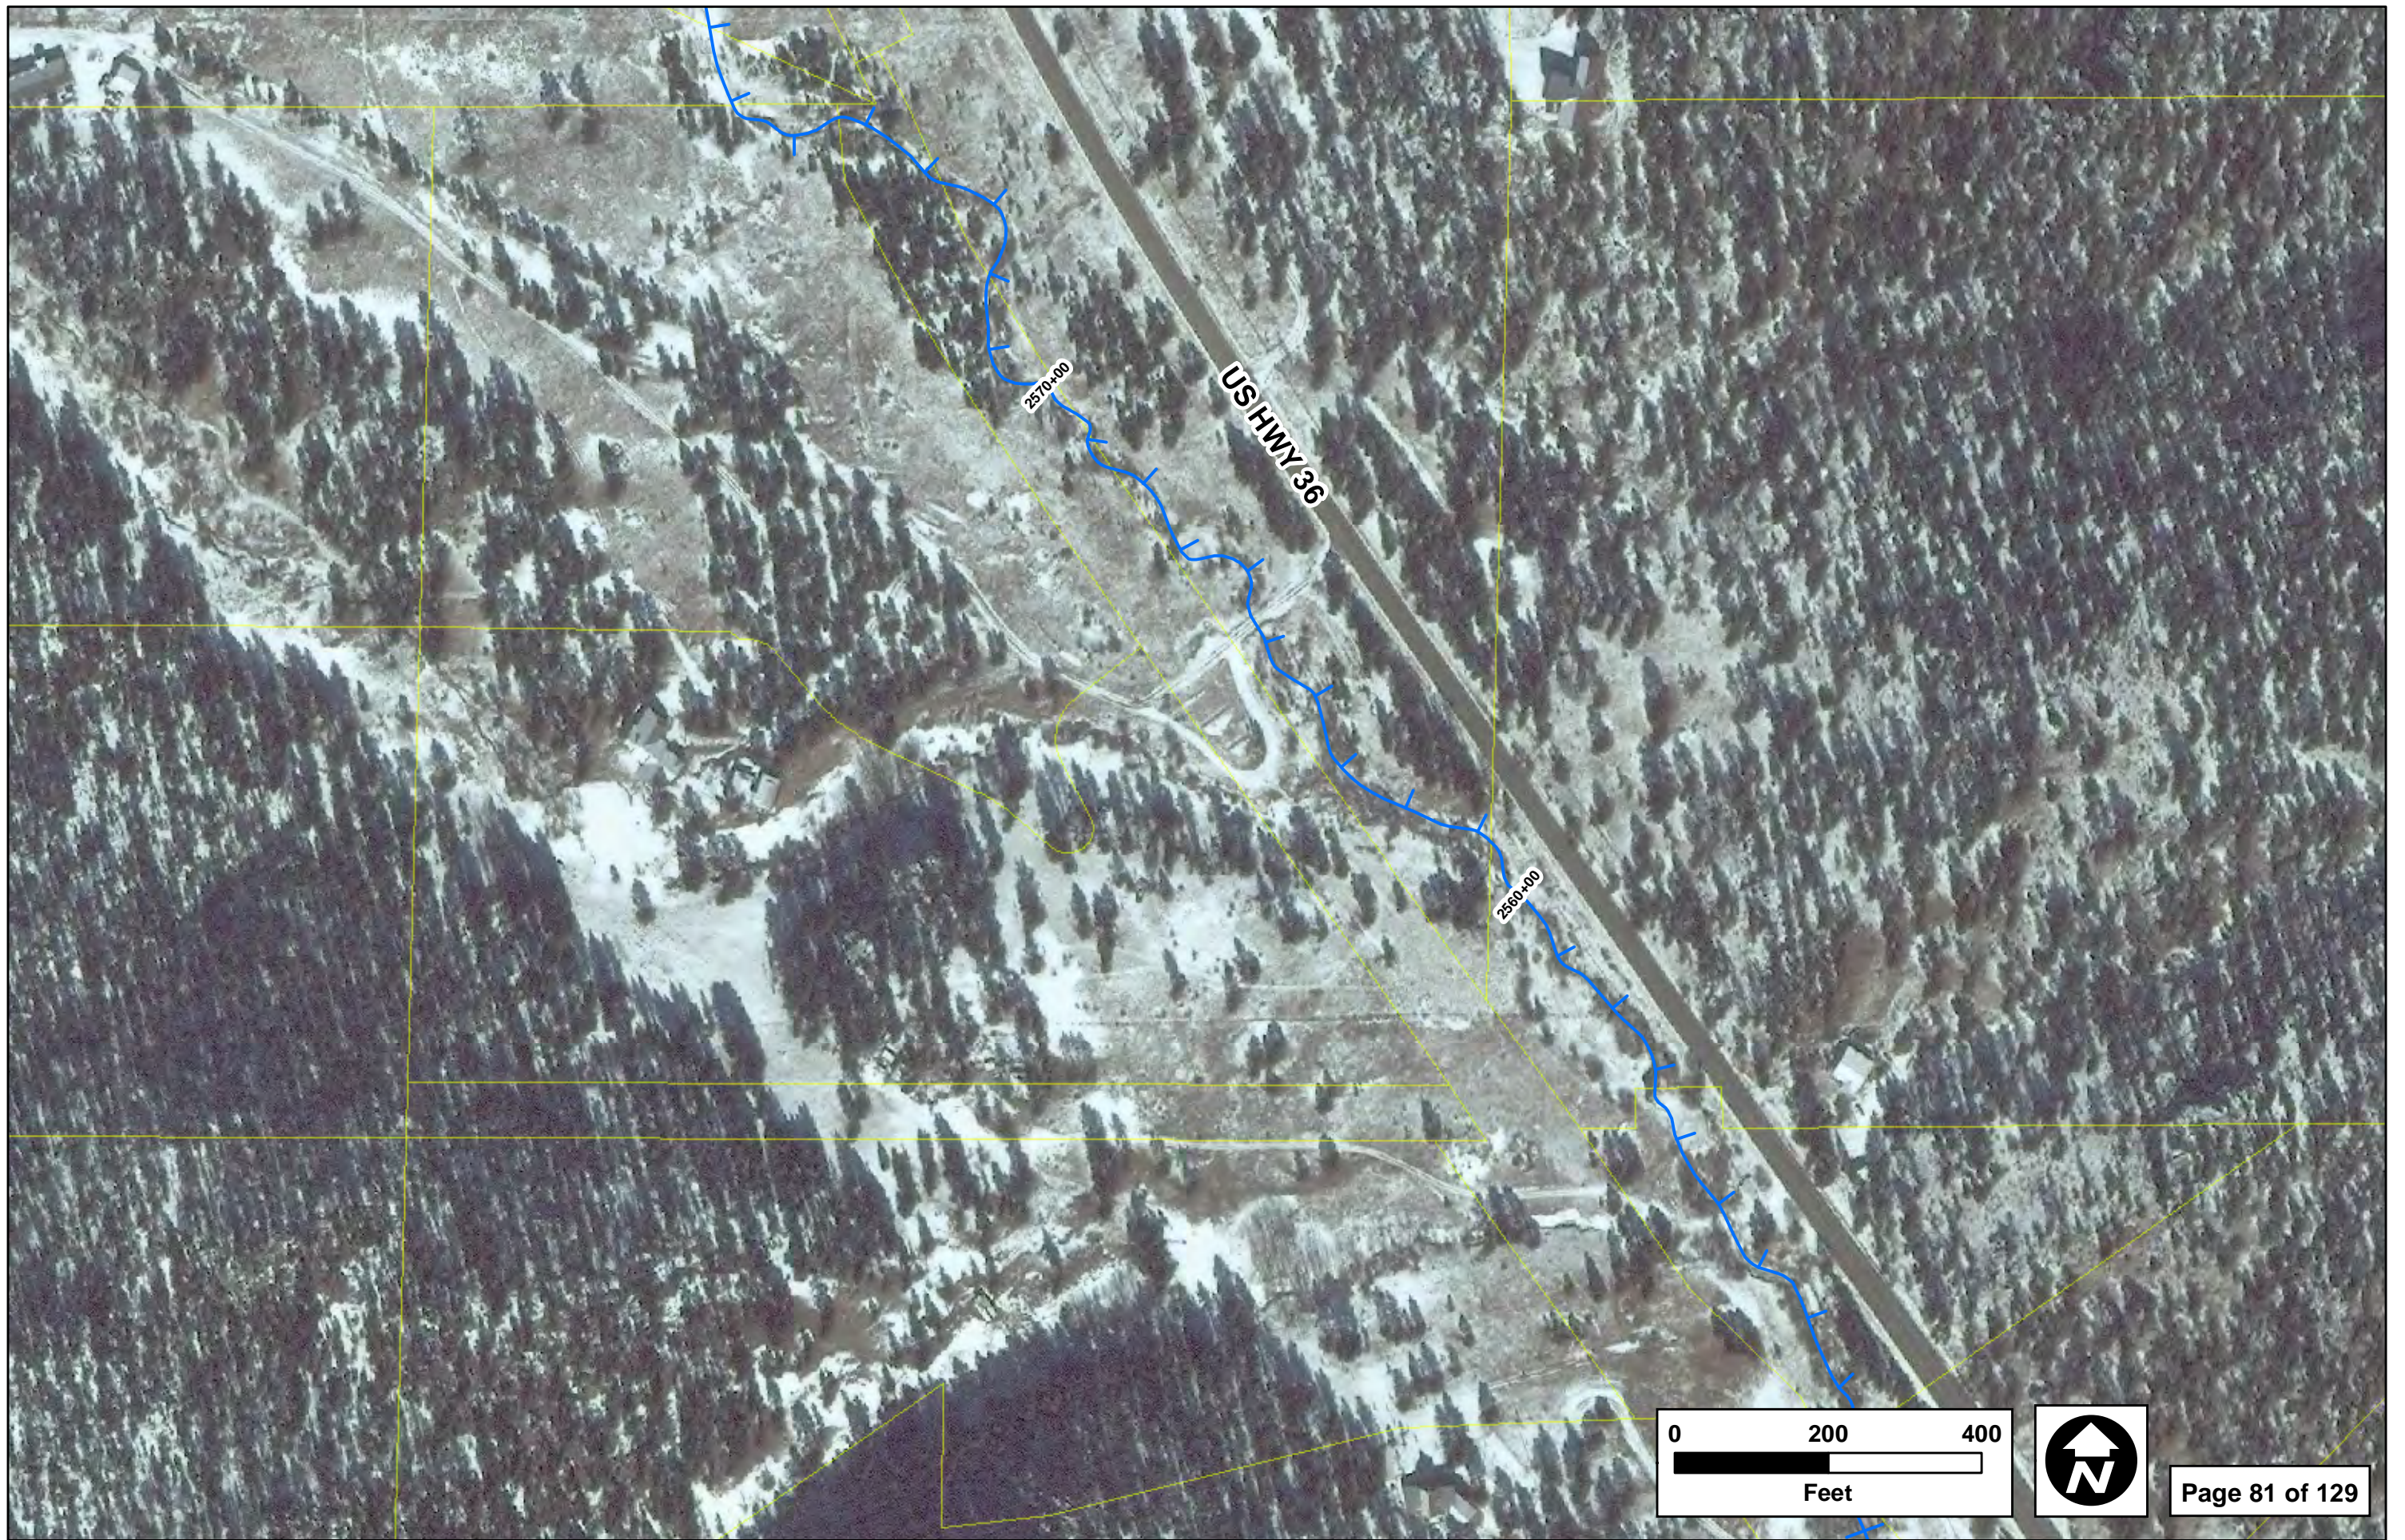
NEIGHBORHOOD: Headwaters
SHEET: 82
STATION: 2574+00 to 2597+00

This is the headwaters of the Little Thompson River. The river runs adjacent to U.S. Highway 36, approximately 200 to 400 feet south-southwest. The river traverses privately owned land. The river corridor is wider than the downstream sections, with less canyon and rock formations controlling the vertical and horizontal alignments. The average channel slope through this reach is 2 percent.

Geomorphic functions of this reach is likely sufficient to allow for the natural regeneration of cottonwood, willow, and other riparian species through seeding and cloning without active restoration. No further actions are suggested at this time.

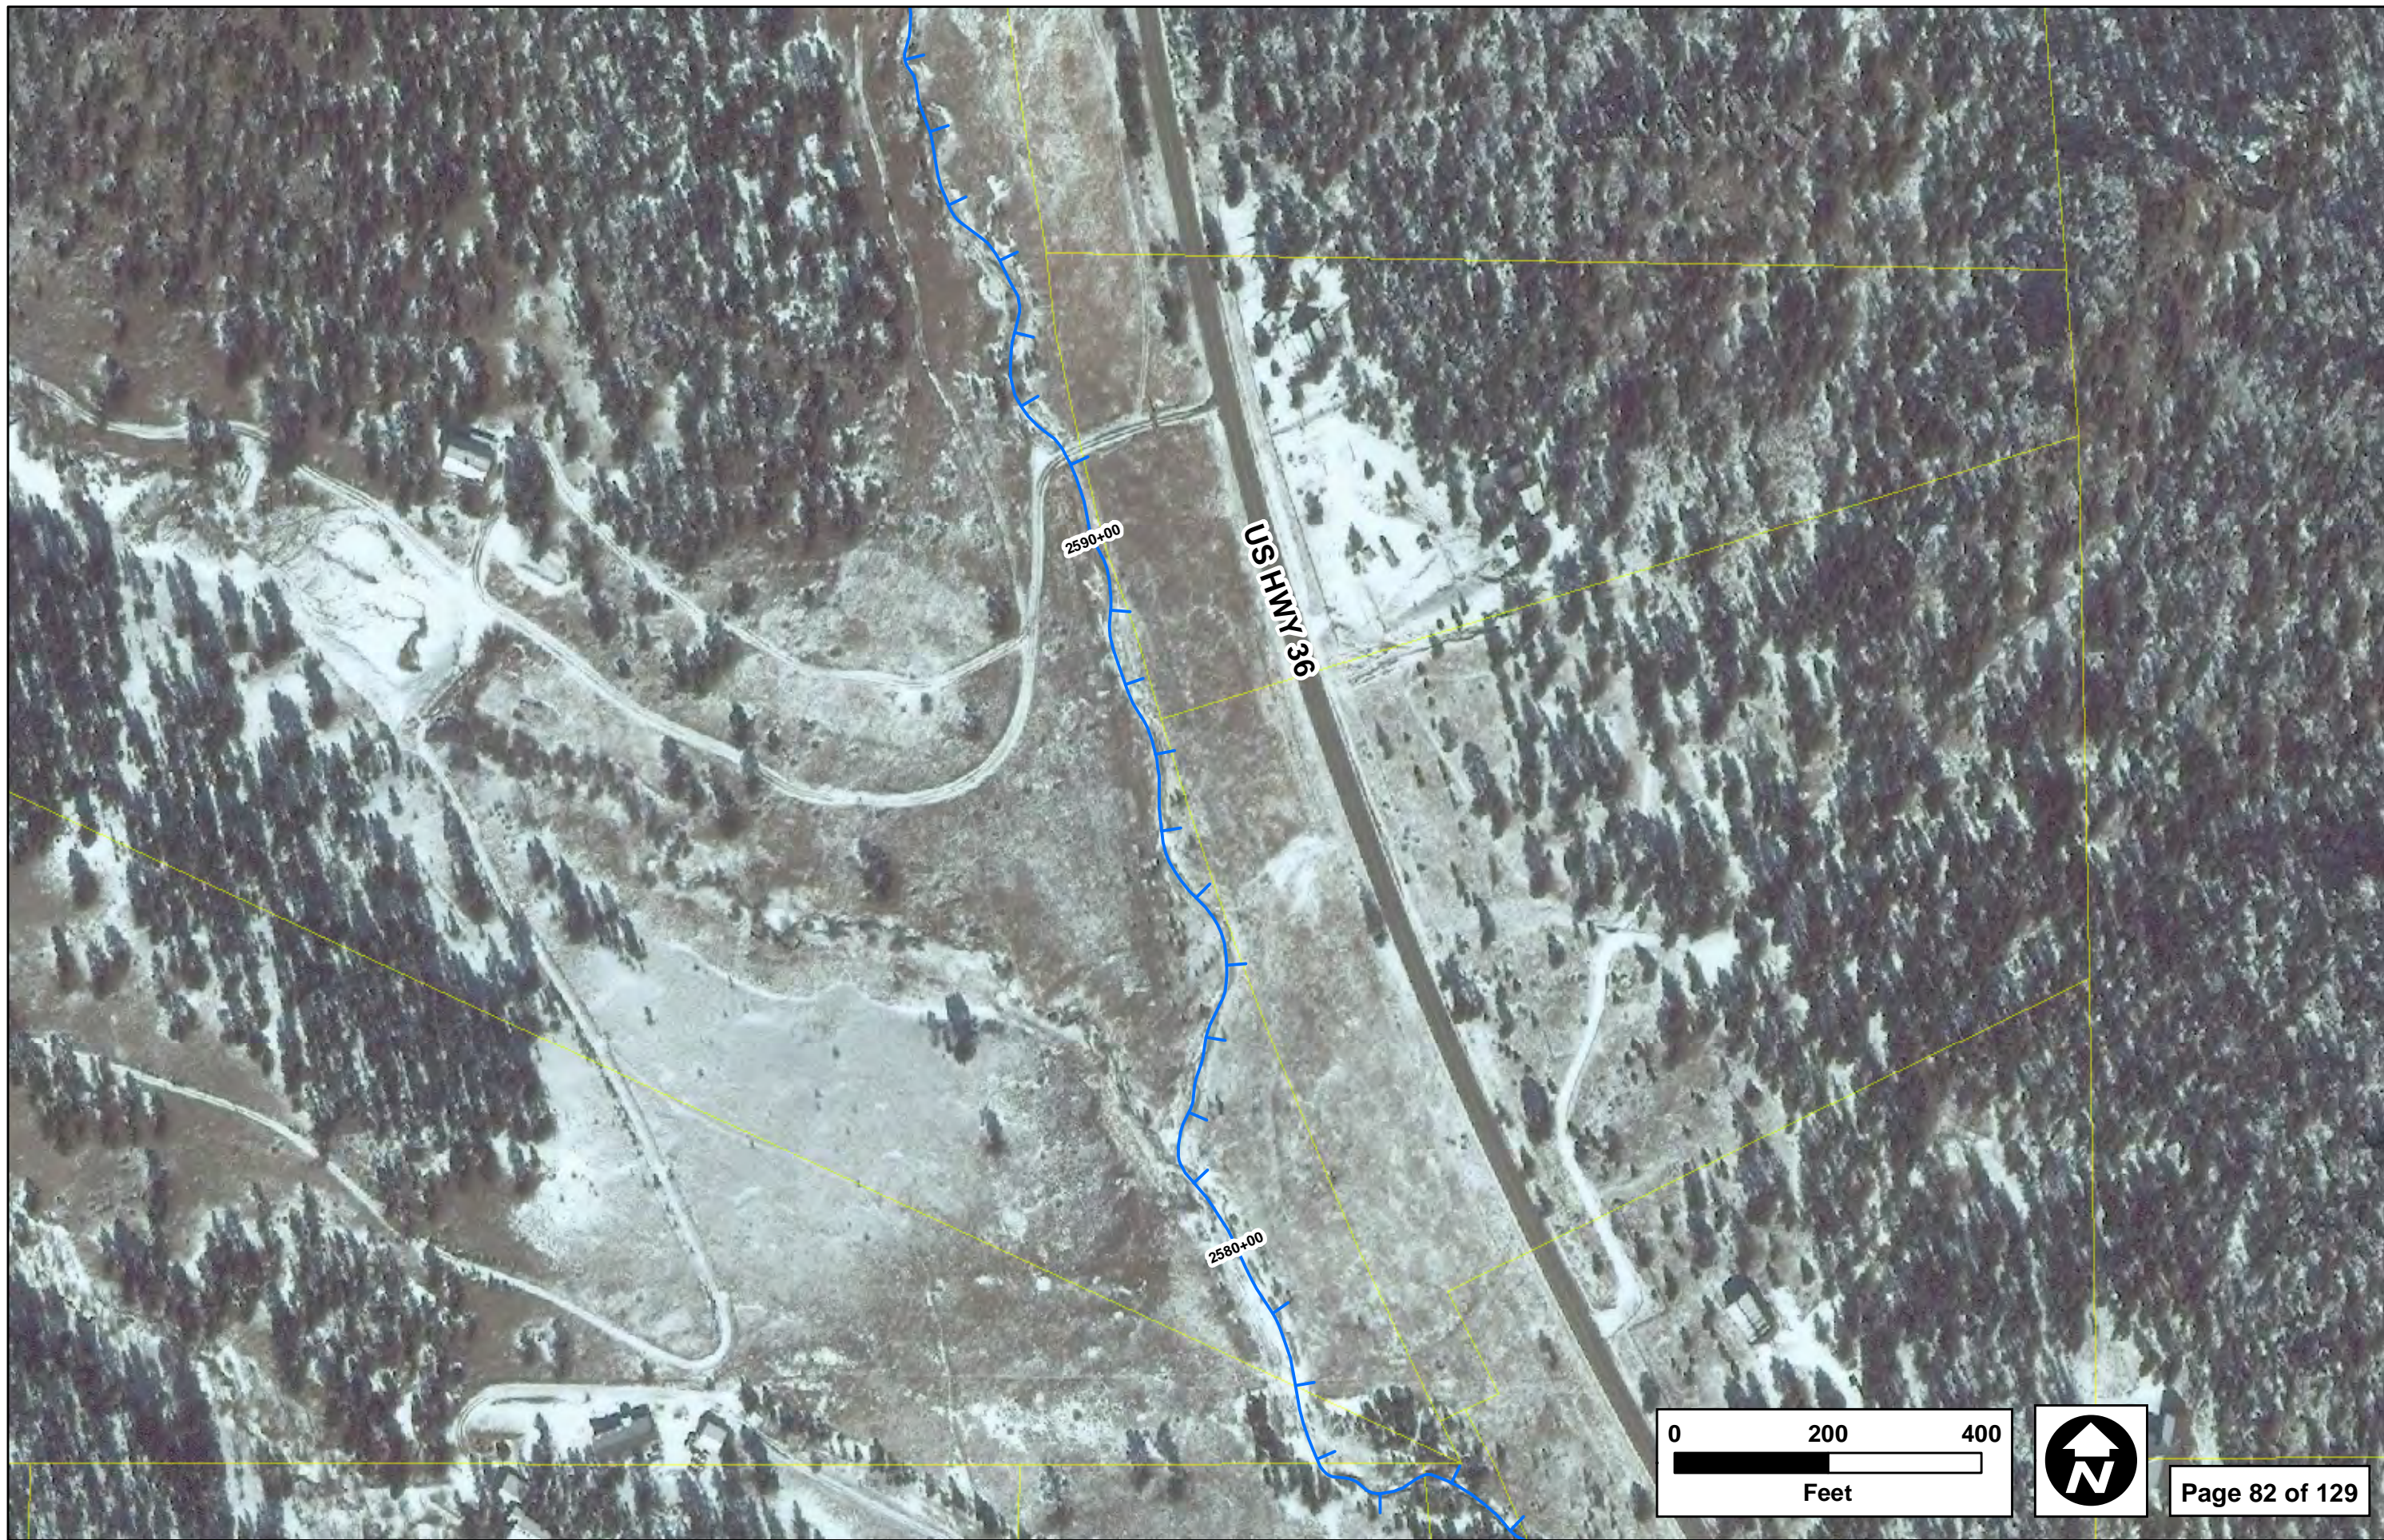
NEIGHBORHOOD: Headwaters
SHEET: 83
STATION: 2597+00 to 2617+00

This is the headwaters of the Little Thompson River. The river runs adjacent to U.S. Highway 36, approximately 200 to 400 feet south-southwest. The river traverses privately owned land. The river corridor is wider than the downstream sections, with less canyon and rock formations controlling the vertical and horizontal alignments. The average channel slope through this reach is 3.1 percent.

Geomorphic functions of this reach is likely sufficient to allow for the natural regeneration of cottonwood, willow, and other riparian species through seeding and cloning without active restoration. No further actions are suggested at this time.
