APPENDIX A

ASSESSMENT PROTOCOL

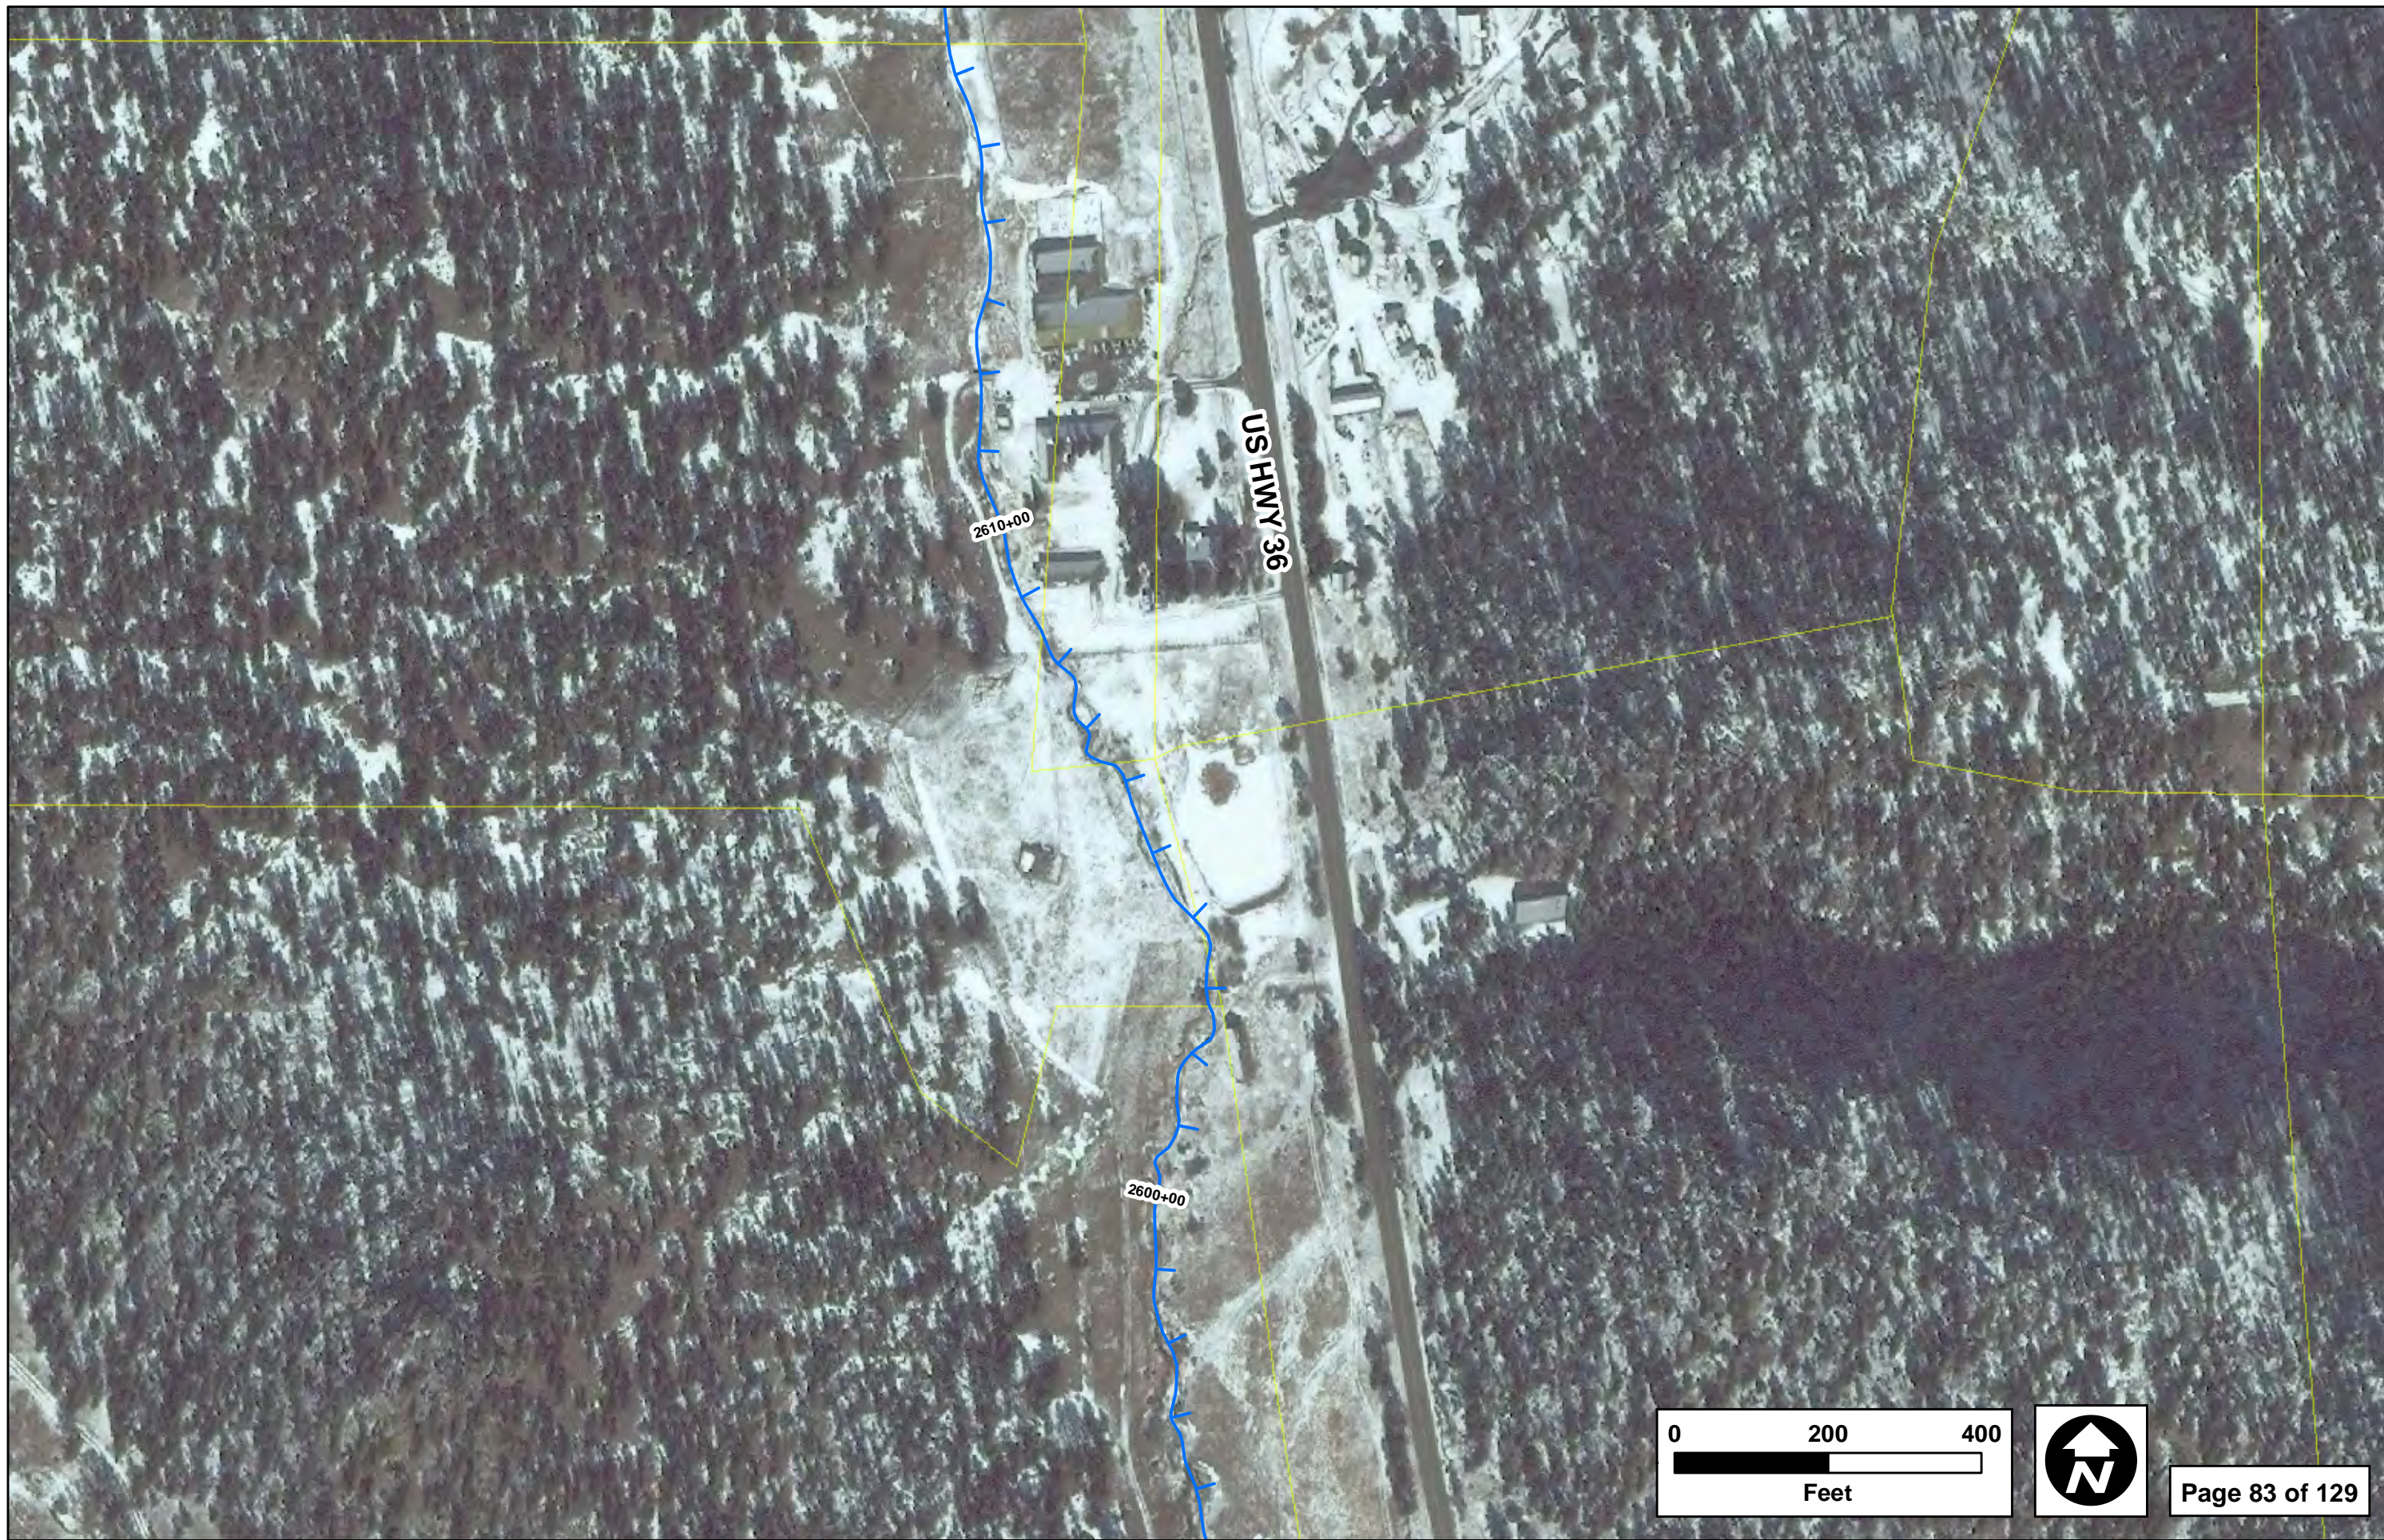
NEIGHBORHOOD: Headwaters
SHEET: 84
STATION: 2617+00 to 2643+00

This is the headwaters of the Little Thompson River. The river runs adjacent to U.S. Highway 36, approximately 200 to 400 feet south-southwest. The river traverses privately owned land. The river corridor is wider than the downstream sections, with less canyon and rock formations controlling the vertical and horizontal alignments. The average channel slope through this reach is 3.1 percent.

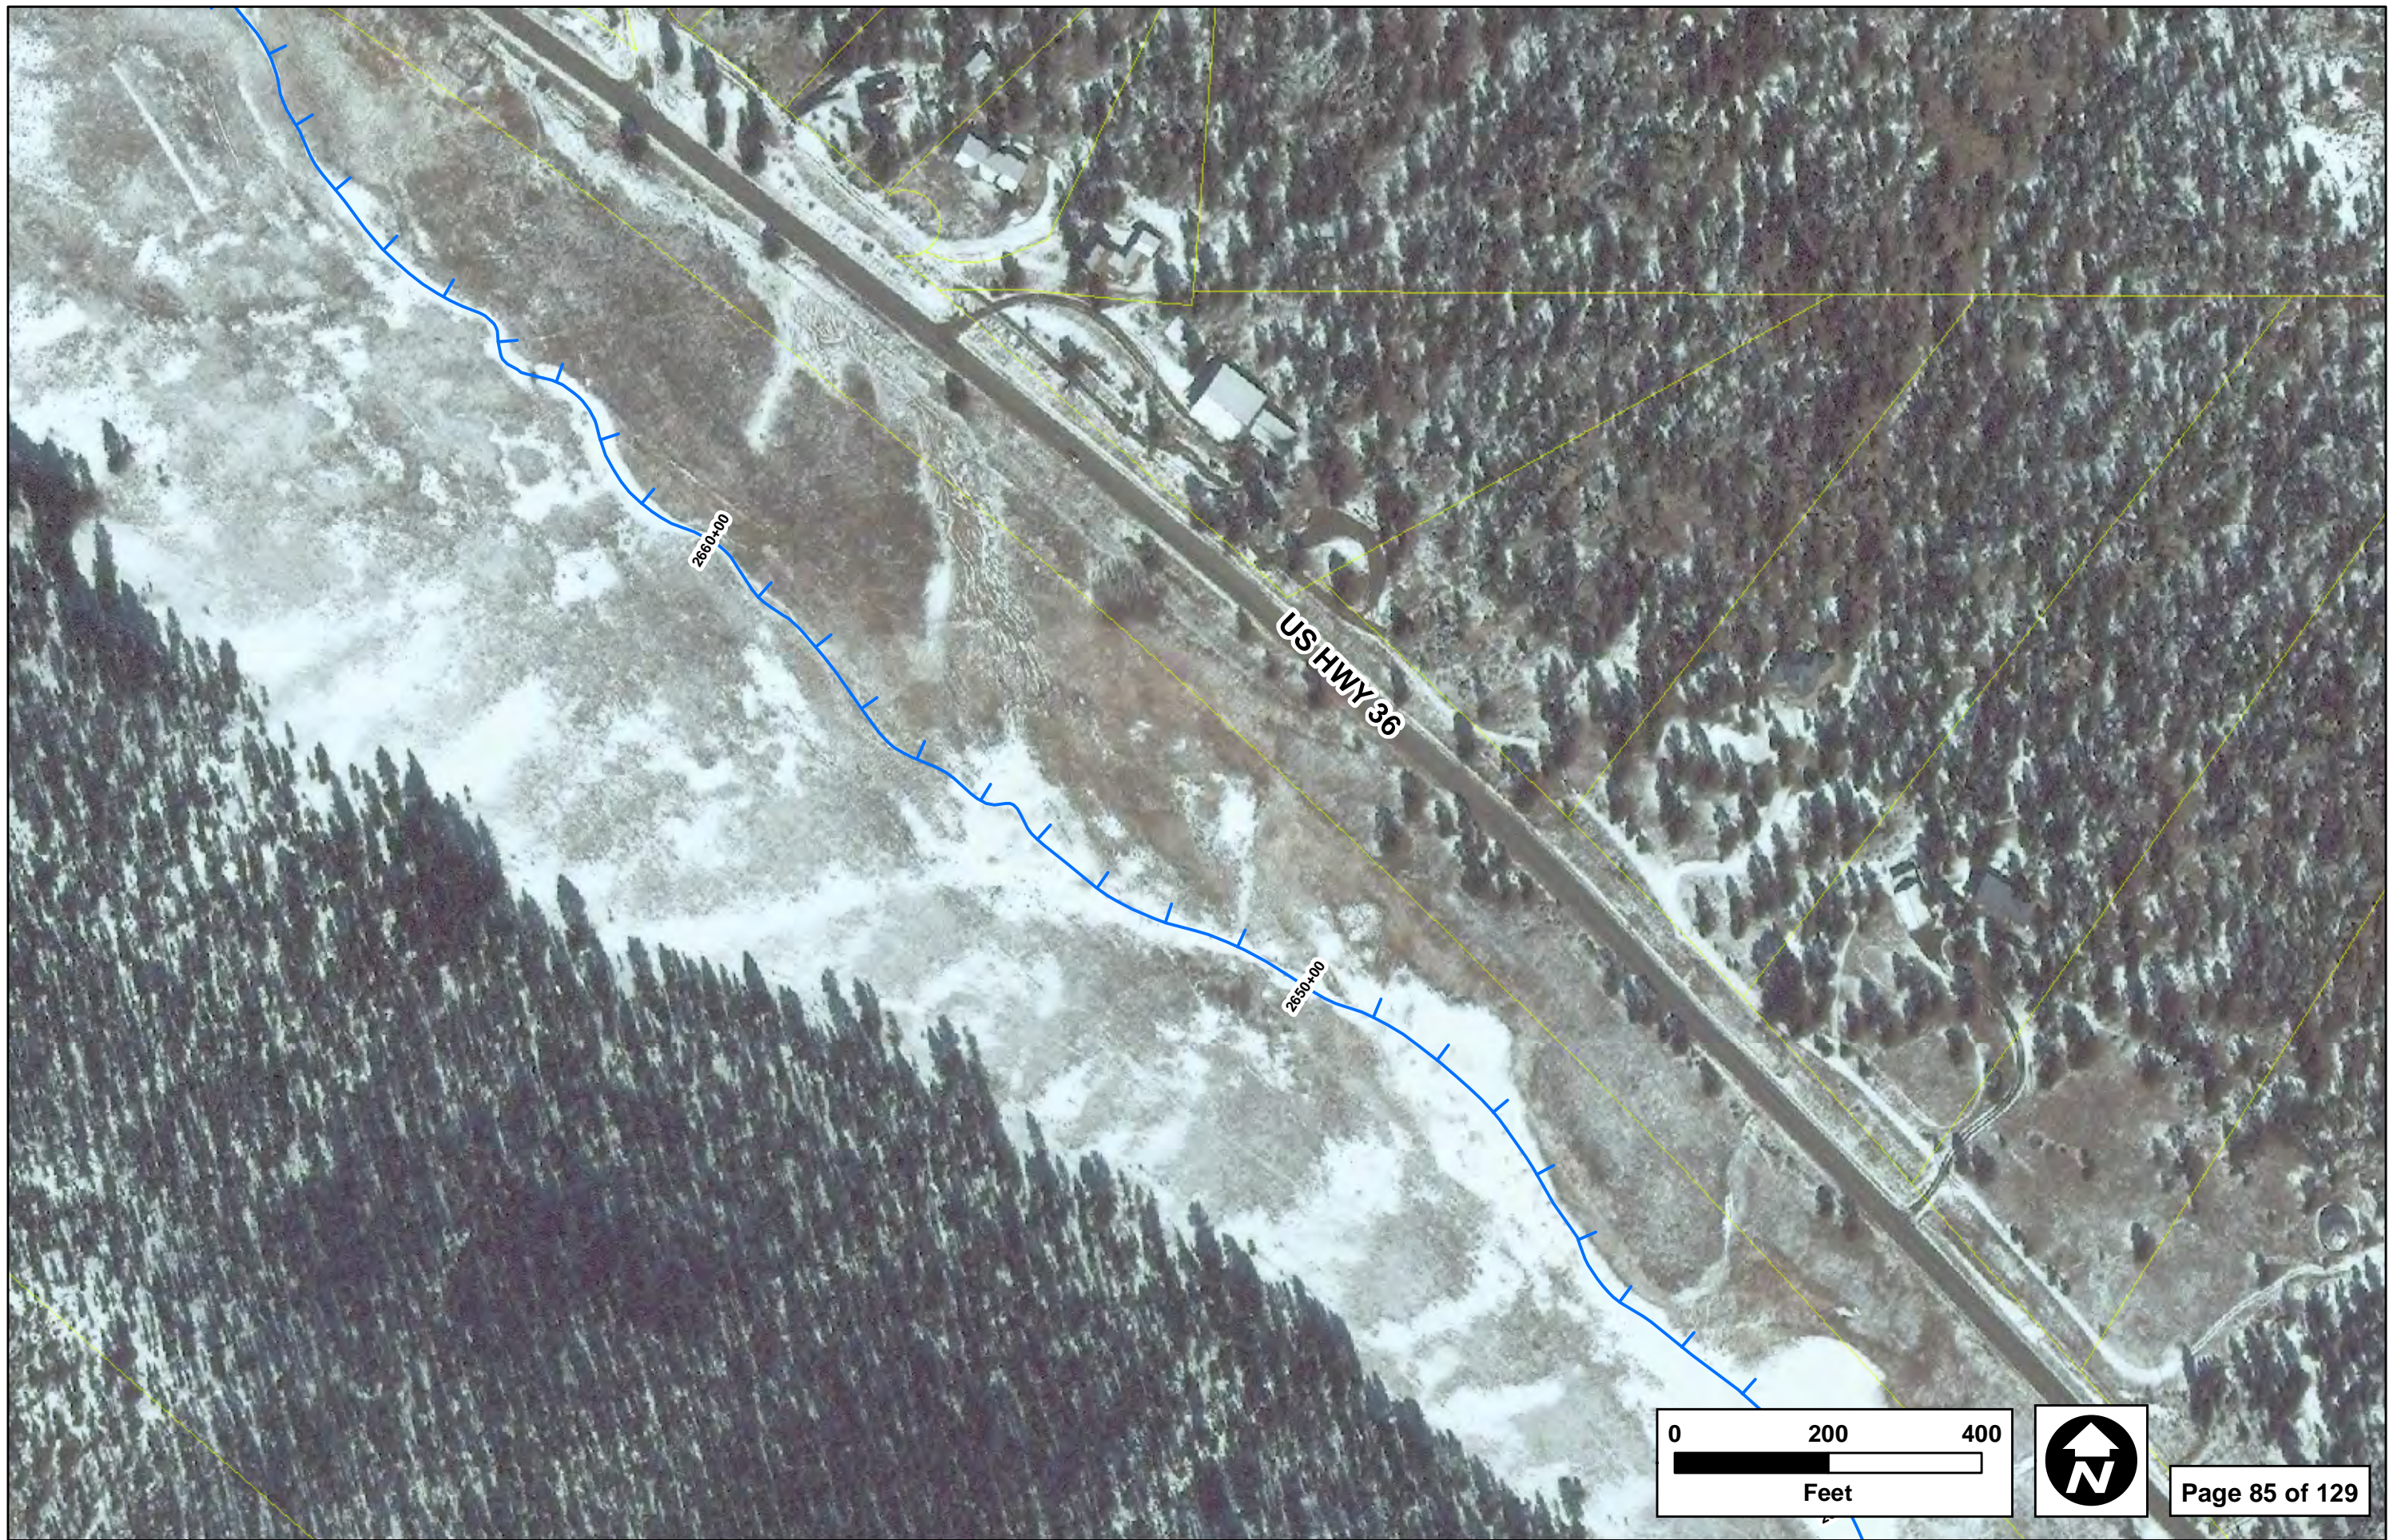
NEIGHBORHOOD: Headwaters
SHEET: 85
STATION: 2643+00 to 2669+00

This is the headwaters of the Little Thompson River. The river runs adjacent to U.S. Highway 36, approximately 200 to 400 feet south-southwest. The river traverses privately owned land. The river corridor is wider than the downstream sections, with less canyon and rock formations controlling the vertical and horizontal alignments. The average channel slope through this reach is 3.1 percent.

Aerial photos of pre-flood conditions and anecdotal information indicate this reach had a sparsely vegetated riparian corridor, typically less than 50 feet wide, comprised primarily of grassess, much of which remains post-flood. This reach sustained very little flood-related damage.

Geomorphic functions of this reach is likely sufficient to allow for the natural regeneration of cottonwood, willow, and other riparian species through seeding and cloning without active restoration. No further actions are suggested at this time.

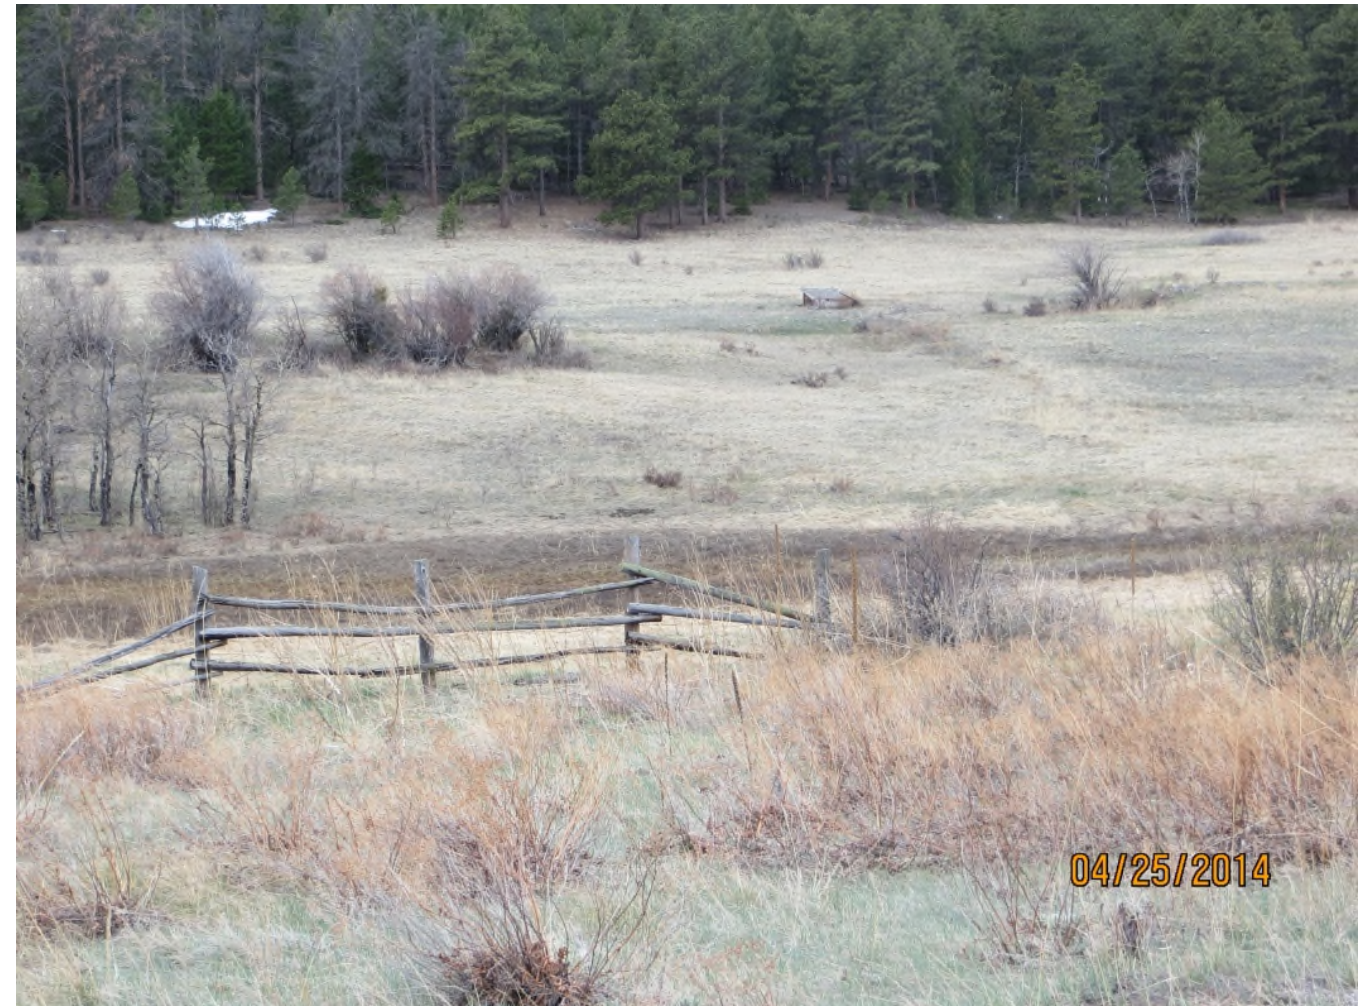
NEIGHBORHOOD: Headwaters**SHEET: 86****STATION: 2669+00 to 2698+00**

This is the headwaters of the Little Thompson River. The river runs adjacent to U.S. Highway 36, approximately 200 feet south-southwest. The river traverses privately owned land. The river corridor is wider than the downstream sections, with less canyon and rock formations controlling the vertical and horizontal alignments. The average channel slope through this reach is 3.1 percent.

Aerial photos of pre-flood conditions and anecdotal information indicate this reach had a sparsely vegetated riparian corridor, comprised primarily of grasses, much of which remains post-flood. This reach sustained very little flood-related damage.

Geomorphic functions of this reach is likely sufficient to allow for the natural regeneration of cottonwood, willow, and other riparian species through seeding and cloning without active restoration. No further actions are suggested at this time.

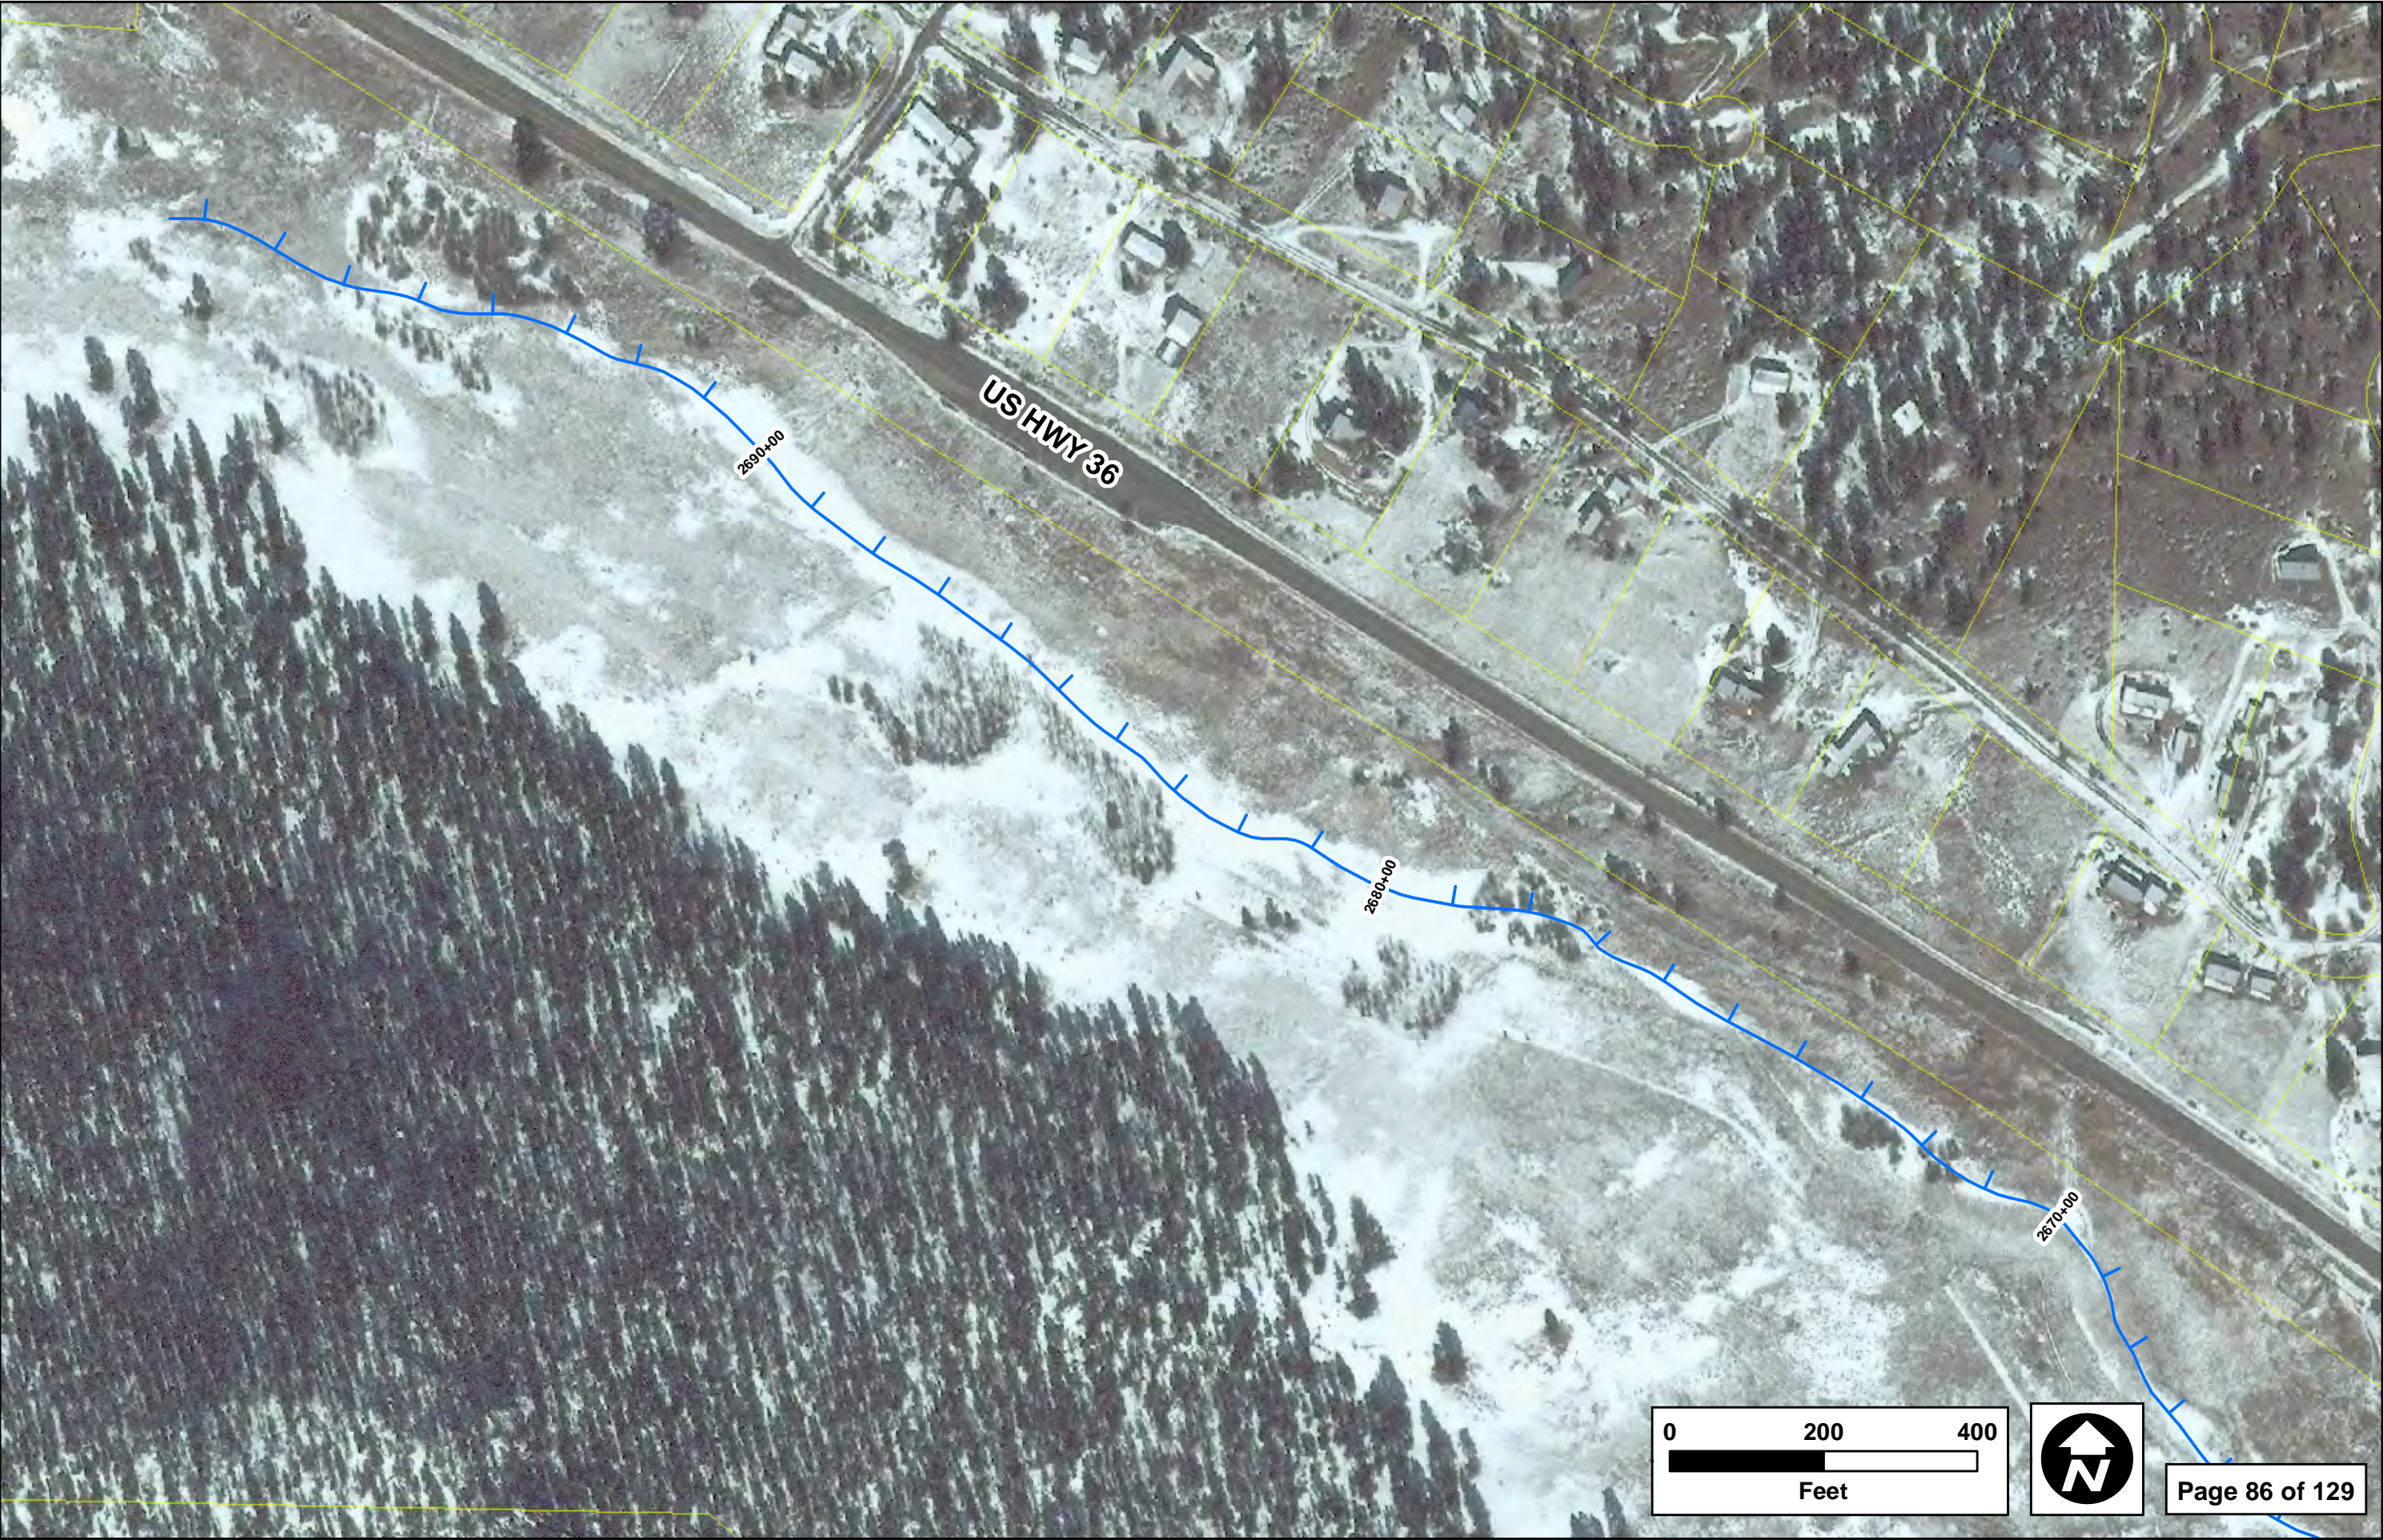
NEIGHBORHOOD: Big Elk Meadows
SHEET: 87
STATION: 30+00 to Big Elk Meadows (West Fork)

The West Fork runs immediately adjacent to County Road 47, crossing it 5 times in less than 2 miles. These crossing were all destroyed during the 2013 flood and field evidence indicates the road was likely overtopped, with the road and canyon walls conveying floodwater. Larimer County replaced the culverts shortly after the flood. The USFS has expressed an interest in replacing these with culverts of increased capacity and culverts that can provide connectivity for aquatic species. As of the fall of 2014 Larimer County, FEMA, the USFS and Central Federal Lands are working to repair the road and possibly replace the culverts. Since this work in not complete, the recommendations and costs for the recommended work remain a part of this Master Plan.

Field observations indicate that the channel size was insufficient for the flood event. As the event was estimated to be in excess of the 500-year flood, it is understandable the channel capacity was exceeded, however, a channel assessment for capacity as well as bank stability under design flood conditions may be warranted along with the implementation of site-specific improvements and culvert replacements noted above.

- 1. Larimer County, FEMA, the USFS and Central Federal Lands should coordinate with the LTWRC regarding the designs and decisions for evaluating County Road 47 along the West Fork including the assess for the potential to reduce the number of crossings.
- 2. Assess channel capacity and culvert capacities; design and replace crossings.
- 3. Improve channel capacity and stabilize banks where required.

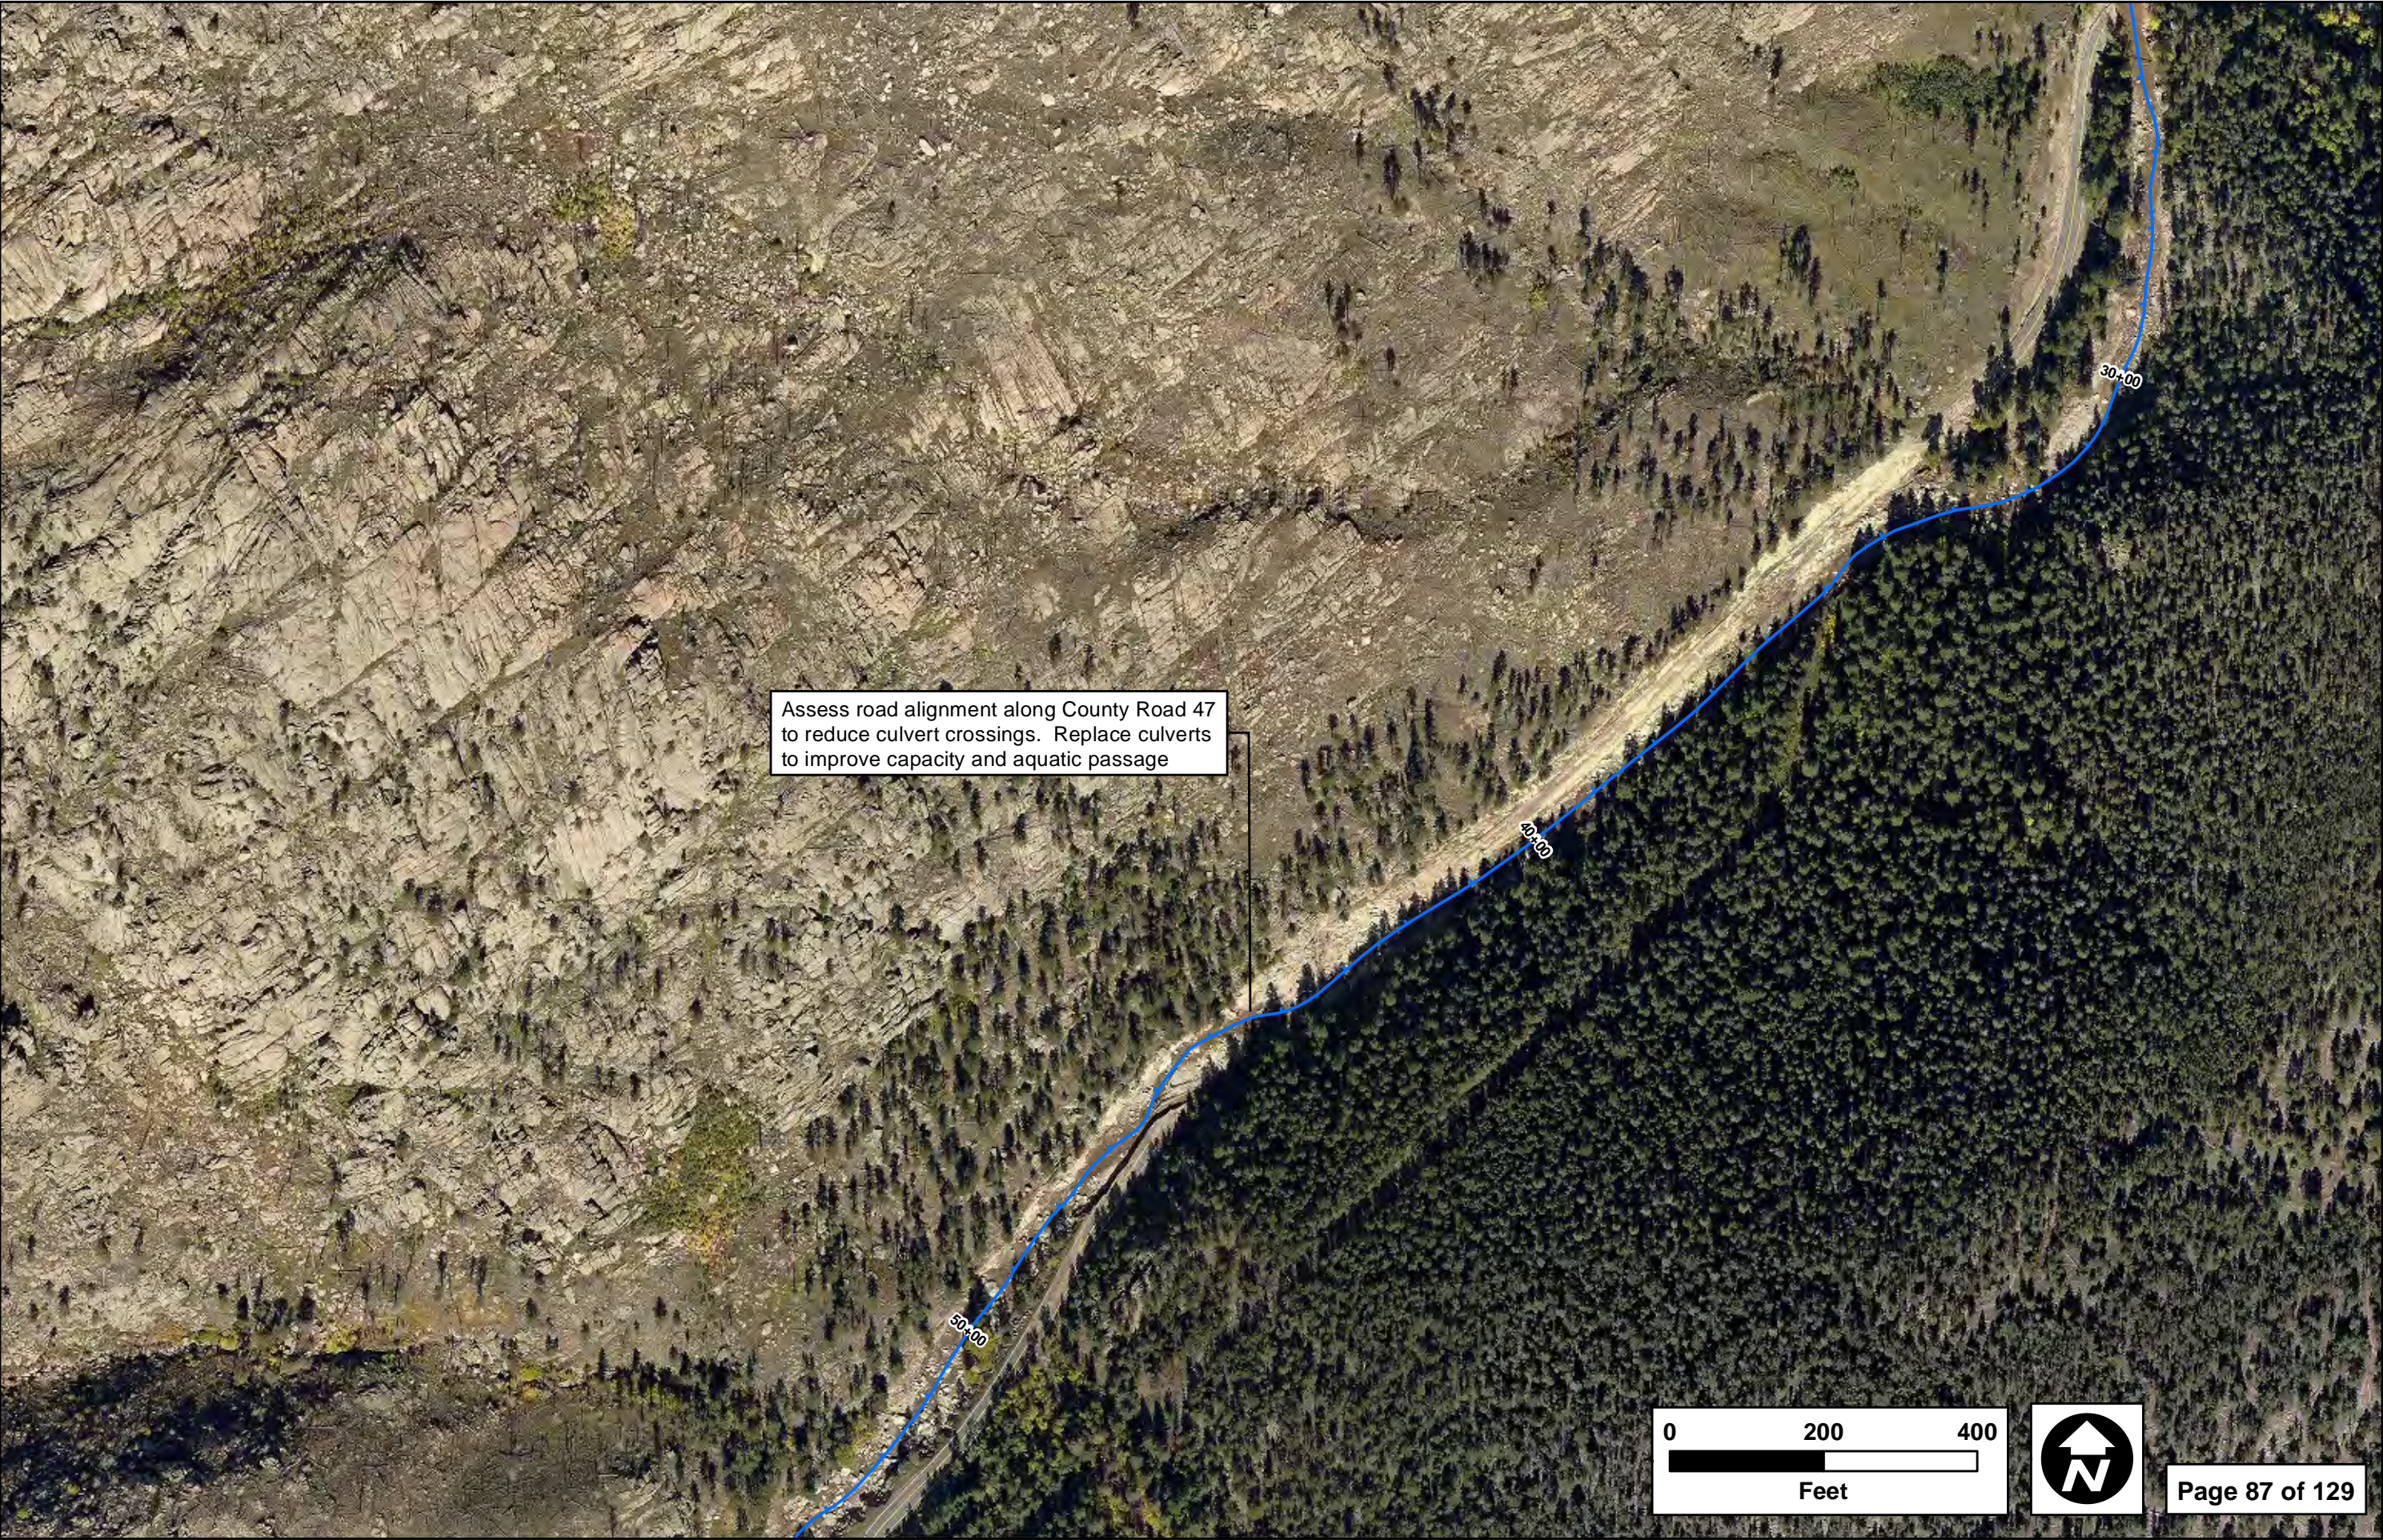
The West Fork runs immediately adjacent to County Road 47, crossing it 5 times in less than 2 miles. These crossing were all destroyed during the 2013 flood and field evidence indicates the road was likely overtopped, with the road and canyon walls conveying floodwater. Larimer County replaced the culverts shortly after the flood. The USFS has expressed an interest in replacing these with culverts of increased capacity and culverts that can provide connectivity for aquatic species. As of the fall of 2014 Larimer County, FEMA, the USFS and Central Federal Lands are working to repair the road and possibly replace the culverts. Since this work in not complete, the recommendations and costs for the recommended work remain a part of this Master Plan.

Field observations indicate that the channel size was insufficient for the flood event. As the event was estimated to be in excess of the 500-year flood, it is understandable the channel capacity was exceeded, however, a channel assessment for capacity as well as bank stability under design flood conditions may be warranted along with the implementation of site-specific improvements and culvert replacements noted above.

Assess road alignment along County Road 47 to reduce culvert crossings. Replace culverts to improve capacity and aquatic passage

- 1. See recommendations on Sheet 87.

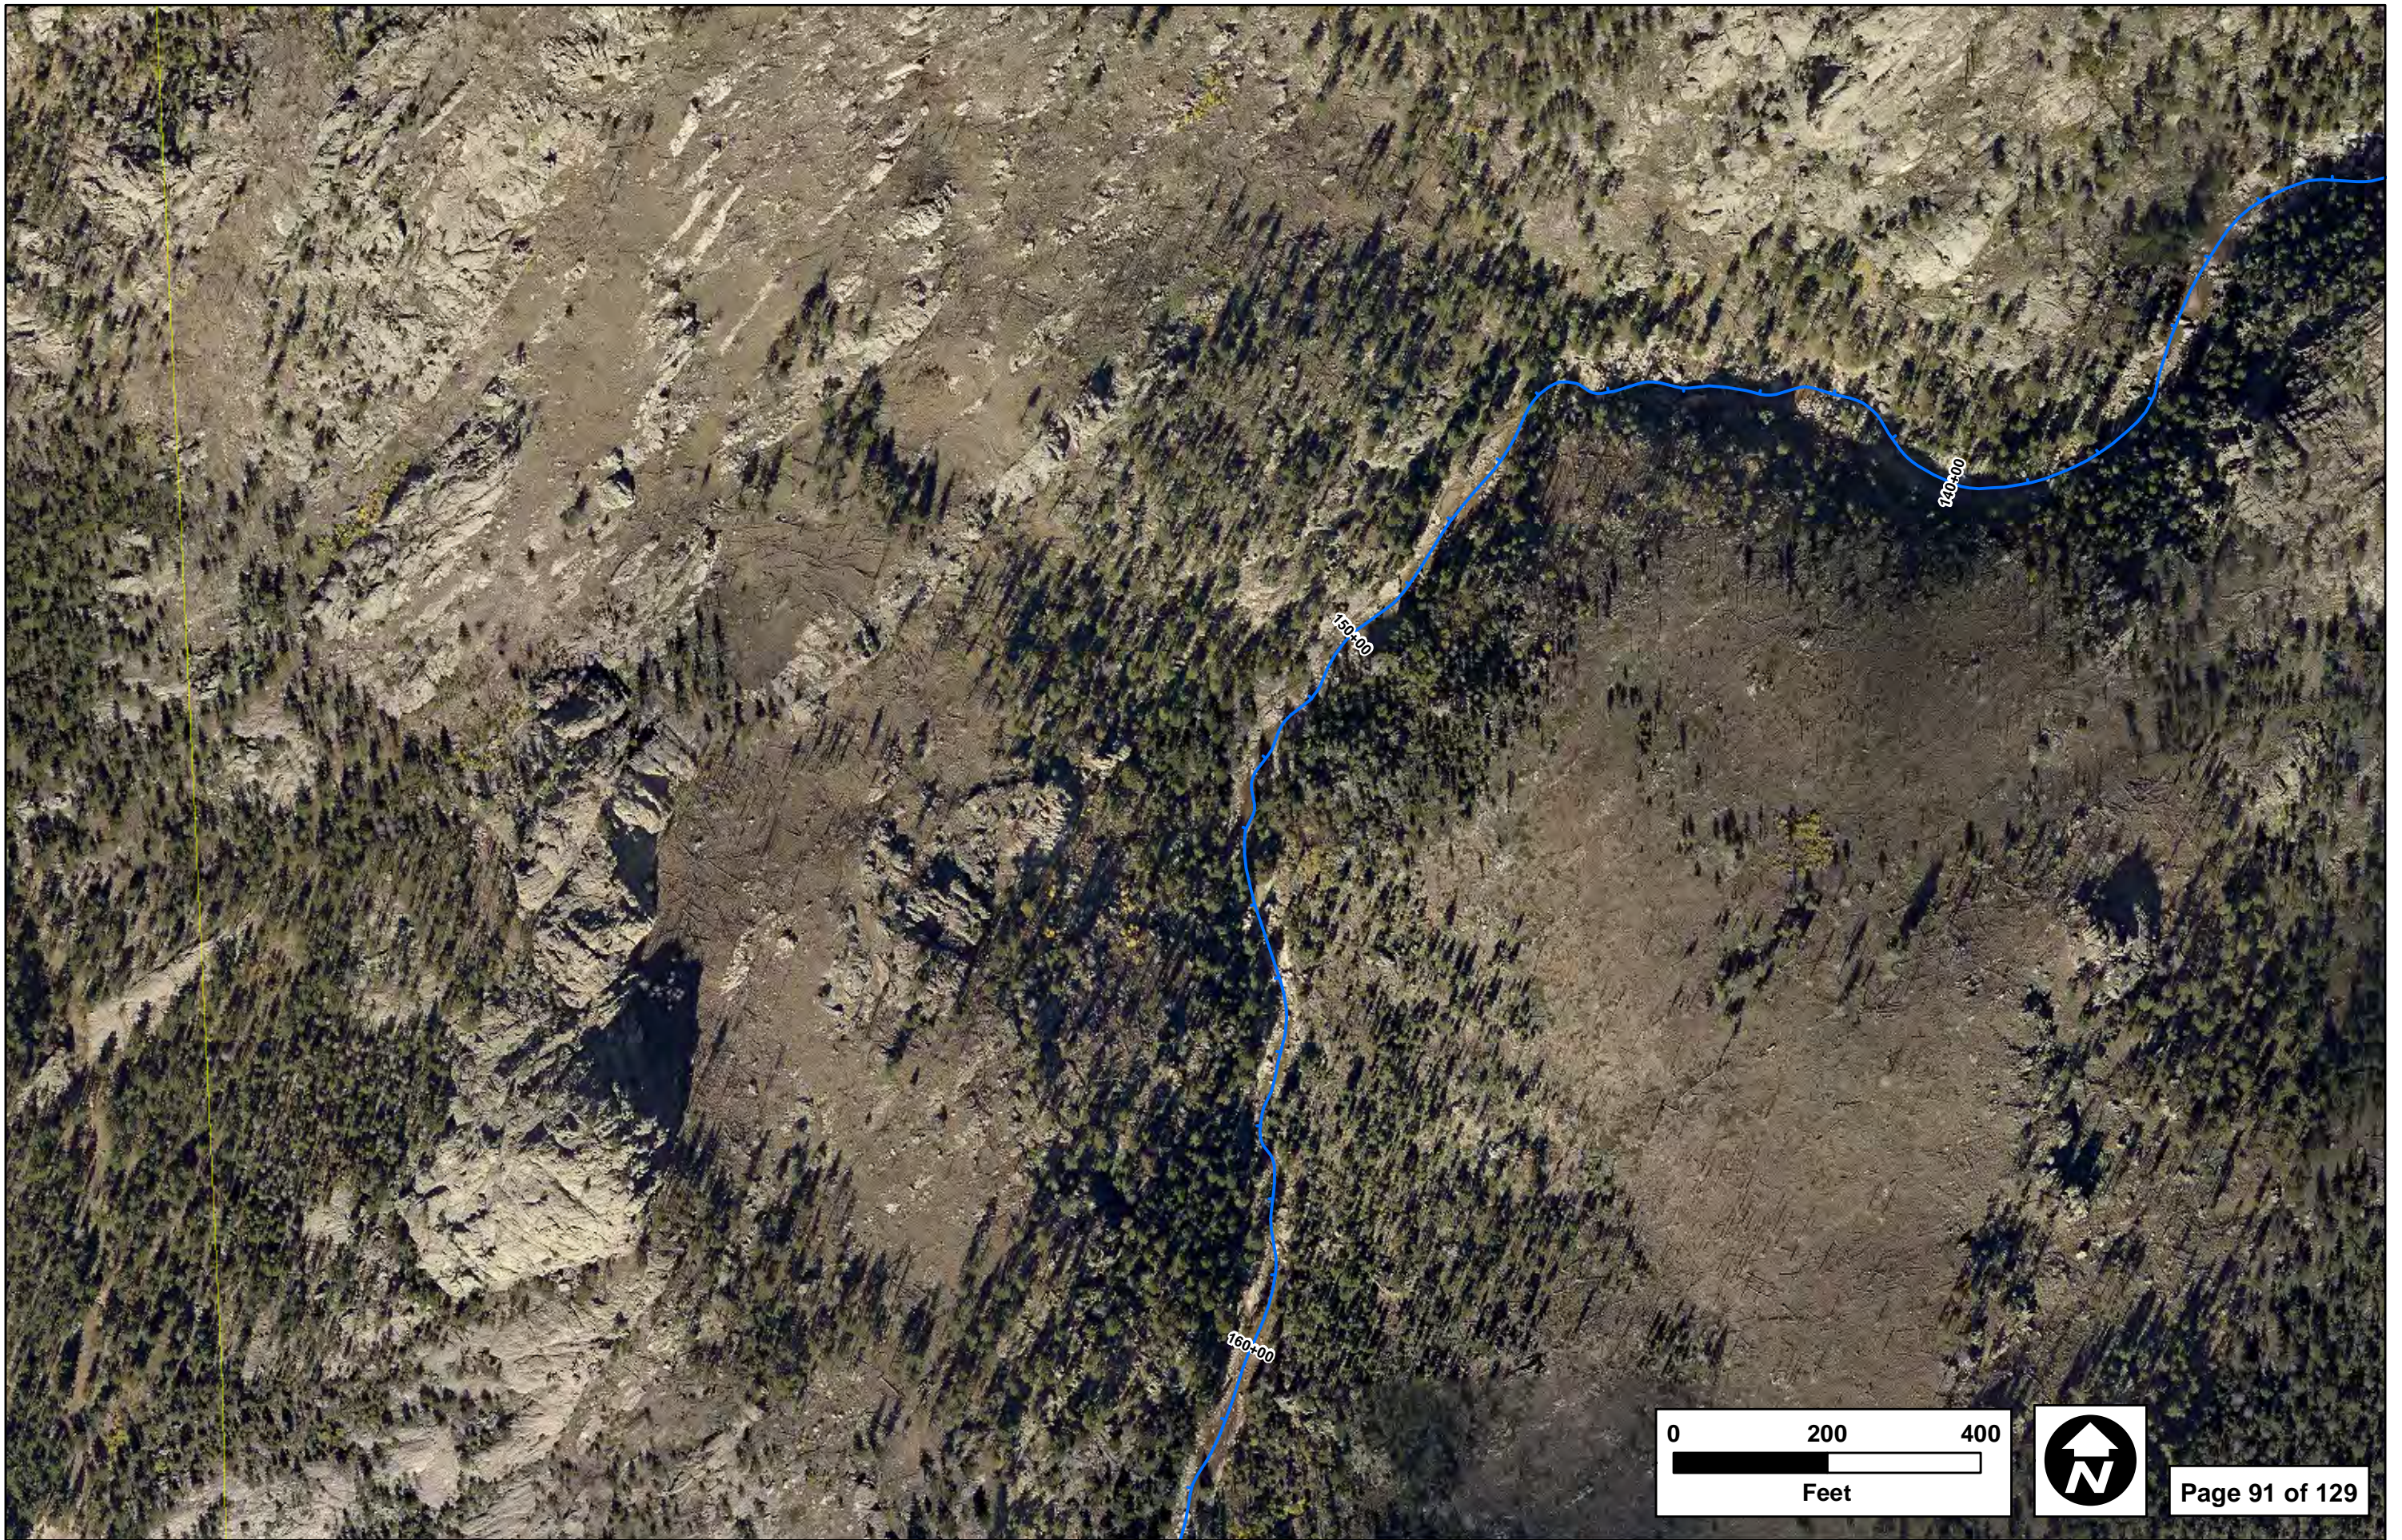
NEIGHBORHOOD: Big Elk Meadows
SHEET: 91
STATION: West Fork below Big Elk Meadows

The West Fork downstream of Big Elk Meadows is generally canyon bound with rock outcrop and walls. In portions of the reach with limited encroachment on the river corridor, the reach appears relatively stable and expected to recover without restoration activities. The USFS has no plans for debris removal or restoration activities outside of the County Road 47 corridor. Thus, no action is recommended outside of the river corridor.

Geomorphic functions of this reach is likely sufficient to allow for the natural regeneration of willow, and other riparian species through seeding and cloning without active restoration. No further actions are suggested at this time.
