APPENDIX A

ASSESSMENT PROTOCOL

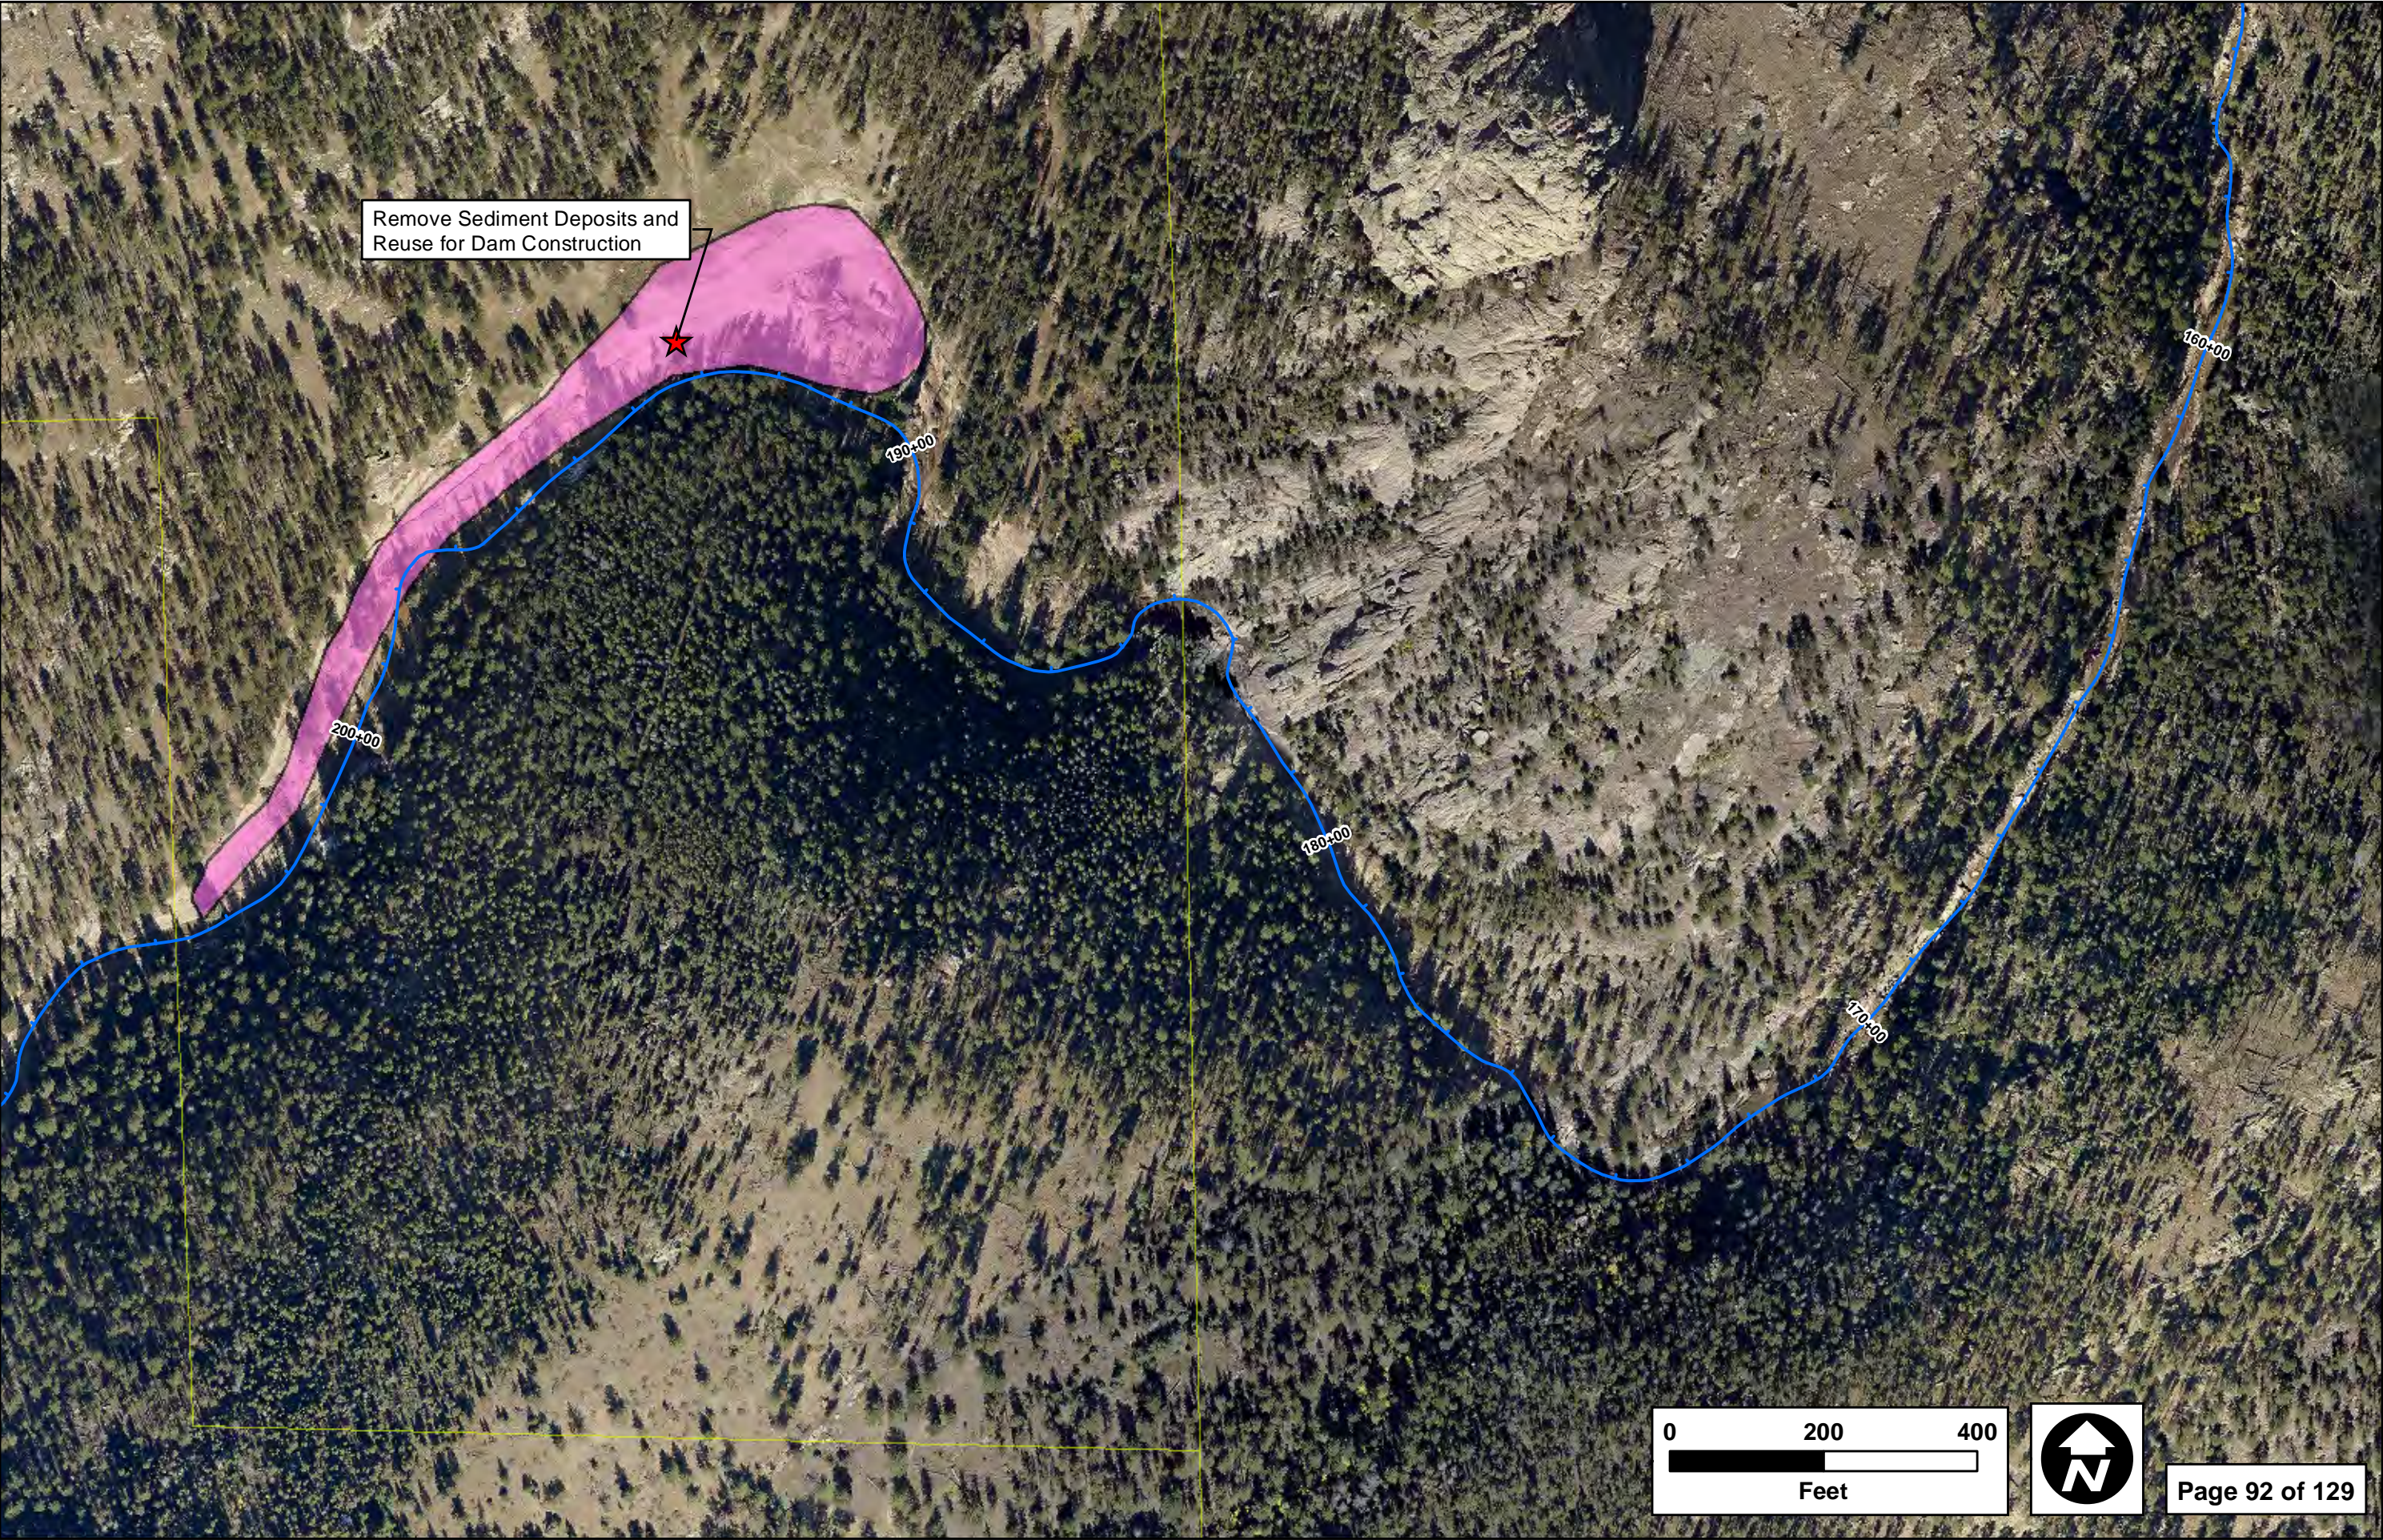
NEIGHBORHOOD: Big Elk Meadows
SHEET: 92
STATION: West Fork below Big Elk Meadows

The West Fork downstream of Big Elk Meadows is generally canyon bound with rock outcrop and walls. In portions of the reach with limited encroachment on the river corridor, the reach appears relatively stable and expected to recover without restoration activities.

Immediately downstream of Big Elk Meadows, there are sediment and debris deposits from the dam failures. Most of this is located on USFS property. Some of these sediment deposits may be usable for the proposed dam reconstruction in Big Elk Meadows. Although the USFS prefers a ‘natural’ approach to recovery, the area immediately downstream of Meadow Lake (the most downstream dam) is unnaturally impacted by deposition due to the dam failures. Thus, some removal of deposits may be warranted in that it could help the recovery of vegetation and it also could provide some building material for the dams. The suitability of the material and ease of access for removal requires detailed evaluation prior to implementation.

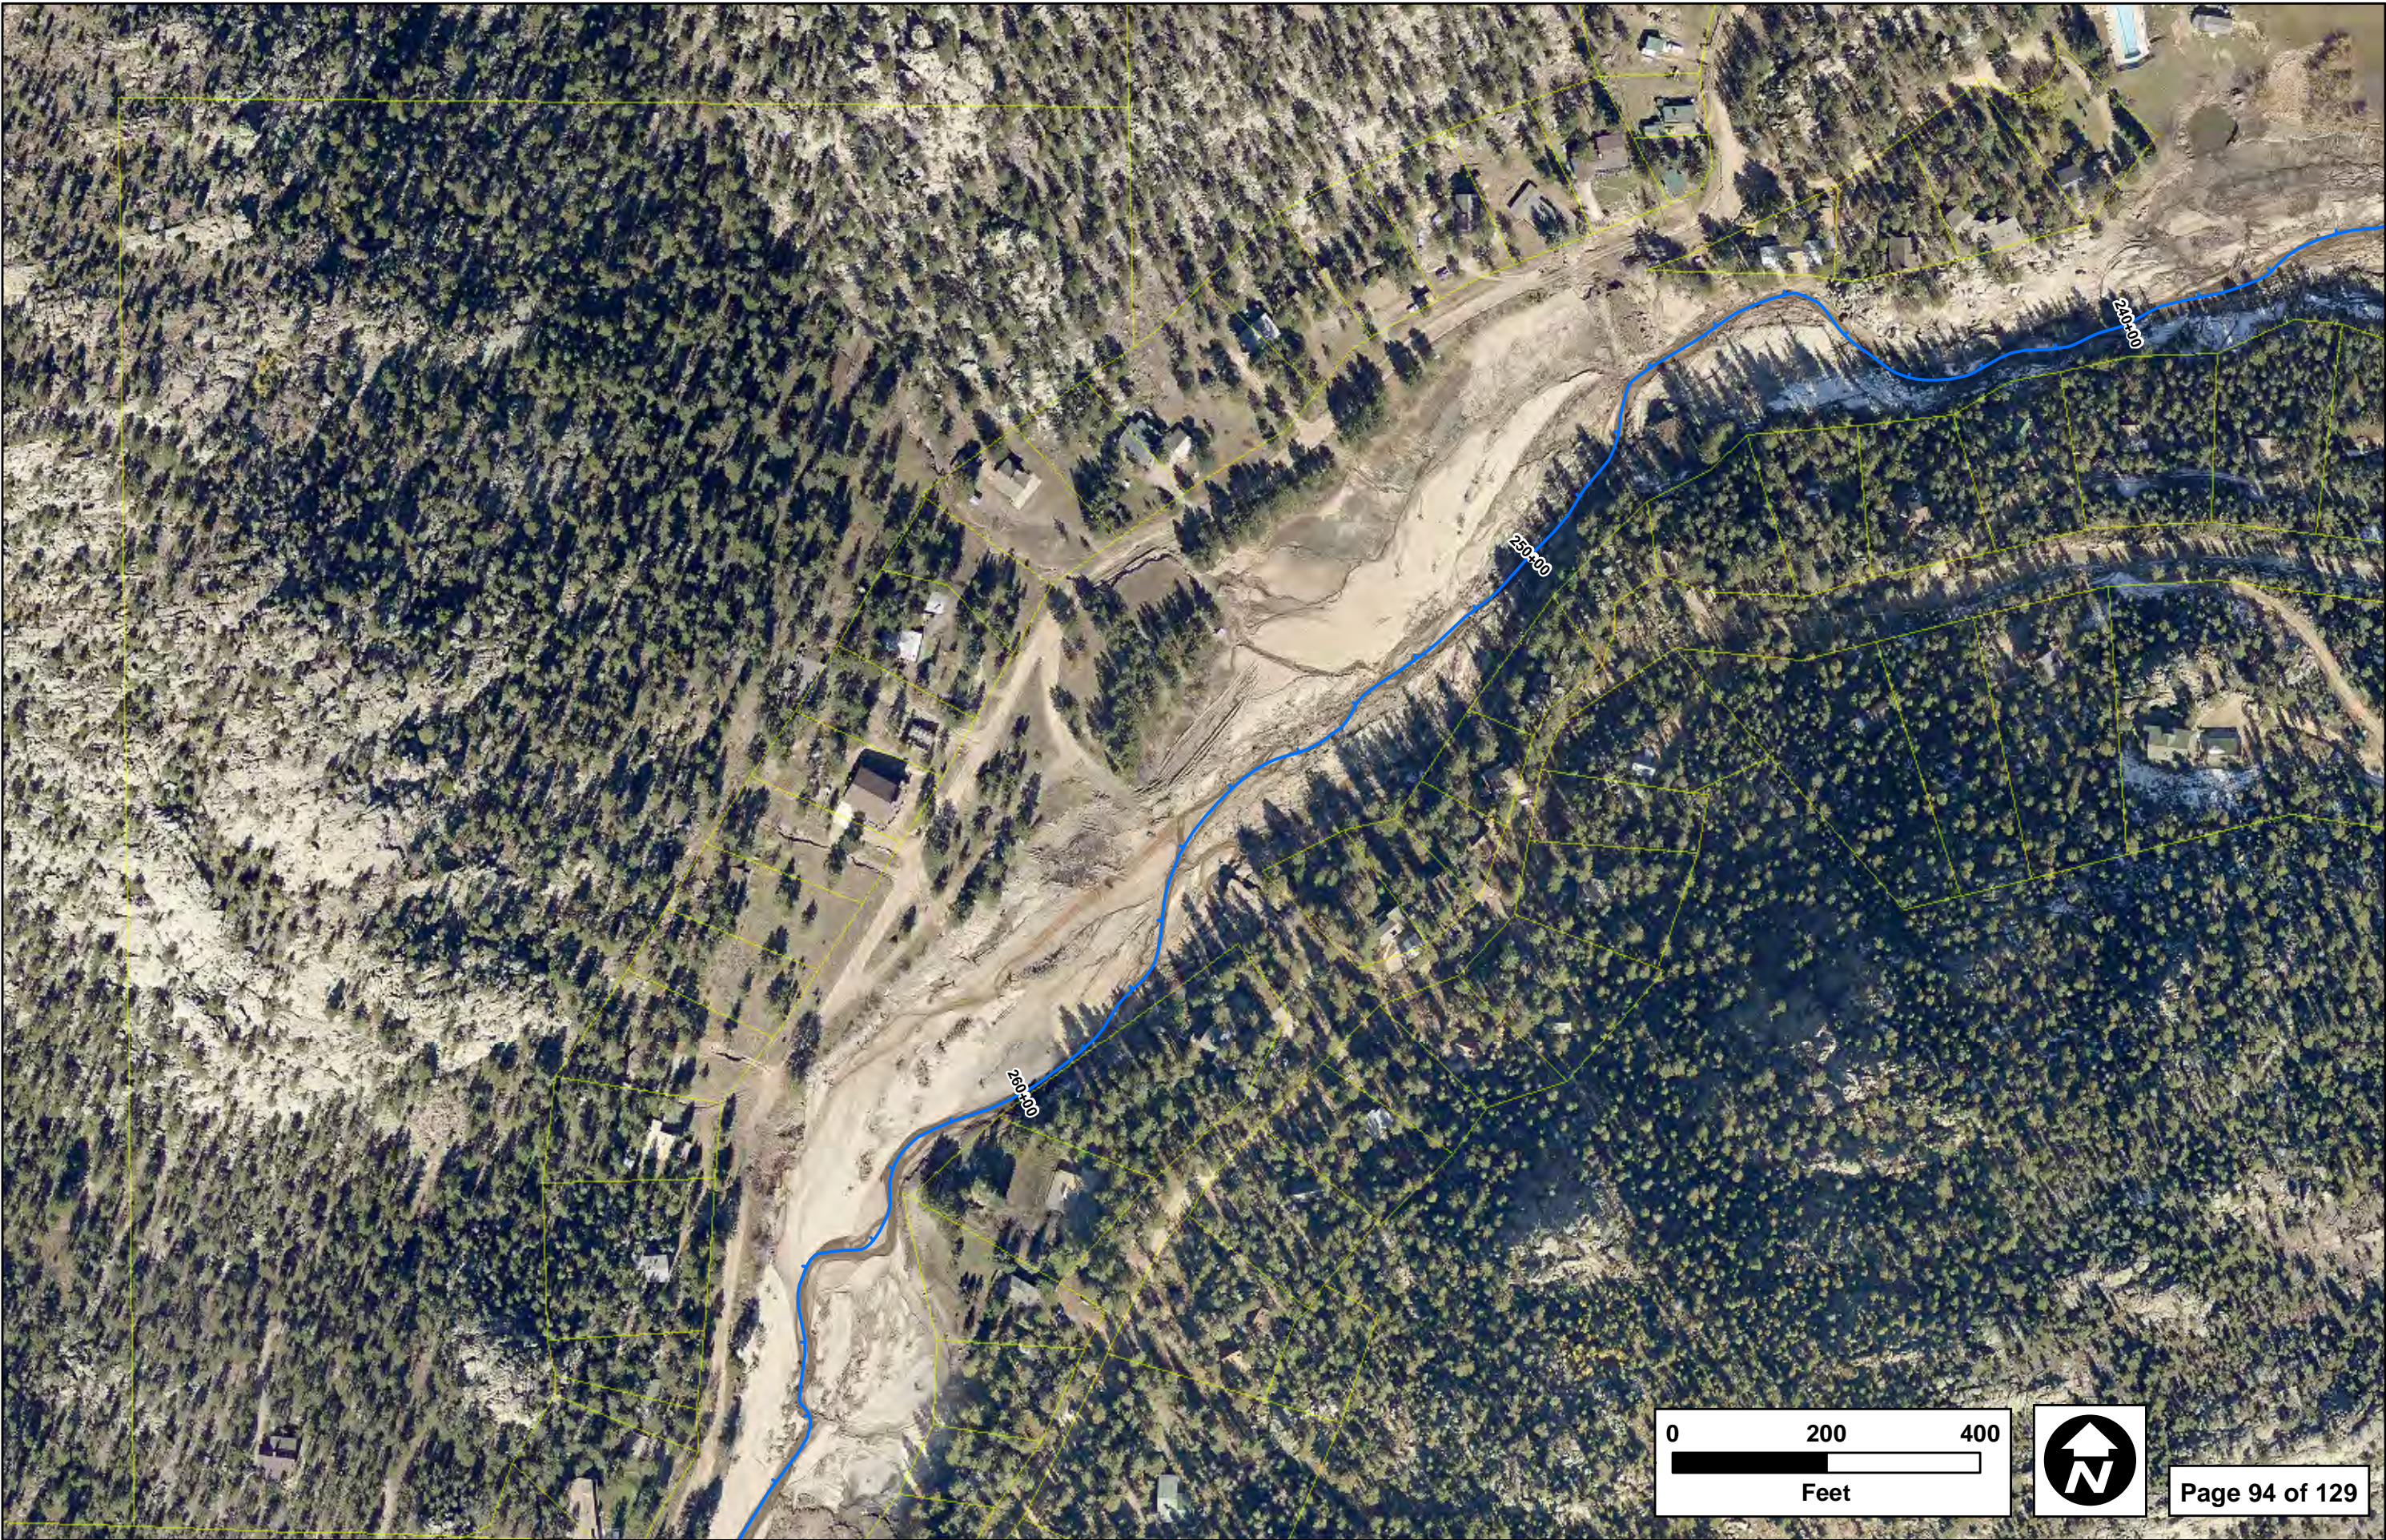
NEIGHBORHOOD: Big Elk Meadows
SHEET: 94
STATION: West Fork at Big Elk Meadows

Within the footprint of Big Elk Meadows, the West Fork was configured into five reservoirs spanning a distance of 1 mile. The dams are owned by the Big Elk Meadows Association and provide a water source for the residence of Big Elk Meadows. All five dams failed during the 2013 Flood. No restoration recommendations are proposed as the dams will likely be reconstructed.

No restoration recommendations are proposed as the dams will likely be reconstructed by Big Elks Meadows Association.

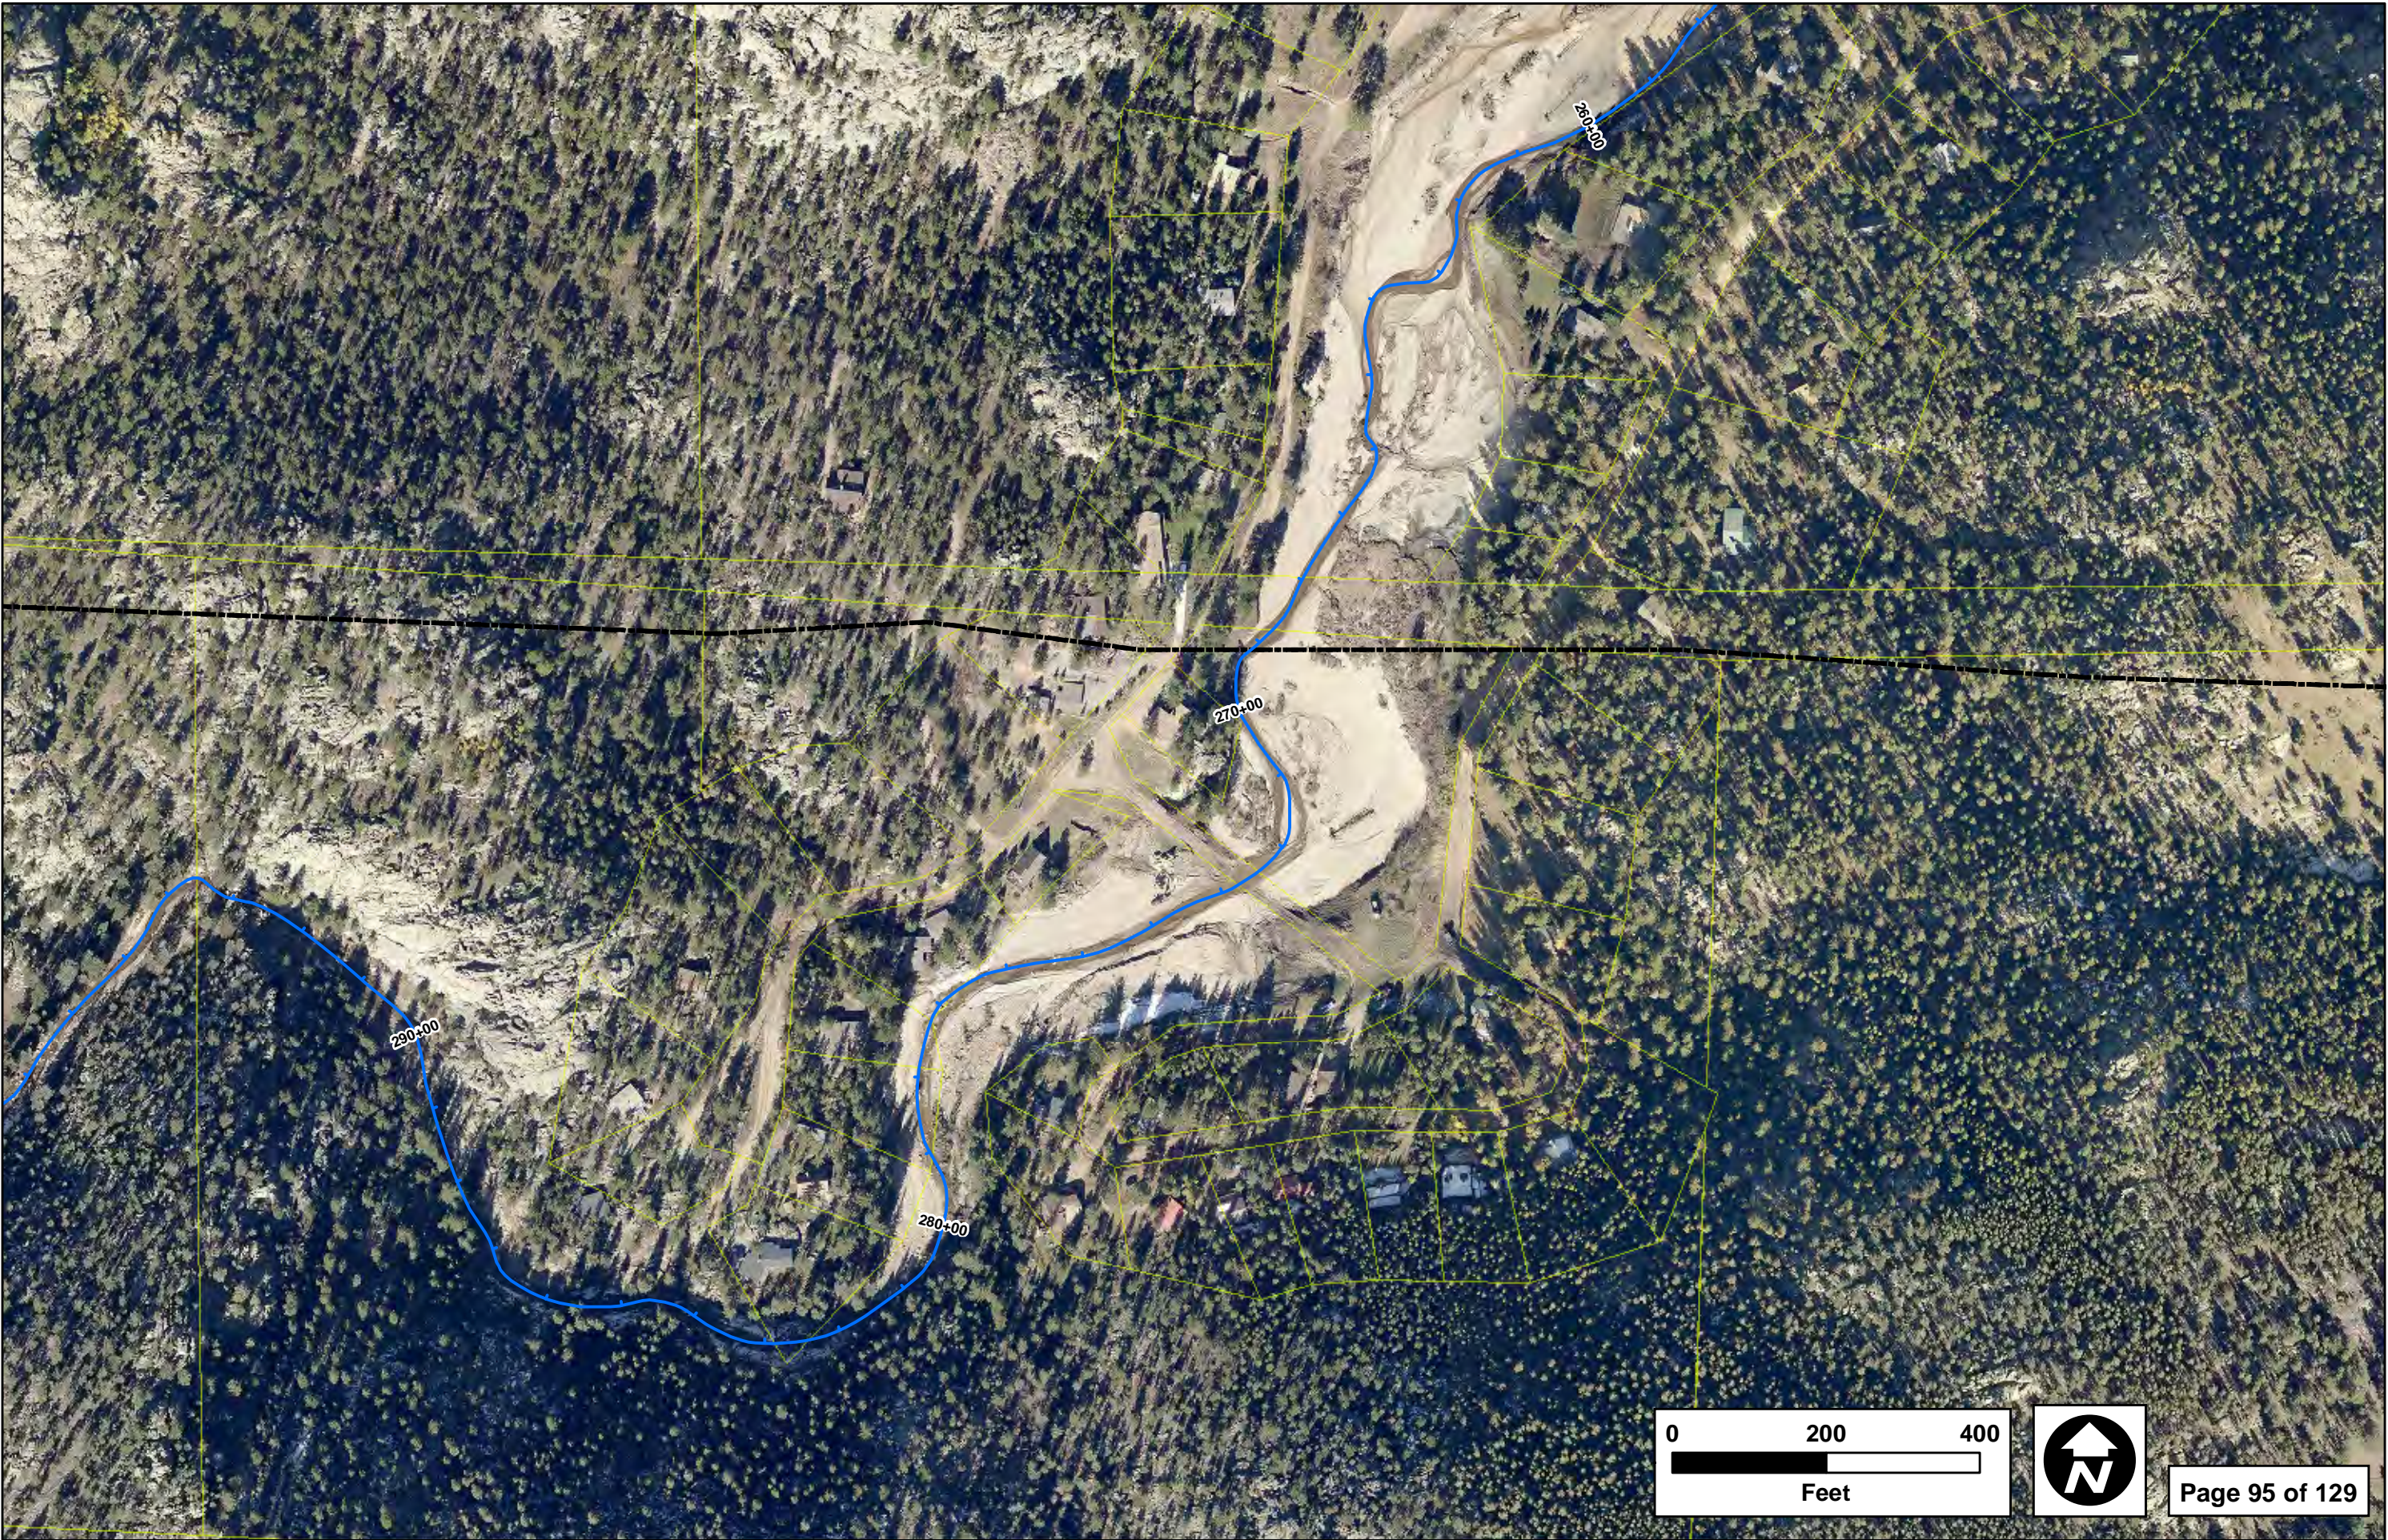
NEIGHBORHOOD: Big Elk Meadows
SHEET: 95
STATION: West Fork at Big Elk Meadows

Within the footprint of Big Elk Meadows, the West Fork was configured into five reservoirs spanning a distance of 1 mile. The dams are owned by the Big Elk Meadows Association and provide a water source for the residence of Big Elk Meadows. All 5 dams failed during the 2013 Flood. No restoration recommendations are proposed as the dams will likely be reconstructed.

No restoration recommendations are proposed as the dams will likely be reconstructed by Big Elks Meadows Association.

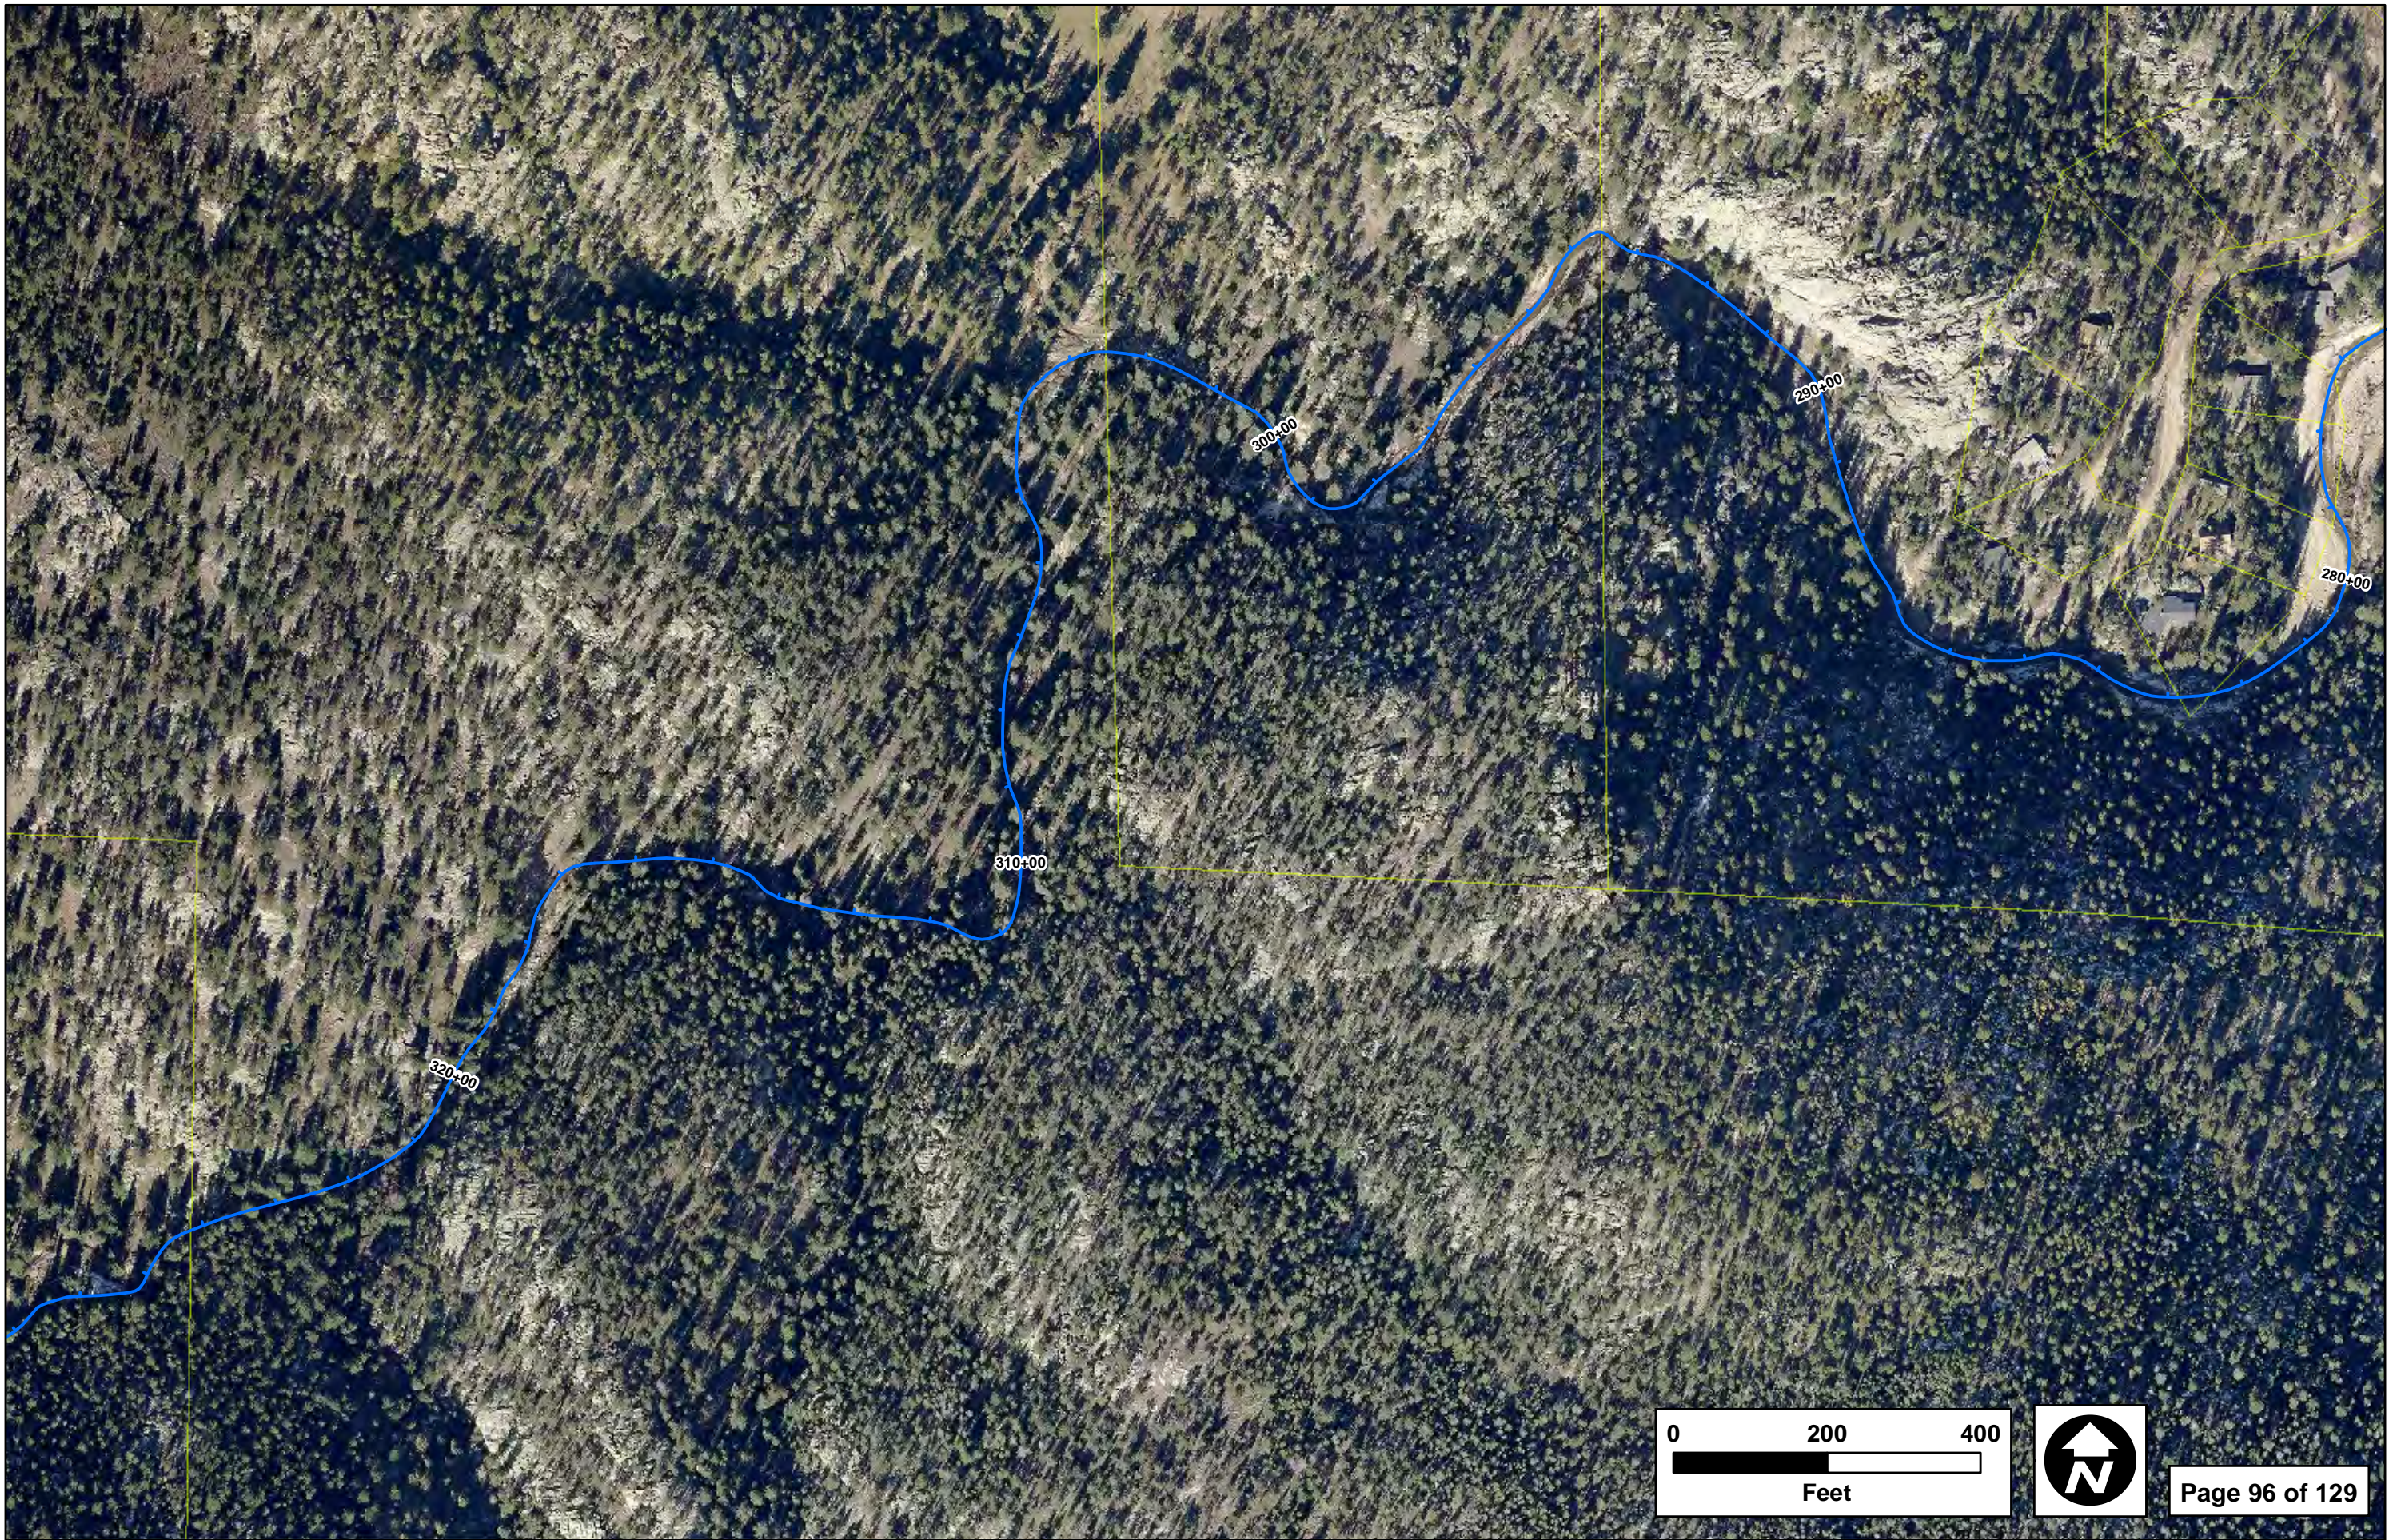
NEIGHBORHOOD: Big Elk Meadows
SHEET: 96
STATION: West Fork above Big Elk Meadows

The West Fork upstream of Big Elk Meadows is generally canyon bound with rock outcrop and walls. This reach is isolated with very limited encroachment on the river corridor. Aerial images indicate a potential debris flow in the upper watershed that may have contributed to the deposition observed in the portions of the West Fork in and near Big Elk Meadows. However, the river appears relatively stable and expected to recover without restoration activities. The USFS has no plans for debris removal or restoration activities.

Geomorphic functions of this reach is likely sufficient to allow for the natural regeneration of willow, and other riparian species through seeding and cloning without active restoration. No further actions are suggested at this time.

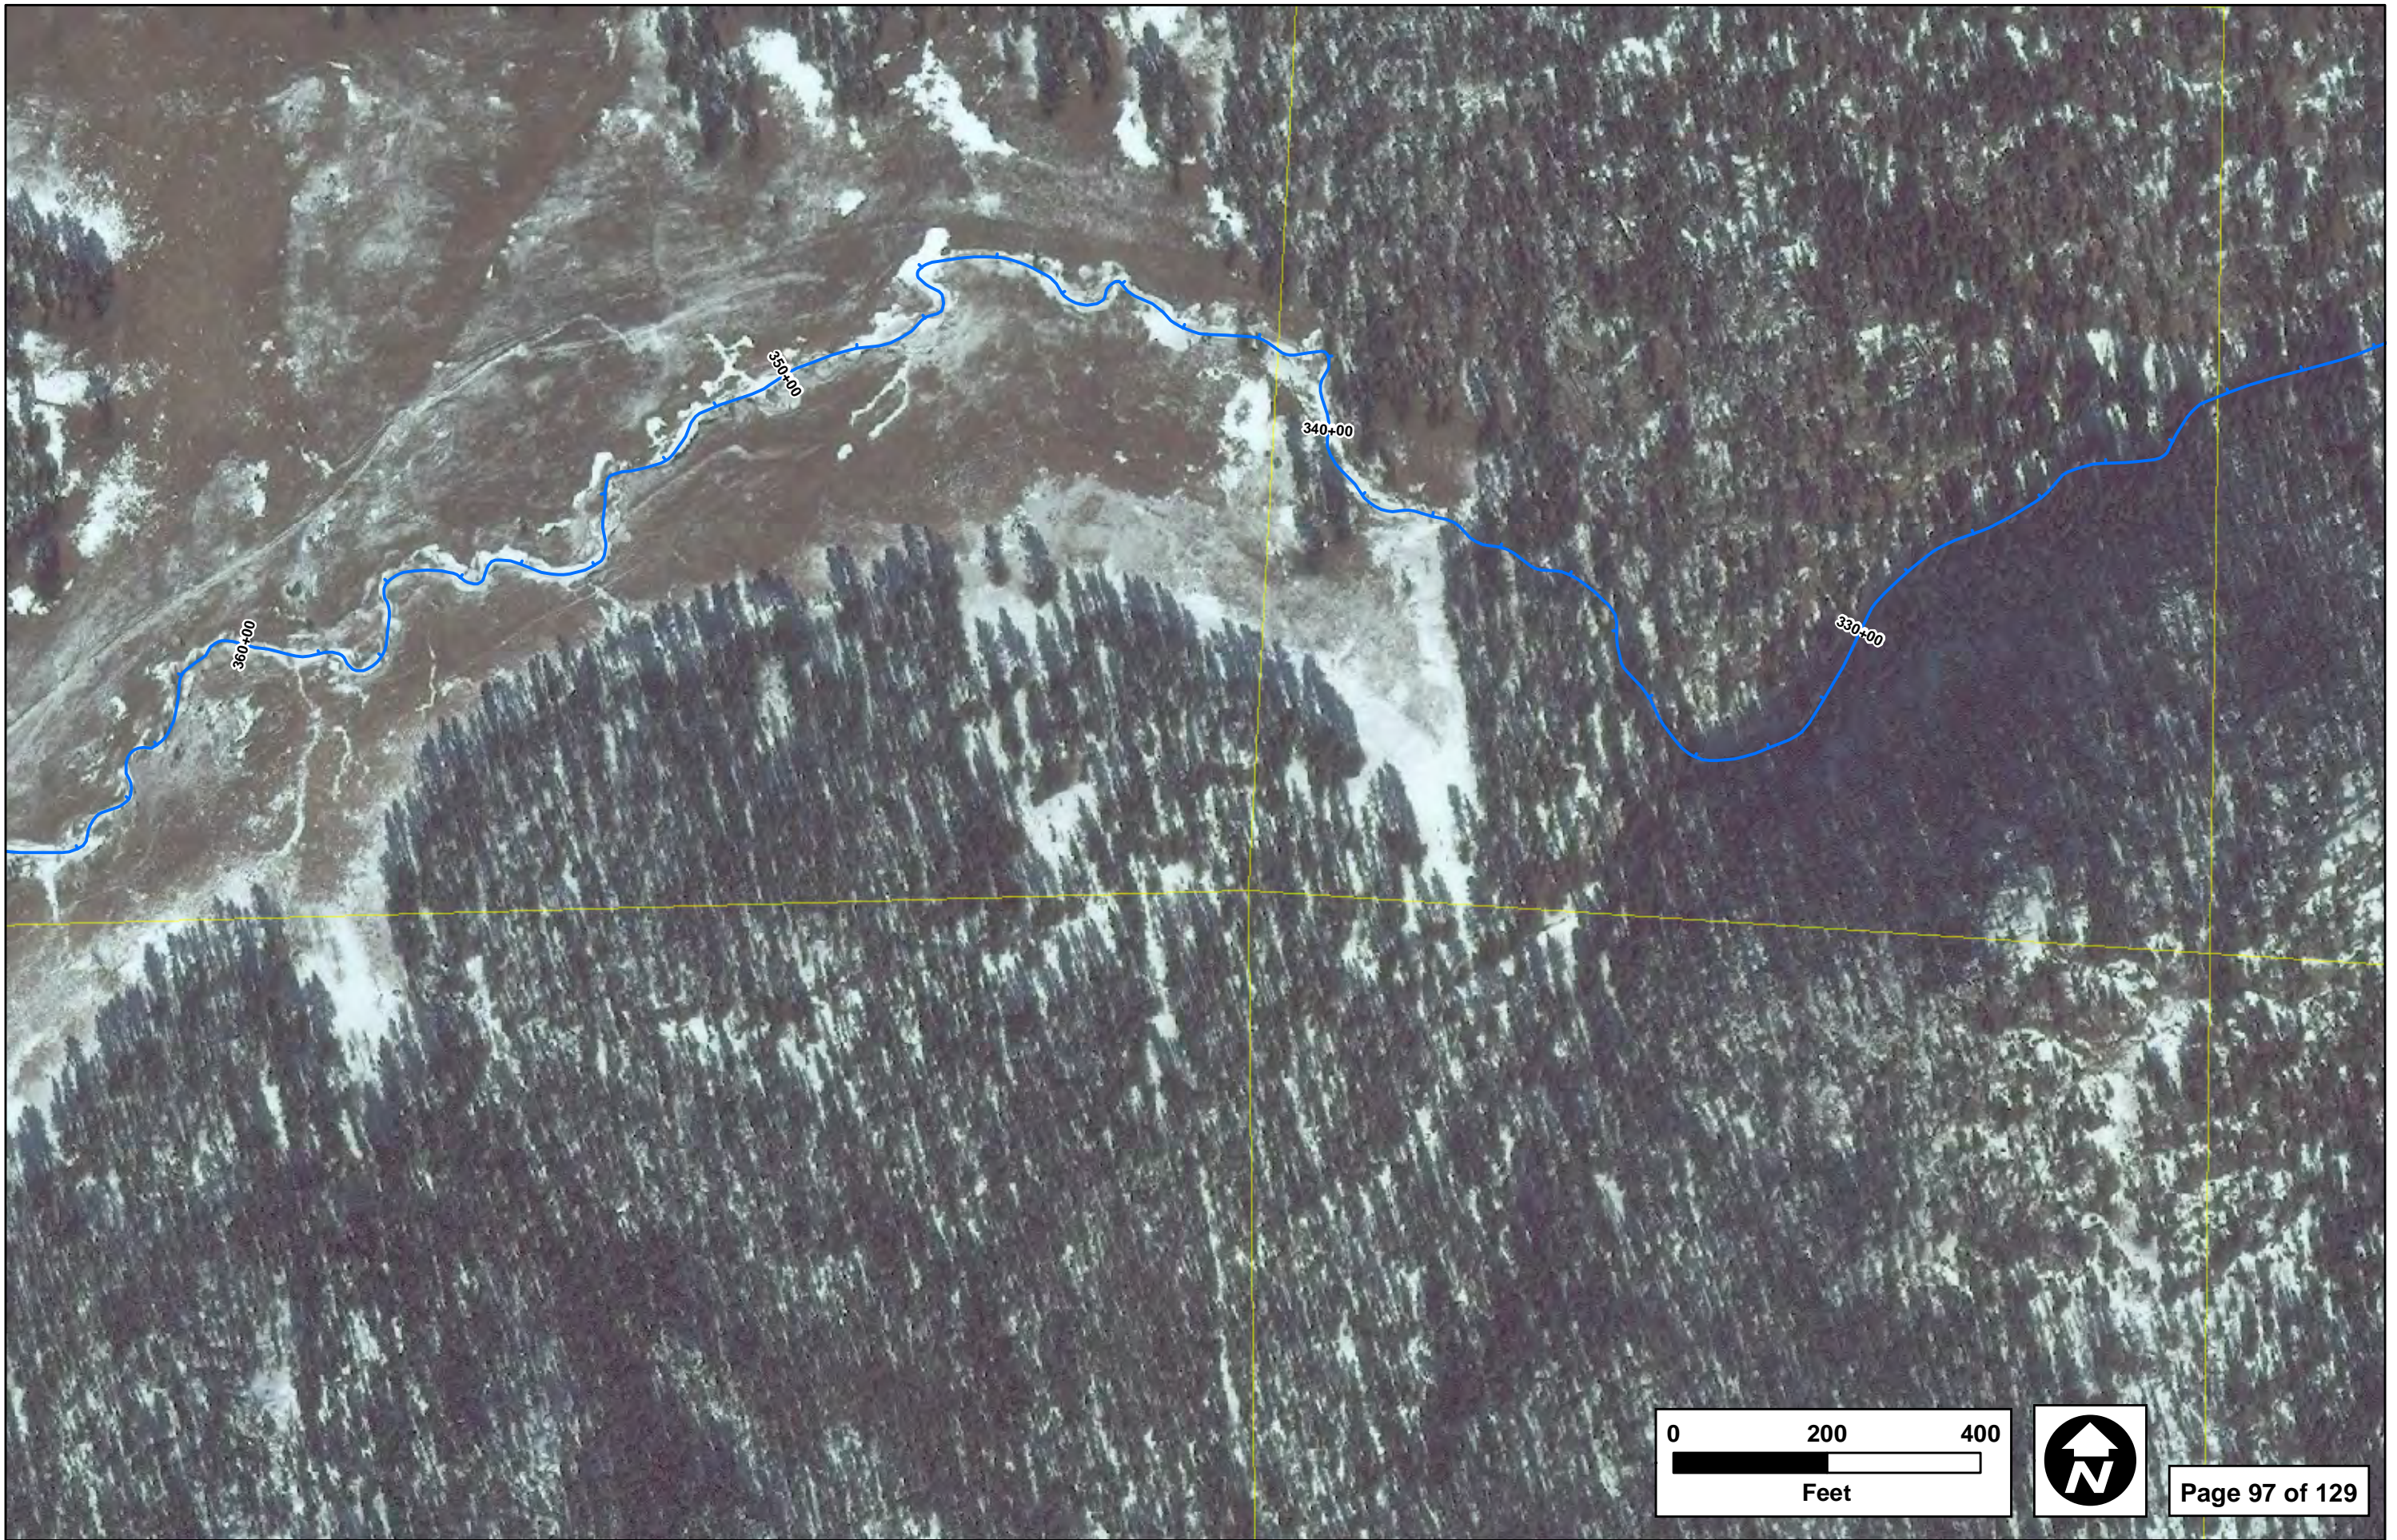
NEIGHBORHOOD: Big Elk Meadows
SHEET: 97
STATION: West Fork above Big Elk Meadows

The West Fork upstream of Big Elk Meadows is generally canyon bound with rock outcrop and walls. This reach is isolated with very limited encroachment on the river corridor. Aerial images indicate a potential debris flow in the upper watershed that may have contributed to the deposition observed in the portions of the West Fork in and near Big Elk Meadows. However, the river appears relatively stable and expected to recover without restoration activities. The USFS has no plans for debris removal or restoration activities.

Geomorphic functions of this reach is likely sufficient to allow for the natural regeneration of willow, and other riparian species through seeding and cloning without active restoration. No further actions are suggested at this time.
