APPENDIX A

ASSESSMENT PROTOCOL

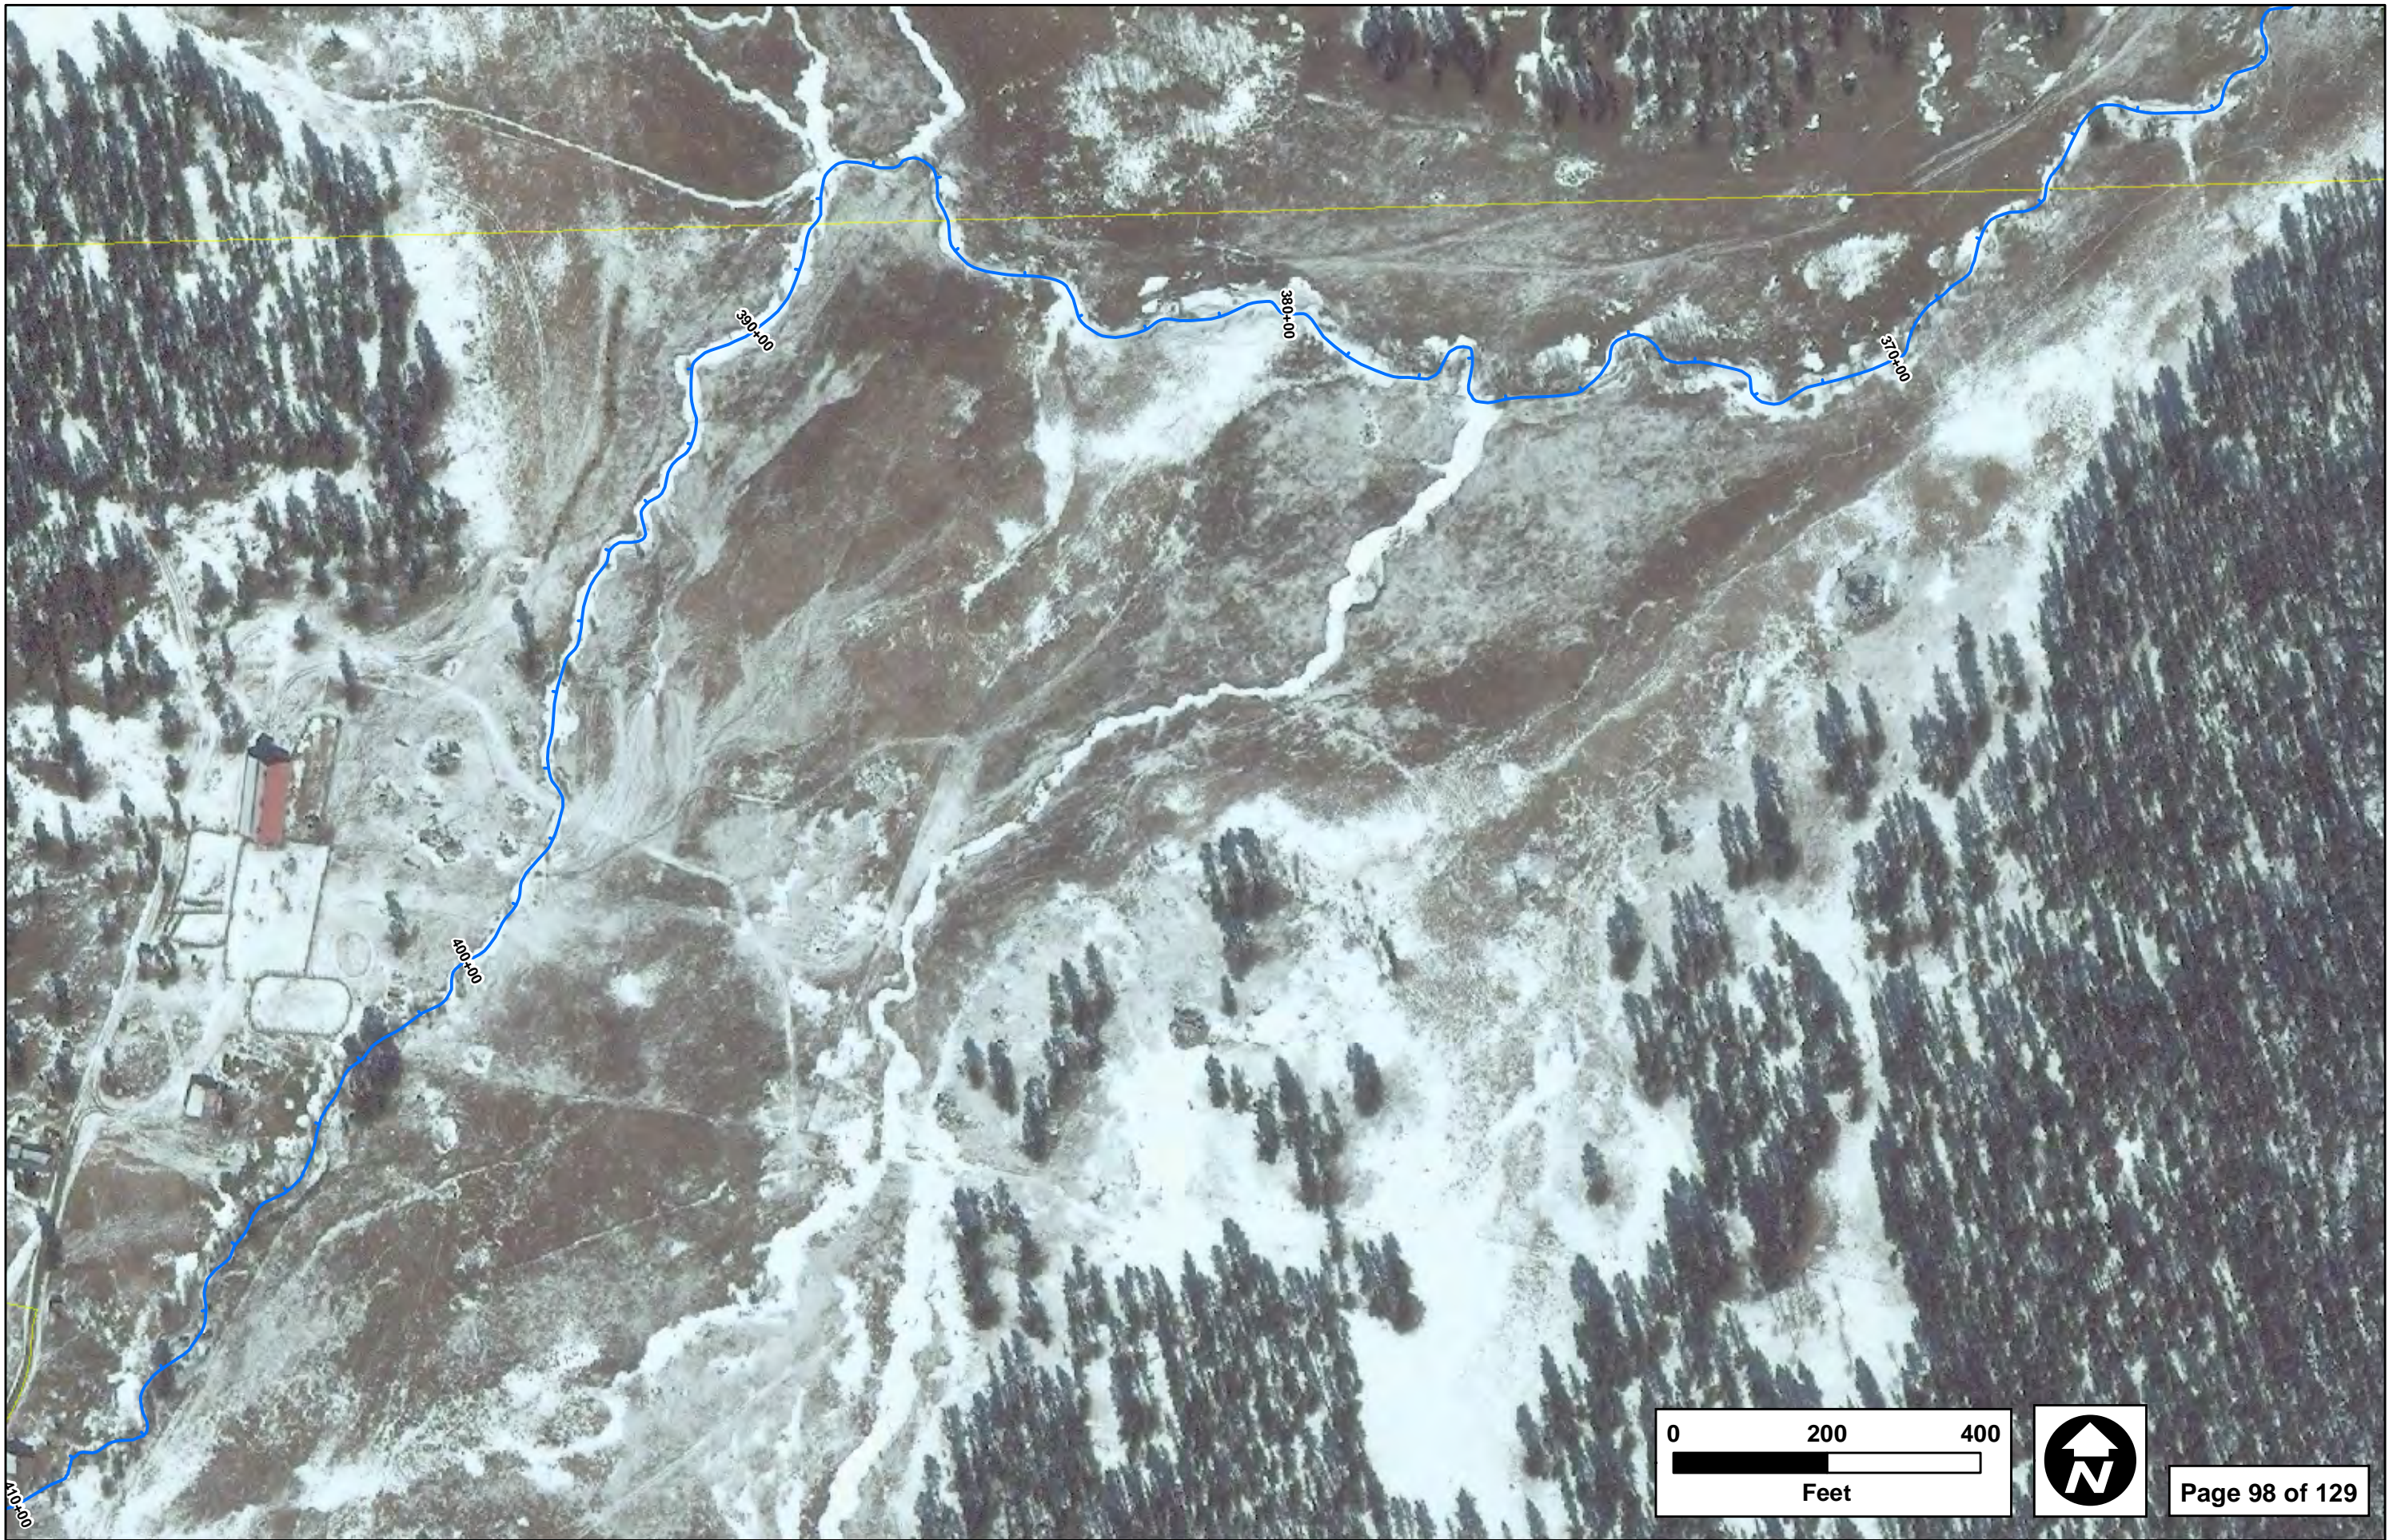
NEIGHBORHOOD: Big Elk Meadows
SHEET: 98
STATION: West Fork above Big Elk Meadows

The West Fork upstream of Big Elk Meadows is generally canyon-bound with rock outcrop and walls. This reach is isolated with very limited encroachment on the river corridor. Aerial images indicate a potential debris flow in the upper watershed that may have contributed to the deposition observed in the portions of the West Fork in and near Big Elk Meadows. However, the river appears relatively stable and expected to recover without restoration activities. The USFS has no plans for debris removal or restoration activities.

Geomorphic functions of this reach is likely sufficient to allow for the natural regeneration of willow, and other riparian species through seeding and cloning without active restoration. No further actions are suggested at this time.

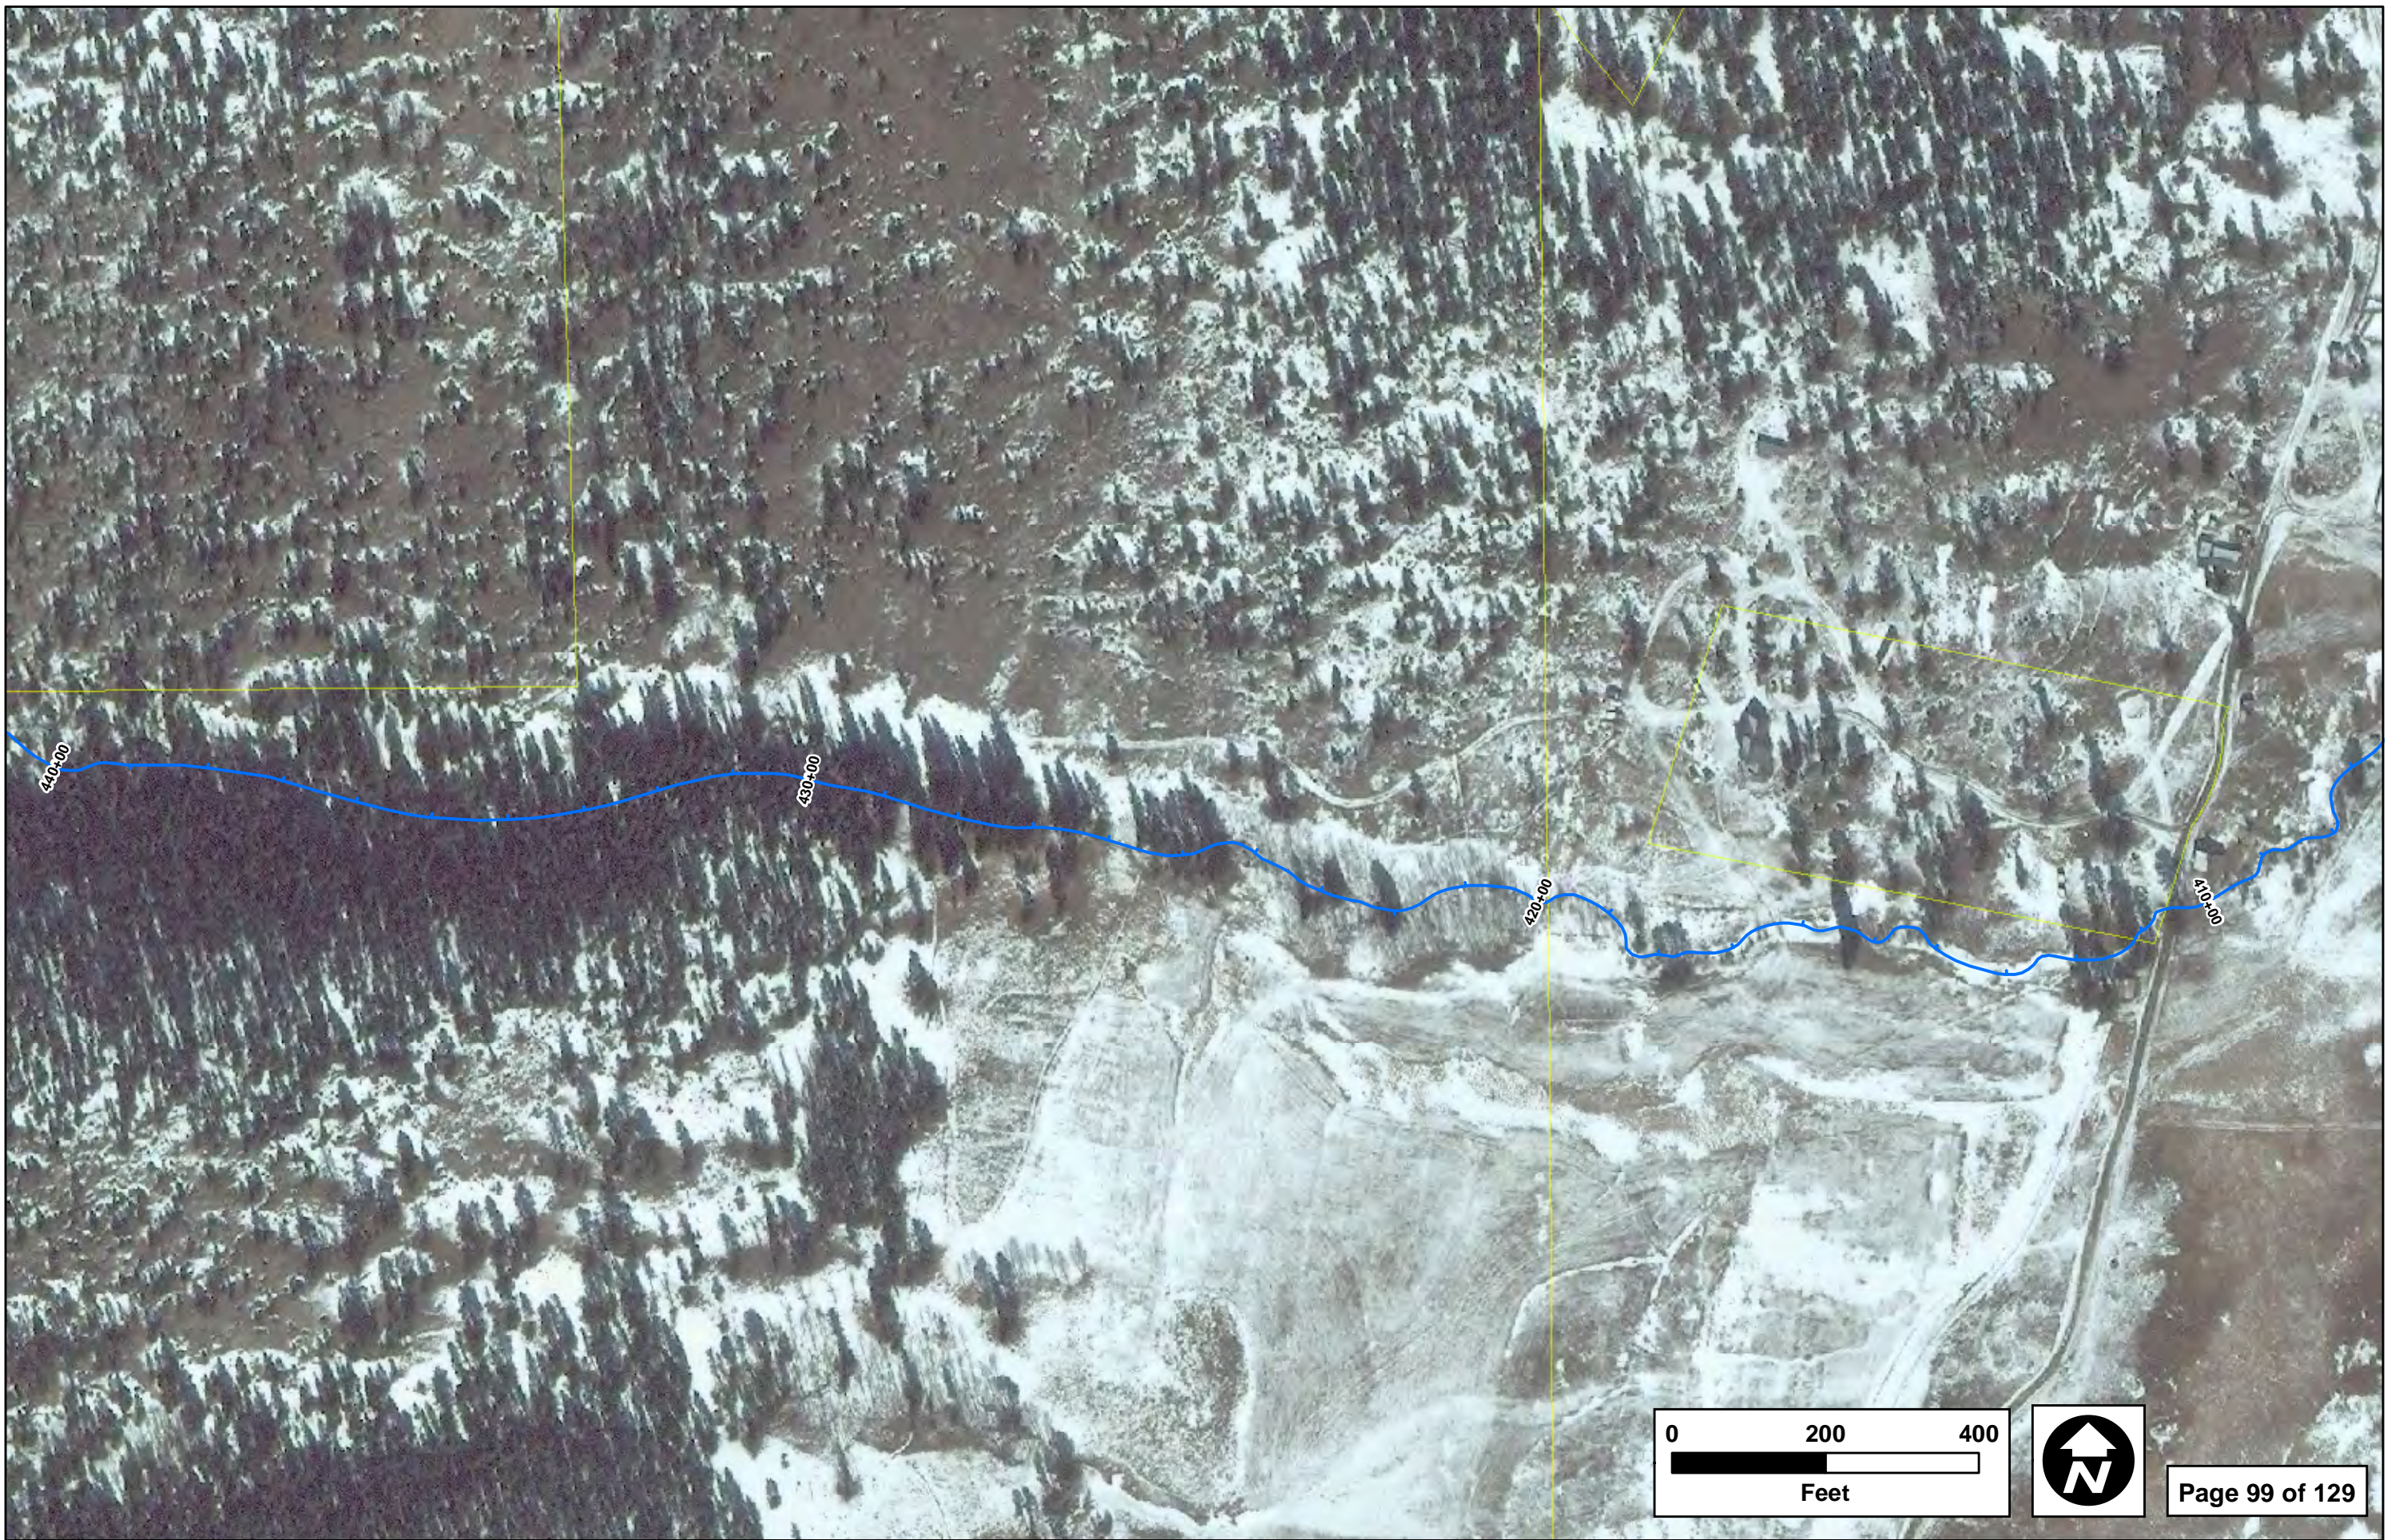
NEIGHBORHOOD: Big Elk Meadows
SHEET: 99
STATION: West Fork above Big Elk Meadows

The West Fork upstream of Big Elk Meadows is generally canyon-bound with rock outcrop and walls. This reach is isolated with very limited encroachment on the river corridor. Aerial images indicate a potential debris flow in the upper watershed that may have contributed to the deposition observed in the portions of the West Fork in and near Big Elk Meadows. However, the river appears relatively stable and expected to recover without restoration activities. The USFS has no plans for debris removal or restoration activities.

Geomorphic functions of this reach is likely sufficient to allow for the natural regeneration of willow, and other riparian species through seeding and cloning without active restoration. No further actions are suggested at this time.
