Boulder County Parks and Open Space Small Grant Program

***Rapid Stream Stability Assessment Validation Study
South St. Vrain River, Hall-II
St. Vrain River, Western Mobile***

December 14, 2015

AloTerra Restoration Services, LLC

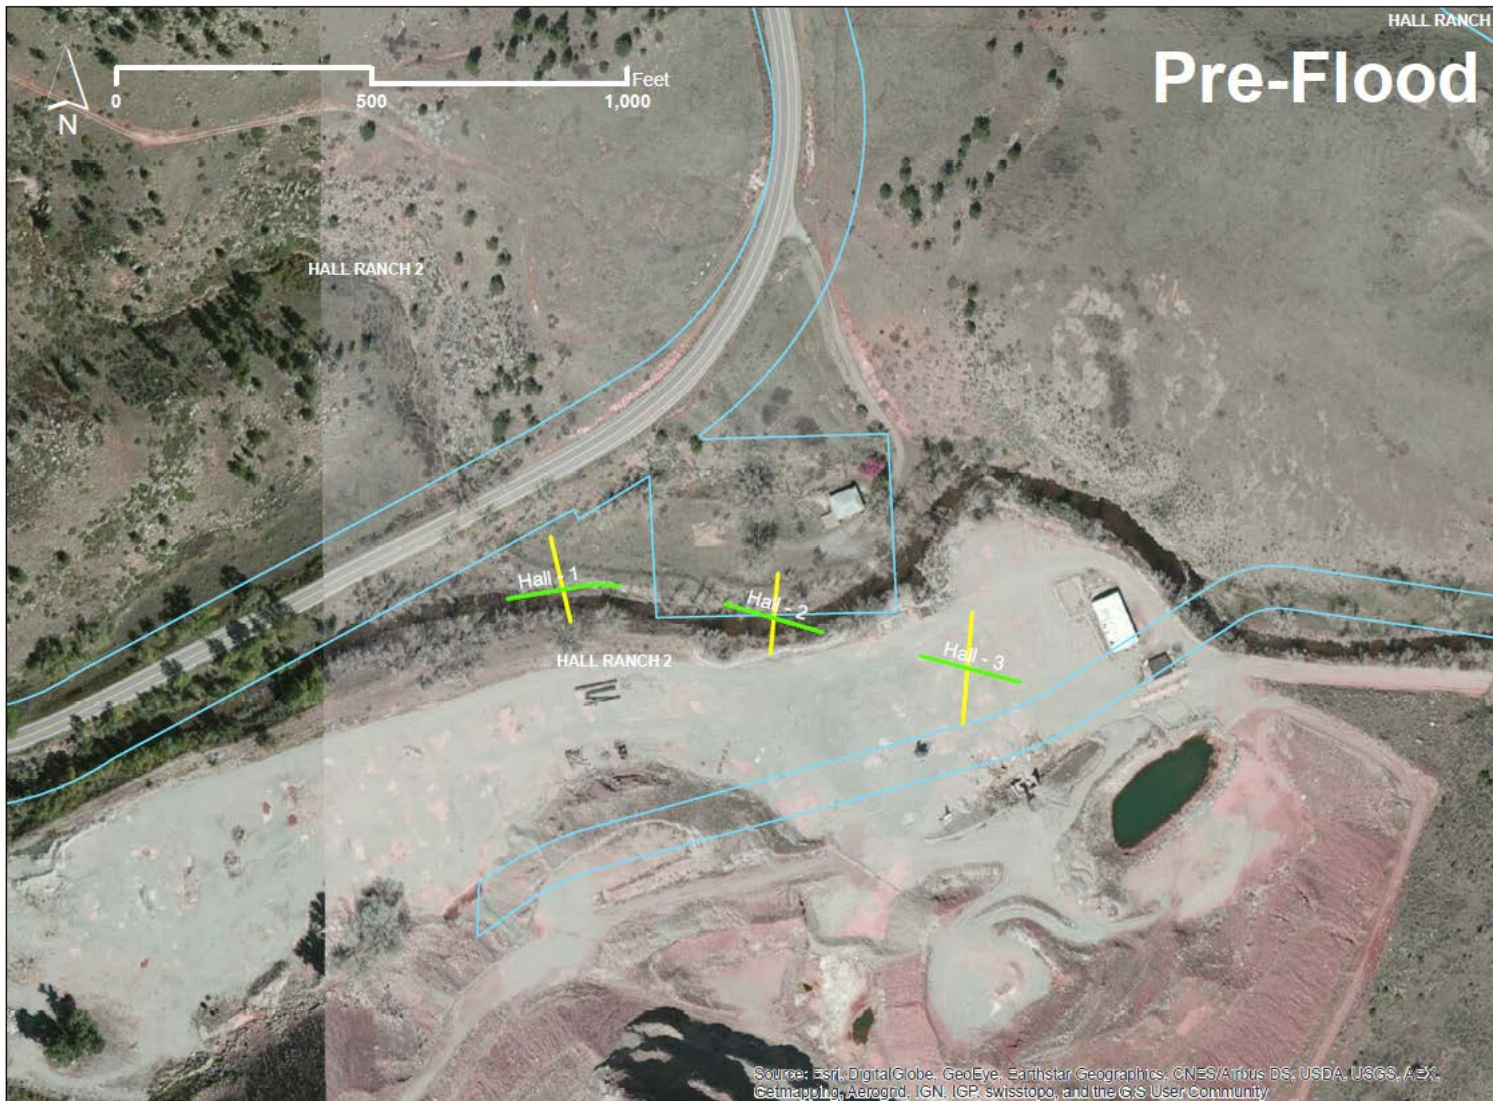
Figure 3. Pre-Flood aerial photograph of the Hall-II site with longitudinal profiles (green) and cross-section survey transects (yellow).

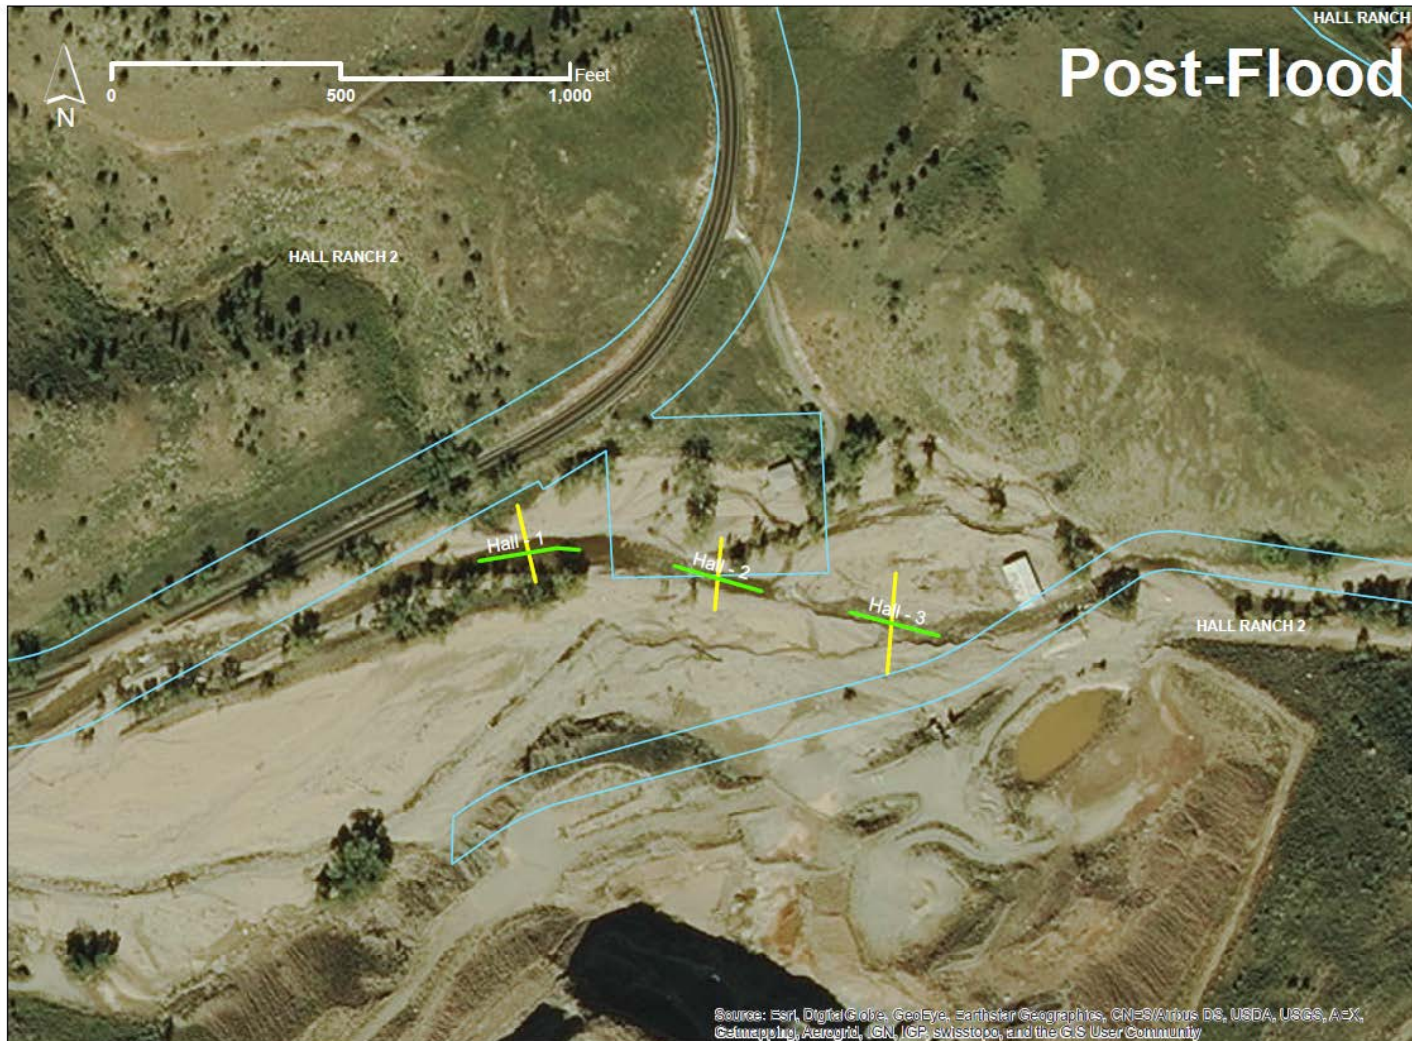
Figure 4. Post-Flood aerial photograph of the Hall-II site with longitudinal profiles (green) and cross-section survey transects (yellow).

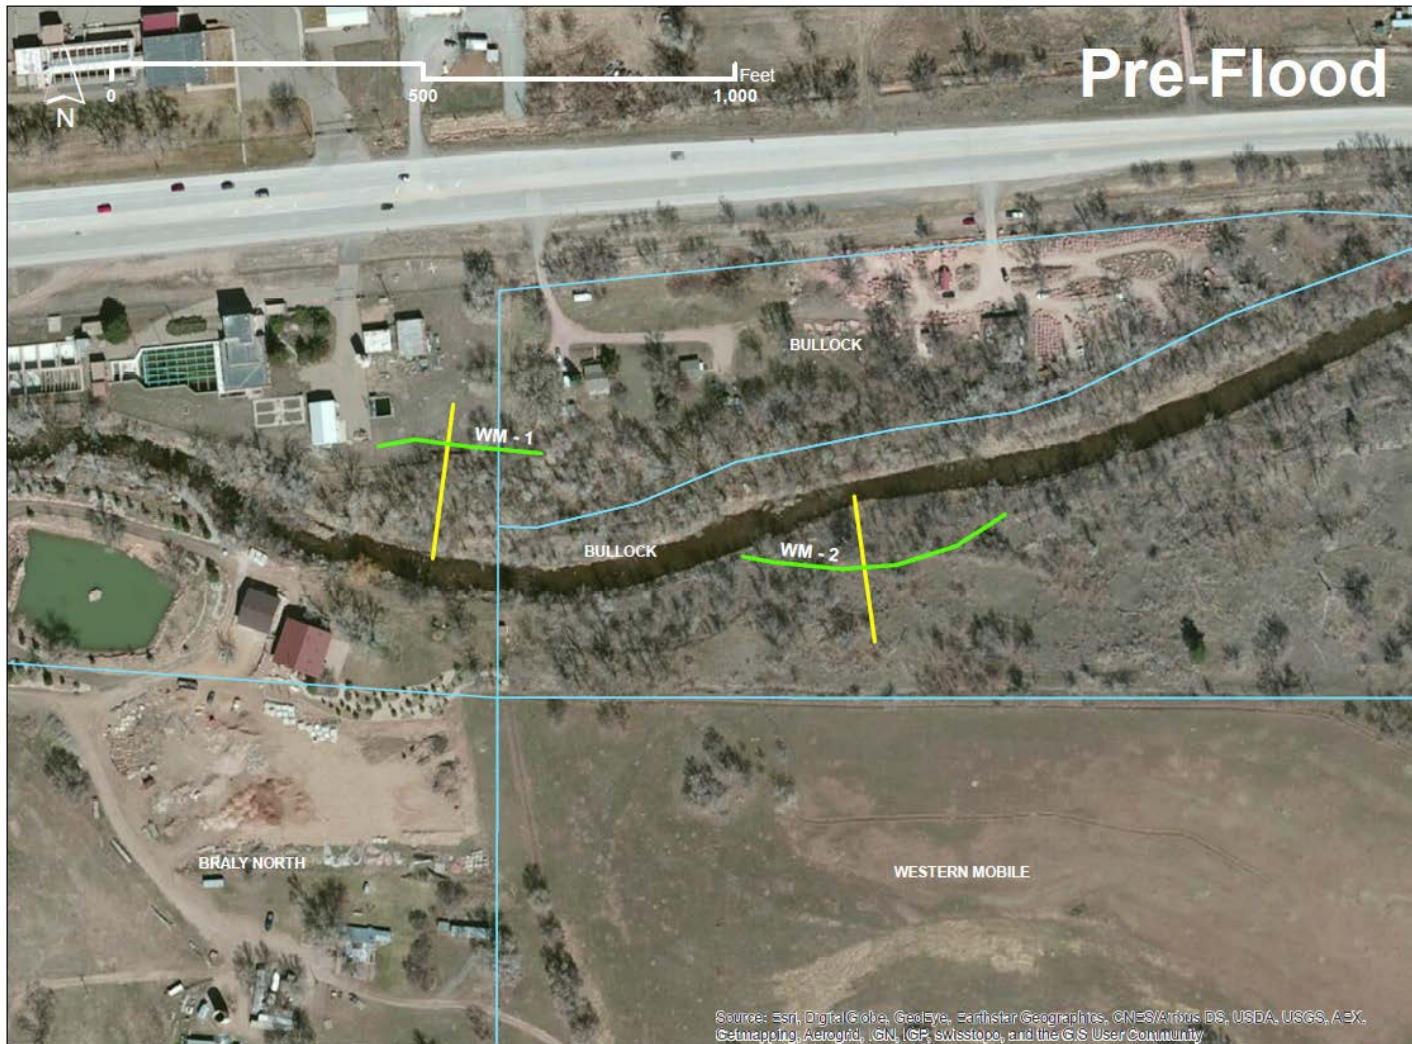
This section of river is very wide, possibly over-widened due to the flood, with top-of-bank widths ranging from approximately 110 to 150 feet and width-to-depth ratios of 16 to 25. Mid-channel bars observed along WM-1 may indicate that the channel is aggrading and beginning to narrow. The banks of WM-1 are very steep and unstable, especially on river left where maximum bank height is about 9.5 feet. The WM-2 reach is a meander bend with more shallow banks on river right and a point bar on river left (max bank height \approx 4.5 feet). Negligible vegetation exists on the banks and riparian area of WM-1. A mature cottonwood and willow forest exists on river left of WM-2 at the edge of the active point bar. Approximately two year old cottonwood seedlings were observed along the toe of the right bank of the downstream end of WM-1 and upstream end of WM-2 providing some level of stability to these banks. However, no perennial vegetation was observed within the rip rapped portion of this bank, only annual herbs and grasses.

within the longitudinal profile. Average reach slope ranges from approximately 0.8% to 1%. A large cobble, gravel, and sand mid-channel bar was observed within WM-1. This is a very wide reach and the presence of this bar indicates that aggradation may be occurring here as the reach narrows over time. Base flow is split here.

Figure 5. Pre-Flood aerial photograph of the Western Mobile site with longitudinal profiles (green) and cross-section survey transects (yellow).

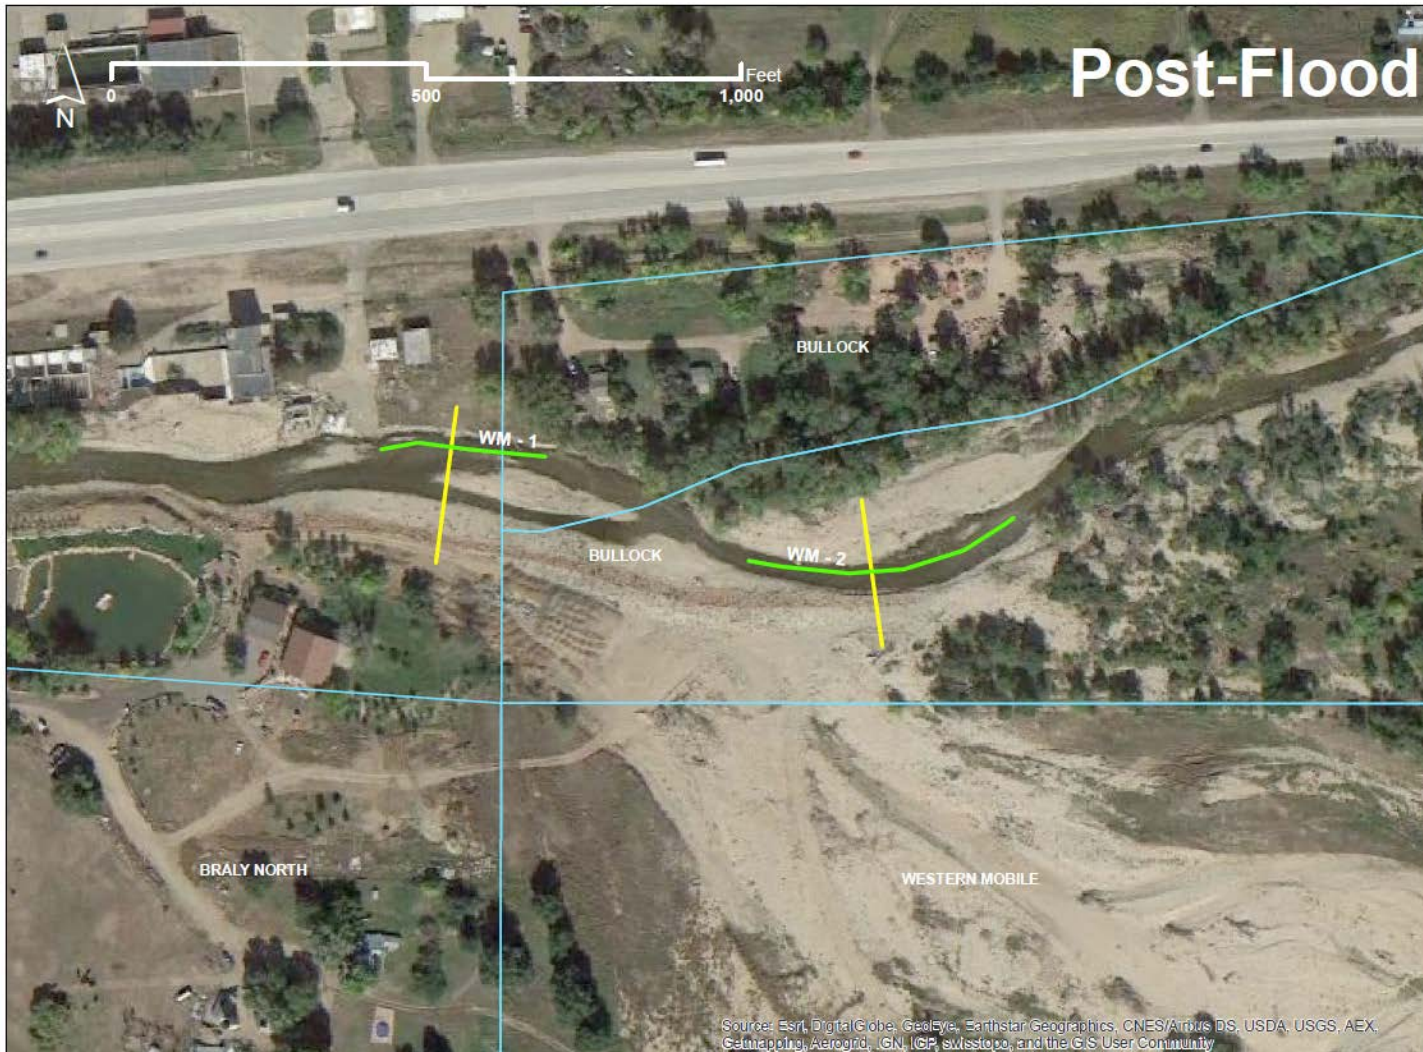
As indicated by the SSA, lack of bank and riparian vegetation as well as very steep, sandy banks are the leading cause of bank stability along these reaches, with the banks of WM-1 being the most unstable. The composite bank stability score is 3.1 / 5.0 and the overall composite stream stability score is 3.5 / 5.0 indicating a moderately unstable system. The average BEHI score is 44 / 50, or “Very High”. These scores are very similar to those of the Hall-II reaches. Bank stability is the over driver of these high instability scores.

Figure 6. Post-Flood aerial photograph of the Western Mobile site with longitudinal profiles (green) and cross-section survey transects (yellow).
