ADDENDUM #2
Community Planning & Permitting
Preliminary Design of Crossings at Kenosha Road at Coal Creek and State Highway 7 at
Dry Creek #3
RFP # 7210-21

ANSWER: Please see the attached documents at the end of this addendum for the bridge inspection reports.

KENOSHA ROAD (CR 28) OVER COAL CREEK
INSPECTION DATE 8/31/2020

PREPARED BY HDR ENGINEERING, INC. FOR THE COLORADO DEPARTMENT OF TRANSPORTATION

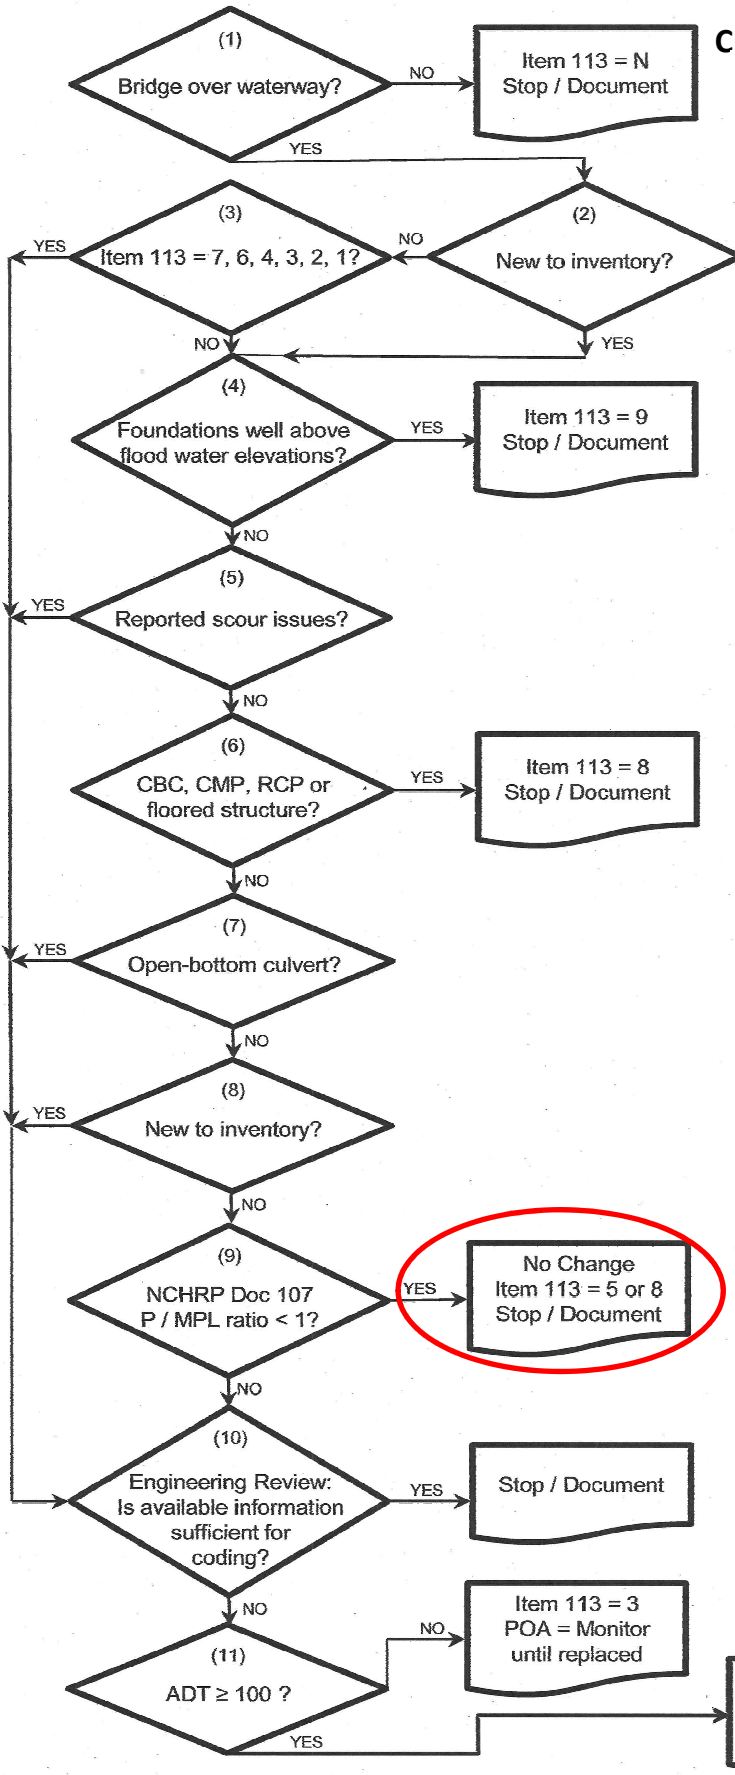
CDOT OFF-SYSTEM BRIDGE SCOUR SCREENING CHART

REVIEWER COMMENTS:
 ERI-KENOSHA is a prestressed concrete double tee girder bridge spanning over Coal Creek. No scour issues were noted during the 2020 inspection. Item 113 = "5".
