USDA Forest Service	Wildland Fire Origin and Cause Supplemental Incident Report (Reference FSH 5309.11, Chapter 20)				Incident Number		22-02-IAIP002										
					Incident Date		12-30-21										
LOCATION																	
Fire Name		Dispatch #	Account Code	Region	Forest	District	State	County									
Marshall Fire-Marshall Mesa Trailhead		COBLX-995	PEPNR9	02	10	1	CO	13									
Origin Location: geographical landmarks, highways, roads, trails, etc.				Township	Range	Section	¼ Sec	Meridian/Datum									
Marshall Mesa Trailhead, Eldorado Springs Rd and Highway 93, Boulder, CO				T1S	R70W	21	NE1/4	WGS 84									
				Latitude (D – M' – S")		Longitude (D – M' – S")											
				39	57	03	105	13 58									
JURISDICTION																	
USFS Only		Identify Other Agency(s)		Lead Origin & Cause Investigator		Est. Suppression Cost		Injuries/Deaths									
N/A		Boulder County Sheriff's Office		Special Agent Travis Lunders		Undetermined		2

USDA Forest Service	Wildland Fire Origin and Cause Supplemental Incident Report (Reference FSH 5309.11, Chapter 20)	Incident Number	22-02-IAIP002
		Incident Date	12-30-21
SYNOPSIS (DATE, FIRE NAME, ESTIMATED ACRES, LOCATION, JURISDICTION); (ESTIMATED

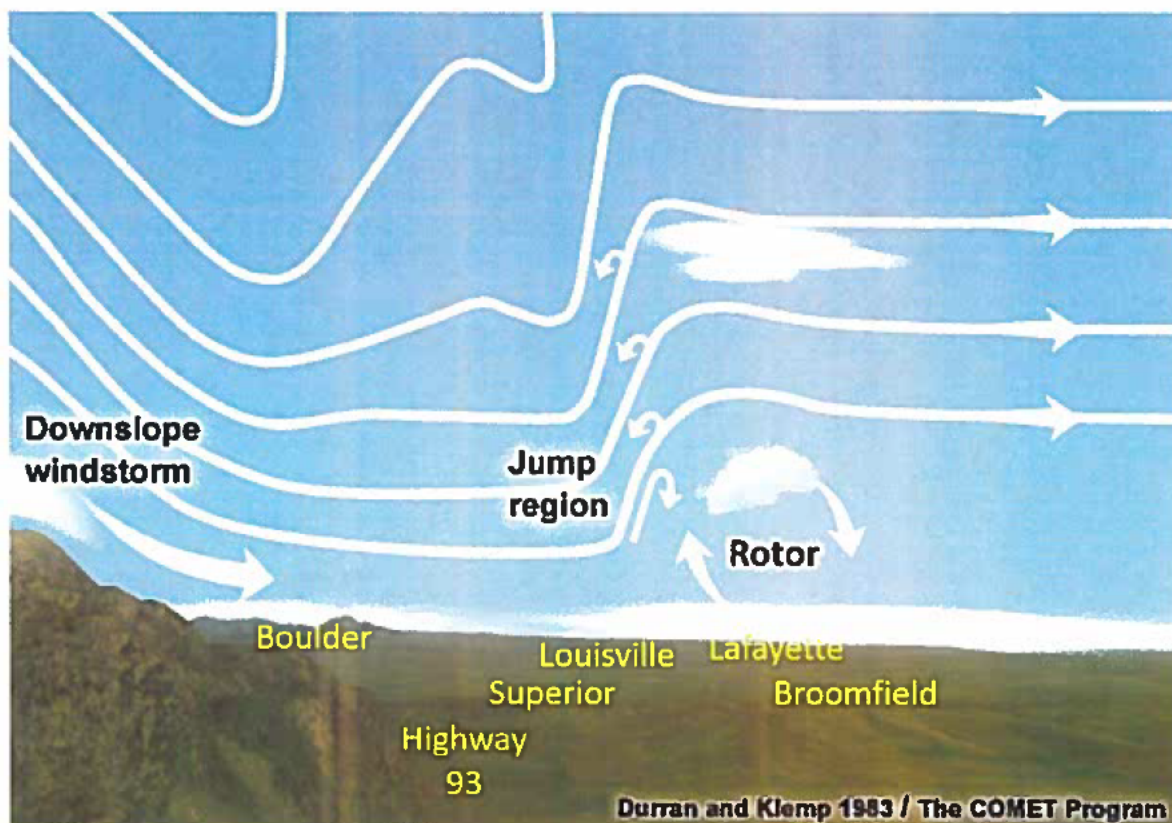
Plenty of video evidence shows the fire and smoke racing off the east, and at some point lifting upward. The rapid rise of the smoke plume is within the jump region, and clouds form on the eastern fringe of this, or on the rising portion of the rotor, shown in Fig. 1 and also in the videos linked below the graphic. As the strong winds continue east, additional waves form further downstream, just as additional ripples form in a stream below a boulder. These appear as alternating areas of clouds in the upward motion areas, and clear skies where the air is sinking.

Figure 1: An idealized schematic of how downslope wind storms occur in the lee of the Rocky Mountains. The typical set up is shown, and the strongest winds occur along and west of the “Jump Region with locations shown in yellow. A rotor is shown over Lafayette, along with a rotor cloud.

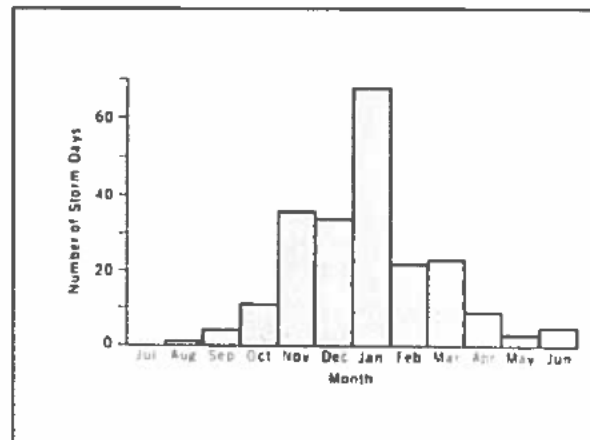
Figure 3: Taken from NOAA technical report Whiteman and Whiteman (1974). These are 151 identified wind storms in Boulder, defined as having at least one gust > 58 mph in the Boulder area during the period of study ending in 1974.

Figure 3 shows the peak occurring in the cold season and in particular in January. This graphic is from the 1970s but the trends are the same as today. An updated study looking at months with gusts greater than or equal to 70 mph from 1969-2021 in the Boulder area shows a similar trend to the dataset that ended in 1974. There is a distinct peak in the occurrence of extreme downslope wind in December and January. Here is the table of days by month with at least one wind gust > 70 mph across the CO-93 corridor from 1969-2021:

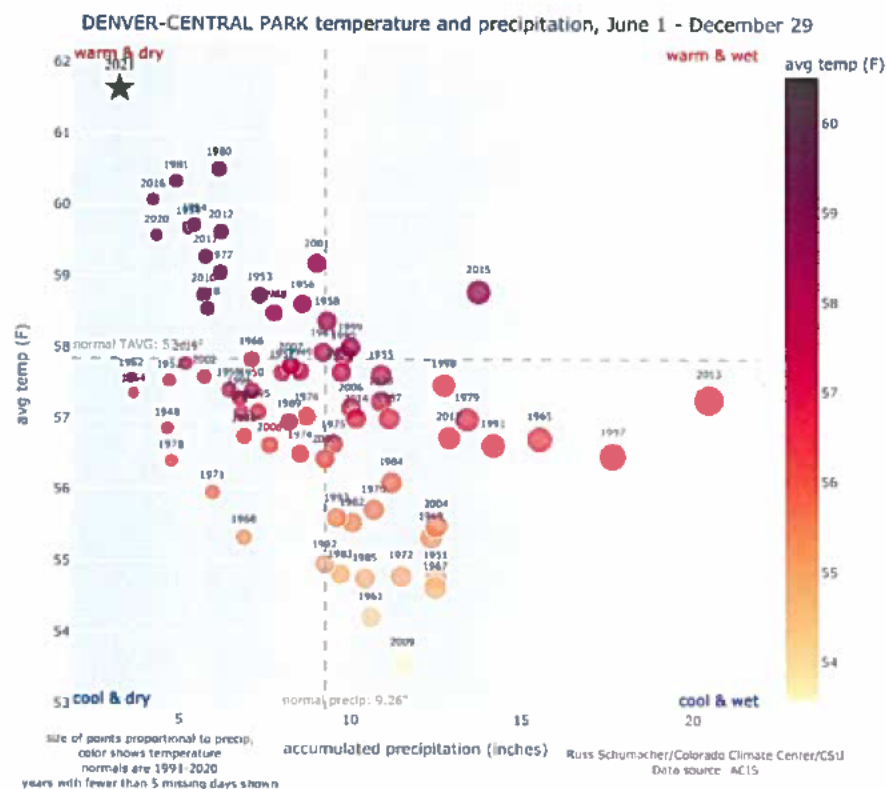
Figure 4: Climate data from Denver-Central Park that combines the effects of temperature and precipitation. Warmest/driest years on record appear in the top left, while cool and wet in the bottom right. 2021 was far and away the warmest and driest on record over the last ~75 years.

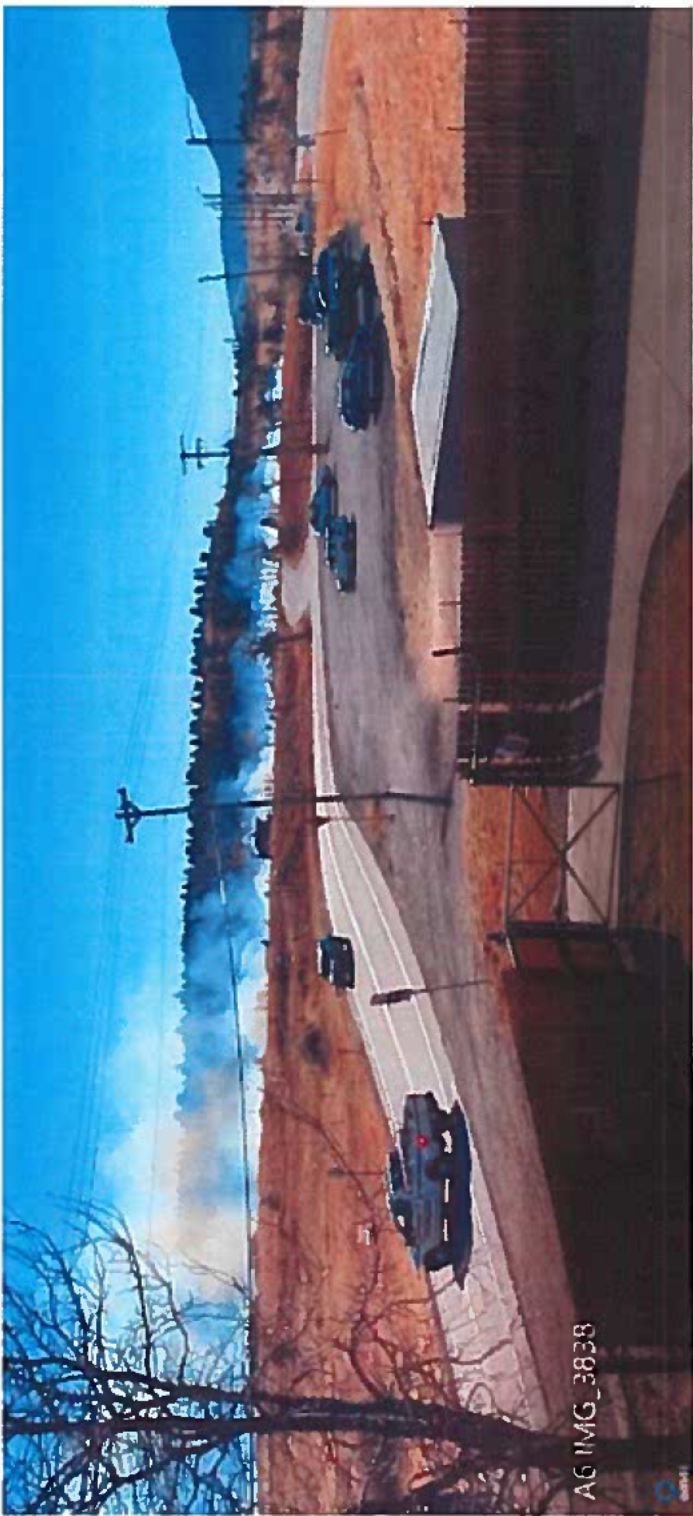
A6 IMG_3838

Marshall Fire
Marshall Mesa Trailhead Origin and Cause Report
Attachment 6
Screenshot from Zoltowski Video
IMG_3838

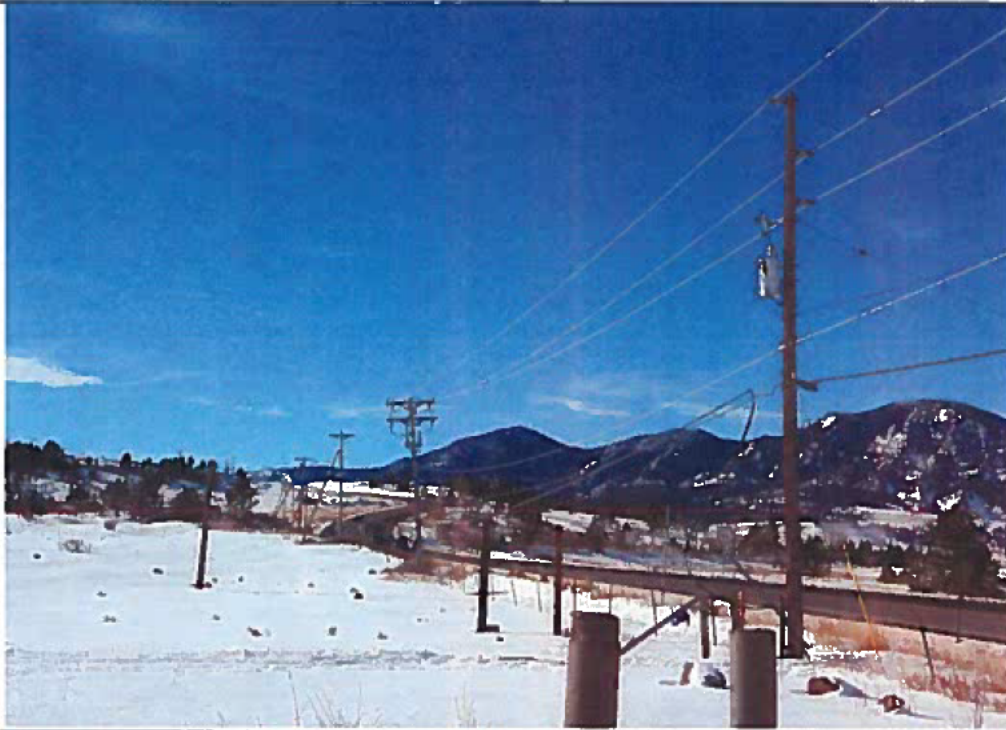
Photograph Number: DSCN0296

Subject:
Severed communication line and
transformer on pole 188688

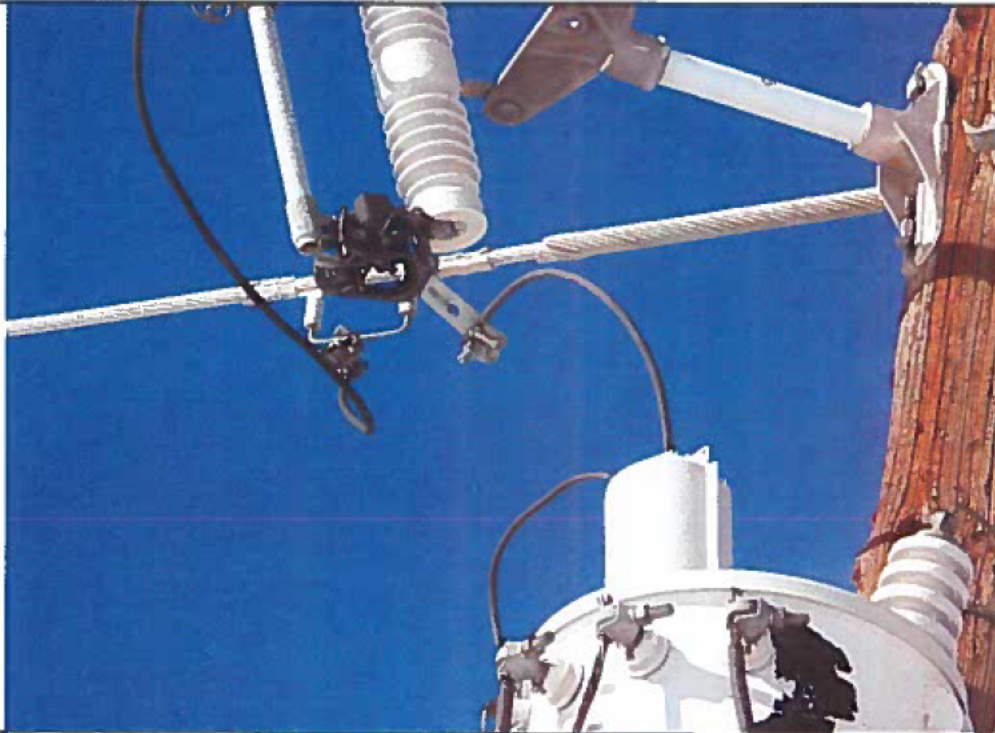
Photograph Number: DSCN0307

Subject:
Intact fuse above transformer on pole
188688

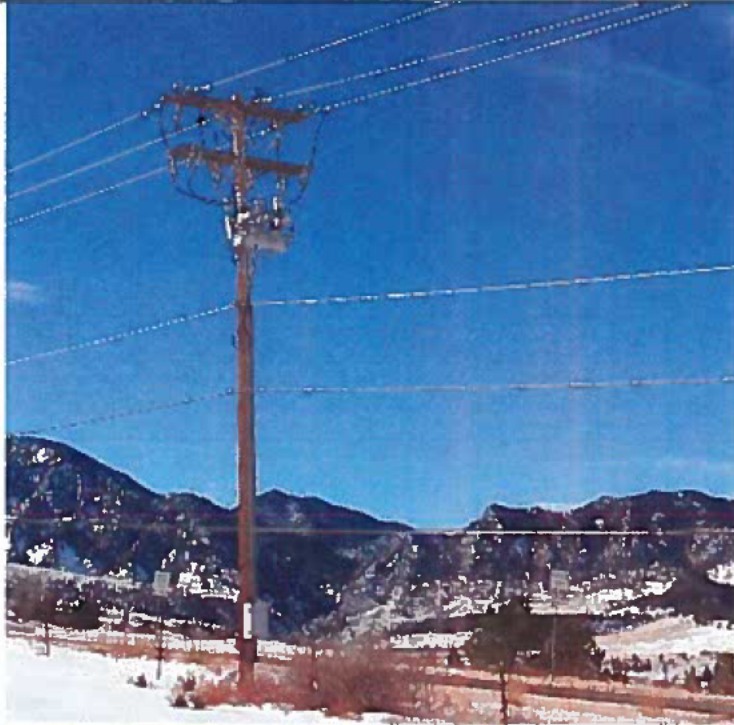
Photograph Number: DSCN0361

Subject: Pole 101507

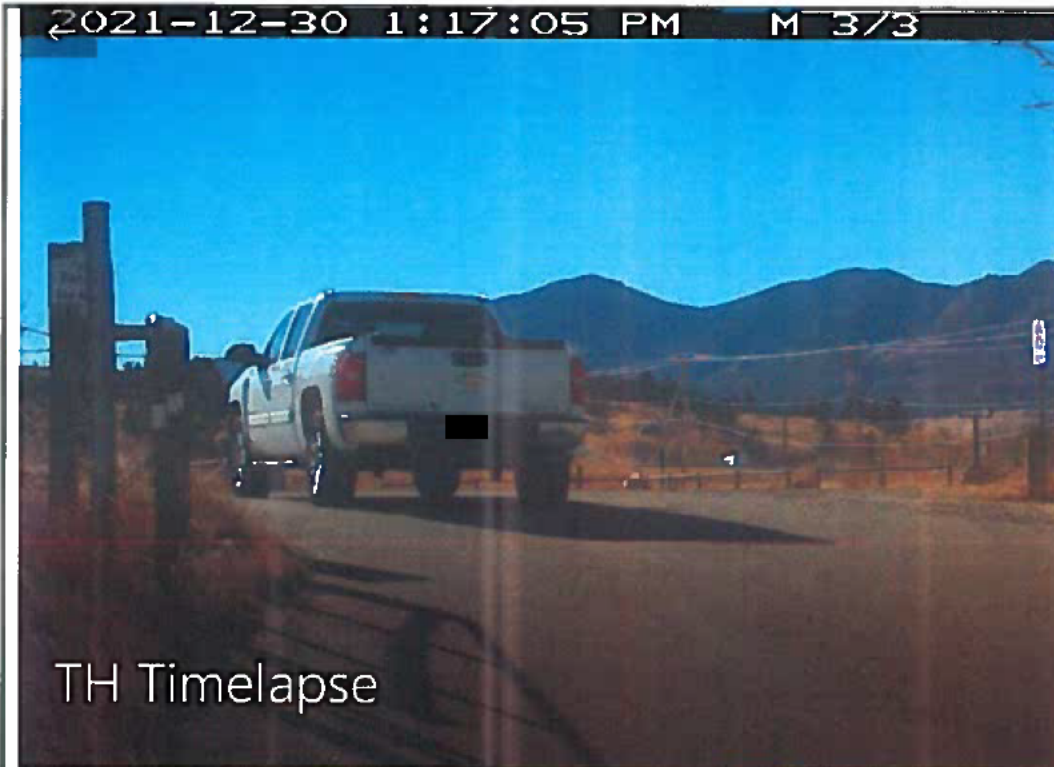
Photograph Number: Trailhead
Timelapse Video

Subject:
Picture with no smoke visible on
southern horizon from trailhead
entrance

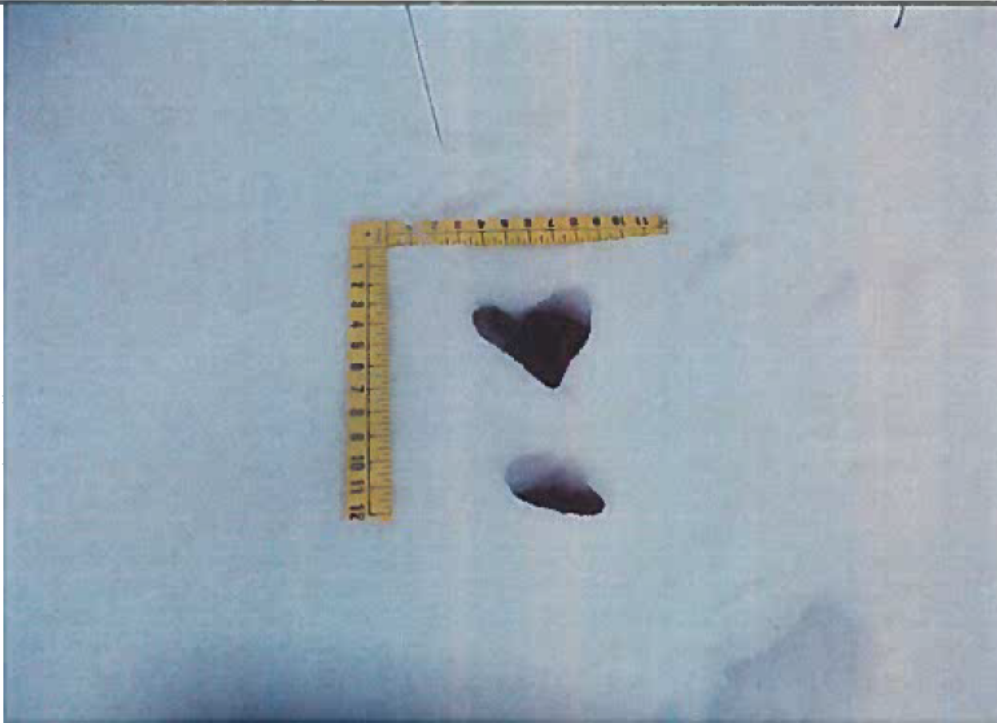
Photograph Number: DSCN 0047

Subject:
Holes created in the snow above
visible holes and cracks in the rock

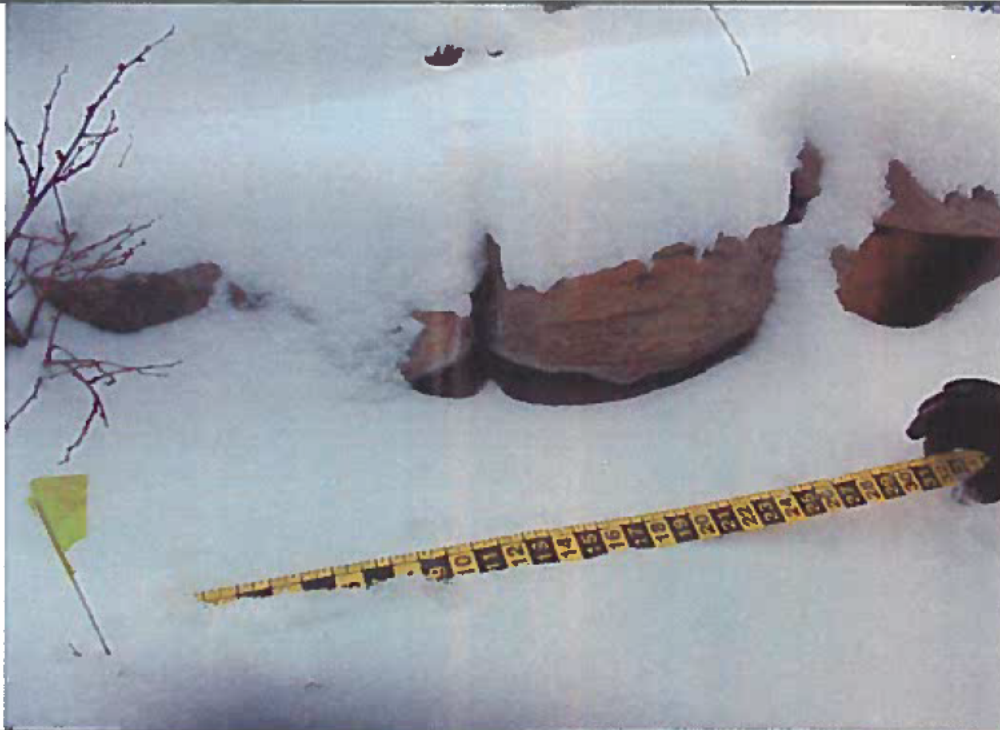
Photograph Number: DSCN 0052

Subject:
Possible vent created by escaping
warm air from underground

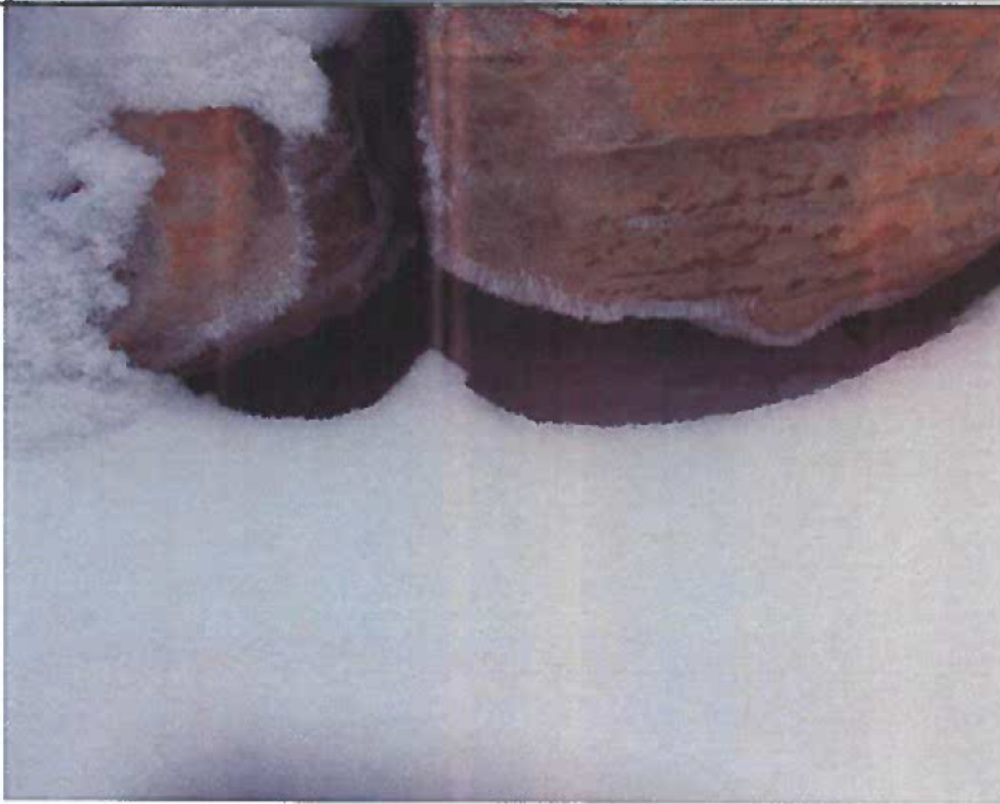
Photograph Number: DSCN 0053

Subject:
Frost crystals on bottom of rock
ledge

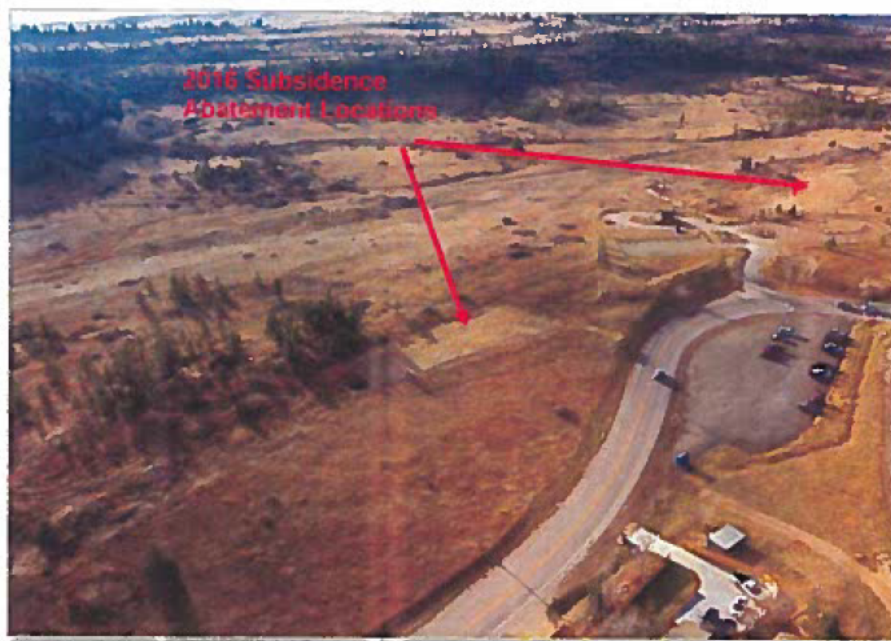
Figure 4-4 – Marshall Mine Fire Looking South

In 2016, two areas of trough subsidence were excavated, compacted, and backfilled to natural grade. Both areas, shown on Figure 4-4, were in areas where surface expression of the mine fire had been observed. During the subsidence mitigation work, a few small vents were uncovered in both locations. In all cases, the exhaust was warm, moist air with temperature less than 90°F. No new evidence of subsidence or other indicators of the coal mine fire were observed during the completion of the remedial activities. Gas monitoring during construction did not detect gases associated with coal combustion over the background levels.

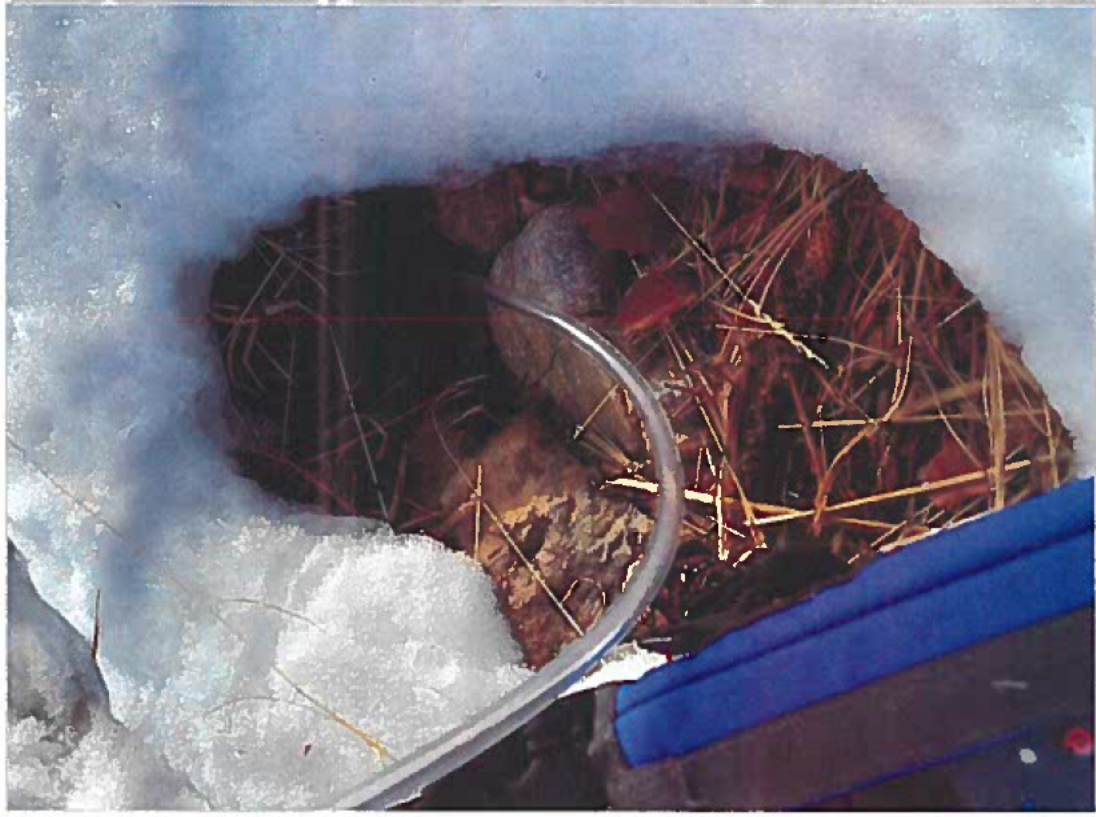
Photo 1. MV1

Locations MV1 through MV9 gas concentrations are typical of closed mine atmospheres with minor venting and minor coal oxidation (slightly increased CO₂ levels and slightly decreased O₂ levels). The temperatures are atypically low for venting mine atmospheres most likely due to minimal amount of venting flowrate and cooling and mixing with ambient air in the fractured rock outcrop. None of the fractures or vents had noticeable air venting from them. Fluctuation of gas readings from near ambient conditions up to the readings listed in the table also suggests low flowrate mine atmosphere air venting that is mixing with ambient air prior to the gas analyzer inlet. There was evidence of animal (rodents and rabbits) in some of the holes sampled, potentially using them as burrows. Hair can be seen on the moss around MV5 in Photo 5. This is supported by video taken during a UAV thermal flight on January 8, 2022 of a rodent running in and out of the fractures in the rock outcrop.

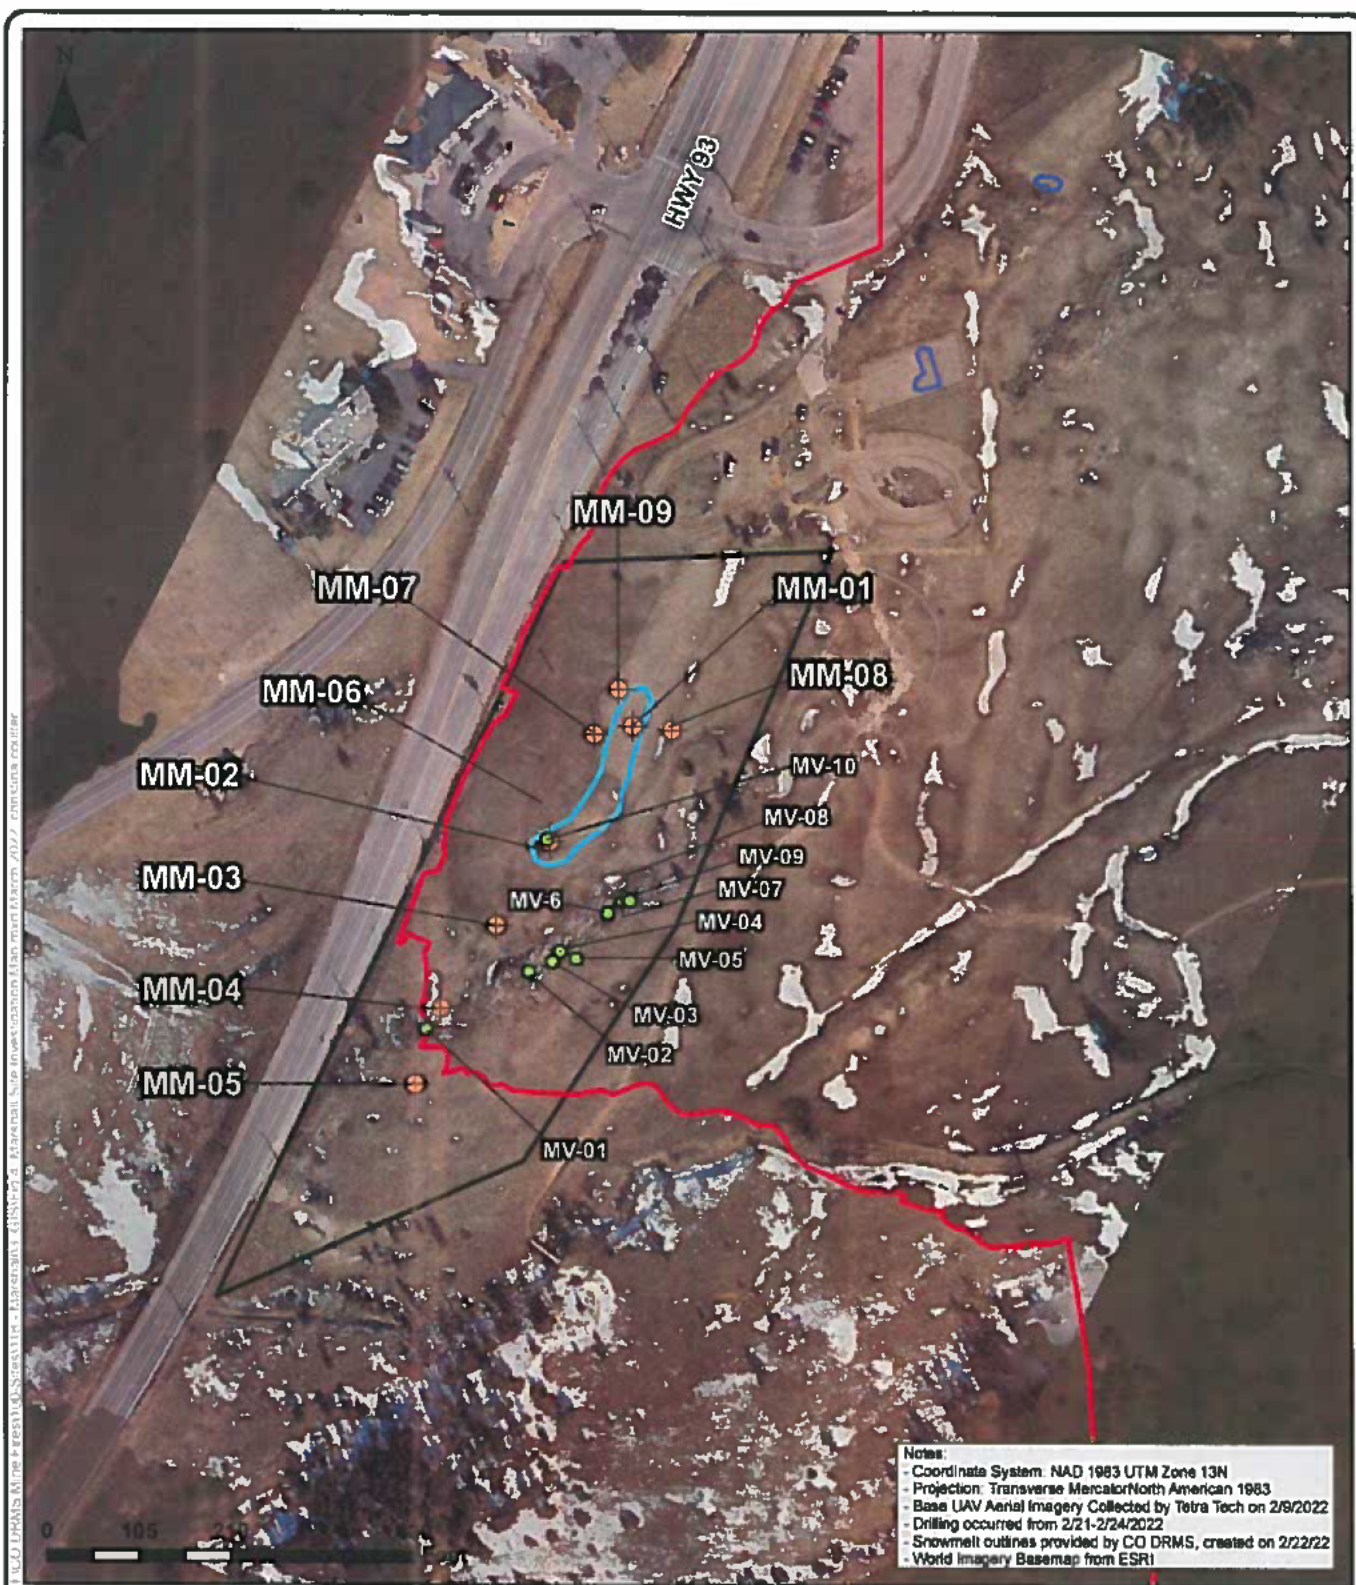
4

Tetra Tech noted slightly elevated temperatures and combustion gases at location MV-10 (**Figure 4**). The presence of CO without heat and CO₂ is typically associated with incomplete combustion or oxidation of subsurface coal. No other indications of mine fire activity were observed including odors, heat, venting gases, or intakes. Fracture temperatures at feature MV01 to MV09 were close to ambient (33°F) and no discernable airflow (intake or vent) was observed.

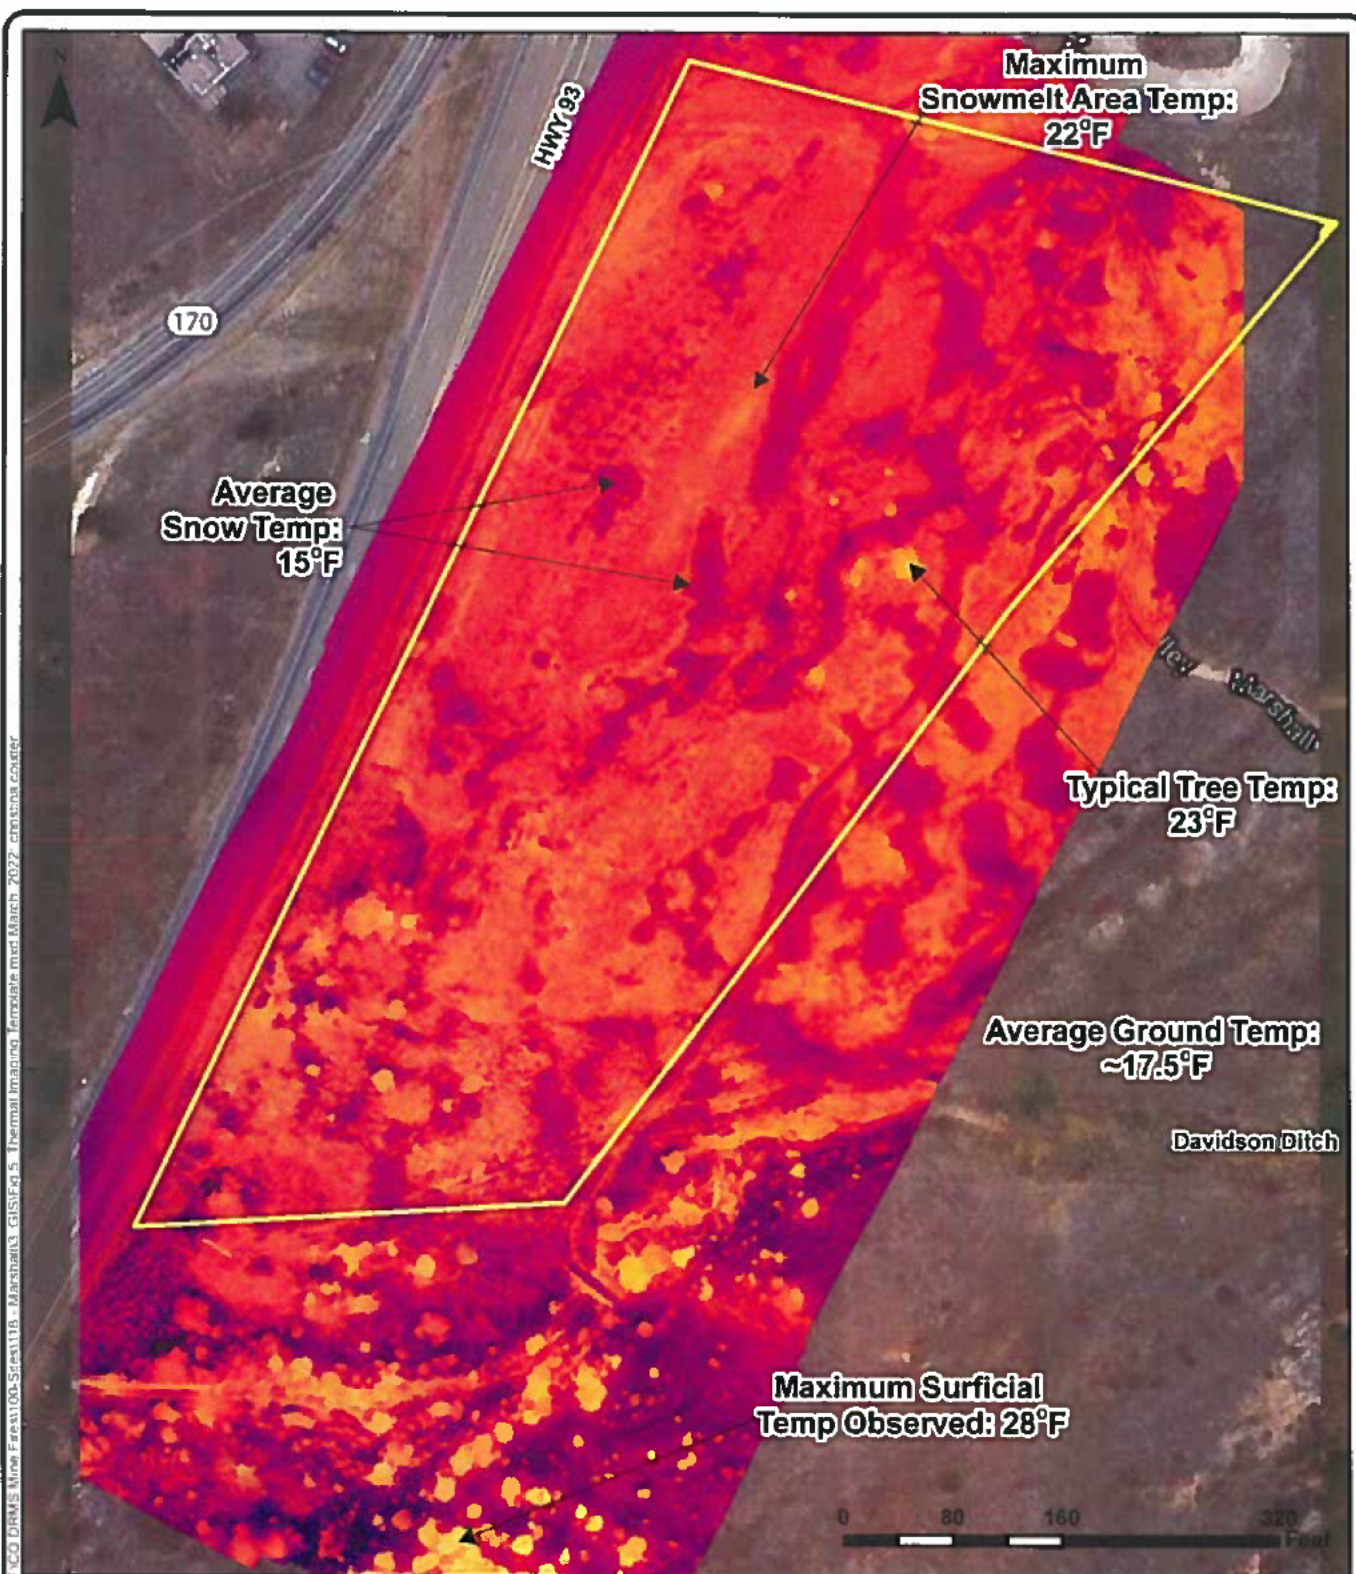
TITLE		Marshall Mesa Underground Coal Fire Investigation Thermal Imaging	
LOCATION		Marshall Area, Boulder, Colorado	
     	APPROVED	JN	FIGURE 5
	DRAFTED	CEC	
	PROJECT#	114-910499	
	DATE	03/16/2022

On January 8, 2022, Tetra Tech performed a UAV-based thermal inspection and mapping of the AOI within Marshall Mesa Open Space. A flight was performed to develop a thermal overlay of the AOI to map potential thermal anomalies, or features with sharp contrast, hot or cold, with the surrounding area (**Figure 5**). The color scale on the

- Thermal imaging performed by Tetra Tech on 01/08/2022.
- Ambient Temp. at 0600 was 34°F, light wind, cloudy.
- Max surficial Temp Observed was 28°F (a tree in the southern portion of the site).
- World Imagery Basemap from ESRI, June 15, 2021.

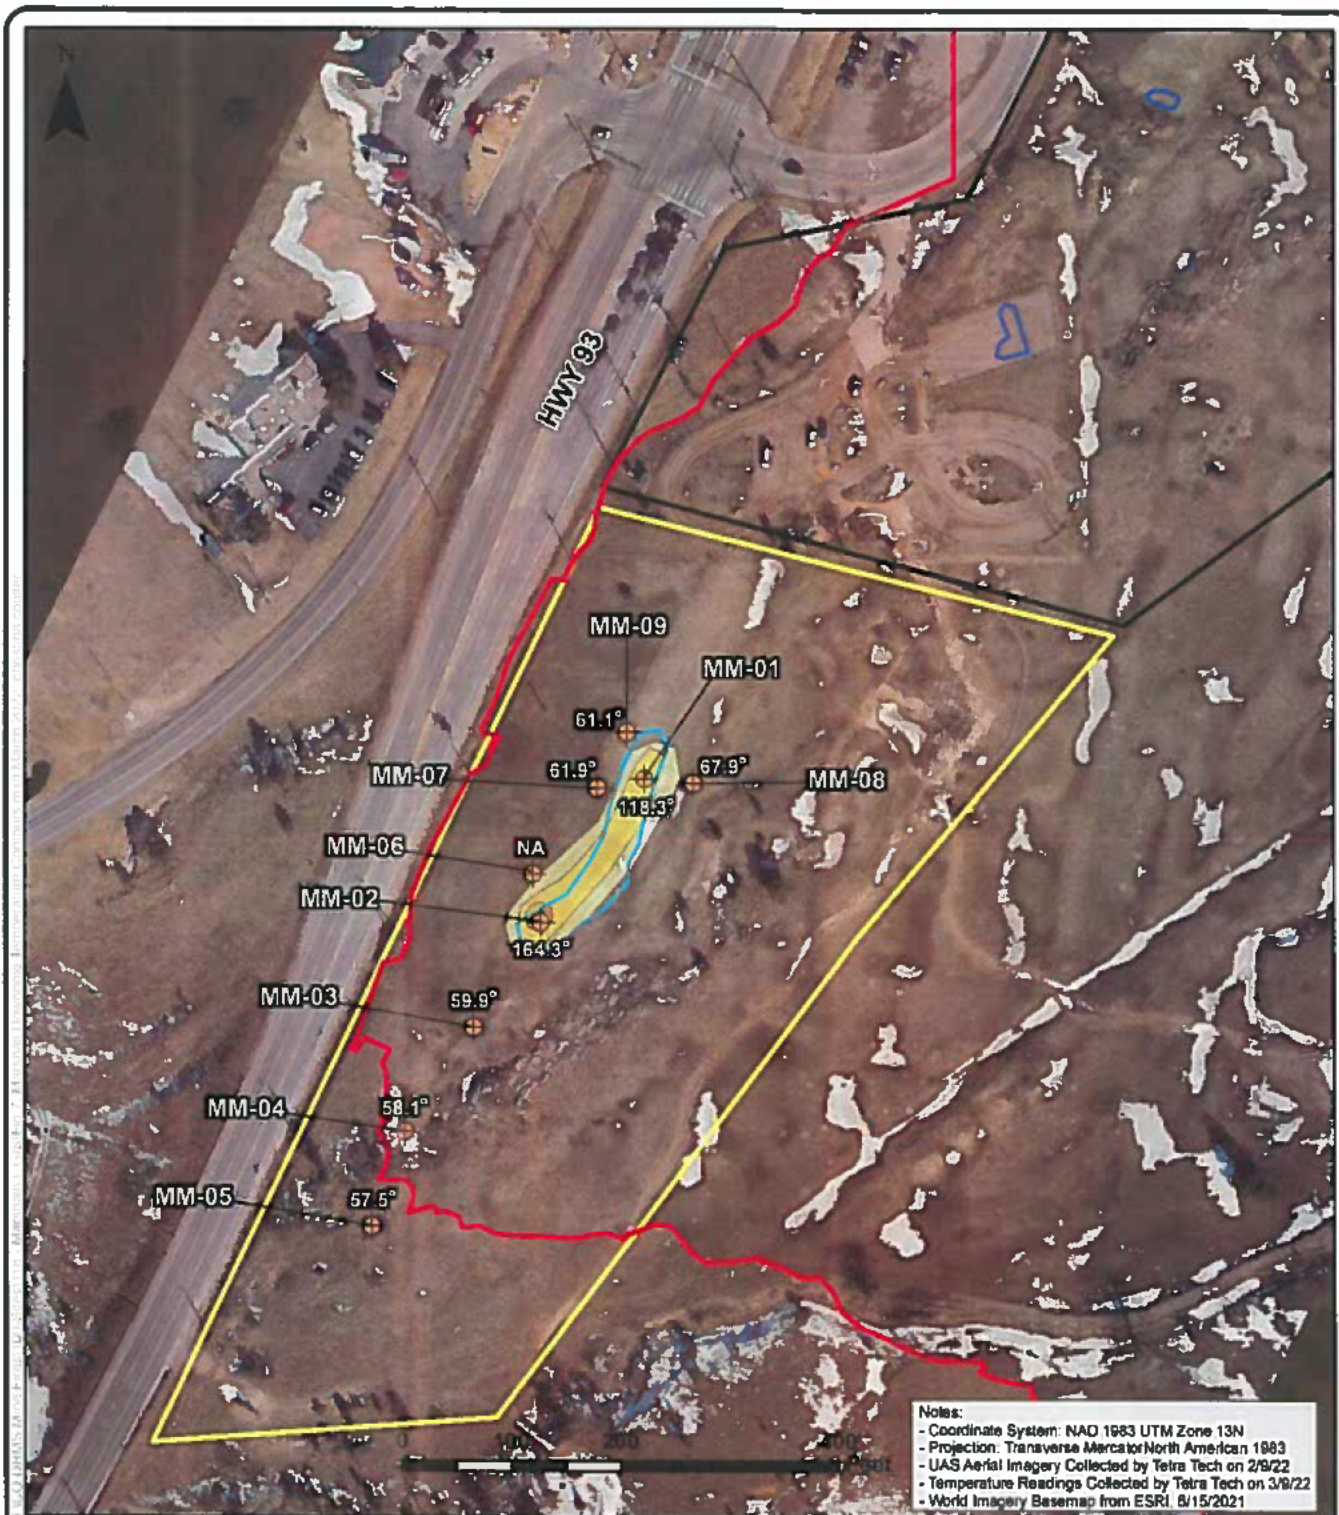
FIGURE
7

Figure 7 presents an overview of the subsurface temperatures observed near the top of the upper coal seam as observed on March 9, 2022. Temperature observations from March 3 to March 9, 2022 remained relatively consistent.

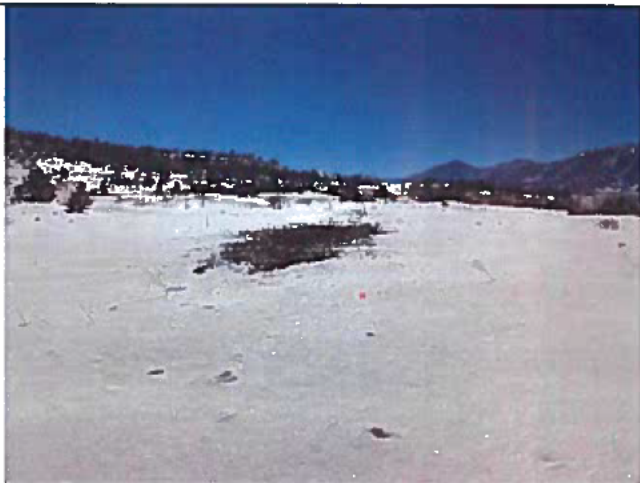
With multiple snowfall events occurring in Boulder during January, February, and March 2022, Tetra Tech was able to visit the site several times to observe snowmelt patterns. During these visits an area was observed that consistently had snowmelt before the surrounding areas despite similarities in aspect and surface material or other factors that could influence differential melting patterns other than subsurface heat. **Image 3** and **Figure 6** show ground and perspective shots of the consistent snowmelt area during a recent storm and an outline of the consistent snowmelt area is shown on **Figure 4**. On the ground temperature observations with the handheld IR thermometer showed ground temperatures in the snow free areas were just above freezing at 34°F and only 1°F to 3°F warmer than background surface temperatures. No other areas of snowmelt were identified in the AOI.

PHOTOGRAPH 1 02-17-2022 View of the snowmelt area to the south.

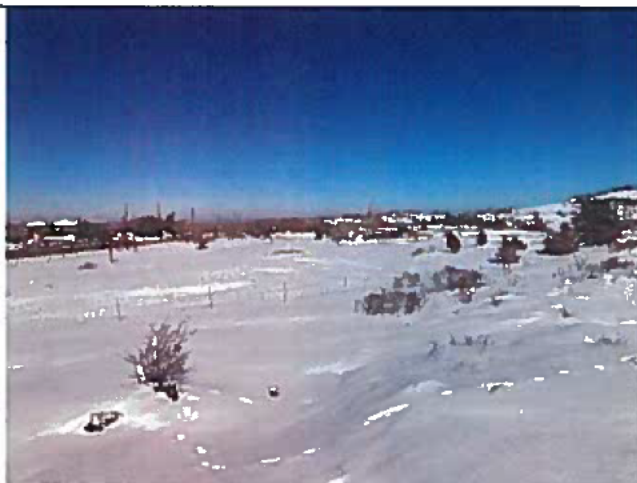
PHOTOGRAPH 2 02-17-2022 View to north across AOI with snowmelt visible.

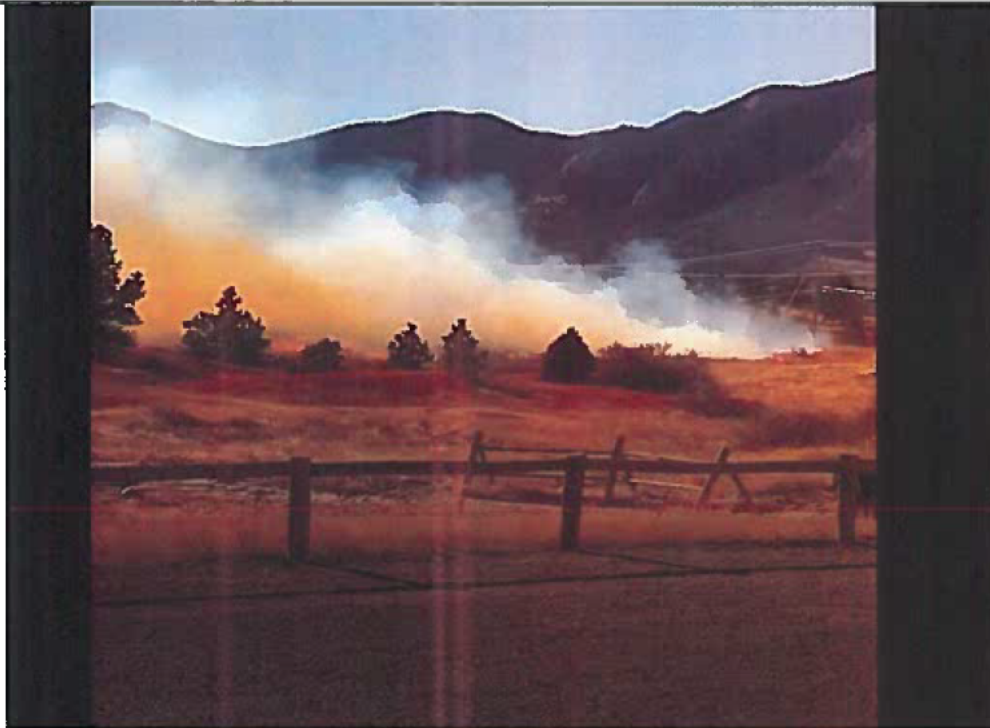
Photograph Number: Tomasello Video

Subject:
Screenshot from Tomasello video shot from Marshall Mesa Trailhead parking area showing east conductor unlashed from power pole MP2

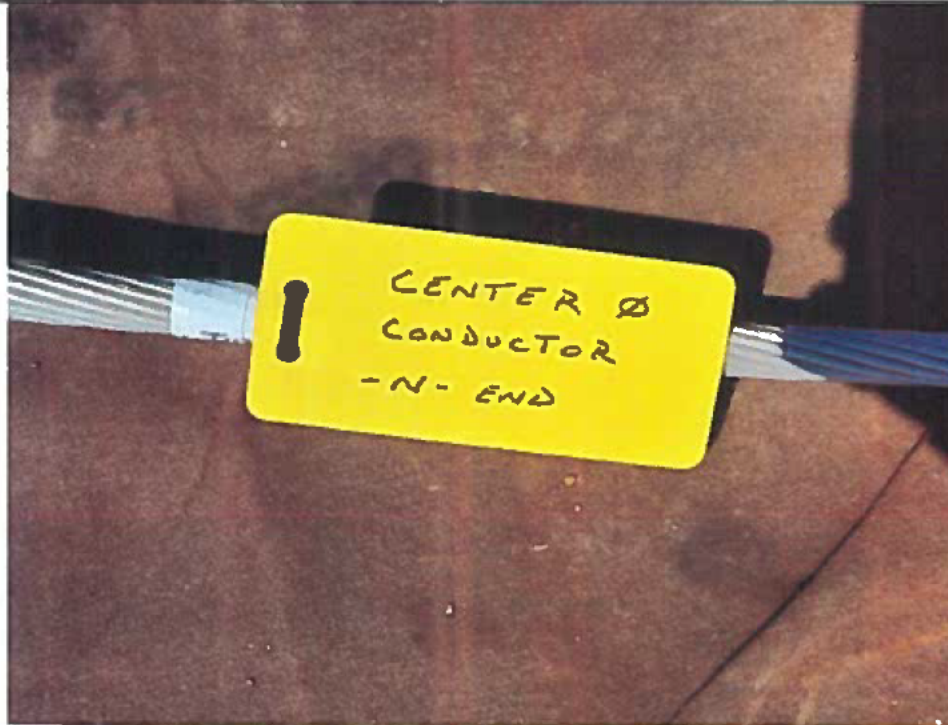
Photograph Number: 122135

Subject:
Identifier tag placed on MP2 Center
Conductor
