1.0 INTRODUCTION

1.2 Background

The purpose of this master plan is to provide planning guidance to improve resiliency along Boulder Creek from the confluence with Fourmile Creek, in Boulder Canyon, to the confluence with the Saint Vrain Creek in the City of Longmont. This plan provides general guidance for stream and ecological restoration among other multiple objectives including:

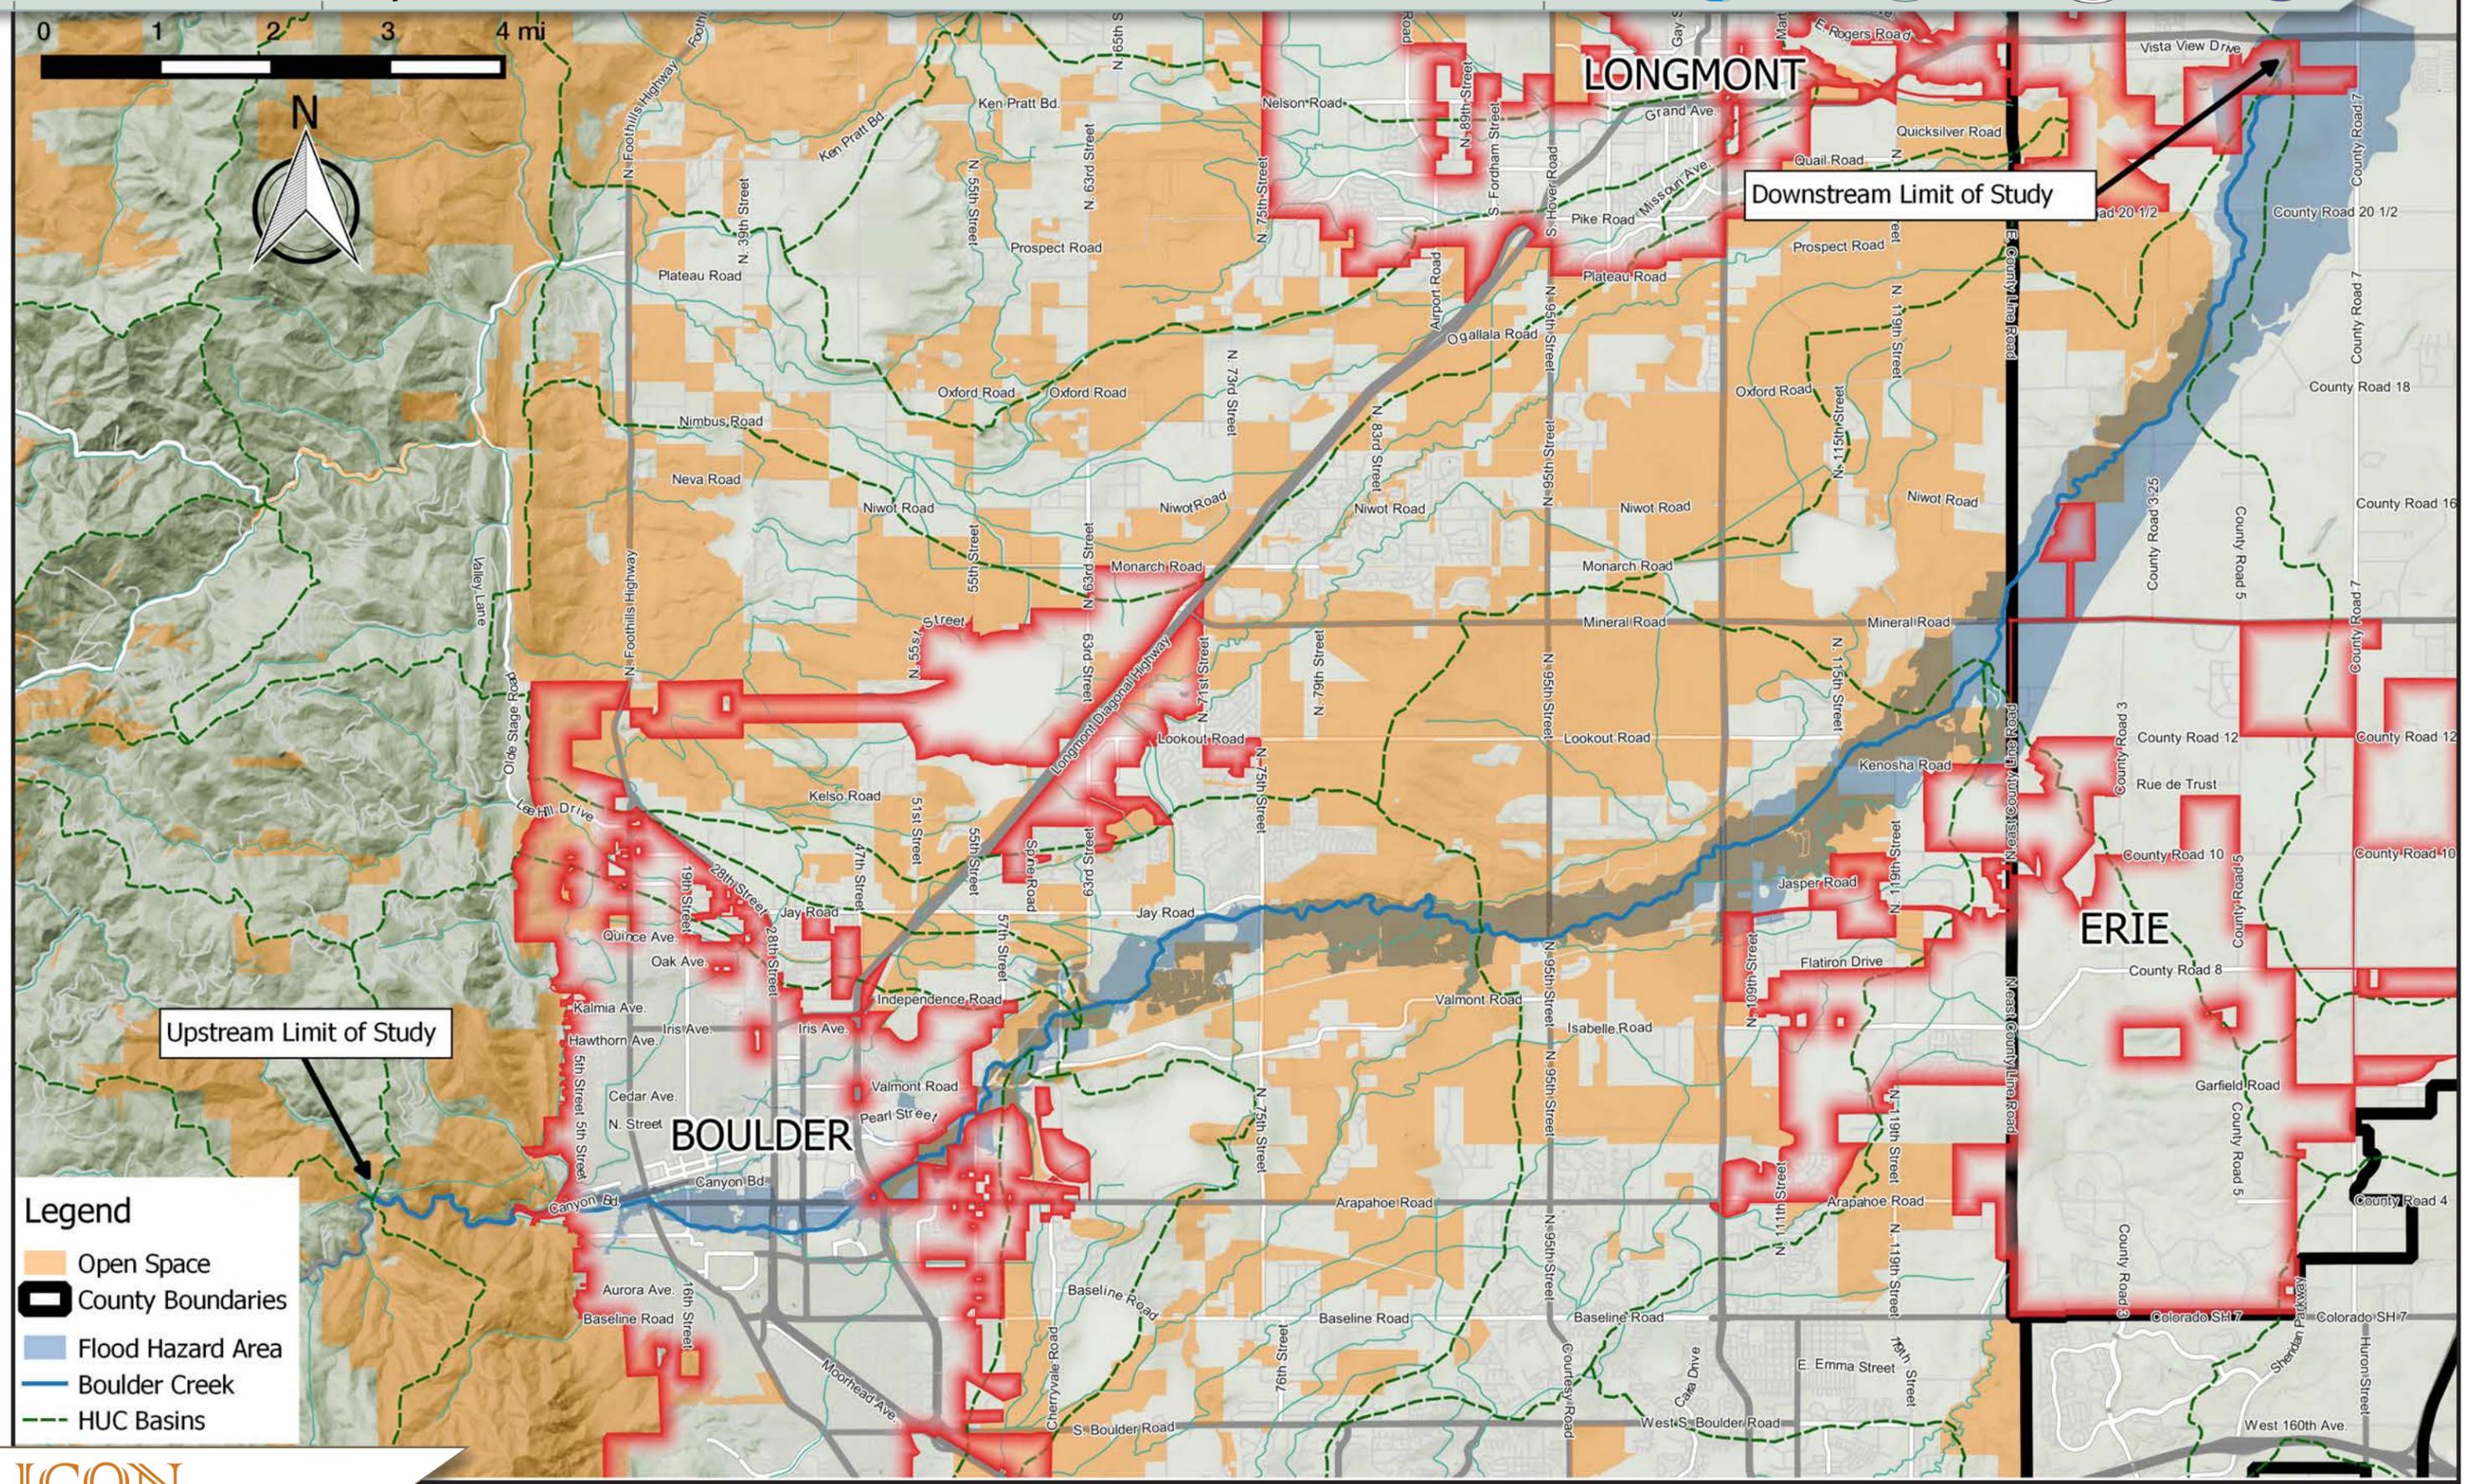
Upstream Limit of Study

Downstream Limit of Study

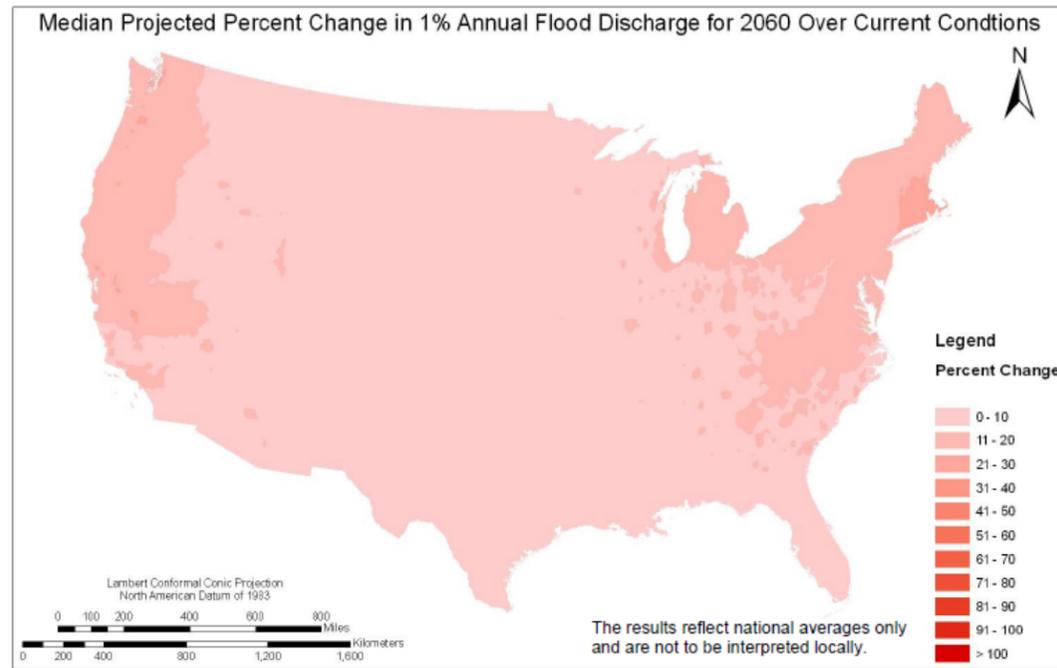
Figure 3-1: 1%-Annual Chance Projections for the United States, 2060 (AECOM, 2013)

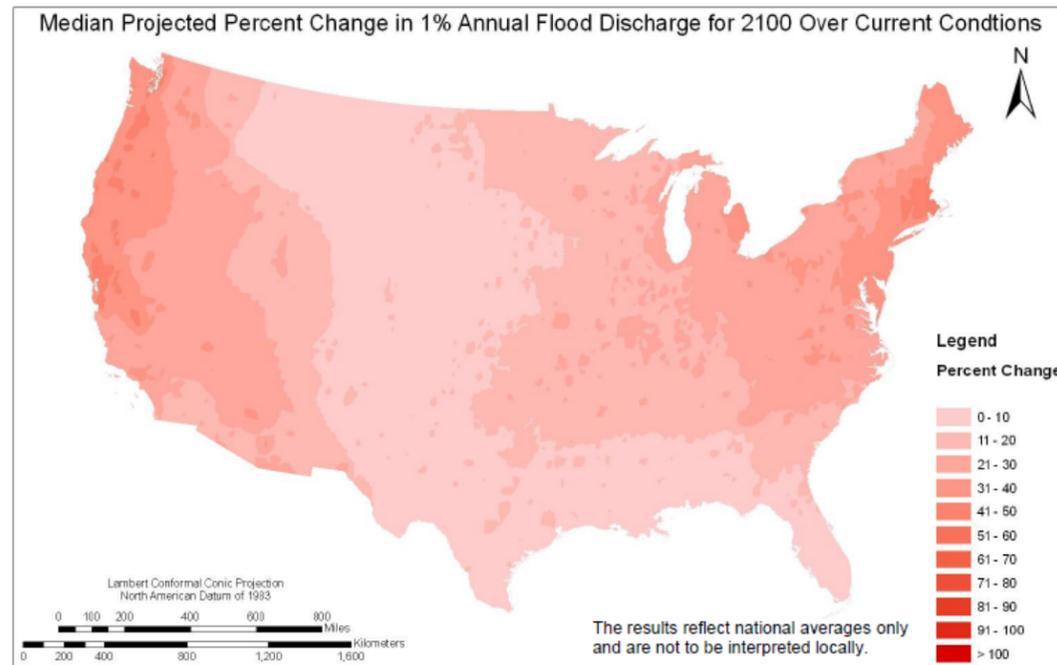
Figure 3-2: 1%-Annual-Chance Projections for the United States, 2100 (AECOM, 2013)

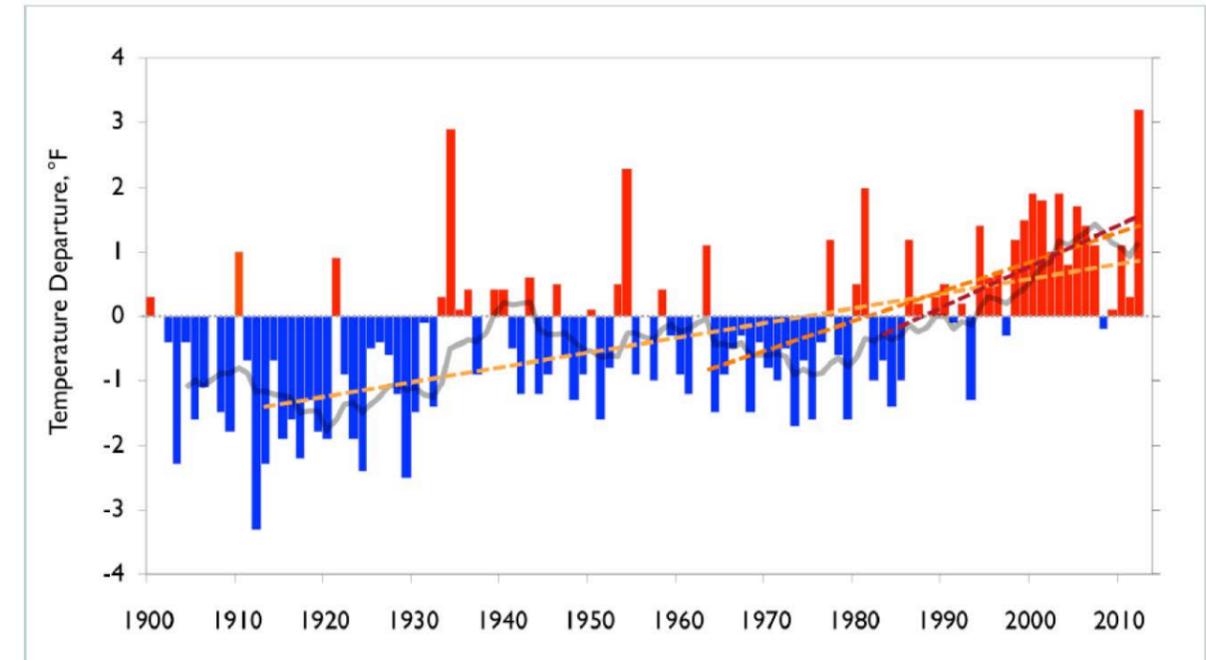
Figure 3-3: Colorado Statewide Annual Average Temperature, 1900-2012 (CWCB 2014)

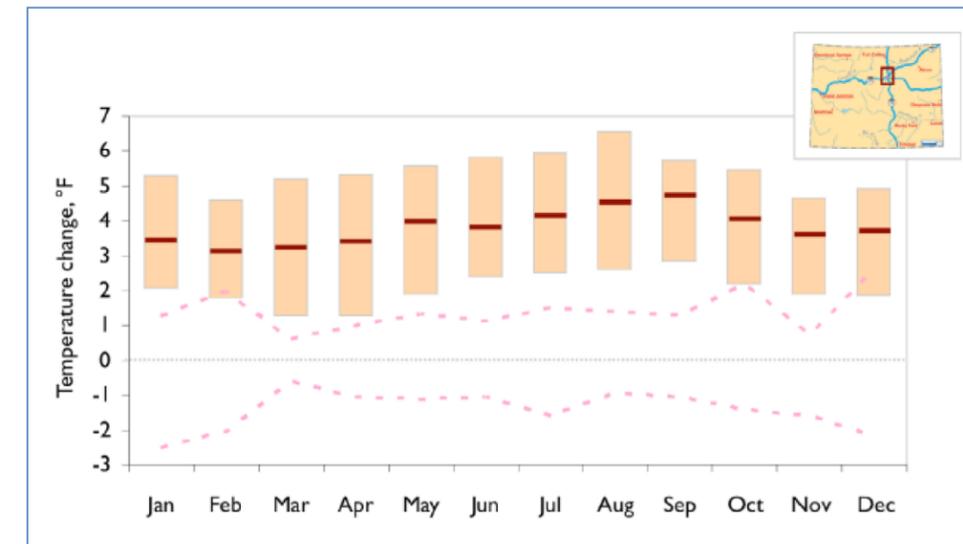
Range from the 10th percentile to the 90th percentile of the individual model projections
 Median projection for each month
 Envelope of observed multi-decadal variability in monthly temperature

Figure 3-4: Projected Monthly Precipitation Change for Denver Metro Sub-region Low-moderate Emissions Scenario for 2035-2064

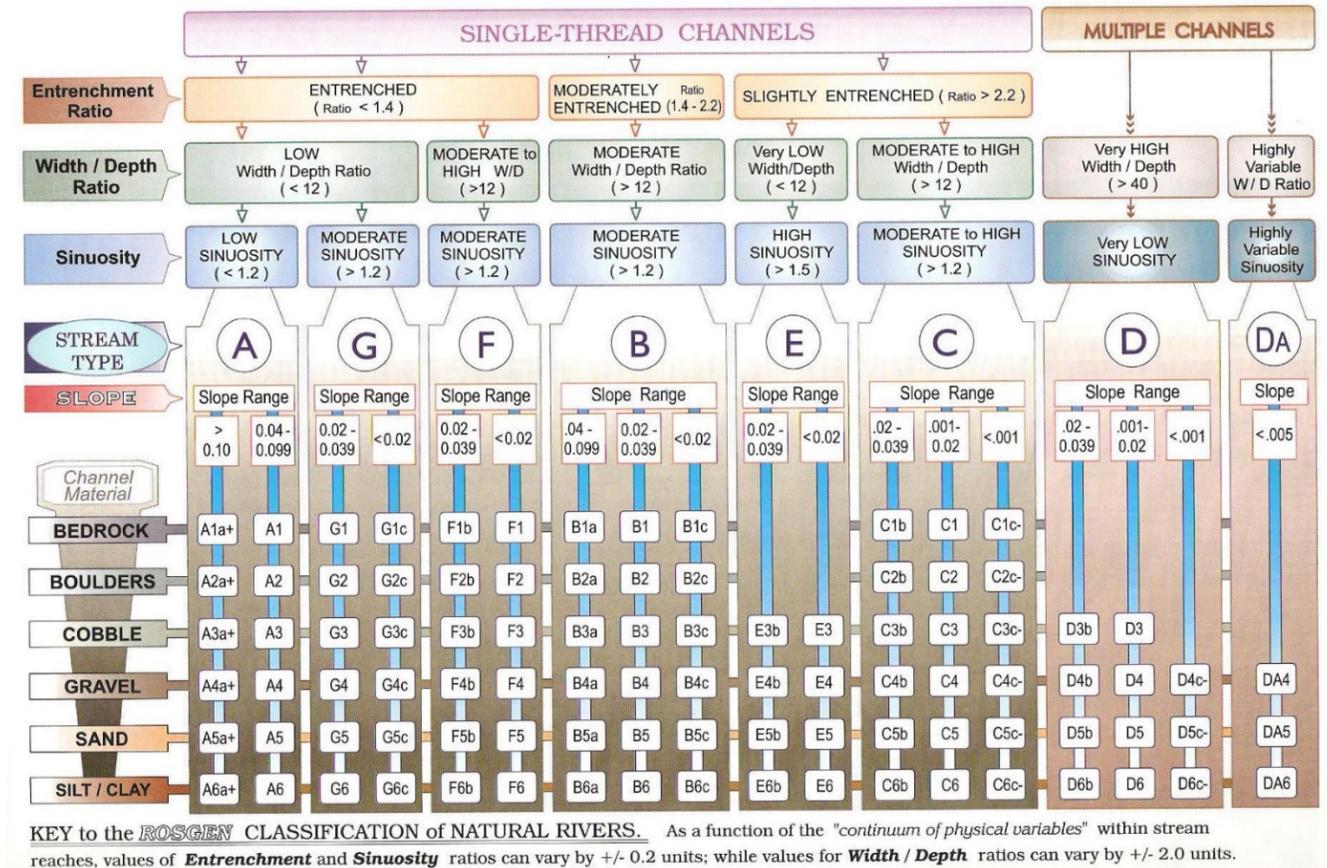
Figure 4-1: Rosgen Classification System System Schematic (from Rosgen 1996)

For the purposes of this master plan, Boulder Creek has been divided into ten separate reaches for description and planning purposes. Descriptions below discuss general observations along each stream reach, in addition to geomorphic classification based on Rosgen methodology. The Rosgen stream classification system is a widely used framework that defines stream types on the basis of geomorphic characteristics including channel slope, sinuosity, width/depth ratio, and entrenchment ratio. The classification system integrates geomorphic pattern with predominate bed material to identify different types of streams (Rosgen 1996). The Rosgen system defines eight Level I stream types on the basis of geomorphic characteristics including single thread or multiple channel condition, channel slope, sinuosity, width/depth ratio, and entrenchment ratio. Level I stream types are identified by letters, such as A, B, and C. The classification system integrates geomorphic pattern with predominate bed material to define 42 Level II stream types, identified by letters and numbers, such as B3, C3, C4, etc. (Rosgen and Silvey 1998). Numbers one through six are used to sequentially describe bedrock, boulders, cobble, gravel, sand, and silt and clay as the predominate bed material. A schematic showing the different Rosgen classification groupings based on observed and measured stream parameters is provided in Figure 4.1. Observation and stream types were determined based on aerial mapping, Google Earth (2013), and field assessments for the full length of Boulder Creek. In general, classification of Boulder Creek typically reflected a Type C stream. Rosgen Type C streams are typically characterized as being a “low gradient, meandering, point-bar, riffle/pool, alluvial channel with broad, well-defined floodplains” (Rosgen 1996). Type C streams have a sinuosity greater than 1.2, an average slope less than 0.02 feet per foot (ft/ft), and a meander width ratio (i.e., meander belt width divided by stream bankfull width) typically between 4 and 20 (Photo 1). These streams are slightly entrenched with well-defined meandering channels. In areas where Boulder Creek was more entrenched through encroachment, the stream was classified as a Type F stream. Finally, stream segments within the Boulder Canyon segment were classified as a Type B stream. Type B streams are defined as having “moderately entrenched, moderate gradient, riffle-dominated channels, with infrequently spaced pools”. The plan, profile, and banks of Type B streams are all considered to be stable. The sinuosity of these stream types are greater than 1.2, with an average slope between 0.02 and 0.039 ft/ft, and a typical meander width ratio between 2 and 8. Type B streams are usually seen in narrower, steeper valleys than Type C streams, and contain colluvial deposition in the reach. Rapids and scour pools are characteristic of Type B streams. Photo 2 gives a representative example of a portion of a Type B channel that was observed in Boulder Canyon. Classifications assigned to individual stream segments are intended to describe their current physical characteristics; they are not intended to indicate information on the current stability of the channel or likely channel evolution.

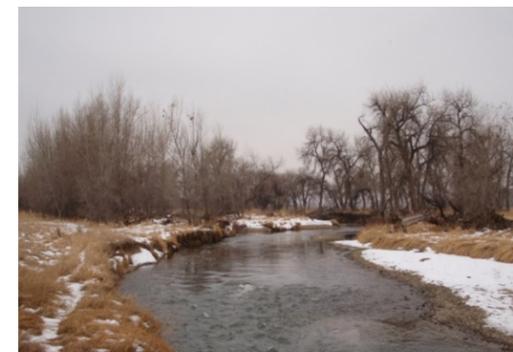
Photo 1: Typical riffle/pool sequence on Boulder Creek in Reach 1 (Type C classification)

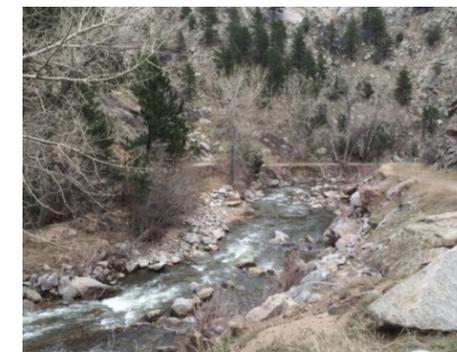
Photo 2: Rapid and scour pools bedforms in Reach 10 (Type B classification)

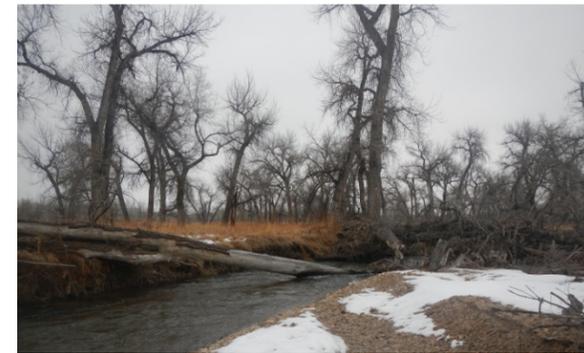
Photo 3: Flood debris along Boulder Creek (Reach 1)

Impacts within this corridor from the 2013 flood primarily reflect avulsions that developed from St. Vrain Creek. During the flood, St. Vrain Creek diverted from its standard path, flowed through adjacent aggregate ponds, and defined a new confluence location with Boulder Creek, approximately 1,600 feet upstream of the historic location. The new confluence location will be carried forward shortening the overall length of Boulder Creek. Although the Boulder Creek generally remained intact, flood debris in this reach still remains.

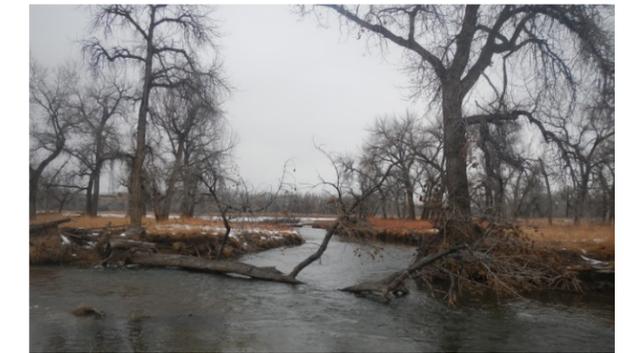
Photo 4: New confluence between St. Vrain and Boulder Creeks (Reach 1)

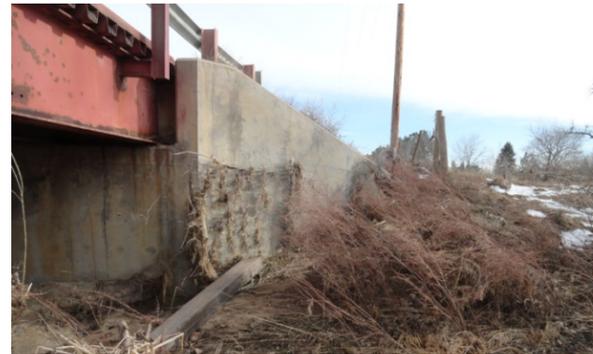
Photo 5: Flood debris at 20½ Road (Reach 2)

Impacts within this corridor from the 2013 flood primary reflect damage along the County’s roadway crossings with Boulder Creek, specifically at County Roads 20½ and 16½. At these locations, flooding resulted in scour around the bridge abutments and piers. The roadways were damaged where they overtopped.

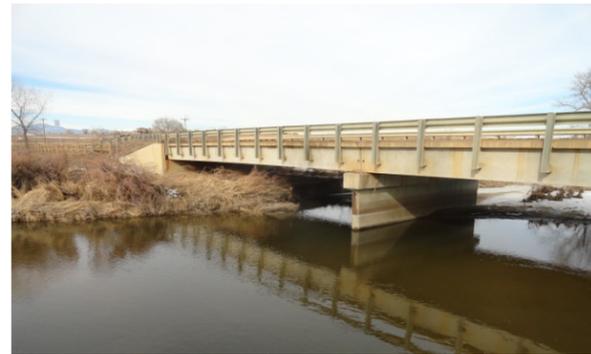
Photo 6: Pier scour at 16½ Road (Reach 2)

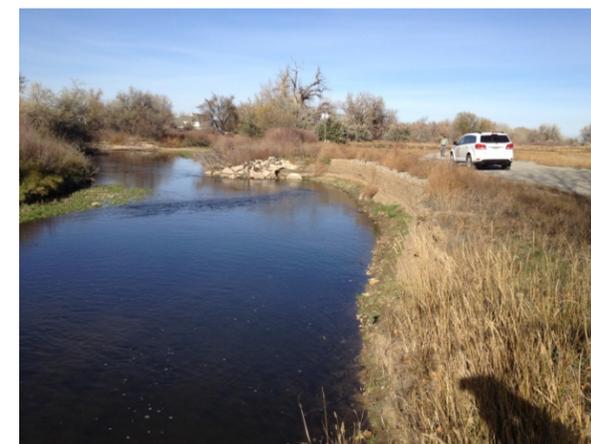
Photo 7: Bank erosion at the Town of Erie Reuse Pond (Reach 4)

During the September 2013 minor damage and breaches occurred of the adjacent ponds. A significant bank cut developed adjacent to the Town of Erie’s re-use pond, downstream of County Line Road. This pond also experienced a deluge of flood waters from overtopping of adjacent ponds and roadways to the south. Following the flood, the south bank of Boulder Creek was reinforced with concrete rubble as a temporary stabilization measure. This bank should be repaired permanently. Upstream of County Line Road, open space ponds breached and the stream bank failed within the Doniphan, Wittemeyer, and Bailey-Kenosha Pond open space properties. Similarly, the bridge connection between the north and south properties in the open space, and existing irrigation diversion was damaged and in need of removal or repair. Damage to stream banks, sedimentation, and flooding of homes also occurred within the Wheeler Ranch property, located between Boulder County Open Space areas and County Line Road.

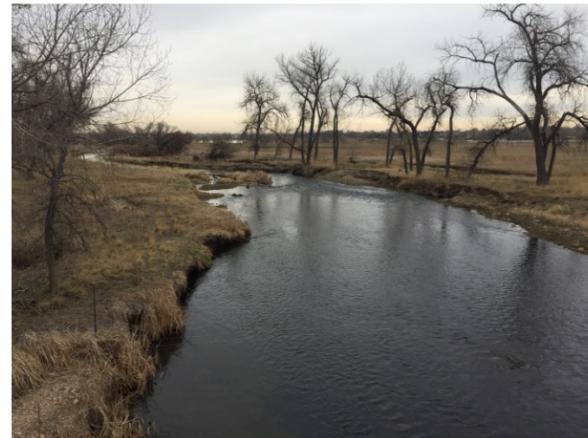
Photo 11: Downstream County Line Road (Reach 4)

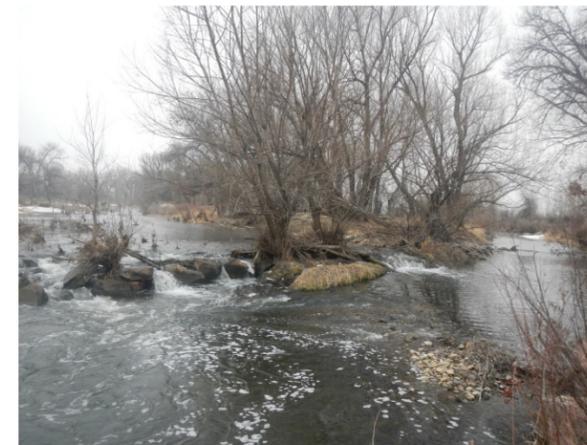
Photo 13: Braided flooding within the Alexander Dawson Open Space (Reach 5)

During the September 2013 flood, Boulder Creek diverted from its banks upstream of US 287 and within the Alexander Dawson Open Space property. The diversion short-cut the preexisting channel and recent restoration features installed by Boulder County and the Urban Drainage and Flood Control District. Overtopping of 95th Street caused by creek avulsion upstream of 95th Street was also significant, and the roadway failed approximately 1,000 feet north of the current bridge location. Significant damage was also noted to downstream ponds and property. This roadway has since been repaired by Boulder County.

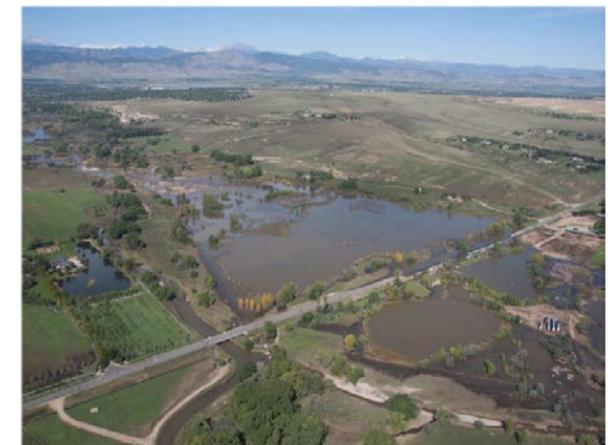
Photo 14: 95th Street flooding (Reach 5) photo courtesy of David Mallory, UDFCD

Photo 14: 95th Street flooding, photo courtesy of David Mallory, UDFCD

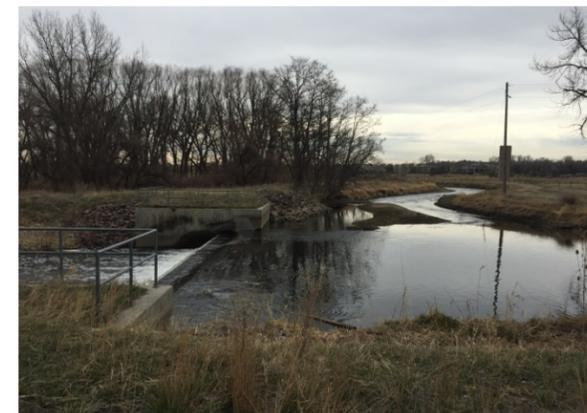
Photo 15: Lower Boulder Ditch Diversion (Reach 5)

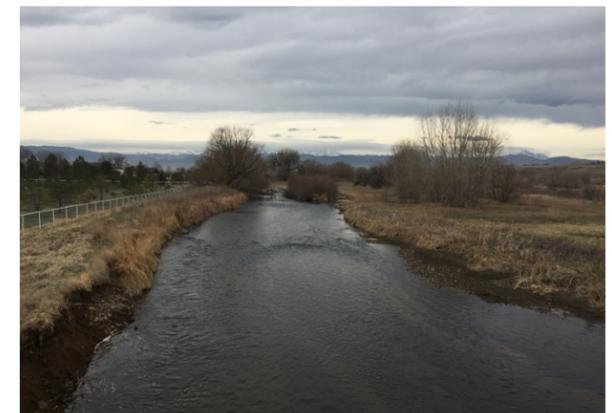
Photo 16: Upstream 95th Street (Reach 5)

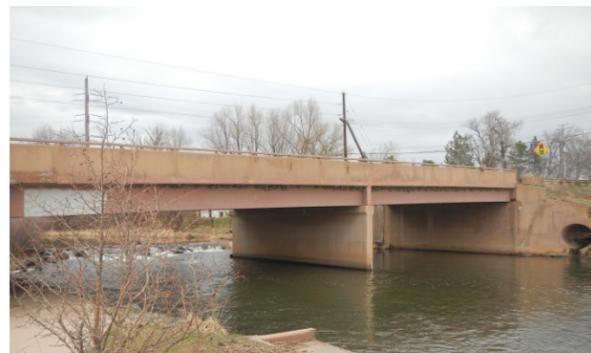
Photo 17: 75th Street Bridge (Reach 6)

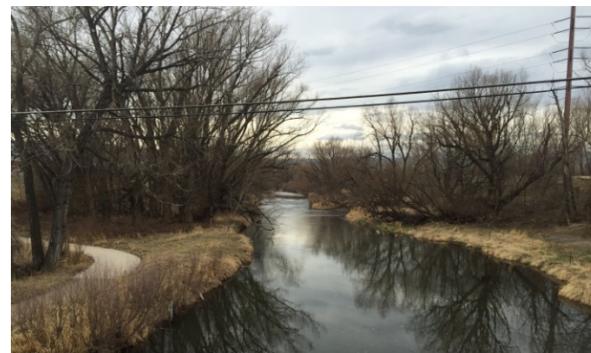
Photo 18: Upstream 75th Street bridge (Reach 6)

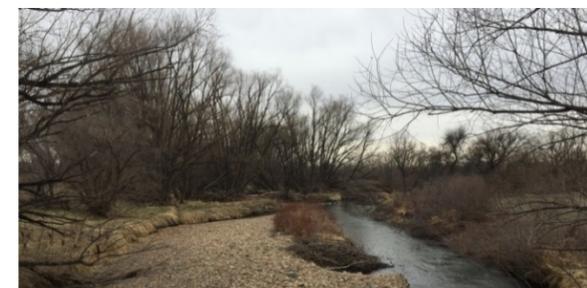
Photo 19: Downstream 61st Street (Reach 7)

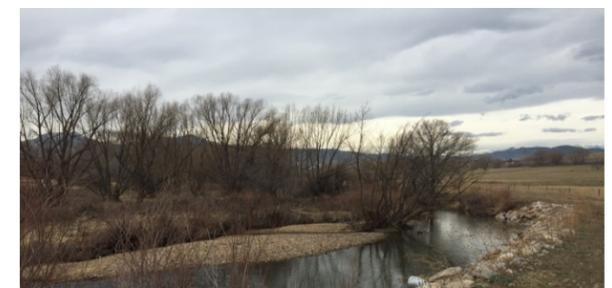
Photo 20: Upstream 61st Street (Reach 7)

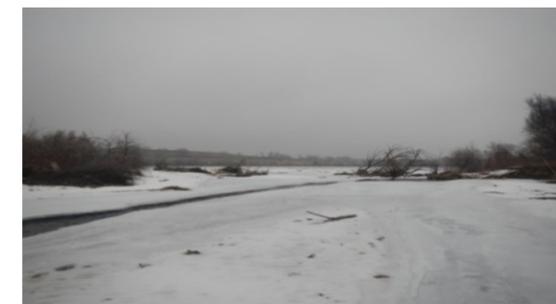
Photo 21: Boulder Creek breach to Pit D (Reach 7)

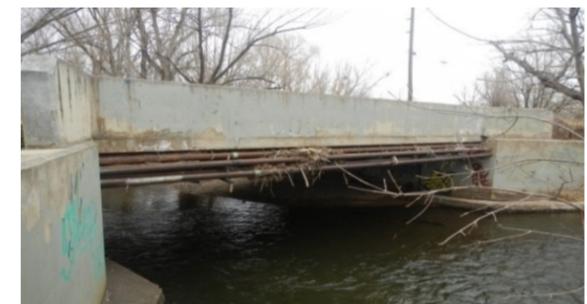
Photo 22: Old Valmont trail bridge (Reach 7)

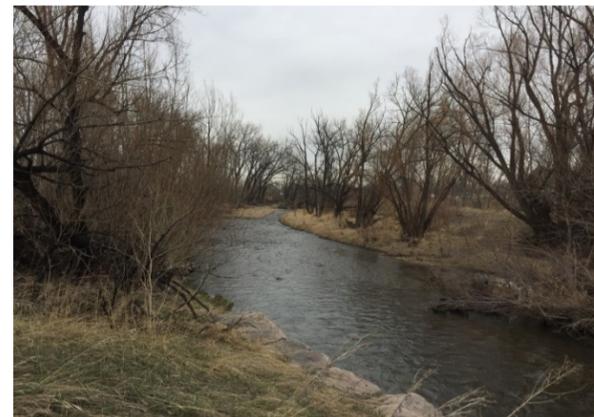
Photo 23: Upstream of Valmont Road (Reach 8)

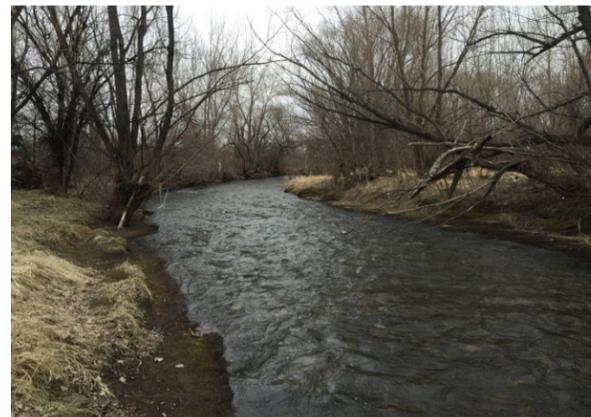
Photo 24: Upstream of 55th Street (Reach 8)

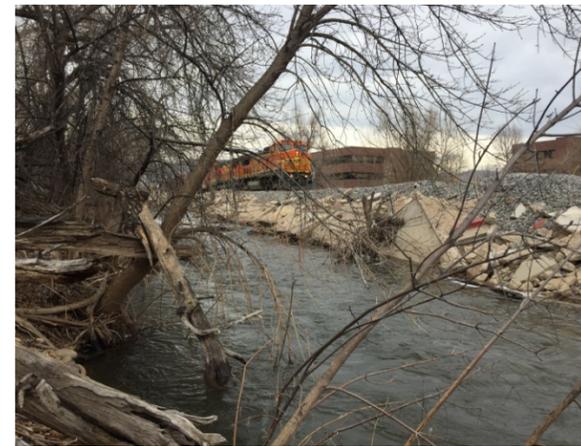
Photo 25: BNSF Railroad Embankment (Reach 8)

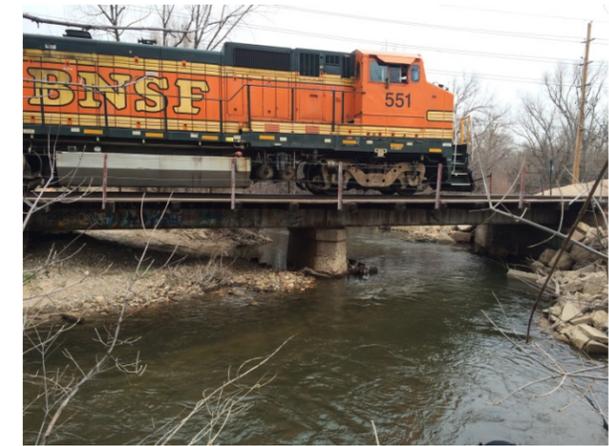
Photo 26: BNSF Railroad Bridge (Reach 8)

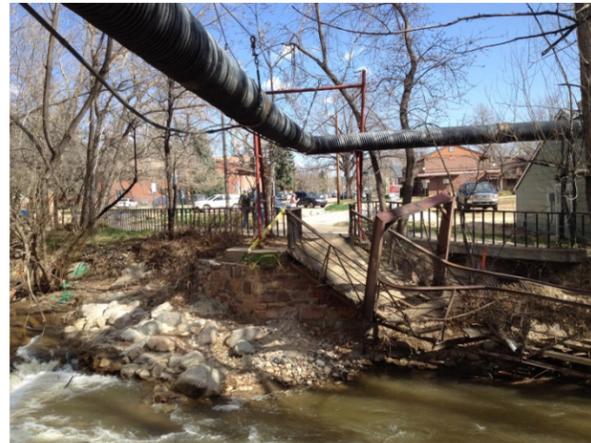
Photo 27: 19th Street Pedestrian Bridge (Reach 9)

Problems within this reach during the 2013 flood event were not as significant as other locations. Flooding occurred within isolated areas of the University of Colorado Campus. The flooding was relatively minor and contained to landscape locations, although an existing pedestrian bridge crossing near 19th Street was washed out. Damage to in-stream structures also occurred along Boulder Creek within the Civic Center area. This damage has since been repaired by the City. The City of Boulder estimated that damages from Boulder Creek exceeded \$41 million; however, these damages were largely attributed to high groundwater and sewer backups.

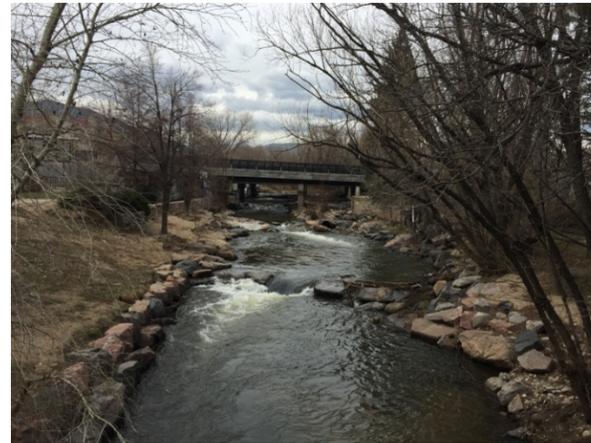
Photo 28: Downstream 28th Street (Reach 9)

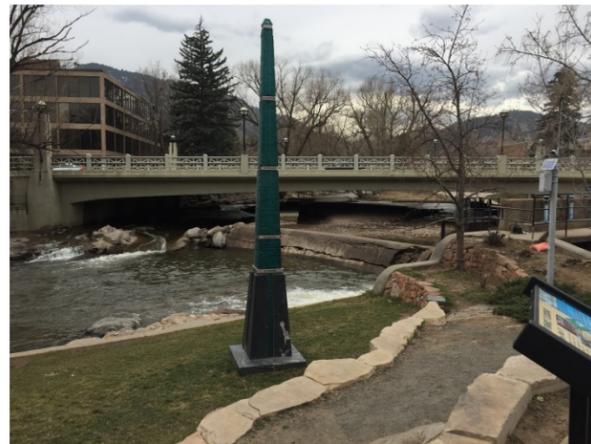
Photo 29: Downstream Broadway Bridge (Reach 9)

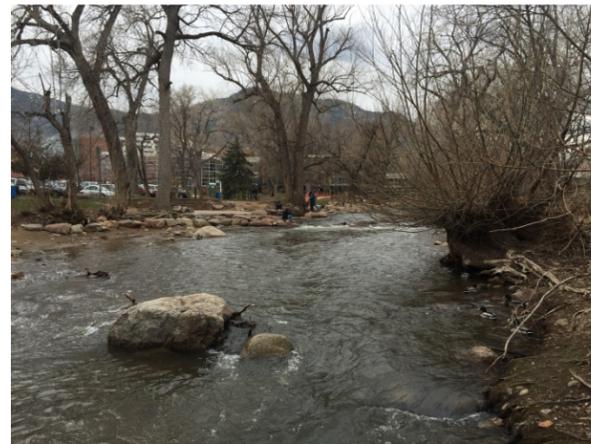
Photo 30: Boulder Creek at Civic Center Park (Reach 9)

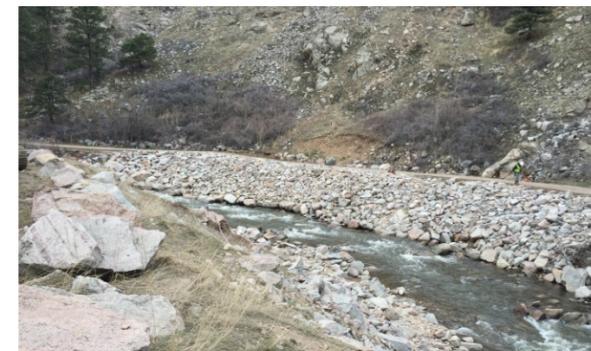
Photo 31: Bank armoring in Boulder Canyon (Reach 10)

boulders and some bedrock. Based on sinuosity, slope and observed bed material, Reach 10 classifies as B1 to B3, depending on the specific substrate at a given location along the reach. The riparian zone is largely impacted by the highway. In areas where the stream and highway are immediately adjacent to one another, streamside vegetation is often completely absent. In a few locations where the highway and stream are separate, a narrow riparian corridor typical for this stream type was observed. Very significant bank and bed armoring exists within this reach. Average stream widths are on the order of 25-35 feet. Much of the armoring is associated with the highway but in other locations armoring appears to have occurred to protect other infrastructure. Bank instability exists in many locations in Reach 10.

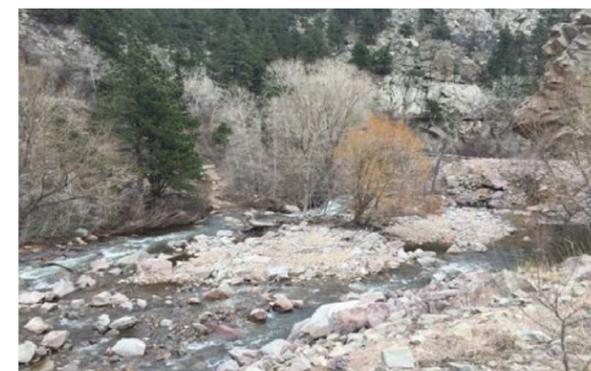
Photo 32: Depositional island in Boulder Canyon (Reach 10)

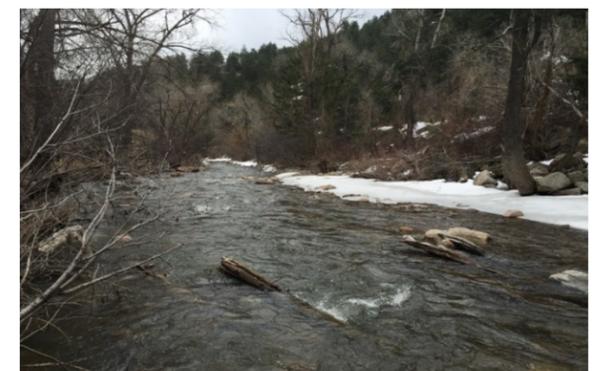
Photo 33: Deposition in Boulder Canyon (Reach 10)

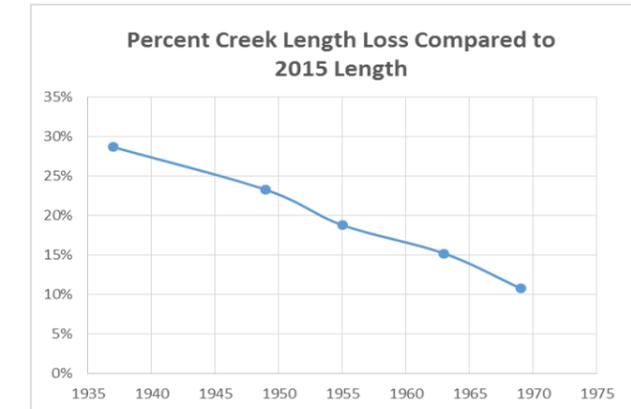
The results of the overlay and tracing exercise indicate that the creek has become straighter over time as is apparent when comparing the current stream length to the historic stream lengths for each data year. Every data year shows a decrease in length in comparison to the current stream length. The table and graph shown in Figure 5-1 show the historic length, the comparable 2015 length and the loss comparison, as a percentage, from the data year to the current year. Note that the extent of mapping for each of the different historic aerial imagery is different. As such, the historic stream lengths shown in the second column in Figure 5-1 represent the length of stream shown on the historic aerial. The 2015 length of stream presented in the third column indicates the current stream length for the individual historic aerial photographs. In order to compare data in Figure 5-1 across the different aerial images of 1937 to 1969, the right hand column showing percent change was added. This column indicates that the present decrease in stream length is greatest when comparing current conditions to 1937 and has decreased over time. This illustrates the continued trend of channel straightening over time.

Year	Historic Length (ft)	2015 Length (ft)	Length Change (ft)	Percent Change
1937	29,555	21,070	8,485	29%
1949	23,620	18,120	5,500	23%
1955	32,115	26,070	6,045	19%
1963	35,570	30,155	5,415	15%
1969	36,560	32,610	3,950	11%

Figure 5-1: Loss of Stream Length over Time as a Percentage

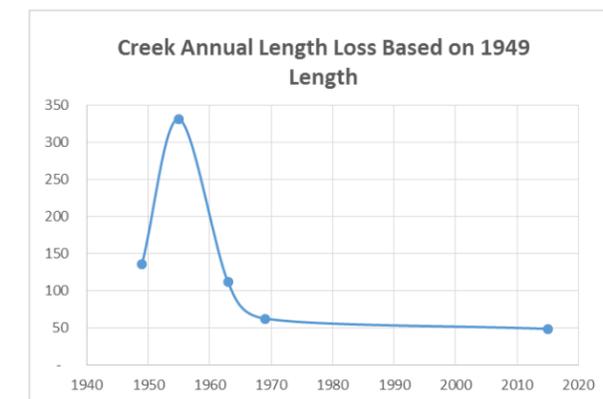
An additional comparison was completed by taking the year with the least stream coverage (1949) and truncating the other historic year lengths to match the 1949 segment ends as a way of normalizing this segment. These values were recorded to see the reduction in the length over the same stream corridor section. As evident in the table below, this segment of channel has experienced channel straightening continually throughout the years. The table and graph below show the length loss when normalizing each year's length to the 1949 stream length. With the data years available, it appears the largest stream straightening occurred between 1949 and 1955.

Year	Historic Length (ft)	Length Change from Previous Data Year (ft)	Length Change Extrapolated on a per Year Basis (ft)
1937	25,250		
1949	23,620	1,630	136
1955	21,630	1,990	332
1963	20,735	895	112
1969	20,360	375	63
2015	18,120	2,240	49

Figure 5-2: Loss of Stream Length

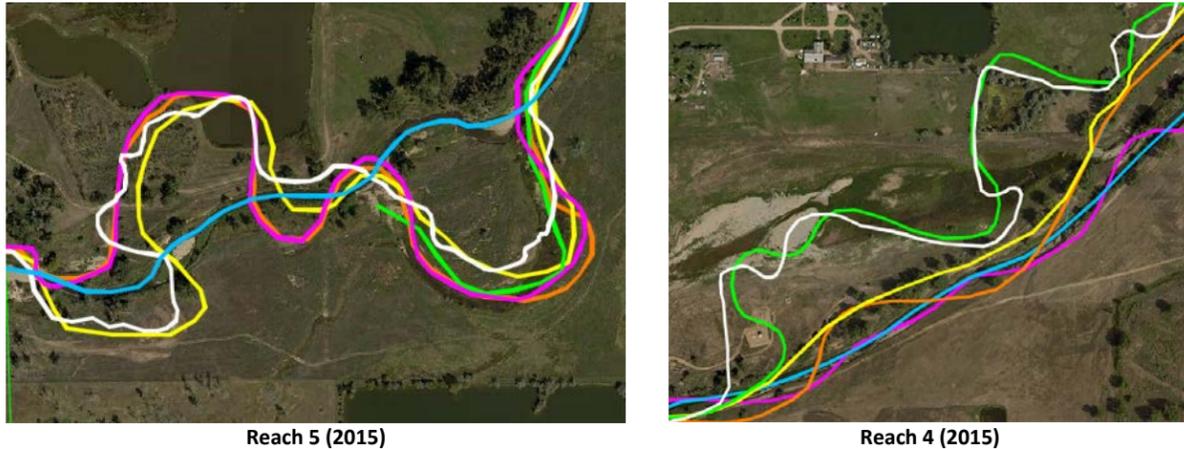
It is apparent from the stream length shortening that there is a corresponding change in the course of the river with the reduction of stream meanders. Below are two figures that show the historic creek pathways in comparison to the existing creek. The figure on the left, Reach 5, shows channel realignment occurring after 1969 and the figure on the right, Reach 4, shows channel realignment occurring between 1949 and 1955. The stream color coding is the following: 1937-White, 1949-Green, 1955-Yellow, 1963-Orange, 1969-Magenta, and 2015-Blue. In all cases the stream has straightened over time.

Figure 5-3: Depiction of Modification to Channel Meanders

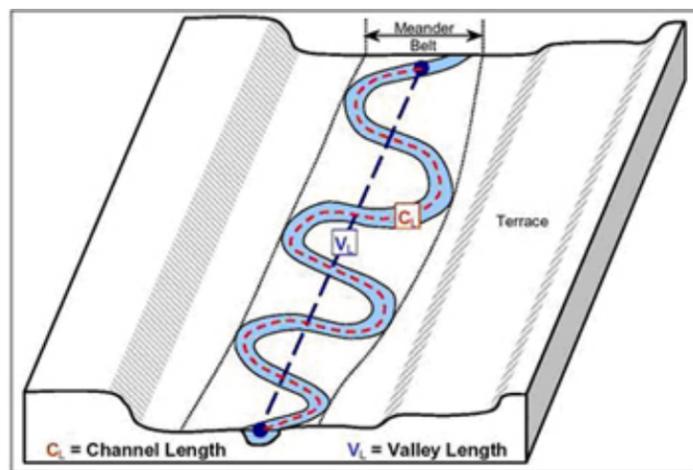
Channelization can be quantified by evaluating stream sinuosity. Sinuosity is the ratio of the length of a stream channel to the length of the valley. A sinuosity value of 1.0 indicates a straight channel whereas a sinuosity of 1.5 indicates that the length of the stream is 50% longer than the straight length of the valley. The higher the sinuosity of a channel, the more it meanders along its length. The figure below provides a graphic representation of a stream. Sinuosity is calculated as channel length (C_L) divided by Valley Length (V_L).

Figure 5-4: Stream Sinuosity

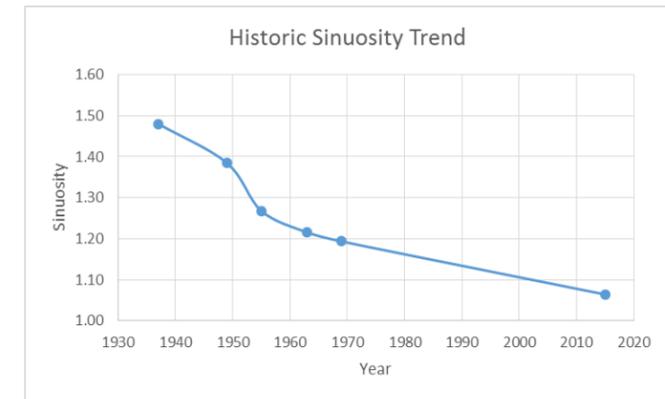
In order to quantify impacts of channelization on Boulder Creek, sinuosity was determined from historic mapping. These calculations were undertaken by measuring a valley length within the normalized section and comparing this value to the data year lengths. The results are shown below.

Year	Historic Length (ft)	Valley Length (ft)	Sinuosity
1937	25,250	17,060	1.480
1949	23,620	17,060	1.385
1955	21,630	17,060	1.268
1963	20,735	17,060	1.215
1969	20,360	17,060	1.193
2015	18,156	17,060	1.064

Figure 5-5: Change in Stream Sinuosity

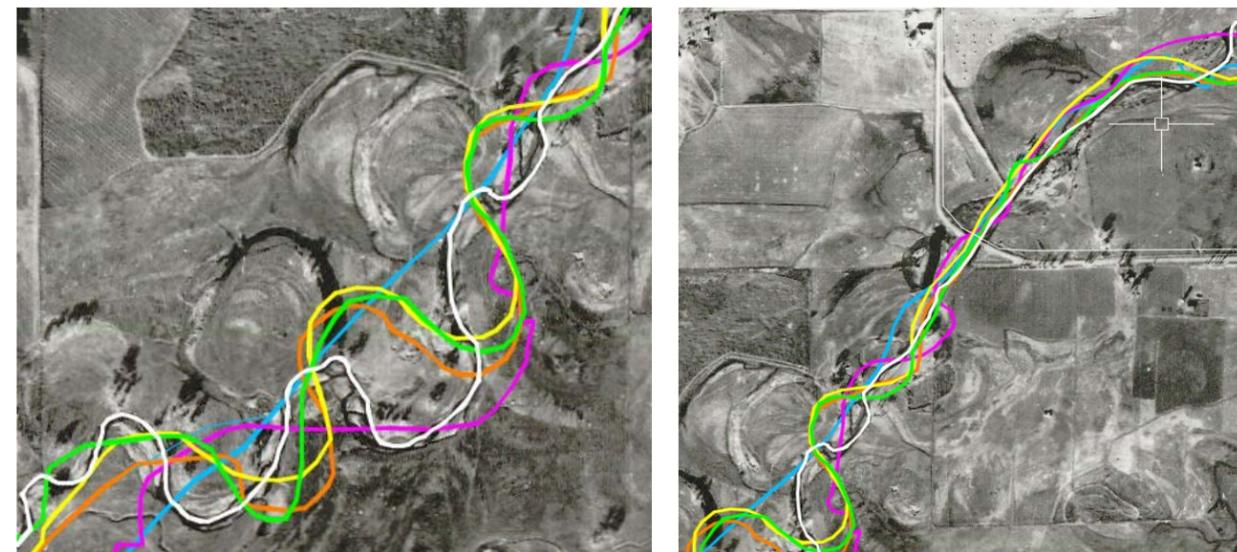
There is evidence of stream realignment occurring prior to 1949 when observing the 1949 photo overlay in Reach 5. There are distinct places where it is apparent that the creek followed a different alignment as is indicative of the curves and bends apparent in the 1949 natural ground surface photos below. Also it is apparent that stream straightening is more pronounced at road crossings as shown in the picture to the right below.

Figure 5-6: Straightening Trends in Reach 5

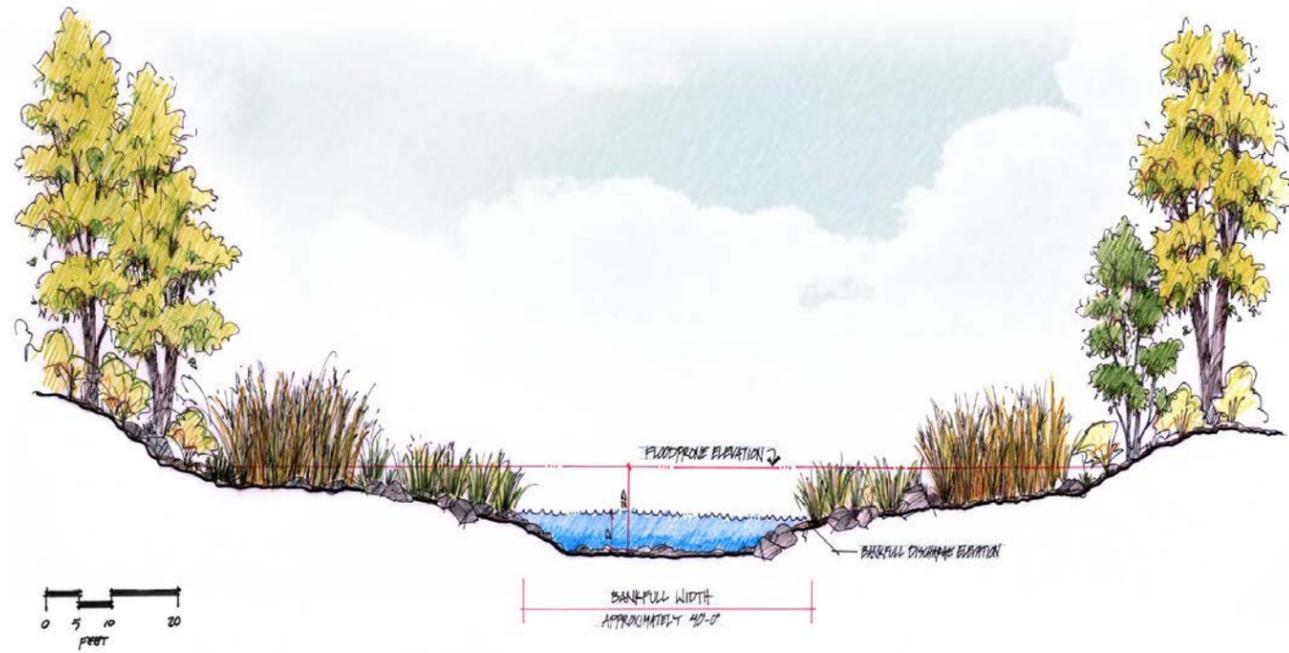
Figure 6-1: Typical Geomorphic Cross-section

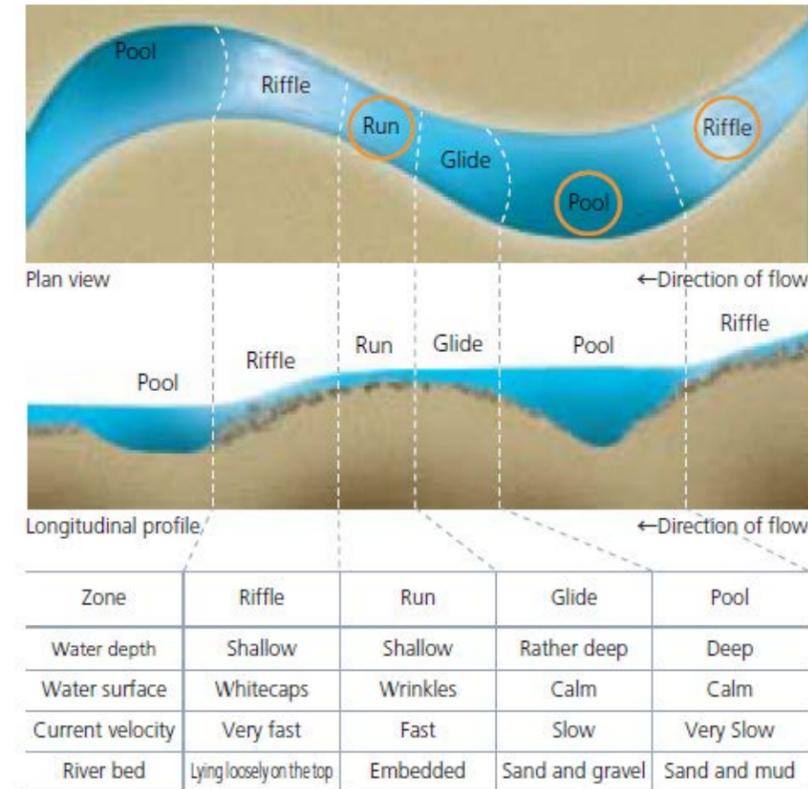
In addition to variability in cross section, variability in channel slopes is a characteristic of natural channels. Features such as step pools, scour pools, rapids and riffles/pool sequences occur naturally and provide variety from both a habitat and aesthetic standpoint. Step pools, rapids and scour pools are bedform types that are typical of Type B stream that would be found in Reach 10. Riffle/pool sequences are alternating stretches of shallow, fast-moving sections (riffles) and deeper, slower pools, with glides or runs in between the end of a pool and beginning of the next riffle to allow for gradual bedform transformation. Riffle/pool sequences are typical bedforms seen in meandering, Type C streams such as Reaches 1-9. A schematic of a riffle/pool sequence, along with glides and runs is shown in Figure 6-2 (obtained from the Public Works Research Institute’s Aquatic Restoration Research Center, 2004).

Figure 6-2: Typical Riffle/Pool Schematic
