1.0 INTRODUCTION

1.2 Background

The purpose of this master plan is to provide planning guidance to improve resiliency along Boulder Creek from the confluence with Fourmile Creek, in Boulder Canyon, to the confluence with the Saint Vrain Creek in the City of Longmont. This plan provides general guidance for stream and ecological restoration among other multiple objectives including:

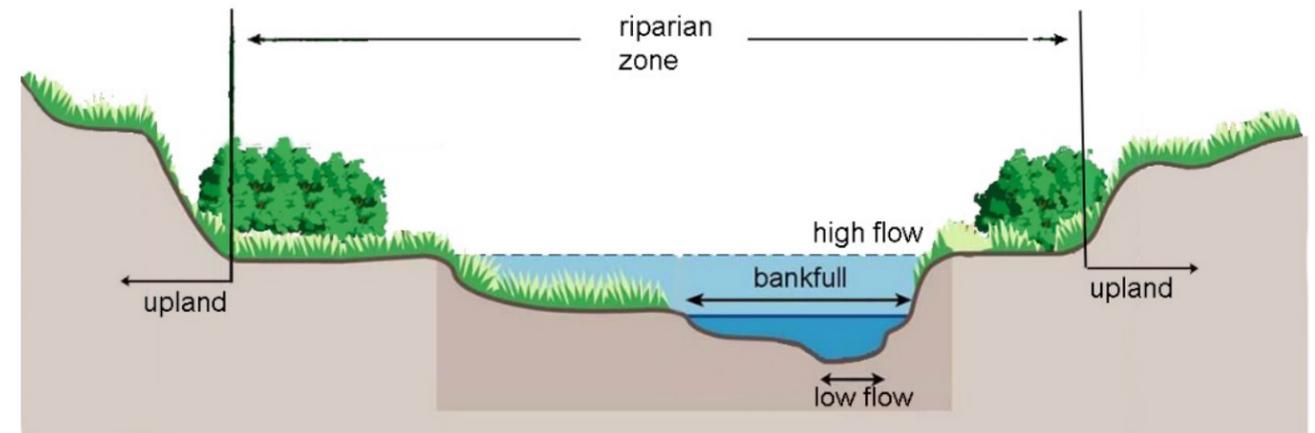
Riparian vegetation also contributes to bank stability by dissipating the energy of moving water and reducing velocity, which is imperative during typical flood events. In an ideal situation, natural stream flows are able to access a broad floodplain. A properly functioning riparian zone protects not only water quality but also the physical integrity of the aquatic environment.

Figure 7-1: Components of a properly functioning riparian zone (Image modified from FISRWG 1998.)

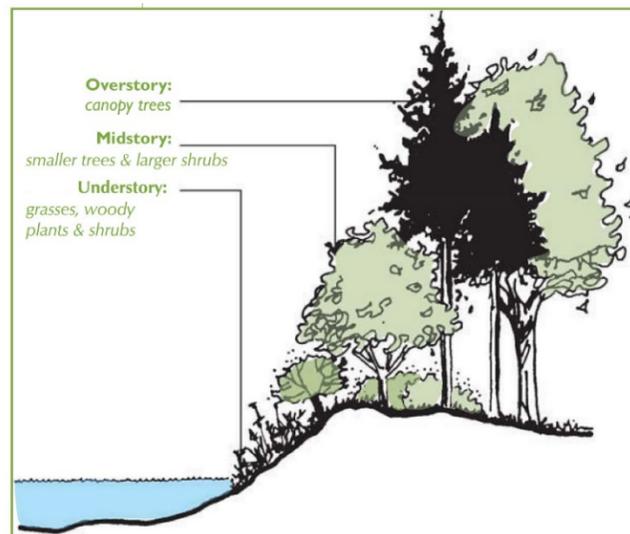
Within the project area, this reference standard community would occur on low terraces and along the immediate streambanks of Boulder Creek through the riparian zone. The unconfined, active stream channel would frequently inundate vegetation through the riparian zone and active floodplain forming a complexity of habitats which support a variety of plant communities. Figure 7-3 depicts the components of a properly functioning and structurally diverse riparian community for Boulder Creek.

Figure 7-2: Components of a Riparian Community (modified from: Montgomery county planning commission 2006).

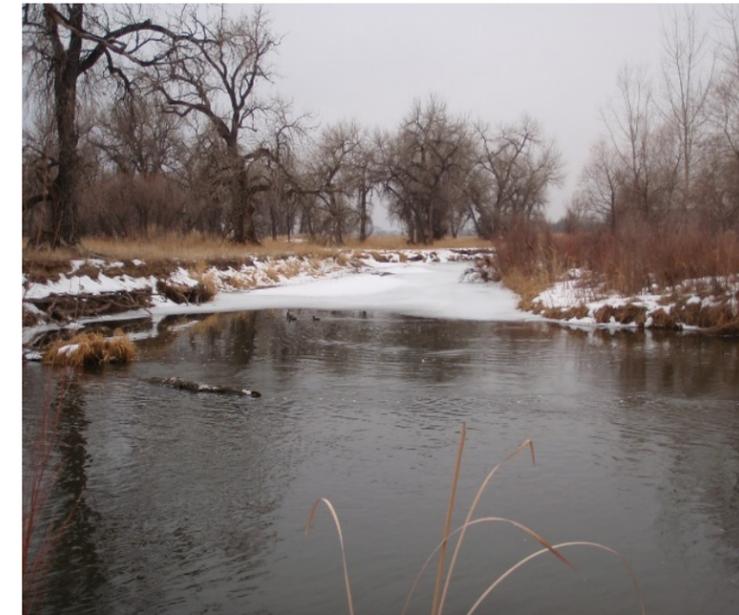
Figure 7-3: Boulder Creek: Example Riparian Reference Standard (dominated by cottonwood overstory with willow midstory and grass understory)

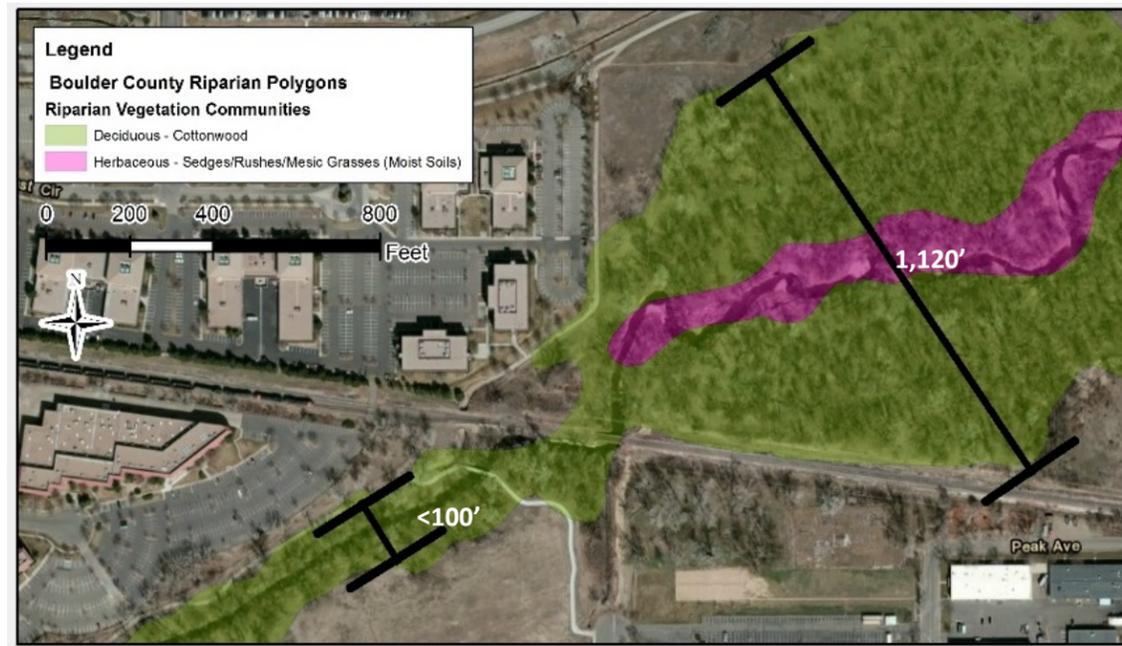
Figure 7-4: Example of varying riparian zone widths through the project area

The narrow riparian zone (left) is limited by land use and bisected by a railroad; the more naturalized downstream section (right) is wide and less confined. (Note: Example is provided for riparian width characteristics only - site specific vegetation communities and species may not represent an appropriate restoration target.)

Higher quality riparian areas typically occur within the project in areas less impacted by human land use. In these areas, Boulder Creek’s riparian zone is wide, stable and densely vegetated extending well over 500 feet across the floodplain (Figure 7-4). The narrow riparian zone (left) is limited by land use and bisected by a railroad; the more naturalized downstream section (right) is wide and less confined.

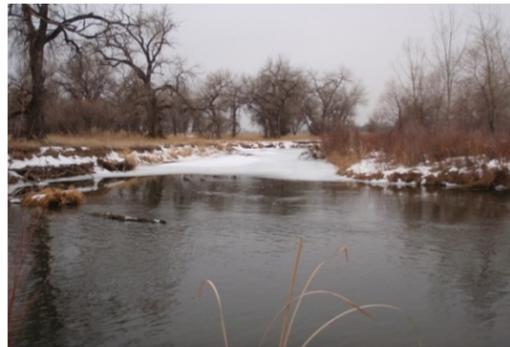
Photo 35. Confluence with St. Vrain Creek. Example of reference standard riparian habitat which includes dense vegetation community with three strata, stable stream banks, a wide floodplain and little human disturbance. Flood flows resulted in minimal damage to the riparian corridor.

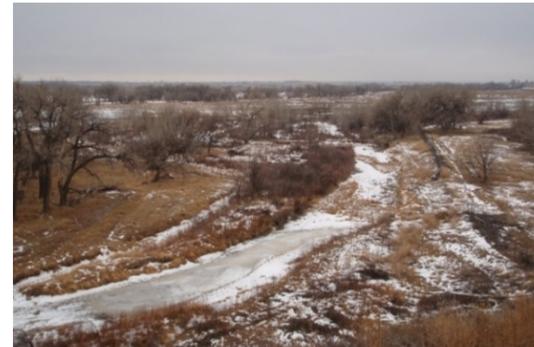
Photo 36. N 107th Street to St. Vrain Creek reach. Here flood flows resulted in abandonment of the pre-flood channel and riparian corridor. Herbaceous vegetation has begun to establish in the previous active channel bottom, indicative of an altered hydrologic regime.

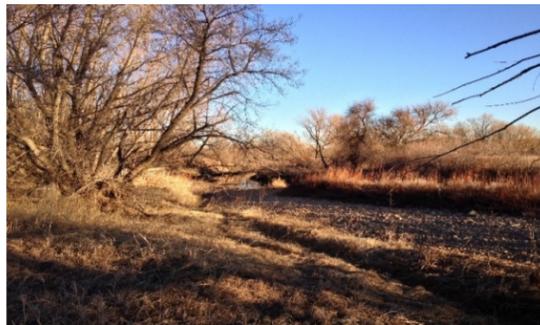
Photo 37. Boulder Creek east from 61rd Street. Example of wide, well vegetated riparian zone with only moderate post-flood disturbance to the riparian zone. At this location, flood flows deposited significant amounts of cobble material within the existing overly wide stream channel which resulted in altered stream flow. The riparian zone is now disconnected from stream flow which can result in long-term habitat community shifts or complete loss of riparian species.

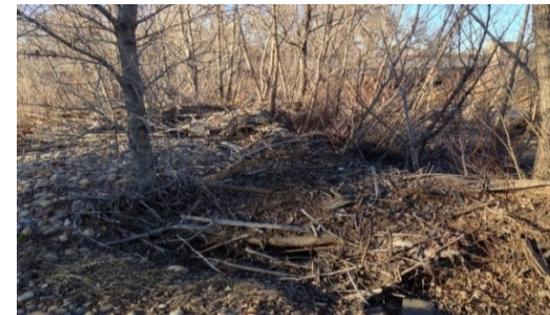
Photo 38. Boulder Creek near Valmont Road. Example of moderate post-flood disturbance to the riparian zone including: significant sediment deposition/vegetation burial, tree damage/loss and significant accumulation of debris from dead/downed trees. While moderate disturbance has occurred in this reach, a majority of the riparian vegetation remains intact and will continue to function.

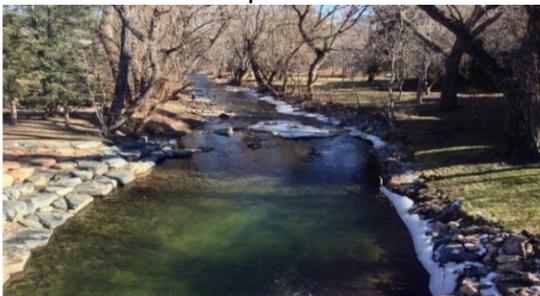
Photo 39. Highly urbanized area within City of Boulder reach characterized by overstory trees and armored stream banks. Through this reach, Boulder Creek overtopped its banks and inundated the existing riparian zone. After the flood event, the riparian zone remains relatively intact.

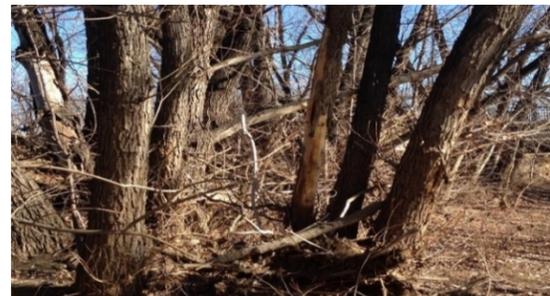
Photo 40. City of Boulder reach example of low-disturbance: debris accumulation and riparian zone tree damage (trunk damage and bark removal) as a result of the flood. For the most part, while damaged, a majority of the riparian vegetation community will persist and continue to function.

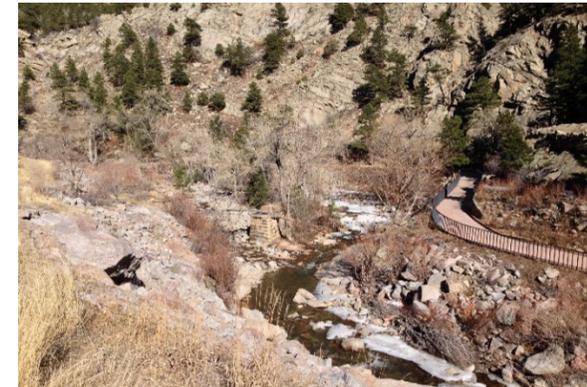
Photo 41. Boulder Canyon reach. The existing riparian zone is characterized by one vegetation strata including either trees or shrubs with no mid- or understory present. Flood damages to the riparian zone are low. Much of the riparian zone remains intact with little change the pre-flood condition.

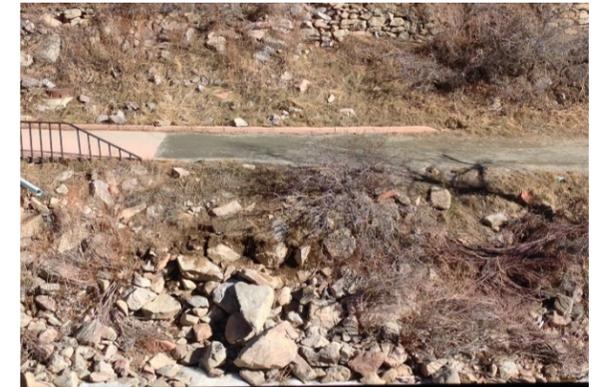
Photo 42. Boulder Canyon reach example of low post-flood disturbances which includes only minor bank erosion and shrub damage.

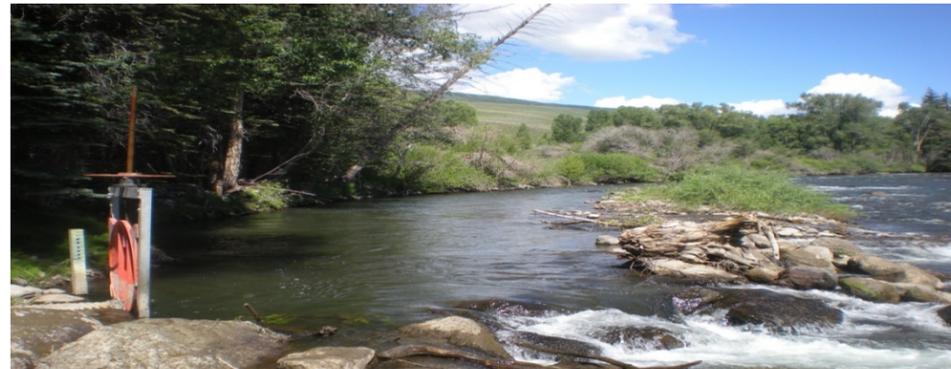
Drop structures, and other existing stabilization measures, which present obstruction to fish passage or macro-invertebrate habitat, have also been proposed to be replaced in a similar manner.

Photo 9.1 - Example of diversion structure and fish passage channel (ERC, East River)

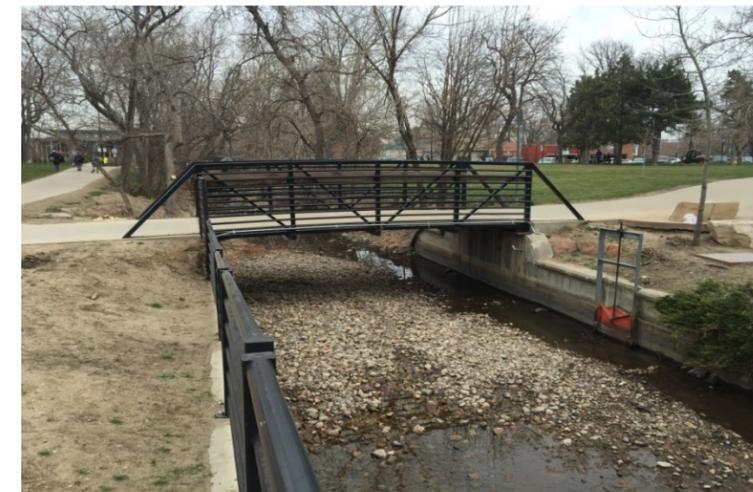
Boulder Slough Mitigation: The slough currently originates as a diversion from Boulder Creek at the structure east of the Broadway Bridge, commonly known as the 12th Street diversion structure. Five ditches divert their respective water rights from this structure and waters co-mingle in Boulder Slough as it traverses the City. The five ditches are the Boulder & White Rock Ditch, Boulder & Left Hand Ditch, McCarty Ditch, Smith and Goss Ditch, and North Boulder Farmer’s Ditch. Boulder Slough extends from Boulder Creek at Broadway downstream to Goose Creek, east of Foothills Parkway. In addition to carrying private irrigation ditch flows, Boulder Slough has the potential to also collect stormwater runoff derived from the area west of the slough and north of Boulder Creek. During the September 2013 flood, flows that entered the Boulder Slough spilled from its banks upstream and downstream of 15th Street and flooded residences within the Goss Grove neighborhood. An alternative has been proposed at 14th street to intercept flows beyond the ditch capacity and convey the overflow to Boulder Creek via a storm sewer. For the purposes of the analysis, the overflows were assumed to be approximately 110-cfs during the 100-year event, approximately half of the 100-year discharge at 18th Street, as referenced by the floodplain mapping study prepared by Anderson Consulting Engineers, Inc. (ACE) in 2014 [Reference 62]. A 48 inch RCP was assumed for the outfall. Any modifications impacting irrigation ditches require written ditch company approval.

Photo 9.2 – Boulder Slough Diversion at Broadway

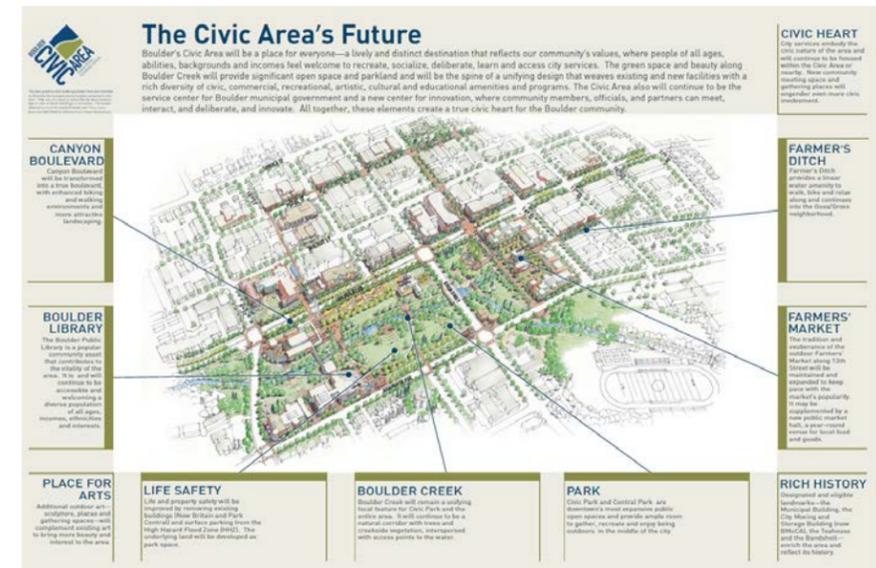
Site Opportunities and Flood Constraints: The west and east area of the Civic Area present different risks in flooding potential. The HHZ has a greater influence on the structures on the west end of the Civic Area. Although the HHZ designations are more confined on the east end, the structures are still inundated by the 100-year floodplain. Below grade parking structures should be avoided in the Civic Area due to the flood risk and groundwater challenges that below grade structures provide.

Figure 9-1: City of Boulder Civic Area Plan [Reference 65]

City of Boulder Civic Center Area Plan: The City of Boulder is currently reviewing redevelopment and improvements options for the Civic Center between 13th Street and 9th Street. With regards to floodplain improvements, the proposed plan includes removal of several buildings and surface parking in an effort to increase floodplain capacity and reduce infrastructure in areas of high hazard designation. With the Civic Center plan, Boulder Creek will continue to be a natural corridor with trees and creek-side vegetation. No specific proposed changes to the channel, ditch diversions, or to the existing crossing structures at 9th, Broadway, and Arapahoe Avenue were identified. An evaluation of potential mitigation improvements was completed by ACE in 2012 [Reference 63]. This evaluation analyzed eleven flood mitigation scenarios using a hydraulic model. The scenarios included variations of the removal of the Park Central and New Britain buildings and increasing the opening of the Broadway and Arapahoe crossing structures. The evaluation determined that the base flood elevations upstream of Broadway could be reduced by removal of the buildings and increasing the opening area of the Broadway crossing, however the municipal building would remain within the 100-year floodplain. Additionally, it was noted that improvements have

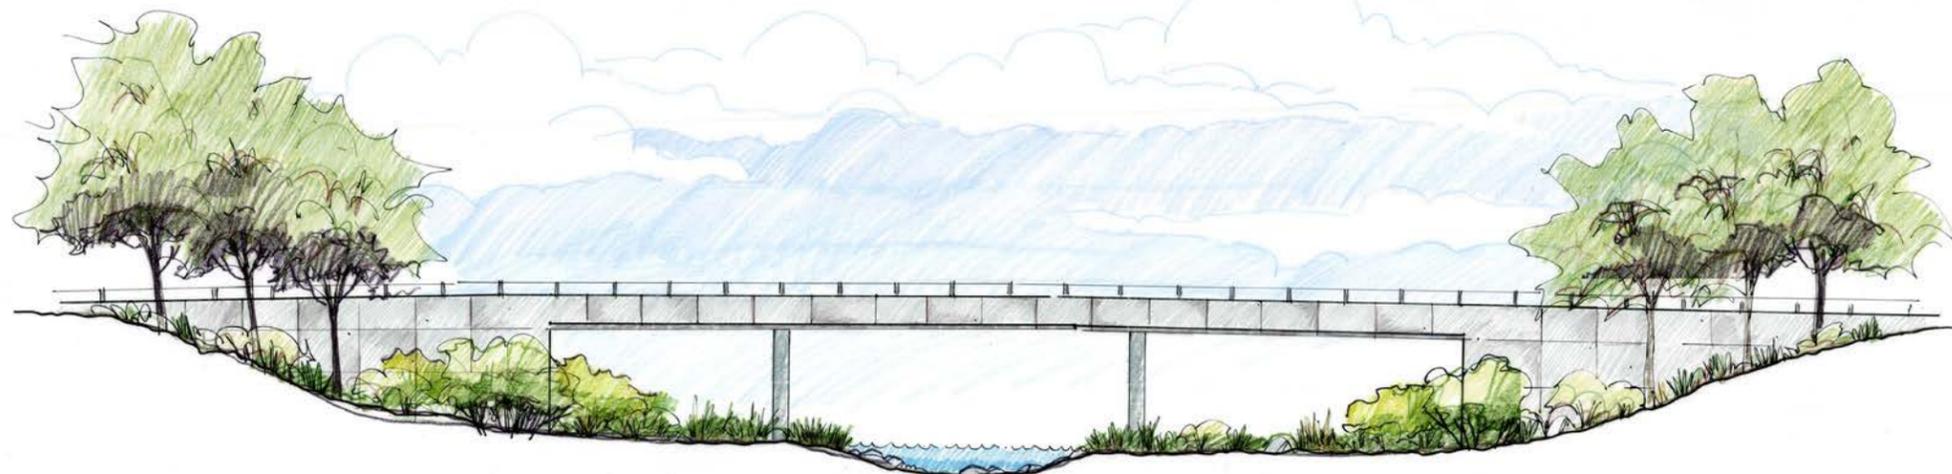
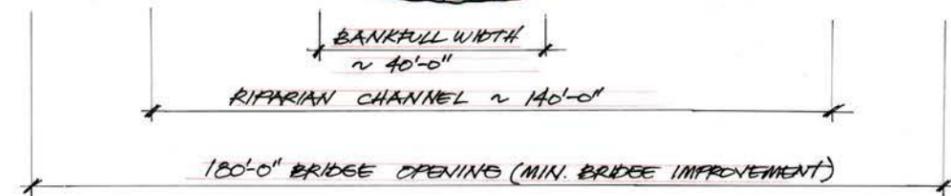
REACH 5 - BRIDGE OPTION A

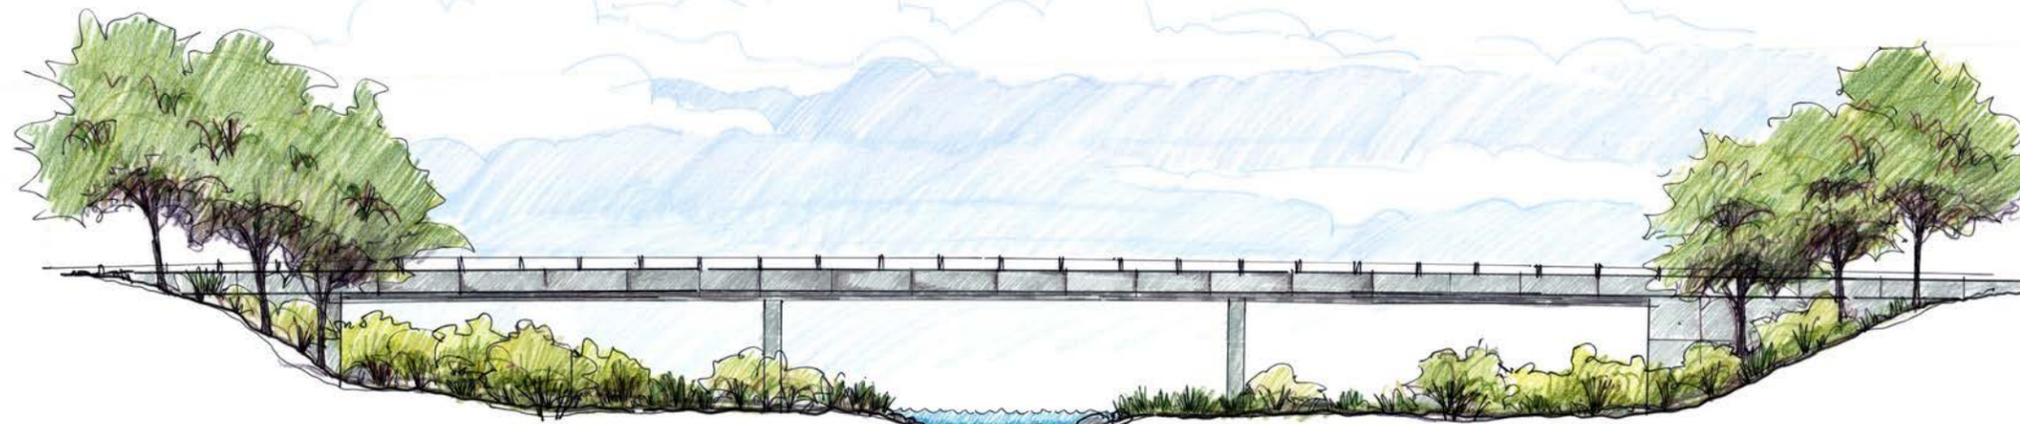
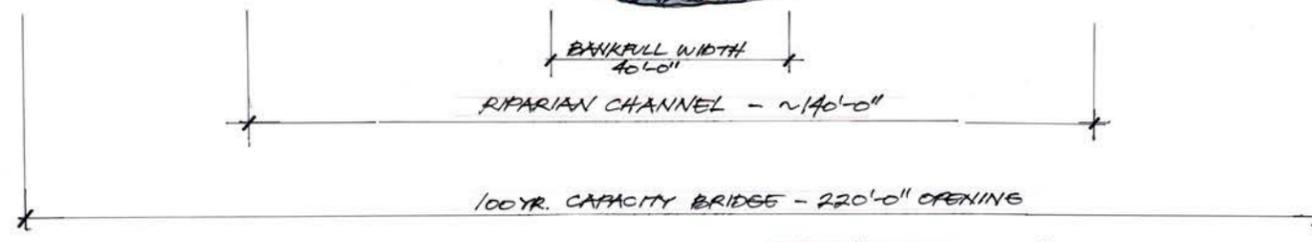
REACH 5 - BRIDGE OPTION B

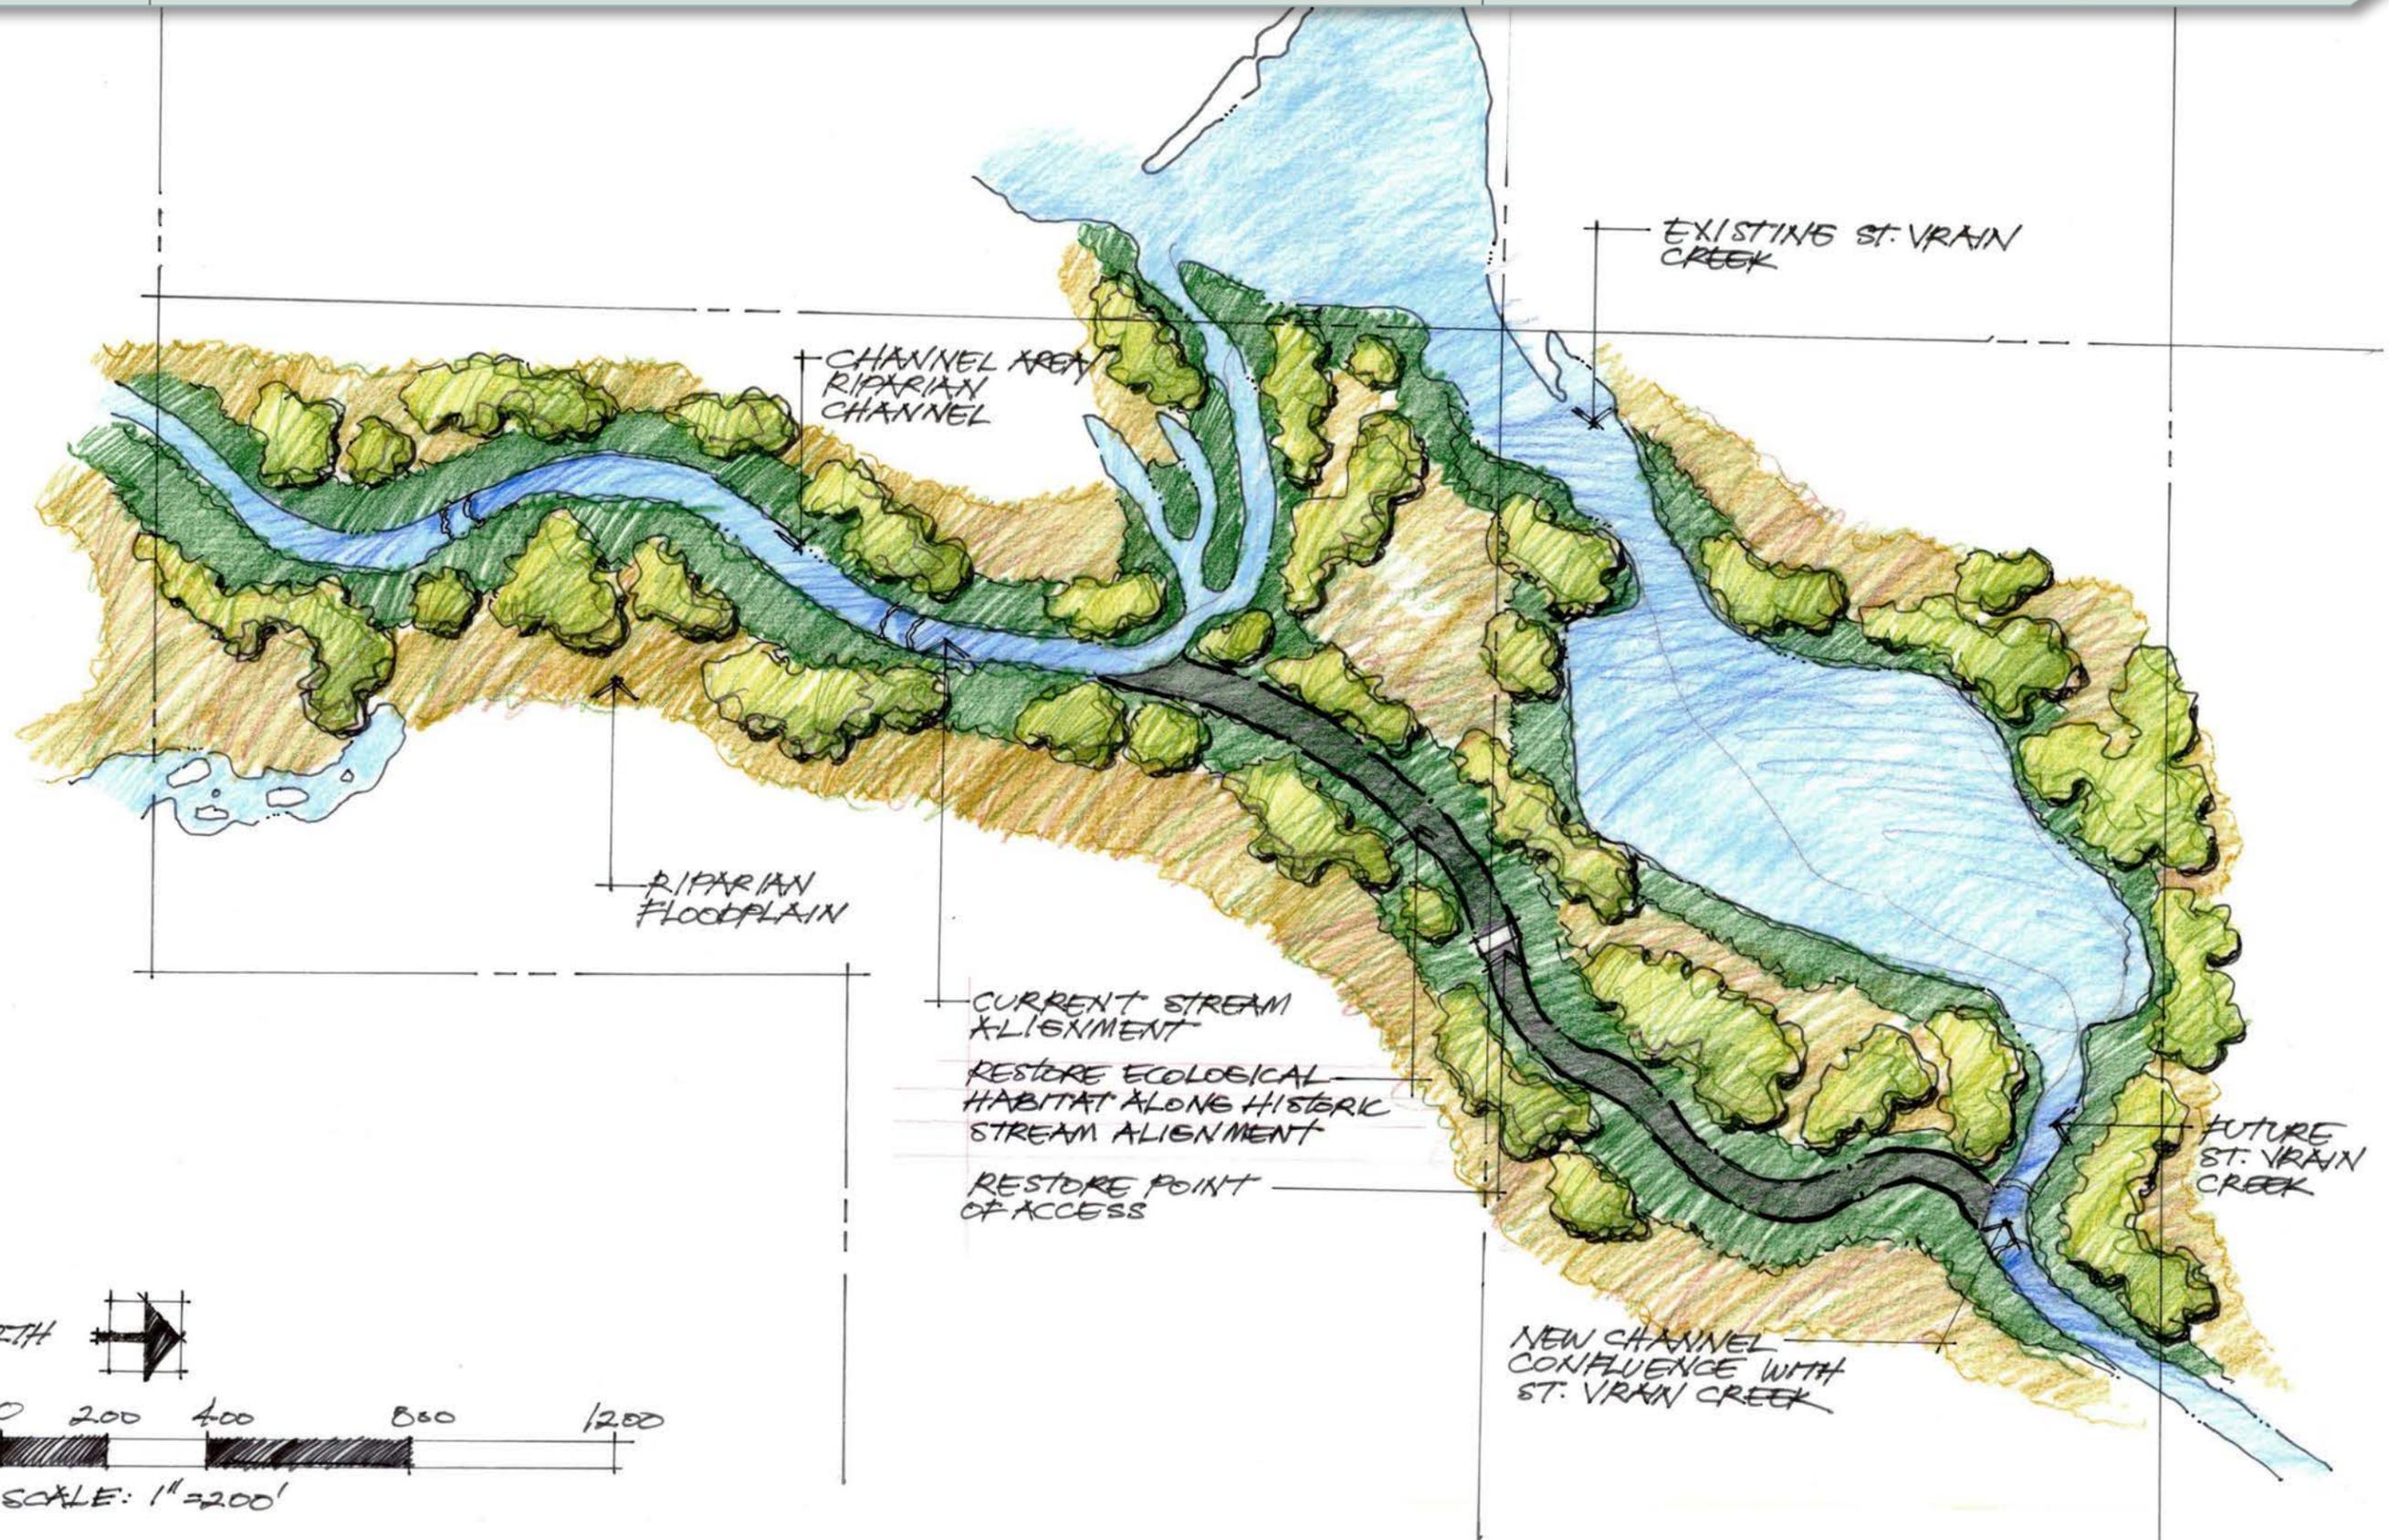
REACH 1 AT BOULDER CREEK

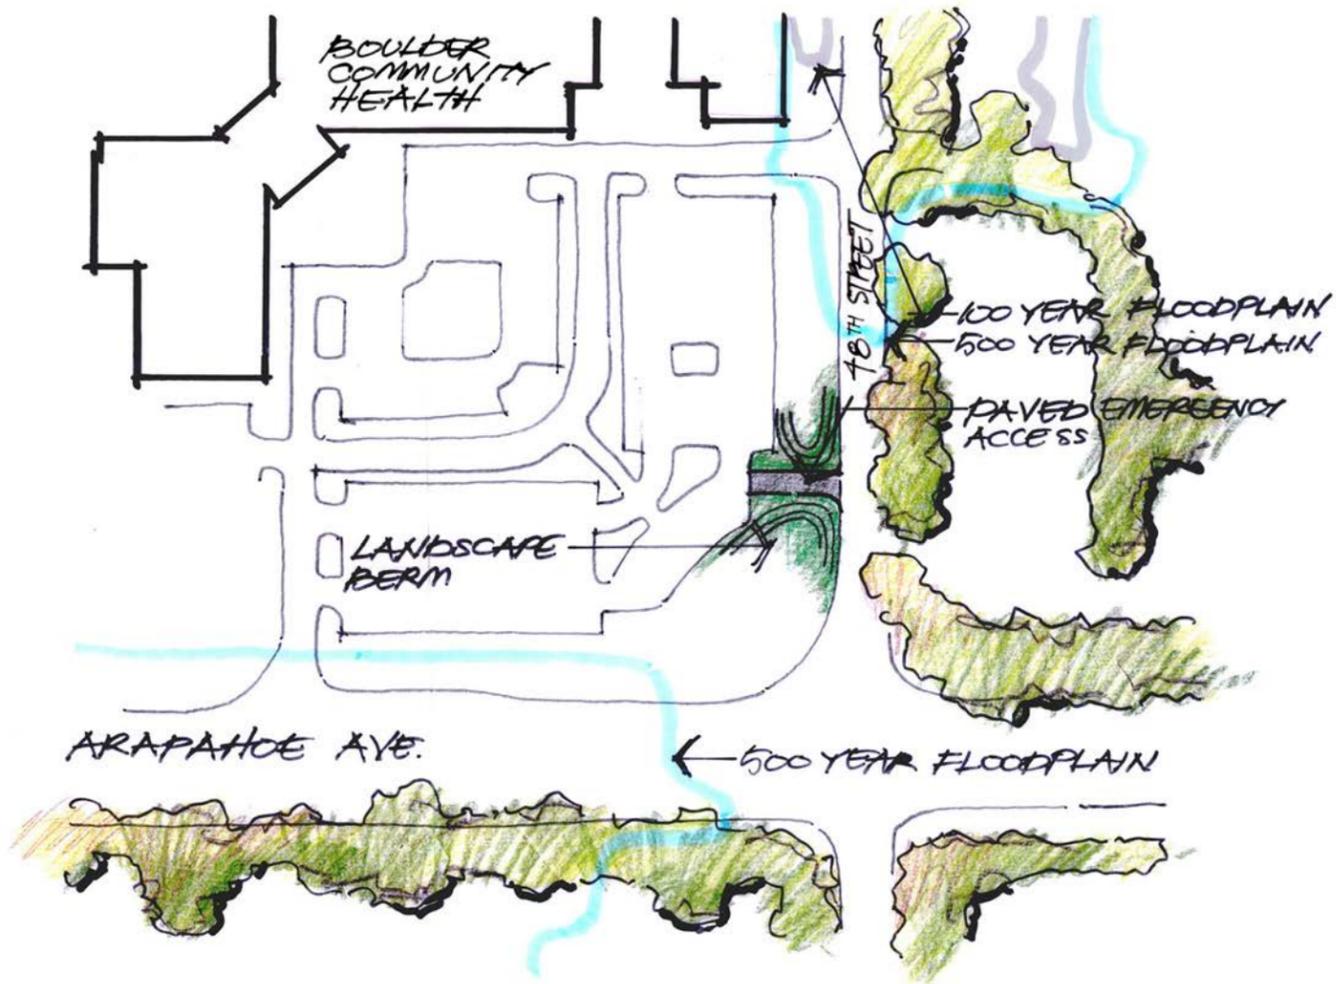
REACH 8 BOULDER COMMUNITY HEALTH
500 YEAR ACCESS

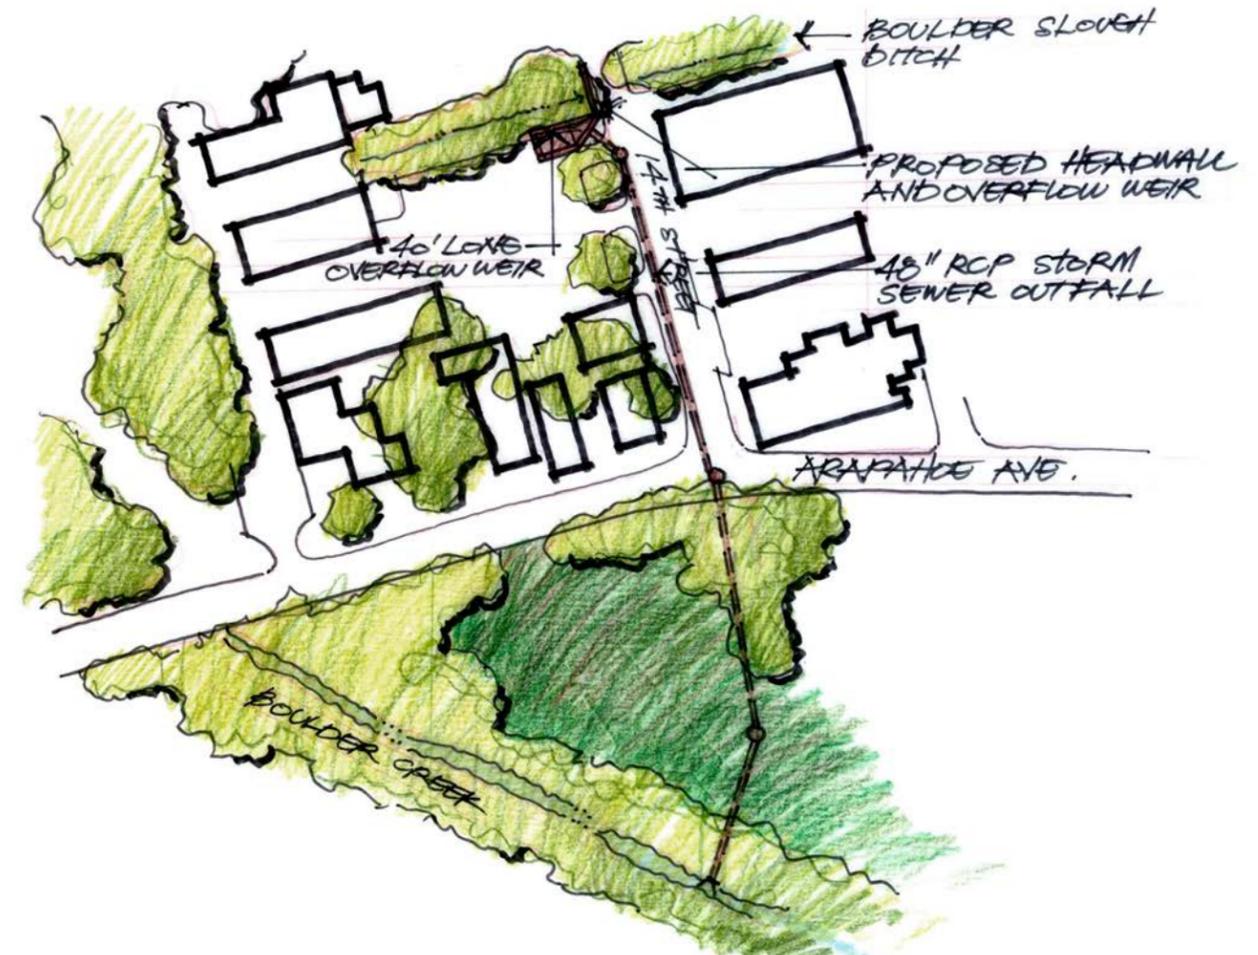
REACH 9 BOULDER SLOUGH DIVERSION
