Preliminary Basis of Design Report

For South St. Vrain Creek Restoration at Hall Ranch

September 2016

Boulder County, Colorado

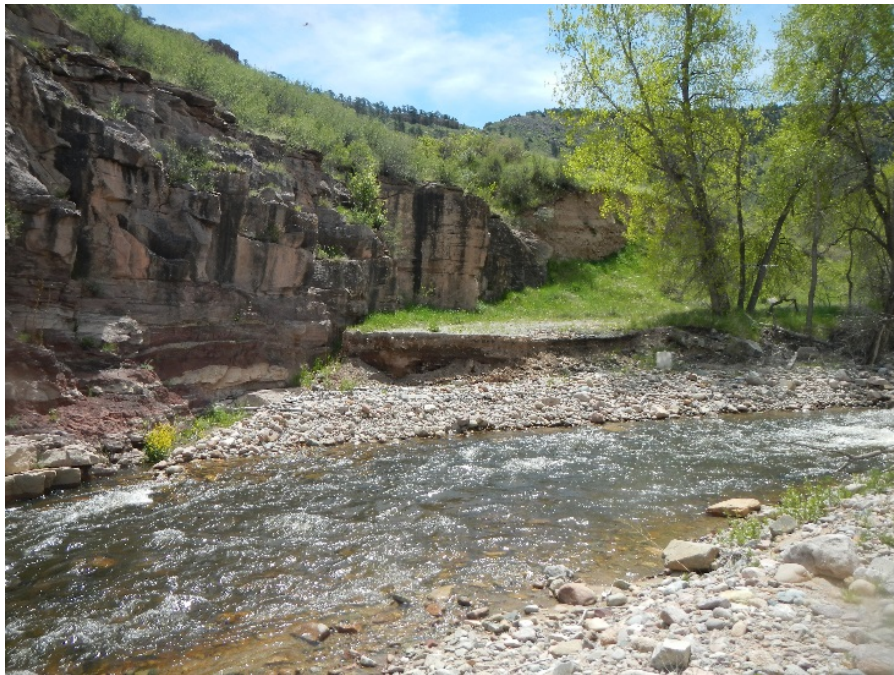
Figure 13. Damaged Old St. Vrain Road

- A portion of Old South St. Vrain Creek Road approximately 1300' upstream of the Andesite Quarry bridge and adjacent to a major rock outcrop has washed away, eliminating the major access to the former quarry for remediation purposes and for future use as access to a new County open space/recreation area. Boulder County is currently working with FEMA on repair of the road. However, the creek will continue to impact the road at this location.

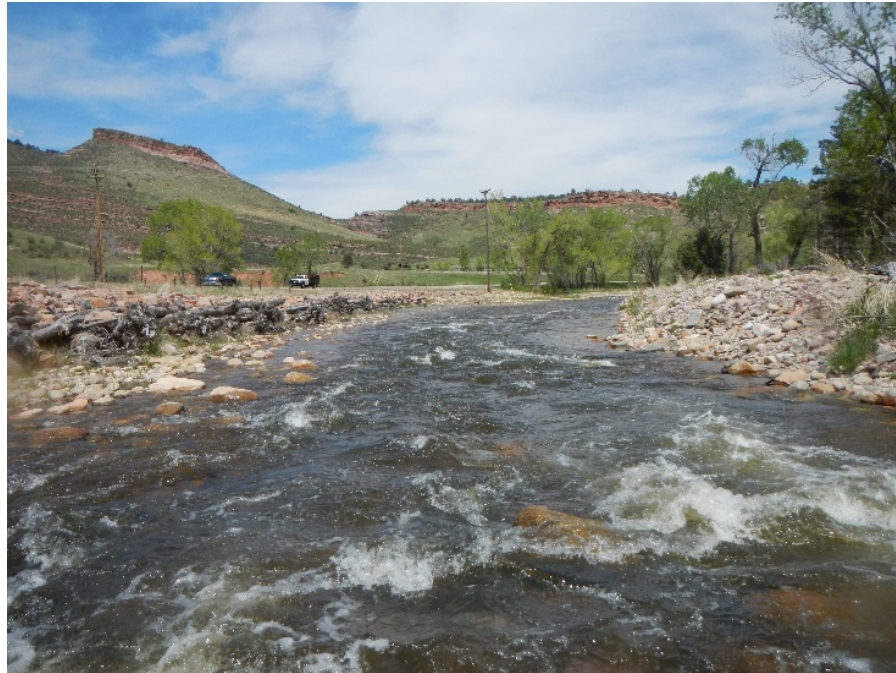
Figure 16. Existing Rootwad Protection at Hwy 7

- A stream avulsion occurred during the 2013 flood that resulted in a new post-flood low flow channel mostly located on non-County owned property. During the avulsion, the cutting of the new channel included eroding a portion of the edge of Colorado State Highway 7, to a post-flood location at the toe of the repaired highway embankment.

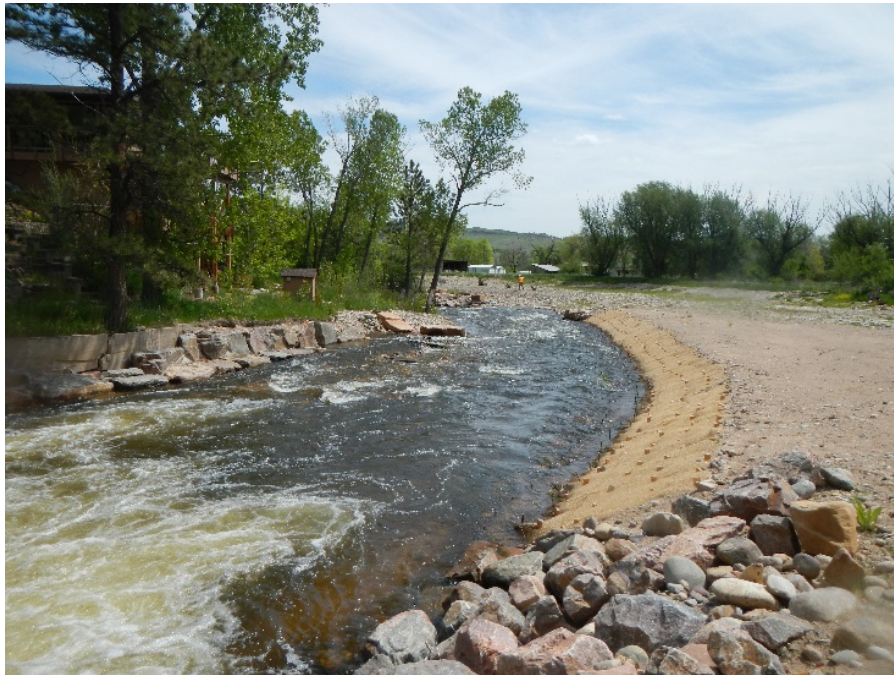
Figure 19. Longmont Diversion Post-Flood Work

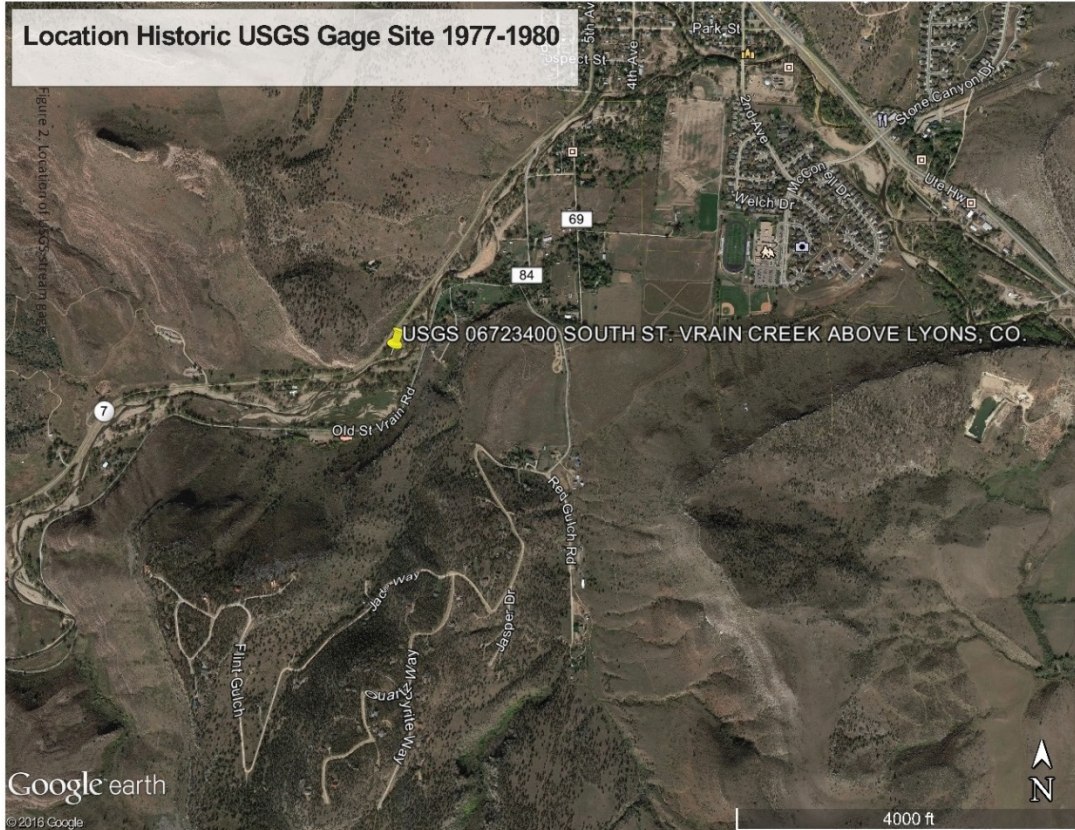
While there is no current stream gage on South St. Vrain Creek in the vicinity of this study, the USGS did operate a stream gage for four water years (1977-1980: USGS Gage No. 06723400) that was located within a few hundred feet of the location of the June 14, 2016 discharge measurement (Figure 22). Though the gage was operated for only a short period of the time, the flows it measured represent a reasonable range of discharges from wet and dry years (Figure 23). The measured flows at that location are considered more accurate compared to scaling flows from other nearby gages that perhaps would not reflect the operational hydrology and flow regulation that influences the South St. Vrain Creek hydrograph.

Figure 22. Location of Historic Gage

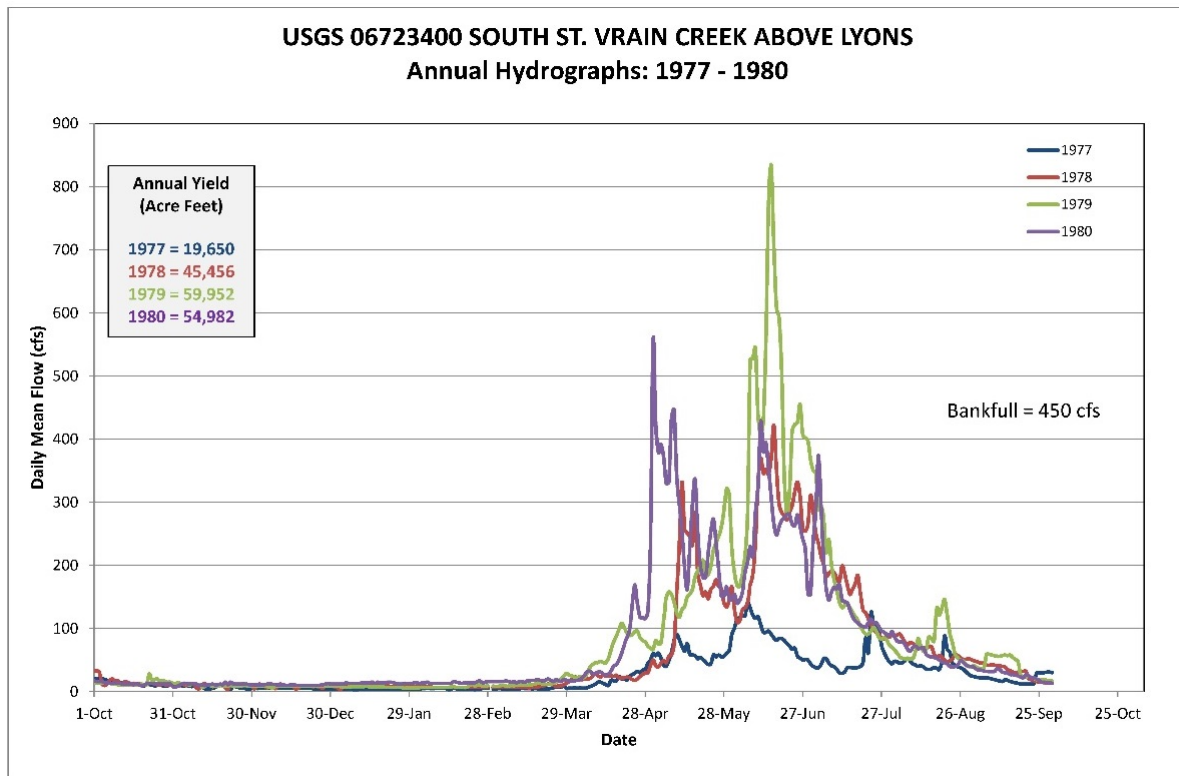
Figure 23. South St. Vrain Creek Above Lyons Hydrograph

To estimate sediment yield using the four years of South St. Vrain Gage data, seasonal daily mean flow (Q) values (April 1 to September 30) were divided by the bankfull value 450 ft³/s (Q_b). Seasonal flow values were used because very little if any sediment is being transported by the low flows from October 1 to March 31 (Figure 23). Using four dimensionless sediment transport equations (Rosgen 2006), the dimensionless sediment transport value was calculated for each seasonal daily mean flow in the period of record based on sediment type and stream channel stability. Multiplying each dimensionless sediment transport value by the bankfull estimate, converting units from kg/s or mg/l to tons/day, summing all dates and dividing by 4 (4 years in the period of record) provides an estimate of average annual sediment in South St. Vrain Creek (Table 1).

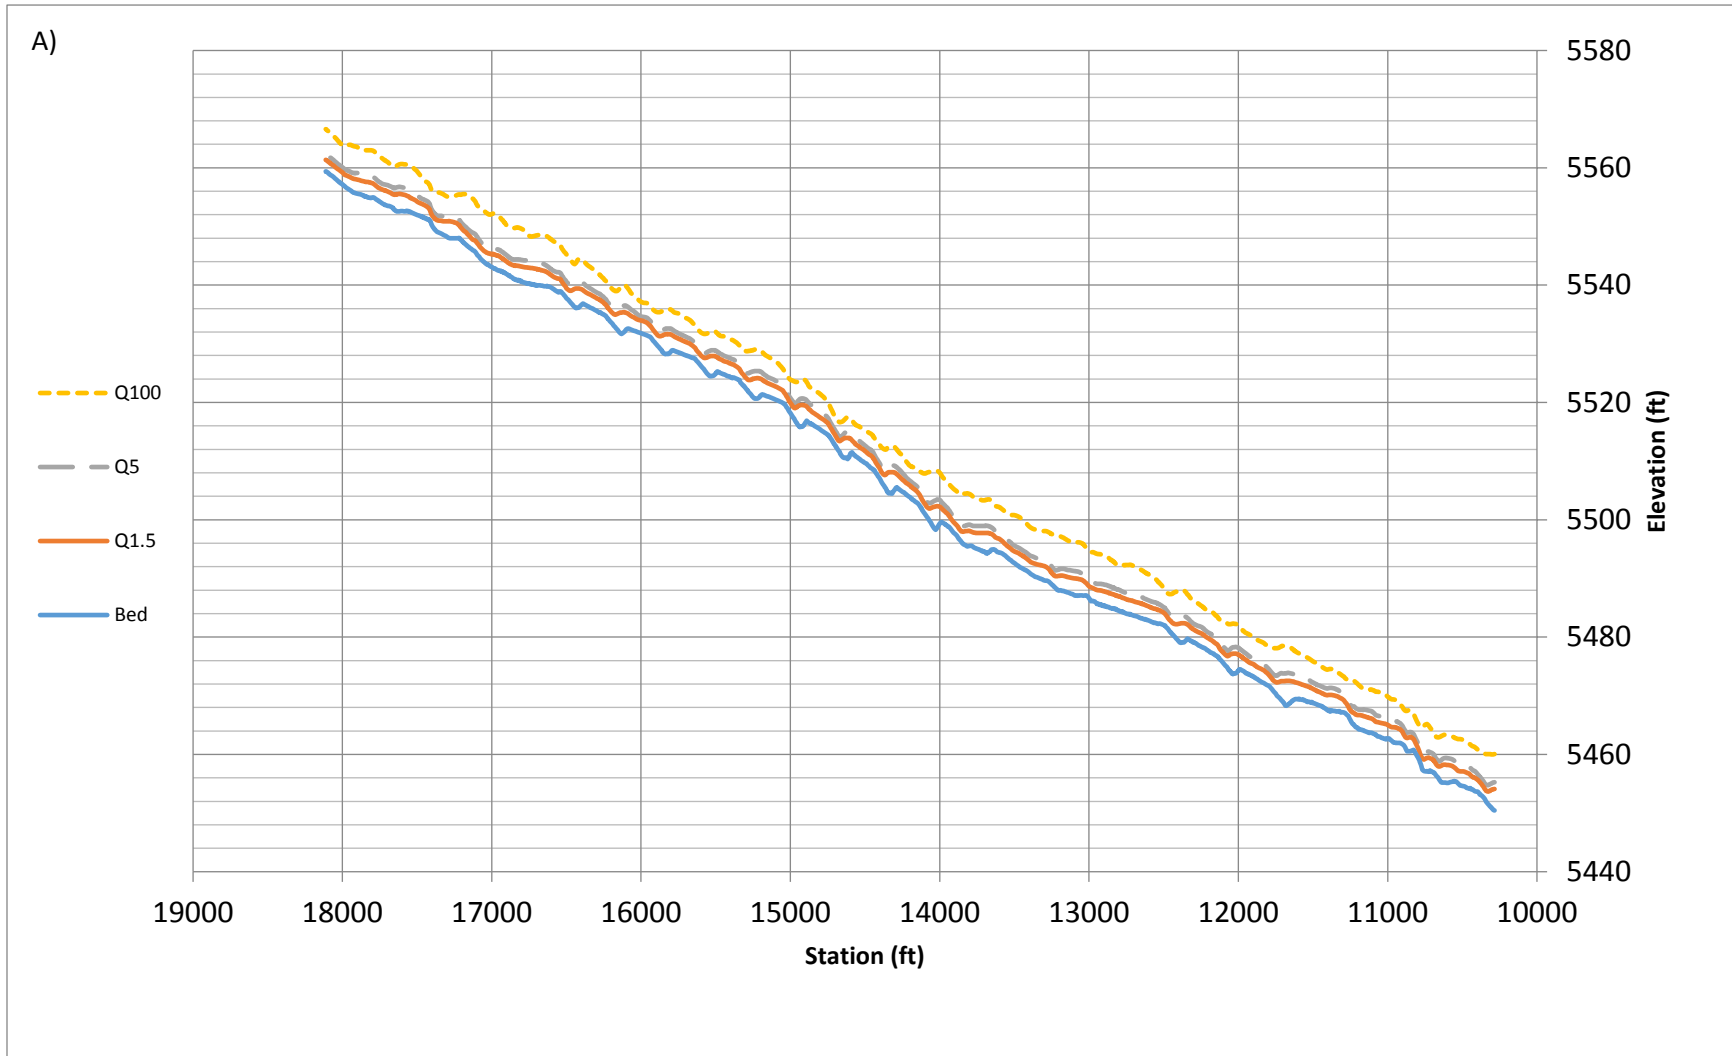
Model results for the proposed conditions were computed for the $Q_{1.5}$, Q_5 , and Q_{100} design discharges for at least 15 hours of simulation to reach a steady state solution for analysis and for comparison to the existing conditions output. The output WSE profiles for each design discharge are shown below in Figure 31 and Figure 32.

Figure 31. WSE profiles of Q1.5, Q5, and Q100 proposed conditions from SRH-2D model for upper sections of model.

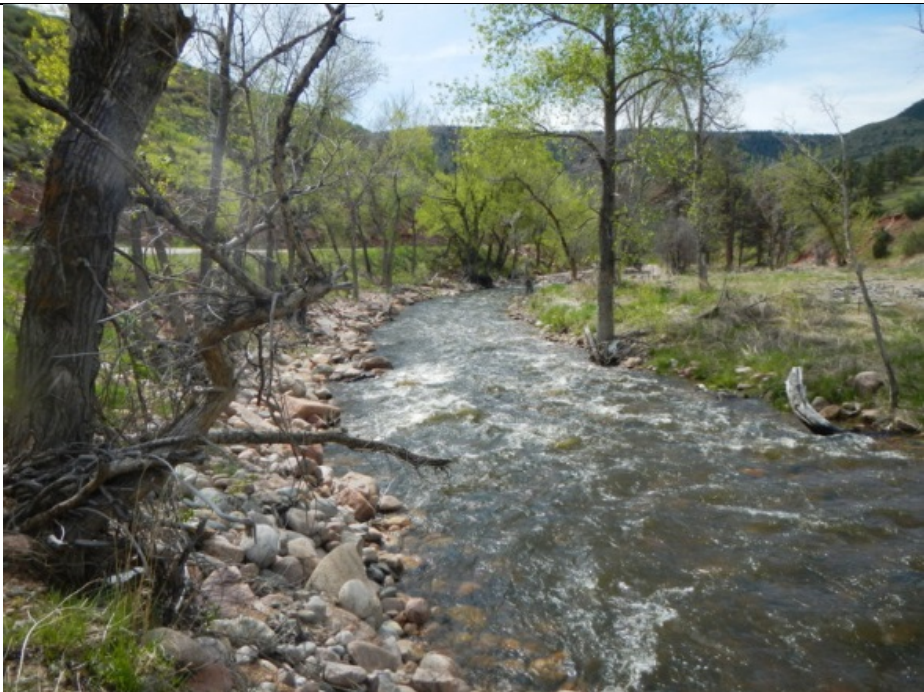
<p>Reach: 8</p>	
<p>RIVER CHARACTERISTICS</p>	
Valley Setting	Confined. Observed confinement ratio of 4

Channel Planform	Channel is generally single thread and straight, but floodplain pockets may contain overflow, secondary, and chute channels.
Bed Morphology	Typical: step-pool, with potential pool-riffle at lower gradient pockets; Large wood is stored in these reaches, providing channel structure, floodplain roughness and jams. Observed: step-pool and plane bed
<p>RIVER BEHAVIOR</p>	
Current Stream Evolution Stage	N/A
Flood Response	Confined areas generally experienced channel degradation and expansion. Floodplain pockets experienced substantial aggradation and loss of established vegetation, with lateral channel migration and avulsions.
Stage Behavior	Low flows are generally single thread, storing sediments in pools and channel margins in confined sections. In the floodplain pocket areas, sediments are stored in bar complexes, along channel margins and in pools. At bankfull flows, pool-riffle sequences and pool structures are flushed of fine sediments. At flood stage, these steep, armored reaches have excess transport capacity for all but the largest sediment (boulders), but the pocket areas are able to store flood energy and debris. Overflow channels activate and chute cutoff channels form in response to vertical accretion in the floodplain.

<p>Confined Valley with Floodplain Pockets (CFP)</p>	
<p>Properties: Generally, found along meander bends in canyon settings, these reaches contain “floodplain pockets” or limited areas of less confinement where sediment may be temporarily stored and where the channel may be more alluvial in nature. Where these reaches share the valley with a road, stream banks are often heavily armored. Because this reach type tends to have a milder slope (observed average slope 1.4%) and has areas with wider valley bottoms than the confined reaches that bracket them, some upstream sediment supply may fall out of transport here aiding in channel avulsion and braiding during floods, resulting in these styles being more geomorphically sensitive and potentially hazardous. Substrate in these reaches ranges from gravel to small boulder.</p>

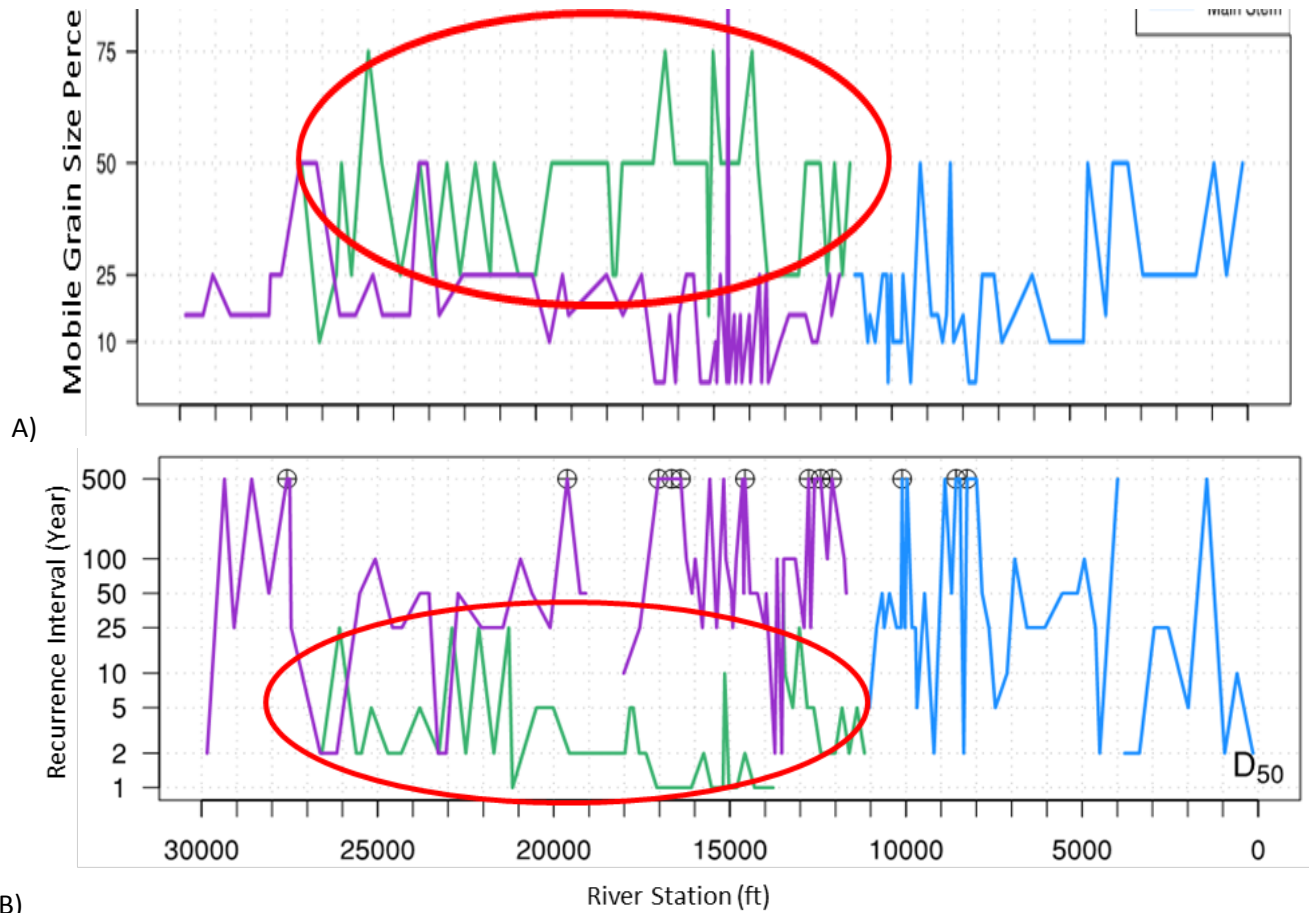
Figure 38. Bed mobility, reproduced from Otak, 2016. South St. Vrain Creek is represented by the green line.

As discussed in Otak (2016), bed mobility was calculated for all reaches of South St. Vrain Creek from the canyon mouth to the Town of Lyons. Bed mobility refers to the ability of a given flow rate and associated shear stress to mobilize sediment. Results show that reaches in South St. Vrain Creek are more readily mobilized. Figure 38 shows that through the South St. Vrain (green line, circled in red), mobile grain sizes are relatively larger than the North St. Vrain and main stem (A) and are mobilized by more frequent flows (B). This behavior is largely a response to the relatively steeper slopes finer bed observed in the South St. Vrain. This also suggests that South St. Vrain Creek is likely to undergo further adjustment.

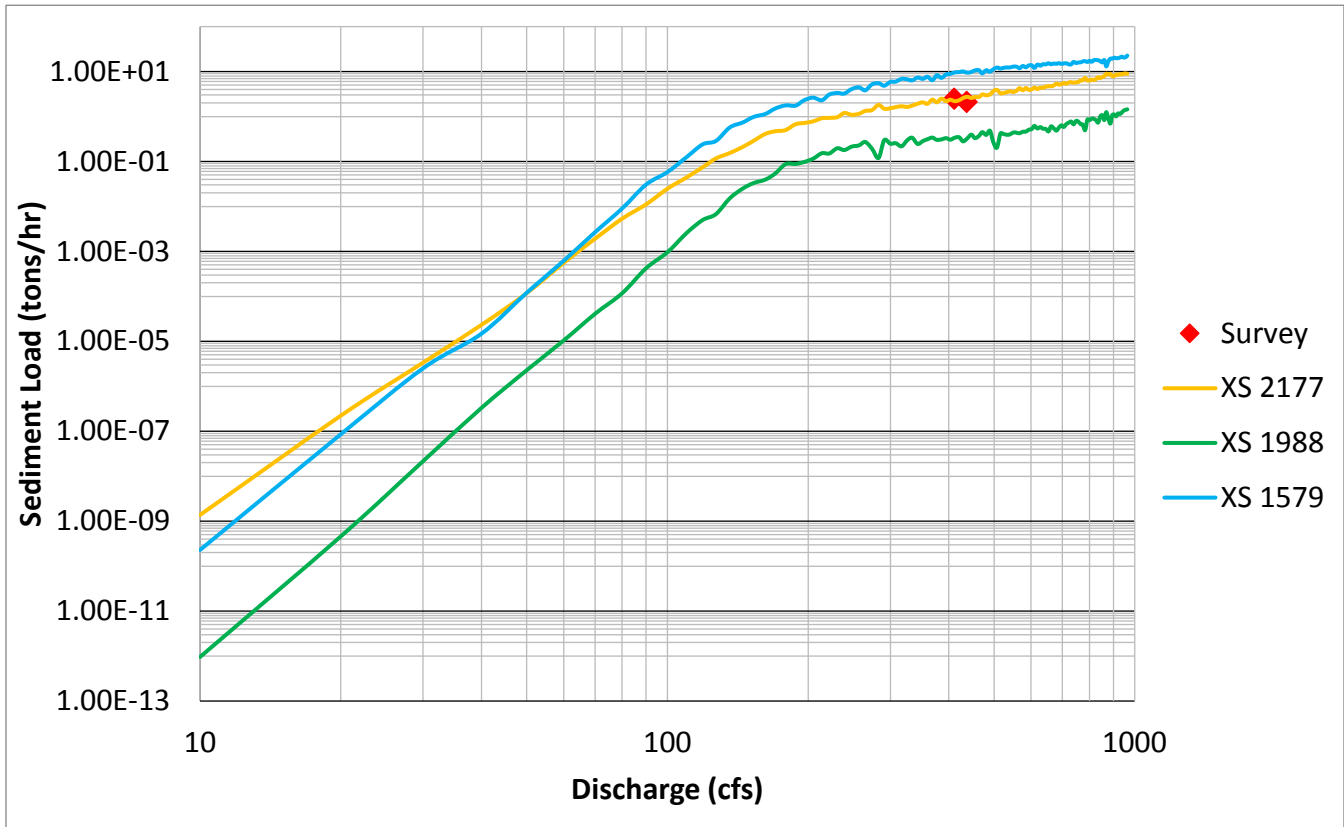
Figure 39. Sediment rating curves for three cross sections of existing conditions and field measurements of sediment transport rates.

The orange line in Figure 39 is the cross section closest to the Old St. Vrain Road Bridge on the downstream side. The field measurements were sampled off of the bridge and align well with the predicted transport from the hydraulic model for this cross section. This result seems to support the validity of the transport and hydraulic models, but this comparison is recognized only to be a snapshot representation of the sediment transport at one particular flow, in a stream undergoing significant adjustment to a large disturbance event.

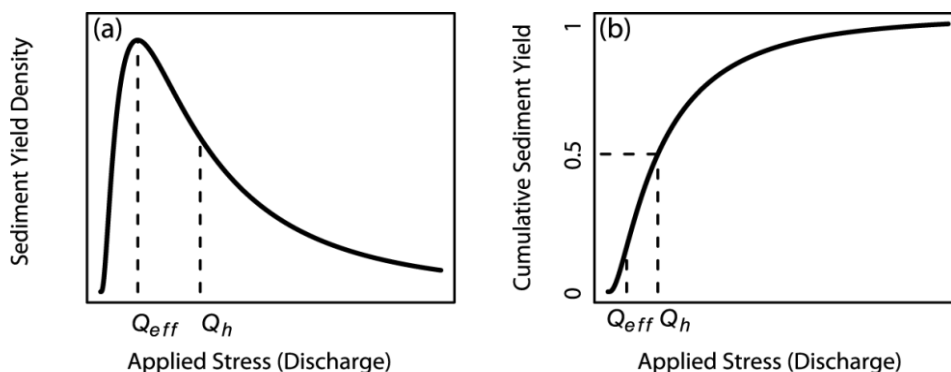
Figure 40. a) Conceptual diagram of sediment yield effectiveness curve used to calculate the effective discharge. (b) Cumulative sediment yield curve used to calculate the half-yield discharge (Otak, 2016)

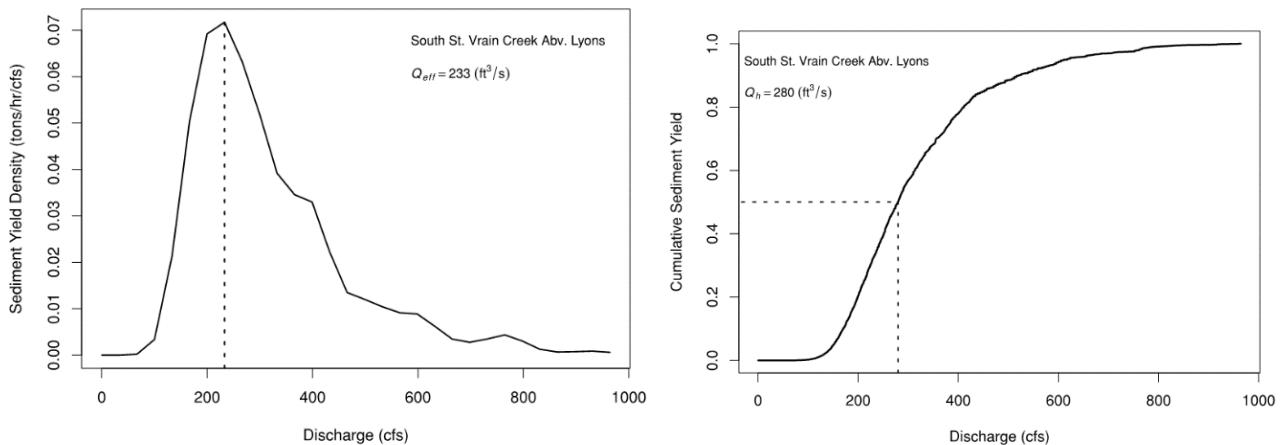
Figure 41. Effective discharge and cumulative sediment yield curves for South St. Vrain Creeks.

Resulting values of Q_{eff} and Q_h on South St. Vrain Creek are similar in magnitude to each other at approximately 230 and 280 cfs, respectively (Figure 41). These values approximate the 1-year recurrence interval flood. Both Q_{eff} and Q_h are most influenced by flow variability, bed material grain size, and channel geometry. All things being equal, Q_{eff} and Q_h decrease with decreasing grain size and increasing channel entrenchment (Sholtes et al., 2014). For this study, Q_{eff} and Q_h were calculated based on post-flood channel geometry and bed material, both of which are likely still adjusting to this disturbance. In general, the flood created larger and deeper channels and brought in finer sediment from upstream bank erosion and hillslope failure. This may have resulted in producing estimates of Q_{eff} and Q_h that are smaller than their pre-flood values. This is likely the case for the South St. Vrain, which exhibits finer sediment and the most geomorphic change relative to St. Vrain and North St. Vrain Creeks.

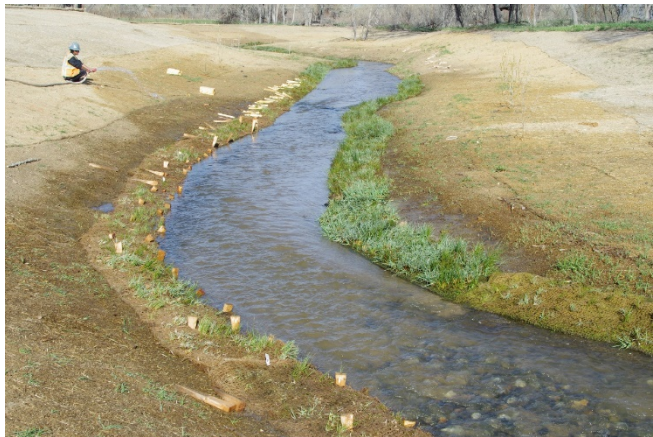
Figure 44. Wetland/Riparian Sod during installation: May 2016

Wetland Sod and Riparian Sod: The Design Team will use wetland sod and riparian sod as part of this project. Wetland and riparian sods are made from native plant material grown from local seed in coconut fiber blankets and installed along the creek channel for immediate revegetation. Seed will be harvested from within the project site and grown specifically for this project by a reputable supplier. That will provide an eco-type planting that will have immediate growth and be naturally adapted to this area.

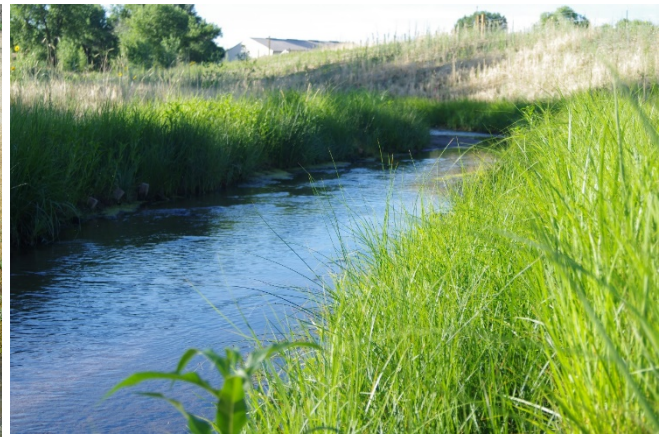
Figure 45. Wetland/Riparian Sod: July 2016

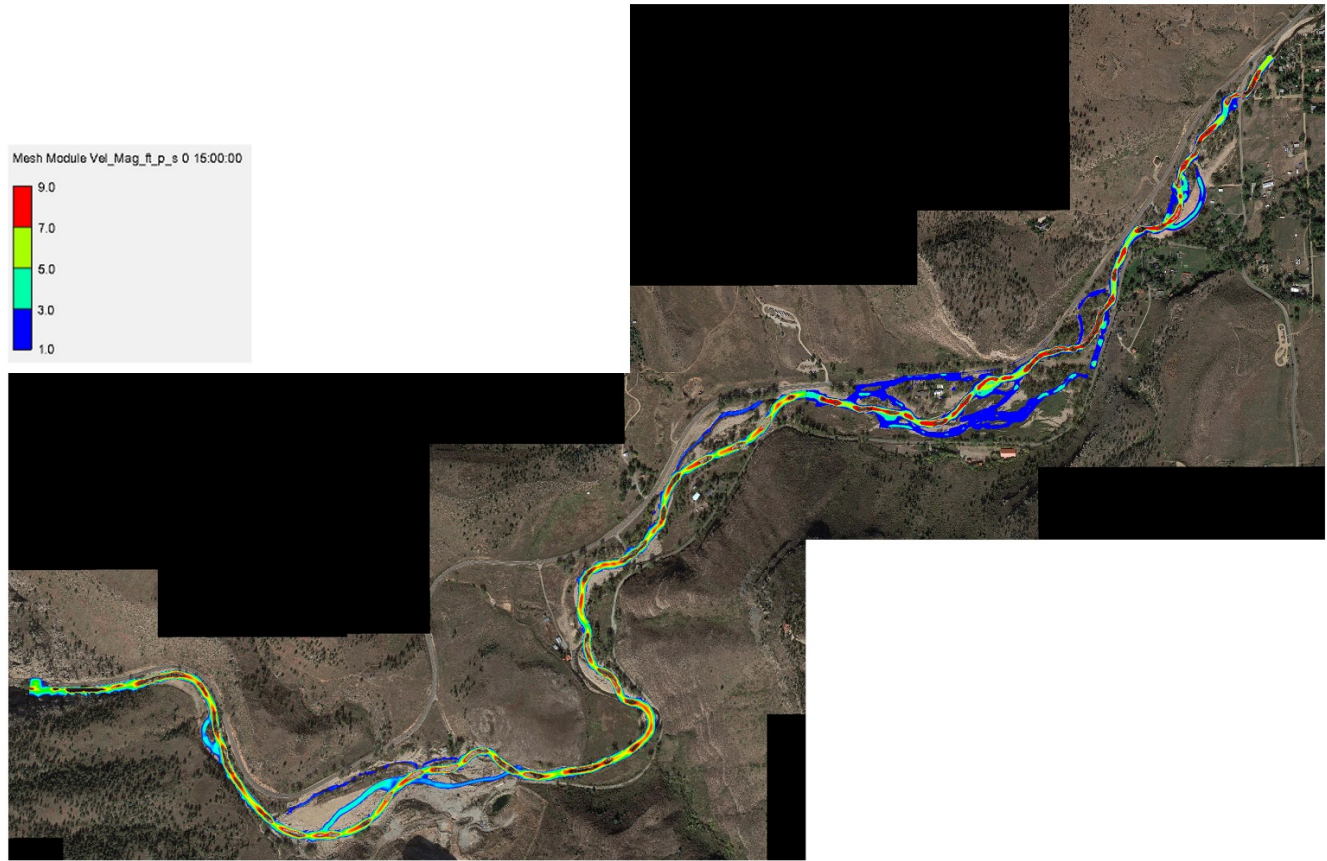
Figure 48. 5-year Peak Discharge Velocities

The Design Team used these design criteria to evaluate the permissible velocities of bioengineering treatments and created a map showing the velocities of the proposed condition during a 5-year peak discharge. This map was then analyzed and used to apply bioengineering treatments in locations that would withstand the “initial” velocities during the 5-year event. See Figure 48 5-year Peak Discharge Velocities.

The velocity map shows creek flows between 1-9+ feet per second (ft/s) at the 5-year peak discharge. Specific locations where velocities were higher and/or infrastructure needed to be protected were selected to receive bioengineering treatments that would resist initial velocities greater than or equal to the 5-year peak discharge ensuring increased protection of vital assets. The bioengineering treatments used are identified per area in Table 17. Bank Stabilization: Bioengineering Treatments.
