FOURMILE EMERGENCY STABILIZATION BURNED AREA REPORT

PART II - BURNED-AREA DESCRIPTION

A. Fire Name: Fourmile Canyon Fire

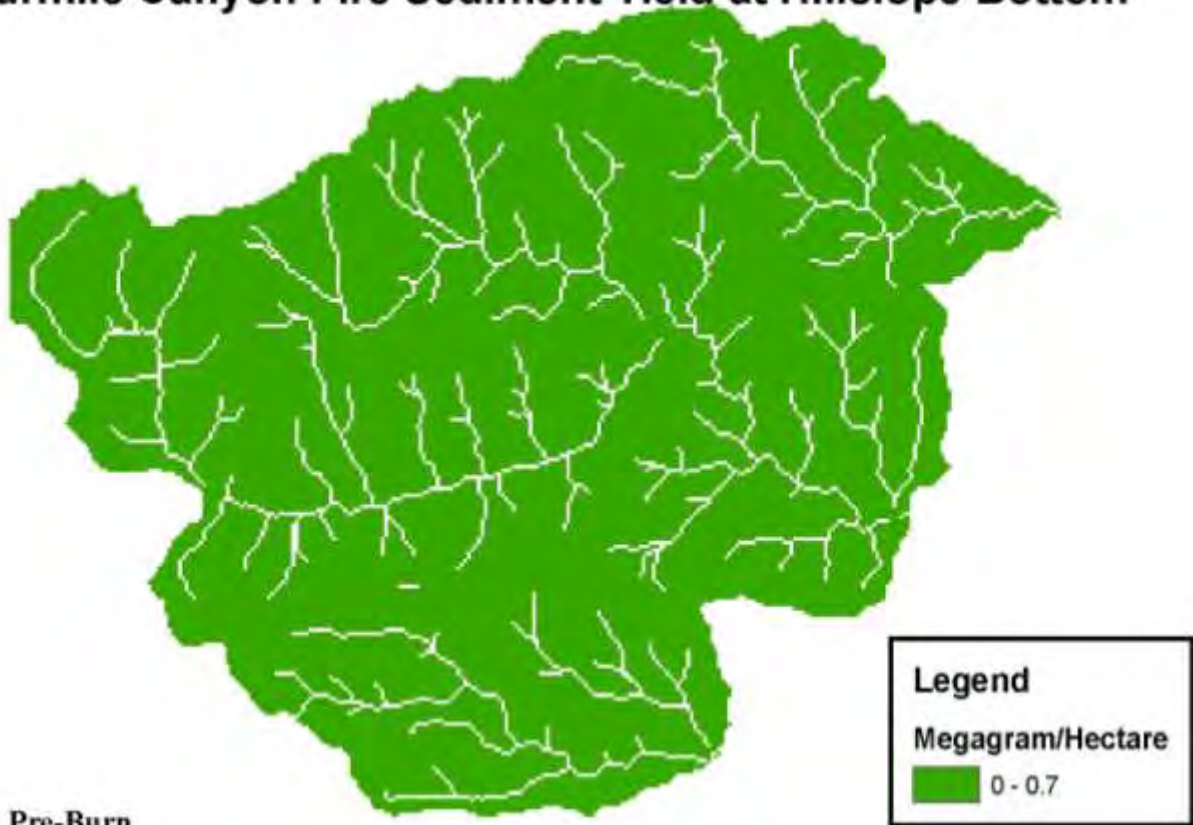
Figure #1 Pre-Burn

Fourmile Canyon Fire Sediment Yield at Hillslope Bottom

C. Soil Erosion: Overall, pre-burn conditions (Figure #1) had a sediment yield at the bottom of hillslopes in the range of 0-.7 Megagrams/Hectare (0 to 0.3 tons/acre). Post-burn sediment yields increased up to 14 Megagrams/Hectare (6 tons/acre) (Figure#2).
