OPERATION, INSPECTION, & MAINTENANCE PLAN FOR ST. VRAIN CREEK REACH 3 RESTORATION

Operation, Inspection, & Maintenance Plan For St. Vrain Creek Reach 3 Restoration

Boulder County

Project No. 110666

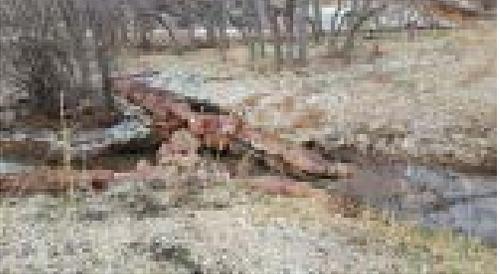
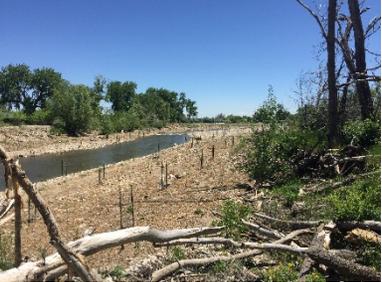
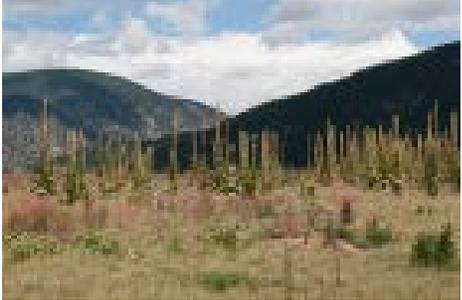
<p>Structure backfill is washing out. Backfill behind an in-channel or bank stabilizing structure will compromise the stabilizing function of the installed structure.</p>	<p>Boulders for an in-channel or bank stabilizing structure become dislodged or displaced. Displaced or failed portions of the structure could cause damage to the entire project reach.</p>	<p>Invasive species take over the disturbed area, outcompeting the native seeding, cuttings, and container plants that were installed at time of construction.</p>

<p>A property owner scavenges boulders from the in-channel structures for yard landscaping. All placed and installed features must remain intact throughout the duration of the O&M agreement.</p>	<p>Seeding and container plants do not survive due to circumstances outside the sponsor's control, for example extreme drought, fire, and/or high flows wash material away. Replacement of plant material that does not survive is highly recommended. Consult with an ecologist prior to replacement to confirm failure mechanism, timing, and planting strategies.</p>	<p>The river has compromised the function of the bioengineering or riprap.</p>

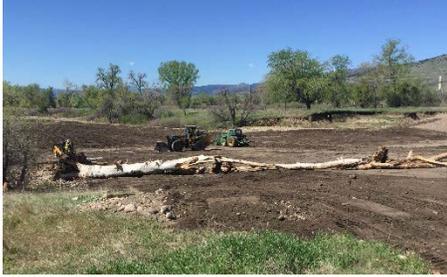
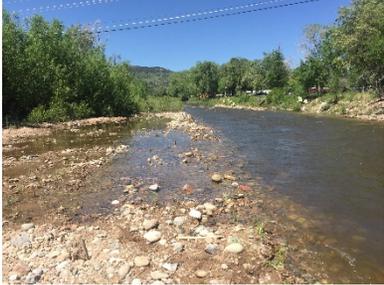
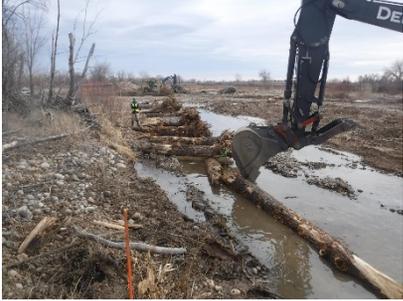
<p>Sediment and wood debris are deposited on a floodplain bench. Benches are designed to capture and hold these materials.</p>	<p>Bankfull channel dimension changes and/or minor bank erosion occurs. Minor lateral migration of the bankfull channel is expected as stream channels adjust and natural stream processes occur. Adjustments that do not compromise the project goals do not warrant intervention.</p>	<p>A significant flood event occurs beyond the projects design parameters and undermines or causes failure of installed structures.</p>
