MEETING OF THE HISTORIC PRESERVATION ADVISORY BOARD BOULDER COUNTY, COLORADO

THURSDAY, JULY 2, 2020 AT 6:00 P.M.

BOULDER COUNTY HISTORIC PRESERVATION ADVISORY BOARD

MINUTES March 5, 2020 6:00 PM

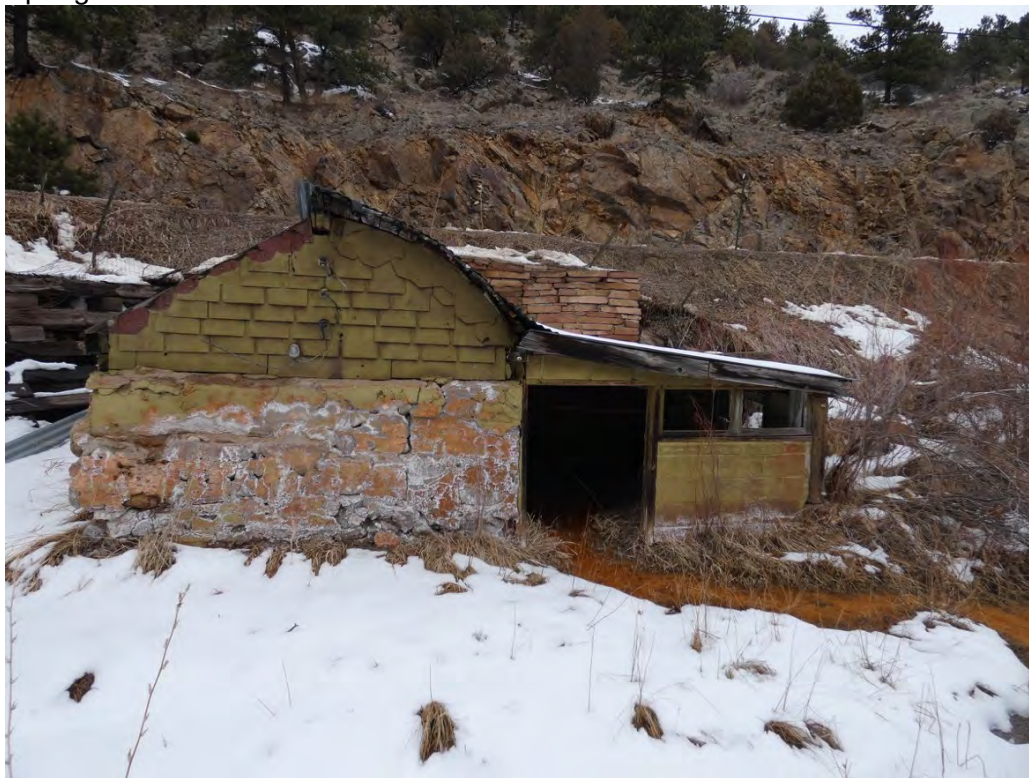
Springhouse – South elevation

The springhouse is located closely along the south side of James Canyon Drive. The structure is a small, rectangular building with no foundation, stone siding, and a metal roof. The west half of the structure has a barrel roof with asphalt shingle siding on the upper half of the south wall and native stone for the siding. The east half of the structure has a shed style roof with cinder block siding. The entry is located on the south elevation (door is missing), along with two window openings to the right of the entrance.

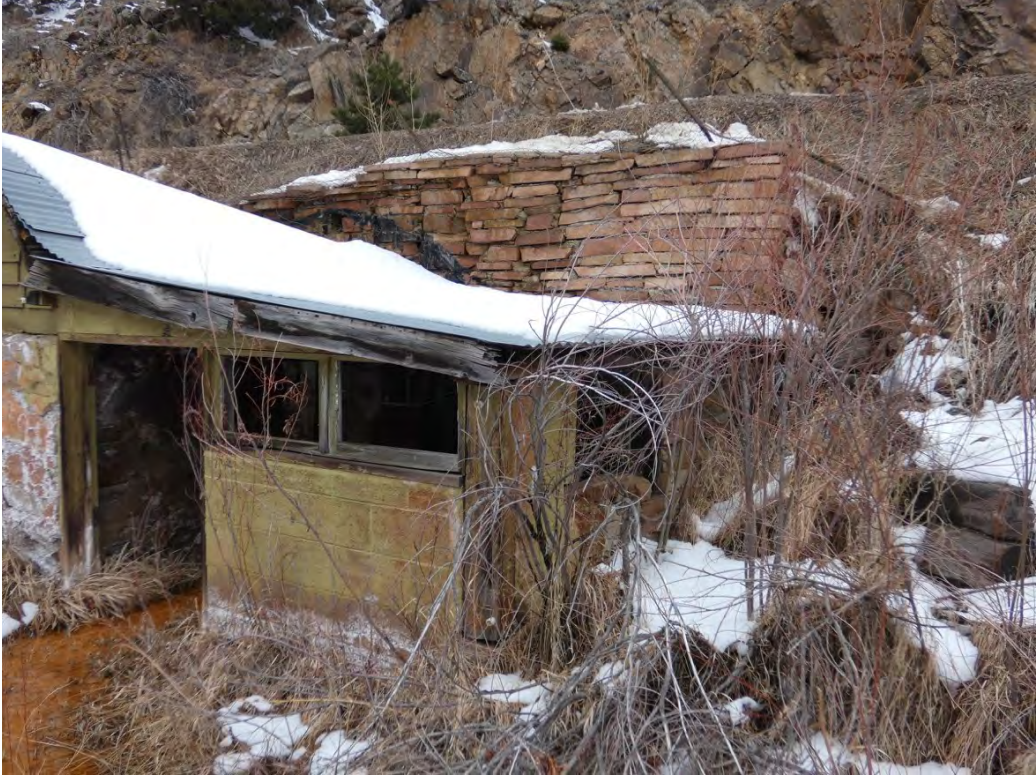
Springhouse – South and east elevations

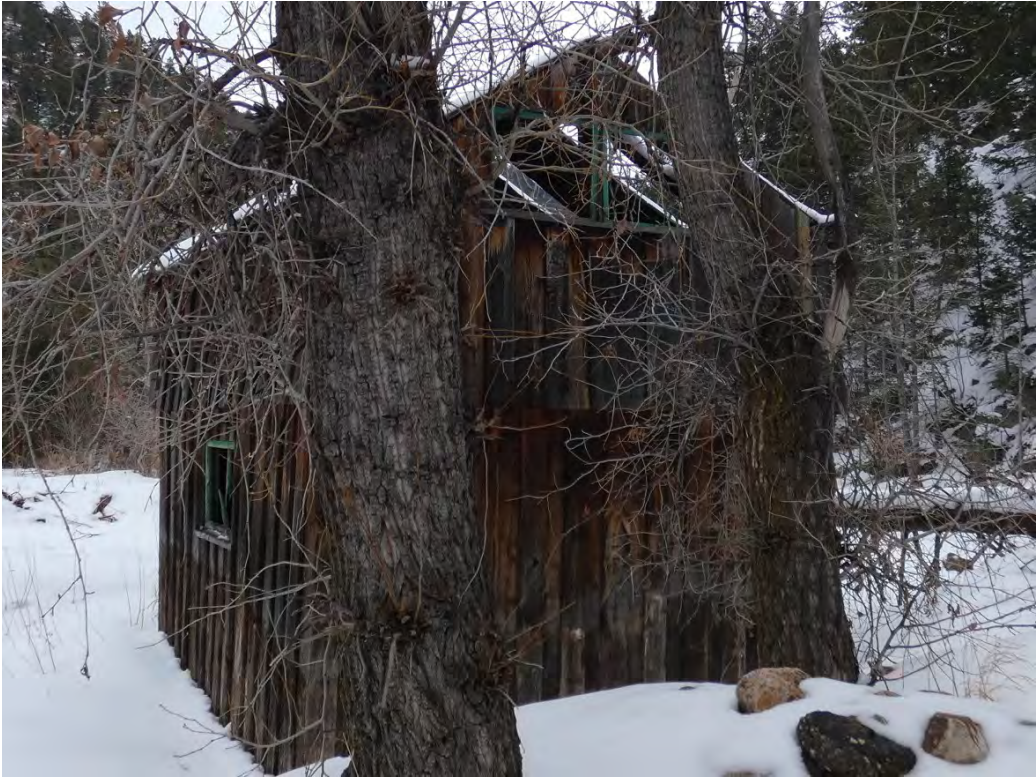
Barn – West elevation

Sitting to the south of the springhouse, the single-unit barn is a wood structure with a pole-frame design. The barn faces east, has a gable roof, asphalt roll roofing, and appears to have no foundation. The barn has two levels, and the second level is visually noticeable on the exterior by an outward tilt in the board-and-batten siding. The entrance is marked on the east elevation by a single opening. A side-hinged door was likely hung here at one time, but no longer exists. Above is a small side-hinged hay loft door, which helps to suggest what the original door that hung below might've looked like. To the right of the entrance is a 4-light wood frame awning window (hinged at top). The north and south elevations both have a 6-light wood frame awning window. The west elevation has two side-by-side 4-light wood frame windows centered on the gable front. All windows are painted green, but nearly all glass panes are broken or missing.

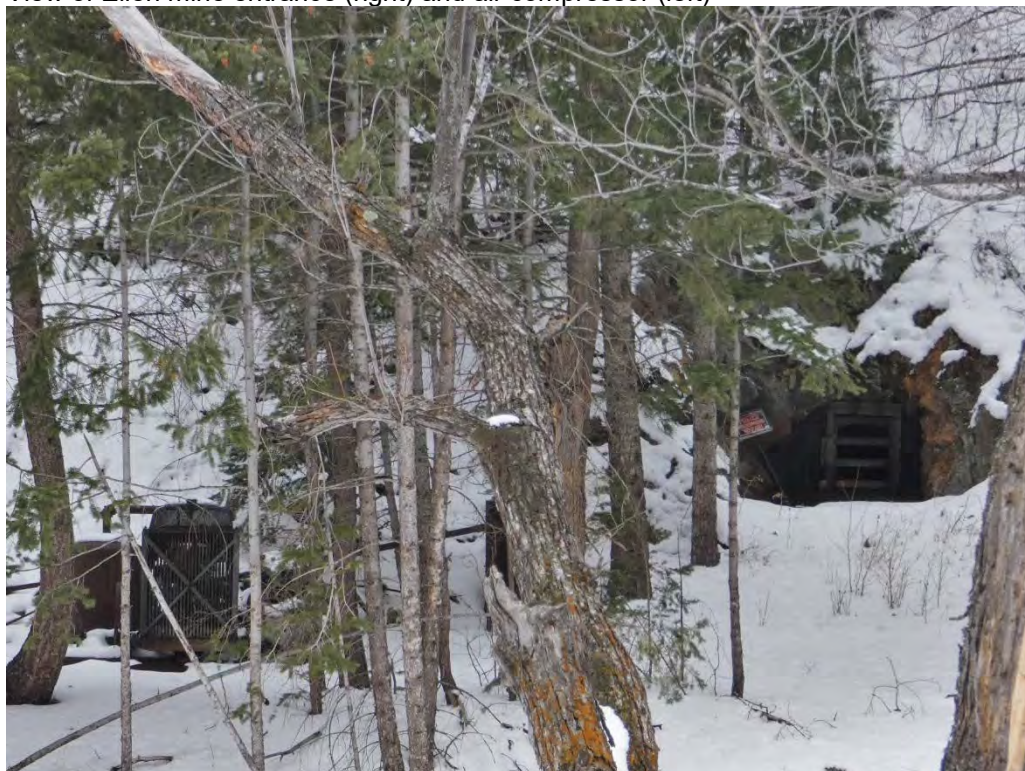
View of Ellen mine entrance (right) and air compressor (left)

The original Seltzer House hotel was built on the property to the west of the springhouse and barn in 1875 but burned in 1903. Remains of the hotel's stone foundation can still be seen. The several buildings associated with the hotel (bowling alley, cottages, stable, etc.) were situated nearby, but all were destroyed either by the 1894 flood or the 1903 fire. Towards the southwest corner of the property is a dynamite tunnel and air compressor that were part of the Ellen mine operation. A wood-frame "mine shack" that probably dated to the 1910s or earlier originally sheltered the compressor and possibly additional machinery. The shack was still around in 1965 but is no longer in existence, leaving the compressor exposed to the elements.

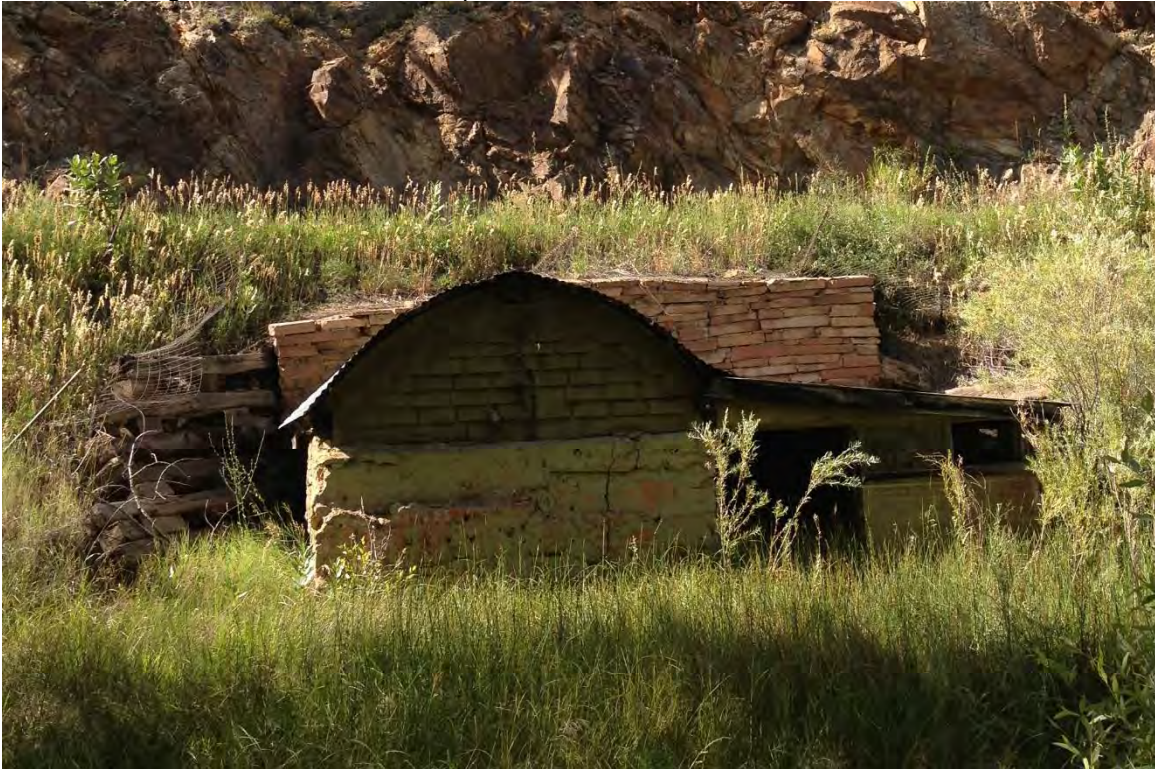
Photo of springhouse from Eric Harms prior to 2013 flood.

Due to deterioration and damage caused by the 2013 flood, the springhouse has lost a degree of its design, materials, and workmanship, but still retains a high degree of location, setting, feeling. The barn and bathroom facility, both of which are nearly fully intact, help to improve association, location, and setting, since both structures were present during the Freel's ownership.

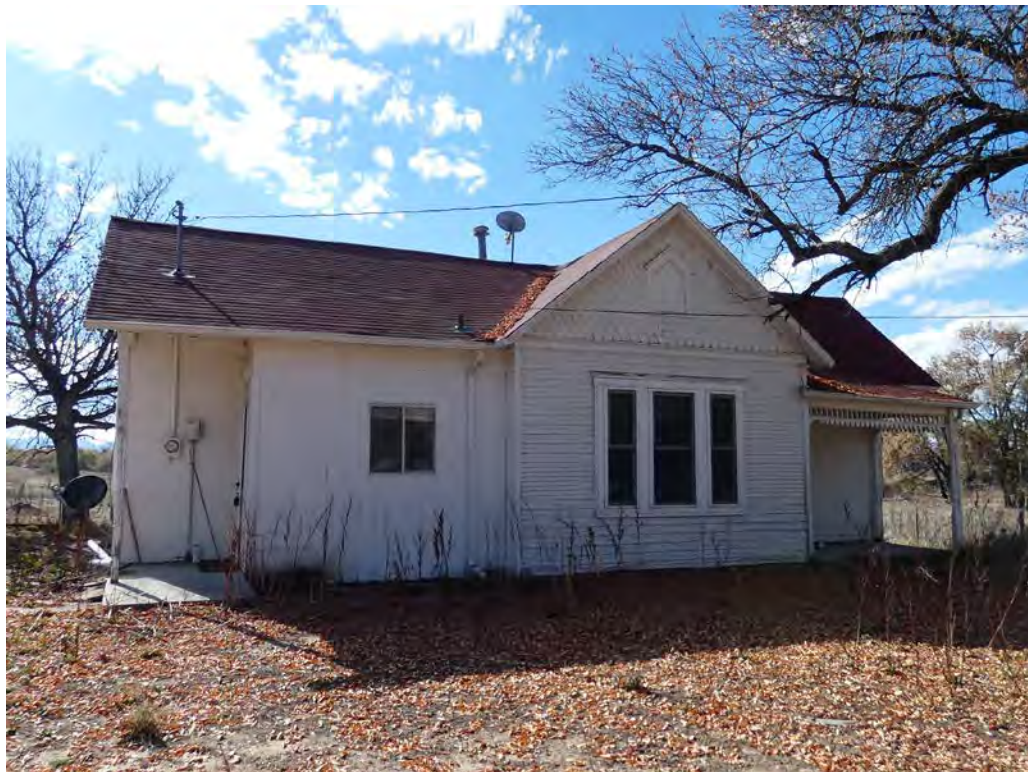
East Elevation

The house sits near the eastern edge of the property facing a driveway that connects with Empire Road to the northwest of the house. The Quenn Anne vernacular residence has asymmetrical massing, a cross-gabled roof, bay window, spindle work detailing on the front porch, clapboard siding, and decorative fish scale shingles on the gable fronts. All original windows have been replaced with vinyl frame windows.

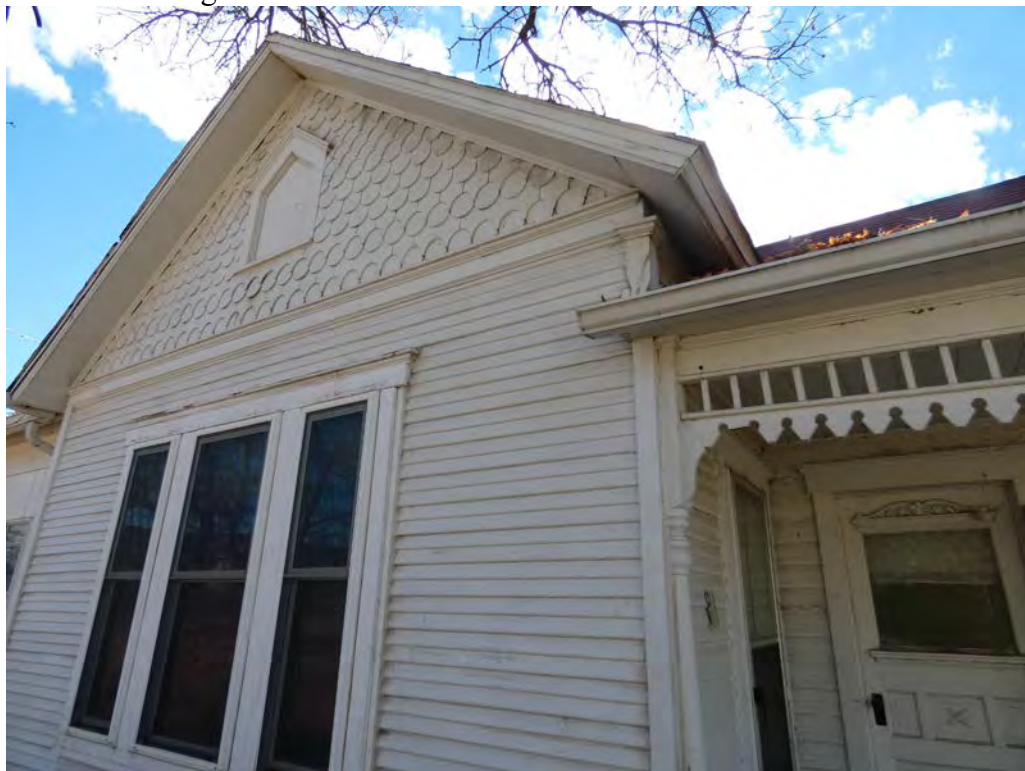
Resource Number: 5BL 13888
Temporary Resource Number:
East Elevation gable front detail

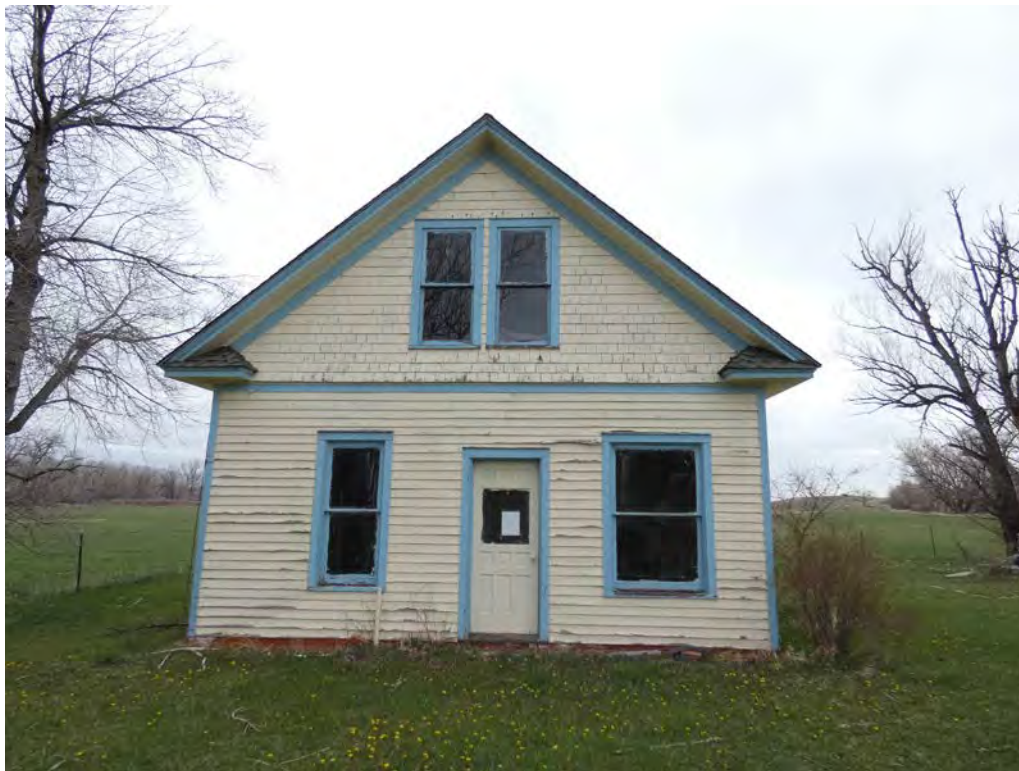
Farmhouse – South Elevation

The farmhouse sits to the west of the raised-ranch house, across the Marshallville Ditch. It is a two-story gable-front building designed in the National Folk style with modest detailing. It has clapboard siding with coursed shingle gable fronts and sits on a brick foundation. An addition off the north elevation sits on a concrete foundation and has drop siding. The south elevation (façade) features the main entry and a single hung window on either side, with the window to the right slightly wider than the

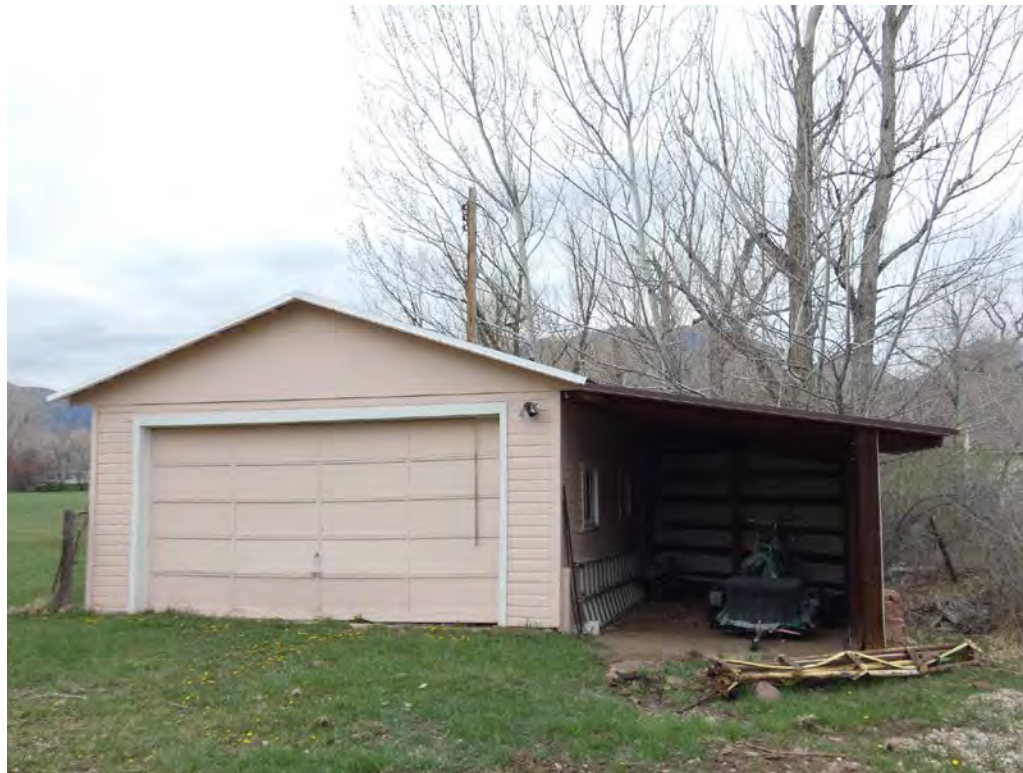
Garage – East Elevation

A two-car garage borders the east side of the Marshallville ditch and faces east. It has frame walls, a concrete foundation, a gable front roof, clapboard siding, and a carport with a shed roof attached to the north side. On the east elevation is a sectional roll-up door. Two 3-over-2 light windows are on the north elevation. The carport, extending off the north elevation, is enclosed with metal siding on north and west sides and remains open to the east. No windows are on the west elevation, and two 3-over-2 light windows are on the south elevation. The roof overhang and rafters are visible on the south elevation.

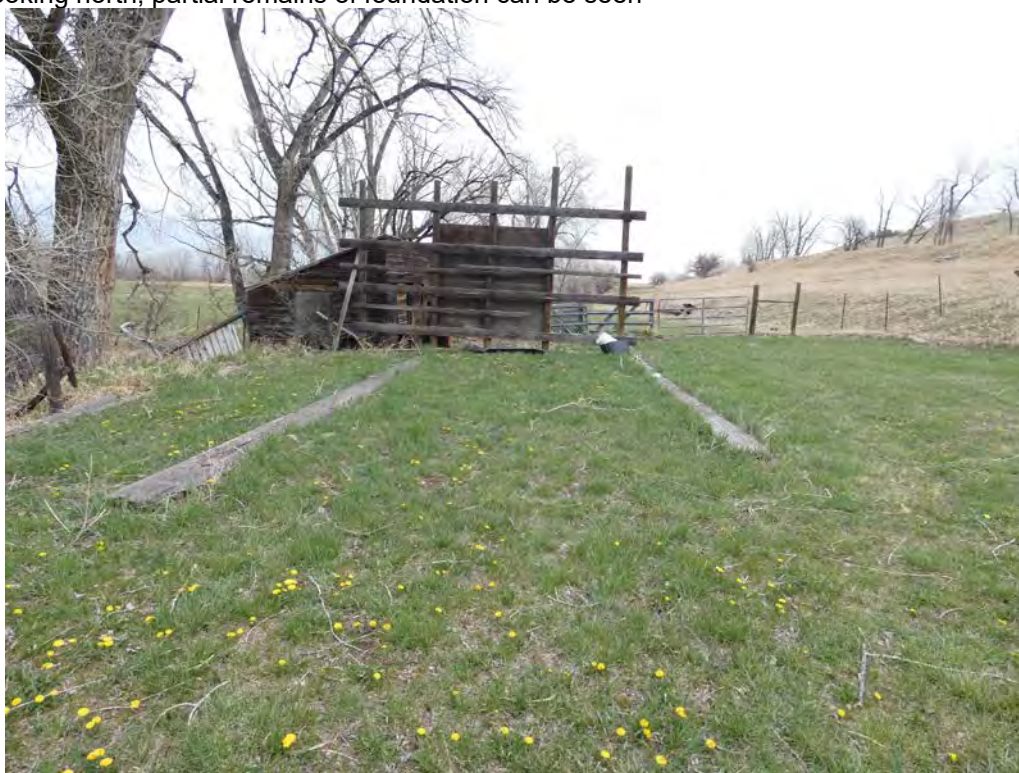
Stable – View looking north, partial remains of foundation can be seen

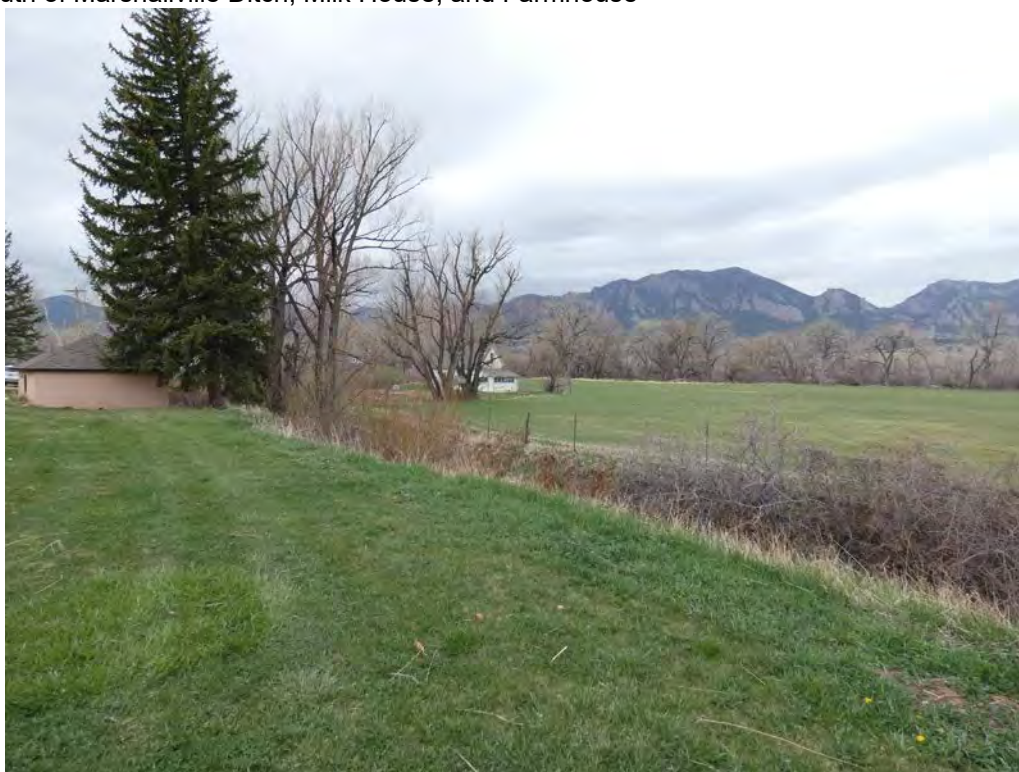
View looking south of Marshallville Ditch, Milk House, and Farmhouse

The spring house and milk house may be near the same age as the farmhouse. Springhouses were a common farm outbuilding typically built near or on top of a running stream (in this case, the Marshallville Ditch), it provided a cool place to store goods and provide fresh water. A barn, c. 1890, used to be situated to the north next to the stable. The milk house sat nearby the barn, providing a cool place to store milk products. Partial remains of the barn foundation can still be seen. It was torn down around 1957 as it had severely deteriorated. The stables that adjoined the old barn to the north still remain, but are in poor condition.
